Characterization of intergranular corrosion defects in a 2024 T351 aluminium alloy

Marie-Laëtitia De Bonfils-Lahovary, Lydia Laffont, Christine Blanc

Marie-Laëtitia De Bonfils-Lahovary, Lydia Laffont, Christine Blanc. Characterization of intergranular corrosion defects in a 2024 T351 aluminium alloy. *Corrosion Science*, 2017, 119, pp.60-67. 10.1016/j.corsci.2017.02.020 . hal-02497140

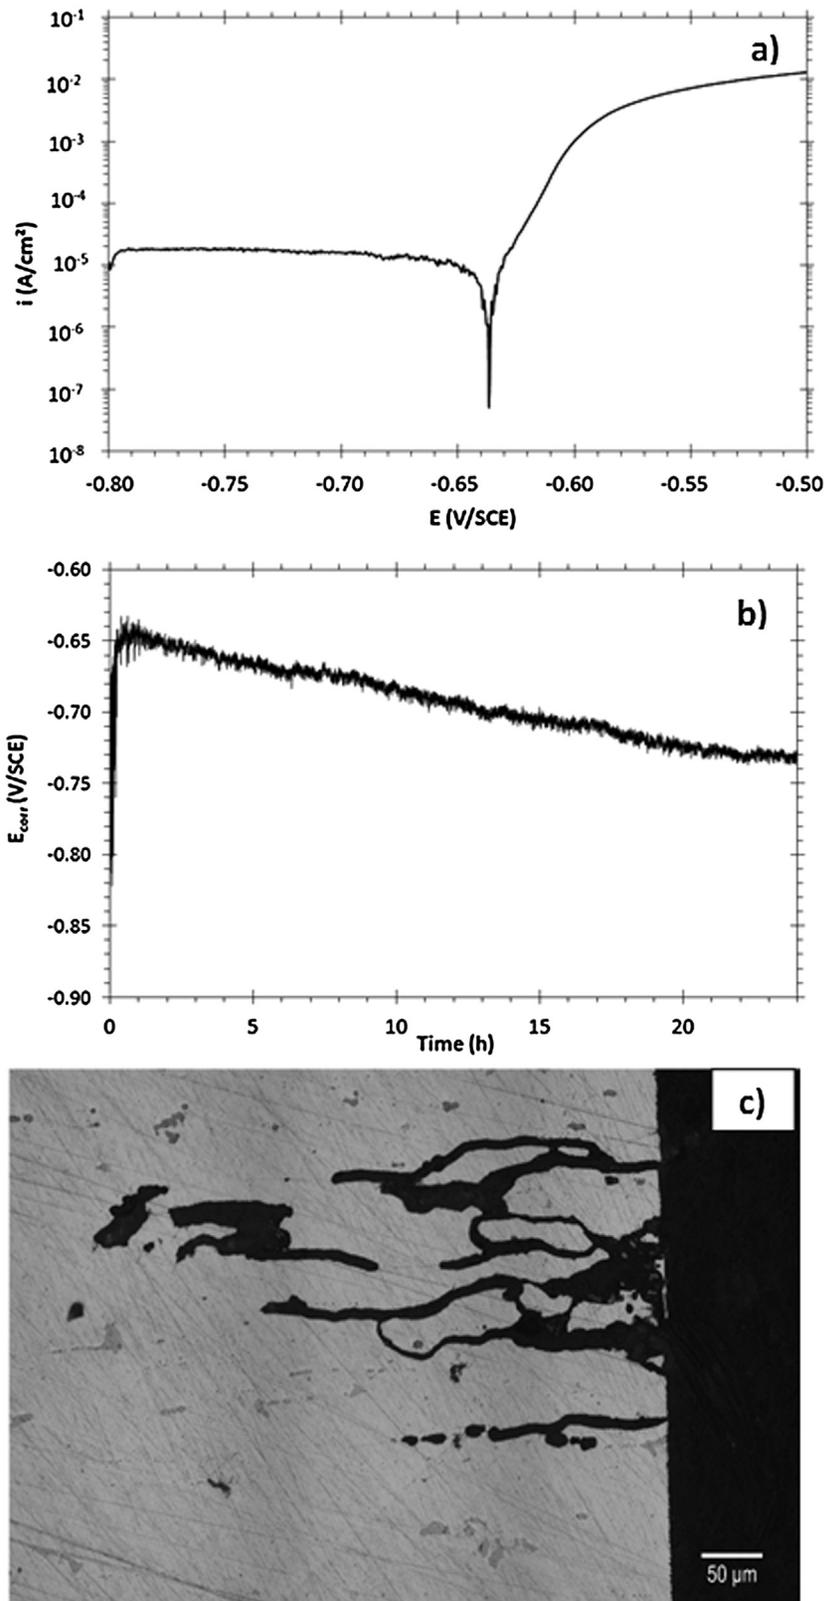
Fig. 1. a) Polarization curve of the AA2024 sample in a 1 M NaCl solution, b) E_{corr} versus the exposure time to 1 M NaCl solution, c) Optical micrograph of intergranular corrosion defects formed after a 24 h exposure at E_{corr} in a 1 M NaCl solution.

Fig. 1 shows a polarization curve (Fig. 1a) plotted for the AA2024 sample in 1 M NaCl solution: a sharp increase of the anodic current densities after the corrosion potential (E_{corr}) confirmed that the alloy was susceptible to localized corrosion at E_{corr} in such an electrolyte. OM observations (not shown here) of the samples after the polarization test showed both pitting and intergranular corrosion. Therefore, we chose in this study to develop intergranular corrosion defects by performing continuous immersion tests at E_{corr} . Fig. 1b shows E_{corr} versus the exposure time to 1 M NaCl solution: a continuous decrease of E_{corr} was observed in agreement with the propagation of corrosion defects. Fig. 1c shows, as an example, intergranular defects grown after a 24 h exposure at E_{corr} in 1 M NaCl. TEM observations of these intergranular corrosion defects were performed for 3 FIB samples. Depending on the sample, several intergranular corrosion defects were present and characterized. Given that the general features observed were similar for all samples, we present here only results for one intergranular corrosion defect, for brevity. Fig. 2 shows a photomontage of TEM images of an intergranular corrosion defect of an AA2024-T351 sample exposed to a 1 M NaCl solution during 24 h and removed by using a FIB/SEM.

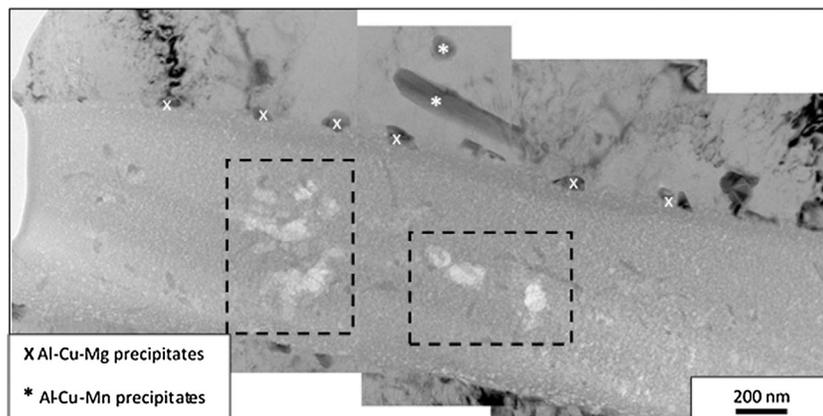
Fig. 2. Photomontage of Bright Field (BF) TEM images showing an intergranular corrosion defect in an AA2024-T351 after a 24 h immersion in a 1 M NaCl solution.

The defect is approximately 1 μm wide and decorated by a chain of precipitates. EDX analyses allow to identify two types of precipitates: Al-Cu-Mg (80% Al – 17% Cu – 3% Mg, at.%) and Al-Cu-Mn (75% Al – 14% Cu – 11% Mn, at.%). The presence of such precipitates was in agreement with literature data concerning the metallurgy of 2XXX alloys and the intergranular corrosion mechanism which attributes the susceptibility to intergranular corrosion of 2xxx alloys to the decoration of their grain boundary network with precipitates such as S phases (Al₂CuMg) or θ phases (Al₂Cu) [3–6]. Usually, the intergranular corrosion initiation is explained by a galvanic coupling between S and θ Cu-rich phases decorating the grain boundaries and the adjacent matrix.

Observations also showed that the intergranular corrosion defect was completely filled with corrosion products which most probably corresponded to alumina. In addition, white flaws were observed inside the intergranular corrosion defect (black dashed squares in Fig. 2). They could be compared to those observed by Thompson et al. in their studies about anodization of Al-Cu model alloys, the authors describing the flaws as the results of an oxidation of Cu-rich impurities [23–26,38,39]. According to these authors, when an Al-Cu model alloy was anodized, Al was first oxidized due to the less negative Gibbs free energy per equivalent for the formation of copper oxide compared with that of alumina. This led to the formation of a few nanometers thick Cu-enriched layer at the interface alumina/model alloy inside the alloy. Inside this thin layer, Cu-rich precipitates, namely θ' phases, were formed, their size depending on the interfacial coherency between the alu-

minium matrix and the Cu-rich layer [24]. Oxygen gas bubbles generated by the oxidation of Cu from these precipitates led to the formation of flaws inside the oxide film, similar to those observed in this study (black dashed squares in Fig. 2) [32]. The presence

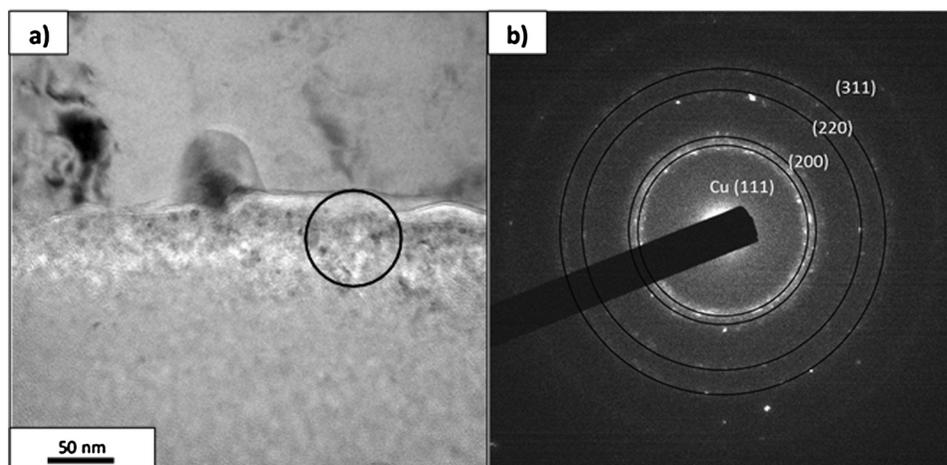
Fig. 3. a) BF TEM image showing a Cu-rich layer at the matrix-oxide interface inside the intergranular corrosion defect for an AA2024-T351 sample after a 24 h continuous immersion in a 1 M NaCl solution at room temperature. The black circle shows the area selected for the SAED pattern obtained in b).

alloy. In particular, the result suggested that, during the corrosion phenomena, a thin Cu-layer might be formed at the interface alumina, i.e. corrosion products inside the intergranular corrosion defect/alloy. Additional TEM observations showed a thin layer composed of nanoparticles of different contrast at the interface between the alloy and the oxide inside the intergranular corrosion defect, as shown in Fig. 3a: it was about 50 nm thick. Furthermore, in Fig. 3b, a SAED pattern characteristic of this layer showed diffraction circles representative of metallic nanoparticles of Cu (Fm-3m, $a = 3615 \text{ \AA}$) showing that this layer was enriched in metallic Cu species.

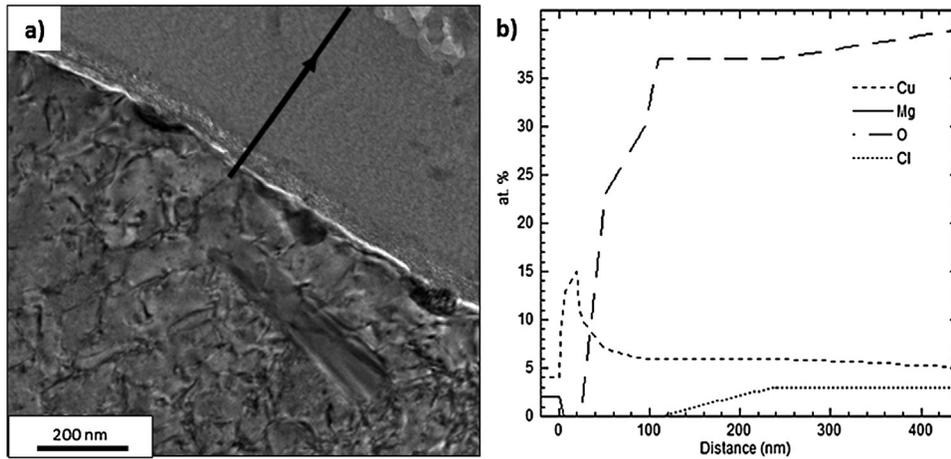
Fig. 4. LAADF STEM image (a) and EDX line profile (b) of the interface alloy/intergranular corrosion defect.

Further analyses were performed to complete these results and an EDX line profile was plotted perpendicularly to the alloy/oxide interface as it is shown in Fig. 4a. Fig. 4b shows the corresponding EDX profile obtained: for this analysis, the Mg signal was helpful to locate the alloy part while the oxygen signal allowed to identify the alumina film. The presence of a Cu-rich layer at the interface between the alloy and the oxide was clearly visible (Fig. 3b). In the first nanometers of the profile, the alloy composition was measured (4 at.% Cu and 2 at.% Mg); then, a Cu peak was observed with Cu content reaching a value of about 15 at.%. The Cu content rapidly decreased inside the alumina film but remained equal to 6–7 at.%. The presence of Cu species inside the alumina film was in agreement with the literature even though the Cu content was lower than that found for Al-Cu model alloys (approximately 40%) [17,21–25,30]. According to Thompson et al., the incorporation of Cu species inside the alumina film should contribute to explain the flaws observed in Fig. 2 [23–26]. Fig. 4b also showed the presence

of chloride species in the alumina film which was related to the exposure conditions certainly due to trapped electrolyte during intergranular corrosion propagation.

corrosion processes and/or electrolyte trapped inside the corroded grain boundaries during the drying process. This should explain the presence of Cl in the alumina film (Fig. 4b), Cl⁻ ions being trapped inside the gelatinous corrosion products/trapped electrolyte. Further, taking into account that the grain boundaries form a complex network and that intergranular corrosion is a network of attack, it

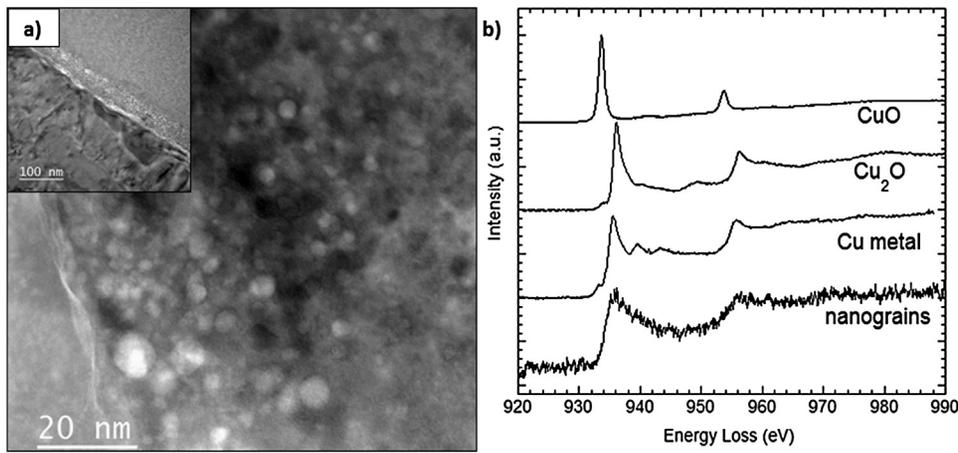
Fig. 5. a) LAADF STEM images of the interface alloy/intergranular corrosion defect showing nanoparticles combined with b) EELS analysis of the Cu-L_{2,3} edges of the nanoparticles of the interfacial layer. Copper oxide references are given for comparison.

In order to determine precisely the chemical nature of the interfacial Cu-rich layer, EELS analyses in STEM mode were performed (Fig. 5). Fig. 5b represents the Cu-L_{2,3} edges of the interfacial nanoparticles layer compared to the Cu-L spectra of the CuO, Cu₂O and metallic Cu references [40]. Results showed that the spectroscopic signatures of Cu in this layer mainly corresponded to the EELS signature of metallic Cu. The presence of Cu₂O could not be excluded while it could be assumed that CuO was not present leading us to assume that the interfacial layer was mainly composed of metallic Cu nanoparticles [9,41].

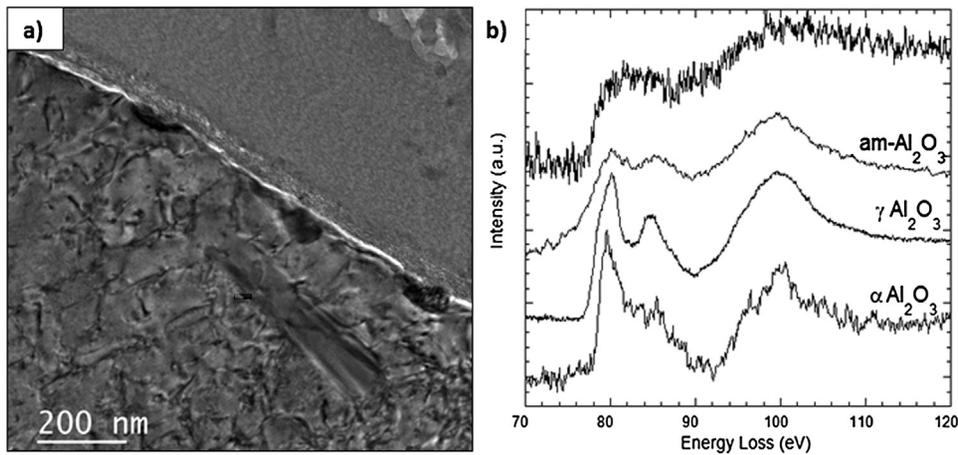
Fig. 6. a) LAADF STEM image with black spots inside the intergranular corrosion defect representing where b) EELS analysis of the Al - L_{2,3} edges was done. Spectra were compared to those of the reference α and γ alumina and amorphous alumina. For more clarity, only one spectrum corresponding to the analyzed oxide film was given.

Concerning the chemical nature of the corrosion products inside the intergranular corrosion defect, a combination of STEM and EELS techniques was also used. This enabled to probe the Al-L_{2,3} edges at the nanometer scale (Fig. 6). The fingerprint approach was also used to determine the nature of the alumina, the reference spectra of both γ , α and amorphous alumina having been obtained in the same experimental condition for comparison. The different peaks related to Al-L_{2,3} edges for γ and α -Al₂O₃ have the same shape of those described by Bouchet [42]. Moreover, the EELS spectra obtained on the corrosion defect do not fit with the Al-L edge of aluminium (oxy) hydroxide as the boehmite γ - AlO(OH), the bayerite (α - Al(OH)₃) and the gibbsite (α - Al(OH)₃) obtained by XANES [43]. Results showed that the shape of the Al-L_{2,3} edges for the corrosion product layer corresponded to those of amorphous alumina showing

that the intergranular corrosion defect was filled with amorphous alumina [44]. The nature of the amorphous phase is also confirmed by the lack of specific structure in HRTEM and a diffuse diffraction pattern. However, given that the sample had been dried prior to sectioning, it was likely that the amorphous alumina was a precipitate formed from either gelatinous Al corrosion products due to the

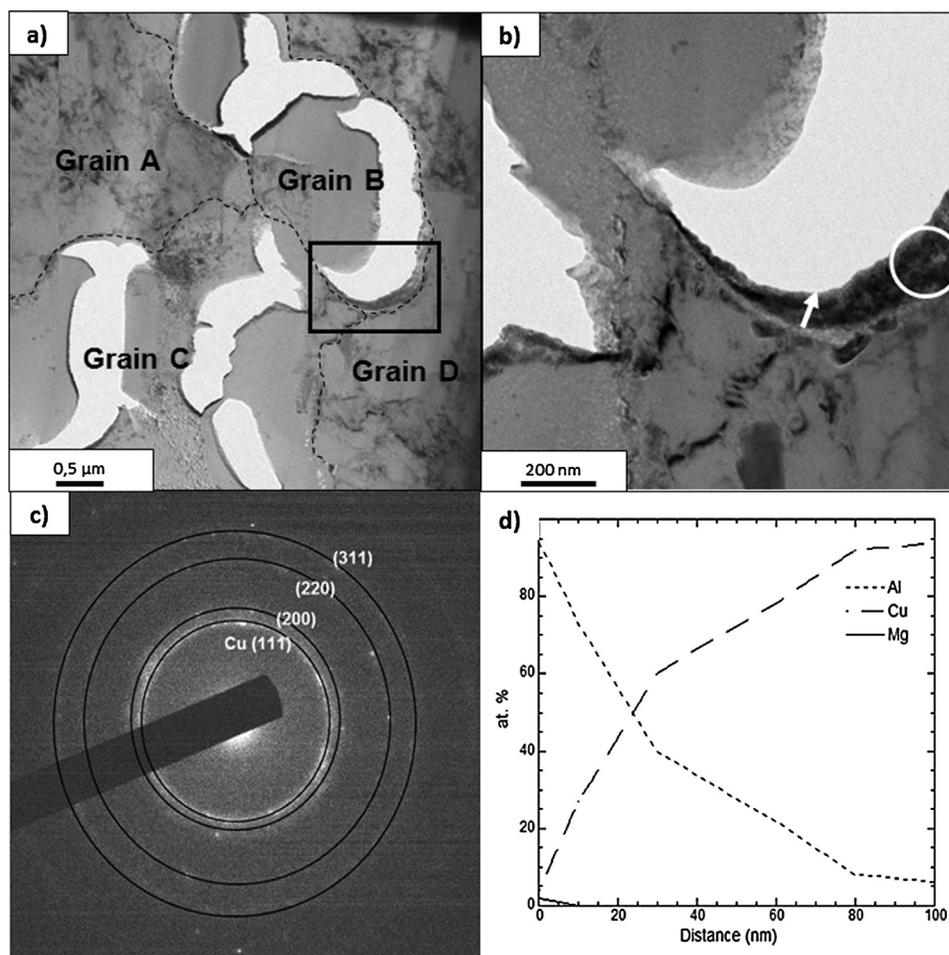
Fig. 7. a) Photomontage of bright field images of an intergranular corrosion defect with the delimited grain represented b) zoom on the tip of the corrosion defect associated with c) SAED pattern (selected area is represented by white circle in b) and d) EDX profile (line profile is represented by a white arrow in b).

Attention was also paid at the chemistry of the tip of the intergranular corrosion defect: another FIB sample was thus prepared at this specific location as represented in the photomontage of bright field image in Fig. 7a. Corrosion was developed across the grain boundary and in the neighbouring grains. Due to the 3D configura-

tion of an intergranular corrosion defect, it was difficult to ascertain that the 'tip' observed was really an active anode. Therefore, several FIB samples were prepared at locations assumed to be the tip of an intergranular corrosion defect. Results obtained were similar and only the results obtained for one 'tip' sample are shown here. As previously (Fig. 2), a chain of precipitates identified by EDX as Al_2Cu was present all along the tip of the corrosion defect which was around $1\ \mu m$ wide. A zoom on the tip (Fig. 7b) revealed the presence on a thin layer (almost 100 nm) at the interface between the alloy and the intergranular corrosion defect. A selected area diffraction pattern obtained for this layer (Fig. 7c) revealed the presence of diffraction circles representative of nanoparticles of metallic Cu (Fm-3m, $a = 3615\ \text{\AA}$). The EDX profile (Fig. 7d) confirmed the presence of the Cu-rich layer at the tip of the intergranular corrosion defect with a Cu content that can reach 90 at.%.
