## **Proof of a composite repair concept for aeronautical structures: a simplified method**

Francis Collombet, Yves Davila, Sergio Avila, Alexander Morales, Laurent Crouzeix, Yves-Henri Grunevald, Hilario Hernandez, Nathalie Rocher, François Cénac

**Keywords:** Composite repair / abrasive water jet machining / composite bonded assembly / light finite elements modelling / mechanical testing

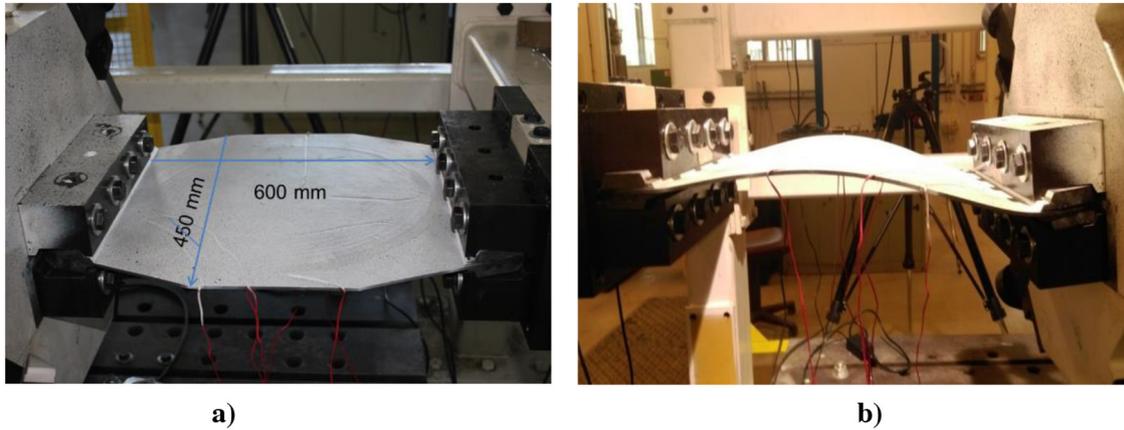
**Fig. 1.** View of the repair evaluator with (a) the start and (b) the last phase of the multi-axial mechanical test, see [5] for details.

To be close to industrial applications, an original methodology of mechanical characterization (called Multi-Instrumented Technological Evaluator tool box) has been proposed [2,5]. The MITE tool box allows the design of case-by-case specific repair evaluators that can be tested in a multi-axial testing machine under complex loading sequences. For achieving such approach, metric composite parts are mandatory according to the real patch repair size and the definition of the SoW because of the case-by-case nature of the composite repair issues. The proof of the interest of the joint patent has been done in the past thanks to the Multi-Instrumented Technological Evaluator tool box [5], cf. Figure 1.

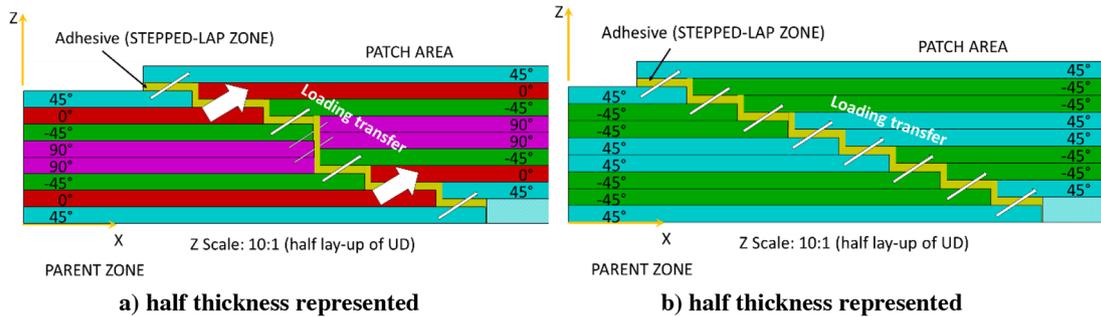
**Fig. 2.** Illustration of two situations of composite specimens with stepped lap respectively with, (a) classical stacking sequence and (b) unusual stacking sequence (scheme of loading transfer and its intensity under tension indicated by the white arrows with respect to their size and direction).

On Figure 2, only the half thickness is shown for clarity. On Figure 2a, the stacking sequence is quasi-isotropic and frequent in the world of composites and in aeronautics. The performance of our approach for such a stacking sequence has been demonstrated on the technological evaluator, and works. Most of the loading flow goes through the plies at  $0^\circ$  and therefore the associated bonded assemblies. The ruptures of the part and the bond occur at the same time (because of the plies at  $0^\circ$ ). It is therefore difficult to know if the bond has been damaged due to the part rupture or vice versa. Furthermore, a tension set-up with an adequate loading capacity is not easily available for such stacking sequences. On Figure 2b, an unusual stacking sequence is shown, only used for demonstration. It has no industrial utility, except for a torsion shaft, but

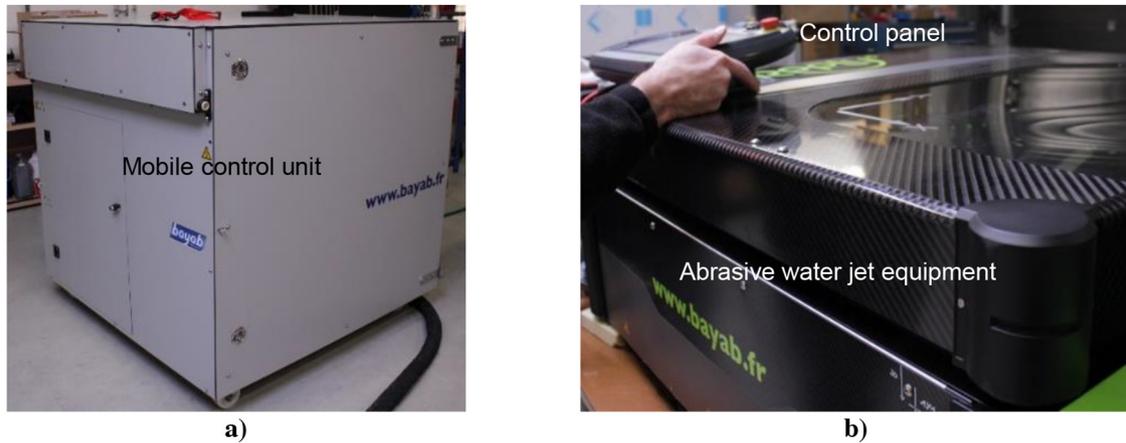
**Fig. 3.** Bayab Industries abrasive water jet machine REPLY.5 with (a) control unit and (b) abrasive water jet equipment (50 kg) and control panel.

The REPLY.5 AWJ machine consists of three principal elements, the control unit which contains the pump and the control system (cf. Fig. 3a), the abrasive water jet equipment (which is light –50 kg – compared to the competing project attempts) and the control panel to operate the machine (cf. Fig. 3b).

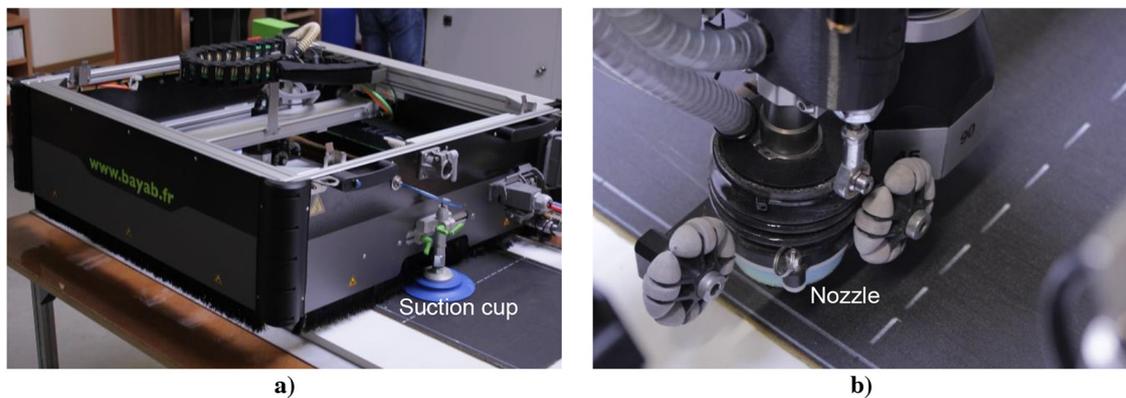
**Fig. 4.** Abrasive water jet machine Reply.5 with (a) levelled machine and (b) nozzle.

After fixing the composite plate onto the workbench, the AWJ machine is placed on top of it and is maintained in position with suction cups (cf. Fig. 4a). In an industrial situation, this suction system allows the positioning of the machine onto a composite fuselage. The machine is then levelled to roughly adjust the distance between the AWJ head (nozzle) and the composite part (cf. Fig. 4b).

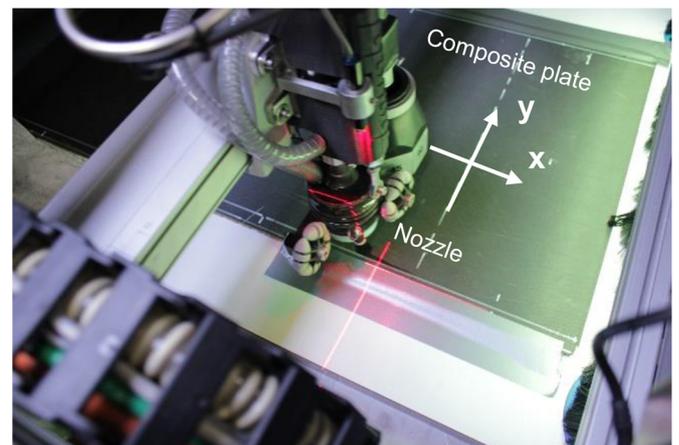
**Fig. 5.** Alignment process of the nozzle over the  $x$ - and  $y$ -main directions of the composite plate.

The machine is aligned by a laser level to the marked along the  $x$ - and  $y$ -main directions of the studied parent composite plate (cf. Fig. 5).

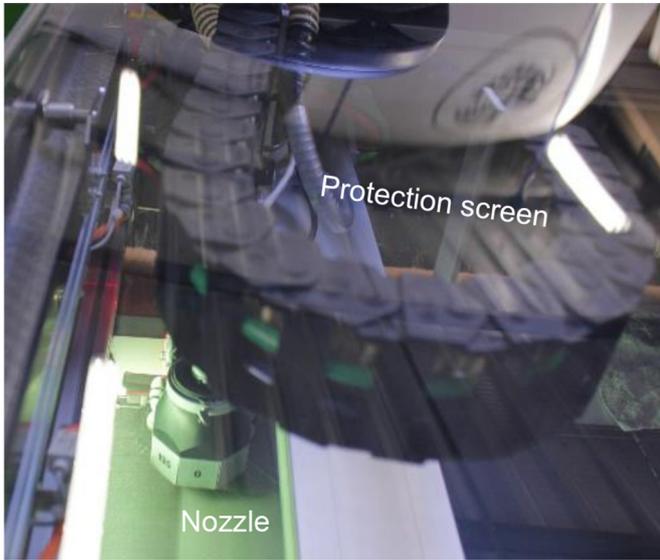
**Fig. 6.** View through the protection screen of the machine during the machining of the step #1 for the stepped lap ratio of 1:20 (step length over ply thickness).

After aligning the machine, the layer of composite material corresponding to the first step (here ply #16) is removed. As an illustration, the first machined step for the step lap ratio of 20 is presented in Figure 6. For the other step lap ratios of 30 and 50, the same procedure is applied. The cut trajectory and cut parameters (water jet pressure, and nozzle feed rate) are programmed into the machine. These parameters are Intellectual Property of Airbus and Bayab Industries and have not been disclosed.

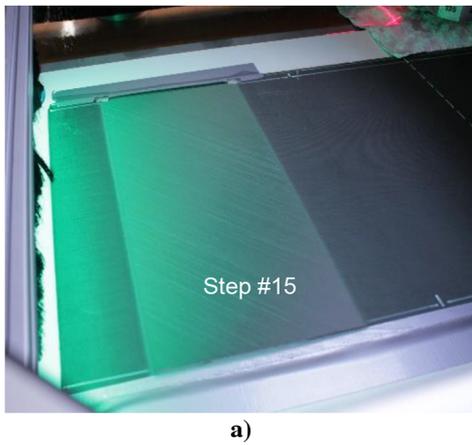
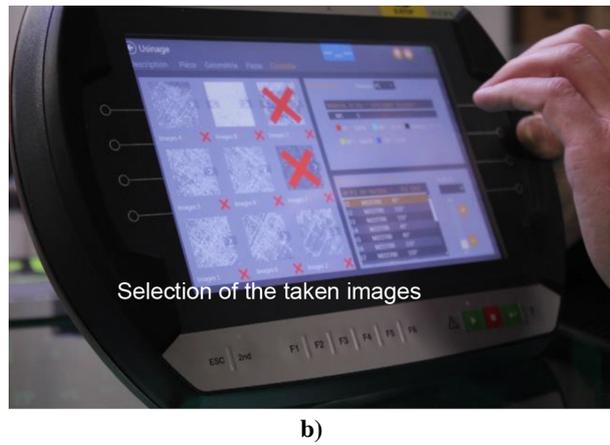
**Fig. 7.** Verification process of the machining surface with (a) overlap zone analysed by image analysis and (b) visualization and selection of the images on the control panel to estimate the location of the interface between plies (i.e. presence of numerous dark spots due to no light diffraction).

lightning emitted by the low-angled light is diffracted differently depending on the angle with respect to the long fibre orientation. The control unit compares the recorded images pixel-by-pixel. For accurate information, a selection of images from the screen of the control panel (cf. Fig. 7b)

shows an estimation of the matrix ratio (percentage of dark spots thanks to no light diffraction,  $\approx 60\%$  according to ply thickness variabilities, [9]) in an interface between two plies. The matrix ratio is evaluated to ensure that just one ply was removed. This is an alternative to direct measurement of the cut depth.

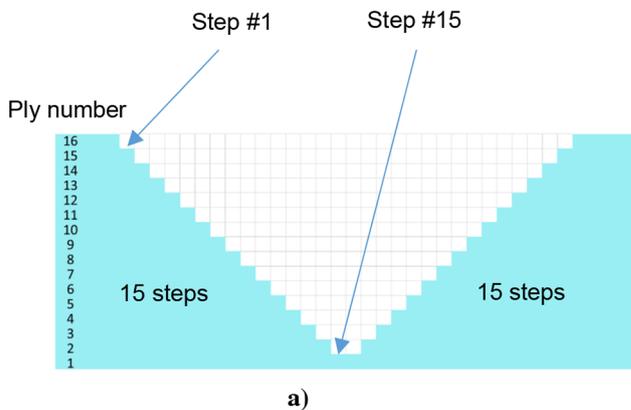
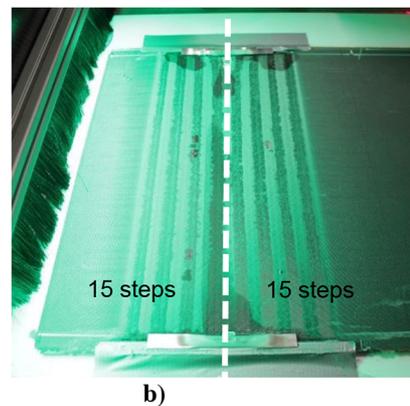
**Fig. 8.** Machining of the 15 steps (for 16 plies in total) with (a) scheme of milled profile (not to scale) and (b) view of the finished milled stepped-lap for the overlap ratio of 20.

Afterward, the process or nozzle alignment, machining and verification are repeated. As an illustration, the resulting stepped lap profile (step ratio of 20) is shown in Figure 8.

After completion of the machining process, the composite plates are cut in halves in order to create the possibility of repairing two sets of plates for each overlap ratio (cf. Fig. 8). This situation is representative of a “through hole” repair. We label the parent plate as “Plate 13”, corresponding to a step length of 13 mm or a step ratio of 50, as shown in Figure 9 and hereafter as an illustration in this paper. Typical Airbus repairs require that the material of the repair patch should be cured at  $120^\circ\text{C}$ , in order to not

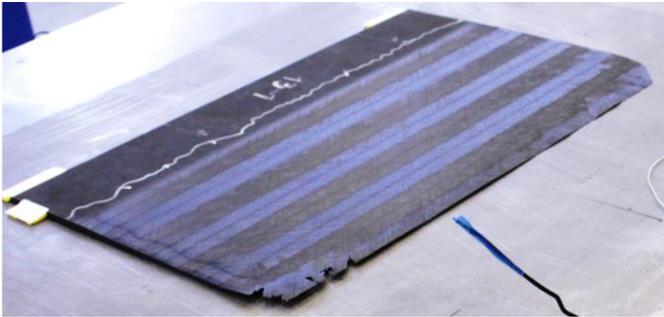
**Fig. 9.** View of parent composite plate noted “Plate 13” (overlap length of 13 mm), shown after AWJ milling phase and before the repair patch installation.

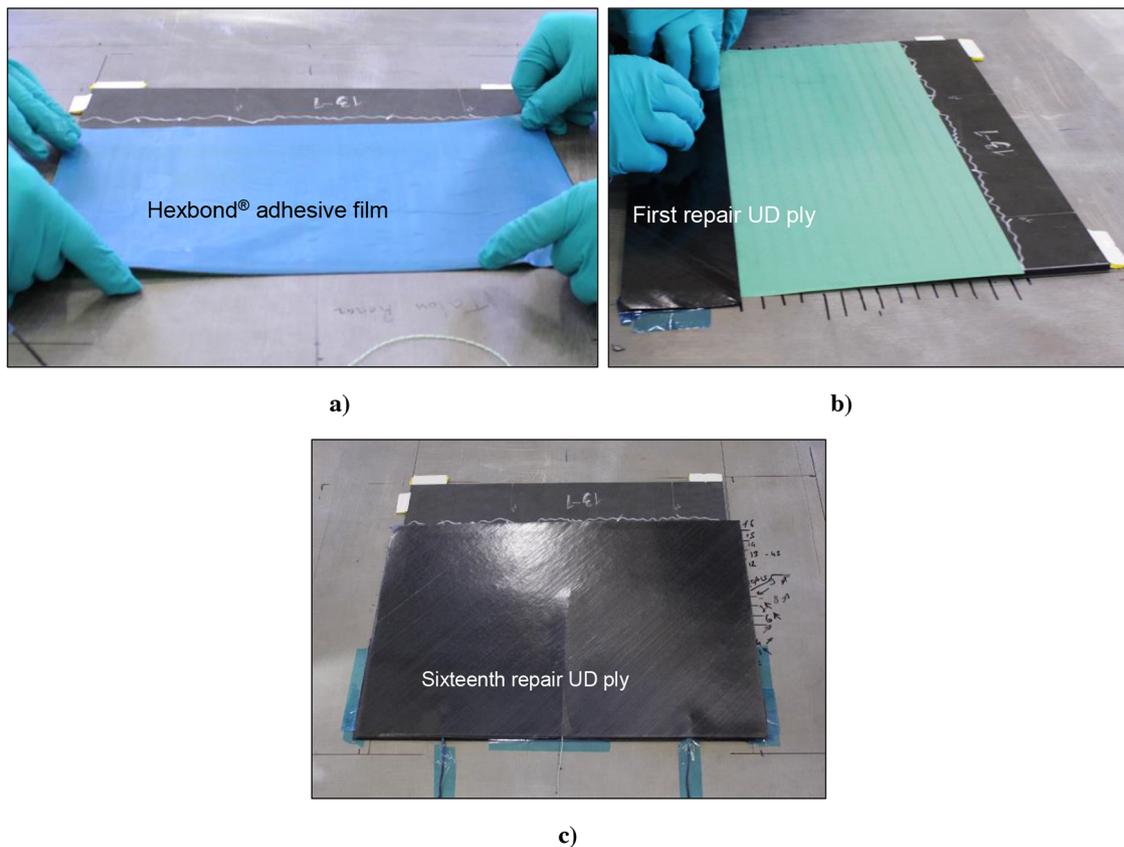
**Fig. 10.** Repair patch installation with (a) lay-up of the Hexbond® adhesive film with its protective plastic film, (b) placement of the first repair ply and (c) after the placement of the sixteenth repair ply.

The surface of the stepped-lap area is degreased and cleaned using alcohol and/or acetone. The repair procedure is composed of different phases. First, the adhesive film of Hexbond® is placed in the stepped-lap area (cf. Fig. 10a). Then, the repair plies are stacked, for the first ply (cf. Fig. 10b) to the sixteenth repair ply (cf. Fig. 10c), using guidelines drawn on the surface of the tooling for adequate ply placement (cf. Figs. 10b and 10c). In the industry (aircraft repair and maintenance), guidelines painted onto the surface of the parent structure (like the aircraft fuselage) are indeed used not only for ply placement but also for ply orientation purposes. After the repair is done, the repaired surface will be cleaned and painted as per SRM indications (Structural Repair Manual [6]).

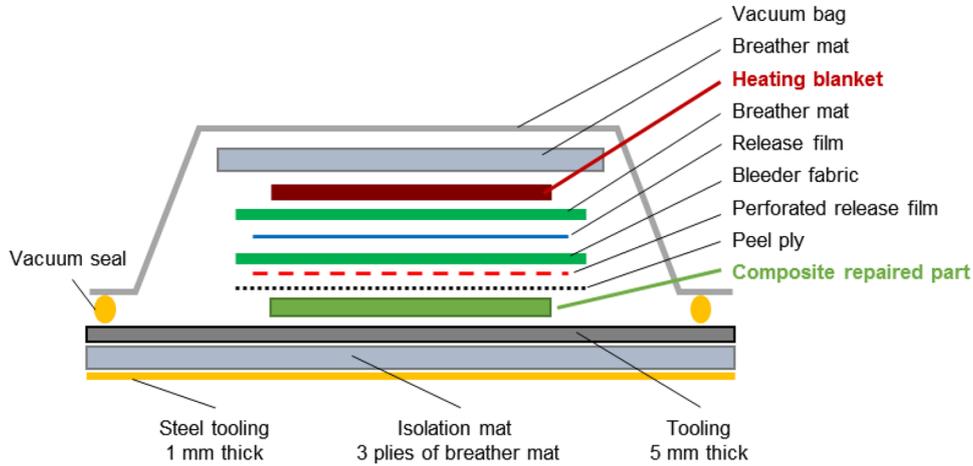
**Fig. 11.** Scheme of the vacuum bag products (not to scale) for the composite patch curing by heating blanket (according to SRM A350 chapter 51.77.11, see [6]).

Once all the repair plies are laid up, the vacuum bag is installed. The sequence of vacuum bag materials is done as per Airbus SRM indications for structural composite repair (cf. Fig. 11).

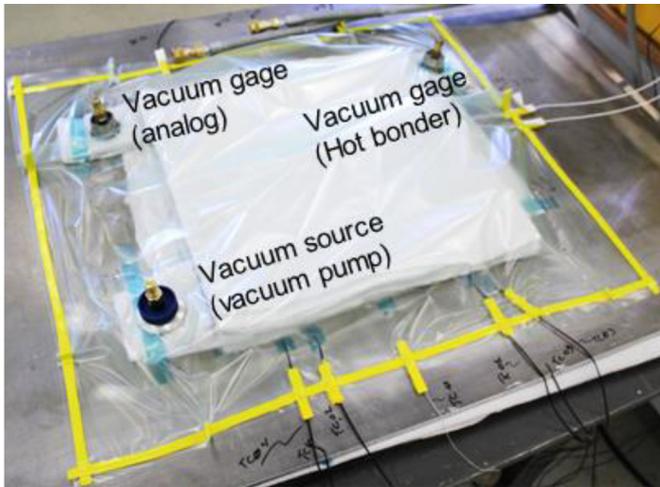
**Fig. 12.** Overview of the vacuum bag products and the connections to the different thermocouples.

Once the vacuum bag is placed and sealed, a vacuum test is performed. The vacuum is applied using the external vacuum pump (cf. Fig. 12).

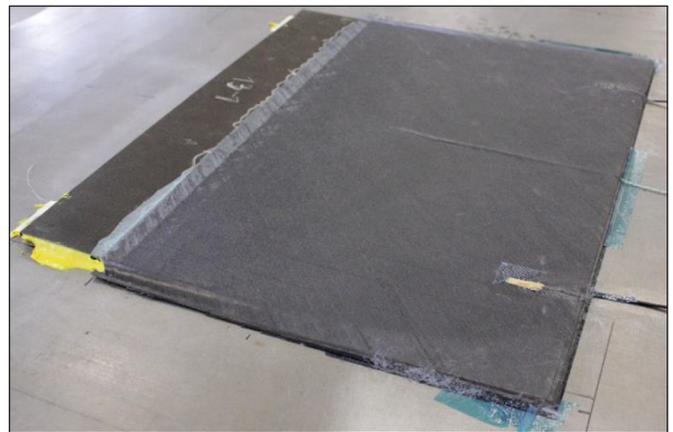
**Fig. 14.** View of finished repair on “Plate 13” after curing (overlap length of 13 mm).

When the curing cycle is complete, the part is demoulded. The resulting part is shown in Figure 14. Finally, coupons for tensile test are cut from the repaired parent plate using an abrasive water jet machine. The central zone is only considered to eliminate defects in the boundary of the parent plate.

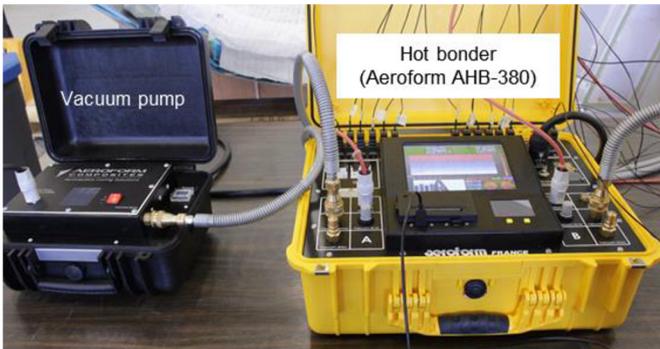
**Fig. 13.** Portable hot bonder Aeroform AHB-380 (right) and the portable vacuum pump (left).

The temperature cycle is programmed into the hot bonder (cf. Fig. 13). The M21 resin cures at 180 °C for 2 h. An intermediate dwell at 100 °C for 30 min is used in order to homogenise the temperature in the unconsolidated patch prepreg and to promote the movement of resin and

removal of entrapped air causing porosities in the material. The temperature ramps are set at 3 °C min<sup>-1</sup>. The vacuum is applied with an external portable vacuum pump (cf. Fig. 13).

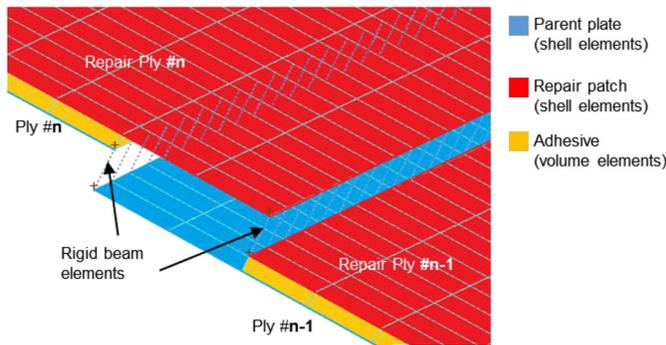
Fig. 15. Mesh detail between two consecutive steps (ply #n and #n-1).

A light finite element (FE) modelling strategy is used [5,7]. This strategy uses shell elements for the composite laminate and volume elements for the adhesive joint (cf. Fig. 15). The mesh of the composite parent zone is modelled with shell elements of 0.44 × 0.44 mm dimensions. One volume element of 0.1 mm thick with the same width and length as the composite shell elements is employed to model the adhesive film with a thickness to length ratio of 1:4.

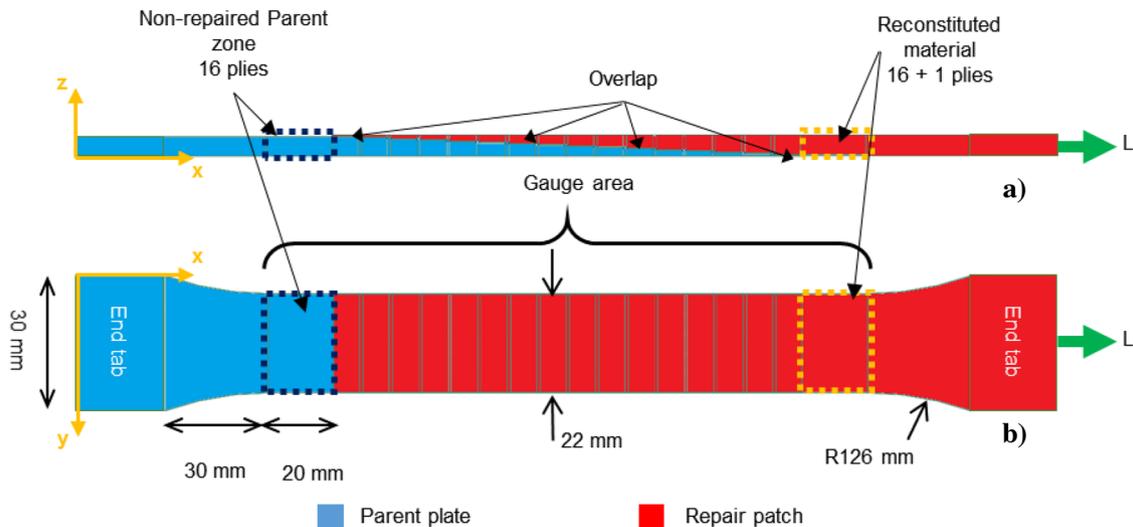
Fig. 16. 3D representation of the FE model (shell thicknesses rendered at their given values) with (a) side view (XZ plane) and (b) top view (XY plane).

The shape of the tensile repaired coupon is shown in Figure 16. The repaired coupon is 22 mm wide in the gauge zone, corresponding to the overlap zone. Its end tabs are 30 mm wide in order to avoid a possible material failure at the machine clamps. The zone of 20 mm length approximately located between the overlap and the tab is considered as representative of a non-repaired area. This zone corresponding to the non-repaired zone of the parent

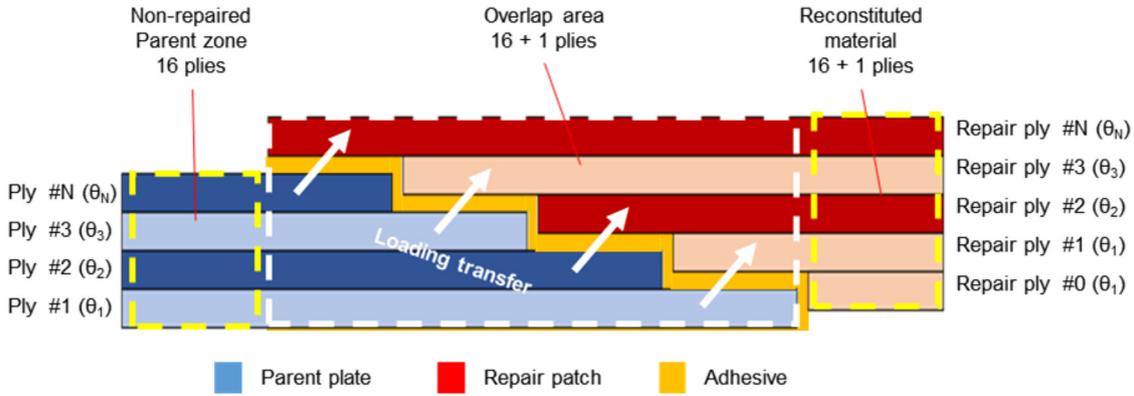
Fig. 17. Scheme of composite repair overlap considerations (not to scale).

zone has the original parent plate of 16 plies, while the reconstituted material in the patch area has one extra ply (repair ply #0) with the same orientation as the repair ply #1. This filler ply is only used to ensure continuity of the bottom surface of the repair, and to provide support for the stacked plies, otherwise there would be ply waviness in the rest of the stack. Thus, this zone has a stacking sequence with 17 plies in total in accordance with composite repair implementation (cf. Fig. 17). As in Figures 2 and 17 uses white arrows to show the loading flow transfer principle from the parent plies to the repair plies.

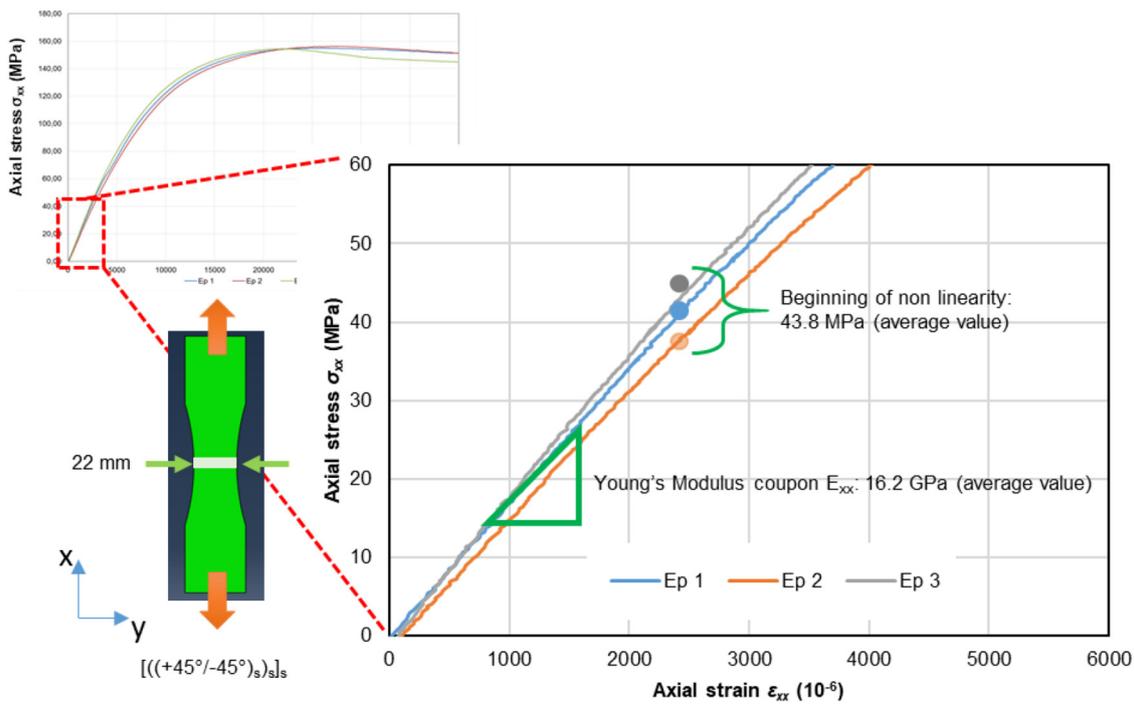
Fig. 18. Inverse identification of the material properties (at the beginning of the non-linear behaviour) using a tensile test on unrepaired specimens extracted from the manufactured mother plate.

stress-strain curve (cf. Fig. 18) is used in the inverse analysis leading to the elastic and our arbitrary or chosen limit values of shear strength and transverse strength matrix identifications (in red on Tabs. 2 and 3). For the other mechanical properties, the values given by the maker are considered to be reliable (in black on Tabs. 2 and 3).

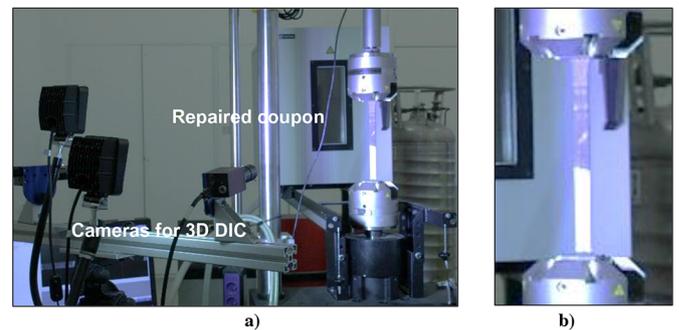
**Fig. 19.** Axial tensile test configuration with, (a) set-up with two cameras for 3D DIC and (b) zoom of the repaired coupon with its DIC speckle (in white).

Three coupons per overlap length were tested in a universal test machine. Here we illustrate with results concerning the 13 mm overlap repair length for the three specimens noted "Ep 13-1", "Ep 13-2" and "Ep 13-3". The non-repaired zone in the parent area was painted for digital image correlation in order to have the stress-strain curve of this particular area (cf. Fig. 19). The zone, with the thinnest cross section because of 16 plies instead of 17 plies in the overlap and the reconstituted zone of the repair patch (cf. Fig. 17), is the zone expected to reach limit values before the others and especially before the adhesive joint repair patch.

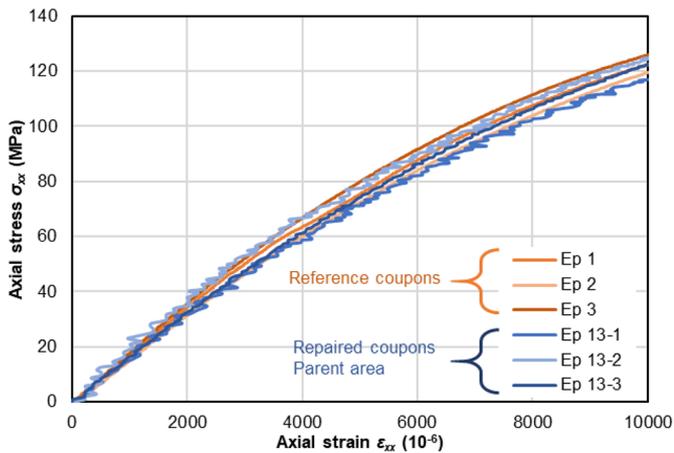
**Fig. 20.** Axial stress  $\sigma_{xx}$  – strain  $\epsilon_{xx}$  curve of the parent area of repair coupons Ep 13-1, 13-2 and 13-3 and reference test coupons Ep 1, 2 and 3.

down to zero. Comparing the test between the repaired composite specimens and the reference coupons, we cannot see any distinction in the mechanical behaviour (cf. Fig. 20). At this moment of the test, the adhesive has not reached a limit value.

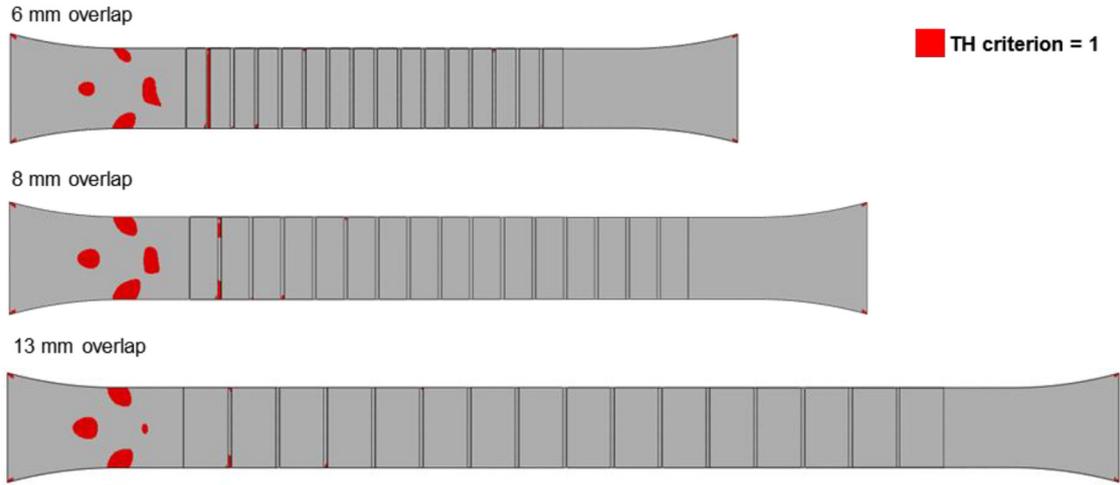
**Fig. 21.** Tsai-Hill criterion (TH = 1 in red when the chosen limit values are reached) in the FE models for the 6, 8 and 13 mm overlap lengths (from top to bottom).

As expected, the place where the limit values are reached is at the parent zone (with cross section reduction compared to the rest of the specimen) between the end tab and the overlap areas. It corresponds to the same situation in the reference coupons. The three overlap ratios exhibit numerically the same behaviour (cf. Fig. 21).

The FE results show that, at a load corresponding to the limit values in the parent composite (TH=1, cf. Fig. 21), the maximum shear value, calculated in the adhesive (area under the  $\tau_{xz}$  curve), is 13.5 MPa in both step #1 and step #16. The rest of the steps in between have a less significant value (cf. Fig. 24). All overlap lengths

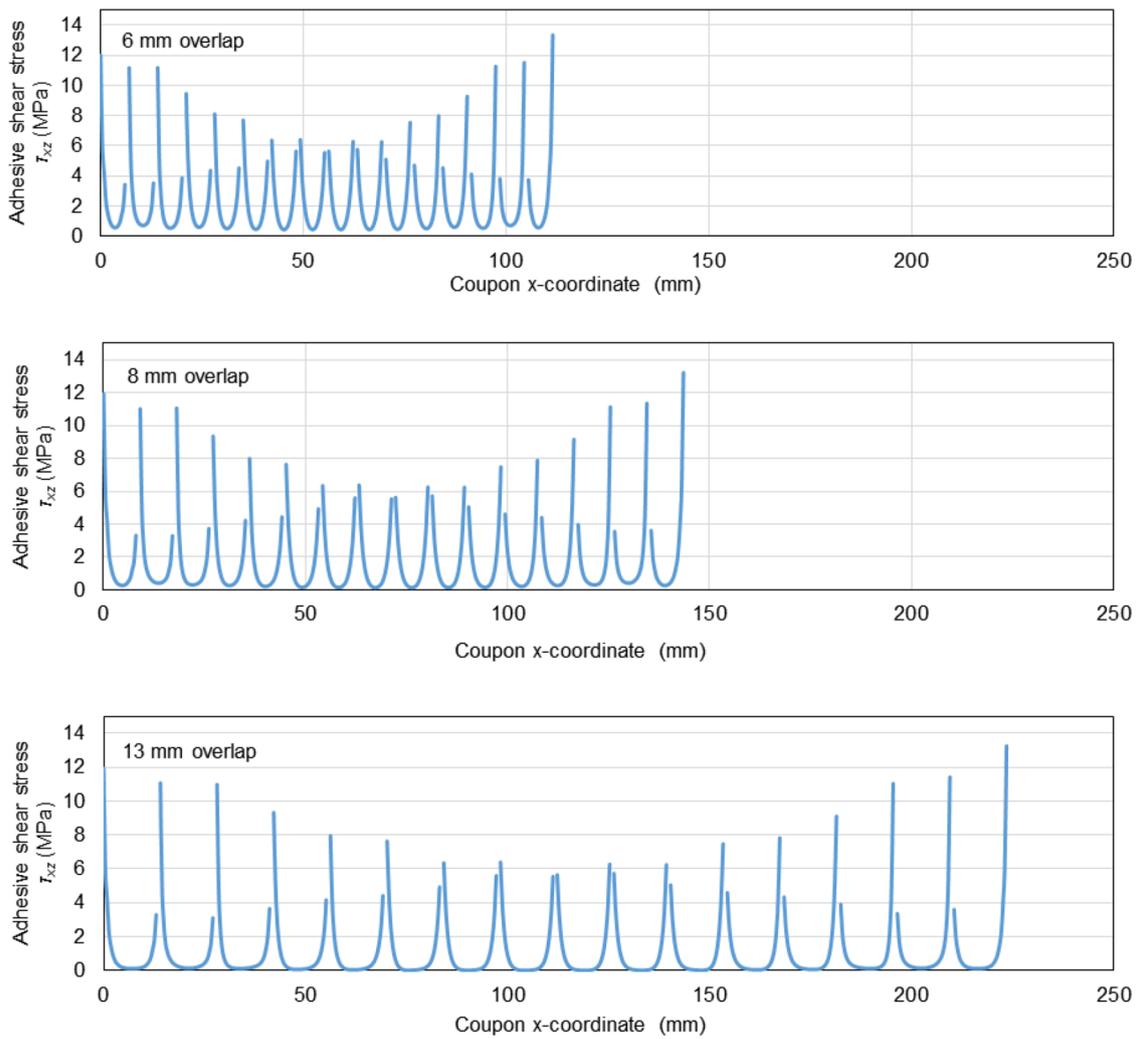
**Fig. 22.** Shear stress  $\tau_{xz}$  distribution in the adhesive in each step (from top to bottom) for the 6, 8 and 13 mm overlap lengths.

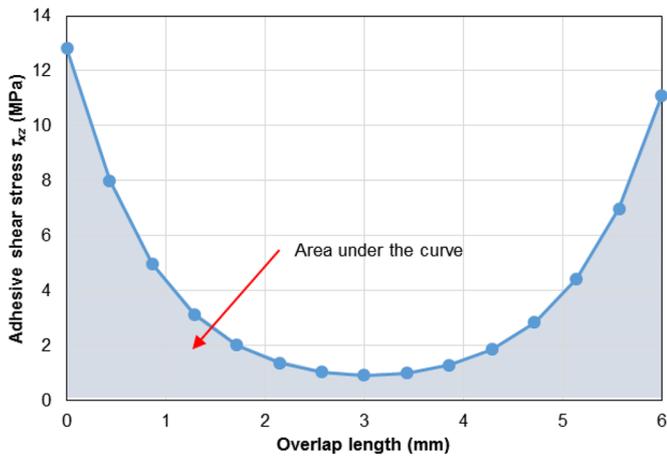
**Fig. 23.** Determination of the average shear value along the adhesive joint for 6 mm overlap length [7].

According to [7,11,12], a criterion to determine whether the bond has cohesively failed by shear stress is to obtain the area under the curve, which is the total stress per unit length that the adhesive carries (cf. Fig. 23). For epoxy adhesives, the shear strength, i.e. the maximum stress that can be applied into the adhesive along the overlap, is 35 MPa. Here, numerically the maximum shear stress was 13.5 MPa, which is indeed 2.5 times lower than the maximum shear stress for the adhesive. It was observed experimentally that no testing coupon had a failure of the adhesive.

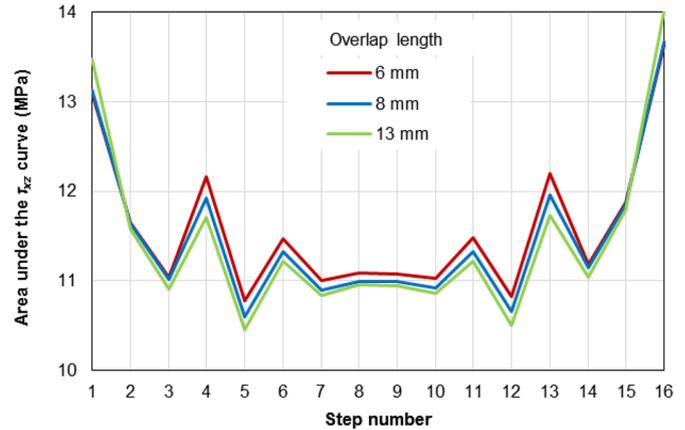
**Fig. 24.** Area under the curve  $\tau_{xz}$ -step length at each step and for the 6, 8 and 13 mm overlap lengths.
