Proof of a composite repair concept for aeronautical structures: a simplified method

Francis Collombet, Yves Davila, Sergio Avila, Alexander Morales, Laurent Crouzeix, Yves-Henri Grunevald, Hilario Hernandez, Nathalie Rocher, François Cénac

Keywords: Composite repair / abrasive water jet machining / composite bonded assembly / light finite elements modelling / mechanical testing

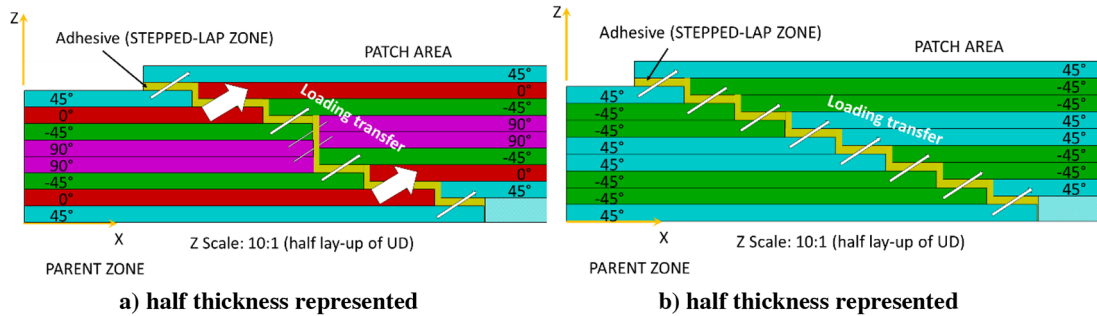
Fig. 2. Illustration of two situations of composite specimens with stepped lap respectively with, (a) classical stacking sequence and (b) unusual stacking sequence (scheme of loading transfer and its intensity under tension indicated by the white arrows with respect to their size and direction).

On Figure 2, only the half thickness is shown for clarity. On Figure 2a, the stacking sequence is quasi-isotropic and frequent in the world of composites and in aeronautics. The performance of our approach for such a stacking sequence has been demonstrated on the technological evaluator, and works. Most of the loading flow goes through the plies at 0° and therefore the associated bonded assemblies. The ruptures of the part and the bond occur at the same time (because of the plies at 0°). It is therefore difficult to know if the bond has been damaged due to the part rupture or vice versa. Furthermore, a tension set-up with an adequate loading capacity is not easily available for such stacking sequences. On Figure 2b, an unusual stacking sequence is shown, only used for demonstration. It has no industrial utility, except for a torsion shaft, but

it allows verification that the bonded area is not the weak link in the system using a classical tension set-up.

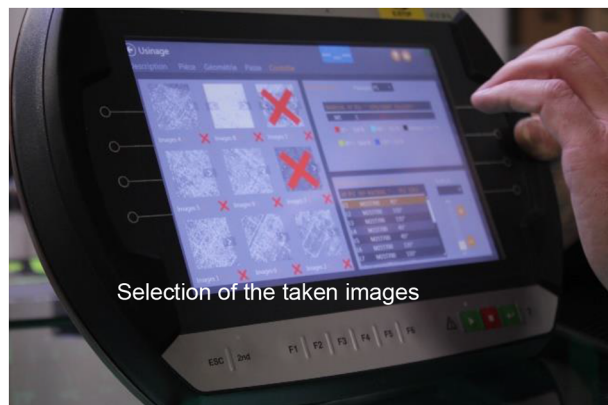
Fig. 7. Verification process of the machining surface with (a) overlap zone analysed by image analysis and (b) visualization and selection of the images on the control panel to estimate the location of the interface between plies (i.e. presence of numerous dark spots due to no light diffraction).

lightning emitted by the low-angled light is diffracted differently depending on the angle with respect to the long fibre orientation. The control unit compares the recorded images pixel-by-pixel. For accurate information, a selection of images from the screen of the control panel (cf. Fig. 7b)

shows an estimation of the matrix ratio (percentage of dark spots thanks to no light diffraction, $\approx 60\%$ according to ply thickness variabilities, [9]) in an interface between two plies. The matrix ratio is evaluated to ensure that just one ply was removed. This is an alternative to direct measurement of the cut depth.

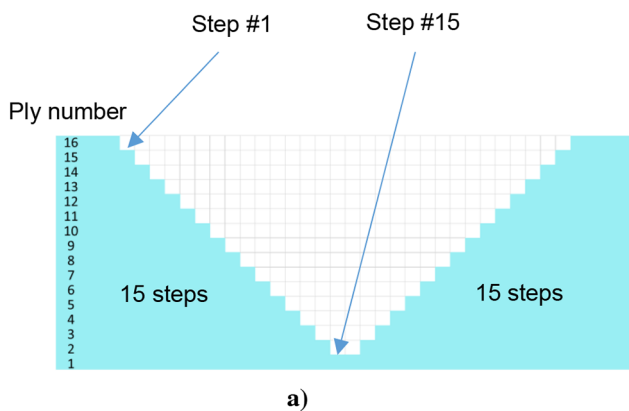
Fig. 8. Machining of the 15 steps (for 16 plies in total) with (a) scheme of milled profile (not to scale) and (b) view of the finished milled stepped-lap for the overlap ratio of 20.

Afterward, the process or nozzle alignment, machining and verification are repeated. As an illustration, the resulting stepped lap profile (step ratio of 20) is shown in Figure 8.

After completion of the machining process, the composite plates are cut in halves in order to create the possibility of repairing two sets of plates for each overlap ratio (cf. Fig. 8). This situation is representative of a “through hole” repair. We label the parent plate as “Plate 13”, corresponding to a step length of 13 mm or a step ratio of 50, as shown in Figure 9 and hereafter as an illustration in this paper. Typical Airbus repairs require that the material of the repair patch should be cured at 120°C , in order to not

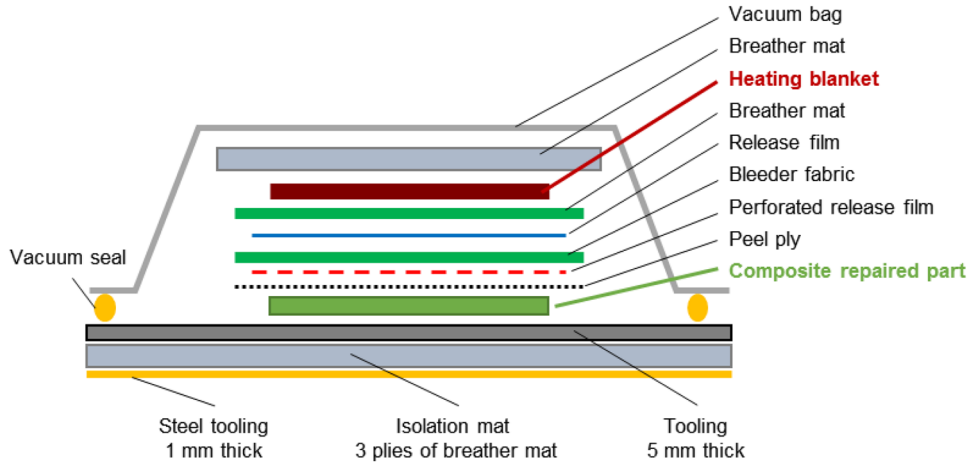
Fig. 11. Scheme of the vacuum bag products (not to scale) for the composite patch curing by heating blanket (according to SRM A350 chapter 51.77.11, see [6]).

Once all the repair plies are laid up, the vacuum bag is installed. The sequence of vacuum bag materials is done as per Airbus SRM indications for structural composite repair (cf. Fig. 11).

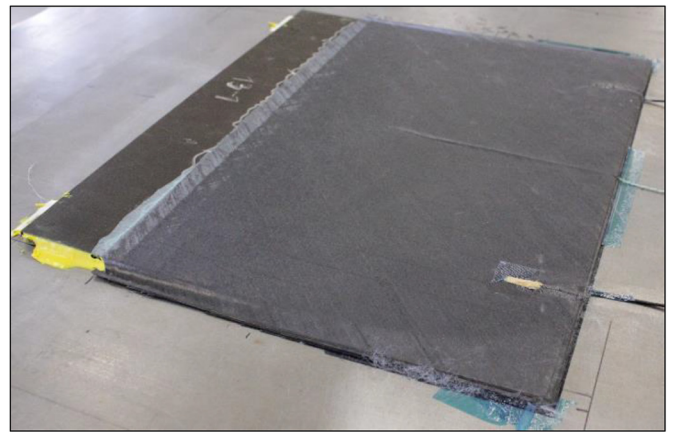
Fig. 14. View of finished repair on “Plate 13” after curing (overlap length of 13 mm).

When the curing cycle is complete, the part is demoulded. The resulting part is shown in Figure 14. Finally, coupons for tensile test are cut from the repaired parent plate using an abrasive water jet machine. The central zone is only considered to eliminate defects in the boundary of the parent plate.

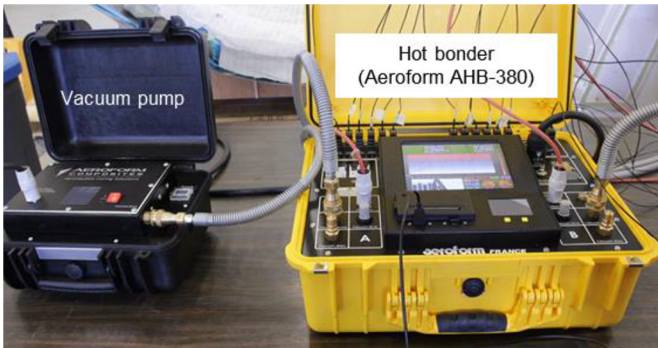
Fig. 13. Portable hot bonder Aeroform AHB-380 (right) and the portable vacuum pump (left).

The temperature cycle is programmed into the hot bonder (cf. Fig. 13). The M21 resin cures at 180 °C for 2 h. An intermediate dwell at 100 °C for 30 min is used in order to homogenise the temperature in the unconsolidated patch prepreg and to promote the movement of resin and

removal of entrapped air causing porosities in the material. The temperature ramps are set at 3 °C min⁻¹. The vacuum is applied with an external portable vacuum pump (cf. Fig. 13).

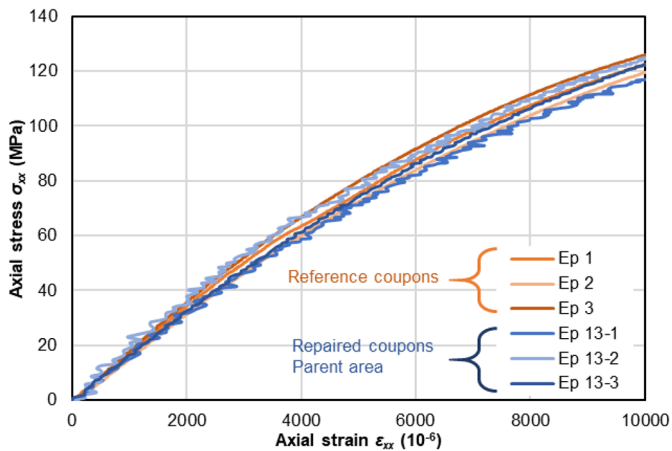
**Fig. 20.** Axial stress σ_{xx} – strain ϵ_{xx} curve of the parent area of repair coupons Ep 13-1, 13-2 and 13-3 and reference test coupons Ep 1, 2 and 3.

down to zero. Comparing the test between the repaired composite specimens and the reference coupons, we cannot see any distinction in the mechanical behaviour (cf. Fig. 20). At this moment of the test, the adhesive has not reached a limit value.

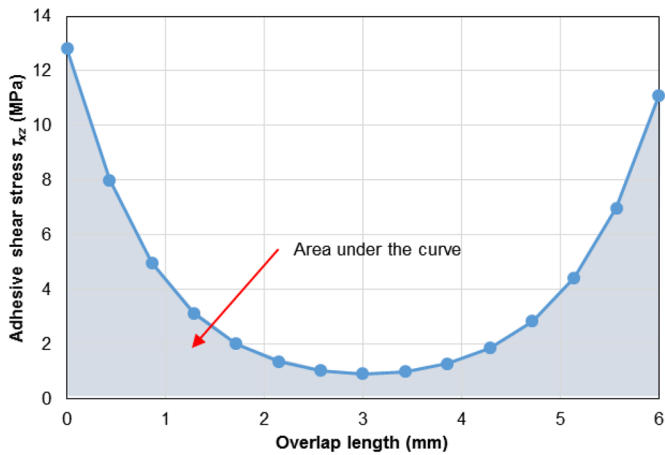
**Fig. 23.** Determination of the average shear value along the adhesive joint for 6 mm overlap length [7].

According to [7,11,12], a criterion to determine whether the bond has cohesively failed by shear stress is to obtain the area under the curve, which is the total stress per unit length that the adhesive carries (cf. Fig. 23). For epoxy adhesives, the shear strength, i.e. the maximum stress that can be applied into the adhesive along the overlap, is 35 MPa. Here, numerically the maximum shear stress was 13.5 MPa, which is indeed 2.5 times lower than the maximum shear stress for the adhesive. It was observed experimentally that no testing coupon had a failure of the adhesive.

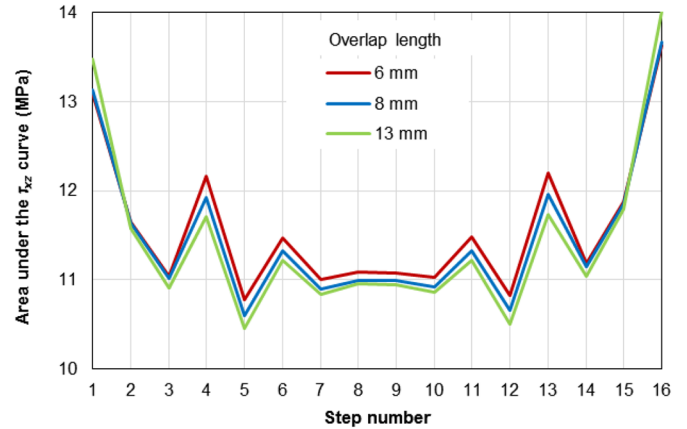
**Fig. 24.** Area under the curve τ_{xz} -step length at each step and for the 6, 8 and 13 mm overlap lengths.

The FE results show that, at a load corresponding to the limit values in the parent composite (TH=1, cf. Fig. 21), the maximum shear value, calculated in the adhesive (area under the τ_{xz} curve), is 13.5 MPa in both step #1 and step #16. The rest of the steps in between have a less significant value (cf. Fig. 24). All overlap lengths
