## **Proof of a composite repair concept for aeronautical structures: a simplified method**

Francis Collombet, Yves Davila, Sergio Avila, Alexander Morales, Laurent Crouzeix, Yves-Henri Grunevald, Hilario Hernandez, Nathalie Rocher, François Cénac

**Keywords:** Composite repair / abrasive water jet machining / composite bonded assembly / light finite elements modelling / mechanical testing

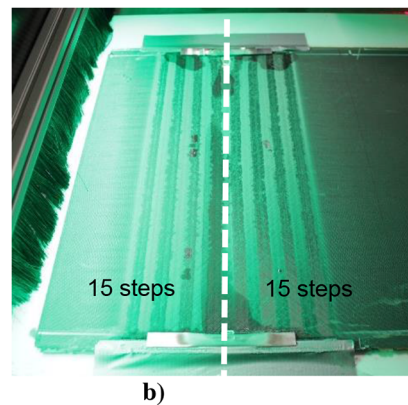
**Fig. 8.** Machining of the 15 steps (for 16 plies in total) with (a) scheme of milled profile (not to scale) and (b) view of the finished milled stepped-lap for the overlap ratio of 20.

Afterward, the process or nozzle alignment, machining and verification are repeated. As an illustration, the resulting stepped lap profile (step ratio of 20) is shown in Figure 8.

After completion of the machining process, the composite plates are cut in halves in order to create the possibility of repairing two sets of plates for each overlap ratio (cf. Fig. 8). This situation is representative of a “through hole” repair. We label the parent plate as “Plate 13”, corresponding to a step length of 13 mm or a step ratio of 50, as shown in Figure 9 and hereafter as an illustration in this paper. Typical Airbus repairs require that the material of the repair patch should be cured at  $120^\circ\text{C}$ , in order to not

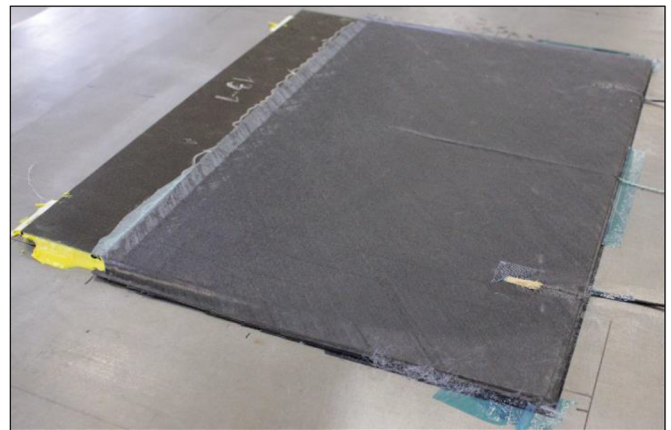
**Fig. 14.** View of finished repair on “Plate 13” after curing (overlap length of 13 mm).

When the curing cycle is complete, the part is demoulded. The resulting part is shown in Figure 14. Finally, coupons for tensile test are cut from the repaired parent plate using an abrasive water jet machine. The central zone is only considered to eliminate defects in the boundary of the parent plate.

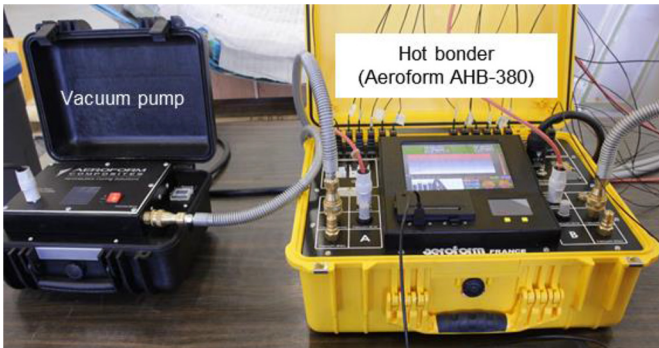
**Fig. 13.** Portable hot bonder Aeroform AHB-380 (right) and the portable vacuum pump (left).

The temperature cycle is programmed into the hot bonder (cf. Fig. 13). The M21 resin cures at 180 °C for 2 h. An intermediate dwell at 100 °C for 30 min is used in order to homogenise the temperature in the unconsolidated patch prepreg and to promote the movement of resin and

removal of entrapped air causing porosities in the material. The temperature ramps are set at 3 °C min<sup>-1</sup>. The vacuum is applied with an external portable vacuum pump (cf. Fig. 13).
