Influence of machining damage generated during trimming of CFRP composite on the compressive strength

N Nguyen-Dinh, Christophe Bouvet, Redouane Zitoune

Abstract

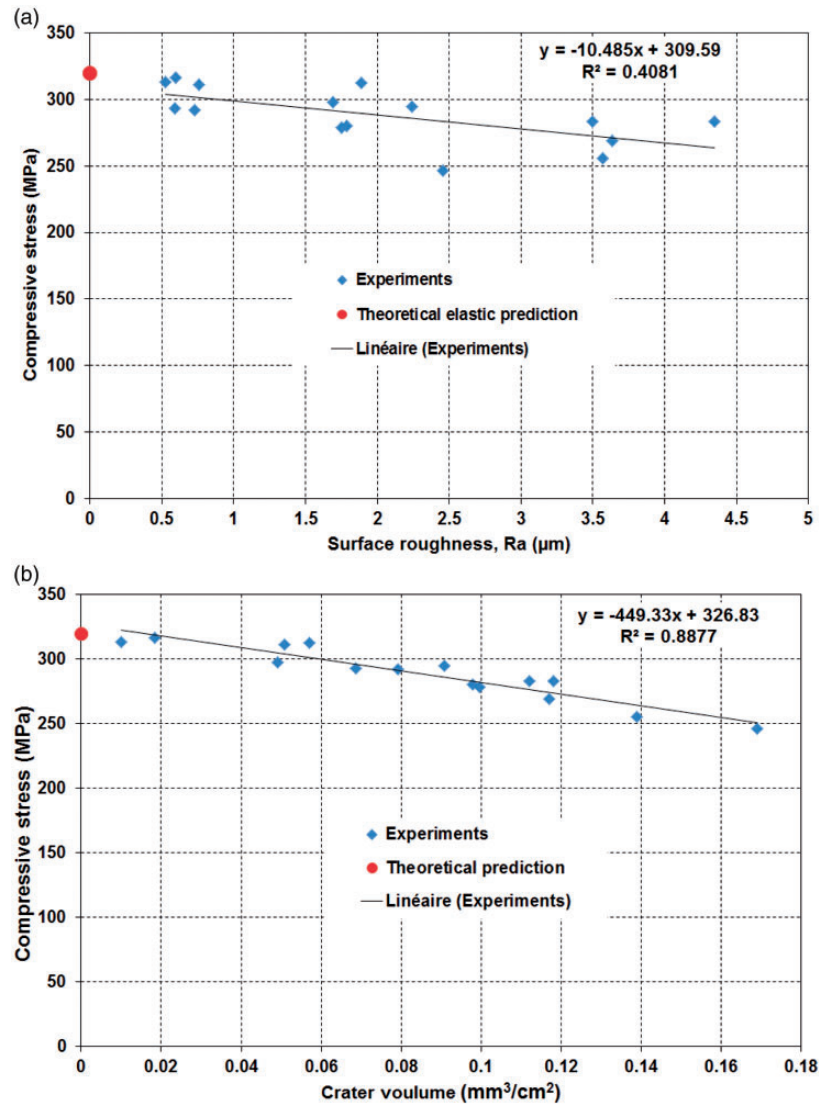
Figure 23. Evolution of compressive strength as a function of (a) surface roughness and (b) crater volume for tested specimens in group A.

The influence of machining damage on the compressive strengths. To find the relationship between machining quality and mechanical behavior which has given a lot of ambiguities in literature as early described, compression tests were carried out on the trimmed specimens in groups A and B. Figure 23 presents the evolution of compressive strength of specimens in

group A as a function of machining quality which was characterized using surface roughness and crater volume. It is seen that an increase in surface roughness or crater volume leads to reduce compressive strength. However, it is difficult to correlate the relation between surface roughness and compressive strength due to huge scatter of results (Figure 23(a)). This is proved by low R-square value which is 0.4081. Inversely, crater volume seems to be a better indicator to correlate machining damage and compressive strength when R-squared value is as high as 0.8877 (Figure 23(b)). In this case, compressive strength totally decreases by approximately 22%, when crater volume increases from $0.01 \text{ mm}^3/\text{cm}^2$ to $0.169 \text{ mm}^3/\text{cm}^2$. The fact is that specimens with good quality have small damage levels which
