Influence of machining damage generated during trimming of CFRP composite on the compressive strength

N Nguyen-Dinh, Christophe Bouvet, Redouane Zitoune

Abstract

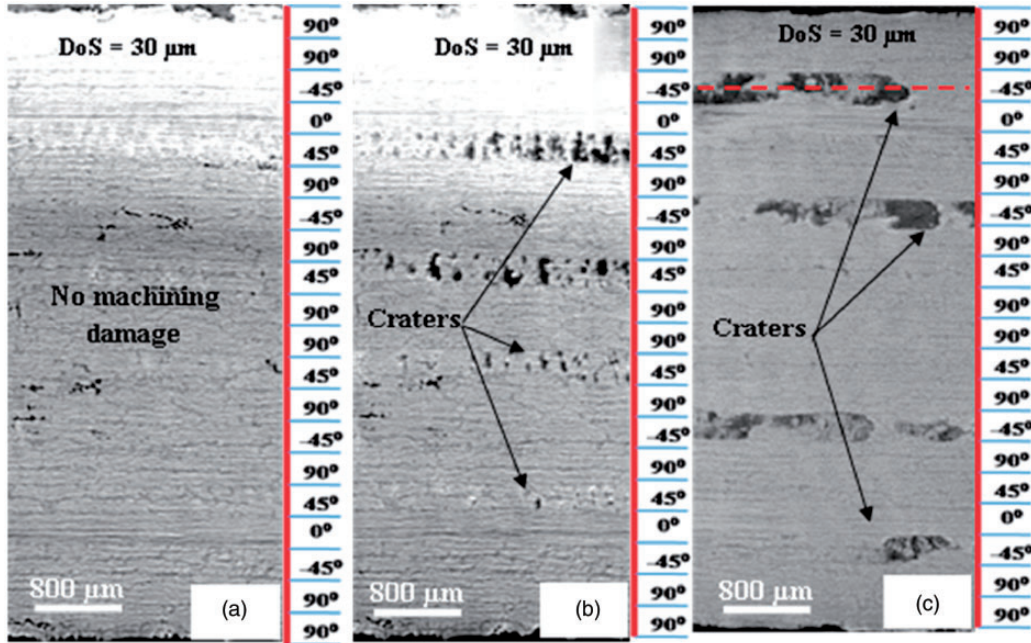
Figure 12. X-ray tomography images showing machining damage under machined surface of specimens in group A at depth of scanning of $30\ \mu\text{m}$ with various cutting parameters (a) good quality with $V_c = 150\ \text{m/min}$, $V_f = 500\ \text{mm/min}$, and $L_c = 0.28\ \text{m}$, (b) medium quality with $V_c = 150\ \text{m/min}$, $V_f = 1500\ \text{mm/min}$, and $L_c = 1.68\ \text{m}$, and (c) poor quality with $V_c = 339\ \text{m/min}$, $V_f = 29\ \text{mm/min}$, and $L_c = 0.28\ \text{m}$.

detailed in Nguyen-Dinh et al.²⁶ Figures 12 and 13 present the machining damage occurring under machined surface of group A and group B specimens, respectively. It can be seen that at the similar $30\ \mu\text{m}$ depth of scanning (DoS), defects generated during machining are not visualized in case of specimen with good quality. Nevertheless, in case of specimens with medium quality, the damage in the form of craters is observed mainly at the -45° layer positions of machined surfaces (Figure 12(b)). In particular, the level of damage, both frequency and altitude, increases in case of poor quality specimens (Figure 12(c)). The evolution of damage formed under machined surface also similarly varies from specimens with good quality to specimens with poor quality in case of group B. X-ray tomography images one more time confirm insistently the machining damage which is shown in Figures 8 and 10 for group A (Figures 9 and 11 for group B). The appearances of craters in machined surface can highly impact on the loading ability of composite specimens. The

of the right side of the specimen, then the 0° ply breaks (fiber failure) at the maximum load of 270 MPa (point b in the Figure 16). We can also refer to the layers shown in Figure 12 where the $-45^\circ/0^\circ$ interface is the first one to delaminate during compression, and 0° layer is the first ply to break during compression, and which are clearly damaged during the machining process.

crater volume and compressive strength in this group as previously mentioned. Additionally, for the main part, the failure of group A is due to delamination of 0/-45 interface, and we observed the -45° ply is strongly damaged during machining (Figure 12). Then the poor machining should more degrade this interface strength. For the group B, the final failure is mainly due to the global failure of the 0° plies, and we observed that the machining damage has little effect on the 0° plies.
