# Influence of machining damage generated during trimming of CFRP composite on the compressive strength

N Nguyen-Dinh, Christophe Bouvet, Redouane Zitoune

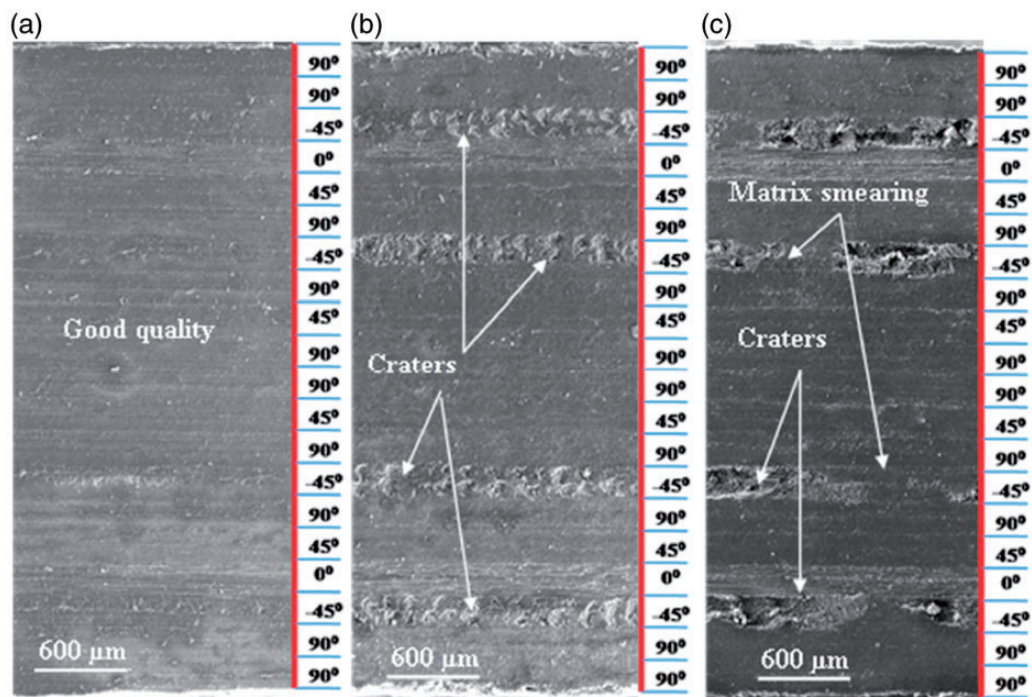
Figure 8. SEM images of machined surface for specimens of group A (a) good quality with  $V_c = 150$  m/min,  $V_f = 500$  mm/min, and  $L_c = 0.28$  m, (b) medium quality with  $V_c = 150$  m/min,  $V_f = 1500$  mm/min, and  $L_c = 1.68$  m, and (c) poor quality with  $V_c = 339$  m/min,  $V_f = 29$  mm/min, and  $L_c = 0.28$  m.

To visualize damage appearing in the machined surface of specimens which are selected for compression test (15 specimens and 12 specimens for group A and B, respectively), SEM observations have been carried out. Figure 8 presents the SEM images of specimens in group A machined at various cutting distances ( $L_c$ ). It can be seen that in case of good machining quality, it is difficult to distinguish the machined damage induced in the different layer orientations of

stacking sequence. However, in case of specimens with medium and poor surface quality, we observe that different kinds of defects in forms of craters, fiber pullout, and matrix smearing are visualized on the trimmed surfaces. These defects, however, are located in the  $-45^\circ$  layers (or  $45^\circ$  depending on the relative position between feed direction and fiber orientation). The difference between the levels of machining damage is strongly impacted by cutting parameters (cutting speed and feed speed) and the status of cutting tool (tool wear). The influences of these factors on the machining damage induced have been detailed in Nguyen-Dinh et al.<sup>26</sup> Similarly, the different levels of machining damage are also visualized in the machined surface of specimens in group B (Figure 9) where defects in forms of craters or holes are mainly observed in the  $-45^\circ$  layer fibers. Logically, the areas and depth of craters across machined surface with poor quality specimens seem more important than those with medium quality.

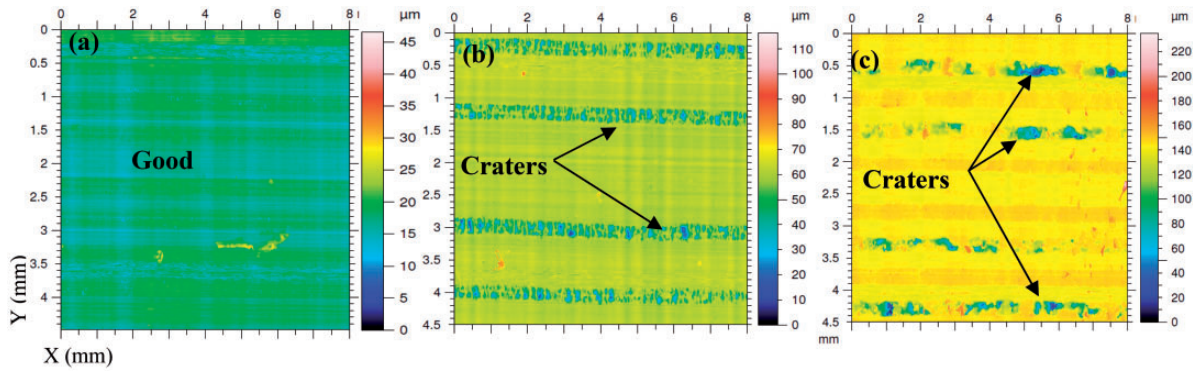
**Figure 10.** Topography profiles showing the appearances of craters on the machined surface for the group A (a) good quality with  $V_c = 150$  m/min,  $V_f = 500$  mm/min, and  $L_c = 0.28$  m, (b) medium quality with  $V_c = 150$  m/min,  $V_f = 1500$  mm/min, and  $L_c = 1.68$  m, and (c) poor quality with  $V_c = 339$  m/min,  $V_f = 29$  mm/min, and  $L_c = 0.28$  m.

Due to the incompetence of roughness criterion as mentioned earlier, it is necessary to suggest new parameters which better quantify machining damage to mechanical behaviors. Topographies are performed to provide the dimensional information of damage features. Topography profiles showing dimensional information of damage of specimens in group A and group B are presented in Figures 10 and 11, respectively.

Craters are dominantly observed, and their depth, area, and volume of crater vary with cutting parameters.<sup>26</sup> In this context, craters are estimated by their volume to quantify machining damage. It can be seen that the maximum depth of craters in the machined surface of specimen with good quality is around  $15\ \mu\text{m}$ . Nevertheless, this value increases 4 and 8 times in case of specimens with medium quality and poor quality, corresponding to  $60\ \mu\text{m}$  and  $120\ \mu\text{m}$ , respectively (Figure 10). Similarly, in case of group B specimens, the maximum depth of craters occurring in machined surface of specimens with good quality, medium quality, and poor quality approximately estimated by confocal technique are  $20\ \mu\text{m}$ ,  $70\ \mu\text{m}$ , and  $110\ \mu\text{m}$ , respectively (Figure 11). Based on these results, it can be said that topography profiles of specimens correctly reflect the damage forms which is demonstrated by SEM images. The total crater volumes in measured areas of tested specimens will be correlated to compressive strength in the last section of this paper.

have less influence on the load carrying capacity of the specimens (Figure 10(a)). On the contrary, specimens with poor quality provide full of matrix degradation covering in the machined surfaces, moreover subsurface damage is superior to that of specimens with good and medium quality (Figure 10(c)). These factors induce discontinuity of the stress state and induce delamination, thus, reducing load carrying ability and compressive strength of specimens.

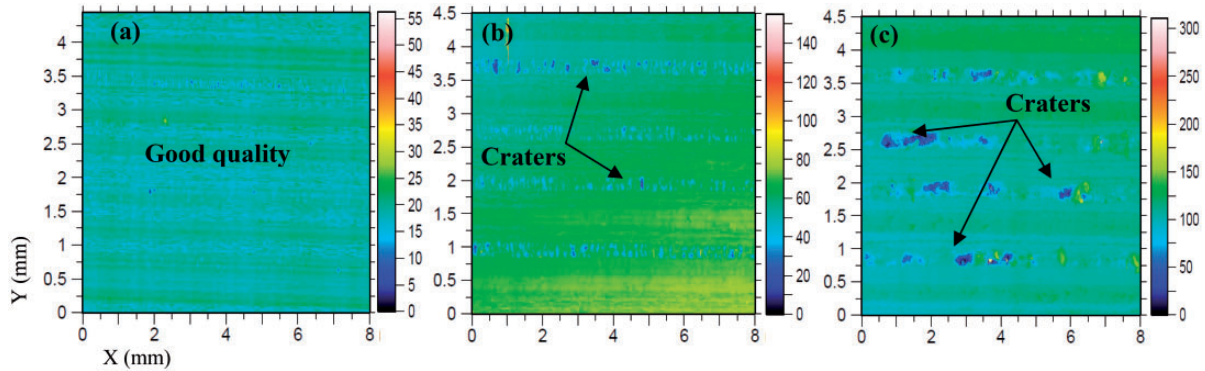
**Figure 11.** Topography profiles showing the appearances of craters on the machined surface for the group B (a) good quality with  $V_c = 150$  m/min,  $V_f = 500$  mm/min, and  $L_c = 0.28$  m, (b) medium quality with  $V_c = 150$  m/min,  $V_f = 1500$  mm/min, and  $L_c = 1.68$  m, and (c) poor quality with  $V_c = 339$  m/min,  $V_f = 29$  mm/min, and  $L_c = 0.28$  m.

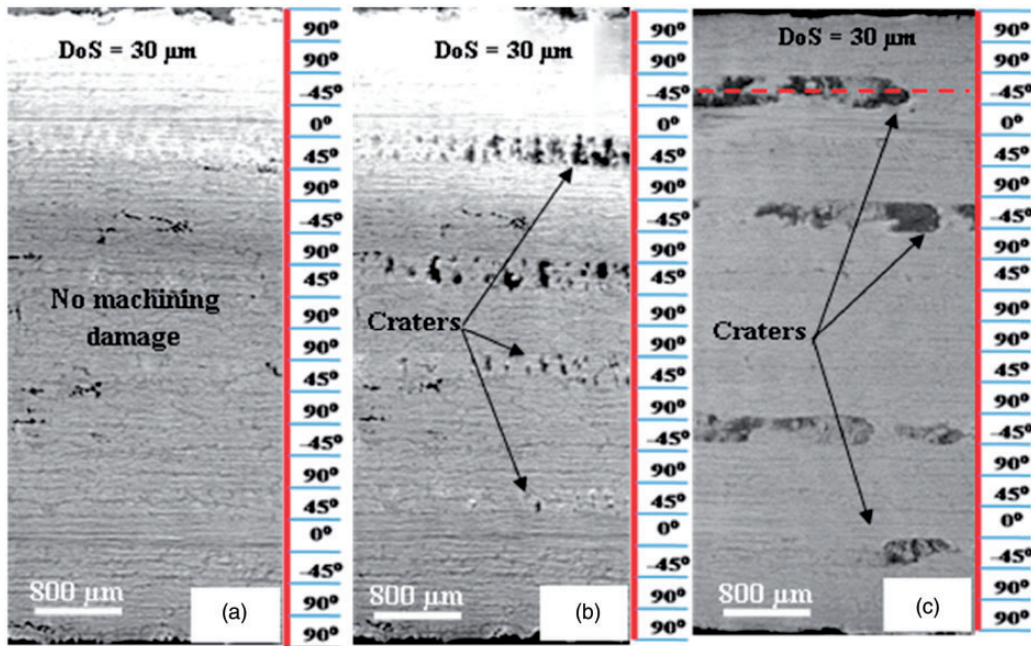
**Figure 12.** X-ray tomography images showing machining damage under machined surface of specimens in group A at depth of scanning of  $30\ \mu\text{m}$  with various cutting parameters (a) good quality with  $V_c = 150\ \text{m/min}$ ,  $V_f = 500\ \text{mm/min}$ , and  $L_c = 0.28\ \text{m}$ , (b) medium quality with  $V_c = 150\ \text{m/min}$ ,  $V_f = 1500\ \text{mm/min}$ , and  $L_c = 1.68\ \text{m}$ , and (c) poor quality with  $V_c = 339\ \text{m/min}$ ,  $V_f = 29\ \text{mm/min}$ , and  $L_c = 0.28\ \text{m}$ .

detailed in Nguyen-Dinh et al.<sup>26</sup> Figures 12 and 13 present the machining damage occurring under machined surface of group A and group B specimens, respectively. It can be seen that at the similar  $30\ \mu\text{m}$  depth of scanning (DoS), defects generated during machining are not visualized in case of specimen with good quality. Nevertheless, in case of specimens with medium quality, the damage in the form of craters is observed mainly at the  $-45^\circ$  layer positions of machined surfaces (Figure 12(b)). In particular, the level of damage, both frequency and altitude, increases in case of poor quality specimens (Figure 12(c)). The evolution of damage formed under machined surface also similarly varies from specimens with good quality to specimens with poor quality in case of group B. X-ray tomography images one more time confirm insistently the machining damage which is shown in Figures 8 and 10 for group A (Figures 9 and 11 for group B). The appearances of craters in machined surface can highly impact on the loading ability of composite specimens. The

of the right side of the specimen, then the  $0^\circ$  ply breaks (fiber failure) at the maximum load of 270 MPa (point b in the Figure 16). We can also refer to the layers shown in Figure 12 where the  $-45^\circ/0^\circ$  interface is the first one to delaminate during compression, and  $0^\circ$  layer is the first ply to break during compression, and which are clearly damaged during the machining process.

crater volume and compressive strength in this group as previously mentioned. Additionally, for the main part, the failure of group A is due to delamination of 0/-45 interface, and we observed the -45° ply is strongly damaged during machining (Figure 12). Then the poor machining should more degrade this interface strength. For the group B, the final failure is mainly due to the global failure of the 0° plies, and we observed that the machining damage has little effect on the 0° plies.

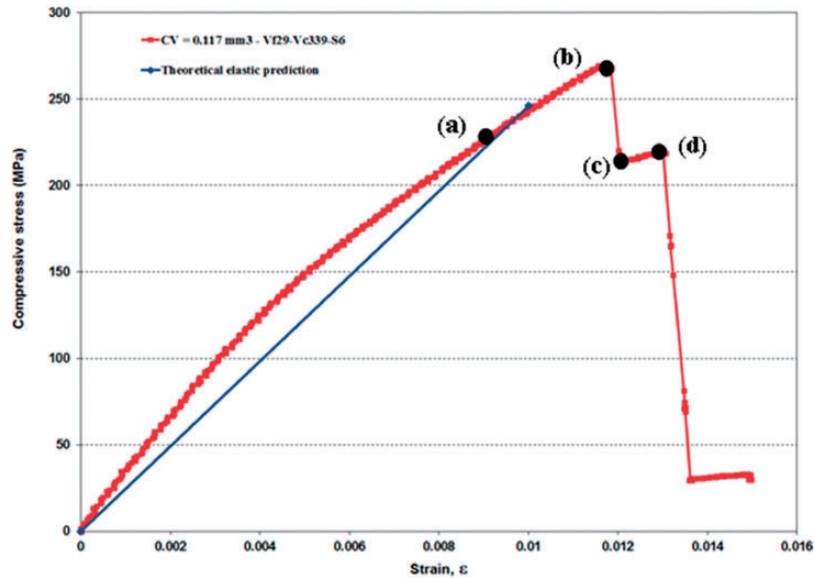
**Figure 16.** Evolution of the load vs displacement obtained for a representative specimen in group A.

It is observed that failure scenario can follow four steps (Figure 16):

- Step 1: The stress increases linearly up to a strain of 0.0035. This increase then becomes non-linear until the first break. It can be seen that the first damage is characterized by the appearance of a crack or delamination at the  $-45^\circ/0^\circ$  interface corresponding to the third and fourth layer of the laminate when the load reaches 220 MPa (point a in the Figure 16).
- Step 2: After that a propagation of crack is observed, and the propagation is accompanied with buckling

- Step 3: An abrupt reduction of load up to 210 MPa is noted corresponding to the delamination of the  $-45^\circ/0^\circ$  interface at the left side and to the compressive fiber failure of the  $0^\circ$  ply (point c in the Figure 16).
- Step 4: Finally, a slight increase in the load up to 215 MPa is observed corresponding to appearance of total fracture (point d in the Figure 16).

theoretical elastic prediction can be noticed (Figure 16). This elastic prediction was done using the classical laminate theory and the material characteristic given in Table 1. The objective of this prediction was to better understand the experimental test and in particular to evaluate a theoretical compressive failure stress of the pristine sample; this point will be discussed in the next section “The influence of machining damage on the compressive strengths”. This difference between the experimental and the theoretical stiffness (Figure 16) should be partially due to the fact that the strain is evaluated with a linear extrapolation of the displacement measured by the machine, and the extrapolation coefficient is evaluated using the extensometer data and the test beginning. Then the strain measurement should be taken with caution. Of course, the best would have been to use extensometer in the gage part of the sample, but this part is too short to avoid the buckling of the

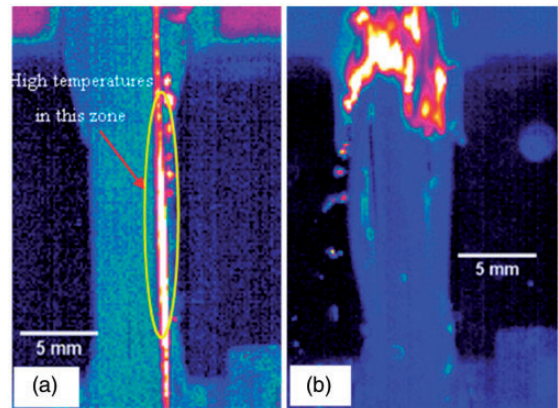
**Figure 22.** Images obtained by the infrared camera during compressive loading on a tested specimen of group B (a) appearance of the first crack in  $90^\circ/-45^\circ$  interface (the fourth and fifth layer) and (b) final break.

samples were put on the grips ends. Moreover, the non-linearity is more or less pronounced depending on the tests (Figure 19). Then first crack/break (point a of the Figure 21), which is schematically presented in Figure 20, occurs in the  $90^\circ/45^\circ$  interface of the two layers corresponding to fourth and fifth layers in stacking sequence, when stress reaches value of 540 MPa (Figure 22(a)).

- Step 2: This crack propagates till the appearance of final break at maximum stress of 790 MPa (point b of the Figure 20). The final break occurs at the end zone of the tightening of the grips which is also a zone of important shear stress (Figure 22(b)).

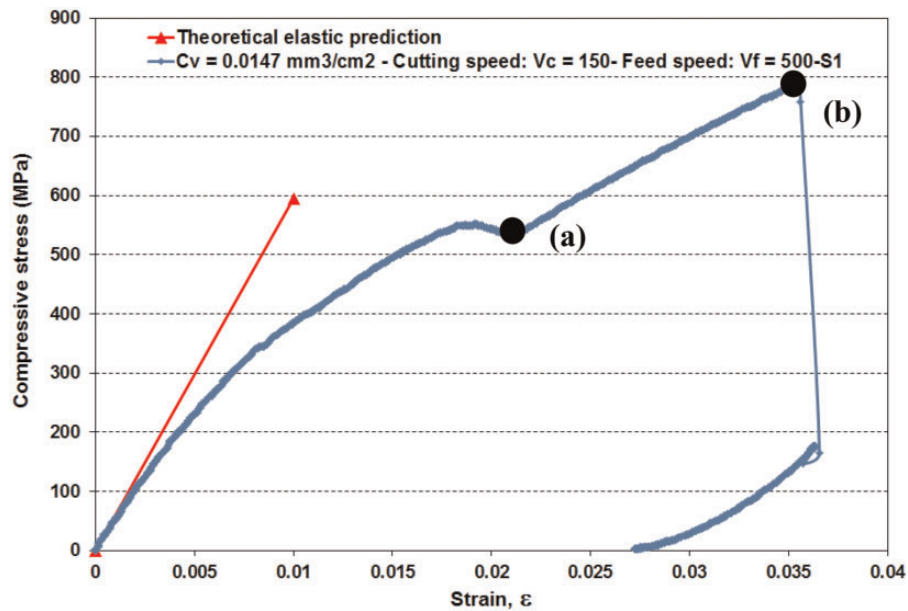
**Figure 21.** Evolution of the load vs displacement obtained for a representative specimen in group B.

To better understand the failure scenario of this group, a stress–strain curve of a specimen, which is considered as good surface quality with crater volume of  $0.0147 \text{ mm}^3/\text{cm}^2$ , is chosen to be the representative of all specimens in group B (Figure 21).

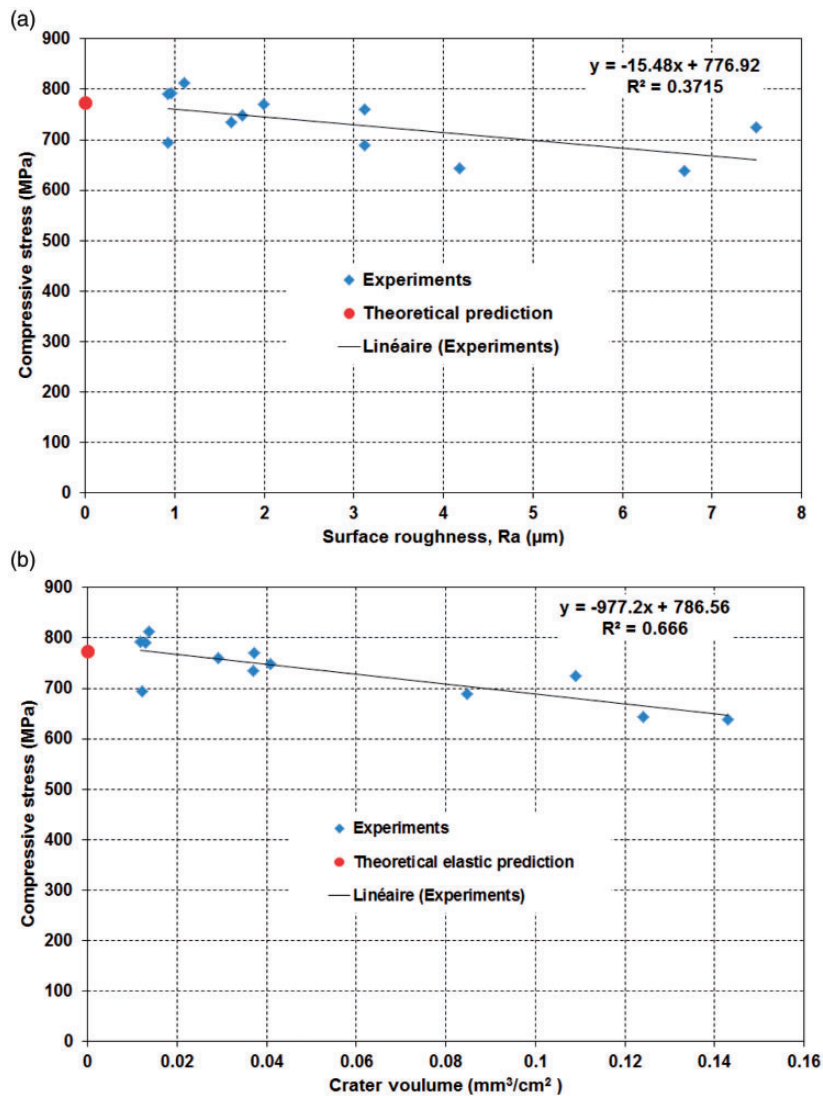
**Figure 24.** Evolution of compressive strength as a function of (a) surface roughness and (b) crater volume for tested specimens in group B.

Regarding the correlation between surface quality and compressive strength in group B, the identical behaviors are also observed (Figure 24). It means that an increase in surface roughness or crater volume reduces the compressive strength, and the relations between crater volume and compressive strength

(R-squared of 0.666) are more realistic than that between surface roughness and compressive strength (R-squared of 0.375). Moreover, it is noticed that the correlation between crater volume and compressive strength of specimens in group A is more consistent than that of specimens in group B. This can be due to the difference in stacking sequence of each type specimen which causes some unavoidable phenomena during the static test. Indeed, in case of group B, after testing of two first specimens we realized that slippage between specimens and tabs occurs (with detachment of the tabs). For this reason, the loading application in two sides of tabs and in the end of specimens for specimens in this group was performed. Some deformations of specimens, as well as small slippage might appear which could reduce the correlation between

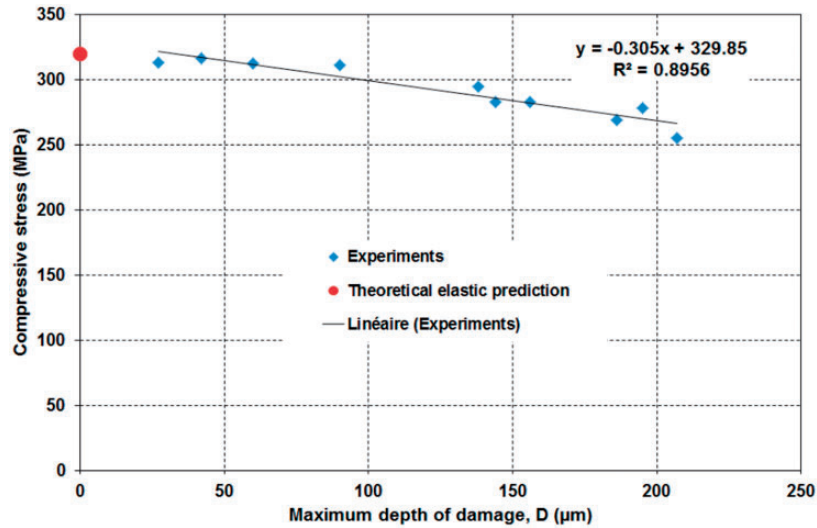
**Figure 25.** Evolution of compressive strength as a function of maximum depth of damage for tested specimens in group A.

To correlate maximum depth of machining damage (depth of craters), 10 tested specimens in group A were selected to X-ray tomography investigation. Figure 25 presents the evolution of compressive strength as a function of maximum depth of damage (D). Based on this figure, it can be observed that the correlation between maximum depth of damage and compressive strength is very good; indeed the R-squared value reaches almost 0.9. This result is realistic and logical because the holes/craters generated during machining are quantified in terms of depth where stress concentration factor plays an important role to reduce loading ability of composite structures during services.
