## Comparison of long-term natural aging to artificial aging in Duralumin

Magali Brunet, Benoit Malard, Nicolas Ratel-Ramond, Christophe Deshayes,  
Bénédicte Warot-Fonrose, Philippe Sciau, Joël Douin

Magali Brunet, Benoit Malard, Nicolas Ratel-Ramond, Christophe Deshayes, Bénédicte Warot-Fonrose, et al.. Comparison of long-term natural aging to artificial aging in Duralumin. The 17th International Conference on Aluminium Alloys 2020 (ICAA17), MATEC Web of Conferences, 326, pp.04007, 2020, 10.1051/mateconf/202032604007 . hal-03058720

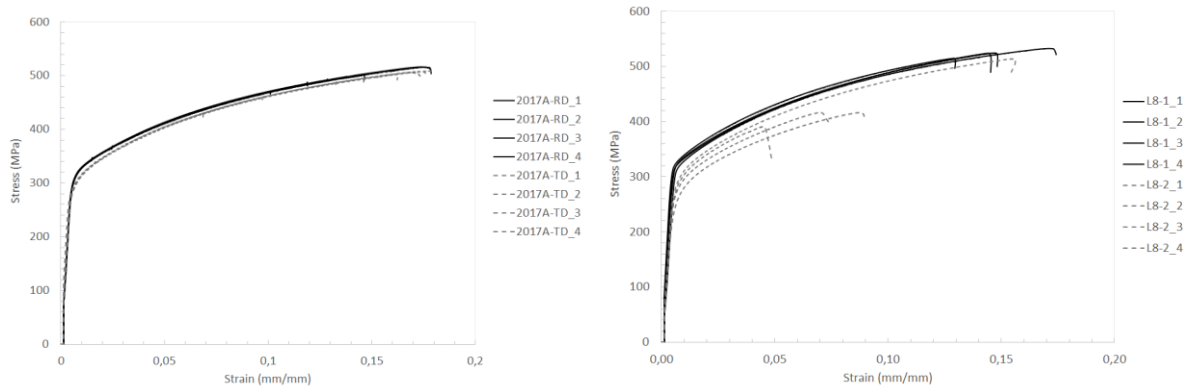
**Fig. 1.** True Stress/Strain curve in two orientations a) RD and TD for 2017A and b) D1 and D2 for L8 in as-received state.

The engineering stress-strain curves for the modern plate (2017A) and the old plate (L8), both in the as-received state are shown in Figure 1 for two directions: rolling direction (RD) and transverse direction (TD). For L8, a circular plate, it was not possible to identify straightforwardly the directions [10]: a labelling D1

and D2 was thus used. They are supposedly the rolling and transverse direction respectively. Figure 1.a reveals that tensile strength curves exhibit good reproducibility for 2017A. On the old alloy however, a heterogeneous behaviour is observed. Early failure occurs quite often in direction D2, the estimated transverse direction. Table 1 summarizes the main mechanical properties. If early-failed specimens are not taken into account, the yield strength (YS), the ultimate tensile strength (UTS) and the elongation are conformed to the expectation for such alloy [15].

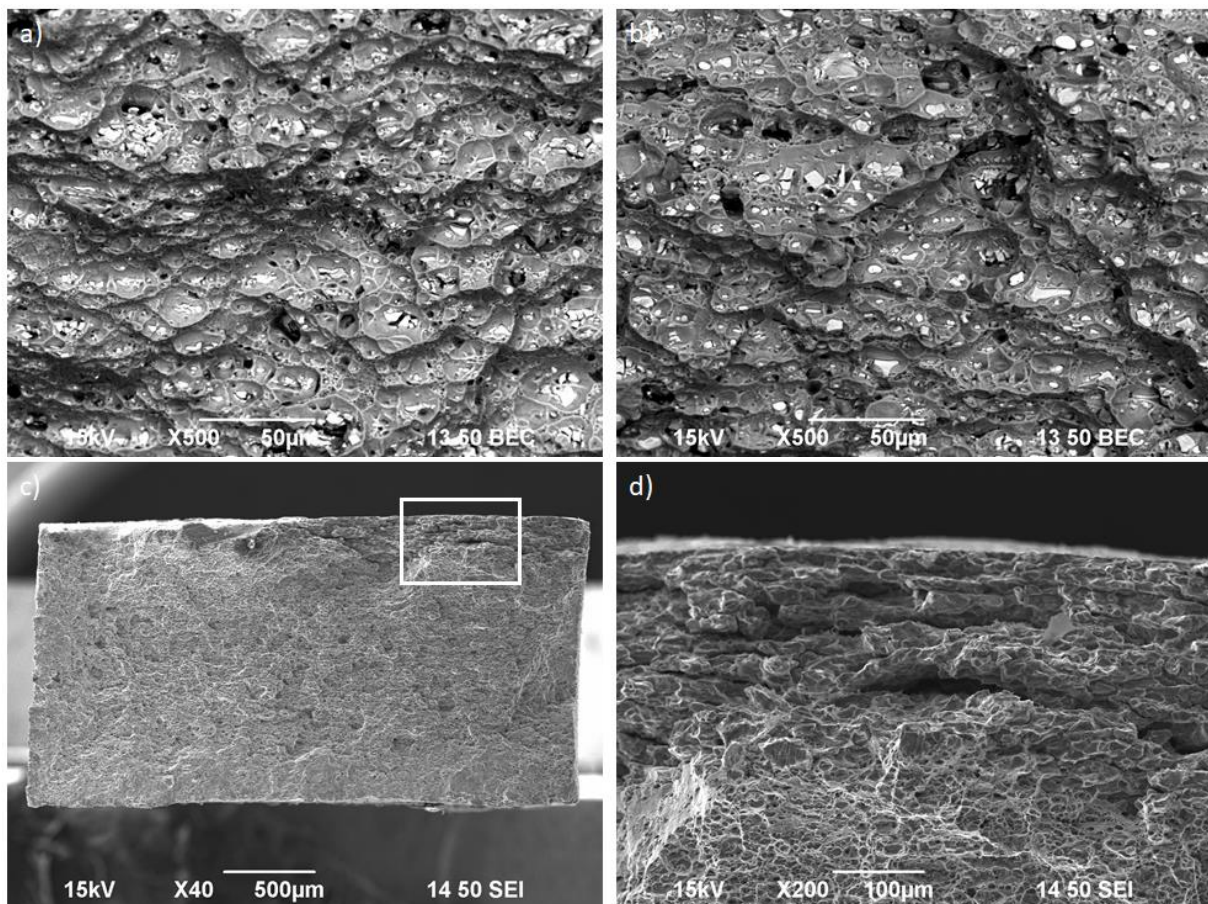
**Fig. 2.** SEM photographs of fracture surface in back-electron scattering mode for a) 2017A-AR, b) L8-AR. Images c) and d) in secondary electron mode, show fracture due to intergranular corrosion on L8-AR in the transverse direction.

Fracture surface analysis was carried out by SEM on post-mortem specimens. Figure 2 presents images representative of each alloy. On both alloys, equiaxed dimples were observed, typically present for ductile fracture caused by uniaxial tensile load. This type of fracture processes by microvoid coalescence. Microvoids nucleate at particles such as precipitates. After nucleation, the voids grow in the direction of the applied tensile stress. The dimples caused by coarse intermetallics are clearly visible in the microstructure of both alloys. Coarse intermetallics in 2017A-type alloys are well-identified: AlMnFeSi mostly (large, grey particles with faceted morphology) together with  $\text{Al}_2\text{Cu}$  (round and bright) and  $\text{Mg}_2\text{Si}$  (dark). They are quite numerous in both samples. Extremely small dimples were also present which could be caused by intragranular precipitation.

In the old alloy (L8), on all the early-failed specimens occurring mainly in the transverse direction, decohesive fracture along grain boundaries were observed (see framed area in Figure 2c and d.). Intergranular corrosion, unspotted before testing on the specimens, seems to be the main cause of this rupture mode. It is known that alloys of the 2xxx series are susceptible to stress-corrosion cracking and that the sensitivity depends strongly on the grain orientation. The transverse direction is thus the most susceptible to cracking, which is observed here.

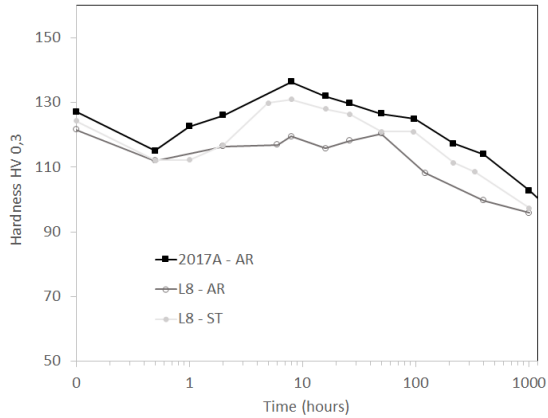
**Fig. 3.** Hardness HV0.3 measurement in the rolling direction of modern alloy 2017A and L8 (A-U4G) when aging at 180°C from an as-received state (AR) and after solution treatment (ST).

Microhardness was measured versus the aging time at 180°C for both plates, in as-received state (AR) and after a solution treatment (ST). Because the materials exhibit similar hardness in three orientation (RD, TD and ND), only hardness in RD is plotted in Figure 3. Artificial aging (180°C) was first applied on the as-received samples. For 2017A alloy, in the early stages of the treatment at 180°C, the hardness is decreasing

Aging treatment at 180°C was then re-applied. In this case, hardness of the old alloy follows the behaviour of the alloy 2017A, reaching a maximum after 8h (see curve L8-ST in Figure 3). It can be concluded that the history of the Breguet's plate was erased. Its aging is thus reversible.

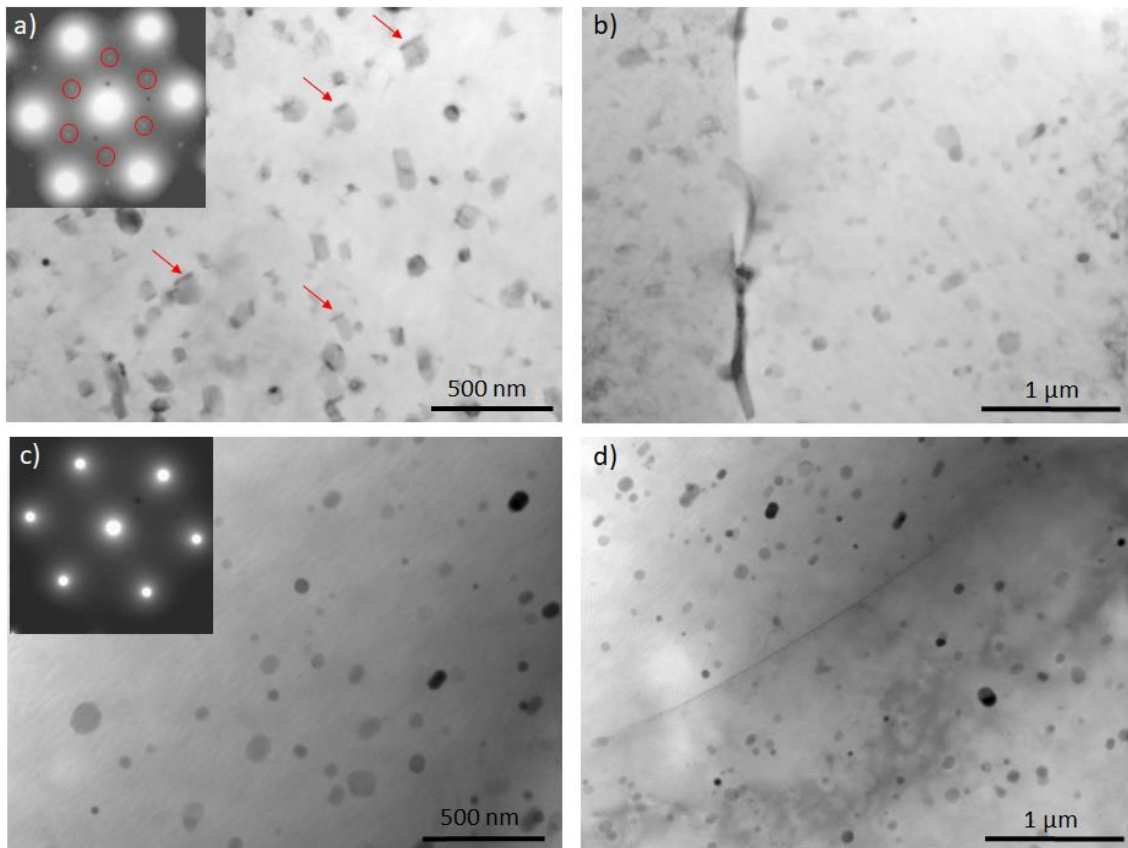
**Fig. 4.** BF-TEM images in  $[110]_{Al}$  zone axis with corresponding SAD patterns of a) and b) L8-AR; c) and d) L8-ST.

On L8-AR, TEM observations (see Figure 4.a and 4.b) reveal a precipitation at grain boundaries and the presence of a precipitation on dispersoids. The precipitation is marked by arrows in BF-TEM image (Figure 4a) and circles in the corresponding selected area diffraction (SAD) pattern. This phase corresponds to  $\Omega$ -Al<sub>2</sub>Cu phase, as identified in [13] on similar Duralumin. No other precipitation is observed in this sample by TEM but it was verified by small angle X-ray scattering (SAXS) that GPZ/clusters are present in this state (see Figure 5). The results show indeed two main contributions: one in the low q-range ( $0.002 < q < 0.1 \text{ \AA}^{-1}$ ) with a  $q^{-4}$  contribution, attributed to large precipitates (dispersoids) and one at high q-range ( $0.1 < q < 1 \text{ \AA}^{-1}$ ), a plateau attributed to GPZ or small clusters in the alloy matrix.

At grain boundaries, the precipitation nature is Al<sub>2</sub>Cu. Precipitation on dispersoids and at grain boundaries could be the sign of the heat experienced by the plate during its life-time. After solution treatment (ST), precipitation on dispersoids and at grain boundaries has disappeared: see Figure 4.c and 4.d.

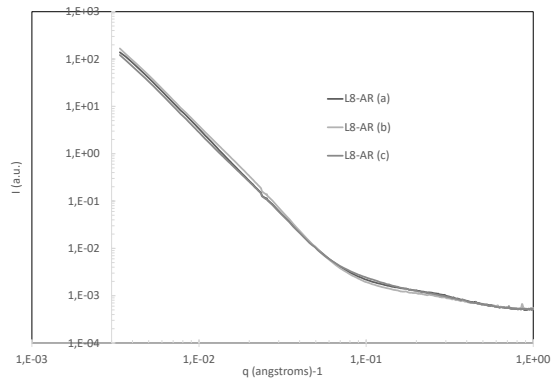
**Fig. 5.** SAXS curves for L8 (3 different zones) in the as-received state.

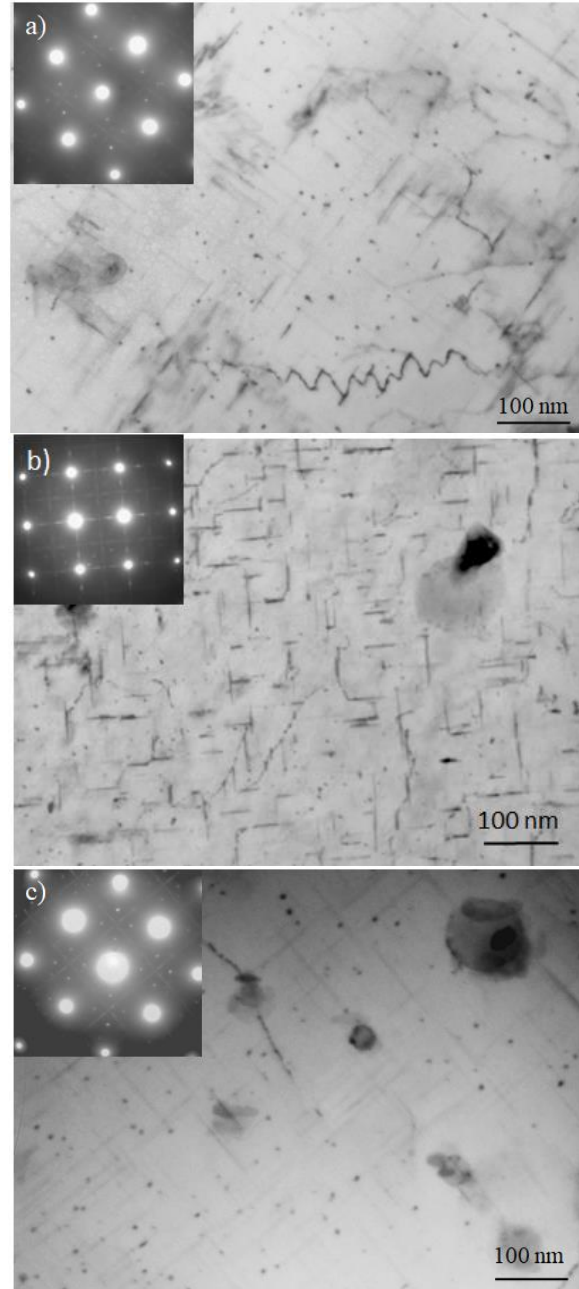
**Fig. 6.** BF TEM images in [110]<sub>Al</sub> zone axis a) L8\_180°C/8h; b) 2017A\_180°C/8h; c) L8\_ST-180°C/8h

The nanostructure is then observed for 2017A and L8 after treatment at 180°C for 8h corresponding to peak hardening. It is shown in Figure 6. The observations of the old plate (Figure 6.a) reveals the presence of a variety of phases:

- the hardening  $\theta''$ -Al<sub>3</sub>Cu phase identified in the SAD patterns thanks to the discontinuous streaks along [200]<sub>Al</sub> [16],
- the  $\theta'$ -Al<sub>2</sub>Cu phase (platelets) identified thanks to faint spots (110)<sub>θ'</sub> at 1/2 of (220)<sub>Al</sub>,
- the Q'(Q)-AlCuMgSi phase which are rods observed end-on in the [100]<sub>Al</sub> direction in the BF images,
- the  $\Omega$ -Al<sub>2</sub>Cu phase with diffraction spots at 1/3 and 2/3 of the [022]<sub>Al</sub> orientation.

This precipitates zoology is equivalent to the one found in the modern 2017A alloy in the same aging conditions (Figure 6.b and [13]). Measurements of the hardening precipitates ( $\theta''$ -Al<sub>3</sub>Cu and  $\theta'$ -Al<sub>2</sub>Cu platelets) are reported in Table 3. On average, platelets are  $86 \pm 29$  nm long for L8\_180°C/8h and  $60 \pm 15$  nm long for 2017A\_180°C/8h. The difference is not significant enough to conclude. However, a much higher number of dislocations are found in the old plate indicating some work-hardening of the L8 plate during its shaping or during its lifespan.

After ST followed by aging at 180°C for 8h, the nanostructure is observed again: see Figure 6.c. The platelets are measured: in the old plate, they are  $65 \pm 18$  nm, and dislocations have disappeared.

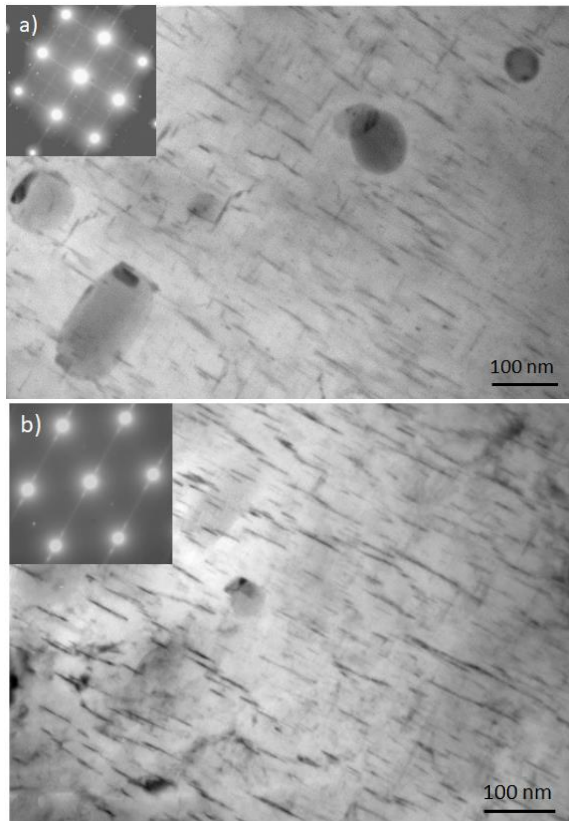
**Fig. 7.** BF-TEM images of 2017A alloy thermally aged at 100°C for 10,000h in a)  $[100]_{Al}$  zone axis and b) in  $[110]_{Al}$  zone axis.

The microstructure corresponding to an aging time of 10 000h at 100°C is shown in Figure 7 and the one for 5h at 180°C in Figure 8.

In the SAD patterns in two zone axes ( $[100]_{Al}$  and  $[110]_{Al}$ ), for the 2017A alloy heat treated at 100°C for 10,000h, we observe discontinuous streaks along  $[200]_{Al}$  with maximum intensities at  $(100)_{Al}$  corresponding to the  $\theta''$ - $Al_3Cu$  phase. The  $\theta'$ - $Al_2Cu$  precipitates, if present, have a low volume density. The  $Q'(Q)$ - $AlCuMgSi$  phase was observed in the BF images (rods seen end-on oriented along  $[001]_{Al}$  direction) but the precipitates are also very few. The diffraction patterns, similar as the ones seen in [16], indicate that the alloy is just before peak hardening. Figure 8 provides the confirmation of a nanostructure very close to the one previously presented (for 8h at 180°C). The length of the hardening precipitates in the two aging conditions, is of the same order of magnitude (see Table 4). A major difference can be found for the  $\Omega$ - $Al_2Cu$  phase: this phase was hardly seen in the 2017A alloy aged at 100°C for 10,000h: diffraction spots are not visible in the SAD patterns (inserts of Figure 7.a and 7.b). However, the phase can be seen on dispersoids in BF-TEM images. It is concluded that the phase is present but in very little quantities and with no significant influence.

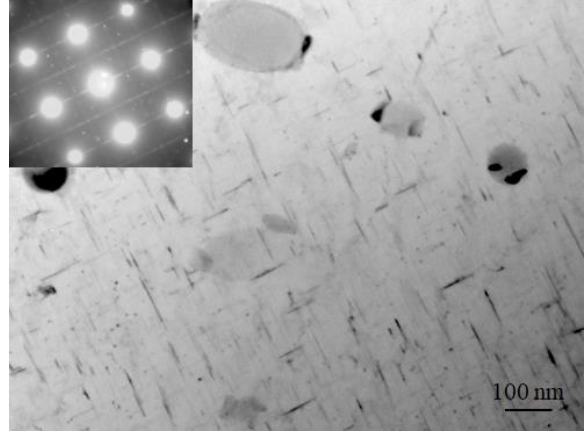
**Fig. 8.** BF-TEM images of 2017A alloy thermally aged at 180°C for 5h in  $[100]_{Al}$  zone axis.
