Comparison of long-term natural aging to artificial aging in Duralumin

Comparison of long-term natural aging to artificial aging in Duralumin.

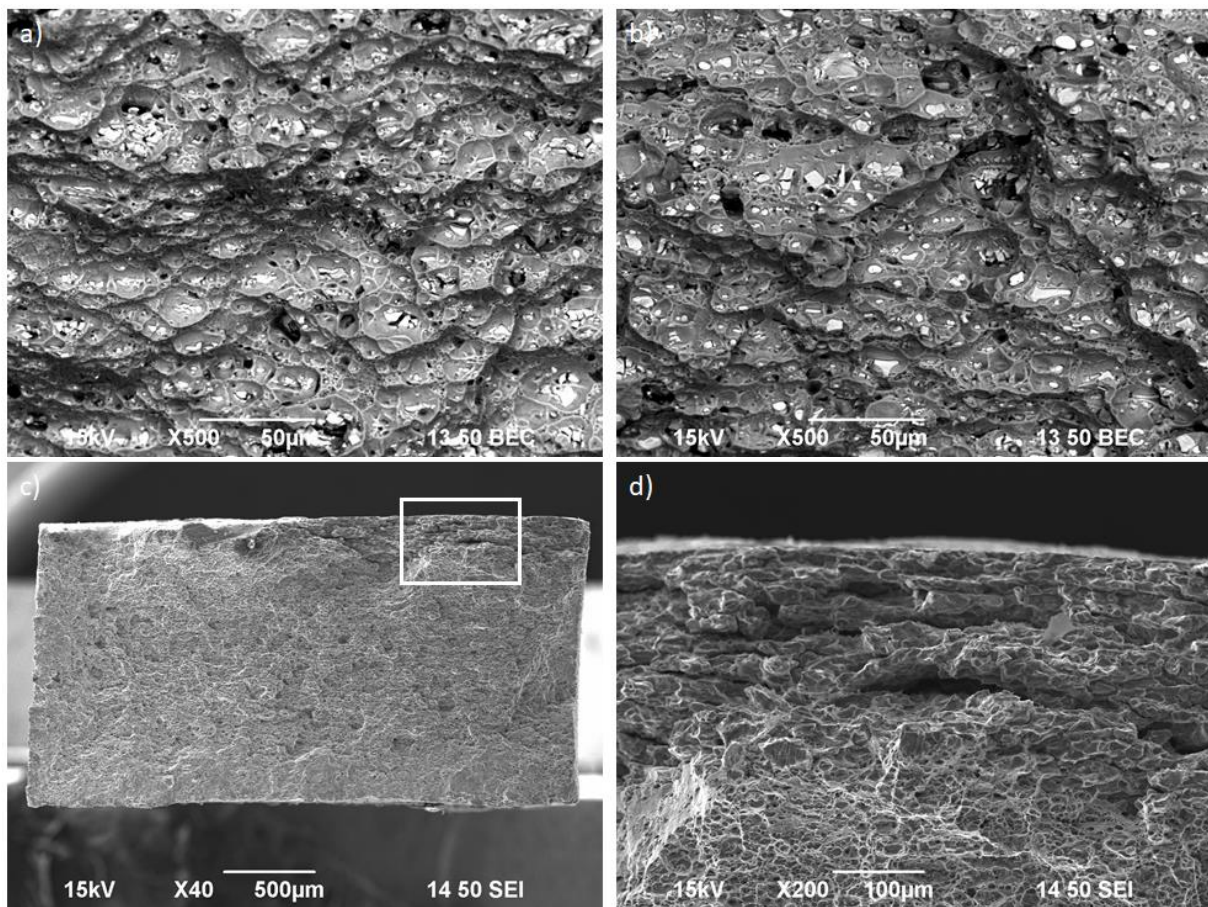
Fracture surface analysis was carried out by SEM on post-mortem specimens. Figure 2 presents images representative of each alloy. On both alloys, equiaxed dimples were observed, typically present for ductile fracture caused by uniaxial tensile load. This type of fracture processes by microvoid coalescence. Microvoids nucleate at particles such as precipitates. After nucleation, the voids grow in the direction of the applied tensile stress. The dimples caused by coarse intermetallics are clearly visible in the microstructure of both alloys. Coarse intermetallics in 2017A-type alloys are well-identified: AlMnFeSi mostly (large, grey particles with faceted morphology) together with Al_2Cu (round and bright) and Mg_2Si (dark). They are quite numerous in both samples. Extremely small dimples were also present which could be caused by intragranular precipitation.

In the old alloy (L8), on all the early-failed specimens occurring mainly in the transverse direction, decohesive fracture along grain boundaries were observed (see framed area in Figure 2c and d.). Intergranular corrosion, unspotted before testing on the specimens, seems to be the main cause of this rupture mode. It is known that alloys of the 2xxx series are susceptible to stress-corrosion cracking and that the sensitivity depends strongly on the grain orientation. The transverse direction is thus the most susceptible to cracking, which is observed here.

Fig. 2. SEM photographs of fracture surface in back-electron scattering mode for a) 2017A-AR, b) L8-AR. Images c) and d) in secondary electron mode, show fracture due to intergranular corrosion on L8-AR in the transverse direction.

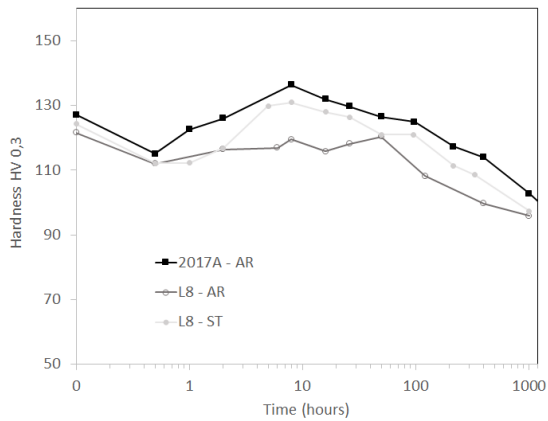
Microhardness was measured versus the aging time at 180°C for both plates, in as-received state (AR) and after a solution treatment (ST). Because the materials exhibit similar hardness in three orientation (RD, TD and ND), only hardness in RD is plotted in Figure 3. Artificial aging (180°C) was first applied on the as-received samples. For 2017A alloy, in the early stages of the treatment at 180°C, the hardness is decreasing

Aging treatment at 180°C was then re-applied. In this case, hardness of the old alloy follows the behaviour of the alloy 2017A, reaching a maximum after 8h (see curve L8-ST in Figure 3). It can be concluded that the history of the Breguet's plate was erased. Its aging is thus reversible.

Fig. 3. Hardness HV0.3 measurement in the rolling direction of modern alloy 2017A and L8 (A-U4G) when aging at 180°C from an as-received state (AR) and after solution treatment (ST).

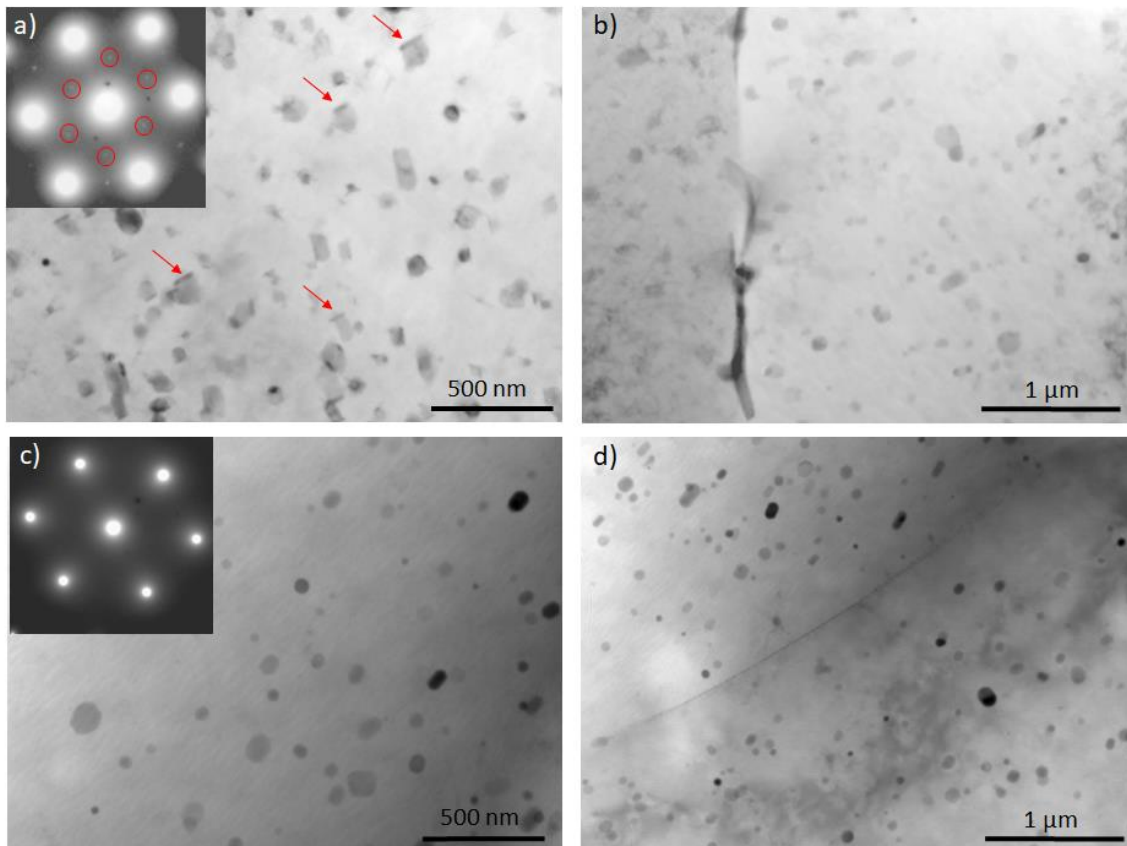
On L8-AR, TEM observations (see Figure 4.a and 4.b) reveal a precipitation at grain boundaries and the presence of a precipitation on dispersoids. The precipitation is marked by arrows in BF-TEM image (Figure 4a) and circles in the corresponding selected area diffraction (SAD) pattern. This phase corresponds to Ω -Al₂Cu phase, as identified in [13] on similar Duralumin. No other precipitation is observed in this sample by TEM but it was verified by small angle X-ray scattering (SAXS) that GPZ/clusters are present in this state (see Figure 5). The results show indeed two main contributions: one in the low q-range ($0.002 < q < 0.1 \text{ \AA}^{-1}$) with a q^{-4} contribution, attributed to large precipitates (dispersoids) and one at high q-range ($0.1 < q < 1 \text{ \AA}^{-1}$), a plateau attributed to GPZ or small clusters in the alloy matrix.

At grain boundaries, the precipitation nature is Al₂Cu. Precipitation on dispersoids and at grain boundaries could be the sign of the heat experienced by the plate during its life-time. After solution treatment (ST), precipitation on dispersoids and at grain boundaries has disappeared: see Figure 4.c and 4.d.

Fig. 4. BF-TEM images in $[110]_{Al}$ zone axis with corresponding SAD patterns of a) and b) L8-AR; c) and d) L8-ST.

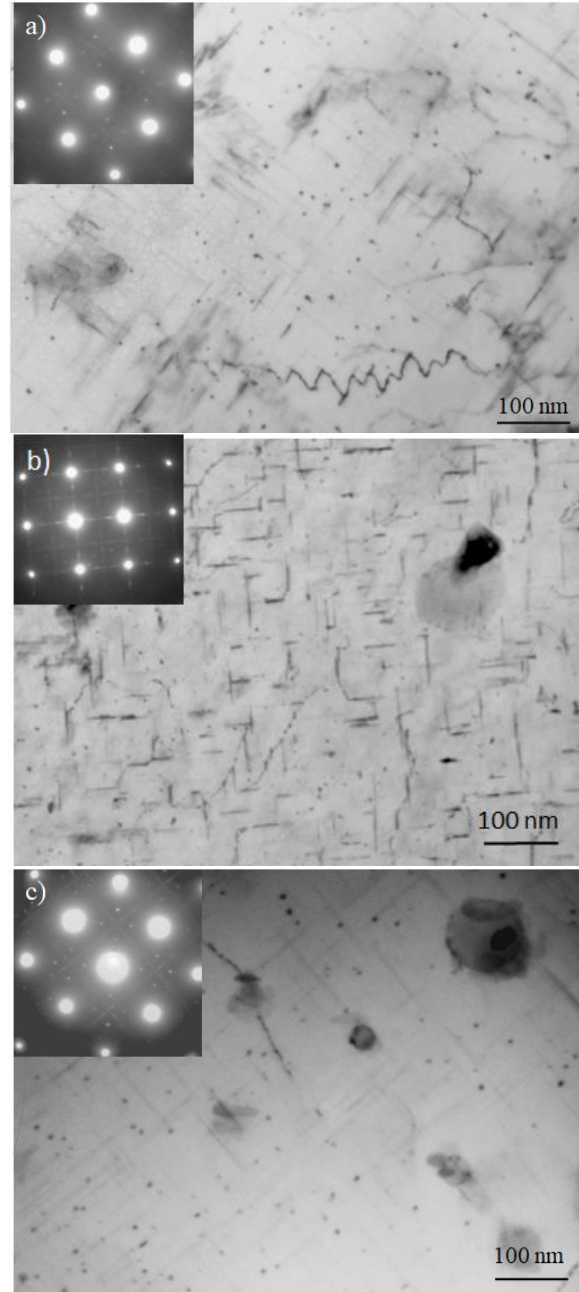
The nanostructure is then observed for 2017A and L8 after treatment at 180°C for 8h corresponding to peak hardening. It is shown in Figure 6. The observations of the old plate (Figure 6.a) reveals the presence of a variety of phases:

- the hardening θ'' -Al₃Cu phase identified in the SAD patterns thanks to the discontinuous streaks along [200]_{Al} [16],
- the θ' -Al₂Cu phase (platelets) identified thanks to faint spots (110)_{θ'} at 1/2 of (220)_{Al},
- the Q'(Q)-AlCuMgSi phase which are rods observed end-on in the [100]_{Al} direction in the BF images,
- the Ω -Al₂Cu phase with diffraction spots at 1/3 and 2/3 of the [022]_{Al} orientation.

This precipitates zoology is equivalent to the one found in the modern 2017A alloy in the same aging conditions (Figure 6.b and [13]). Measurements of the hardening precipitates (θ'' -Al₃Cu and θ' -Al₂Cu platelets) are reported in Table 3. On average, platelets are 86 ± 29 nm long for L8_180°C/8h and 60 ± 15 nm long for 2017A_180°C/8h. The difference is not significant enough to conclude. However, a much higher number of dislocations are found in the old plate indicating some work-hardening of the L8 plate during its shaping or during its lifespan.

After ST followed by aging at 180°C for 8h, the nanostructure is observed again: see Figure 6.c. The platelets are measured: in the old plate, they are 65 ± 18 nm, and dislocations have disappeared.

Fig. 6. BF TEM images in [110]_{Al} zone axis a) L8_180°C/8h; b) 2017A_180°C/8h; c) L8_ST-180°C/8h
