Study of post-impact behaviour of thin hybrid carbon/epoxy and glass/epoxy woven composite laminates under fatigue tensile loading – Part I: Experimental study

A. Rogani, Pablo Navarro, Steven Marguet, Jean-François Ferrero, C. Lanouette

Study of post-impact behaviour of thin hybrid carbon/epoxy and glass/epoxy woven composite laminates under fatigue tensile loading - Part I : experimental study

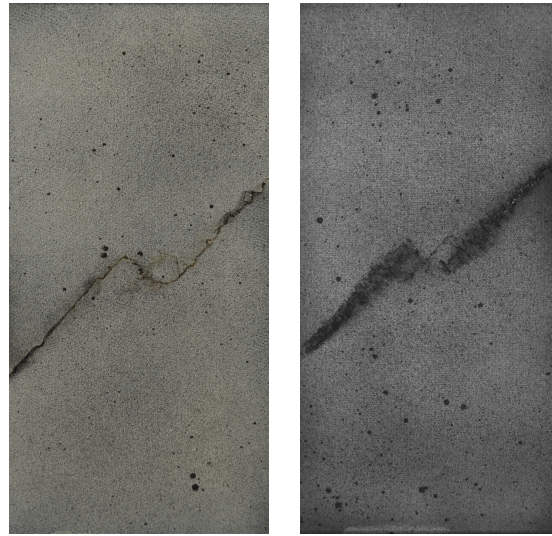
Figure 10: Fracture surfaces obtained after fatigue tensile test on impacted sample of configuration G0C45C45

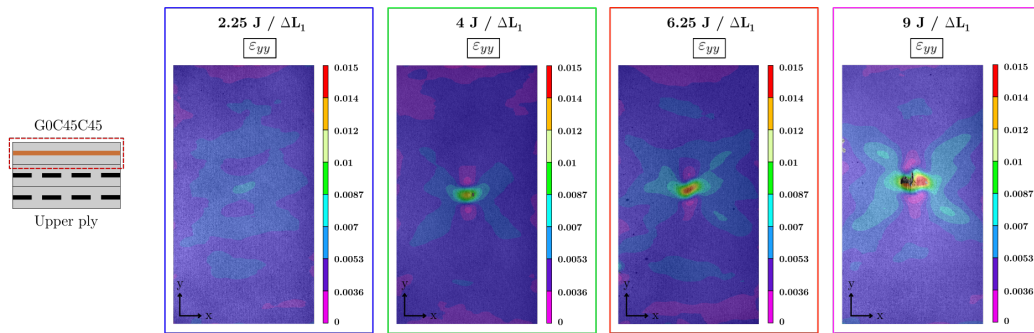
Figure 14: Strain field ε_{yy} in the glass ply of an impacted sample of configuration G0C45C45 at the beginning of the fatigue tensile loading depending on the impact energy

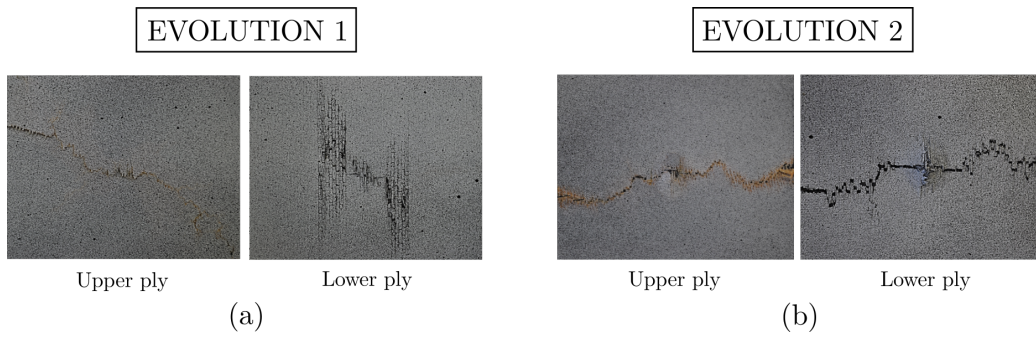
Figure 16: Two post-impact damage evolutions obtained after fatigue tensile test on impacted sample of configuration G0C45C0

displacement level (Figure 16) :

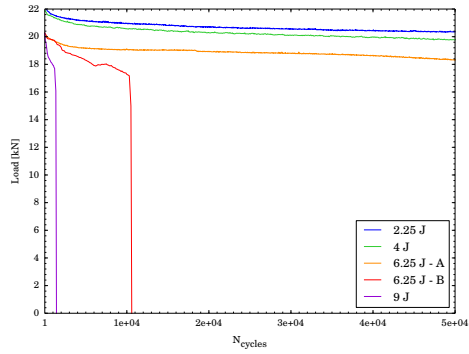
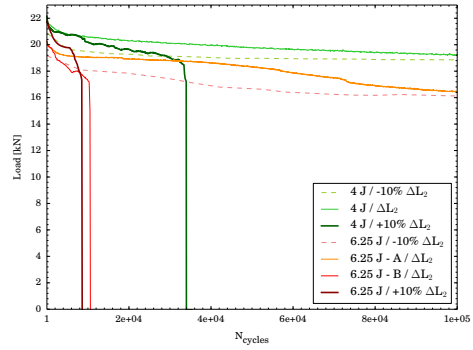
Figure 17: Load evolution depending on the number of cycles for the configuration G0C45C0

The curves on Figure 17 show that the load decreases faster i.e the damage propagation accelerates with the increase of the impact energy or the loading level. For instance, Figure 25 presents the damage in the upper and lower plies at 500 000 cycles for several impact energies and displacement levels. An increase of these levels leads to a more important propagation of fibres breakages in the glass ply and a more developed matrix damage in the vertical and horizontal directions in the lower ply. More, the number of cycles at the glass ply failure decrease with this increase (Table 6).

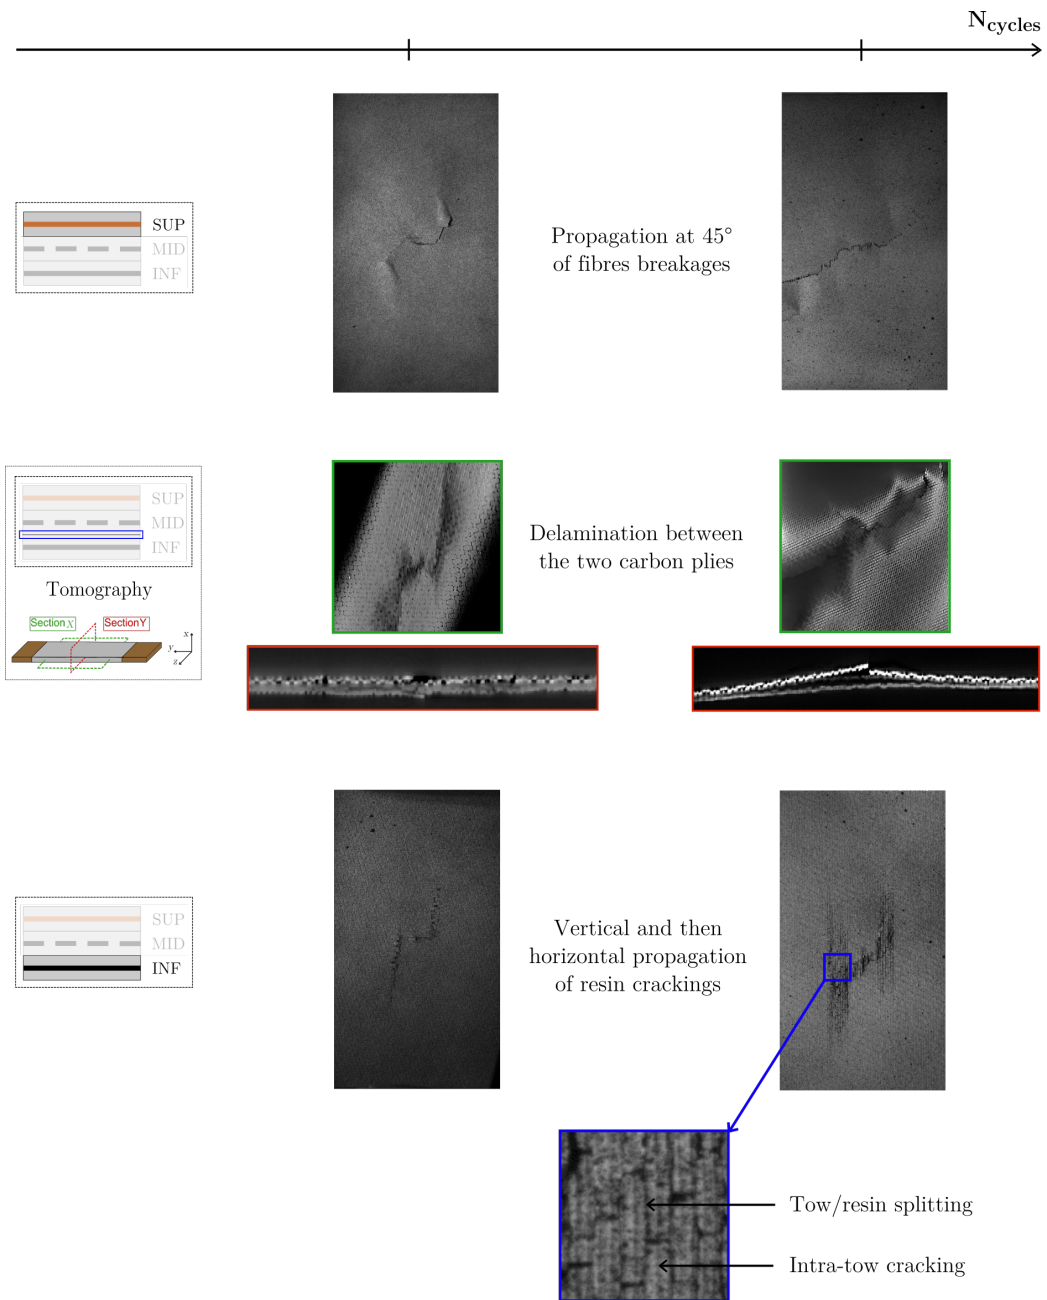
Figure 18: Post-impact damage propagation scenario obtained for a sample of configuration G0C45C0 subject to a fatigue tensile test

For the evolution 1, the load decreases progressively. It is due to the progression of the post-impact damage in the sample. Figure 18 presents the damage propagation observed by RX tomography. Fibres breakages propagate at $\pm 45^\circ$ in the glass ply. Vertical matrix damaging propagates in the lower carbon ply. Delamination propagates between the two carbon plies. If the number of cycles increases, the fibres breakages in the glass ply reaches the edges of the sample. Furthermore, delamination growths and the matrix damage in the lower carbon ply progresses vertically but also horizontally.

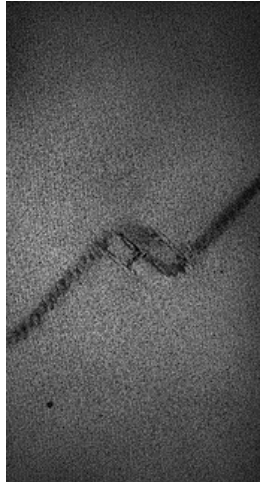
Figure 19: Fracture surfaces obtained after fatigue tensile test on impacted carbon woven laminate of configuration C45C45

For the configuration C45C45, the post-impact damage propagates at $\pm 45^\circ$ (Figure 19). RX tomographies realized after fatigue loadings indicate no presence of fibers breakages but the development of two types of matrix damaging : tow/resin splittings and intra-tows crackings (Figure 20). The damage monitoring based on DIC indicates that the propagation initiates with tows/resin splittings from each tip of the initial fibres breakages. They

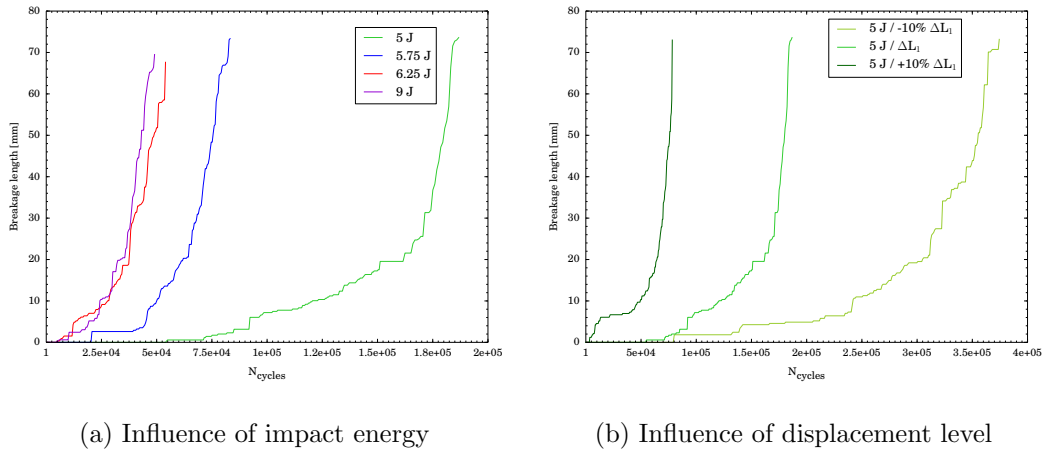
Figure 22: Fibres breakages length evolution depending on the number of cycles in the configuration V0V0

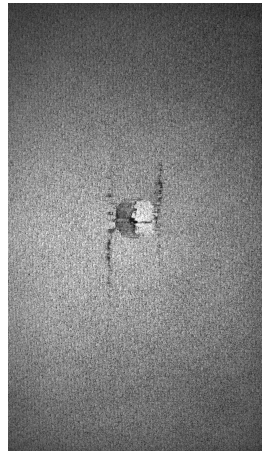
Figure 23: Fracture surfaces obtained after fatigue tensile test on impacted carbon woven laminate of configuration C0C0

Second of all, the damage propagation observed for G0C45C0 configuration is analyzed with the help of damage propagation results on C0C0 samples. Indeed, the vertical damage propagation observed in the lower carbon ply oriented at $(0/90)^\circ$ is explained by the observations made during a fatigue tensile test on an impacted sample of configuration C0C0. Indeed, in this case, the post-impact damage also propagates vertically (Figure 23).

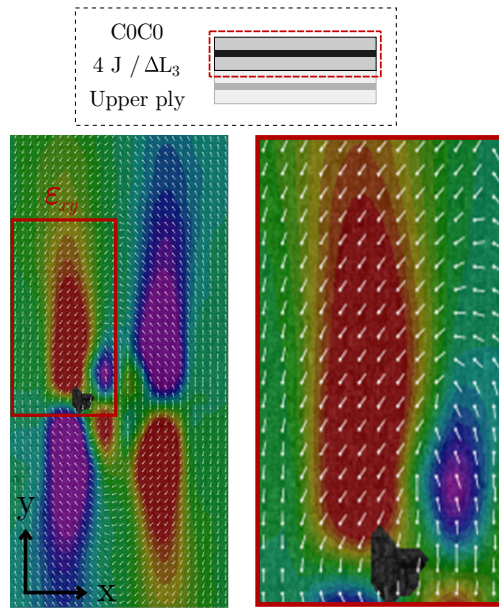
Figure 24: Strain field ε_{xy} obtained during fatigue tensile test in the upper ply of an impacted carbon woven laminate of configuration C0C0

The DIC indicates the presence of vertical areas strongly loaded in shear (Figure 24). The damage propagates into this areas and is governed by resin damaging. In fact, RX tomography shows the emergence of tows/resin splittings and intra-tows crackings.

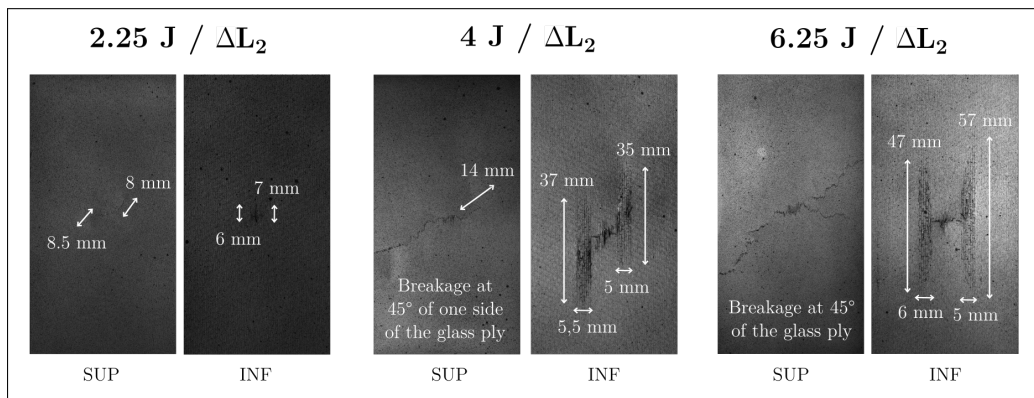
Figure 25: Influence of the impact energy and the displacement level on the damage propagation of evolution 1 in the upper and lower plies of an impacted sample of configuration G0C45C0

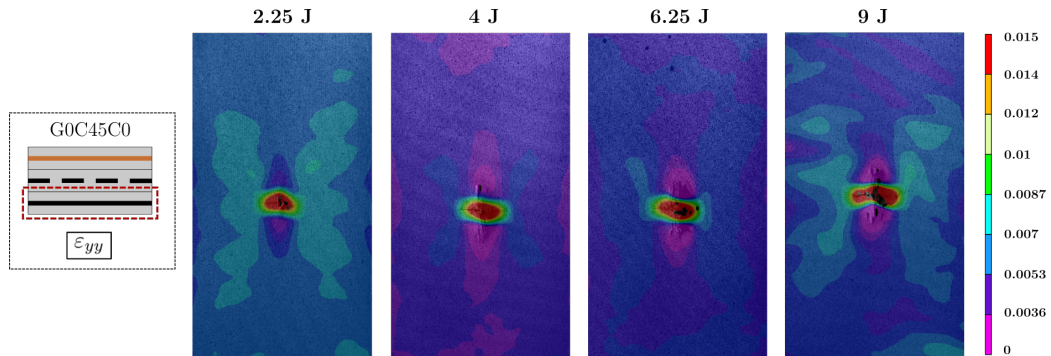
Figure 26: Strain field ε_{yy} in the lower carbon ply of an impacted sample of configuration G0C45C0 at the beginning of the fatigue tensile loading depending on the impact energy

The change of the post-impact damage scenario is obtained by an increase of the impact energy (post-impact damage size) or the displacement level. In fact, the fibres in the lower carbon ply are more loaded in tension at the beginning of the tensile fatigue test (Figure 26). Their breakage leads to the evolution 2 with a fast and simultaneous propagation of fibres breakages in each ply as in quasi-static.

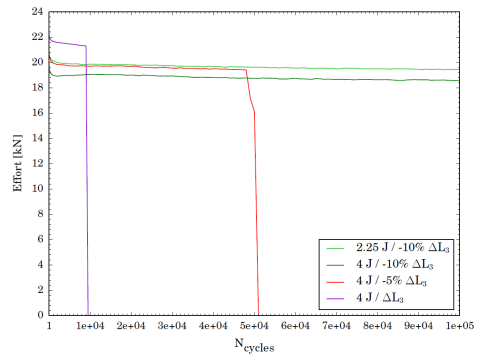
Figure 31: Load evolution depending on the number of cycles, impact energy and displacement level for the configuration G0C0C45

gates at $\pm 45^\circ$ in the lower carbon ply and delamination progresses between the glass ply and the middle carbon ply (Figure 30). In this case, the increase of the impact energy leads to a faster damage propagation. The vertical propagation of the damage in the glass ply indicates that, as for the laminate G0C45C0, the glass ply elongation is monitored by the middle carbon ply. Thus, the change of the stacking sequence modifies the damage propagation scenario in the glass ply. In fact, the load curves show that the final failure of the glass ply never occurs for these samples (Figure 31).
