Qalhât Development Project, Season 2015B-2016A, Final Report

SEASON 2015B-2016A

Excavations on the Ceramic Workshop B41

I-B. The 2015b-2016a season - 1. Excavations of the southeast part of the Mosque (Spans 1 and 2)

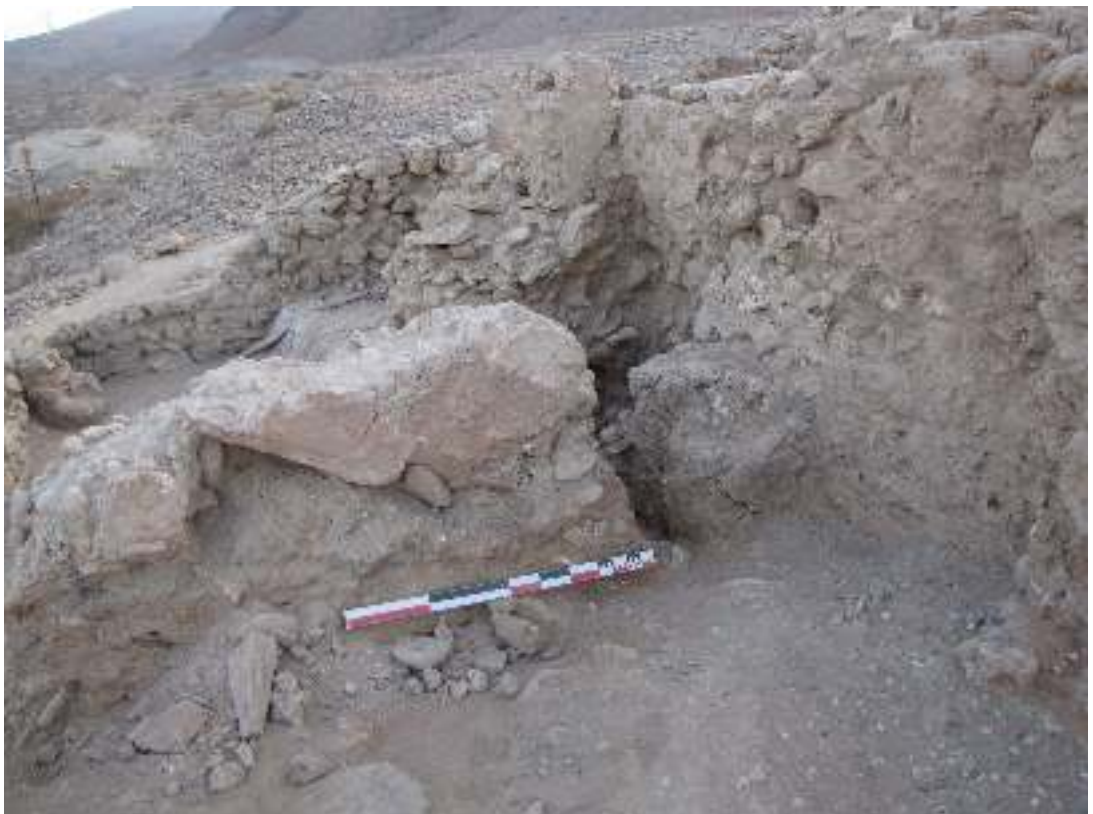
Fig 1-8 : *the buttress B12-347, at right of the fallen pillar that was once standing above*

To the south, the buttress **B12-347 Fig 1-8** is built against the walls B12-277/281, in the alignment of the wall B12-278 which separates the room B12-L and B12-R. 1m long by 0.40m wide, its elevation is only preserved for around 1m high, the upper part having collapsed. It is built in the same way as buttress B12-322, with medium corals and limestone blocks and bigger ones at the angles, bounded with a gray mortar and showing remains of coating. Its size and location also clearly indicate that it was bearing a pillar of the first floor. As a matter of fact, remains of the pillar were found at the foot of the buttress, with a cubic basis and two drums of the octagonal column that once supported the roof of the entrance hall. The collapsing of this pillar is undoubtedly the reason for the disappearing of the upper part of the buttress. The setting of the massive buttresses in this area is similar to the setting in the other parts of the basement, showing the

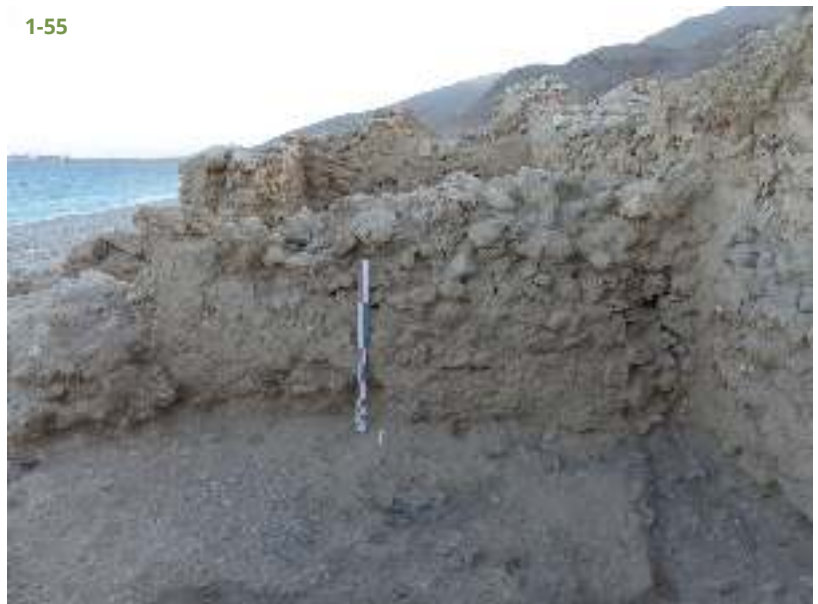
Fig 1-55 : the wall B12-292 in room B12-S

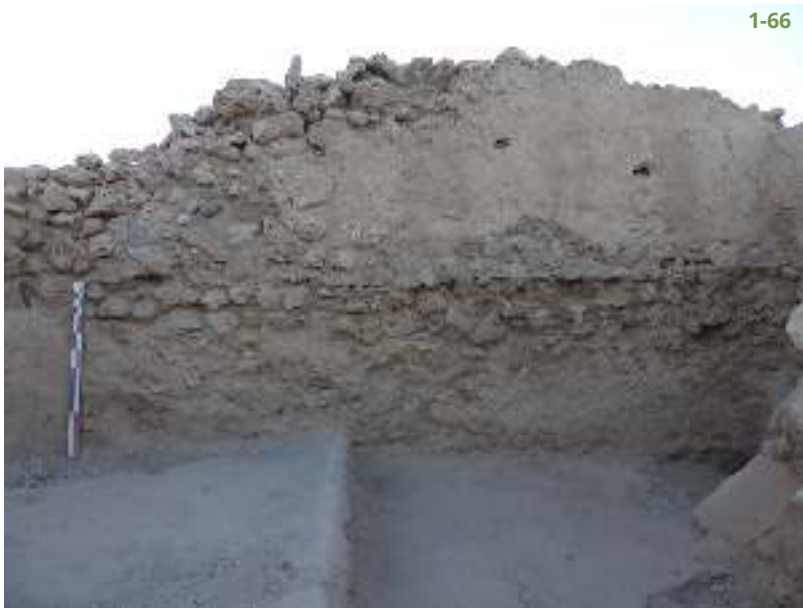
Fig 1-66 : the wall B12-110 in room B12-R

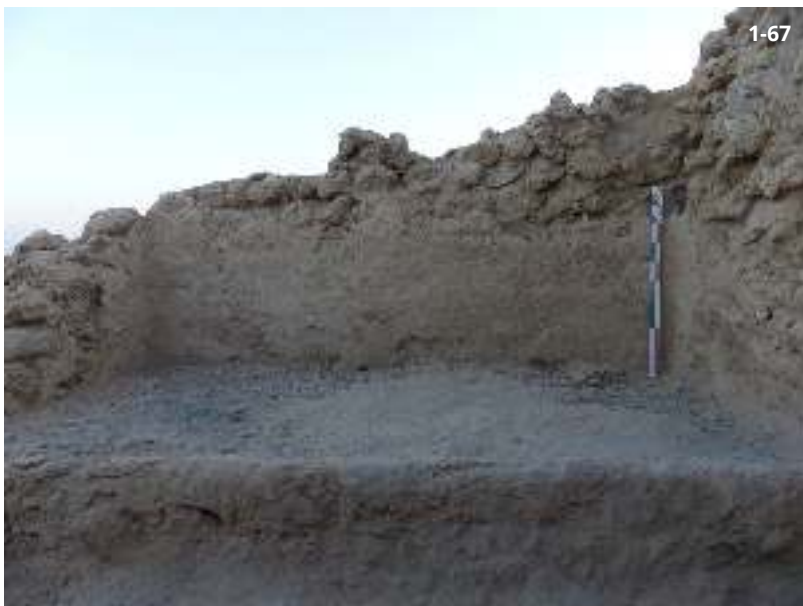
Fig 1-67 : the wall B12-42 in room B12-R

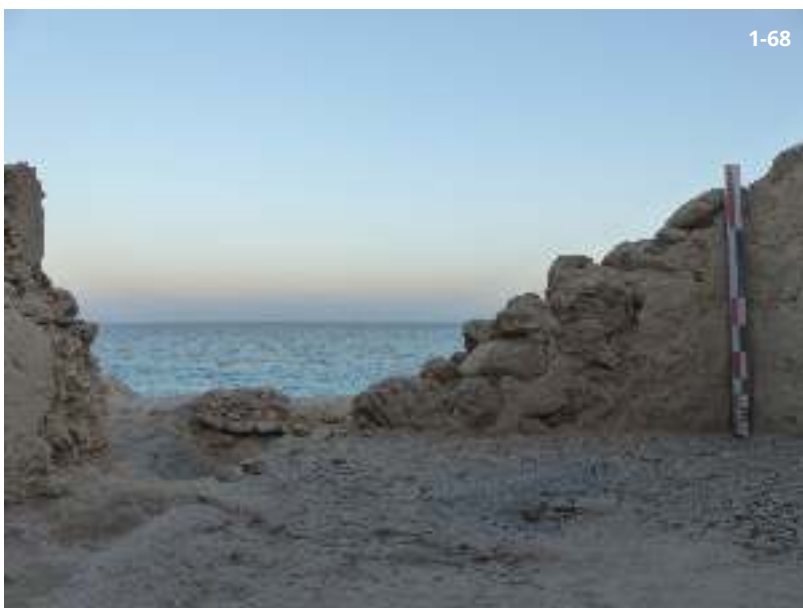
Fig 1-68 : the wall B12-276 in room B12-R

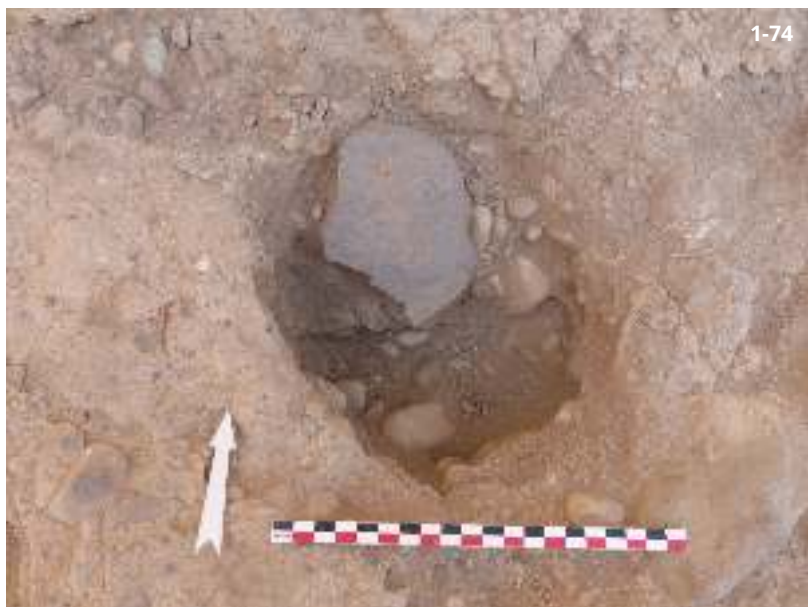
Fig 1-74 : the posthole B12-342, half excavated

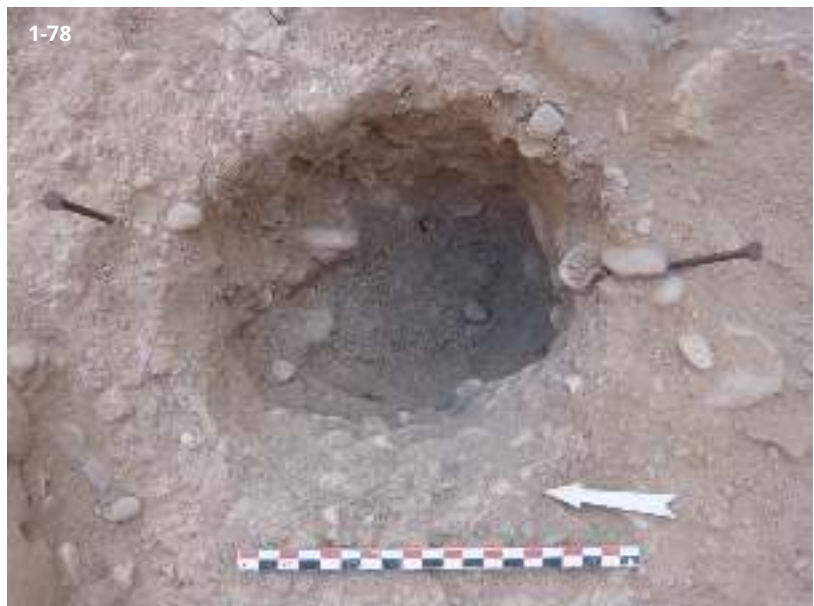
Fig 1-78 : the posthole
B12-318, fully excavated

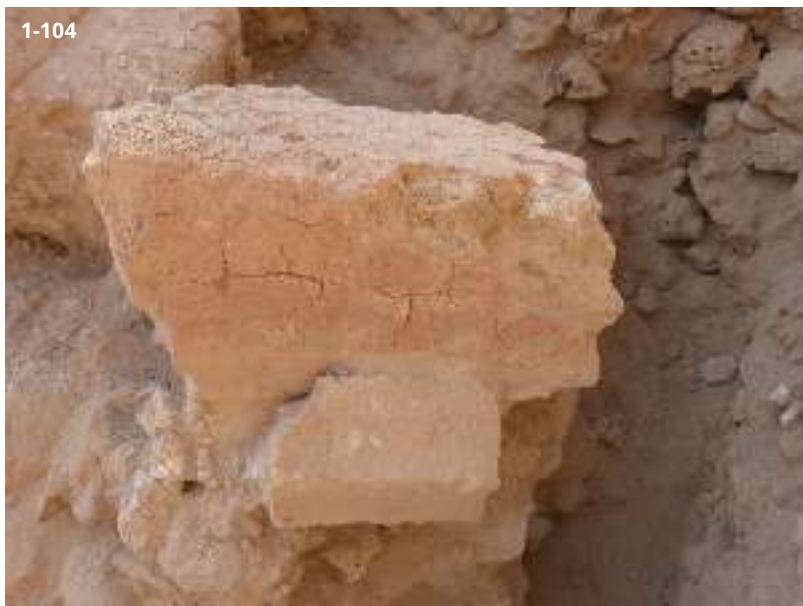
Fig 1-104 : the architectural element IsoArc 512, fragment of jamb of a gate with molding

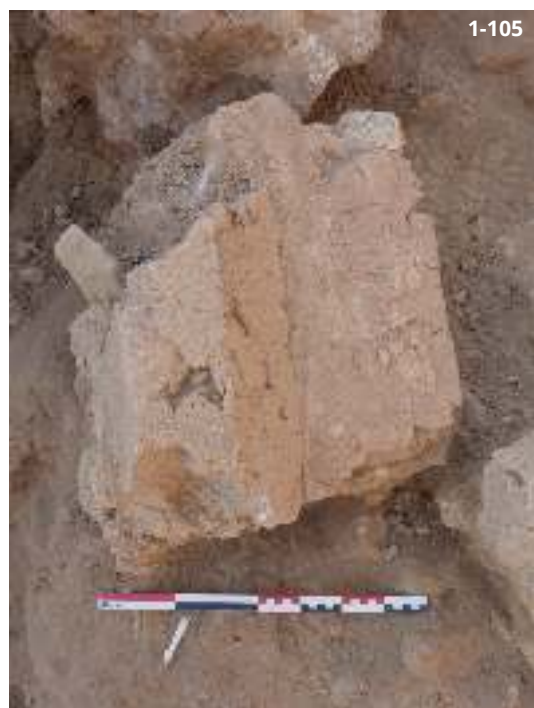
Fig 1-105 : the architectural element IsoArc 515, fragment of jamb of a gate with molding

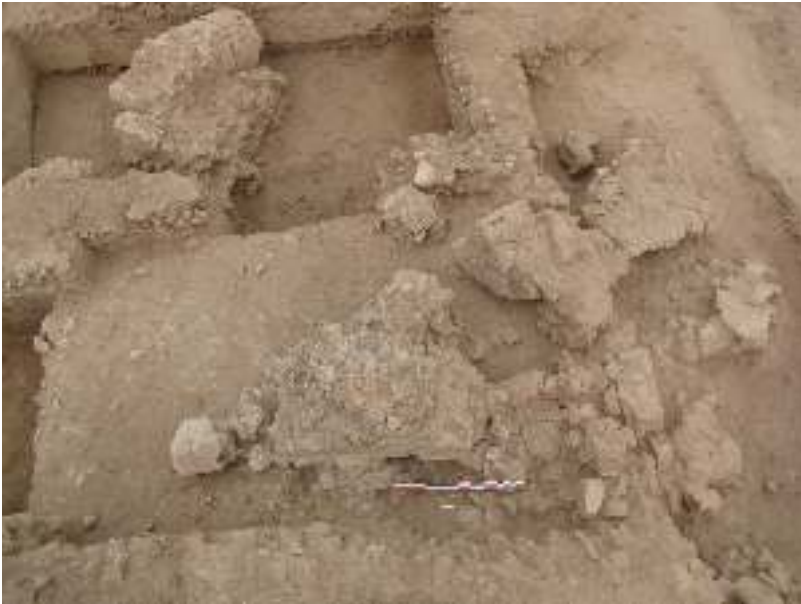
Fig 1-109 : General view of the south end of the room B12-B with the collapsed architectural elements at the end of the 2013-2014 season

In the south part of the room B12-B, several architectural elements were left in place at the end of the previous season, waiting for being methodically dismantled as they were too fragile to be preserved in one piece (Fig 1-109). The first days of the season 2015b-2016a were so devoted to the removal of those architectural remnants. They were mainly fragments of spandrels with decorated panels made of molded mortar (Fig 1-110). The panels, though variously preserved, were carefully removed from the core of the architectural elements and stored for further conservation and display (Fig 1-111). After this precise dismantling, place was free for ongoing excavations which quickly revealed the presence of a massive gate at the south end of the corridor B12-B, confirming the hypothesis of the long corridor crossing the entire basement from north to south.

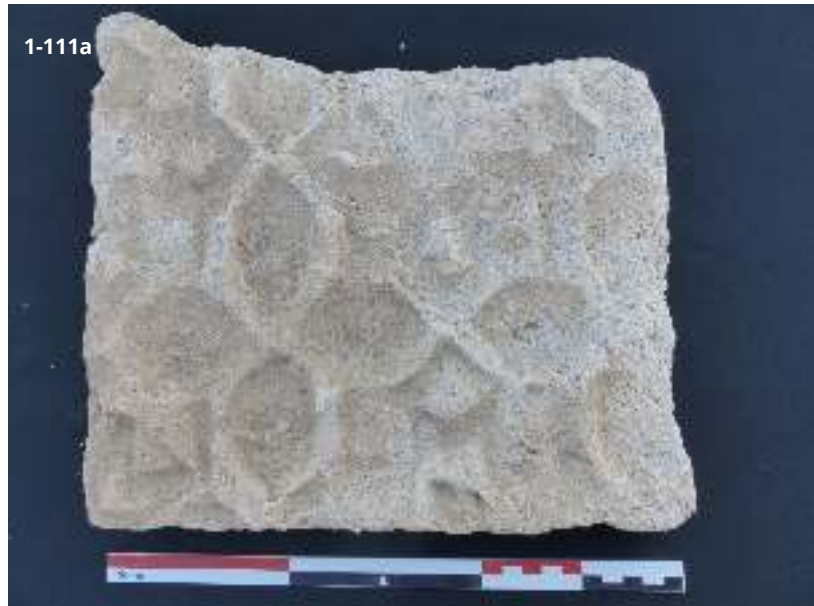
Fig 1-111 : Molded panels after dismantling of the architectural elements

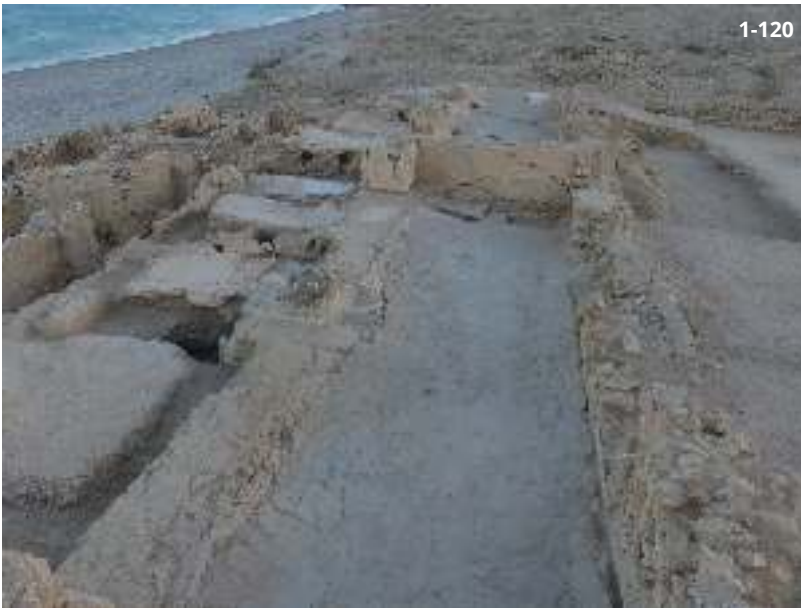
Fig 1-120 : general view of the prayer hall at the end of excavations, from the north

The structures and stratigraphy observed in the north and south parts are the same, except for some little differences which often date back to the later phase of reoccupancy. The two parts will so be presented as a whole, only the registration numbers of the structures and levels are different even if the structure or the level are the same. The whole excavated area, including the part already excavated by the QP, is around 181m² and corresponds to the preserved western half of the prayer hall, the eastern half having fallen into the caves of the basement. (FIG 1-120)

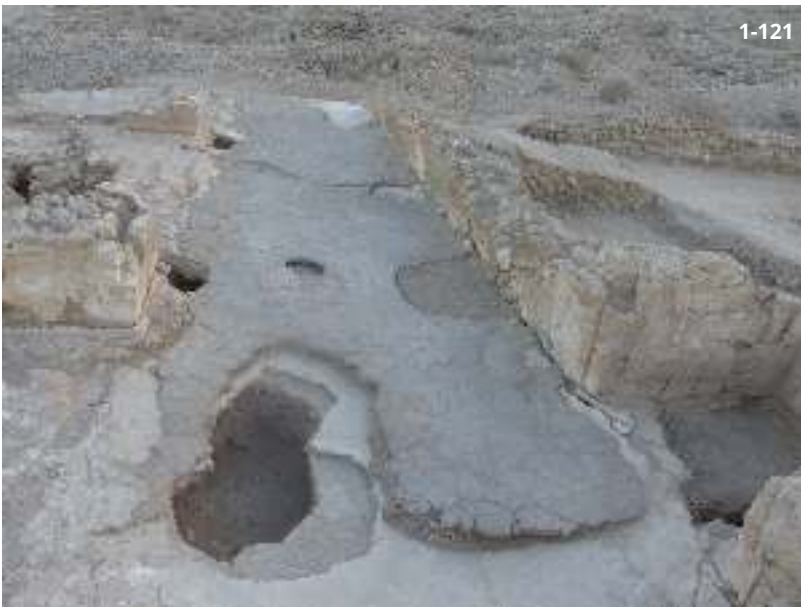
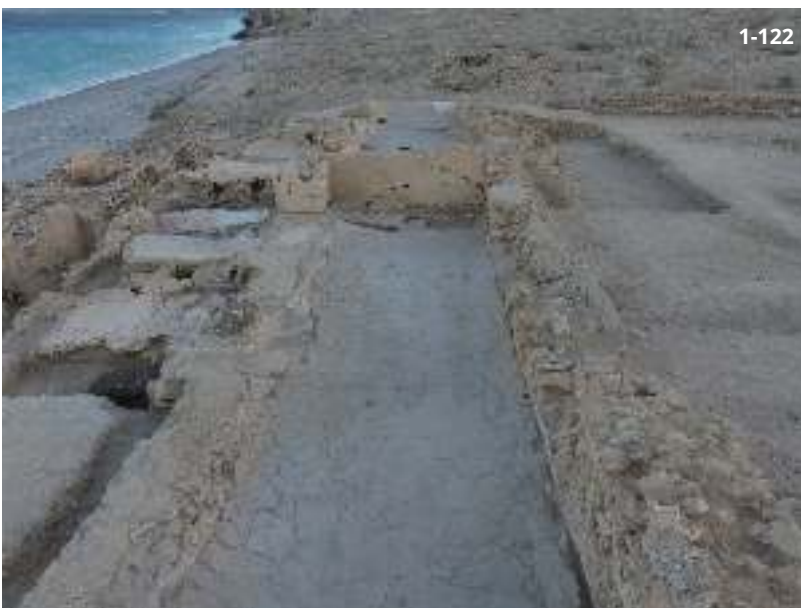
Fig 1-121 : general view of the qibla wall, south part with the mihrab at right

Fig 1-122 : general view of the qibla wall, north part at right, with the minbar in the background

▪ The west qibla wall (Fig 1-121 and 1-122)

The *qibla* wall is made with large corals and limestone blocks and some large pebbles, bonded with different types of mortar, from beige to black in color, presumably because of repairs. To the west, on its external face, the wall B12-01 is covered by a coating made of a strong dark gray mortar which probably dates back to the last phase of repair. Its eastern internal face is covered by a beige coating with some whitish parts, presumably resulting from the fact that the inside was covered with a white plaster now disappeared. The remains of a frieze (Fig 1-123) made of glazed tiles in the shape of stars and crosses fixed at the base of the wall are preserved on the north and south parts of the wall, the tiles having mostly vanished and being only visible by their prints in the mortar. The frieze originally rose around 1m high, at least in some places. Highly eroded and not well attached to the wall, this frieze is still partly visible to the south, but in the north it has fallen down during the course of excavations. Remains have been taken and stored for a possible later display. Fig 1-124

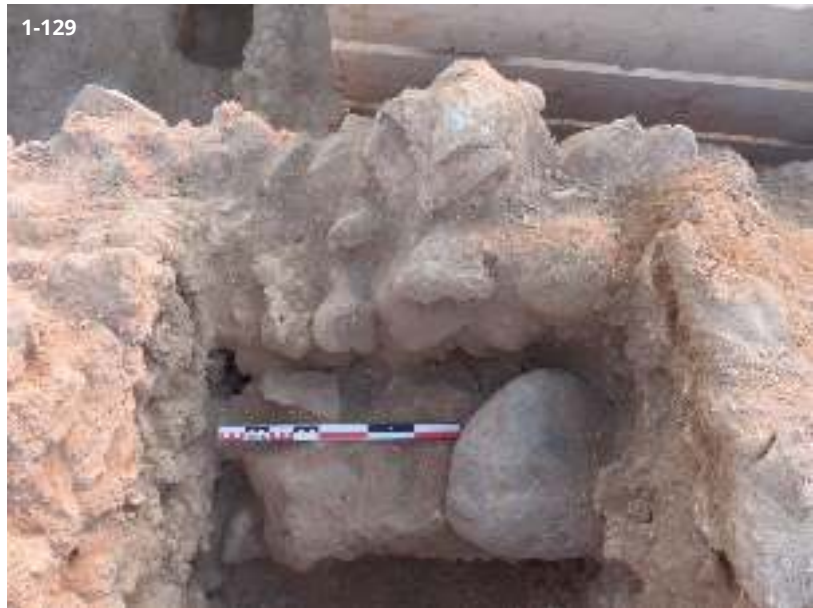
Fig 1-129 : the thickening B12-391 (under the scale) of the wall B12-46 behind

Against the north wall B12-183, at the north-east corner of the preserved first floor, a sounding was opened into the backfill of the basement. It appeared that the wall B12-46 was strengthened by the addition of the thickening **B12-391** (Fig 1-129). This masonry, made of large corals and pebbles bonded with a beige mortar and built against the west facing of the wall B12-46, is 0.40m wide and was observed for 0.85m long (the length of the sounding) but it goes on southerly for an unknown distance.

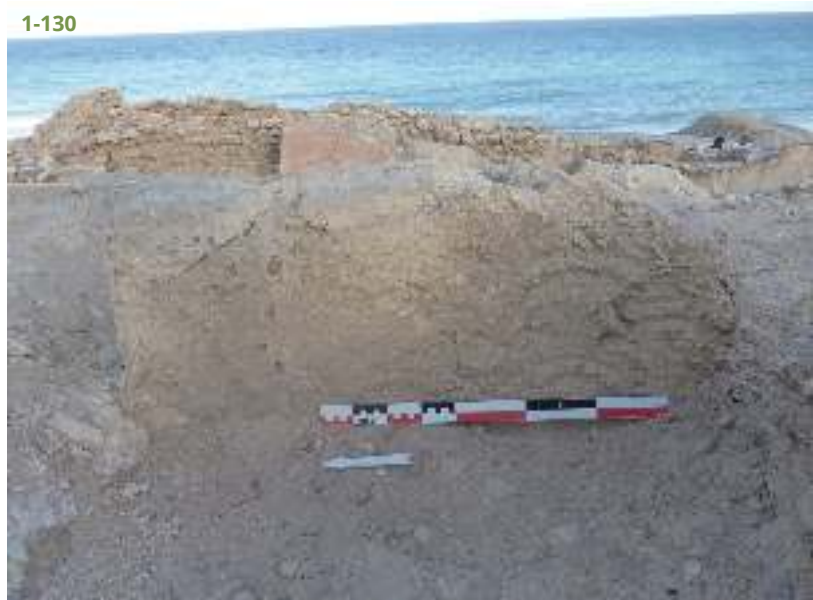
Fig 1-130 : the buttress B12-406

Shortly to the south, the vacuum of the floor also permitted to observe the presence of a massive buttress (**B12-406**), 0.90m long by 0.50m wide for an unknown height as it was only unearthed in its upper part (Fig 1-130). It is made with corals and limestone blocks bonded with mortar and covered with a rough gray coating where fingerprints are still visible. Though badly preserved, it appears to be quoined with the wall B12-46 and, as it is built just opposite the buttress B12-114 in the corridor B12B, under the east-west alignment of the pillars of the prayer hall, its architectural function was obviously to support the heavy weight of the pillars and arches above.

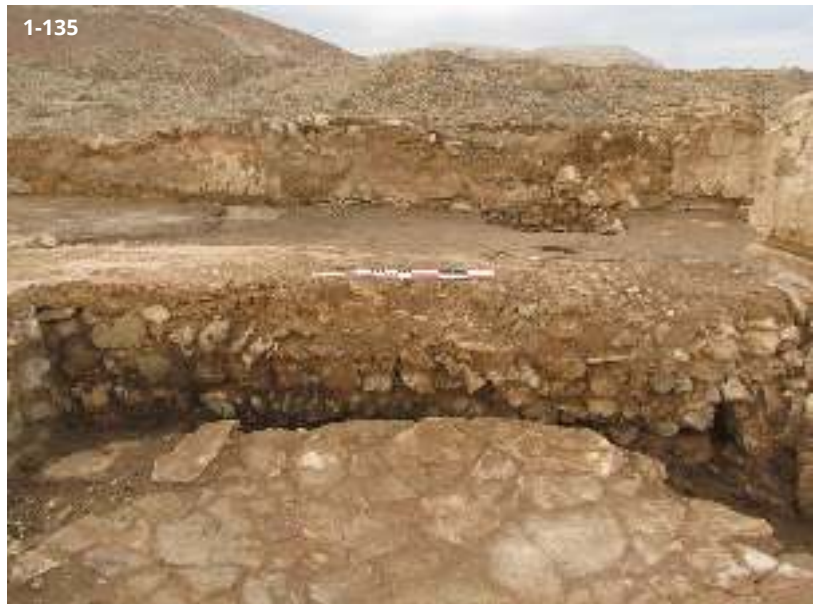
Fig 1-135 : visible elevation of the intermediary wall B12-45, in the south part

Parallel to the wall B12-46, the wall **B12-45**, which runs under the preserved row of pillars of the prayer hall, under the floor between the two backfilled spans 5 and 6, was partially observed where the floors have cracked or collapsed (**Fig 1-133** and **Fig 1-134**). It is 25m long for an assumed width around 1m, and was- observed for 0.50m high in average under the level of the floor. It is quoined with the wall B12-183 to the north and presumably with the wall B12-41 to the south, but the state of preservation is not good enough to be affirmative. The wall is made with medium pebbles, corals and limestone blocks bonded with a powdery brown mortar, apparently mainly made with soil. No trace of coating was observed. **Fig 1-135**

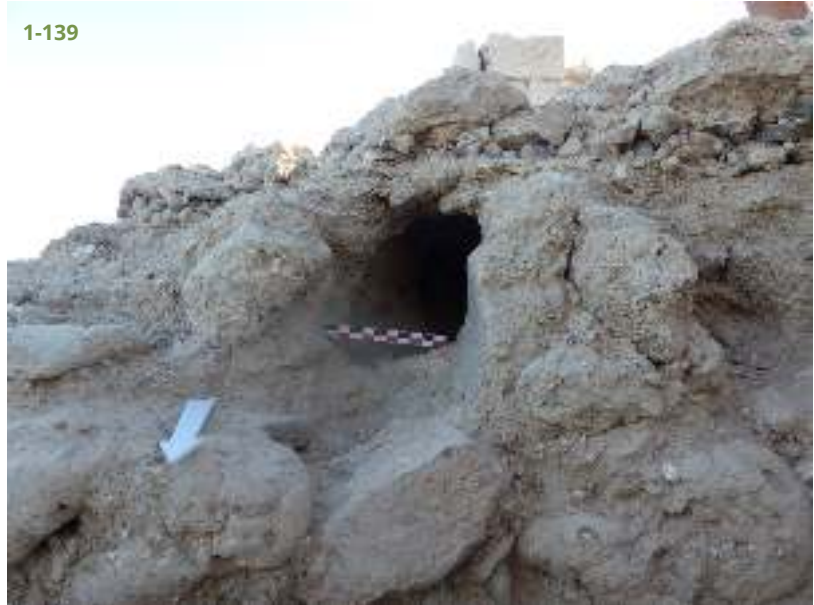
Fig 1-139 : the assumed beamhole B12-408

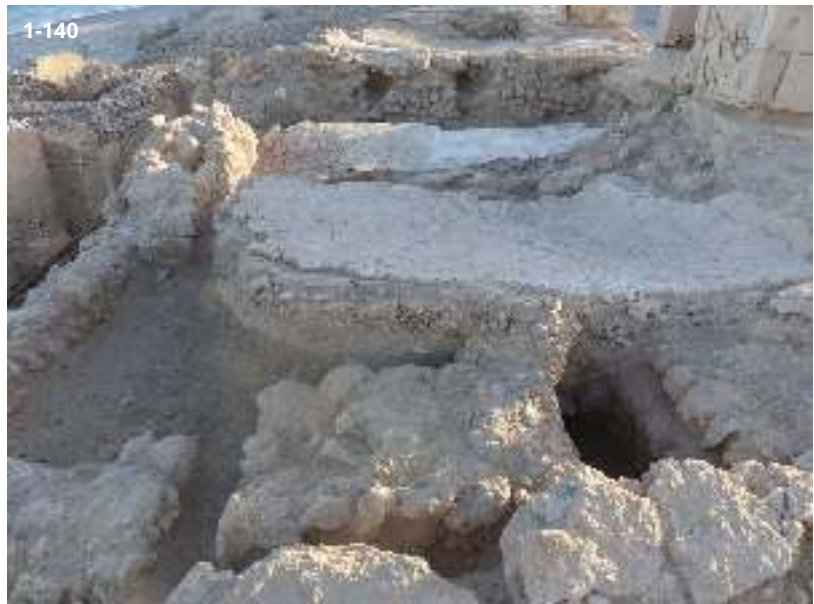
Fig 1-140 : the openings B12-403 (at right) and B12-404 (at left) in the shear wall B12-405

To the north, the wall **B12-405** is 3.45m long by 0.60m wide and was uncovered for 0.50m wide (**Fig 1-138**). It is quoined to the walls B12-45 and B12-46 and made with medium corals and limestone blocks bonded with powdery brown mortar and no coating was observed. It is pierced in its upper part by three holes which do not seem to have the same function. The westernmost, **B12-408**, is 0.15m wide and high and runs into the wall for 0.40m, meaning it does not cross the entire width of the wall (**Fig 1-139**). Its shape and size, the organic sediment found inside it and some wood prints observed on the mortar clearly suggest that this hole is a beam-hole. It was probably not the case for the two easterly holes, **B12-403** and **B12-404**, which are both crossing the wall and where no organic sediment or wood prints were observed (**Fig 1-140**). They are both of the same size, 0.25m wide and around 0.30m high. At the top of B12-403, prints of small wood planks were observed, which were quite probably used to cover the top of the cavity. Similar fittings must have been in existence over the cavity B12-404, and presumably over the other similar structures observed in the other walls, but they probably vanished following the dilapidation of the building. It is very likely that those cavities were used as aeration holes.

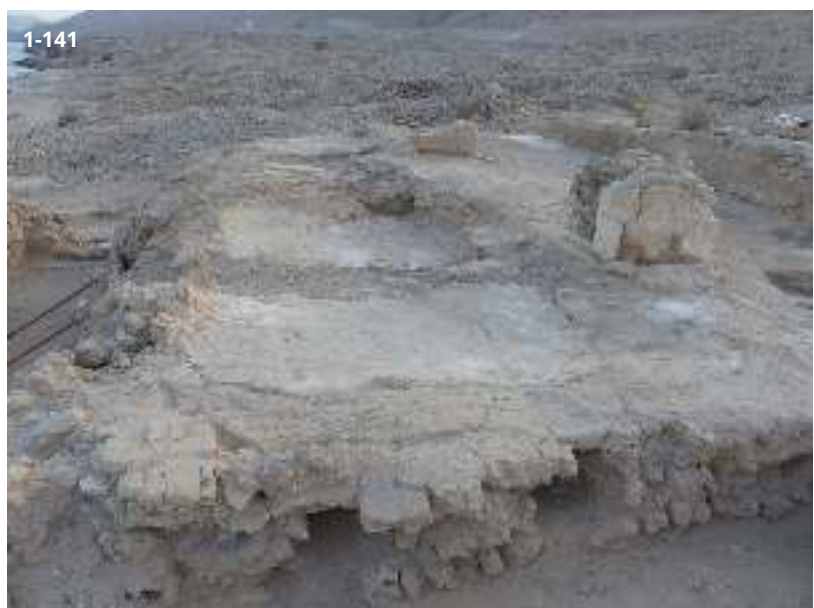
Fig 1-141 : the shear wall B12-50 with the openings B12-395 (at left) and B12-396 (at right)

The same pattern was observed in the wall **B12-50**, which is built in the middle of the span and was already uncovered in the QP sounding. This wall, 3.25m long by 0.60m wide and uncovered for around 0.50m high, is made with medium corals and limestone blocks bonded with a powdery brown mortar and is quoined to the wall B12-45 and B12-46. Here also no coating was observed and three similar cavities were uncovered at the top of the wall. The westernmost, **B12-397**, set at the corner with the wall B12-45, is 0.10m wide and 0.13m high and, though not entirely unearthed, it does not seem to cross the entire length of the wall. Its function is not absolutely certain but it could be a little beam-hole. To the east however, the larger cavities **B12-395** and **B12-396** are more likely aeration holes. They are both 0.17m wide and around 0.40m high and they cross the entire width of the wall B12-50 (**Fig 1-141**).

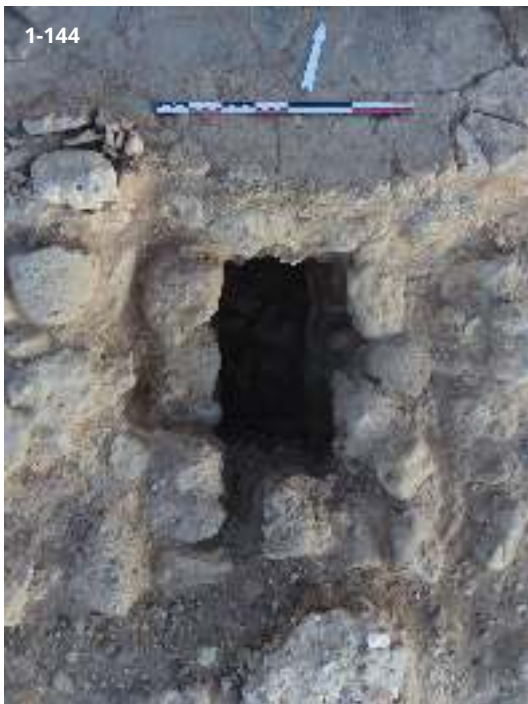
Fig 1-143 : the opening
B12-350

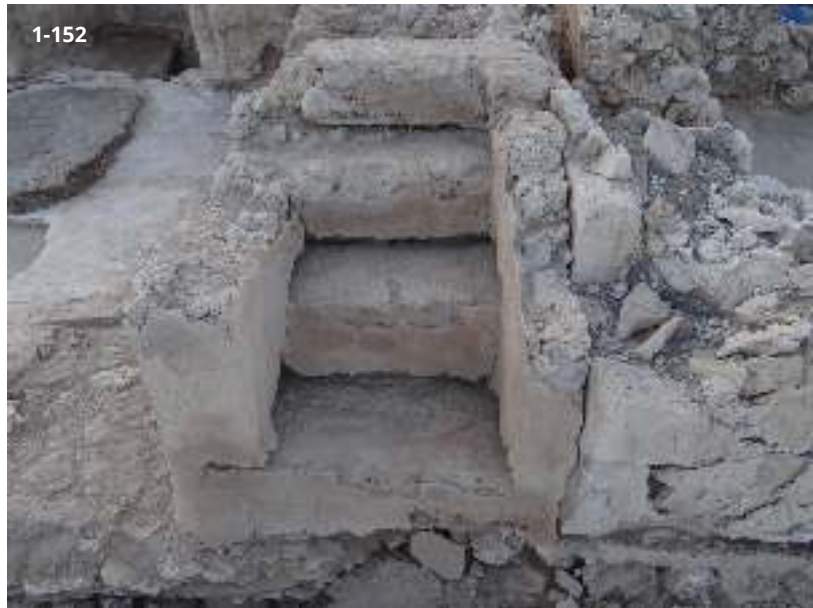
Fig 1-152 : *the remaining steps of the minbar B12-03, with the prints of wooden planks*

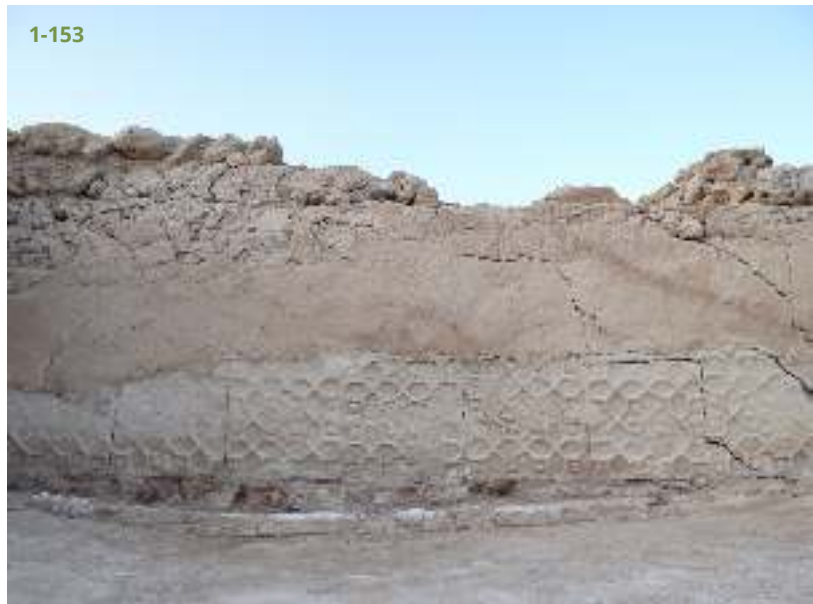
Fig 1-153 : *the frieze made of molded panels on the south side of the minbar B12-03*

The *minbar* is mainly made with corals bonded with a strong gray mortar and covered on all sides by a fine pinkish beige coating. The south face, on the *mihrab* side, is decorated by a frieze made of 8 panels of molded plaster, which is partially covered by the coating and does not extend until the eastern end of the *minbar* (Fig 1-153). It is also possible to distinguish, behind the groove of the third steps, a coated face with some glazed tiles. Those two elements strongly suggest that the *minbar* was originally shorter, probably as long as the preserved frieze, around 2.80m, which is also the distance between the *qibla* wall and the west face of the pillar right at north. The *minbar* was so afterward extended to the east by the addition of two more steps. This extension was built against the pillar to the north, whose south face is partially included into the masonry of the *minbar*. The yet visible coating was only applied afterward and partially covering the top of the molded panels, which were also at that time probably covered at their bottom by the raising of the last floor (see below). This last *minbar*, the one yet visible, was very simple, without decoration, and the general stratigraphy of the prayer hall suggest that it was made during the last stage of repair of the building, at the beginning of the 16th century (Fig 1-154). The assumed former masoned one underneath, which had replaced the first wooden *minbar*, appears to be more decorated, with molded panels and glazed tiles, and it is quite reasonable to consider that it was built during an important stage of repair that was observed elsewhere in the prayer hall and which seems to have occurred in the middle of the 15th century, but only the destruction of the actual *minbar* could confirm both its presence and dating.

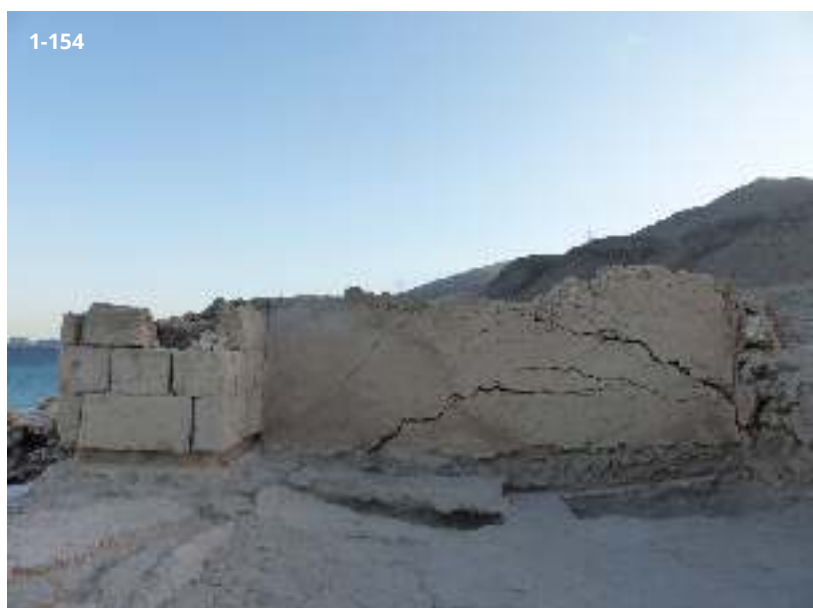
Fig 1-154 : *the north side of the minbar B12-03, last stage of use, without decoration*

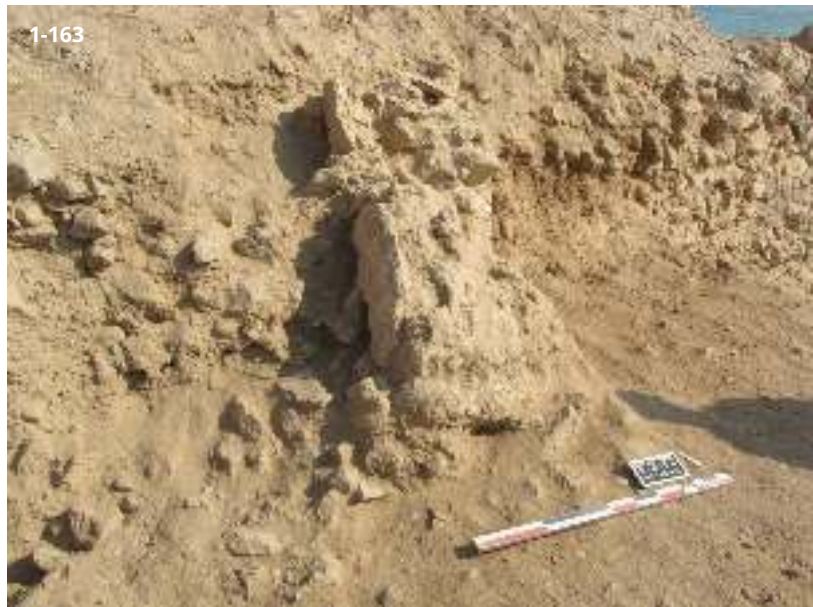
Fig 1-163 : the architectural element IsoArc808 found in the south street, probable element of the southern half engaged pillar

To the south, the half-pillar that was bonded to the wall B12-41 was not preserved as the elevation above the floor level had fallen into the south street. A rectangular masonry found in this area (**Fig 1-163**), in the north-south axis of the row of pillars, probably came from it, but more likely from the upper part of the pillar and not from its basis, as the element was found covered with coating, which was not observed on any of the basis of the remaining pillars.

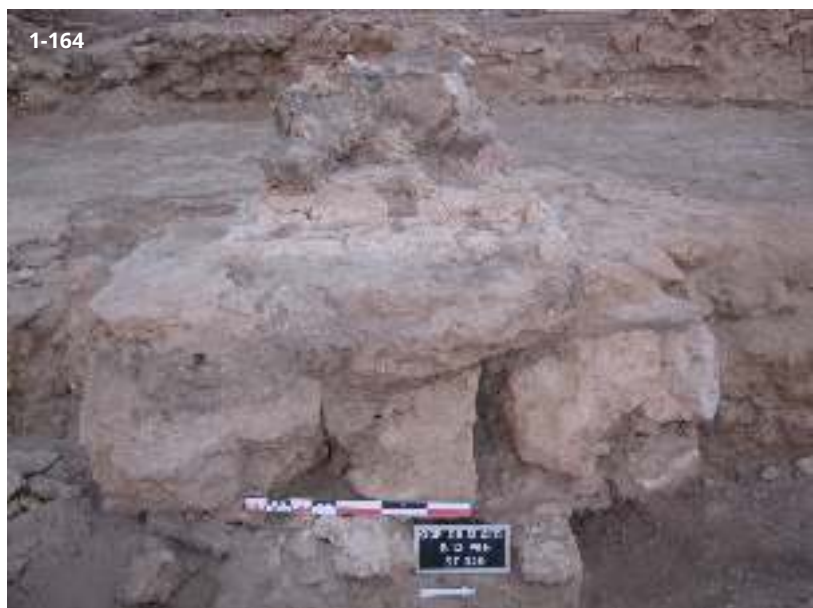
Fig 1-164 : the reinforcement B12-329 under the pillar B12-323

Under all pillars, except the northern engaged one, a rough and quickly made reinforcement was observed, more or less circular in plan around the basis of pillars, and built over the wall B12-45 and the buttresses observed under most of the pillars. It is under the pillar B12-323 that this reinforcement (**B12-329**) was the best observed (**Fig 1-164**). The masonry, which is irregular, is mainly made with plaques of masoned floors and fragments of walls bounded with a strong gray mortar containing many small pebbles and fragments of ceramics. It is very likely that this reinforcement was made by cutting the masoned floors, digging a more or less circular pit around the basis of the pillar. It was afterward filled with this coarse masonry which was probably encompassing the underneath buttress B12-392 whose upper end was probably partially destroyed to allow a better fixing between it and the reinforcement. It is also possible that the above pillar was repaired at the same time. To the south, a similar reinforcement (**B12-417**), made in the same way, was also observed under the pillar B12-05, but mainly in plan as no major sounding was opened around it. The reinforcement **B12-356**, under the pillar B12-232, was better studied (**Fig 1-165**): in plan where the masoned floors were destroyed, and partially in elevation with a small sounding at its foot. It is made with large corals and rough limestone blocks, bounded with a compact gray mortar, and the fittings presented no facing, suggesting that the stones were put loose in a foundation pit. Finally, the reinforcement **B12-399**, under the pillar B12-44, was also mainly observed in plan and very partially in elevation. It is also a rough masonry made with all sizes corals and limestone blocks, bounded with a gray to black mortar.

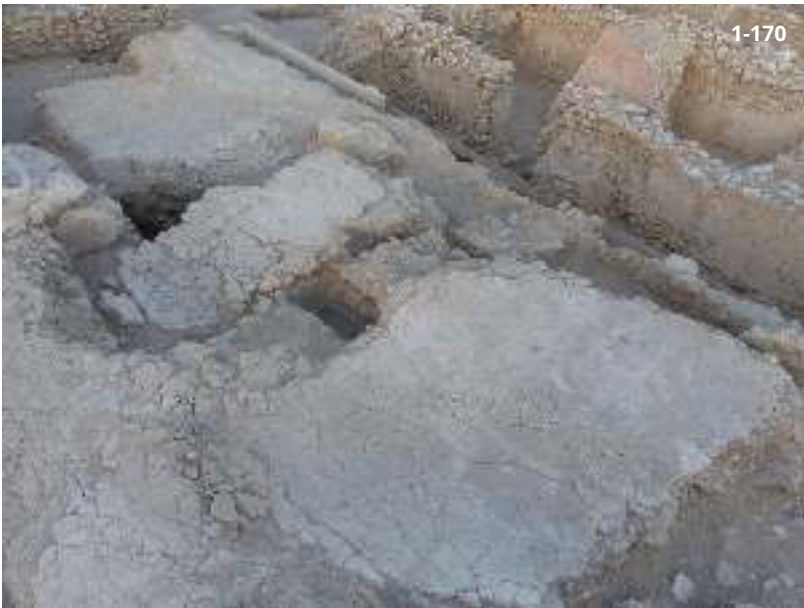
Fig 1-170 : *subsidiencies of the floors of the prayer hall, in north part*

This first floor B12-297 and the floor support B12-298 suffered a subsidence, probably due to the slight drop of the underneath backfill, which was more important to the east than to the west (Fig 1-170). In span 6, the subsidence is around 0.10m deep and, even if some cracks are visible, the floor is still more or less in good state. In span 5, the floor is far more cracked and the subsidence can reach 0.30m, the subsidence effects being well visible against the walls of the basement. Explanations for this difference of subsidence effects can be the quality of the backfill, which could have been rammed to the west and/or more airy to the east, or that some part of the backfill under the span 5 slowly infiltrated through the separating wall with the easterly corridor B12-B. In any way, the first floor was too damaged and irregular over span 5 to be properly used and a second masoned floor was made.

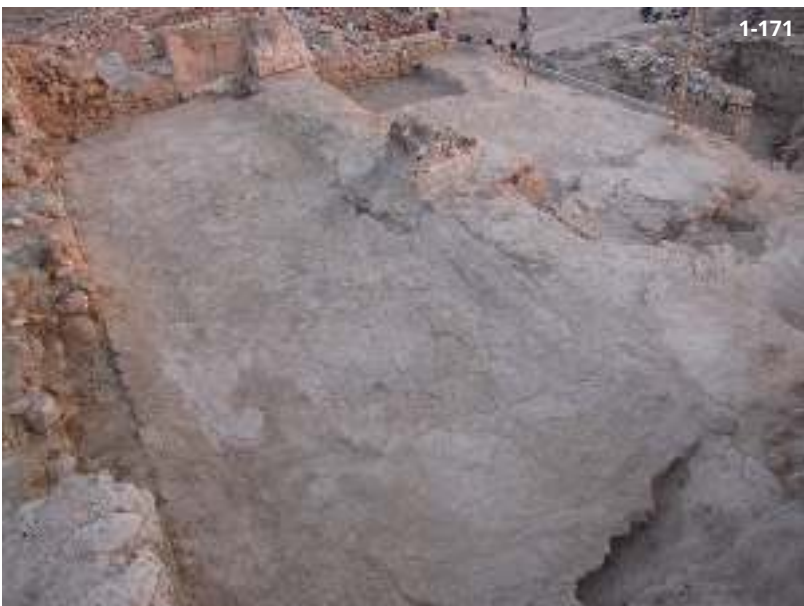
Fig 1-171 : *general view of the floor B12-294, in north part*

This second floor (B12-294), even if cracked, is still present over the main part of the span 6, covering most of the former floor and floor support, but preserved to the east, over span 5, only at the south extremity (Fig 1-171). The rest of it has disappeared, washed away by erosion or fallen into the basement in corridor B12. This second floor B12-294 is separated from the first floor B12-297 by a thin layer of small pebbles (Uf3839) leveling the subsidence of the lowest floor, inside which the material was too scarce to allow a dating. It is made by a rough gray mortar containing many small pebbles and its thickness varies from 0.03m to 0.11m, following the more or less importance of the subsidence of the underneath floor. As it is leaning against the north face of the first masoned *minbar*, it is very likely that this floor was put in place at the same time, in the course of the 14th century.

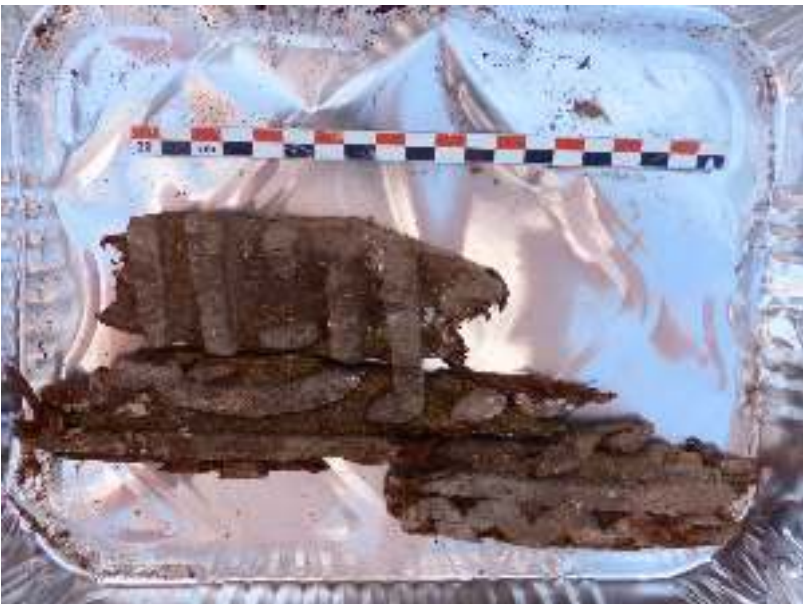
Fig 1-196 : fragment of carved and golden painted wood

Twelve pillars, and six engaged half-pillars to the north and south, supported three north-south lines of arcades and two east-west lines in the middle of the prayer hall, demarcating a central nave in front of the *mihrab*. The pillars of the central nave and the ones to the north and south were differently decorated and the same difference may have occurred in the upper part of the vaulting. The roof was supported by the arcades and by east-west beams linking the pillars and, according to the description by Bras de Albuquerque and the testimony of a single small fragment of wood decorated with carving and golden paint (Fig 1-196), these beams may have been carved and highly decorated.

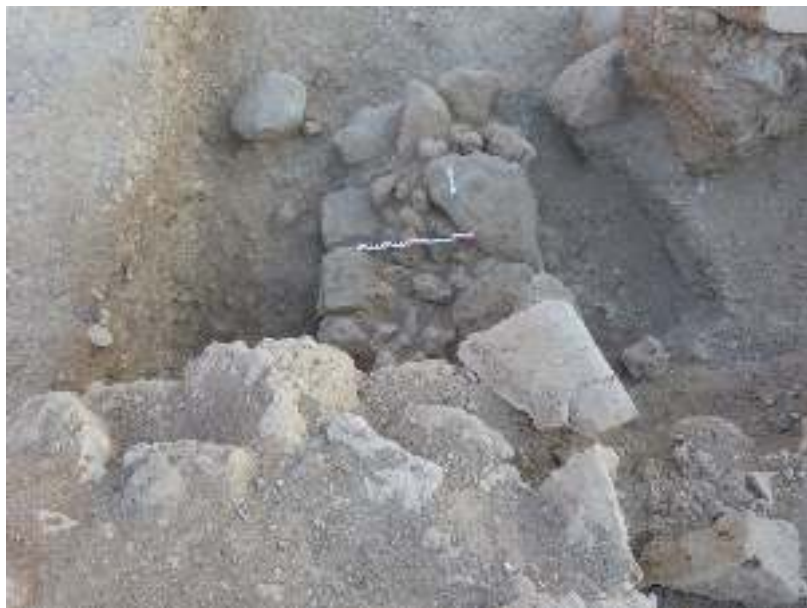
Fig 1-202 : the remains of the wall B12-74, with the staircase in area B12-N in the foreground

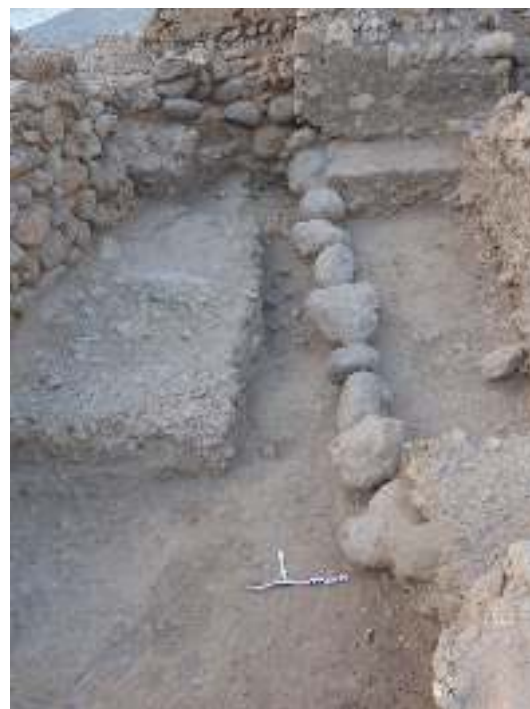
Fig 1-203 : the remains of the wall B12-407, with a possible recovery trench at left and the north-east corner of the Mosque in the background

Set at the north-east corner of the Mosque and partially running under it, or at least under of thickening or a repair of the north wall of the building, the wall B12-407 (**Fig 1-203**) could have had the same use of strengthening the foundations. Made of massive pebbles and limestone blocks with no binder preserved, it is now 4m long by 0.50m wide but it appears that its eastern half was recovered to be reused. The fact that this wall is ending at north more or less in the same alignment that the north side of the wall B12-477 is in favor of this hypothesis. In this configuration, it is possible that the terrace was ending, at east, plumb with the line of the wall B12-407.

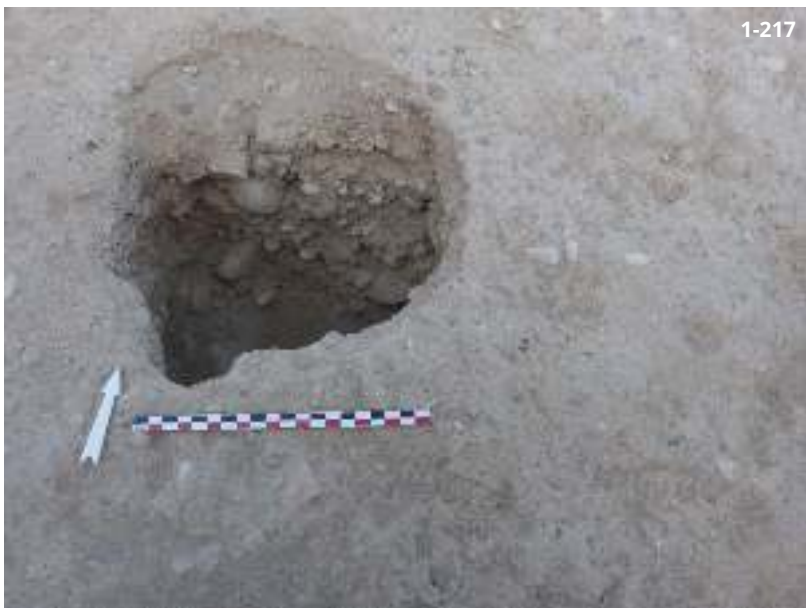
Fig 1-217 : the posthole B12-420, half excavated

Finally, north of the staircase B12-167, three postholes (**B12-420 (Fig 1-217)**, 0.30m wide by 0.20m deep, **B12-421 (Fig 1-218)**, of the same size and **B12-438 (Fig 1-219)**, around 0.35m wide and 0.05m deep) and an oval pit (**B12-425 (Fig 1-220)**, 0.60m long by 0.40m wide and deep) were also dug through the earthen floor, but here also their functions remained unknown.

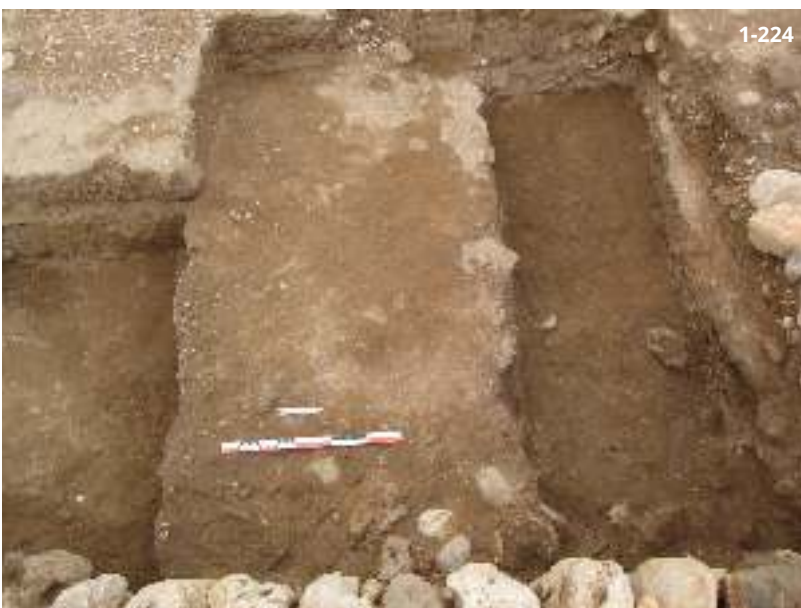
Fig 1-223 : the foundation trench of the wall B12-199, cutting the previous floor and backfills

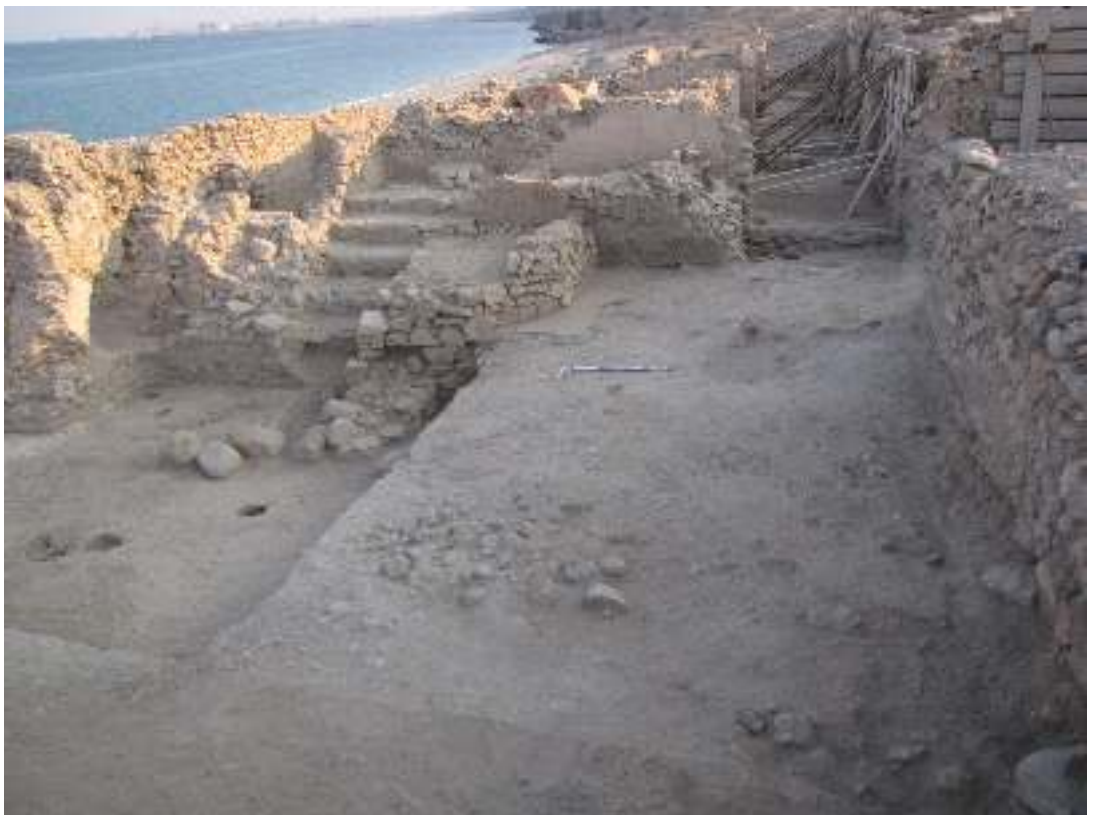
Fig 1-235 : general view of the north low courtyard, nearly at the end of excavations, with the first floor at left and the second one at right

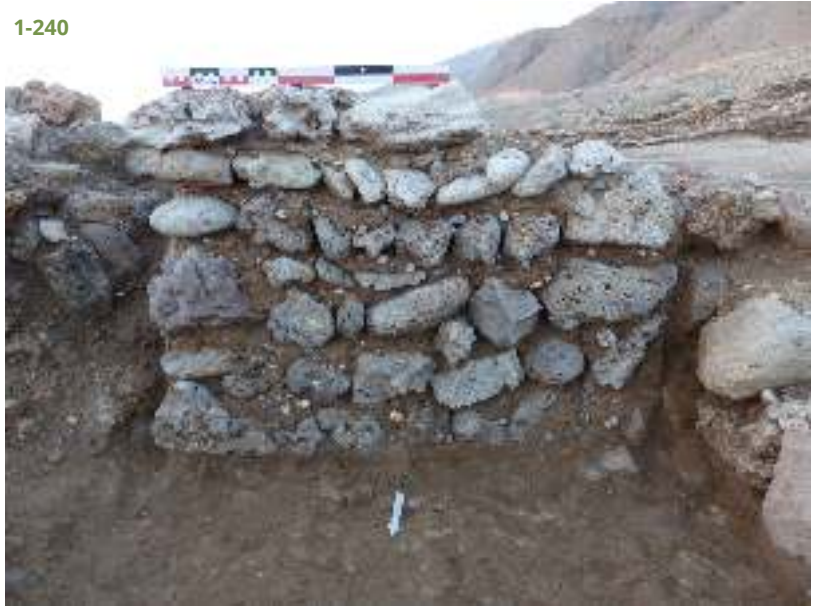
Fig 1-240 : the north side of the wall B12-467, inside the room B12-E
