Qalhât Development Project, Season 2015B-2016A, Final Report

SEASON 2015B-2016A

Excavations on the Ceramic Workshop B41

I-B. The 2015b-2016a season - 1. Excavations of the southeast part of the Mosque (Spans 1 and 2)

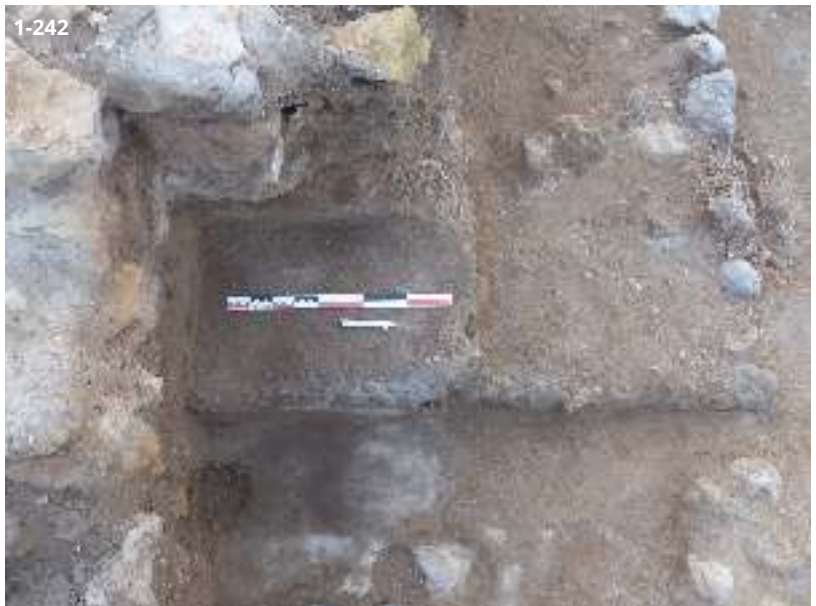
Fig 1-242 : the step or bench B12-460, under the scale

In the south interior of the room, several damaged structures related with the northern remains of the basins were unearthed. The structure **B12-460 (Fig 1-242)**, 0.65m long by 0.40m wide and 0.15m high, is built against the south wall B12-471, around 1.20m west of the *qibla* wall. It is entirely covered with strong gray coating, probably waterproof, and can be identified as a step or more likely an edge of the basin, to receive the water for ablation and drain it to the north basin. It was associated with the structure **B12-475 (Fig 1-243)**, built at west against the masonry B12-467/468/469, made with various sized limestone and corals blocks bonded with a disintegrated mortar and covered, in the lower part, with the same strong gray coating as the structure B12-460. Preserved for 0.65m long by 0.60m wide and 0.60 high, the structure B12-475, though badly preserved, was quite undoubtedly a low bench, where people were sitting during the ablation.

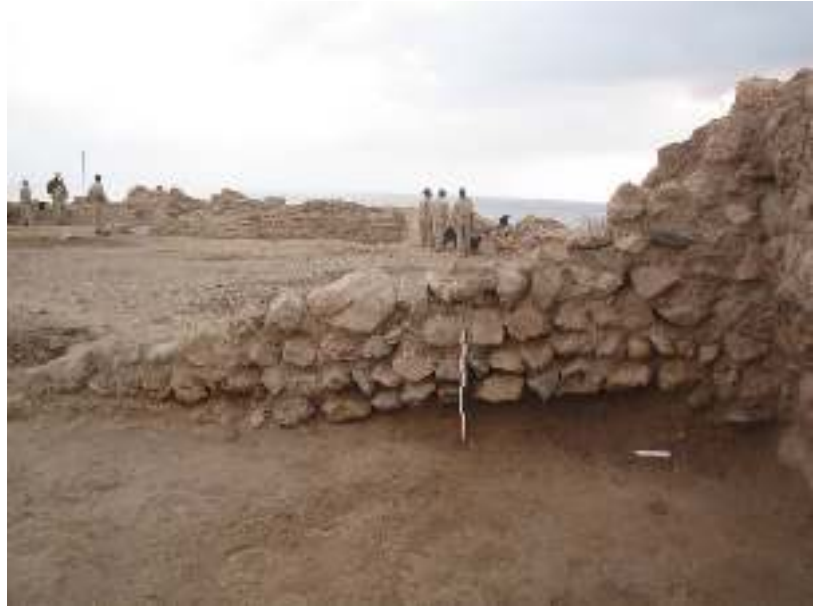
Fig 1-254 : the wall B139-09 built over sand, visible behind the white arrow

Two small walls were built over the sandy eolian levels, **B139-08** (Fig 1-253) around 2.70m east of the room B12-C and **B139-09** 3m east, whose foundation is not horizontal but follows the slope of the heap of sand accumulated against the south enclosure wall (Fig 1-254). They are both made with medium limestone and corals blocks bonded with earth, 3.10m and 2.80m long by 0.40m wide and between 0.40m to 0.30m high. The two walls created the first stage of the room B12-A, which was opened at north at this time and, according to the ceramic material found in the windy natural layers, the construction occurred in the course of the 16th century, a certain time after the abandonment of the Mosque.

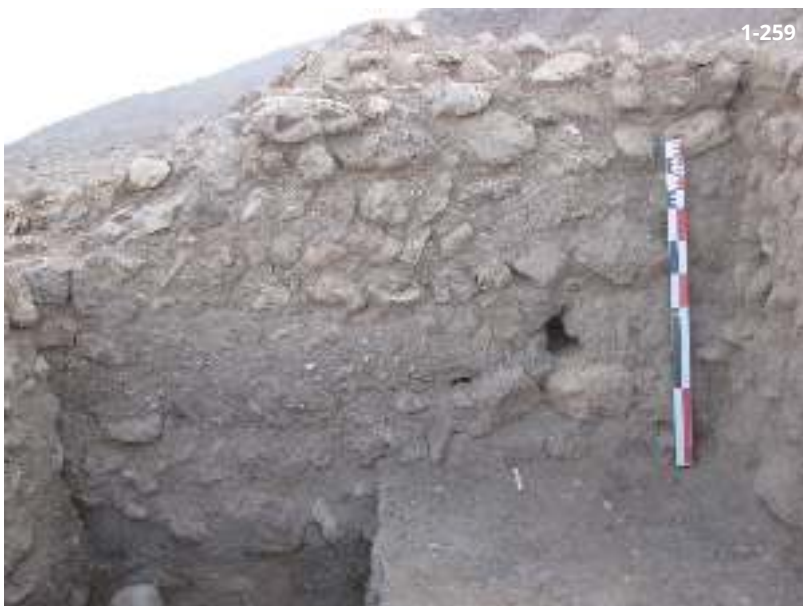
Fig 1-259 : the wall B255-08, inside elevation

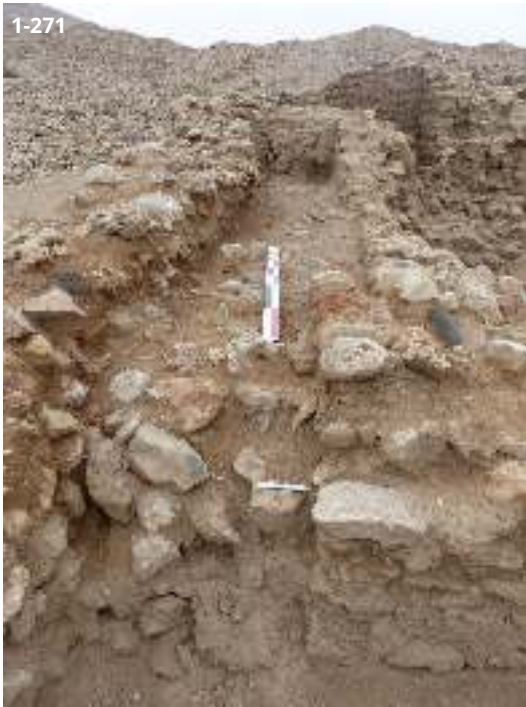
Fig 1-271 : general view of the assumed corridor B255-C, unexcavated

The room B255-A was probably originally reachable by the winding narrow corridor B255-C (Fig 1-271), 0.60m to 0.90m wide, which is delimited at south by the wall **B255-01** (Fig 1-272), 6m long by 0.65m wide in average and externally uncovered for about 0.40m high, and at north by the wall **B255-03** (Fig 1-273), 4.50m long by 0.60m wide for an unearthed elevation of more than 1m at north. The inside of the corridor was only excavated down to the upper course of the walls and excavations were so stopped on artificial layers. The walls are made with small limestone and corals blocks bonded with a grayish mortar badly preserved and it is possible that their winding shape is accidental and due to the pressure of the collapse or possible backfills. The room B255-C was identified as a corridor because of its shape and location, but further excavations could reveal another identification, as a staircase for example.

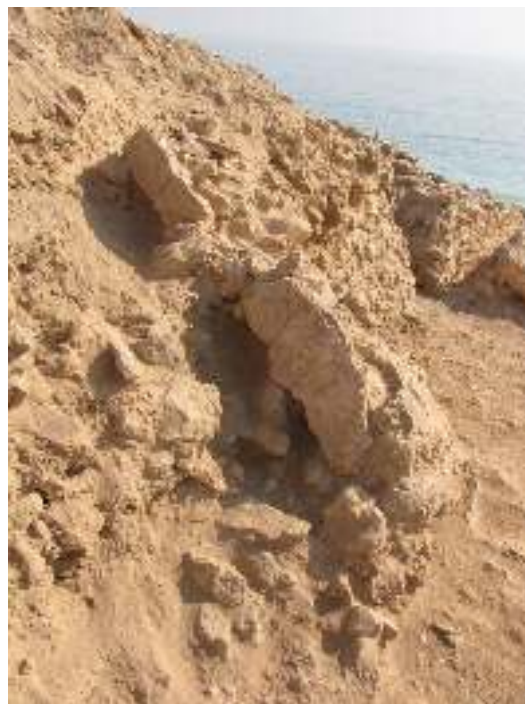
Fig 1-281 : the architectural element IsoArc888, remains of an engaged pillar in the prayer hall

In the middle of the south wall B12-41, in the alignment of the inside dividing wall between the spans 5 and 6, a large rectangular architectural remain (IsoArc808) (Fig 1-281) was unearthed, which was badly

preserved and too cracked to be moved. It is undoubtedly the remains of the rectangular engaged pillar which was built against the north facing of the wall at first floor, aligned with the remaining pillars of the prayer hall. Prints of the decoration were observed and glazed tiles found around, but most of the upper parts of the pillar has disappeared.

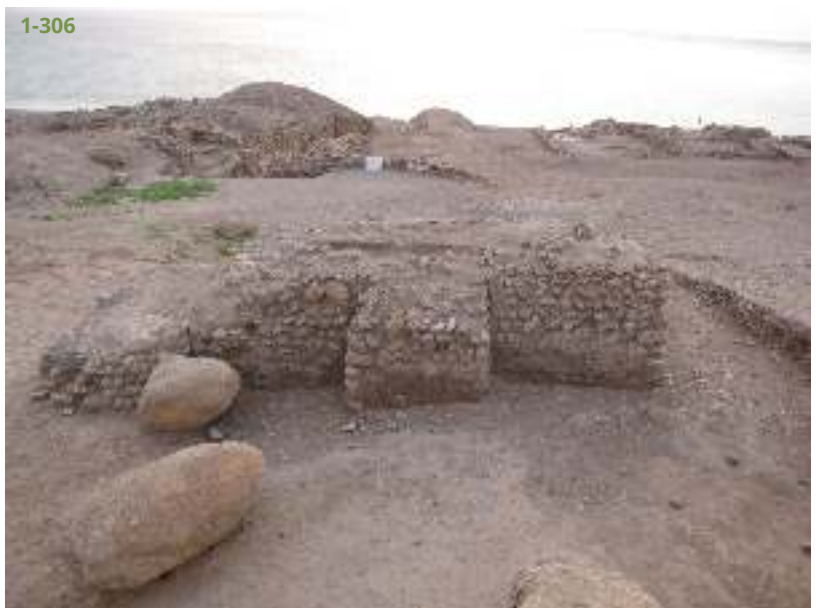
Fig 1-306 : general view of the west side of the building B197

The west side is made by the walls B197-02, B197-03 and B197-04, all quoined and built together but differently registered because of their different identifications (Fig 1-306).

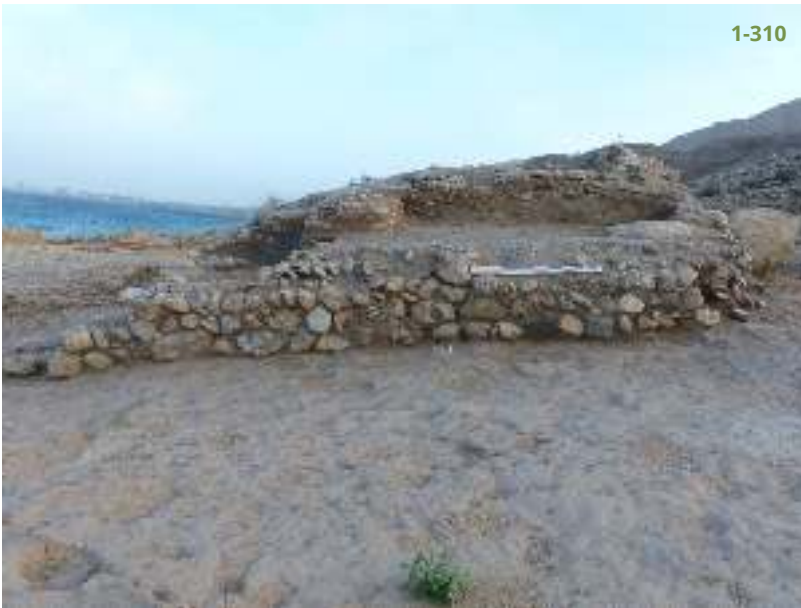
Fig 1-310 : the wall B197-07, in the foreground

The north side of the stairs is made by the wall **B197-07 (Fig 1-310)**, nearly parallel to the wall B197-05, 5m long by 0.50m wide for a maximal preserved elevation of 0.70m high. It is made with large to medium corals and limestone blocks, bonded with earthen mortar, and no trace of coating was observed. Its west end, at the junction with the wall B197-08, is unfortunately destroyed.

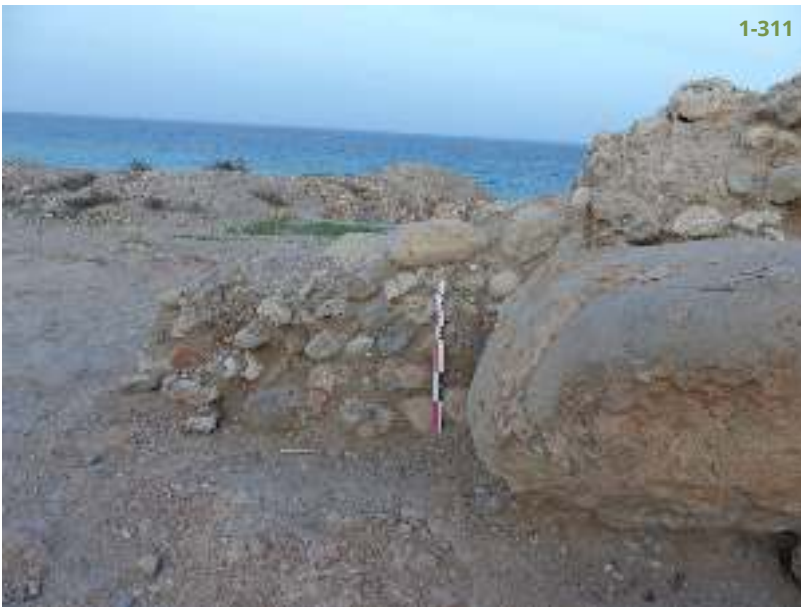
Fig 1-311 : the wall B197-08, with the massive natural pebble at right

The west wall **B197-08 (Fig 1-311)**, poorly preserved, is built against a very massive natural pebble which has detached from the puddingstone cliff edge and has rolled down the slope. It is in fact quite impossible to state if the stair was built against the large stone or if it has later detached from the cliff and has rolled against the wall. It is 1.46m long and around 0.50m wide in average with a maximal preserved elevation of 0.70m, made of large to medium unorganized corals and limestone blocks bounded with earthen mortar and without coating. Though the presence of the large stone did not help the observation, it seems that the wall B197-08 is leaning against the corner of the walls B197-03 and B197-05, and could so be a later addition.

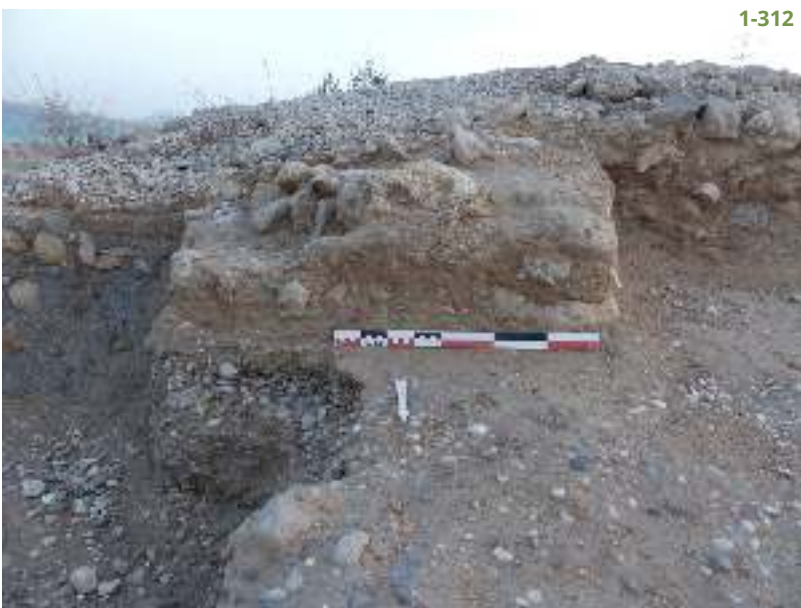
Fig 1-312 : the assumed step B197-05

In the east part, built against the wall **B197-05 (Fig 1-312)**, the construction B197-09 is 1m long by 0.55m wide for a preserved elevation of 0.35m high, and is entirely covered by a strong grayish beige coating. It has been interpreted as the final step of the stair, reaching the circulation level of the southerly main building. Other much damaged steps are guessable at east and it is very likely that the west part was occupied by a small terrace or a high bench.

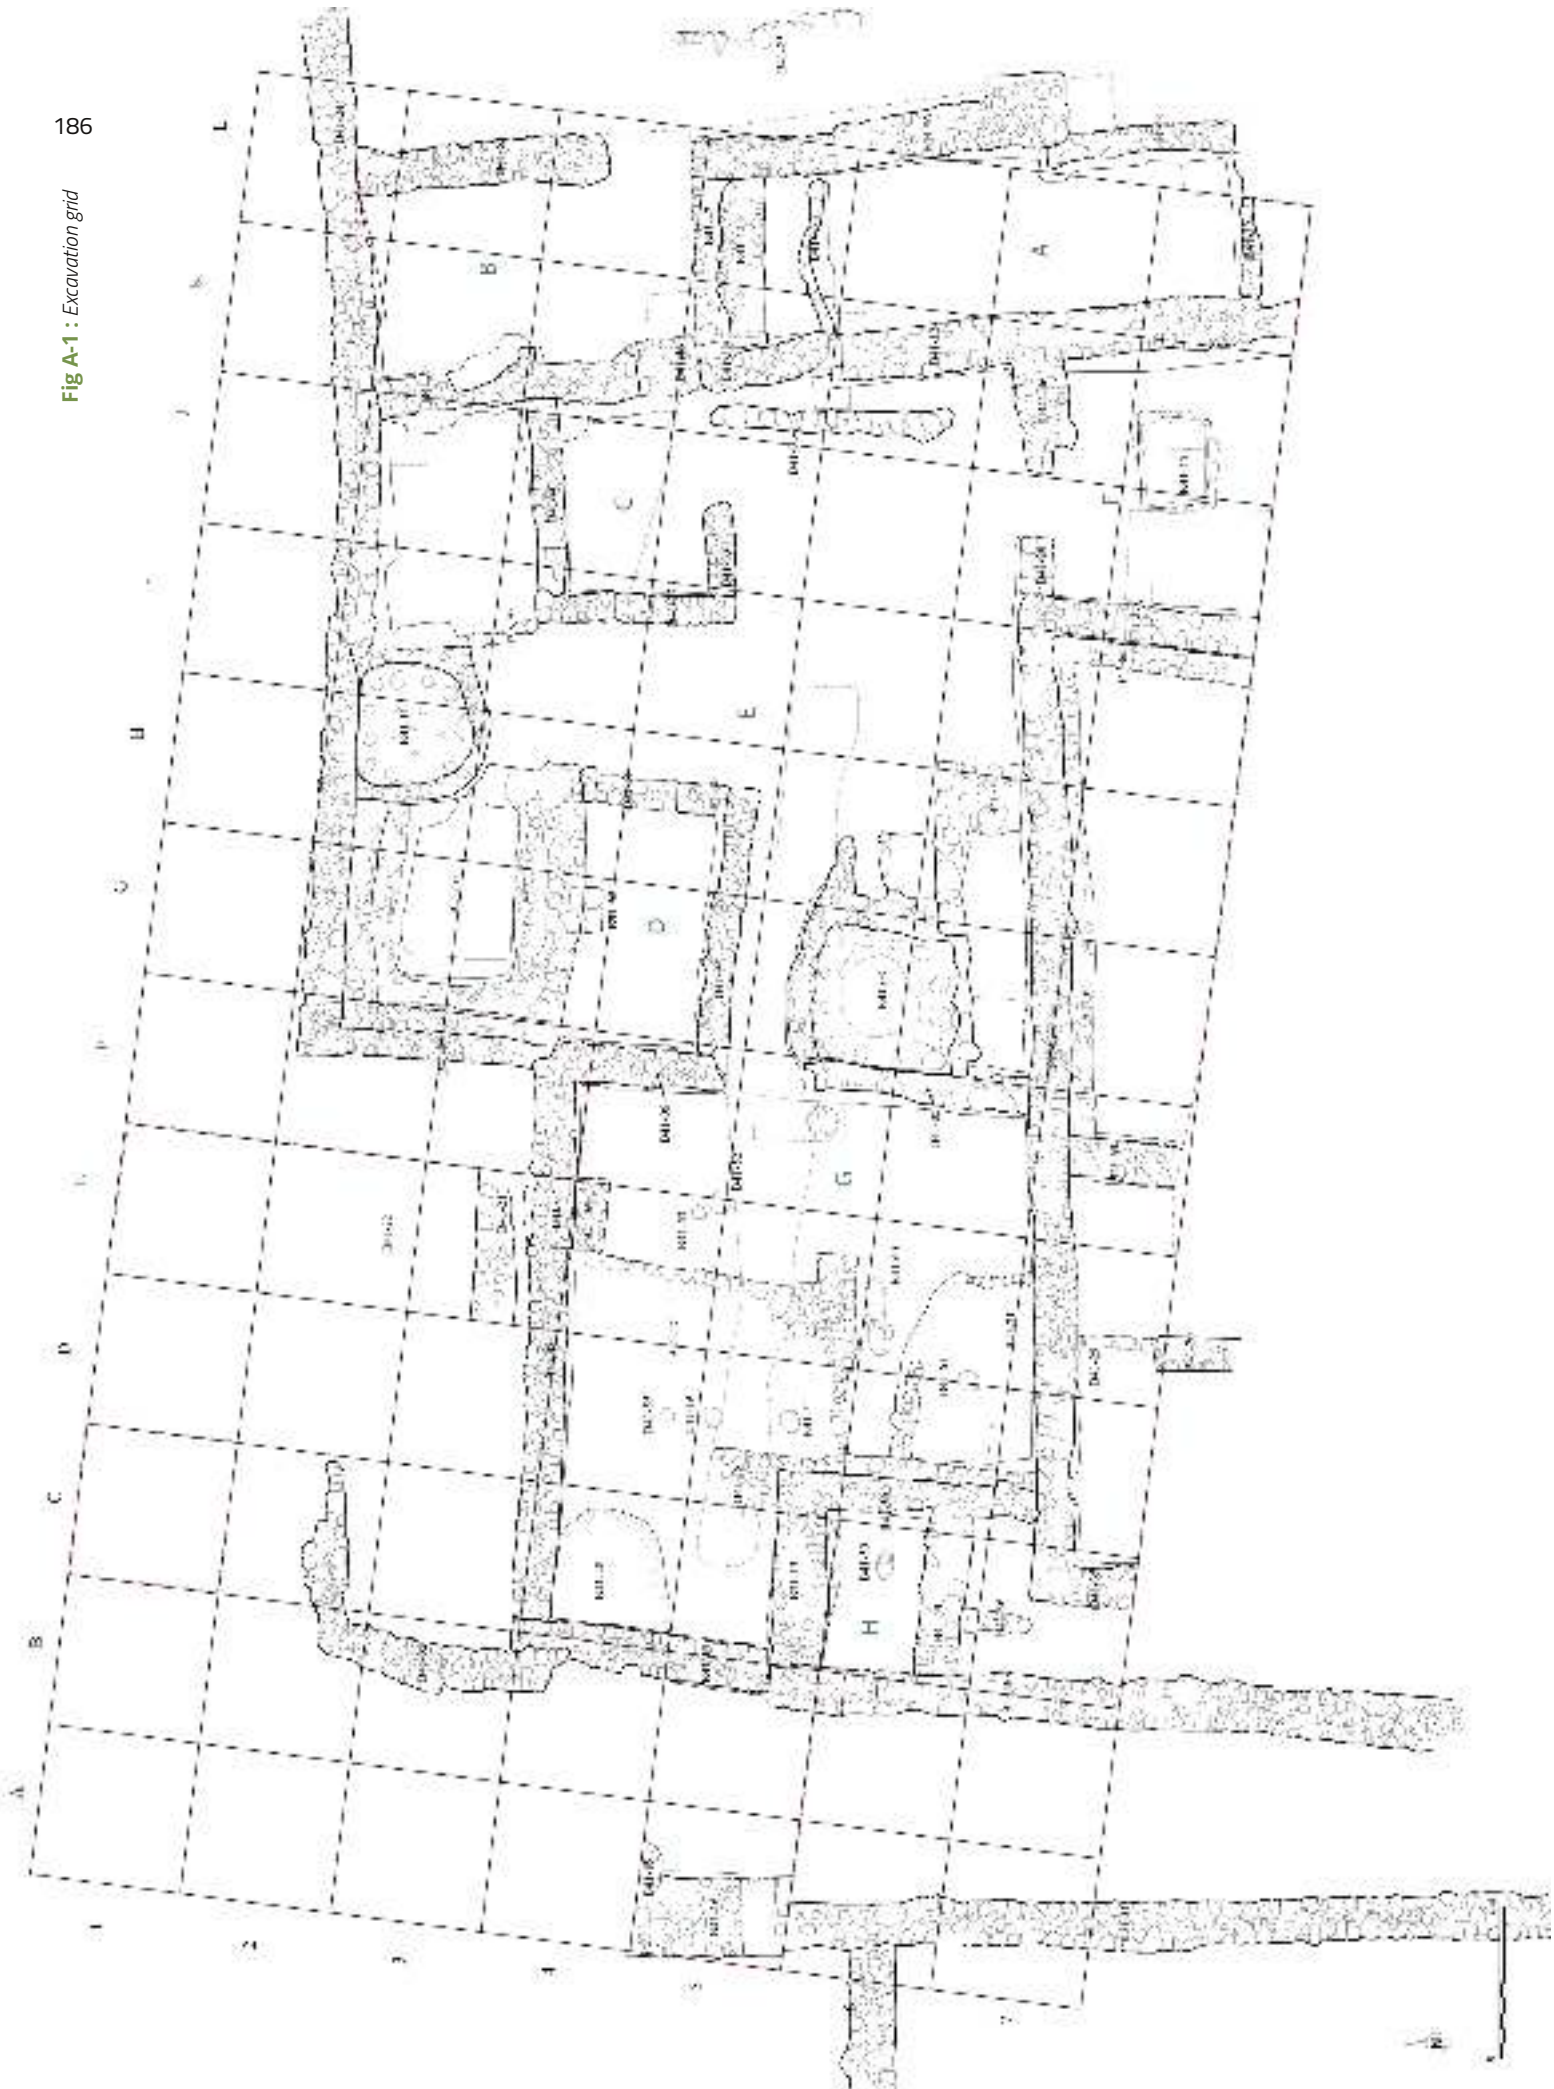
Fig A-1 : Excavation grid

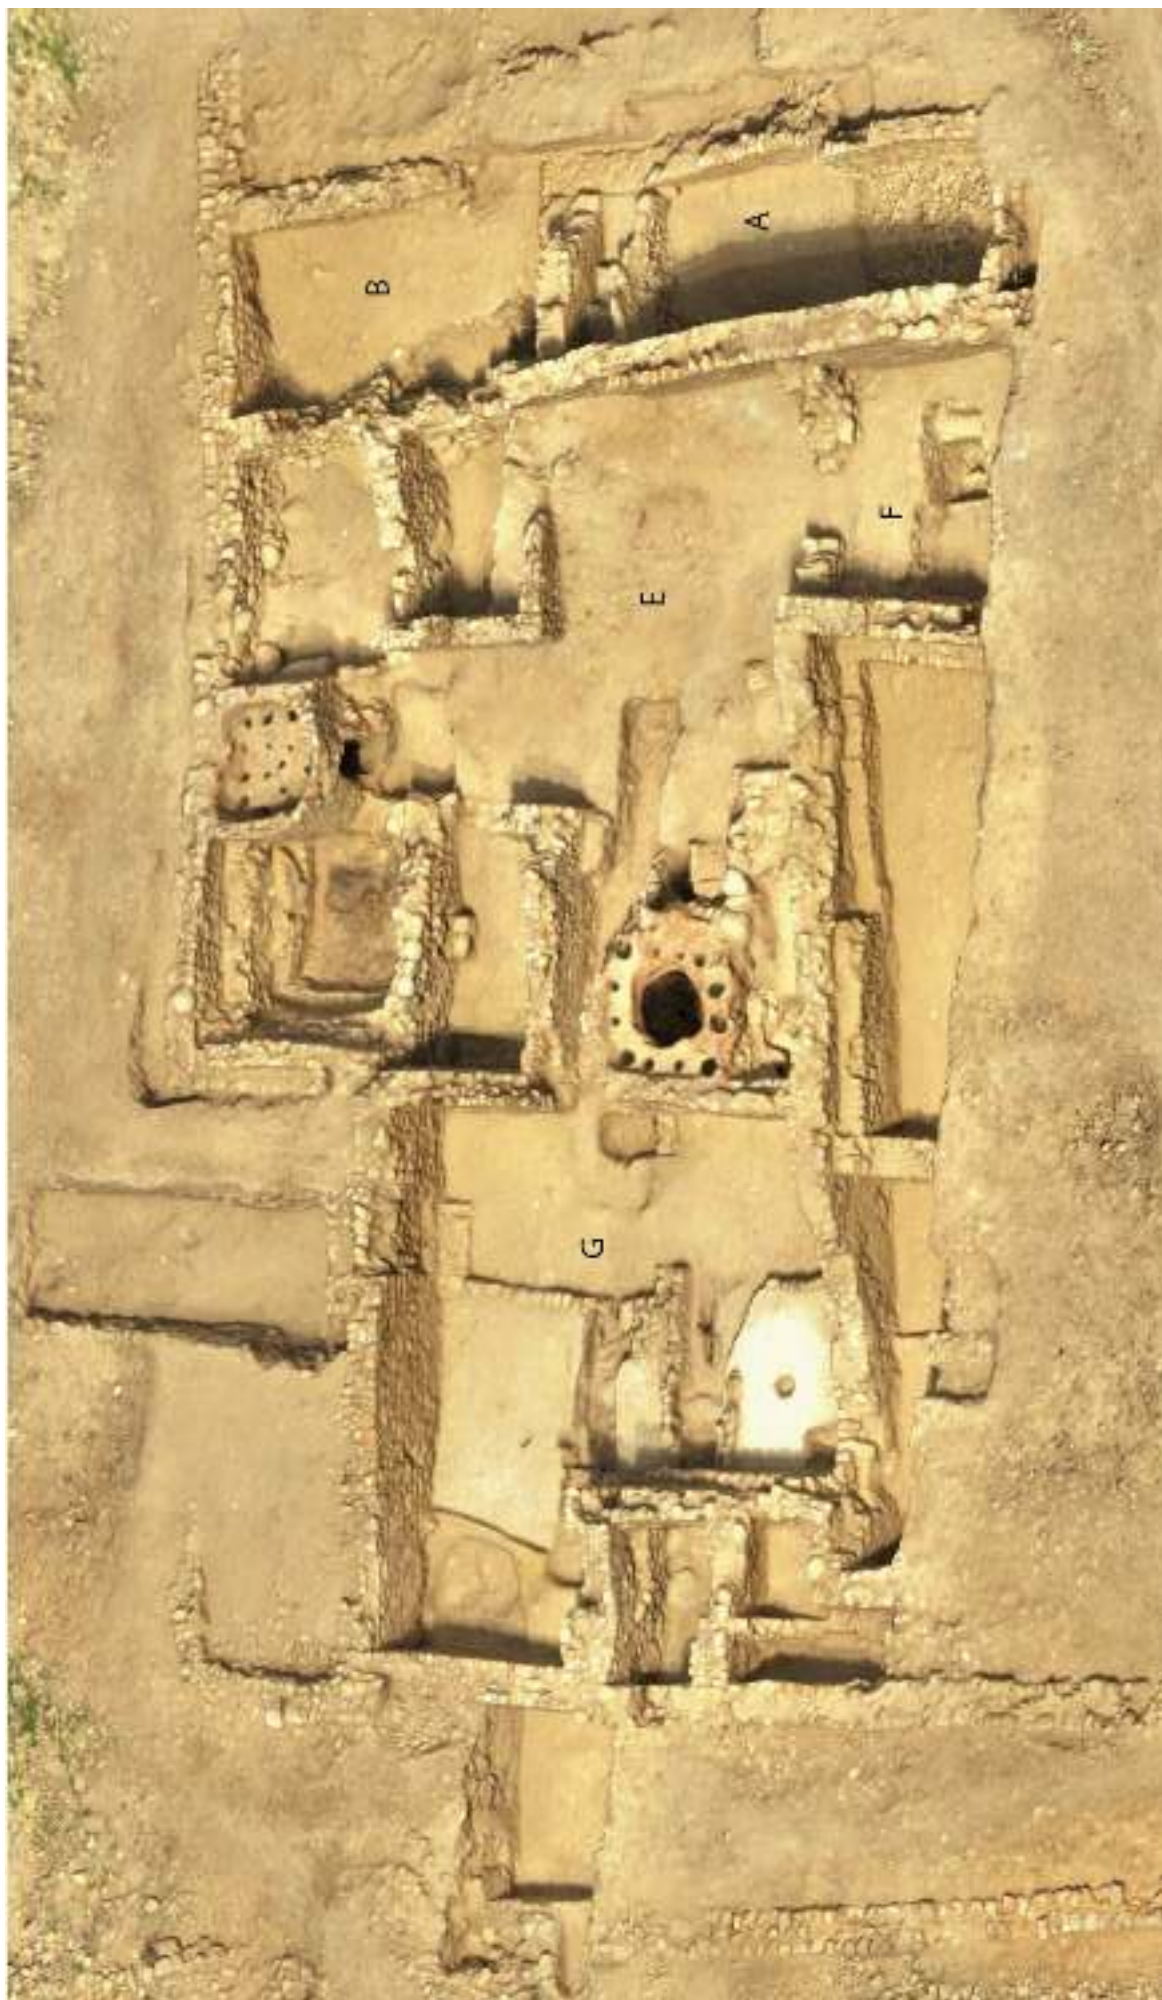
Fig A-27 : General view of B4.1 phase 1

B41-71 was more likely a discharge area (Altitude 30.69m). It measures 2.50m long, 1.55m wide and 0.24m high (Fig A-27). This platform is constituted by a plaster level more or less compact with ceramic inclusions and gravel (UF 6411). It is delimited by two low stone walls. It should be noted that a post hole (B41-61) was dug at the centre of the platform. Thereafter levels of wastes (UF 6412, UF 6407) covered this structure. These are heterogeneous loose silt levels. They contain inclusions of charcoal, mortar, plaster and many ceramics. At the end of phase 2, the space related to the B41-71 platform is sealed by UF 6231. It is compact homogeneous brown clayey silt. It contains ceramics and gravels and charcoal residues.

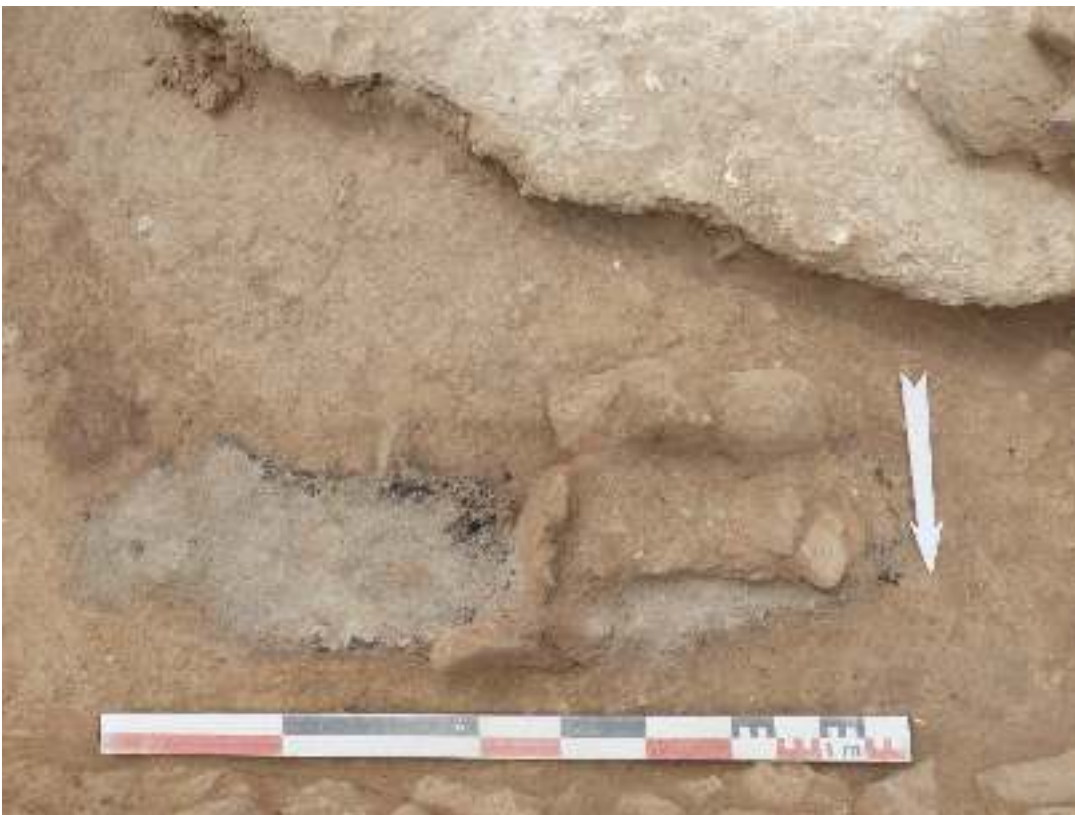
Fig A-34 : *Structure B41-60*

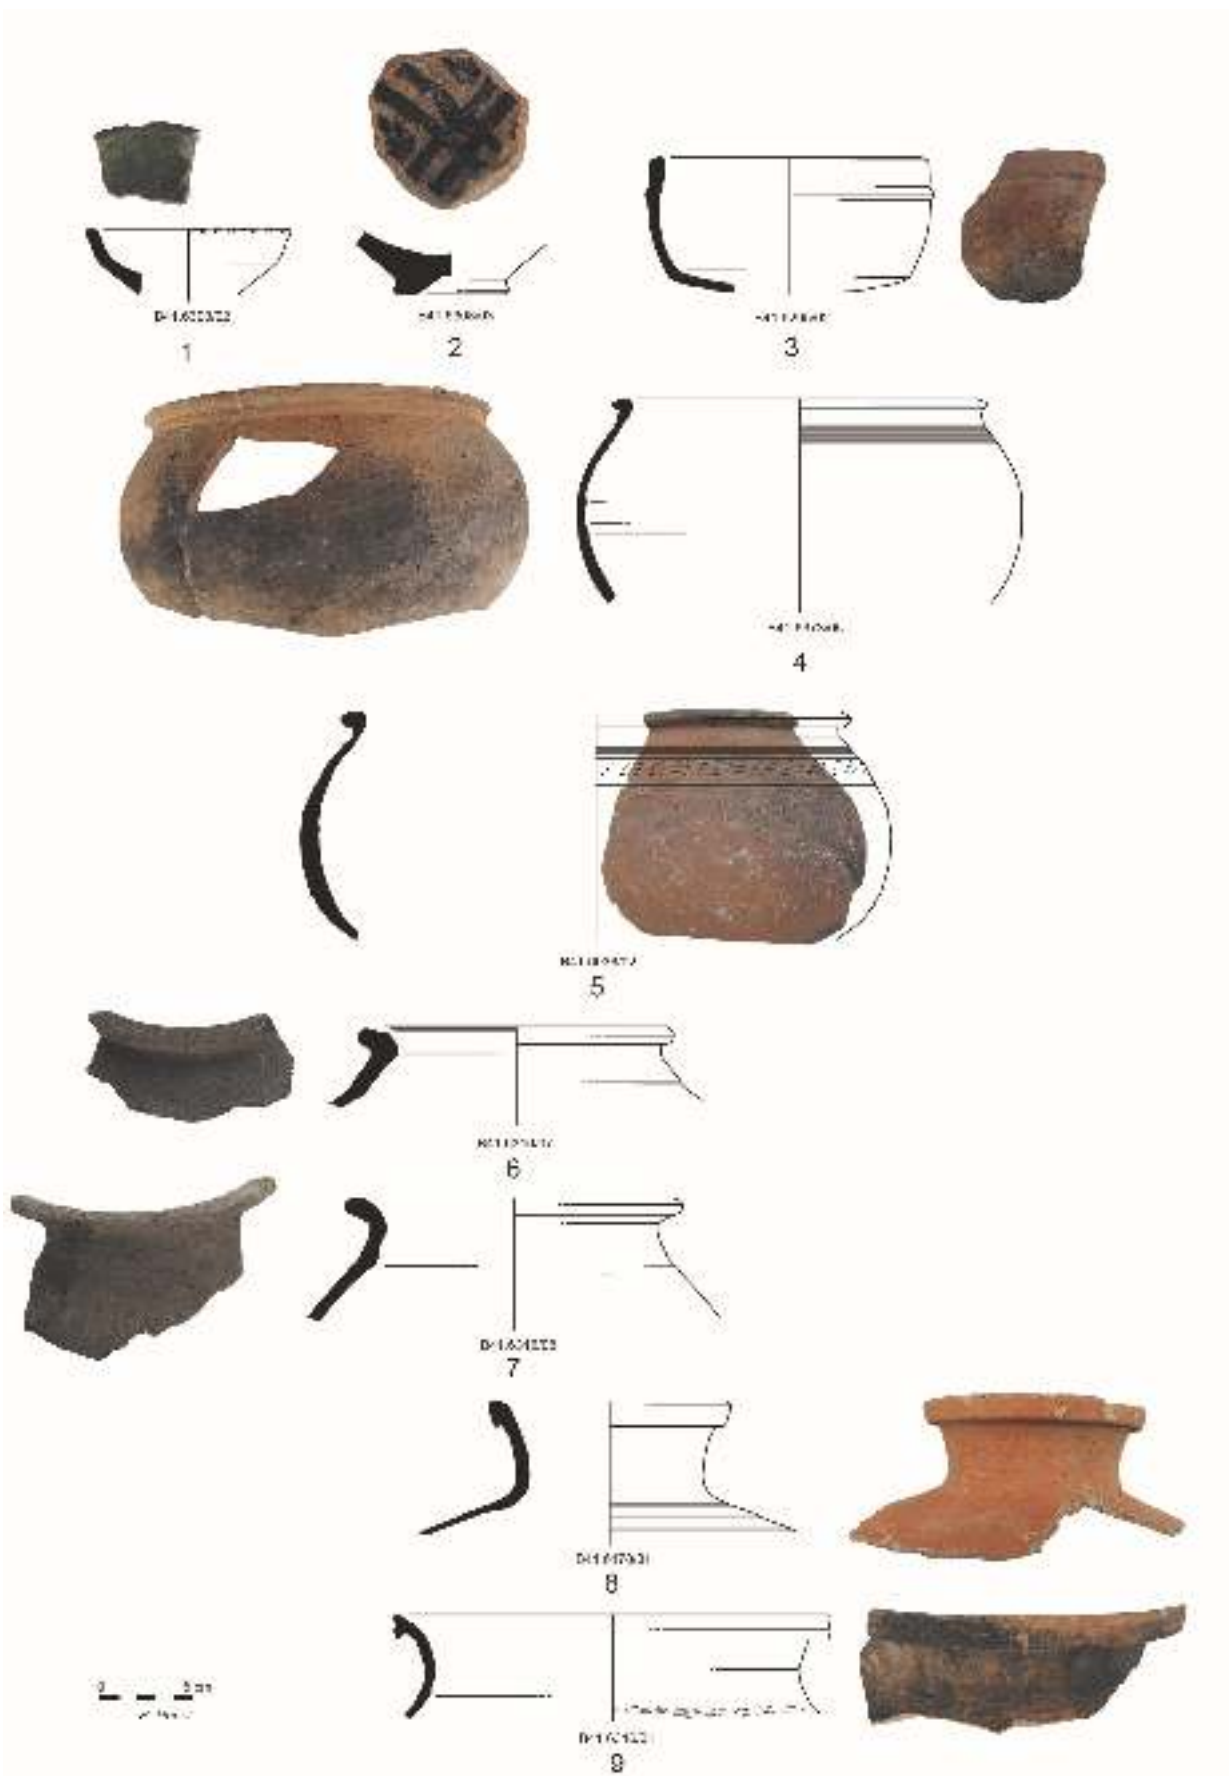
Fig A-64: Imported ceramic phase 4. N°1: plain green glazed bowl; n°2: iranian painted underglazed ware; n° 3-5 : cooking pots; n° 6-7: indian black cooking pots; n°8-9: indian red ware.

The « mustard » bowls, common between 1250 and 1350, disappear. The few examples are residuals, founded principally in rubbish levels. Whereas some productions dated from the 14th century appear: the bowls with turquoise glaze so-called "blue speckled", bowls with black painting patterns under light pinkish glaze (Fig A-64: 2) and the plain or painted under glazed fritware.

A new shape of cooking pot is present in the levels of the 4th phase (Fig A-64: 4-5) next to the cooking pots coming from Julfar (Fig A-64: 3). This new shape is globular with everted rim and combed decoration on the shoulder. It is uncommon in the levels of the houses of Qalhât, some pieces are found in levels dated to the late 14th century. Their origin remains unknown for the moment. The importations from India change with a decline of painted jars and the frequency of cooking pots in red or light brown fabric with orange slip (Fig A-64: 8-9).

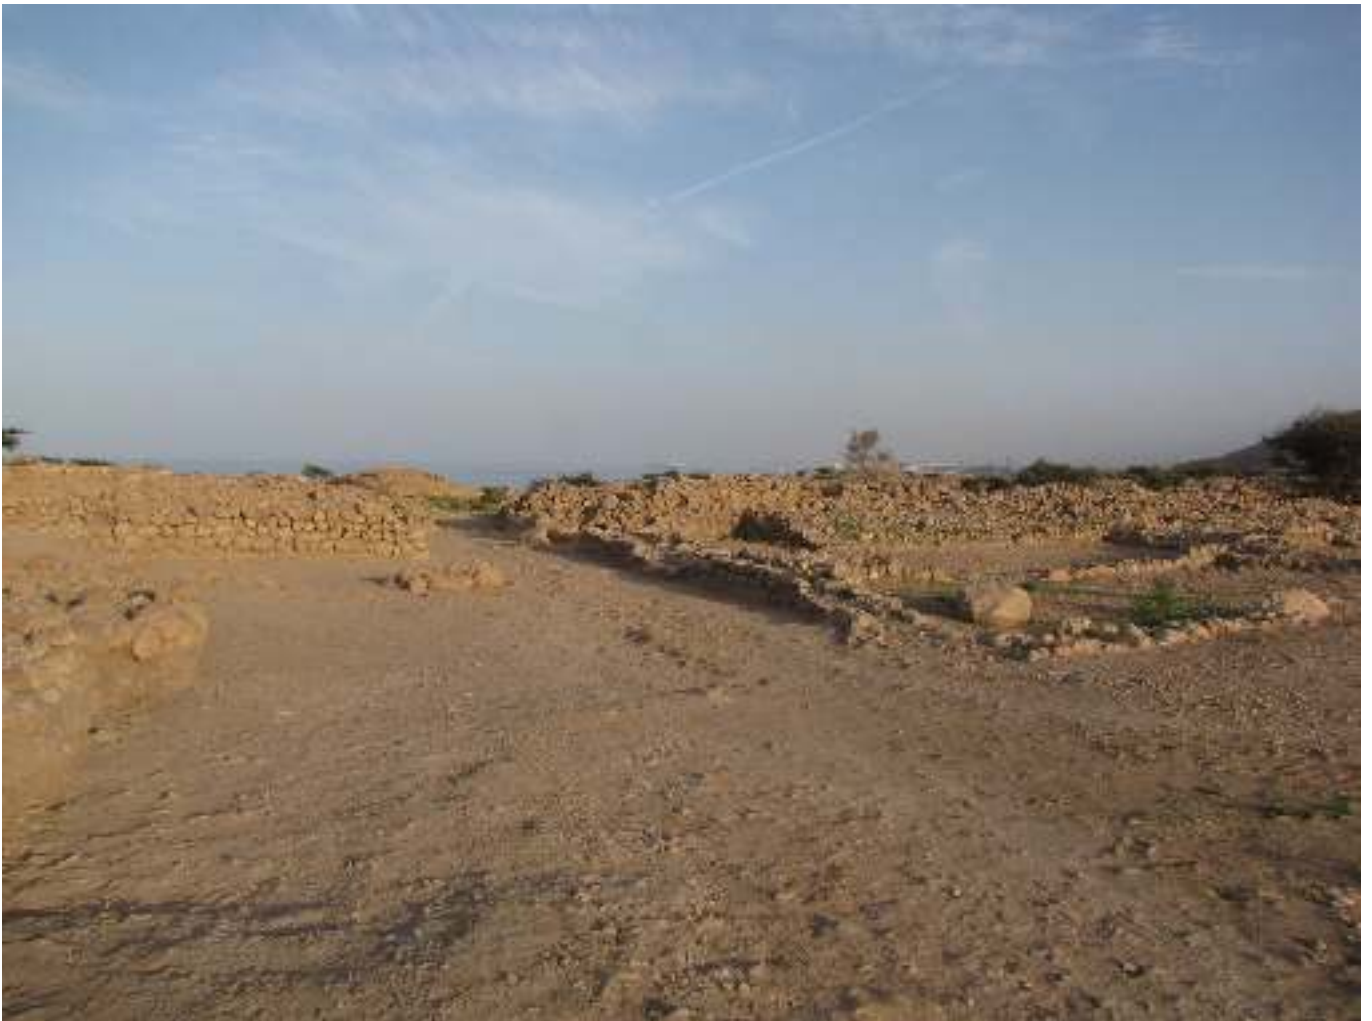
Fig 3-1 : general view of the west gate (B31), from the outside of the city

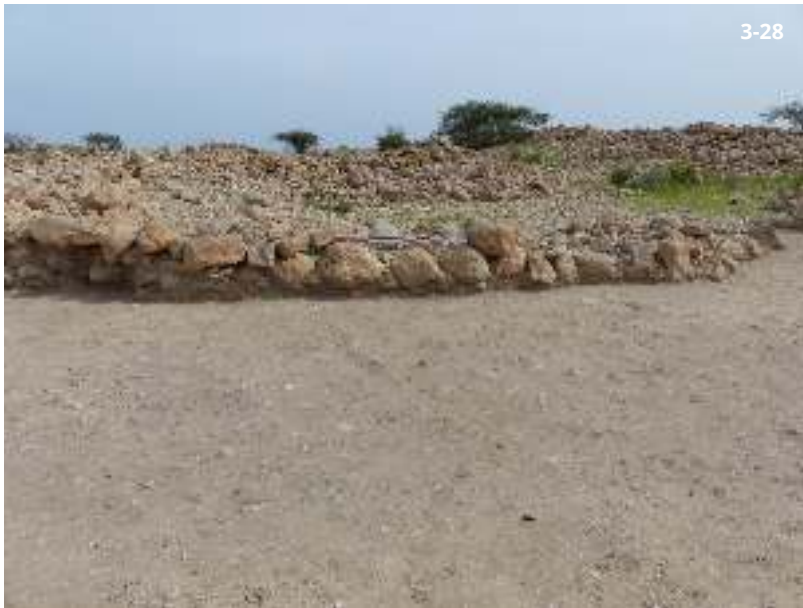
Fig 3-28 : the wall B282-01, outside elevation

The wall B282-01 (**Fig 3-28**) is curved, nearly half-oval, for a maximal length of 7.30m and a width from 0.90m to 1.30m, for a maximal preserved elevation of 0.85m high. The south external facing is made with medium to large limestone blocks without proper binder and the north internal facing is visible on the ground but not excavated, as the level of small pebbles reached is a backfill level and not a collapse layers.

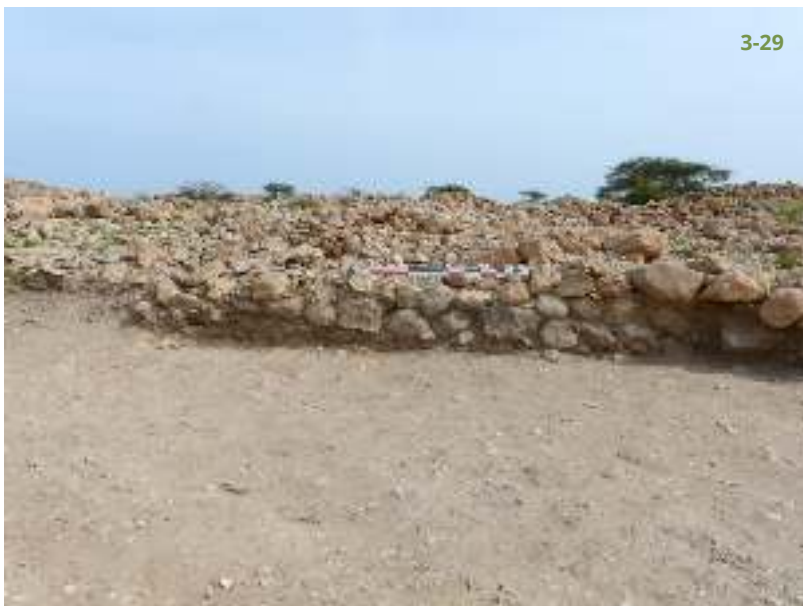
Fig 3-29 : the wall B282-02, outside elevation

The wall B282-02 (**Fig 3-29**) is more linear and misaligned with the wall B282-01, excavated for a maximal length of nearly 3m and a preserved elevation about 0.60 m high. Its width is still unknown and a possible perpendicular return may be guessed at east, along and under the wall B282-01. From two to three courses of stones were unearthed on the south side. They are made of medium limestone blocks poorly bonded with earth. This wall probably extends westward but this area was not excavated.

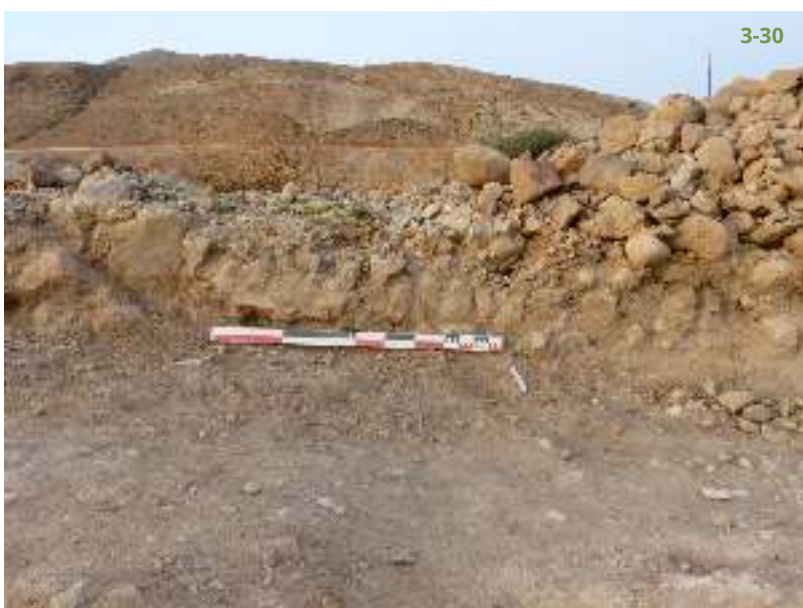
Fig 3-30 : the wall B283-01, outside elevation

The wall B283-01 (**Fig 3-30**) represent the west part of the northern limit, with an external facing made of one course of small corals and limestone blocks, poorly bonded with earth, and presenting remains of a damaged coating of pinkish plaster. It has been observed for 2 m long but extend westerly under the heap B31-09, and its width is unknown, like its southern extension remains uncovered.

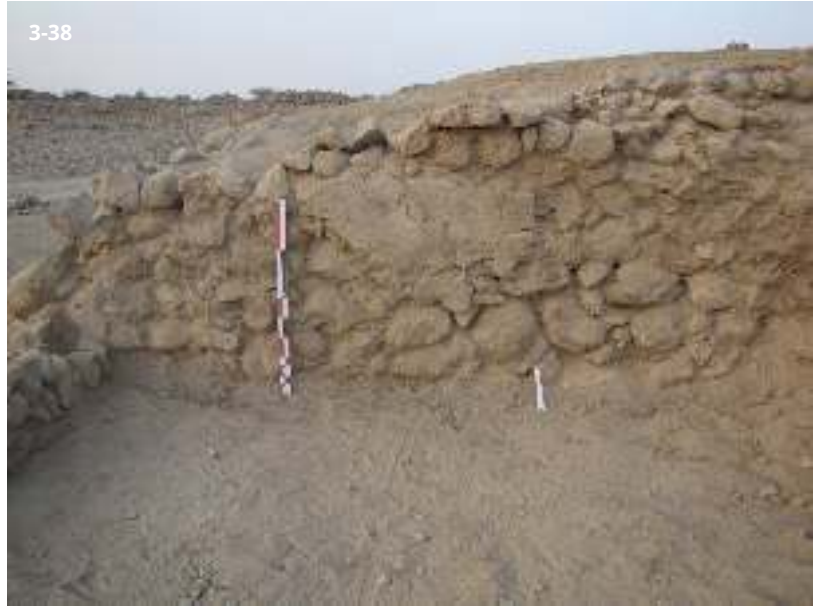
Fig 3-38 : the wall B29-03, partially excavated, with its remains of coating

The south wall **B29-03** (Fig 3-38) is also common with the room B29-B but it is here hidden by the south terrace B29-C (*infra*). In the room B29-A, the wall is internally 5m long by 0.75m wide in average for a preserved elevation of 1.50m to more than 2m near the corner with the room B29-C. It is also made with massive pebbles and limestone blocks in the lower courses and medium ones in the upper ones, bonded with grayish earthen mortar. A large plaque of grayish coating was also found still preserved on the wall. The layer of collapse **Uf5504**, which was covering the wall, contained few corals and remains of coating and plaster which could come, according to the location, from the wall at first floor. A sounding (SD2) was opened in the corner between the main building and the south terrace, which showed that the wall B29-03 is partially built directly over the bedrock and partially over a very thin layer of backfill (maybe from natural origin) which is leveling it (Fig 3-39).

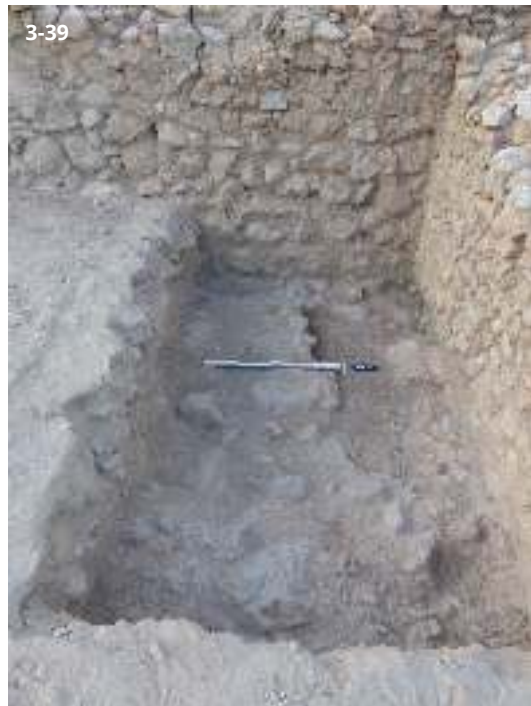
Fig 3-39 : the sounding SD2, with the wall B29-03 (in the background) built over the bedrock

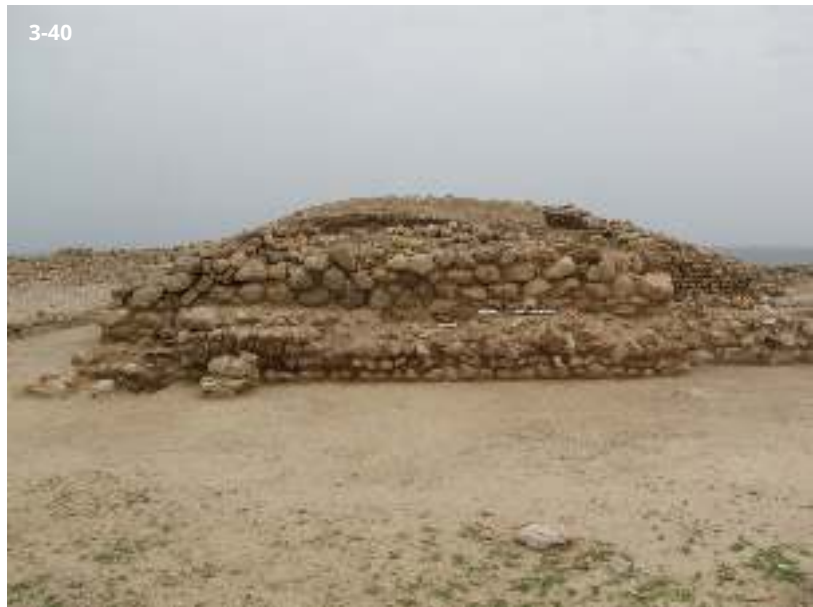
Fig 3-40 : the wall B29-01, in the background behind the scale

The west limit of the room B29-A is made by the wall **B29-01** (Fig 3-40) which is externally 7.80m long by 1m wide for a preserved elevation of almost 2m. The lower part is now hidden behind an outlying wall B29-12 but is probably also made with massive pebbles and limestone blocks; medium ones are visible in the upper part, bonded with grayish earthen mortar. No remains of coating were observed on the visible parts of the wall but many remains were found in the collapse (**Uf 5505** and **Uf5506**), which can in fact also come from the elevation of the wall at first floor.

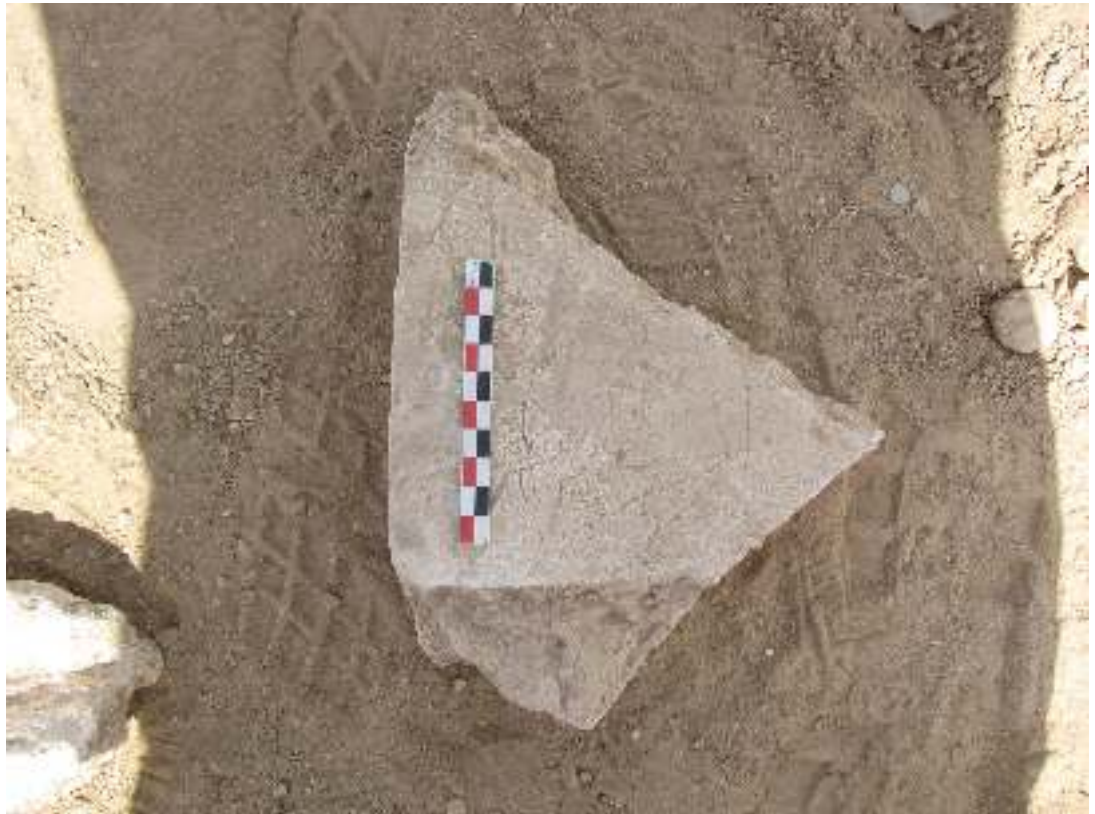
Fig 3-45 : the fragment of plaster (IsoArc 1159) with the remain of arch (down, at right)

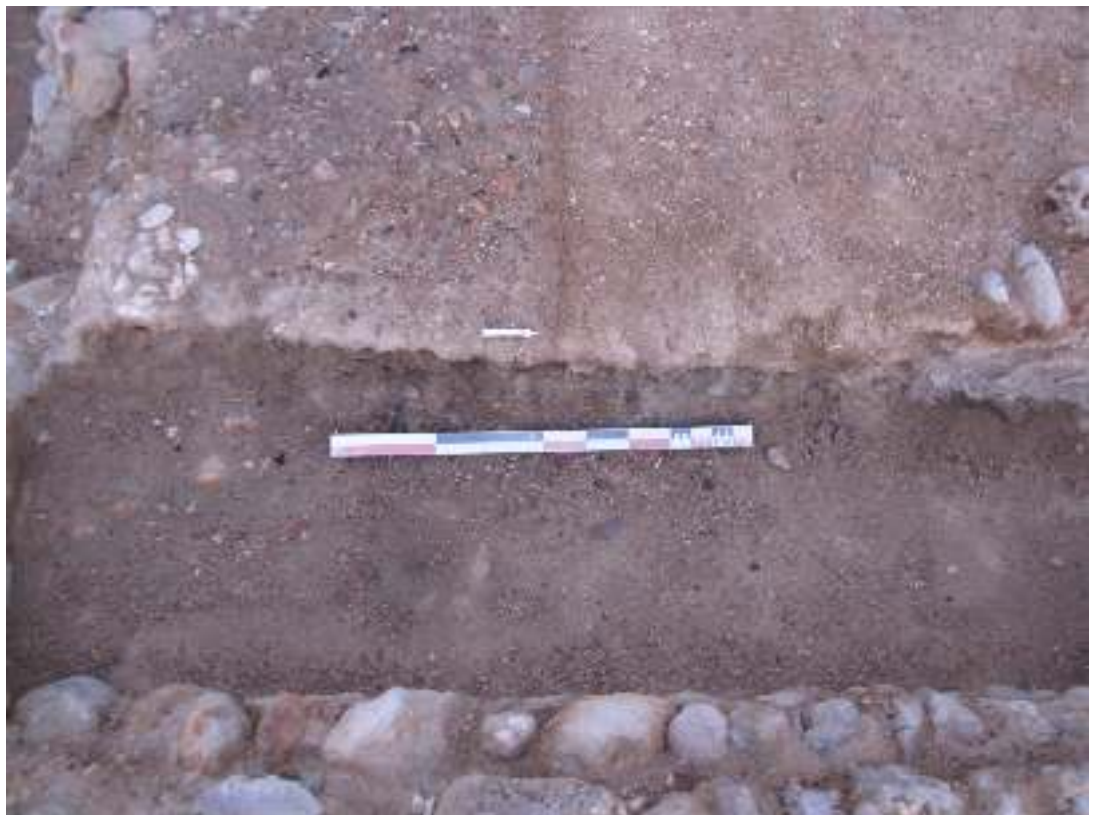
Fig 3-46 : view of the sounding SD4, with the reddish earthen floor Uf 5516 (at right of the arrow) above the backfill layer Uf 5517 (down, and behind the arrow)

Under the earthen floor, the backfill (**Uf5517**) was excavated for around 0.50m deep only. It is a mixture of small rocks, various rubbish, ashes, charcoals and black soil (Fig 3-46). Its facies undoubtedly confirms its identification as a backfill and not a layer of collapse and proves that the circulation level was at first floor,

around 2.50 above the neighboring ground (Fig 3-46). So, apart from the dividing wall B29-30 and probably the center of the wall B29-04, all the other walls are now preserved under the level of the first floor. All possible internal fittings have so disappeared.

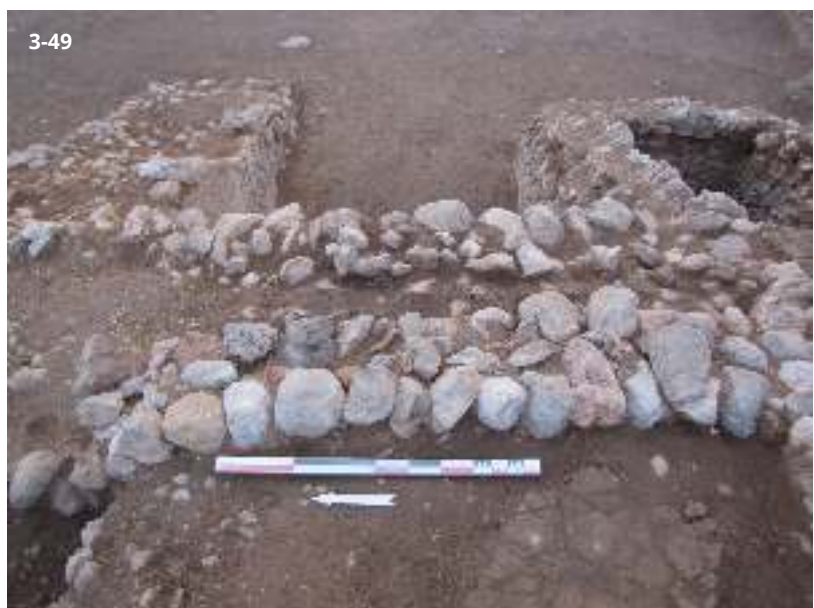
Fig 3-49 : *the inside elevation of the wall B29-05, with the top of the wall B29-26 behind*

East of the room B29-B, a low wall **B29-05 (Fig 3-49)** was uncovered, 3.10 m long and 0.60 m thick, for a preserved internal elevation of around 0.20 m (only one course of stones) and an outside elevation on its east side of around 0.50 m (three to four courses of stones). It is made with medium pebbles and limestone blocks poorly bonded with earthen mortar and no remain of coating was observed. The wall is built over the lower part of the wall B29-03 but is with the upper part which is the remain of the elevation at first floor. It is so contemporary of the construction of the building and was undoubtedly the eastern limit of the inside of the room B29-B. Between the east side of the wall B29-05 and the eastern end of the building made by the wall B29-26, a narrow external space, around 1 m wide, was so in existence. It could have been used as a passageway to the south terrace B29-C but it was in existence before this later addition to the building. Some kind of high gallery or external tribune might be a better interpretation, the function of which could be decorative by creating animation on the east facade of the building.
