Qalhât Development Project, Season 2015B-2016A, Final Report

SEASON 2015B-2016A

Excavations on the Ceramic Workshop B41

I-B. The 2015b-2016a season - 1. Excavations of the southeast part of the Mosque (Spans 1 and 2)

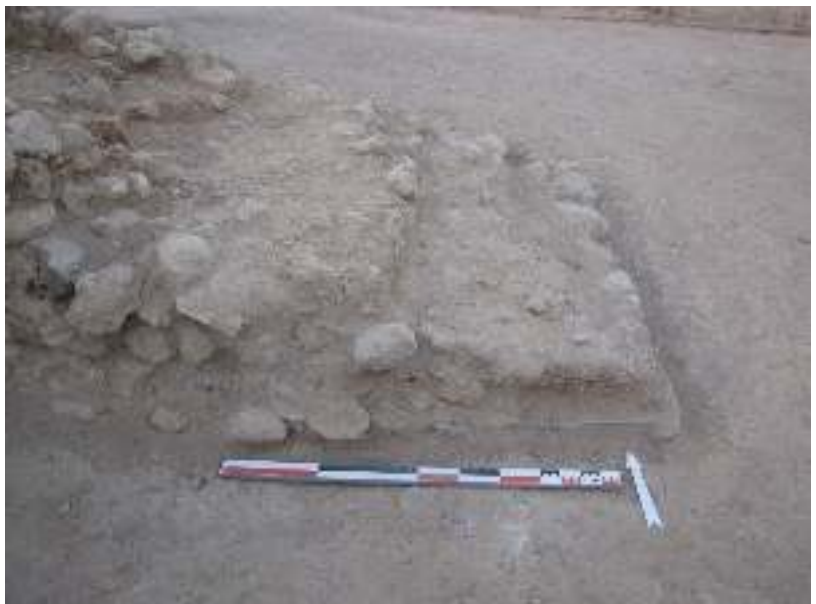
Fig 3-57 : the first two steps of the stair B29-33

The steps are not preserved but more or less guessable by the alignment of stones which are the remains of the facings. Five steps can yet be seen and, according to the actual altitude and the assumed restitution, at least a sixth one must be considered and a seventh one is very likely. The two first steps, which are the best preserved (**Fig 3-57**), are wider and lower than the upper ones, around 1.80m long by 0.75m to 0.90m wide and most probably about 0.30m high. Those two steps were not outlined by handrail and it is very likely that they were covered by coating but no remain of it was found.

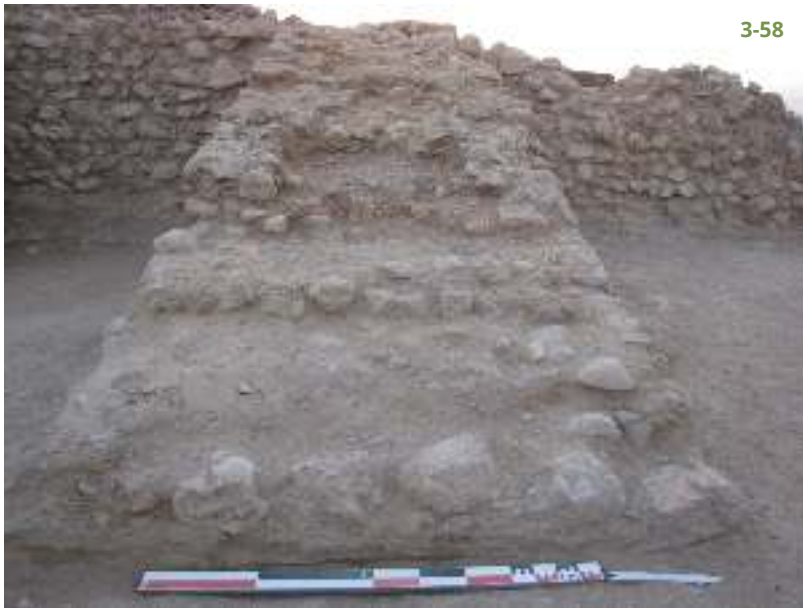
Fig 3-58 : *the first two steps (in the foreground) and the upper steps (guessable in the background) of the stair B29-33*

The upper steps are more damaged and it is difficult to be affirmative about them (**Fig 3-58**). They were apparently bounded at north and south by a handrail, which is very badly preserved, and so were smaller than the low steps, about 0.80m long by 0.60m wide. They could also have been higher, probably 0.50m but five steps about 0.30m high were probably enough to reach the east upper gallery, where one large step or two small ones were sufficient to reach the floor of the room B29-B.

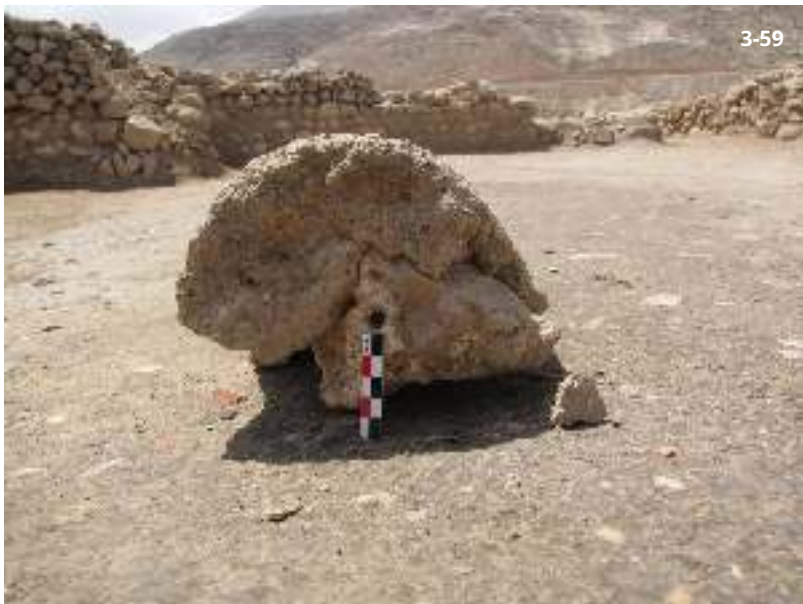
Fig 3-59 : *lateral view of the possible remains of a handrail (IsoArc 1165)*

In the layer of collapse (**Uf5531**) excavated around the stair B29-33, a fragment of masonry with a half-round face covered with strong gray coating (**IsoArc1165** ; **Fig 3-59**) was found. According to its location, it could be the remains of the handrail outlying the upper steps, the top of which was half-round. This handrail could have been very low, no more than 0.50m high, as some examples of stairs with low handrail are still visible today in the oldest houses of the actual village of Qalhât. The handrail could have extended until the walls B29-05 and B29-27 and have the same height; in this configuration, the access to the upper gallery in front of the room B29-B was blocked by the pursuit of the handrail, and was so probably not used as a passageway.

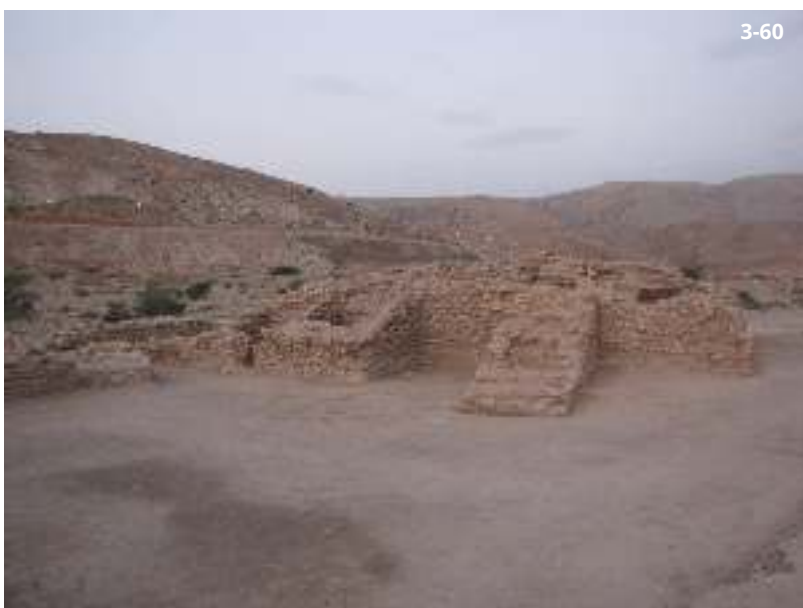
Fig 3-60 : *general view of the east side of the building B29, with the stair B29-33 at right*

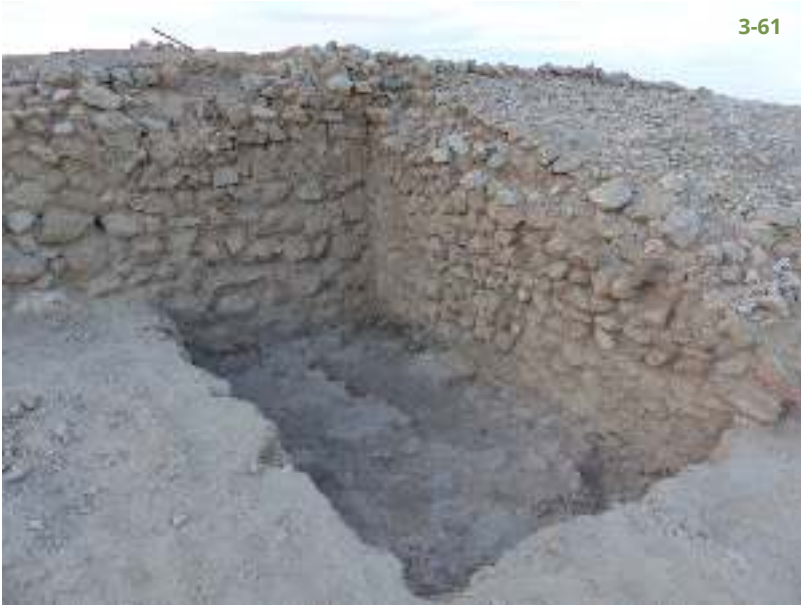
Fig 3-61 : the wall B29-06 (at right) leaning on the wall B29-03 (at left)

The room B29-C is delimited to the east by the wall **B29-06 (Fig 3-61)**, which is built against the wall B29-03 and over the bedrock partially leveled. It is 3.76m long and 0.60m thick for a preserved elevation from nearly 2m near the wall B29-03 to 0.80m at its south end. It is made with medium pebbles and limestone blocks bonded with earthen mortar with few remains of coating.

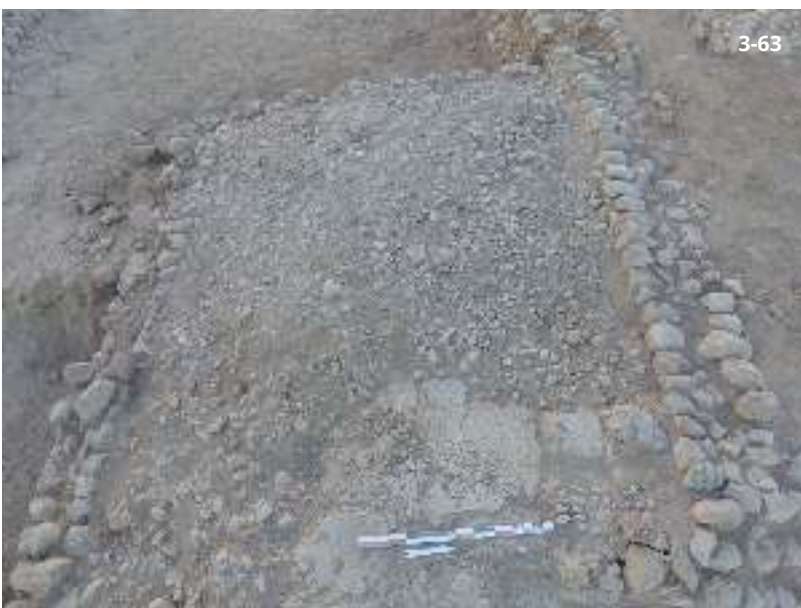
Fig 3-63 : general view of the room B29-C with the level of backfill Uf5510, mainly made of rocks

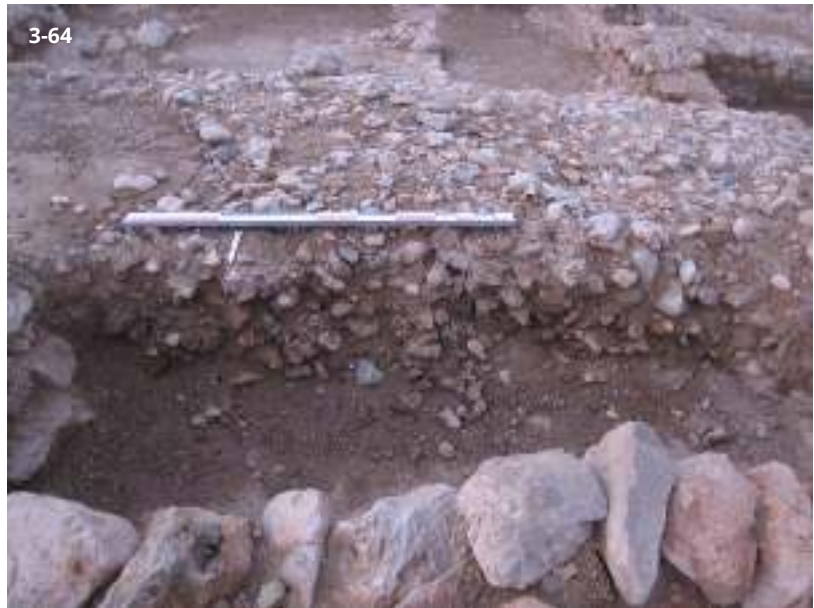
Fig 3-64 : *the sounding SD6*

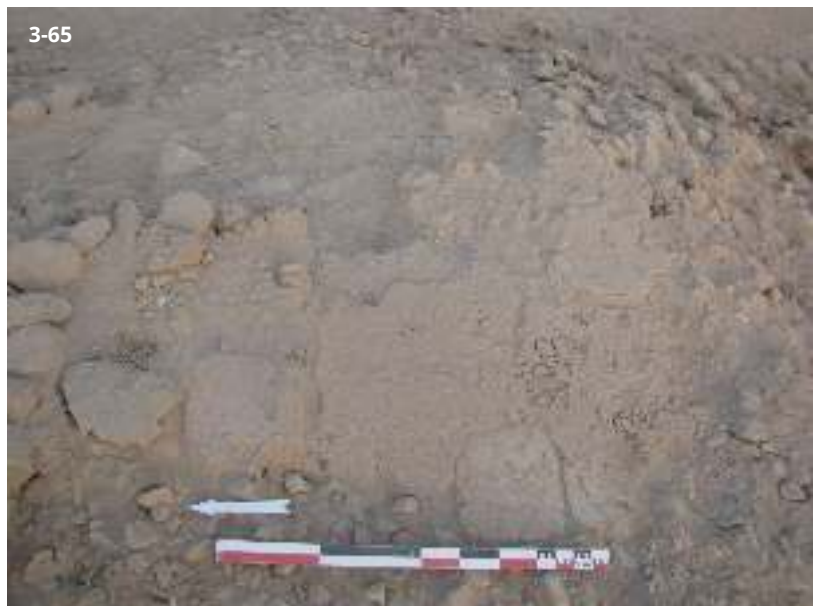
Fig 3-65 : *the remains of coated floor B29-11, in room B29-C*

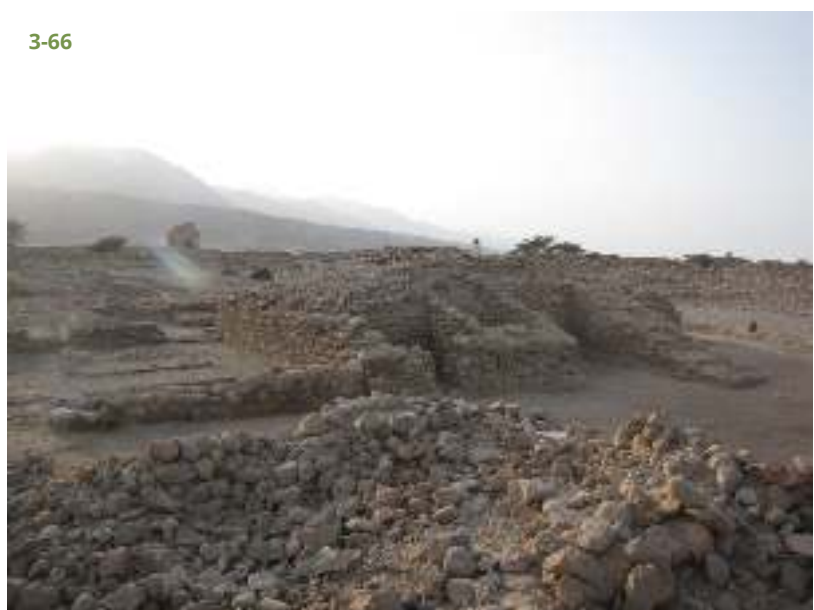
Fig 3-66 : *general view of the rooms B29-D and B29-E, with the high terrace B29-C behind*

The room B29-C is bounded to the east by two square small rooms B29-D and B29-E at ground level, which were built at the same time though an internal later refitting has probably occurred. (**Fig 3-66**).

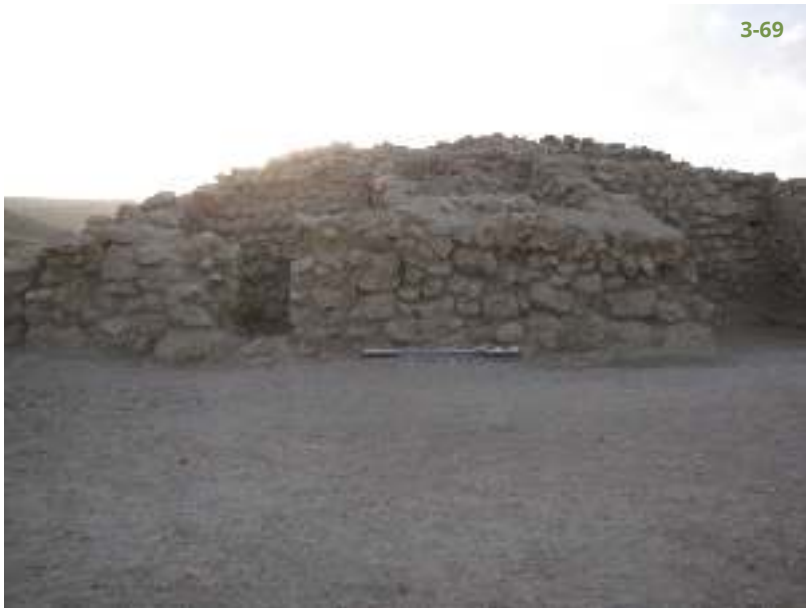
Fig 3-69 : general view of the east side of the rooms B29-D and B29-E, with the wall B29-20, the threshold B29-21 and the wall B29-22 from left to right

To the east, the limit is made by the wall **B29-20**, which is 1.30m long externally and 0.70m thick for a maximal preserved elevation of 0.80m, and by the wall **B29-22**, common with room B29-E and which is here 0.60m long internally by 0.75 m thick for a preserved elevation less than 0.80m, both being separated by the threshold **B29-21**, which is only 0.35m wide (Fig 3-69). The walls are made with large limestone blocks and medium pebbles bonded with earthen mortar. The same strong gray coating was found at the foot of the walls, mainly north of the wall B29-22. The threshold B29-21 (Fig 3-70) is made with medium pebbles partially polished and apparently only bonded with earth. As the south jamb of the gate has a little slide, it is possible that the gate was originally a little bit wider than it is today, but in any case no more than 0.40m wide.

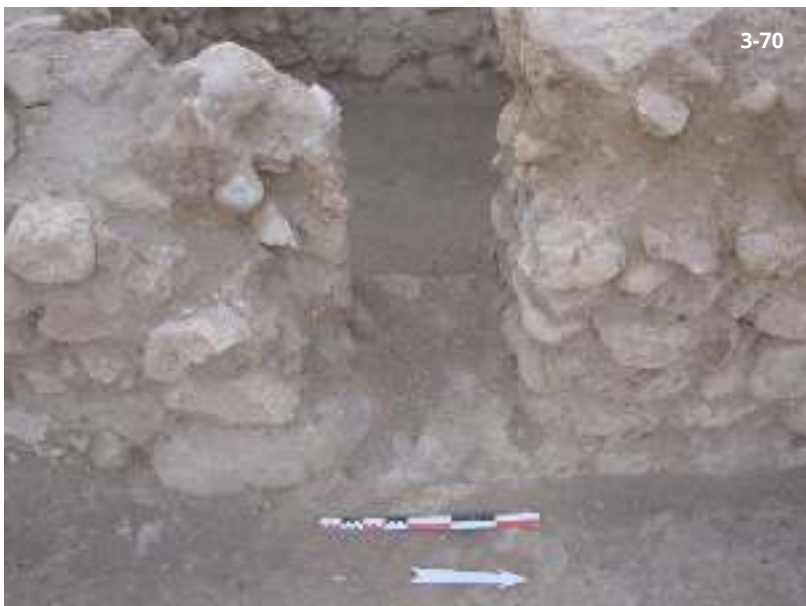
Fig 3-70 : the threshold B29-21

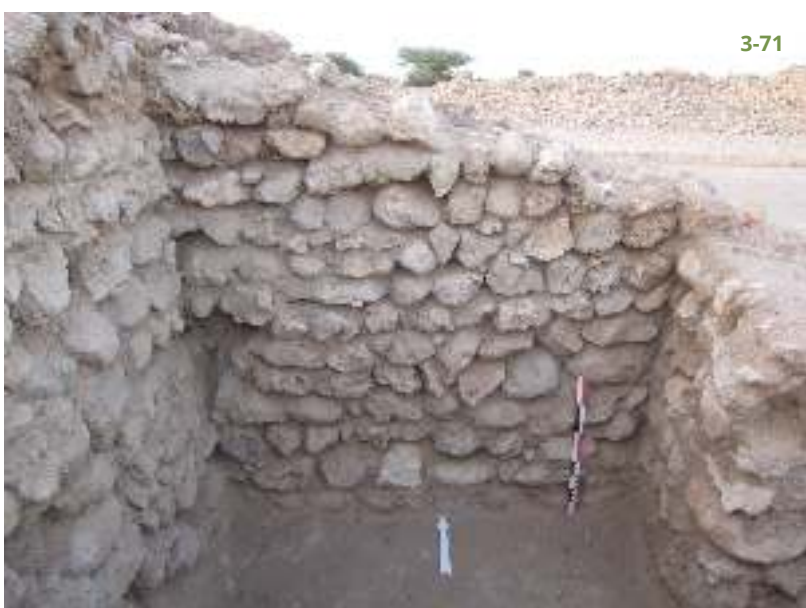
Fig 3-71 : the wall B29-23 in the room B29-D
