## Qalhât Development Project, Season 2015B-2016A, Final Report

**QALHÂT (ASH-SHARQYJAH)**

**SEASON 2015B-2016A**

**FINAL REPORT**

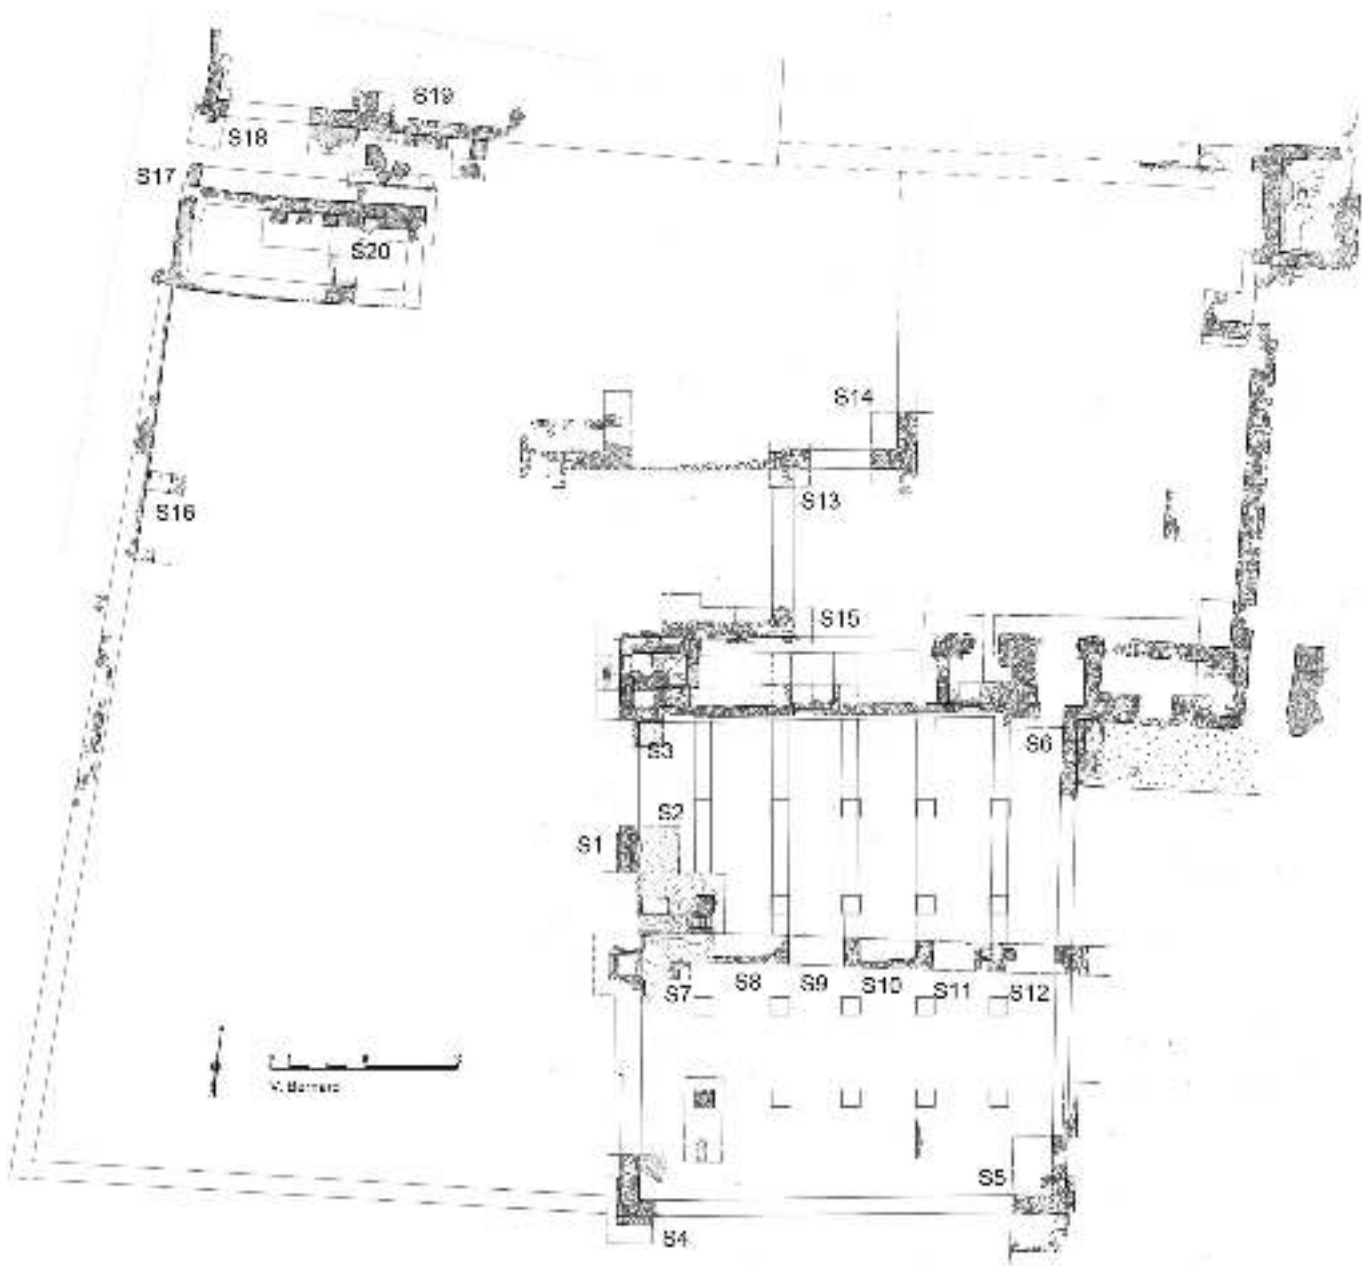
**Fig 1-1 :** *The Great Mosque B12 at the end of the QP soundings*

The Mosque properly said is located in the south-east corner of the Complex and the QP soundings uncovered a square building, 25m long east-west and 26m north-south, variously preserved. A long trench opened in the axis of the building also found the mihrab and the minbar and revealed that the mosque was built on two levels, with the prayer hall on the first floor. The ground floor, which was identified as a basement, was assumed to be divided into six spans by north-south walls, parallel to the shore and qibla wall, which were divided into compartments by shear walls. The easternmost four spans (1 to 4) were packed by the collapse of the prayer hall, when the two westernmost spans (5 and 6) were filled by a backfill. It was so assumed that the westerly spans were never accessible, while the easterly ones, or at least some compartments, were originally empty and probably accessible, as cellars. The prayer hall itself was nearly entirely destroyed and washed by erosion, except to the west, on top of the backfilled spans 5 and 6. Only one meter high of the qibla wall was preserved, together with the bases of the pillars of the westernmost row, founded on top of the basement wall between the two spans. **Fig 1-1**

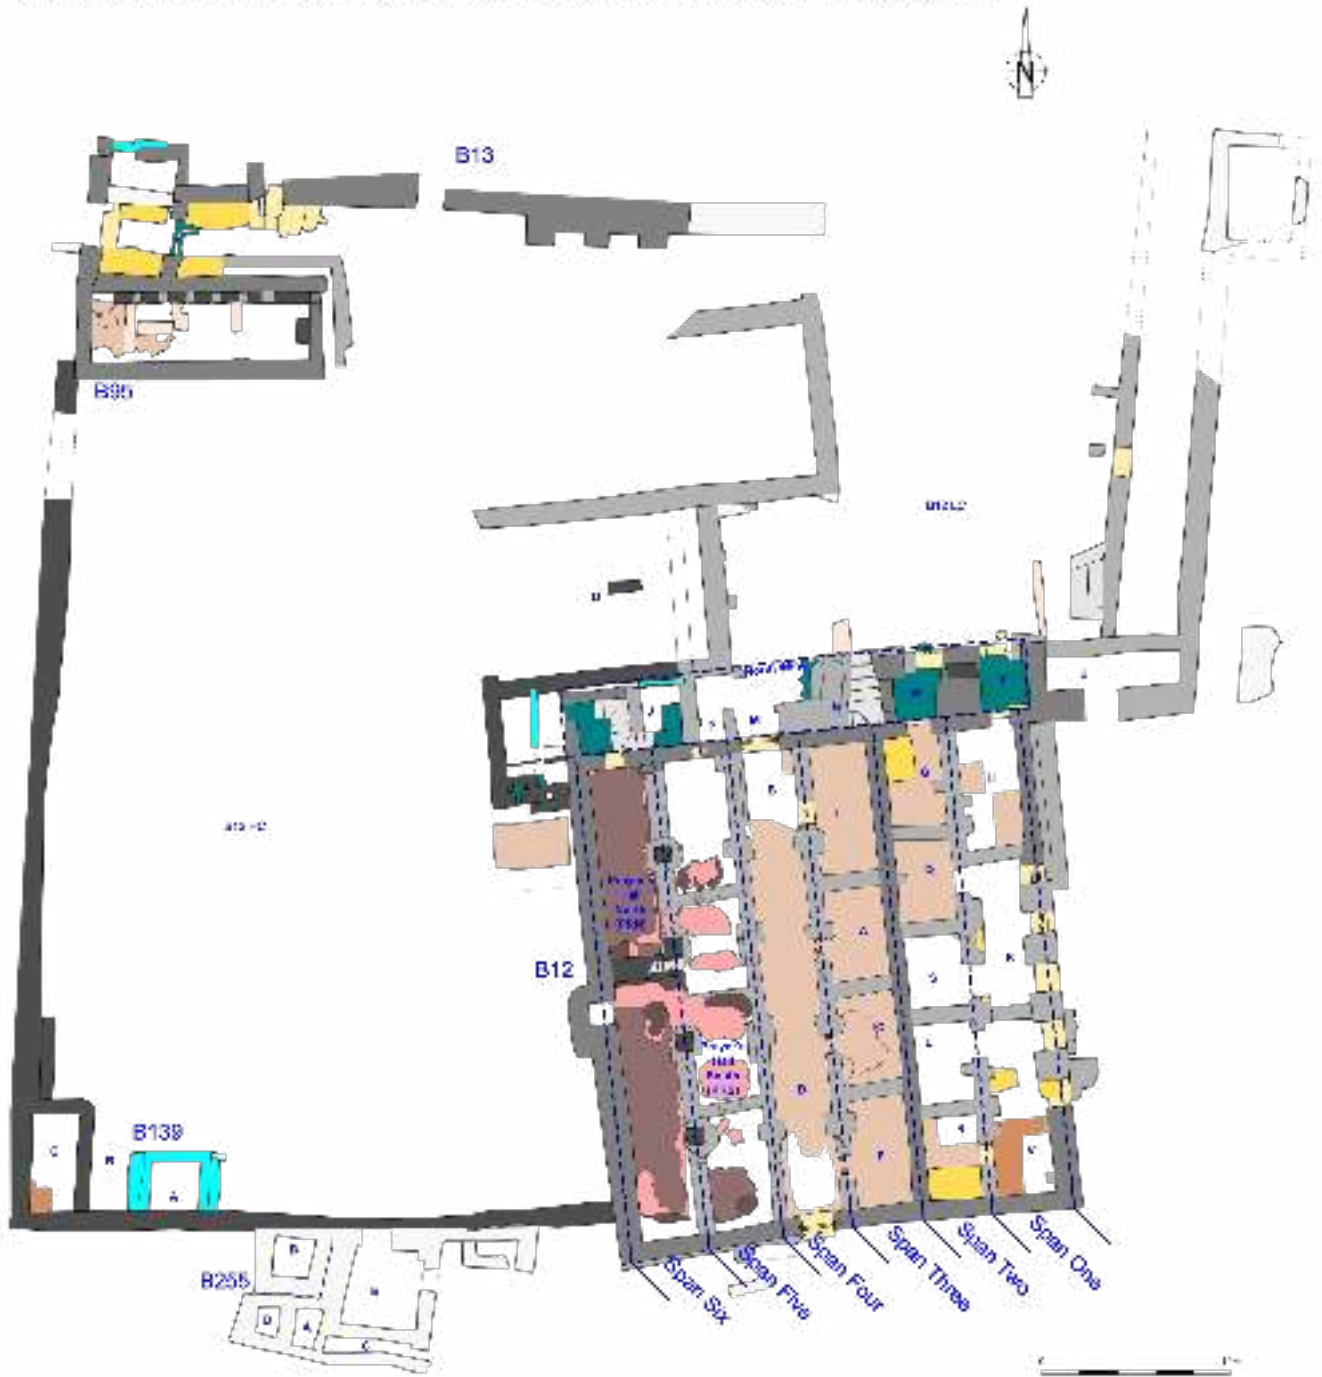
Fig 1-3 : Internal Divisions of the Mosque Complex and surrounding buildings

Qallîât (Ash-Sharqiyah - Sultanate of Oman), The Complex of the Great Mosque, site plan

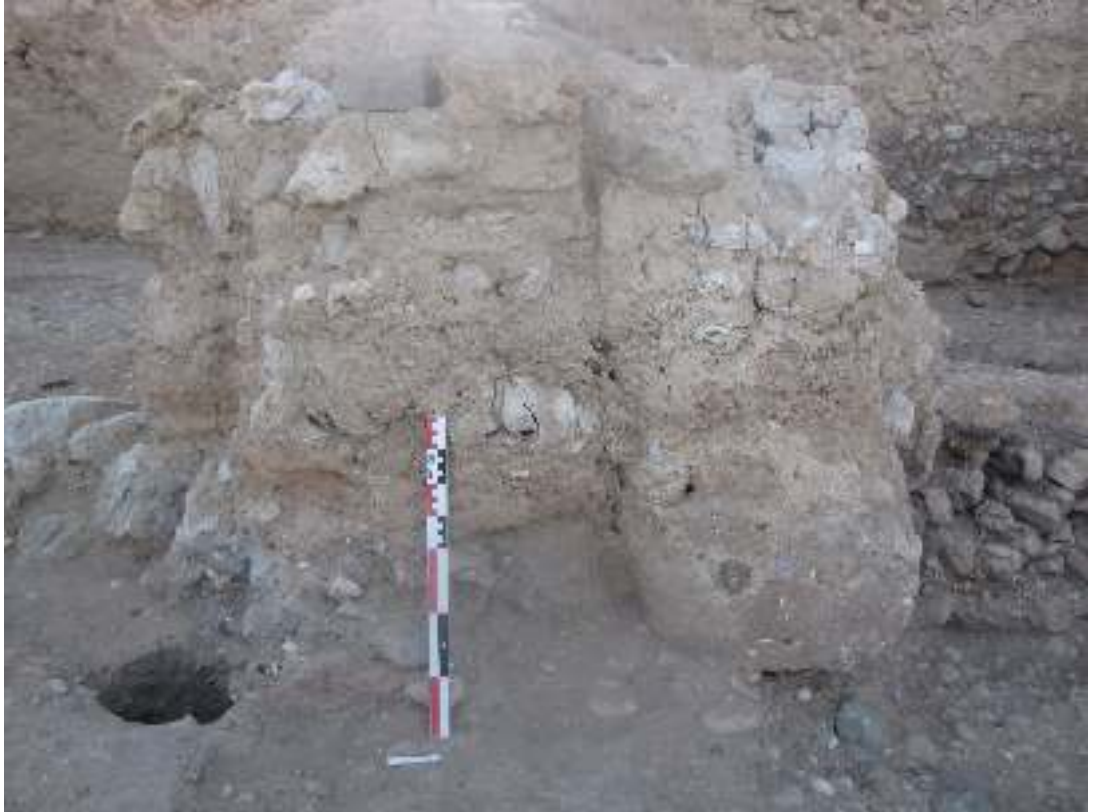
**Fig 1-7 :** *the buttress B12-322, at right*

The buttress **B12-322 Fig 1-7** is built against the wall B12-309, in the alignment of the wall B12-292 that separates the room B12-L and B12-S. It is preserved up to a maximal height of 1m and measures 1.10m long by 0.45m wide at its base. It is made with medium corals and limestone blocks, with bigger stones at the angles, and bounded with a rough gray mortar with inclusions of charcoal and small pebbles. It seems that this buttress was extended to the north for about 0.50m to give its actual size. The size and location clearly suggests that this buttress was made to support a pillar from the entrance hall in the first floor and the extension could be a later strengthening but could also dates back to the first stage of construction. In this hypothesis, the builders would have first made a too small buttress which had to be extended to support the weight of the pillar and roof above. This kind of construction's error was observed in other places of the basement. North of the buttress, a small horizontal projection of the coating might indicate that a bench once existed next to the gate to room B12-S, but the state of preservation is too bad to be affirmative.

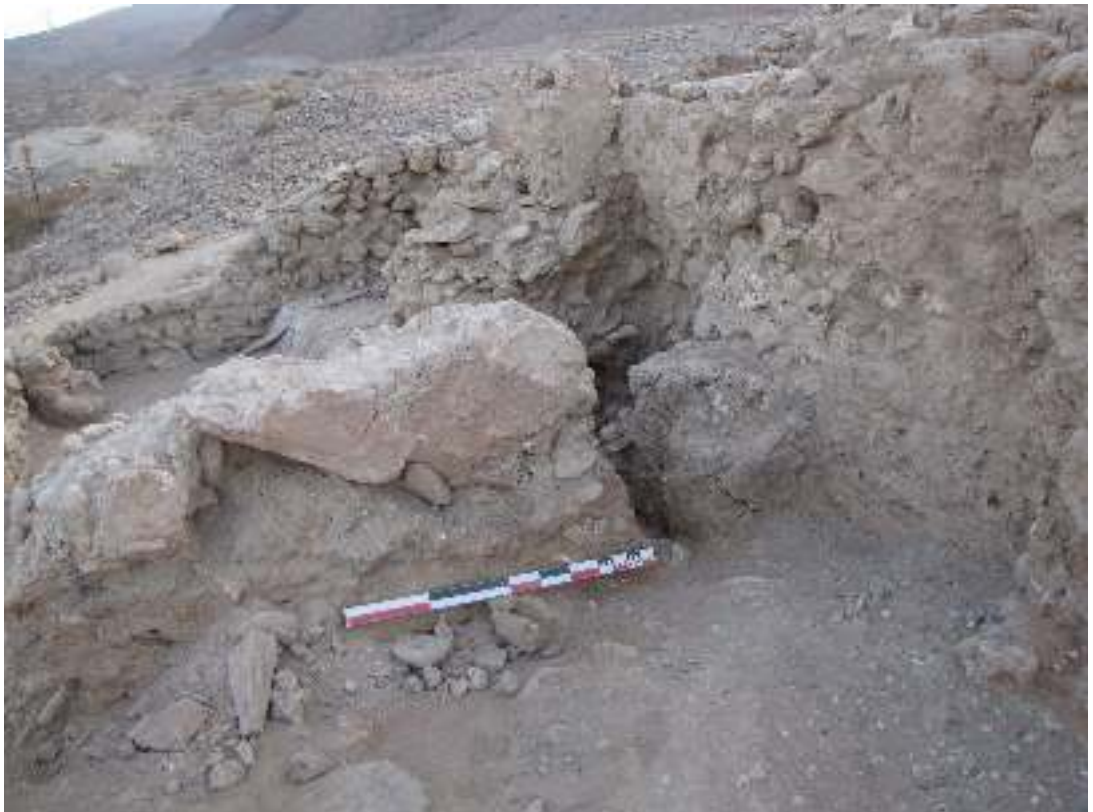
**Fig 1-8 :** *the buttress B12-347, at right of the fallen pillar that was once standing above*

To the south, the buttress **B12-347 Fig 1-8** is built against the walls B12-277/281, in the alignment of the wall B12-278 which separates the room B12-L and B12-R. 1m long by 0.40m wide, its elevation is only preserved for around 1m high, the upper part having collapsed. It is built in the same way as buttress B12-322, with medium corals and limestone blocks and bigger ones at the angles, bounded with a gray mortar and showing remains of coating. Its size and location also clearly indicate that it was bearing a pillar of the first floor. As a matter of fact, remains of the pillar were found at the foot of the buttress, with a cubic basis and two drums of the octagonal column that once supported the roof of the entrance hall. The collapsing of this pillar is undoubtedly the reason for the disappearing of the upper part of the buttress. The setting of the massive buttresses in this area is similar to the setting in the other parts of the basement, showing the

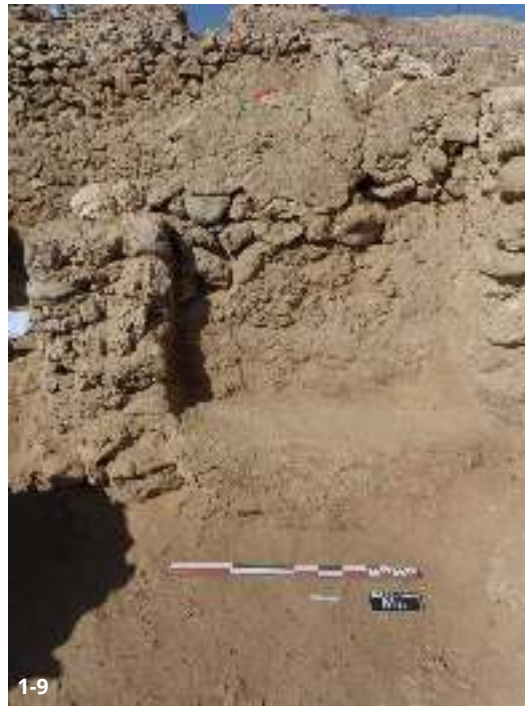
**Fig 1-9** : the buttress B12-376, at left of the bench B12-299

Apart from those two massive buttresses that have an architectural use, smaller ones were also uncovered which were certainly not used as a support for an above construction. To the north, the buttress **B12-376** (Fig 1-9), 0.70m long by 0.35m wide, is built right against the gate that gave access to the room B12-S and could either be used as a jamb for the gate or, more probably, as a border for the bench B12-299 that was found next to it. North of the massive buttress B12-247, the smaller one **B12-320** (Fig 1-10), 0.50m long by 0.35m wide and 1.90m high, is built against the wall B12-281 at 0.50m south of the gate to room B12-L. It is badly preserved, especially at its north-east angle where it is only preserved for around 1m high. It is made the same way as other buttresses with a quite well made gray mortar and its coating, which is linked with the coating of the wall B12-281, is also well preserved. In comparison, the small buttress **B12-321** (Fig 1-11) is very badly preserved. It is located about 0.50m north of the gate to room B12-S against the wall B12-277. Only the upper part of it, around 1.50m above the floor where the buttress measures 0.55m long by 0.38m wide, is preserved and it has slipped down from its original location, all its lower part having collapsed. It is made the same way as the other construction but bounded with a poorly made mortar containing many sand. The use of this badly mixed mortar is quite obviously responsible of its poor state of conservation and a security bench has to be let in place to prevent a complete decay of its remains.

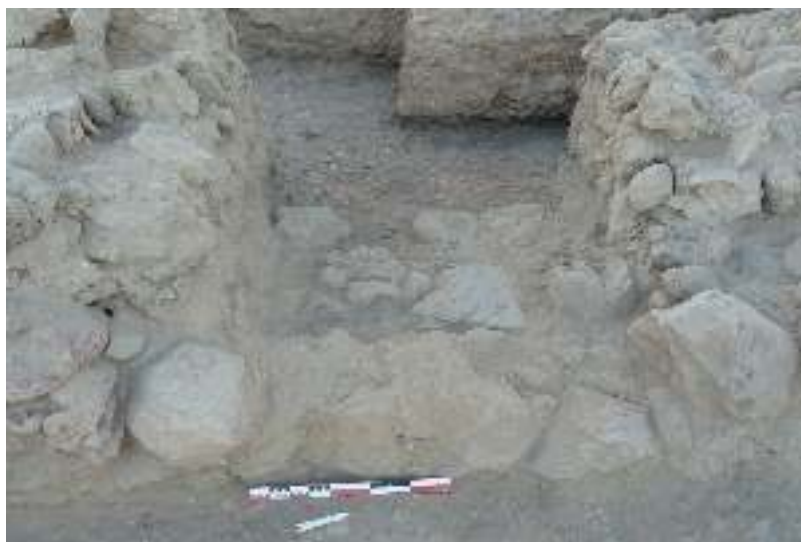
**Fig 1-16** : the threshold B12-300

The threshold **B12-300** (Fig 1-16) of the following gate, between the abutments B12-184 and B12-301, is 1m wide between the two jambs and 1.60m long from the outside to the inside. It is about 0.50m high from the outside floor (which is the natural bedrock) and it shows a small step more or less in its middle, as the northerly threshold. But this particular fitting, which can be considered as a plinth, was not observed in the other thresholds to the south and it is not possible to know whether this small step is a late addition or an original fitting.

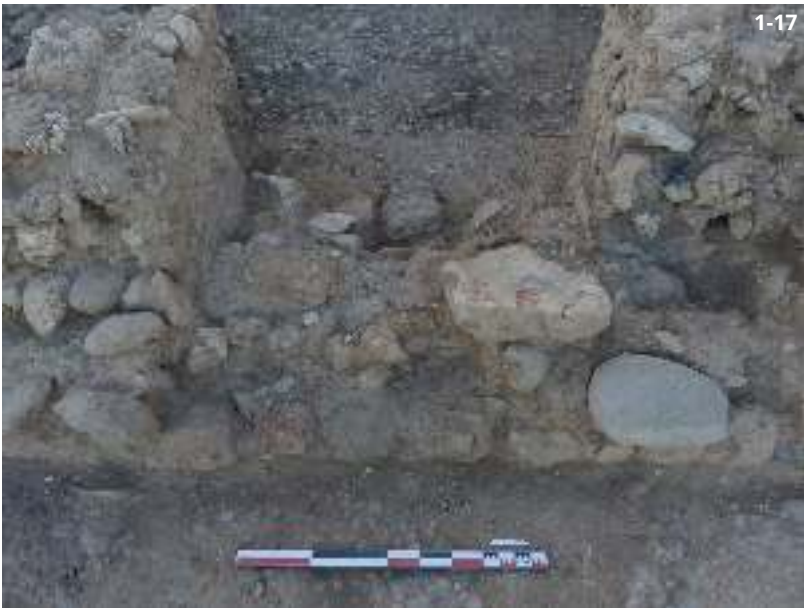
**Fig 1-17 :** *the threshold*  
B12-360

The threshold **B12-360** (Fig 1-17), to the south between the abutments B12-301 and B12-308, is 1m long between the two jambs and 1.20m long from the outside to the inside. It is 0.50m high and two small steps, though highly damaged, can be visible one the outside, while one step may also be assumed to the west for climbing down to the interior. Such kind of stepped threshold were already observed in Qalhât, especially in the southern part of the building B94, and they are very common in old Omani houses. It is also possible that, to the east, some kind of a street-walk bordering the façade of the mosque might have existed, but remains are too scarce to be affirmative. The eastern steps are made with small limestone blocks and pebbles, probably coming from the beach, while the threshold itself is made of bigger material. Some of the stones of the threshold have a polished aspect, testimony of a long time walking, and the indurate floor is made by a mix of soil and plaster, the whole being brown and halfway between rammed earth and mortar floor.

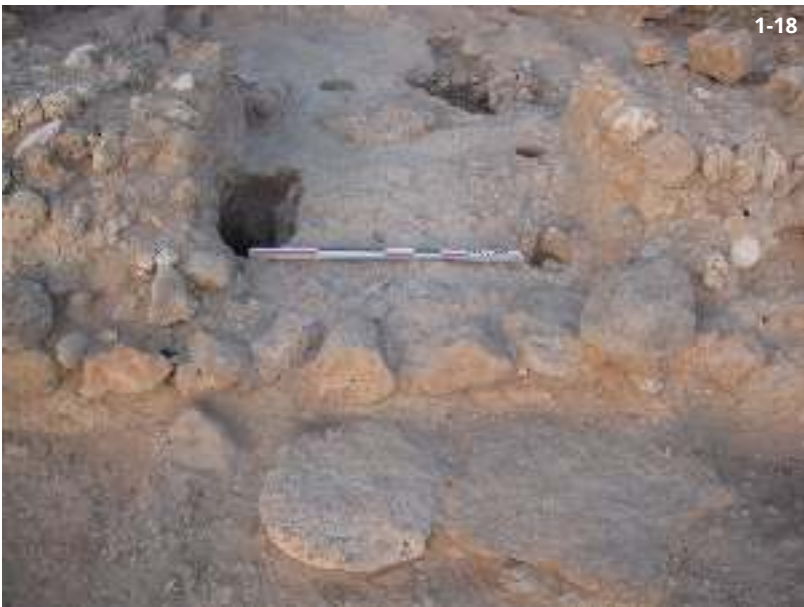
**Fig 1-18 :** *the threshold*  
B12-359

The threshold **B12-359** (Fig 1-18), to the south between the abutments B12-308 and B12-311, is 1.50m long between the two jambs and 1.10m wide from the outside to the inside, at least as it is a little damaged and pierced by later fittings. It shows also steps on the outside, the first one being made by massive pebbles and slabs of bedrock (B12-282/283/284) and around 0.30m high and 0.60m wide. Over it a second step was built, made of smaller limestone blocks and of a smaller width, around 0.40m, and around 0.20m high, to finally reach the threshold itself whose floor is made in the same way as the previous ones.

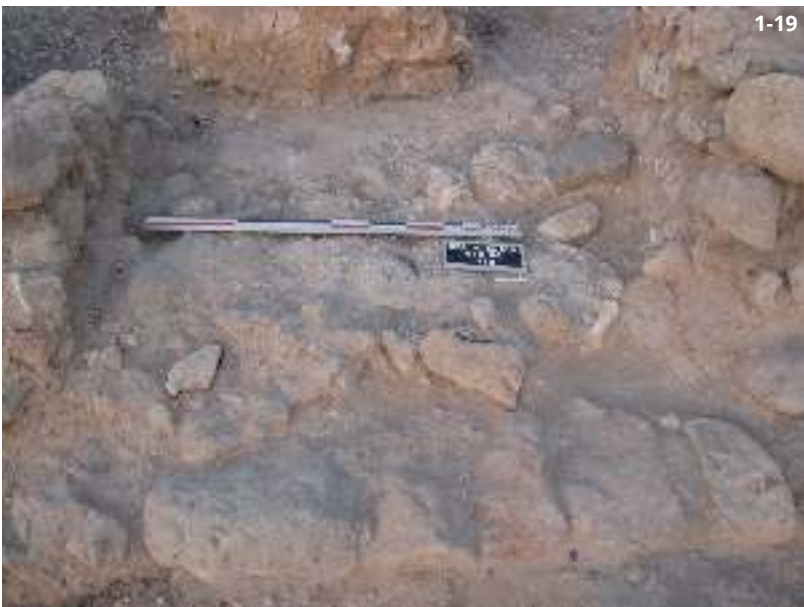
**Fig 1-19 :** *the threshold*  
B12-372

Finally, the southernmost threshold **B12-372** (Fig 1-19) is framed by the abutments B12-311 and B12-16, 1.75m long between the two jambs and 1.60m wide from the outside to the inside. A massive structure on the east (B12-280) could be an exterior step, but would in this case be much bigger than the previous one and not preserved for the entire length of the threshold. As no other step was observed either internally or

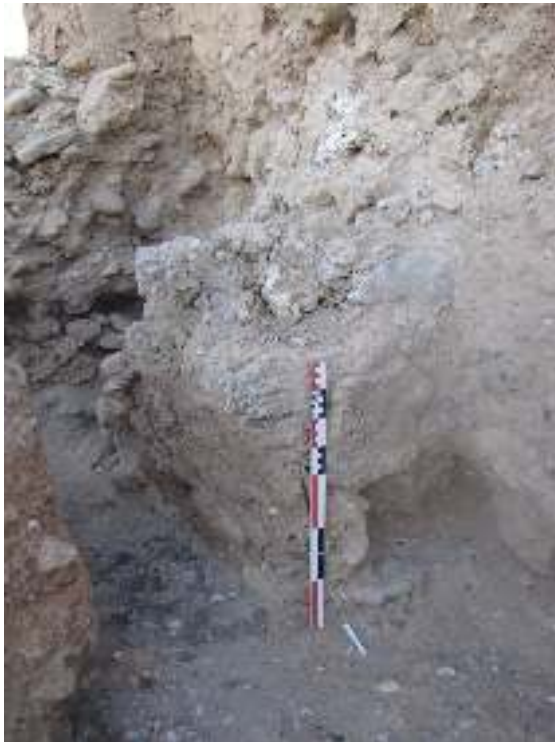
**Fig 1-20 :** *the buttress B12-348*

Two small buttresses were unearthed against the internal facing of the wall B12-16, in the southernmost part of room 21K. The southernmost, **B12-14**, 0.60m long by 0.45m wide for around 0.50m high, was already excavated by the QP, while the northern one, **B12-348** (Fig 1-20), 0.70m long by 0.25m wide and 0.50m high, was excavated during this season. Both are made with small limestone and corals blocks bounded by a rough gray mortar containing very few small pebbles and show remains of damaged coating. They can have been used for shelves, between them and/or between B12-14 and the wall B12-42 but no traces of lines of mortar or coating to support the plates of shelves were found. However the lines could have disappeared with the coating or the plates were higher than the actual elevation and so not preserved. Also, as mentioned above, the small buttress B12-348 could have worked with the small buttress B12-321 built in front in the other side of the room, to create a symbolic division for the south part of the room B12-K, this part being not reachable from an eastern gate. Even if there is nothing to be affirmative, it is possible to imagine a door fixed on the two buttresses, or a small beam with a curtain to close the space. In this configuration, the southern part of the room B12-K would have present some kind of private use, together with the back room B12-R in the adjacent span 2, which aspect also shows the same kind of privacy with its large bench, as will be see below.

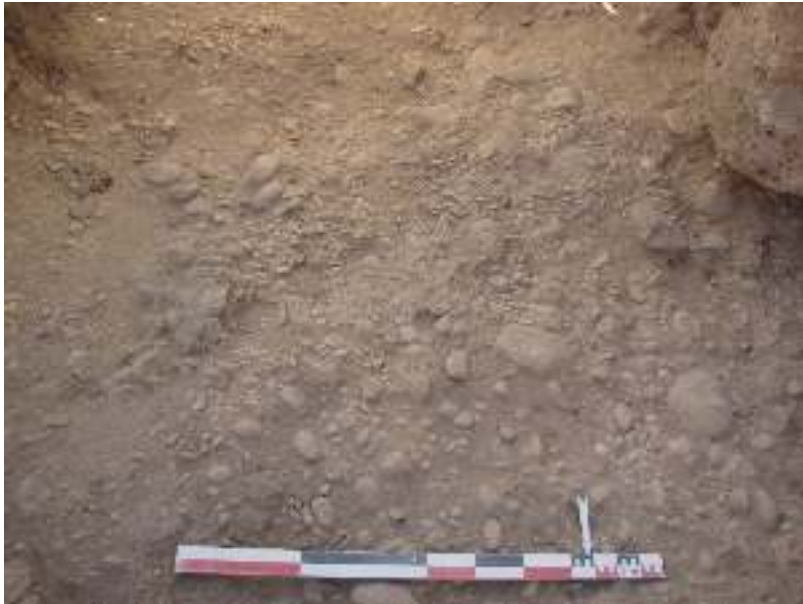
**Fig 1-22** : the possible working area Uf3832, in the center

Unique in the basement by its size and the number of its entrances, the room B12-K is also the only one where no coated floor was found and ever made. It is also the only internal area where the natural bedrock was unearthed, although only in its northern part. In this area, over the bedrock, some isolated levels were registered, such as the **UF3832** (Fig 1-22), located near the gate to the room B12-L. This level is made of sand and silt, with many small fragment of powdery white pinkish mortar and a little of plaster and very small pebbles. It is very possible that this level is the remain of a working area where the mortar used in the construction, or repairing, of the building was made. It could therefore date back to the beginning of the 14th century, but no material was found to confirm this dating, which is logical for a working area. The levels **UF3874** and **UF3875** (Fig 1-23), closed to the thresholds B12-359 and B12-372, are very similar in shape and components and could also be the testimony of a construction phase. But all three could also be considered as a leveling on the irregular bedrock to create a flat level above which was put the circulation floor, which is made here by a thin level of small pebbles covering the northern part of the room. It is very likely, considering the associated ceramics which date to the end of the 15th century, that the floor of small pebbles was frequently removed and renewed, as it was observed in the others rooms.

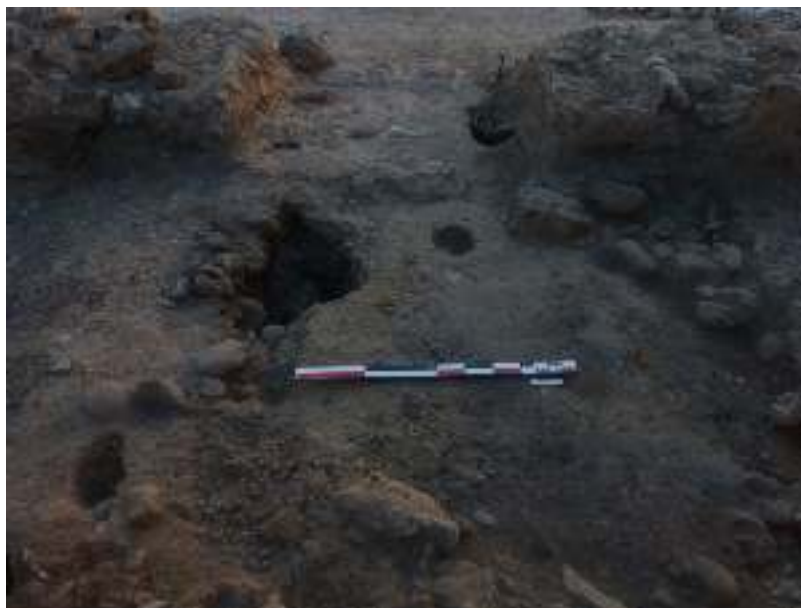
**Fig 1-25** : the earthen floor Uf3830 with the threshold B12-359 in the background

The floor **UF3830** (Fig 1-25) covers all the southern half of the room B12-K and seems to be the last floor during the use of the Mosque, as it is covered by later reoccupation levels. It is a rammed earth floor made with sandy dark brown silt mixed with little charcoals and plaster and containing an important quantity of very small pebbles which could be infiltration from the upper level but could also be a voluntary mix as this kind of floor made with pebbles bounded with silt was observed elsewhere in Qalhât, mainly in courtyards, but nowhere else in the Mosque Complex. This floor is leaning against the south external wall (where it has been registered as **UF3886**), the western walls, the low wall B12-357 and slightly covers the western extremities of the thresholds, confirming the hypothesis that this floor was put in place in the last stage of use of the building. Six postholes and two pits were found piercing this floor but, as the covering levels are very similar in likeness and components, it is very difficult to state if those pits and postholes were made during the use of the floor or during the later occupancy, dug from the upper levels through the rammed earth floor. However, as some of the pits are located in the middle of the area and threshold, and thus greatly complicating the internal circulation, it is very likely that they were made when the building was no longer in its primary use.

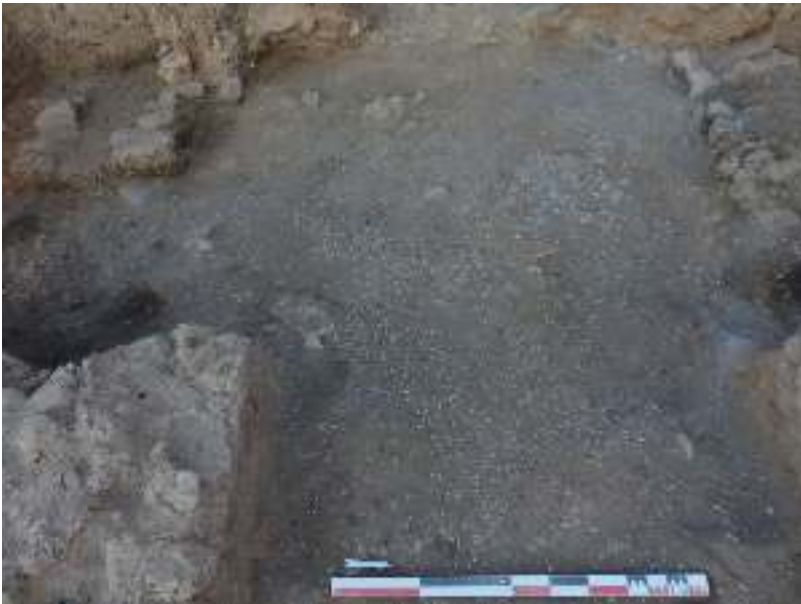
**Fig 1-26** : the sanitary floor  
Uf3825

The rammed earth floor UF3830 is covered, in the excavated part and quite presumably also in the unexcavated parts, by a thin layer only made of small pebbles (**UF3825**) (Fig 1-26) which can be considered as a sanitary circulation level, in the exact same fitting as the one observed in other rooms above the coated floor. Dating by ceramics indicates that this level was in use in the beginning of the 16<sup>th</sup> century, shortly before or after the arrival of the Portuguese invaders. Remains of hearths and burning areas could state that the invaders occupied this area for a while or be the remains of the fire that the Portuguese are supposed to have made, though the burning areas would have been, in this case, more important and visible on the walls, which is not the case.

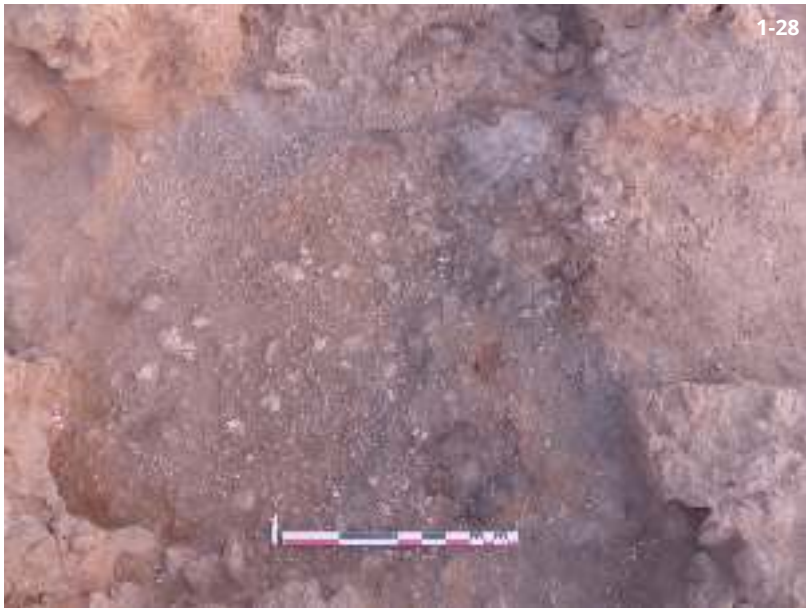
**Fig 1-28** : the sanitary floor  
Uf3814

Afterward, a sanitary floor made quite exclusively of pebbles mixed with a little bit of brown silt and ashes (**UF3814**) (**Fig 1-28**) was spread over nearly all the southern half, the reoccupation of the northern half being less visible. Right above this level, an important quantity of oyster's shells were found. Those remains can be linked to a craft activity (pearl production?) or simply to a food production and seems to clearly state that the Mosque was no longer in use when this layer was put in place, as both activities didn't suit to a religious building. A layer of ashes (**UF3815**), which can be considered as a damaged hearth, was found nearby above the sanitary floor UF3814, between the gate to room B12-L and the threshold B12-359, and could have been used to cook the oysters before their consumption, and so giving more credit to the hypothesis of a food production. Other concentrations of ashes were also observed above the floor UF3814, but they were not well-preserved enough to determine if they were remains of hearths or simply parts of the backfills or rubbish rejection.

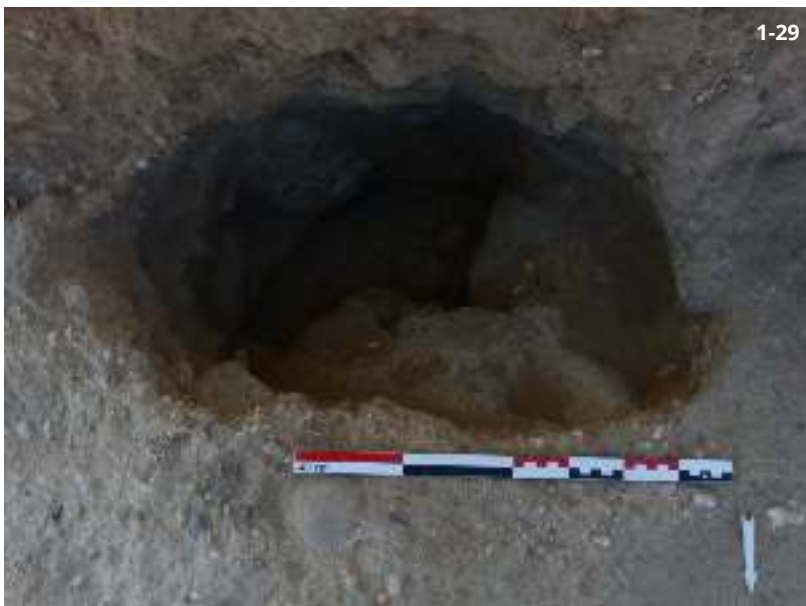
**Fig 1-29** : the pit B12-374  
fully excavated

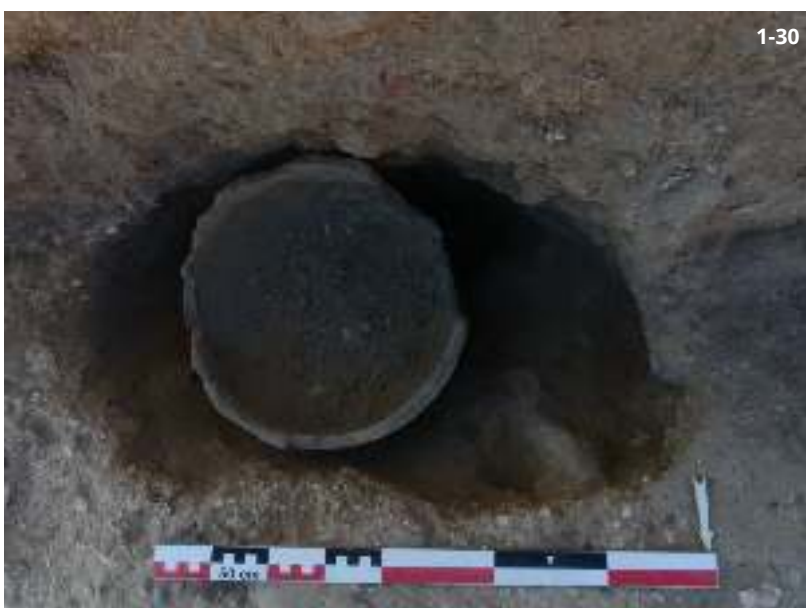
**Fig 1-30** : the pit B12-374  
with the upside down jar  
used as a brazier

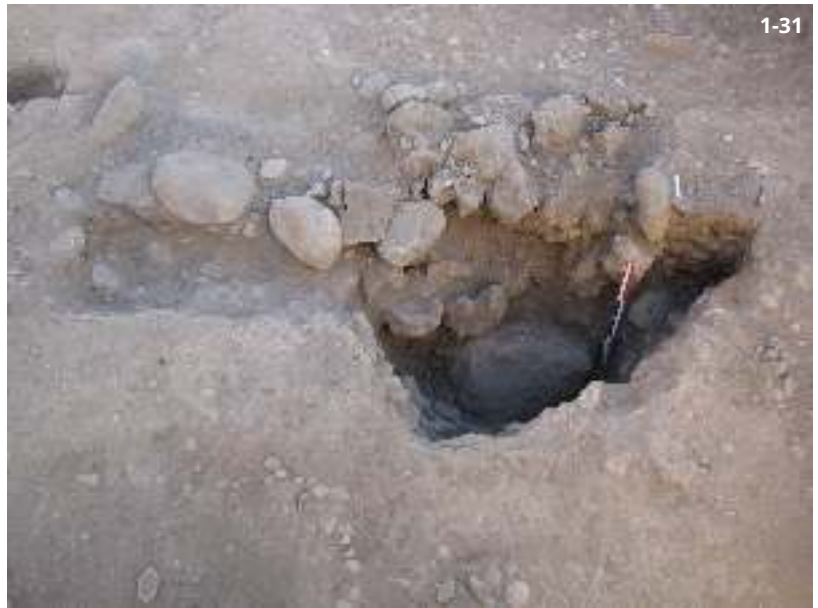
**Fig 1-31 :** the pit B12-366 at right and the pit B12-377 at left, half excavated

Shortly to the west, the oval pit **B12-366** (**Fig 1-31**), 0.80m long by 0.70m wide for a depth of 0.40m, was filled with a soft brown sandy silt containing some fragments of ceramics, animal bones and shells. Its function is yet unclear, though it might have been used as a rubbish pit which would have been cleared before its final abandonment, or also as a pit for a massive post which would have been used for strengthening the support of the roof above. Next to it, the oval pit **B12-377**, 0.45m long by 0.30m wide for a depth of 0.15m was cut by the pit B12-366. Its function remained unexplained. It is also possible that some of the several postholes unearthed in the area were used to support the roof, which was undoubtedly still standing during this stage of reoccupation as its remains were found in the collapse above those layers but could have known some damages, requiring a strengthening. The postholes **B12-361** (**Fig 1-32**), 0.30m long by 0.22m wide for a depth of 0.27m, located at south of the wall B12-322, **B12-362** (**Fig 1-33**), 0.15m wide for a depth of 0.12m, located at south of the previous one, **B12-363** (**Fig 1-34**), 0.16m long by 0.10m wide for a depth of 0.10m, located at south B12-308, and **B12-364** (**Fig 1-35**), 0.24m wide for a depth of 0.10m also at south of B12-308, were found with small stones probably used to prop a post which could have helped to maintain the damaged roof, but could also have been used for simple sticks where to hang clothes, jugs, curtain or any kind of human goods. The postholes **B12-365** (**Fig 1-36**), 0.20m wide for a depth of 0.05m, next to the small buttress B12-320, and **B12-370** (**Fig 1-37**), 0.25m wide for a depth of 0.05m and located at south of the pit B12-366, could also be of the same kind as the same first four ones described, but their remains are scarcer and no propping stones were found. It is in fact impossible to be affirmative about the use of those postholes, the only reasonable thing to say about them is that their sizes and locations clearly state that they were not used for shelves, as it is the case for the postholes found in the other rooms, which are aligned and set along the walls.

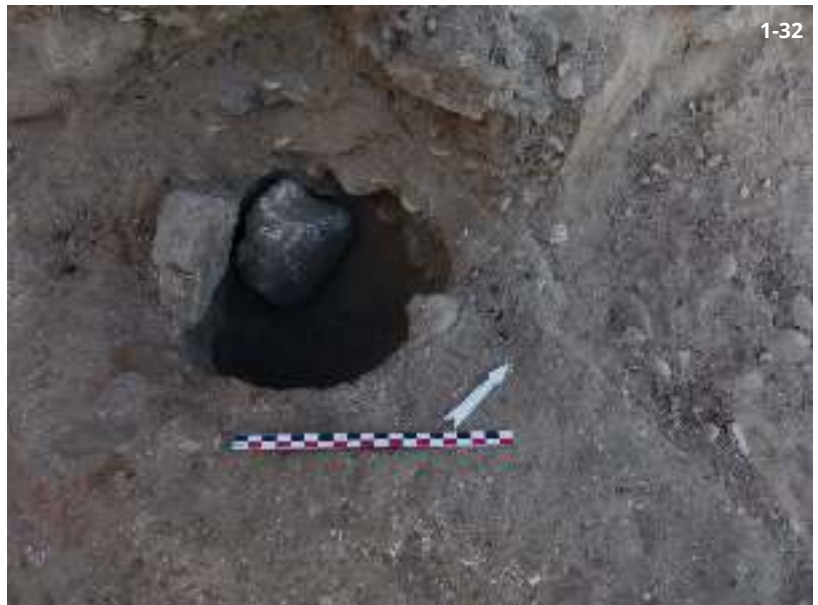
**Fig 1-32 :** the posthole B12-361

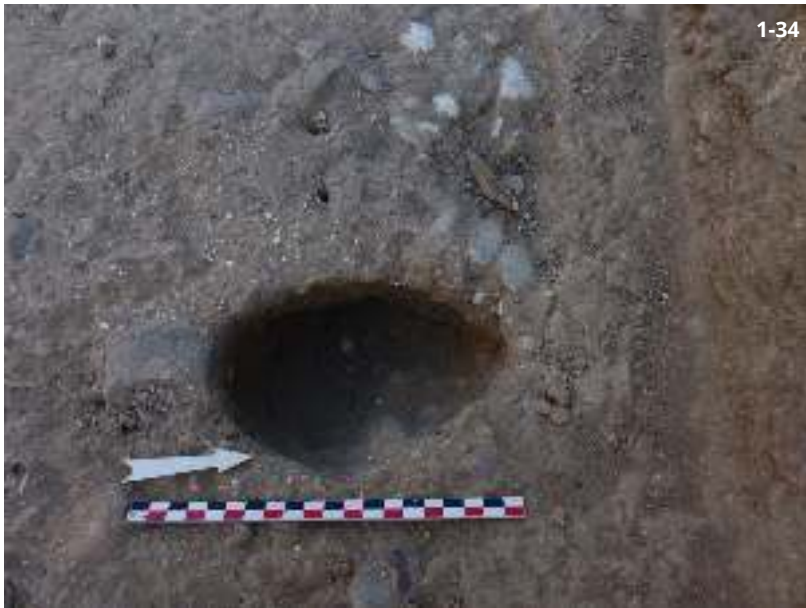
**Fig 1-34 :** the posthole  
B12-363

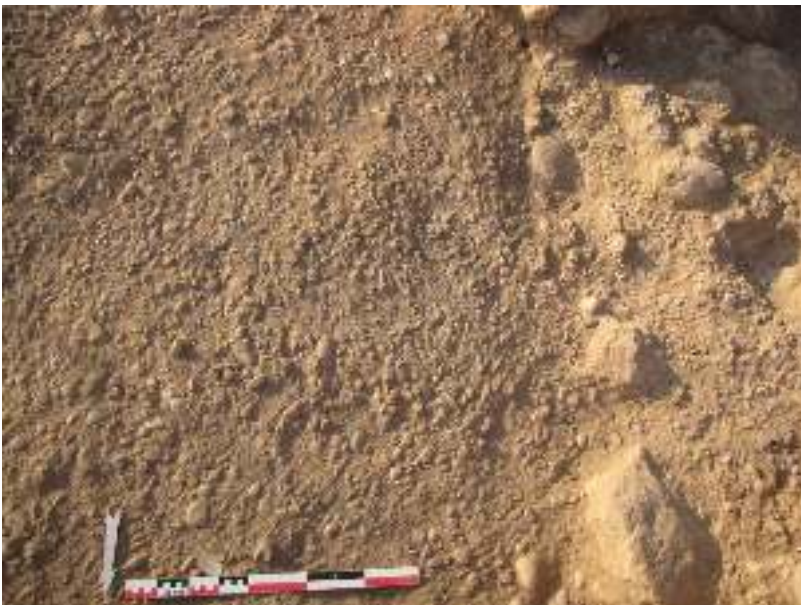
**Fig 1-40** : the sanitary floor  
Uf3684

A final stage of occupancy was observed above the aforementioned one, mainly concentrated in the middle of room B12-K. A new level of floor (**UF3684**) (**Fig 1-40**), made again of small pebbles mixed with a beige sandy silt, was uncovered, well-preserved next to the eastern accesses B12-359 and B12-360, more disturbed in the middle where the collapse had greatly damaged this layer. Three hearths were found above this level. The first one, **B12-351** (**Fig 1-41**), 0.60m long by 0.50m wide and 0.07m deep, was set against the wall B12-311 which western facing was partially cut, probably by the settler or by the fire activity. The second one, **B12-352** (**Fig 1-42**), 0.85m long by 0.60m wide and 0.10m deep, was set against the wall B12-308 and also slightly damaged its western facing. Some stones probably coming from the collapse were reused in the bottom of this hearth to circumvent the fire and maybe prop a container. The last one, **B12-353** (**Fig 1-43**), 0.30 wide and 0.08m deep, was set near the gate to room B12-S. All the hearths were observed filled with ashes and charcoals and small fishbones and shells were found nearby, clearly suggesting that they were made by fishermen who were occasionally squatting the abandoned building when it was slowly starting to fall into decay. No major fittings were observed related to that late reoccupation and it can be assumed that the human presence only occurred for a short time, no more than several days.

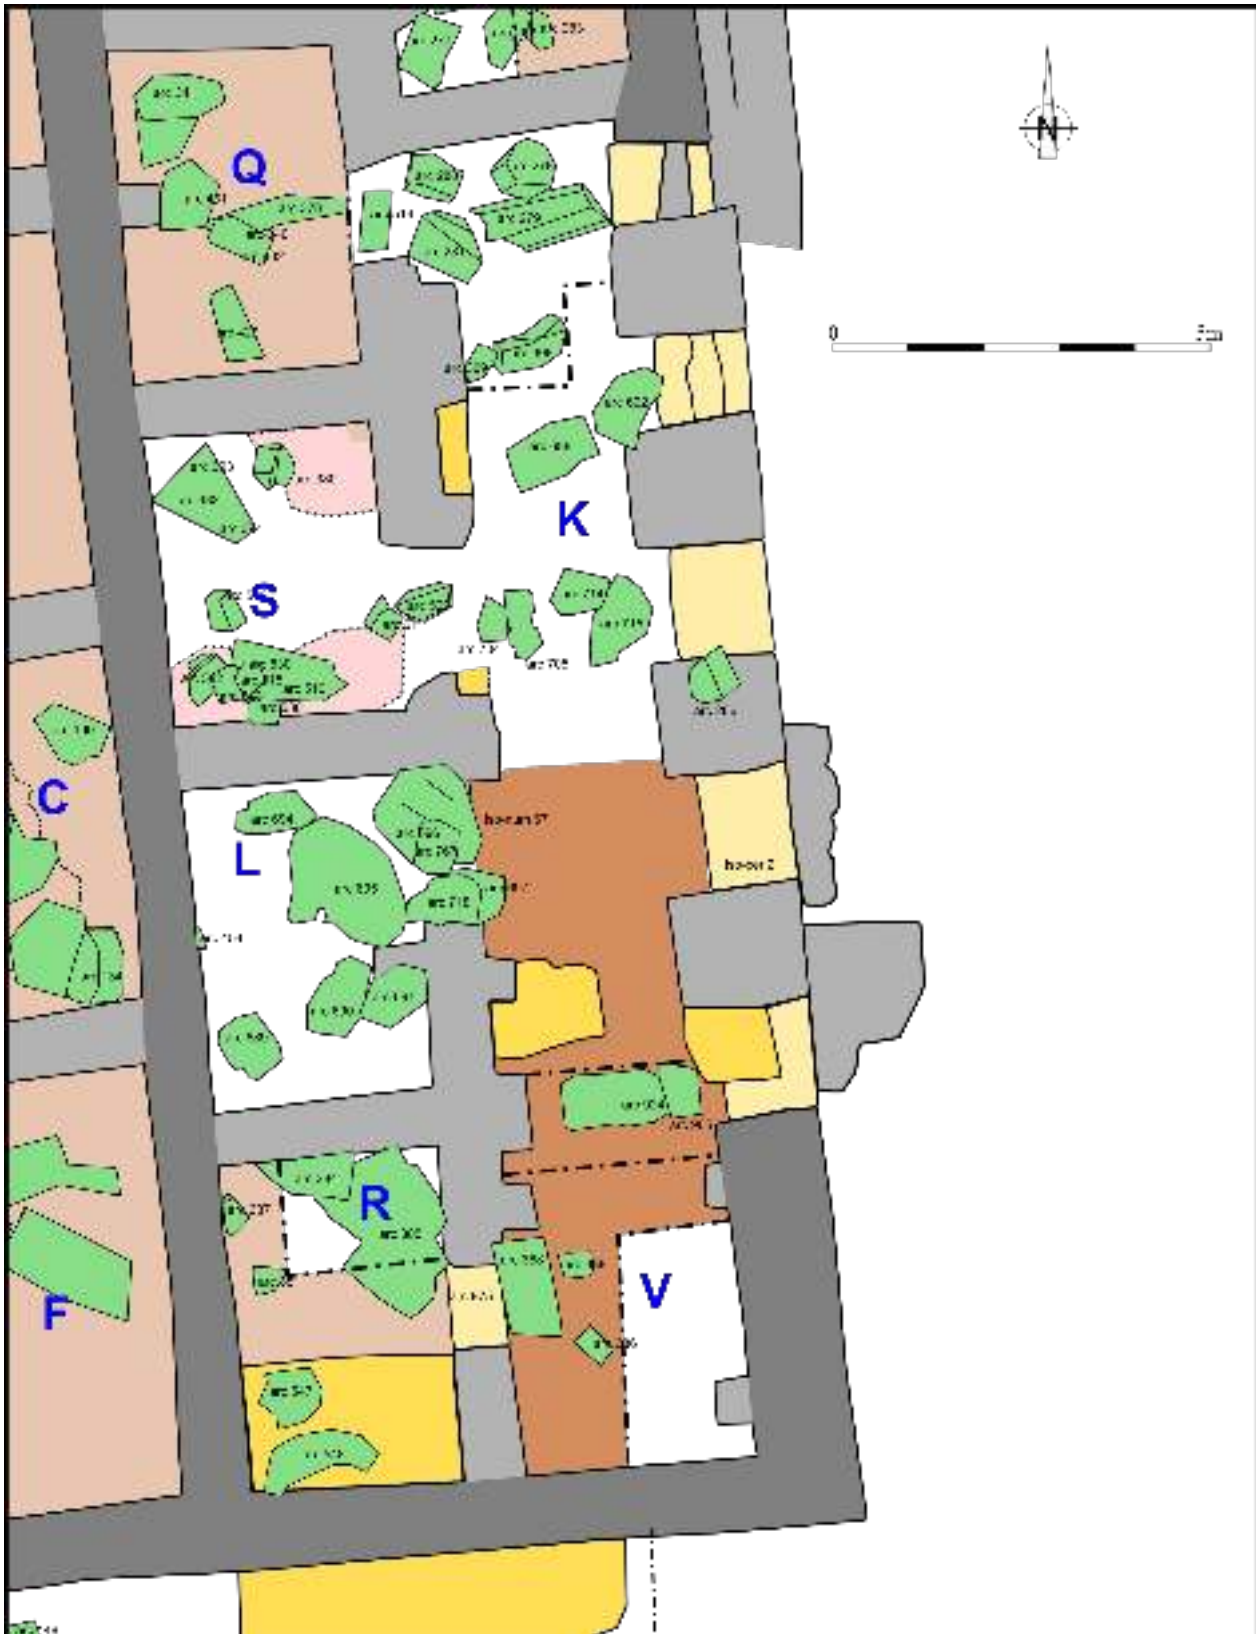
Fig 1-44 : Site plan of the main architectural elements

### I-B1c. Architectural elements **Fig 1-44**

All the architectural elements found in the collapse levels (registered as IsoArc) were registered in a database. They will not be described hereafter, except for the main ones which gave the more interesting information about the architectural fitting of the Mosque. More details are given below in the dedicated chapter and catalog.

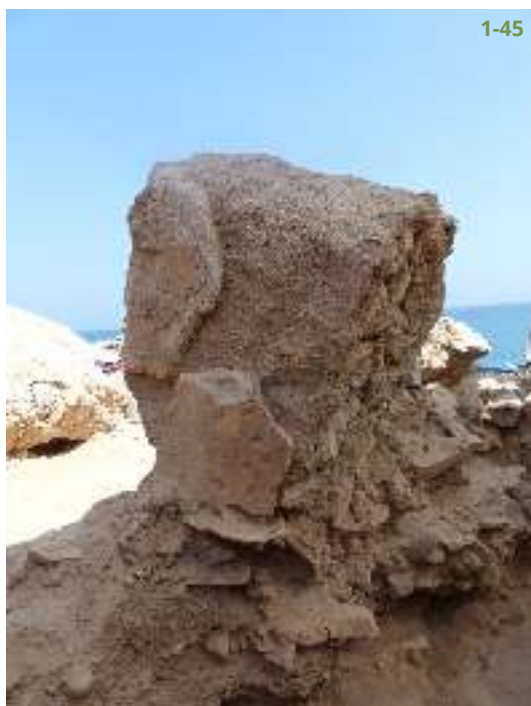
**Fig 1-45** : the architectural element IsoArc 688

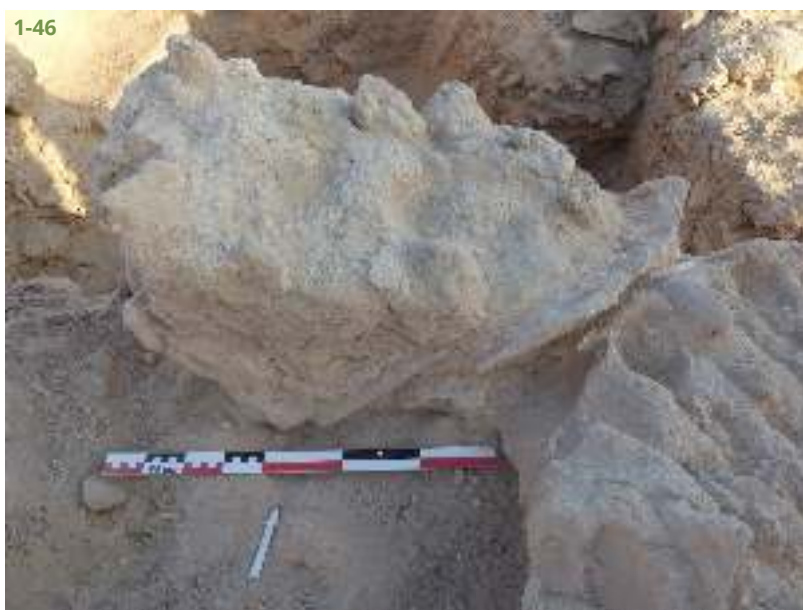
**Fig 1-46** : the architectural element IsoArc 714

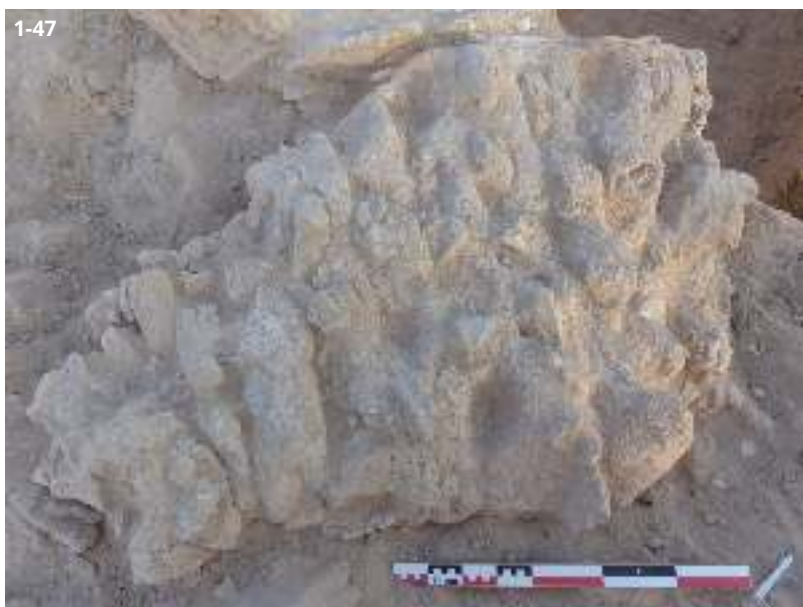
**Fig 1-47** : the architectural element IsoArc 715

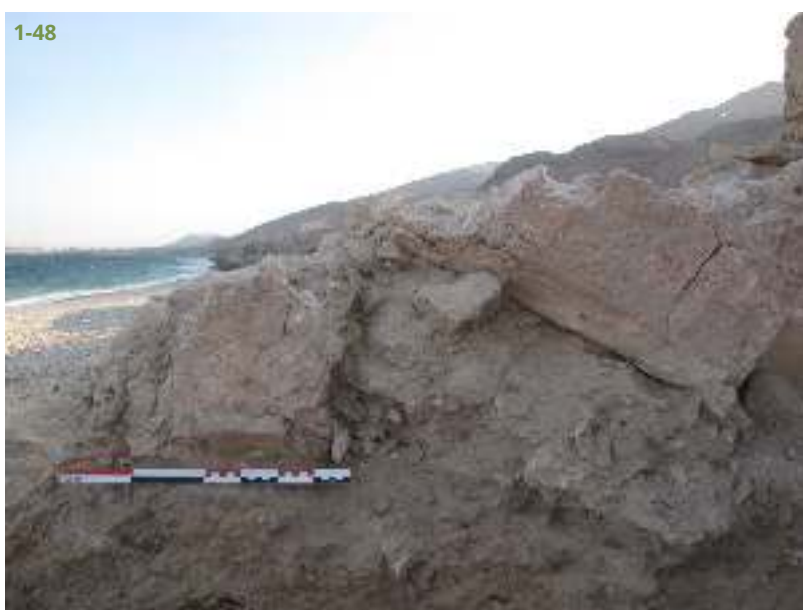
**Fig 1-48** : the architectural element IsoArc 924, square basis and octagonal tambour of a pillar from the first floor

It is simpler with the **IsoArc924 (Fig 1-48)**, more at south, which is enough preserved to be affirmative, the cubic basis and two fragments of the octagonal drum being preserved and clearly visible. It was found at the foot of the massive buttress B12-347 above which it was originally standing. The column did not strictly toppled from its original location but slipped down from it as the top of the buttress collapsed. Indeed, if the column had toppled, the basis would be closed to the buttress and the drum to the east, as it is the case of the IsoArc251/285 in room B12-H; but in this case the drum is near the buttress B12-347 and the basis further east. The same effect of slipping was observed in the prayer hall, especially in the south side near the south gate of B12-B with the engaged column B12-327.
