## Qalhât Development Project, Season 2015B-2016A, Final Report

**QALHÂT (ASH-SHARQYJAH)**

**SEASON 2015B-2016A**

**FINAL REPORT**

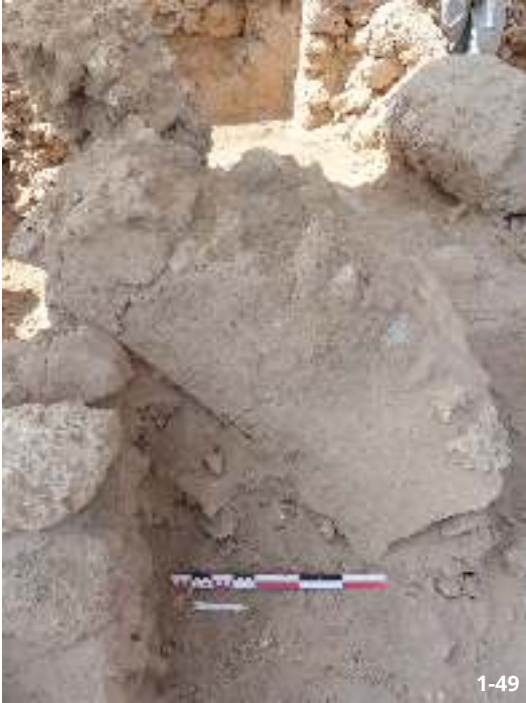
**Fig 1-49 :** the architectural element IsoArc 692, fragment of arch

Found in the immediate proximity of the threshold B12-300, the **IsoArc692 (Fig 1-49)** is the remain of an arch and the only remain of this kind unearthed in the room. It is very tempting, due to its location, to assume that the arch was originally at the top of the gate that gave access to the room from the beach but it can also come from another place of the Mosque and has followed the slope of the collapse. If the arch really came from the top of the gate, its size and curve might suggest that the gates in front of the beach were topped by segmented arches.

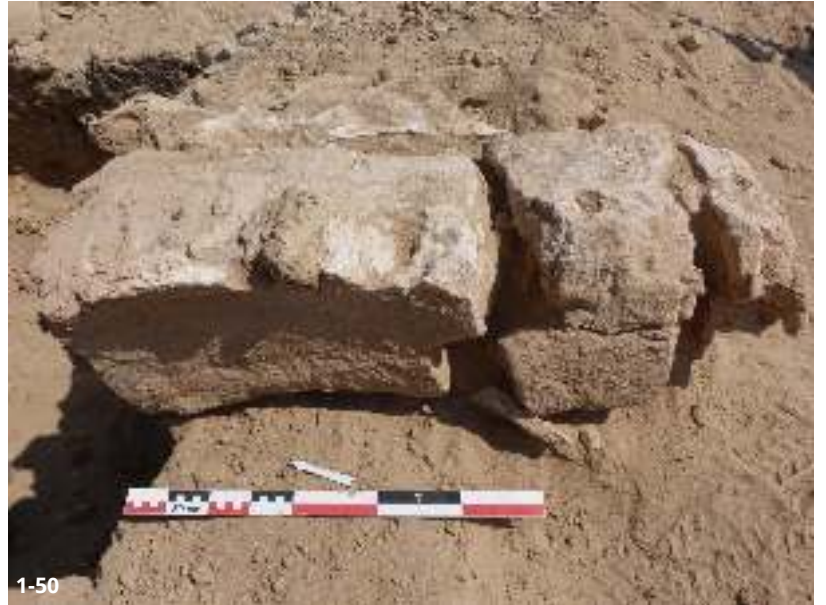
**Fig 1-50 :** the architectural element IsoArc 705, possible fragment of niche

Unearthed right in front of the gate to room B12-S, nearly in the exact center of the span, the **IsoArc705 (Fig 1-50)** is a fragment of a wall showing a curve on its rear coating and a possible vertical bow, the remains being too fragmented to be affirmative for this last identification. It is very possible that this fragment is a remain of a vaulted opening (gate or window) or more likely a shallow niche. This fragment undoubtedly came from the wall that was dividing the first floor into prayer hall and entrance hall, above the long uninterrupted wall between the spans 2 and 3 where the architectural elements unearthed during the 2013b-2014a season had allowed to assume the presence of gates, niches (which could be considered as *mihrab*) and windows (see previous report and drawn restitution for further details). The **IsoArc829 (Fig 1-51)**, which is a fragment of an engaged pilaster, also comes from the dividing wall on the first floor, the same kind of fitting having been observed during the previous season. Those two architectural elements have slipped down following the slope made by the collapse. As they have slipped over the remains of the walls of the eastern part of the basement, it so means that most part of the

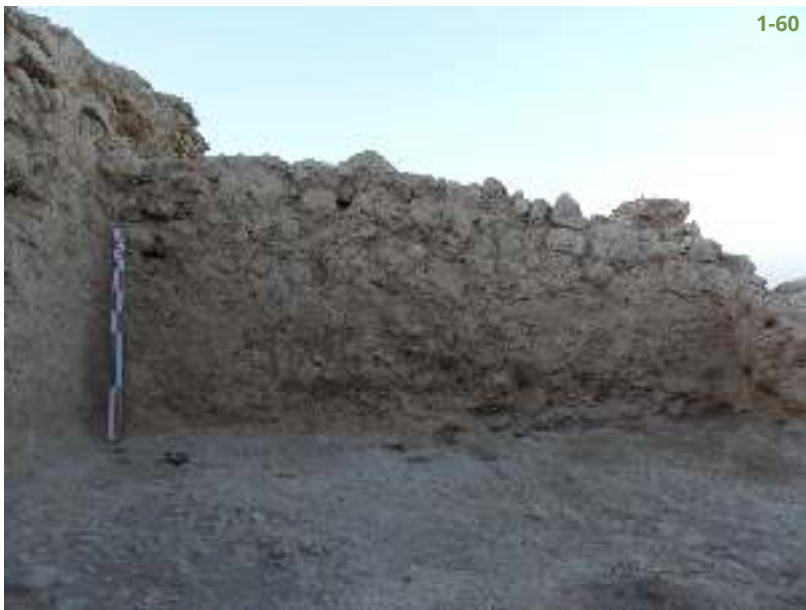
**Fig 1-60 :** the wall B12-292 in room B12-L

To the south, the room B12-L is better preserved than the room B12-S. Of an internal length of 4.20m by an internal width from 3.05m at north to 2.90m at south, the useful surface of the room is a little more than 12m<sup>2</sup>, buttress and access excluded. It is delimited north by the wall **B12-292** (Fig 1-60) common with room B12-S and already described, west by the long uninterrupted wall **B12-110** (Fig 1-61), which is here 4.30m long by 0.80m wide and 2.20m high, and south by the wall **B12-278** (Fig 1-62), common with room B12-L and which is 2.85m long by 0.75m wide and 2.30m high. To the east, the delimitation with room B12-K is made by the wall B12-309 at north and **B12-281** (Fig 1-63) at south, which is 2.20m long by 0.75m wide and 1.70m high, both being separated by the gate, in front of the eastern external gate with the threshold B12-359; its jambs are badly preserved, but no as badly as the room B12-S. The northern jamb, made by the wall B12-309, is more or less preserved and a rabbet was observed. The southern jamb, made by the wall B12-281, is more destroyed and the limit of the gate has only be guessed by the print of the mortar. The gate is so 1.35m long (rabbet excluded) and 0.75m wide, and a stepped threshold was also identified according to the stones uncovered and the scarce remains of mortar, but it was not enough preserved to be affirmative about its size and shape (Fig 1-63 bis). All walls are quoined and made in the same way, with massive limestone blocks and pebbles at the bottom and smaller stones and corals blocks in the upper part, bounded with a gray mortar containing many small pebbles. A rough gray to beige coating, similar to the one of the other rooms of the basement, was covering the walls. It is variously preserved, with important gaps in the middle of the walls and mainly missing on the eastern size.

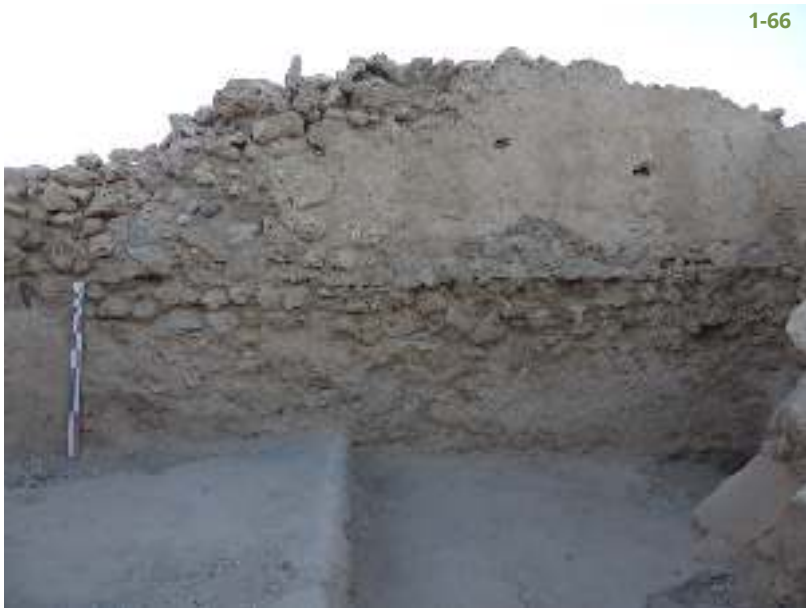
**Fig 1-66 :** the wall B12-110 in room B12-R

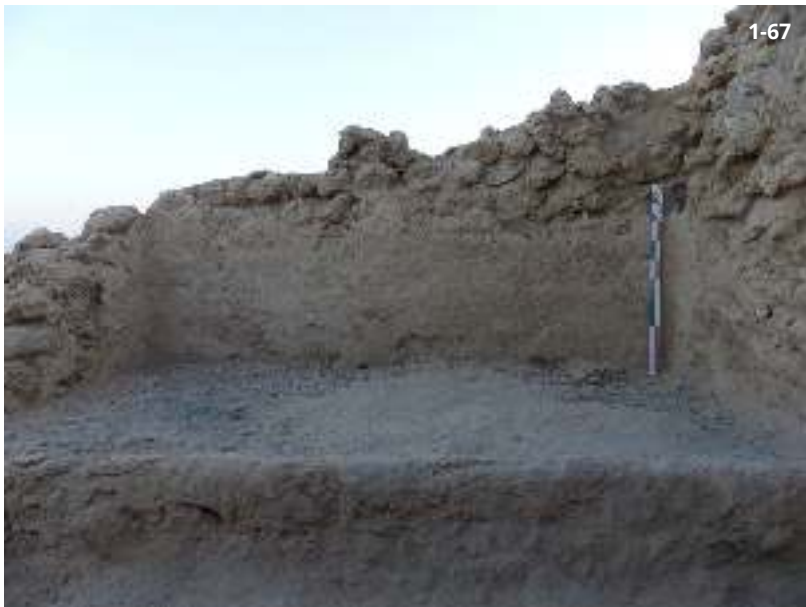
**Fig 1-67 :** the wall B12-42 in room B12-R

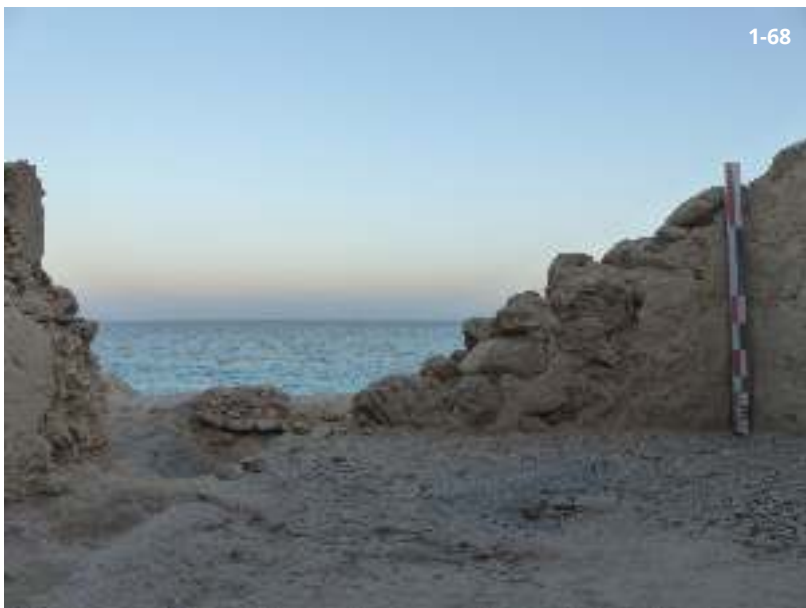
**Fig 1-68 :** the wall B12-276 in room B12-R

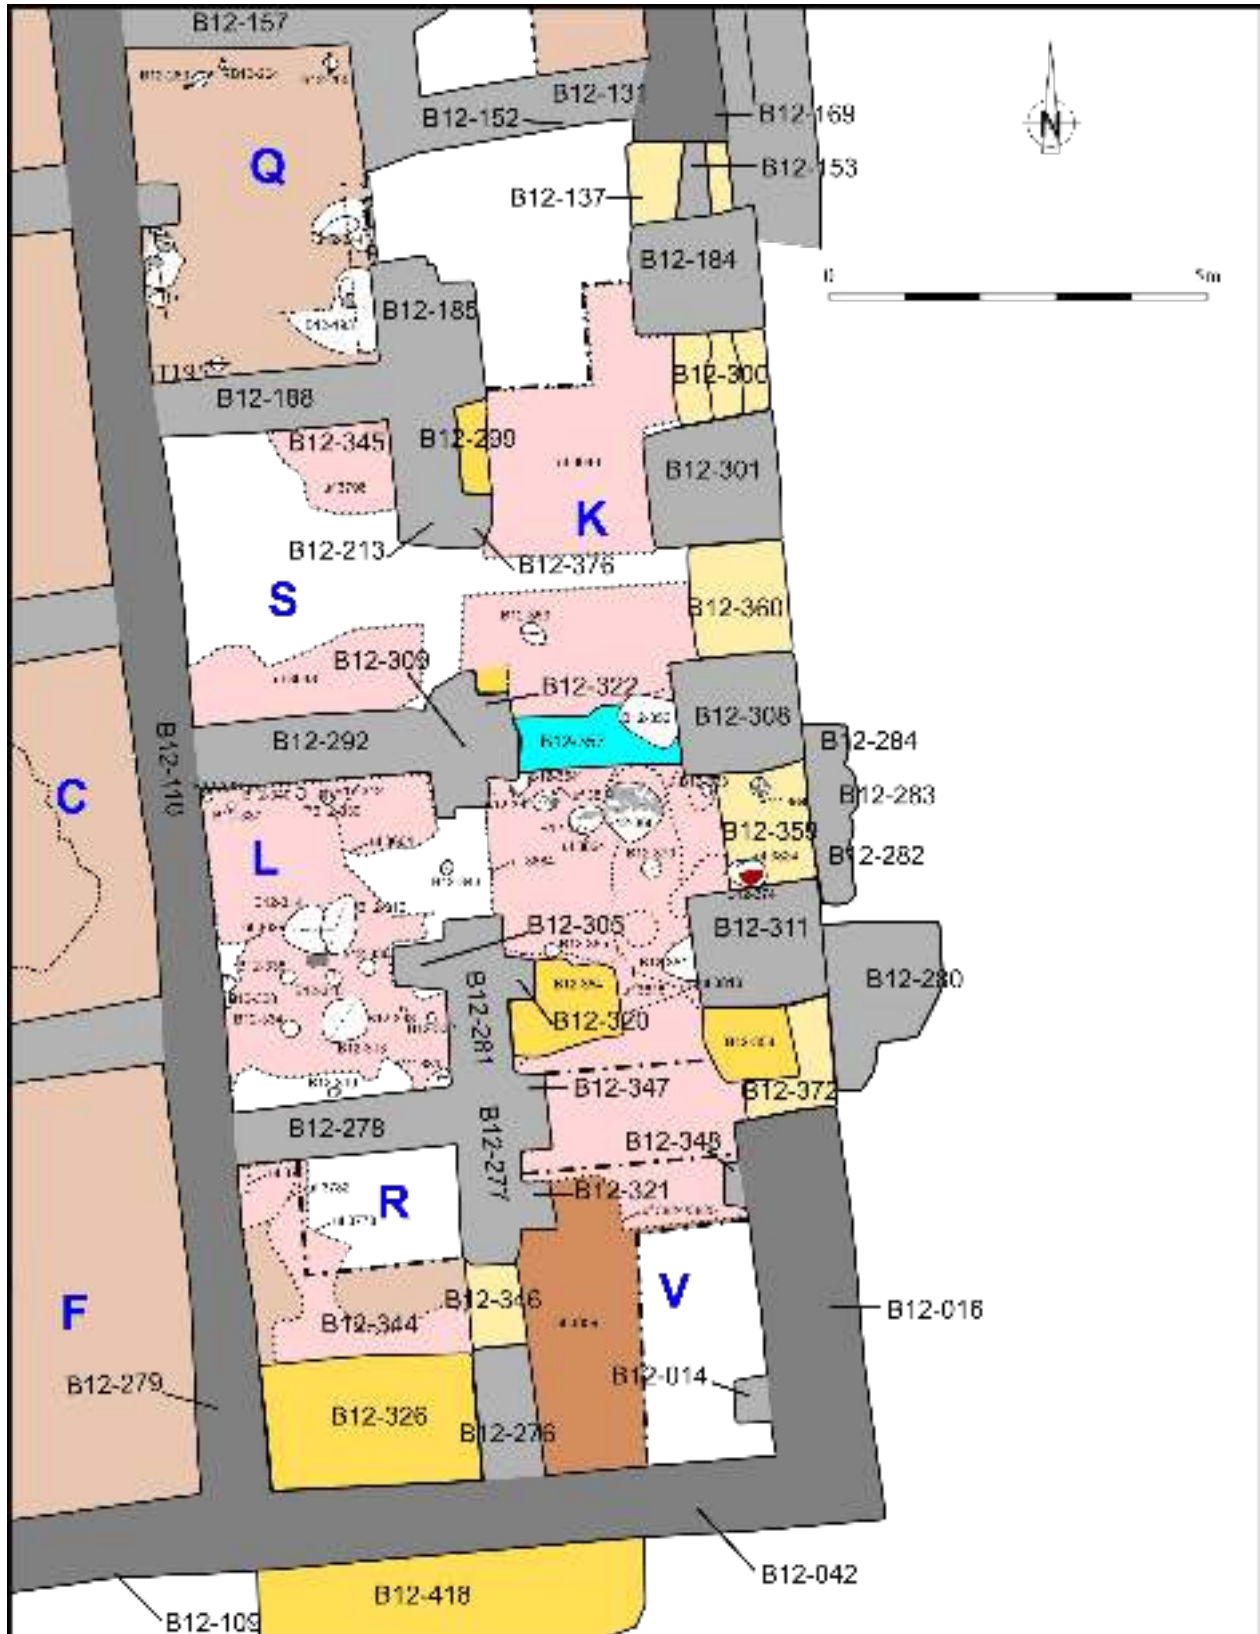
**Fig 1-73 :** Site plan of the stratigraphical units and light structures of the south-east part of the basement

### I-B2b. Stratigraphical analysis (Fig 1-73)

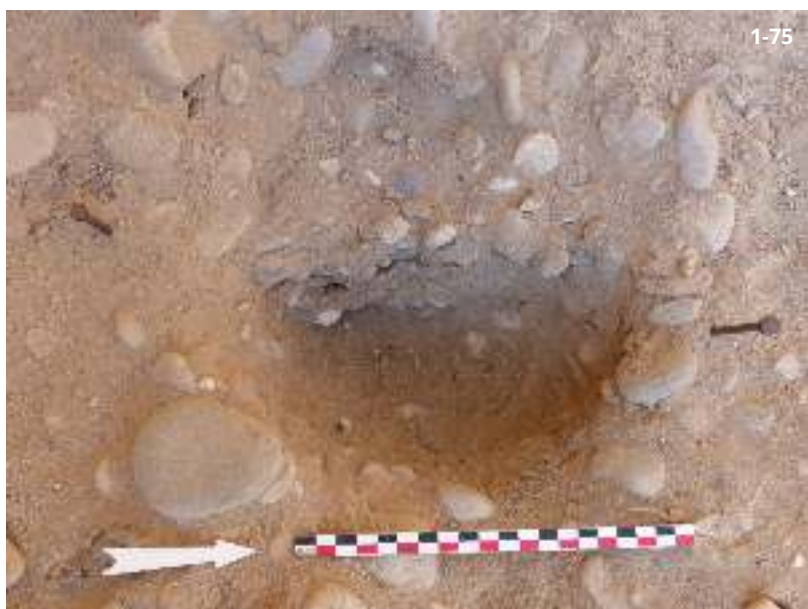
**Fig 1-75 :** the posthole B12-328, half excavated

The three postholes **B12-328** (Fig 1-75), **B12-335** (Fig B1-76), and **B12-336** (Fig 1-77), all seizing around 0.25m for 0.20m deep, seem to work all together and most probably belong to the occupancy of the room. It is surely the case for B12-336, which was covered by a later low wall, and for B12-335 which was filled by the layer of the later reoccupation. It is less clear for B12-328, but as the three postholes are aligned together and also aligned with the small buttress B12-305, the four structures may have been used to create a separation in the room, nearly in its southern half. It is possible to imagine that those postholes were used to hang curtains for creating a private area but surely not to support some rows of shelves as they are not located along the walls. Located between the postholes B12-335 and B12-336 but slightly misaligned, the posthole **B12-318** (Fig 1-78), 0.20m wide and 0.15m deep, could also belong to the same fitting but evidences to link it to the phase of occupancy are doubtful.

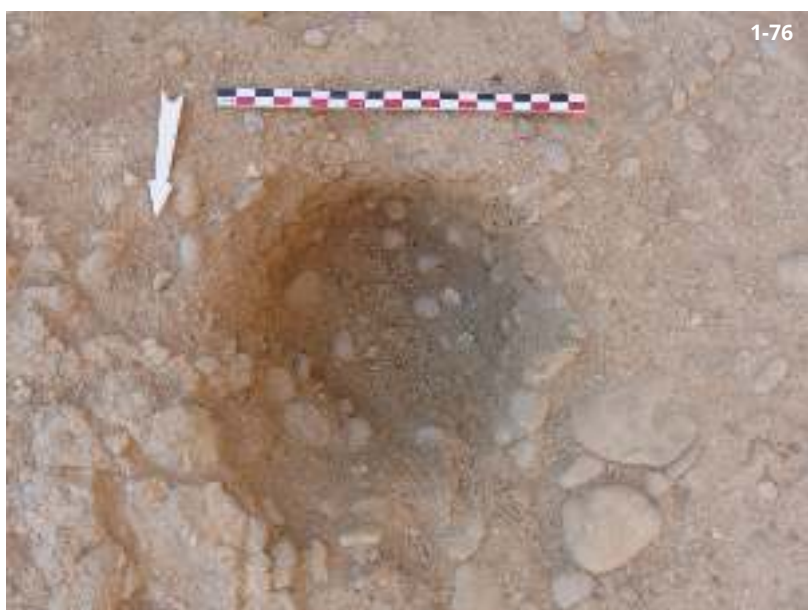
**Fig 1-76 :** the posthole B12-335, fully excavated

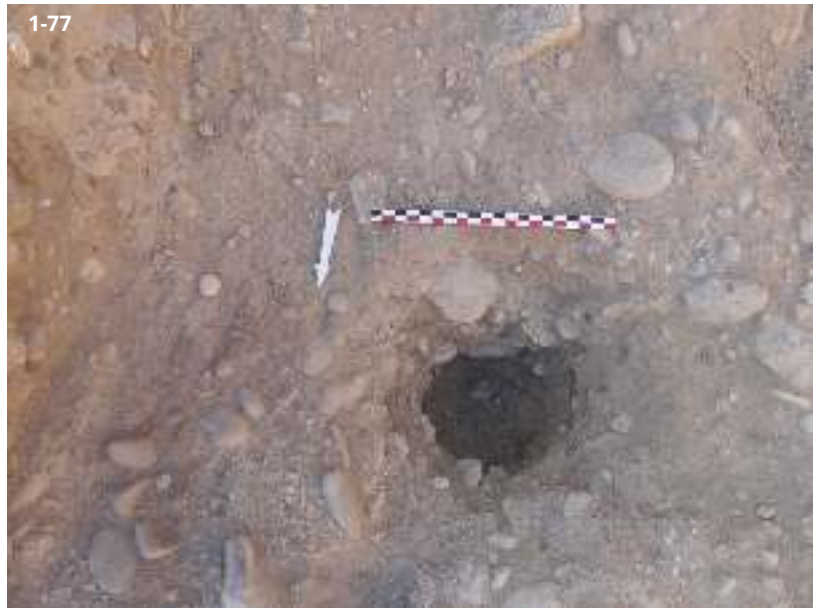
**Fig 1-77 :** the posthole  
B12-336, fully excavated

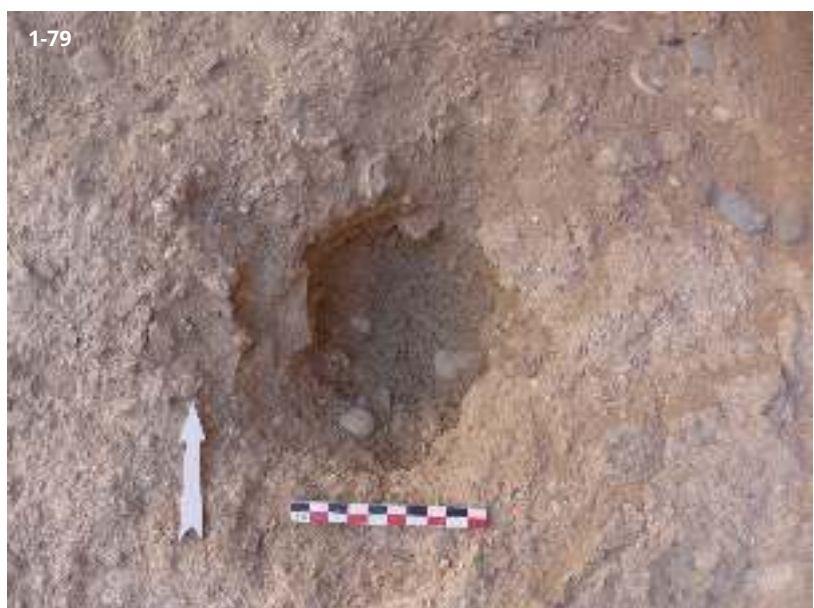
**Fig 1-79 :** the posthole  
B12-332, fully excavated

In the southern part of the room B12-L, the postholes **B12-332** (Fig 1-79), 0.15m wide by 0.10m deep, and **B12-334** (Fig 1-80), 0.20m wide and 0.15m deep, seem also to belong to the phase of occupancy as they were covered by the level of the next phase of reoccupation, but their function is less explainable than the aforementioned postholes. The first one is problematical because its location would have hindered the fitting of the assumed shelves along the wall B12-281 while the second one might have worked with the postholes B12-328/335/336 as it is creating a right angle with their alignment, but cannot be conveniently explained. In any way, the presence of the small buttress B12-305 and of several postholes located alongside the walls is a reminder of the room B12-Q where similar fitting were observed. In that case also, the presence of shelves was strongly assumed. It must also be noted that in the room B12-L, the presence of the usual sanitary floor made of some pebbles over the coated floor was not observed, to the contrary of most other rooms in the basement.

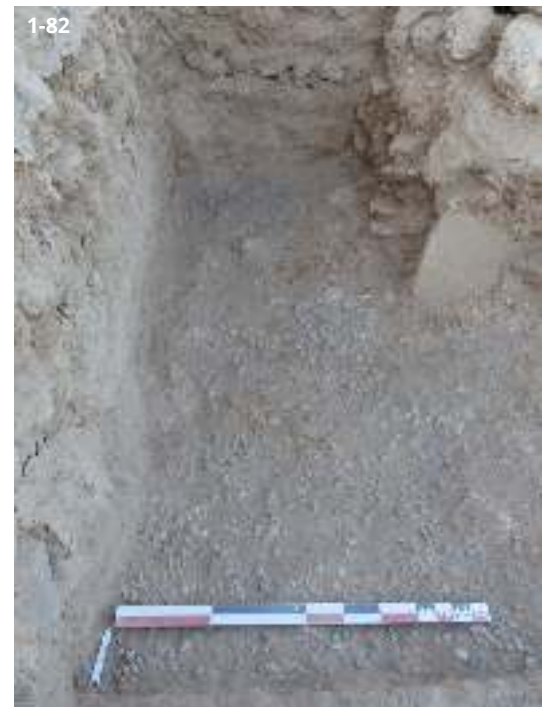
**Fig 1-82 :** *the sanitary level Uf3747*

can so explain why it looks different from the other coated floor. But excavations and evidences were too scarce to be fully affirmative. A sanitary level (**UF3747**) (Fig 1-82) made of small pebbles mixed with sandy beige silt was observed in the northern part of the room, spread above a level of backfill (**UF3778**), made of brown sandy silt and containing some stones which were used to level the subsidence of the coated floor. Though the ceramic material was too scarce to give an affirmative dating, there is no reason to doubt that the sanitary floor was spread in the same time as the other sanitary floors, which means in the beginning of the 16<sup>th</sup> century.

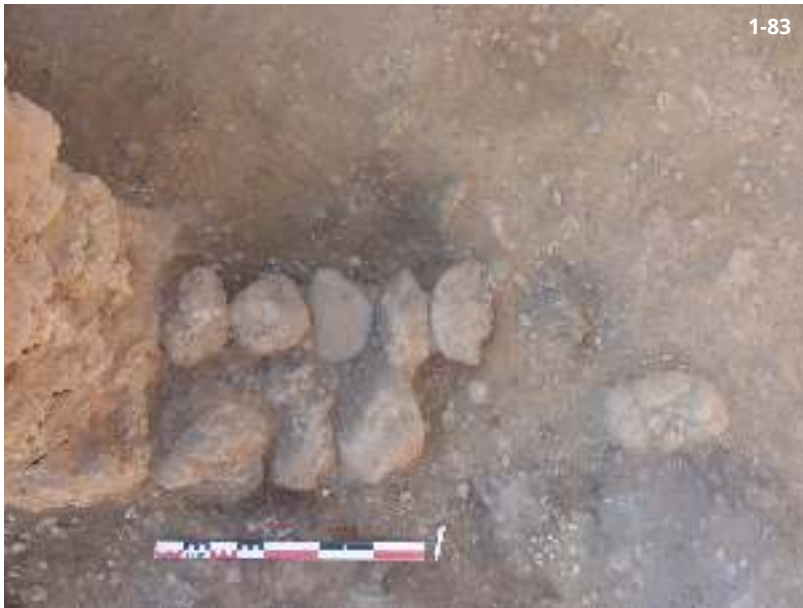
**Fig 1-83 :** the low wall B12-315 at the feet of the buttress B12-305

postholes (B12-332, 334 and 335). A low wall (**B12-315**) (**Fig 1-83**) was also built right to the west of the small buttress B12-305. It is 0.65m long by 0.45m wide and only 0.15m high, i.e. one course of stones. But as it is made only with stones with no binder and no coating, it is possible that the wall was once higher and that it was not visible among the collapse until its bottom. This wall is associated with the floor UF3704 as it was marking its northern edge. It is quite probable that this wall was used to make a delimitation between a privacy space to the south, while the northern part of the room would have been used as a more domestic area. The postholes uncovered in the south-eastern corner (**B12-331**) (**Fig 1-84**), 0.15m wide by 0.10m deep, **B12-332**, 0.15m wide by 0.10m deep, and **B12-333** (**Fig 1-85**), 0.10m wide by 0.10m deep) could be the remains of a fitting in this area related to this phase of reoccupation, which cannot be determined. Also, it is possible that the posts in the holes B12-328 and B12-335 were still in existence, or the holes were reused, when the low wall B12-315 was made, as it is ending very close to B12-335. A closing by a curtain can still be imagined, though no strict evidence can be firmly given.

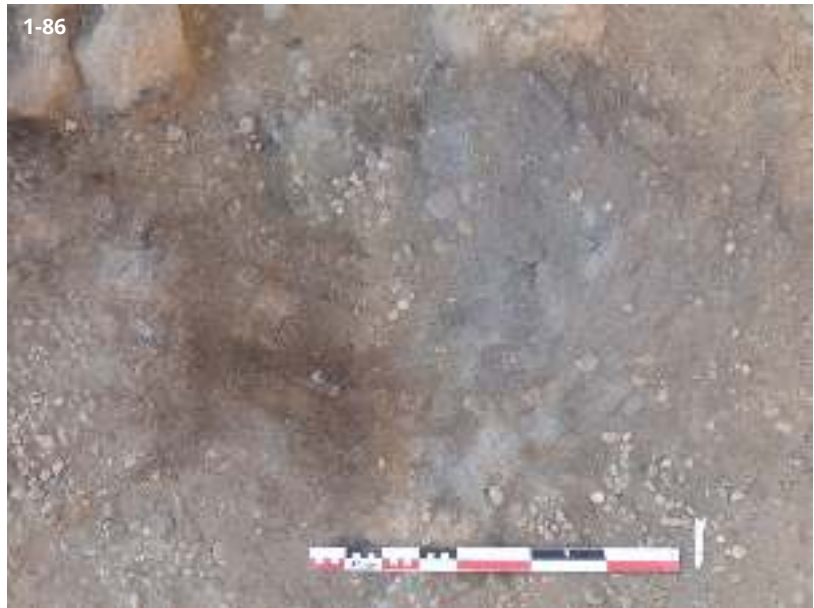
**Fig 1-86** : the hearth B12-314

The northern part of the room B12-L seems to have been used as a domestic area, as a hearth (**B12-314**, around 0.65m wide) (**Fig 1-86**) was uncovered there. This hearth is contemporary with the low wall B12-315 immediately to the south, and some of its stones were burnt by the fire. Traces of the action of the fire were also observed over the underneath coated floor B12-316. It is possible to imagine that the roof above was partially damaged at the time the hearth was set to allow the evacuation of smoke. In that hypothesis, the other postholes uncovered in the northern part of the room (**B12-337**) (**Fig 1-87**), 0.10m wide by 0.06m deep, **B12-338** (**Fig 1-88**), 0.15m wide by 0.10m deep, **B12-339** (**Fig 1-89**), 0.10m wide and deep and **B12-340** (**Fig 1-90**), 0.15m wide by 0.10m deep) could have been used for supporting the remains of the roof along the northern wall B12-292, or for another kind of fitting yet not conveniently explainable. It is also very likely that the posthole **B12-343** (**Fig 1-91**), 0.20m wide by 0.10m deep, built in the middle of the gate from room B12-K was also dug during this phase of reoccupation and was used to support the wooden panels of a door.

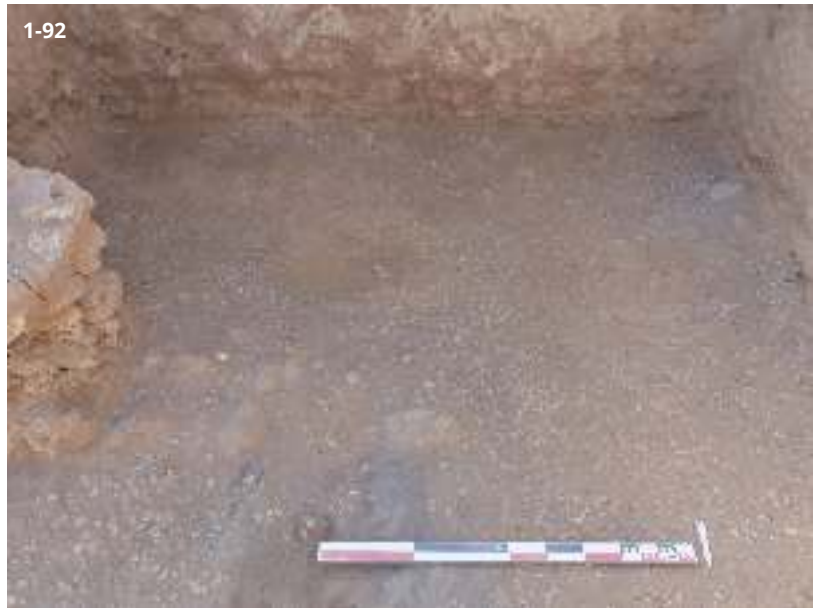
**Fig 1-92 :** *the earthen floor*  
*Uf3693*

A second phase of reoccupation was found in the room B12-L: a level of small pebbles bounded with gray brown sandy silt (**UF3693**) (**fig 1-92**) was spread nearly all over the rooms, covering all the structures mentioned above. Only one structure was uncovered relating to this second phase of reoccupation, a hearth (**B12-313**, 0.70 long by 0.60m wide) (**Fig 1-93**) set in the southern part of the room. In the north-east part of the room, over the floor UF3693, an area of ashes (**UF3664**) was also found, containing many charcoals, burnt corals, animal bones, ceramics and some nails probably coming from beam burnt in the hearth. It is quite probably the rejection area of the hearth B12-313 and the dating of ceramics indicates a broad 16<sup>th</sup> century. It is possible that this second phase of squatter reoccupation occurred shortly after the first one, while the structures of the main reoccupation in room B12-K were still in use, but the dating cannot be precise enough to be affirmative.

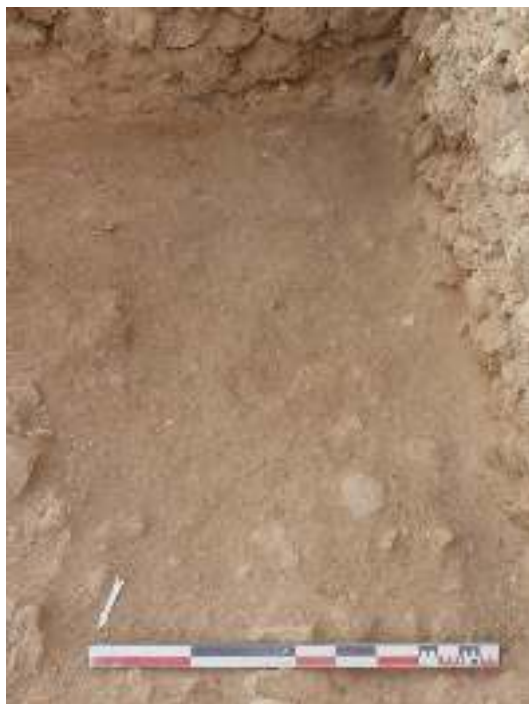
**Fig 1-97** : the possible late reoccupancy UF3643

A squatting occupancy was also observed in the middle of the room, where the layer **UF3643** (**Fig 1-97**) is made of small pebbles and charcoals and ashes. As in room B12-L, it seems that some people spend a little time in the ruins and made a rough hearth that was later damaged by the collapse above. The highest level of collapse excavated during this season (**UF3641**) is similar to the level UF3644, only separated from it by the short squatter reoccupation UF3643. It is also made with a beige soil and contained many limestone and coral blocks of all sizes, plaques of roof, fragments of coating and mortars and some massive architectural elements, most of them coming from the separating wall of the first floor. Some elements of beams were also uncovered, which might either come from the beam supporting the upper roof or from the columns where the wood was used to prevent the damages resulting of earthquakes. Above it, the highest level of collapse was excavated during the previous season.

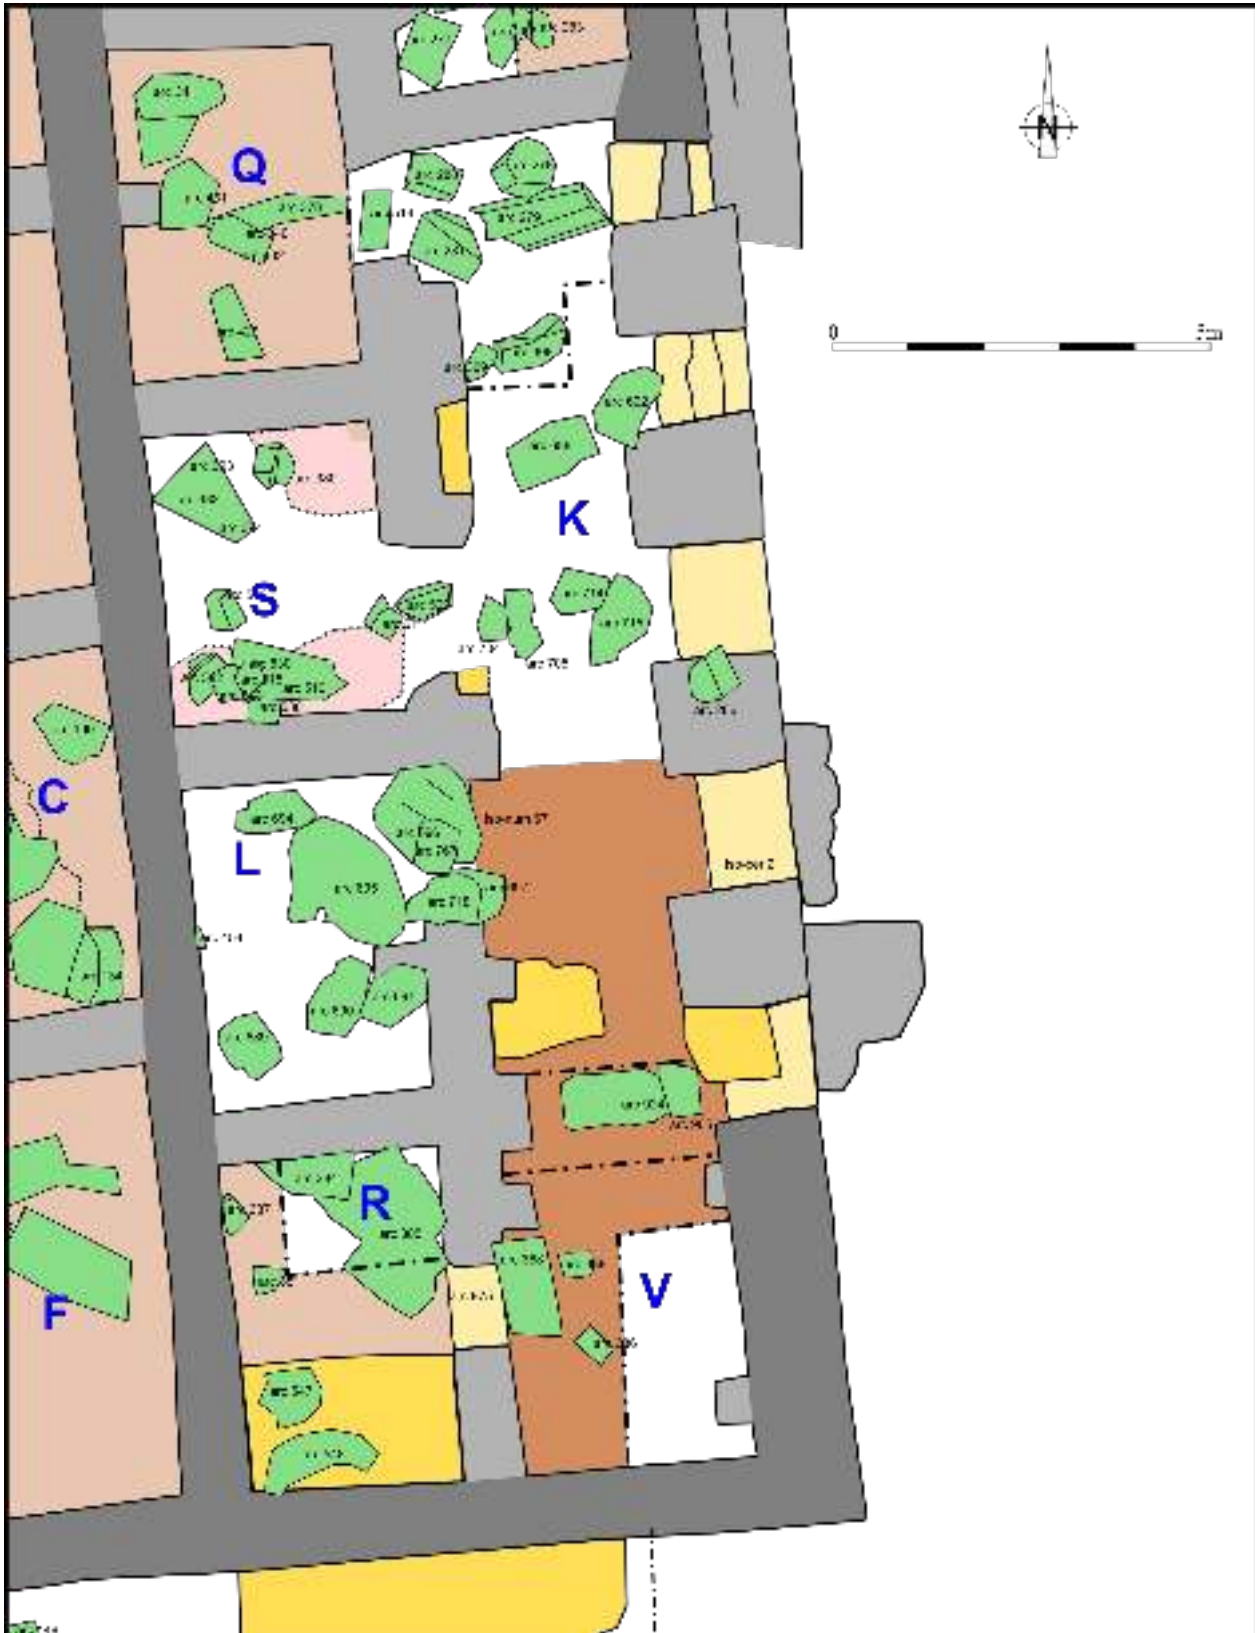
Fig 1-98 : Site plan of the main architectural elements

I-B2c. Architectural elements Fig 1-98

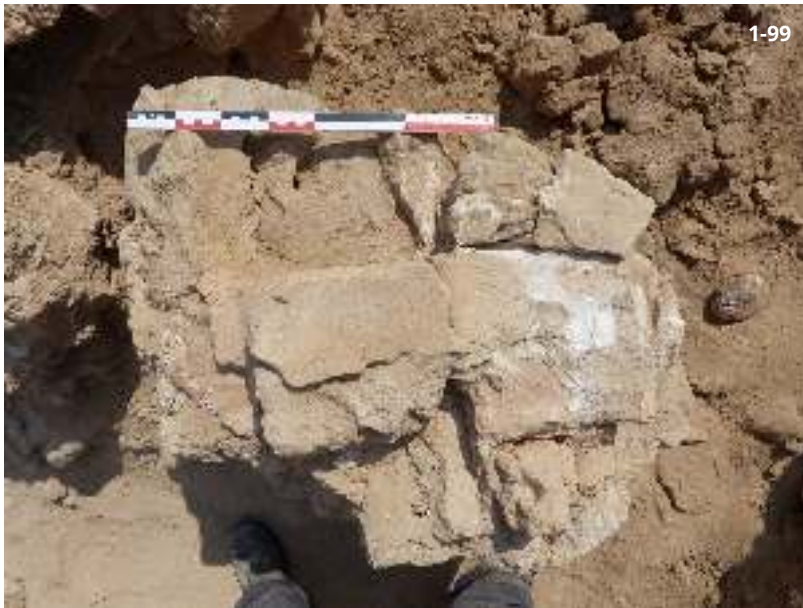
**Fig 1-99 :** *the architectural element IsoArc 689, possible blocking for a gate*

Most of the architectural elements found in the rooms B12-L, R and S came from the dividing wall separating the first floor into prayer hall and entrance hall. In the room B12-L, the **IsoArc689 (Fig 1-99)** appeared to be a blocking for an opening, quite probably a gate rather than a window according to its size. A vertical beam imprint was visible on one face of this blocking which could have been used for a door-frame, which might indicate that a original gate was reduced in size, a smaller door being created in the blocking. In the same room, the **IsoArc690 (Fig 100)** and **IsoArc694 (Fig 101)** are fragments of the separating wall, with remains of the white coating bearing traces of small engaged pilasters.

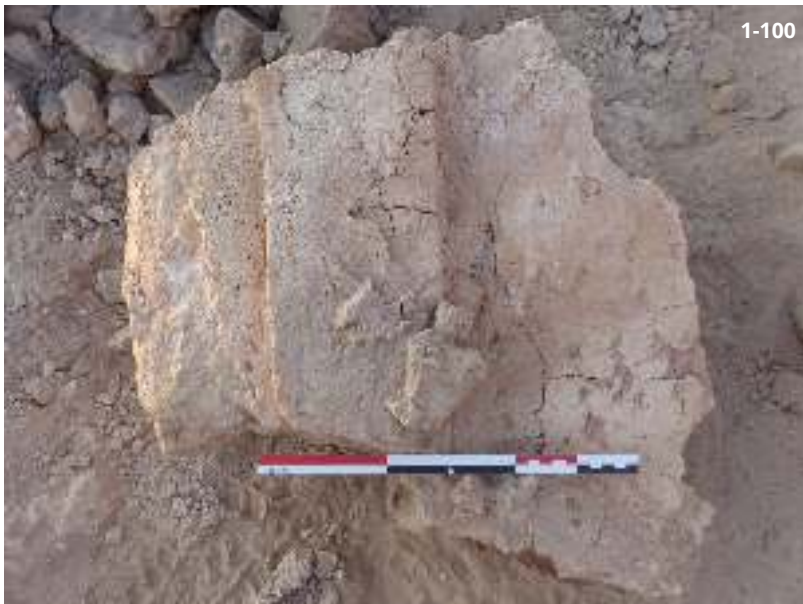
**Fig 1-100 :** *the architectural element IsoArc 690, fragment of engaged pilaster*

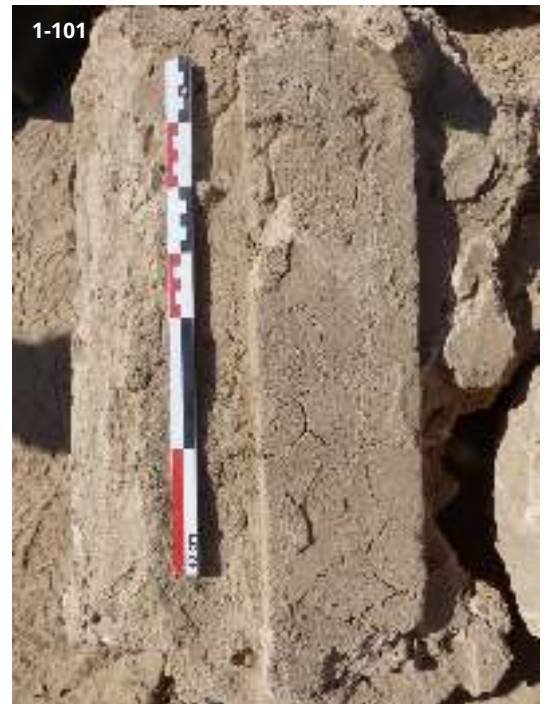
**Fig 1-101 :** *the architectural element IsoArc 694, fragment of engaged pilaster*

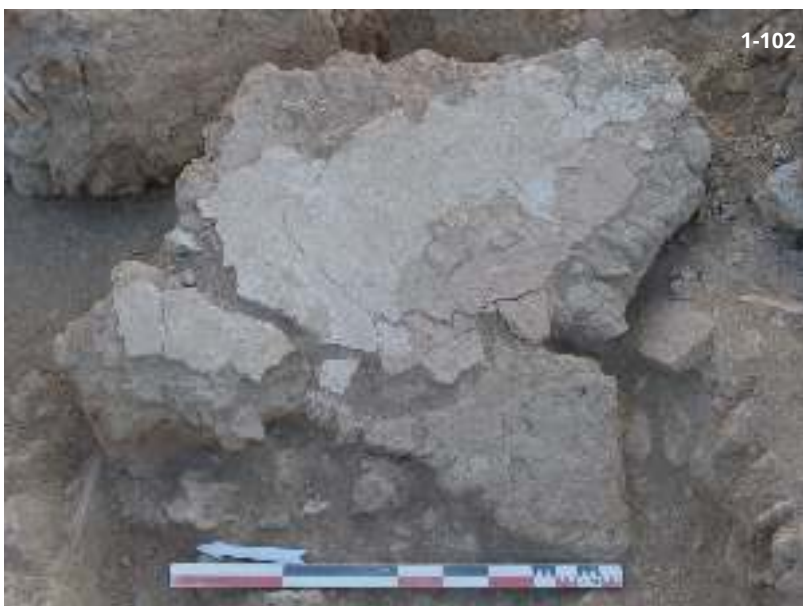
**Fig 1-102 :** *the architectural element IsoArc 695, possible fragment of a vaulted gate*

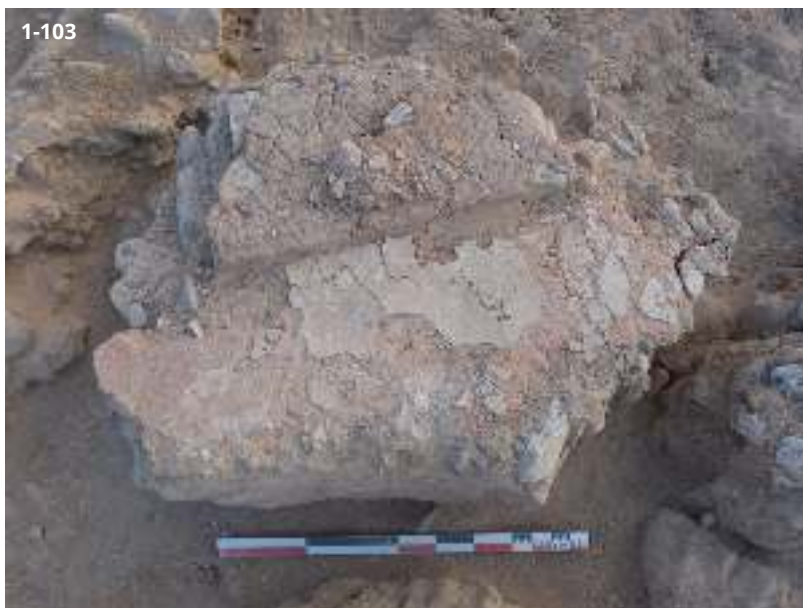
**Fig 1-103 :** the architectural element IsoArc 696, possible fragment of a vaulted gate with engaged pillar

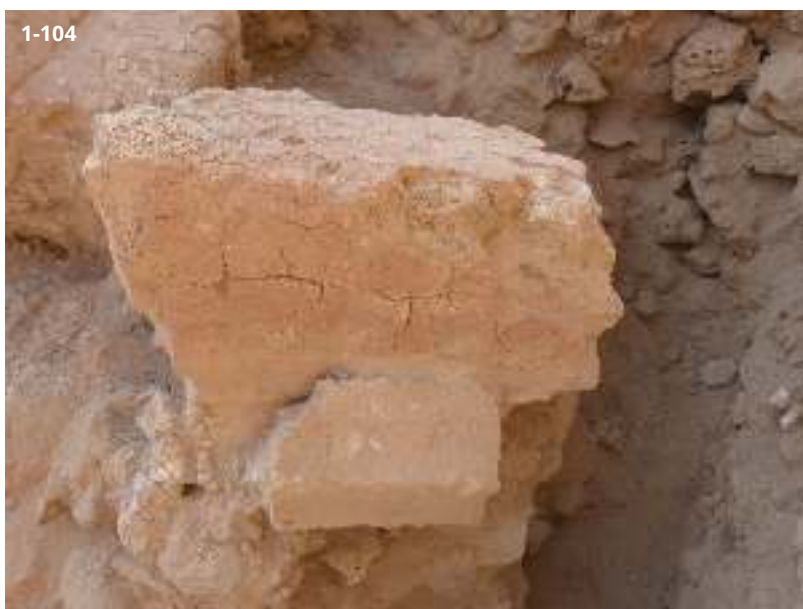
**Fig 1-104 :** the architectural element IsoArc 512, fragment of jamb of a gate with molding

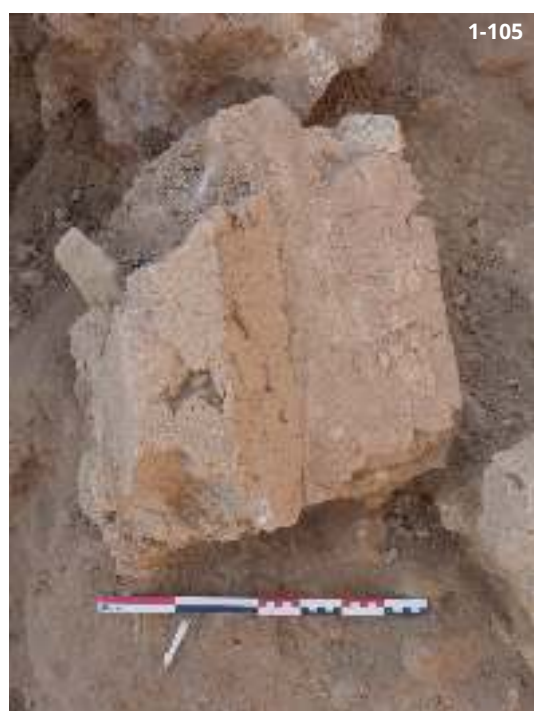
**Fig 1-105 :** the architectural element IsoArc 515, fragment of jamb of a gate with molding

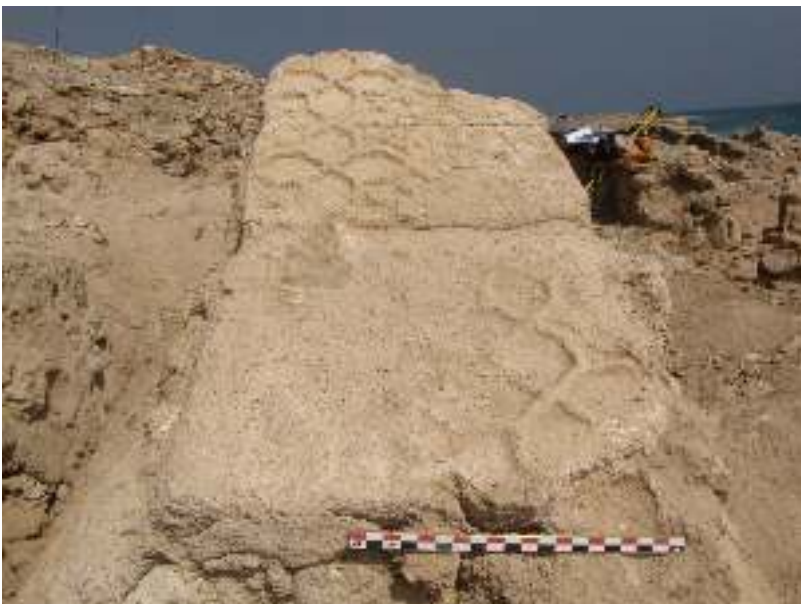
**Fig 1-110 :** Architectural element (capital and spandrels) with molded decoration before dismantling

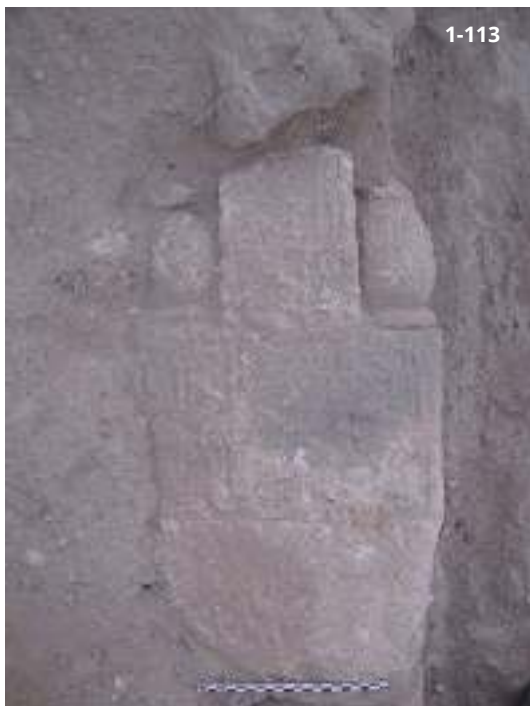
**Fig 1-113** : the carved gravestone in reuse

The upper step, set between the two jambs of the gate, is 1.72m long by 0.42m wide and 0.15m high. It is made partly with corals and limestone blocks bounded with a gray mortar, and partly with a reused tombstone (**IsoLap01**) (**Fig 1-113**). Though highly eroded, the gravestone presents in its central panel and its central pediment some carved letters which could not be deciphered until now. The central pediment is flanked by two small egg-shaped jars, more or less looking like a pomegranate. The gravestone was removed from the threshold to prevent further erosion and stored in proper condition.

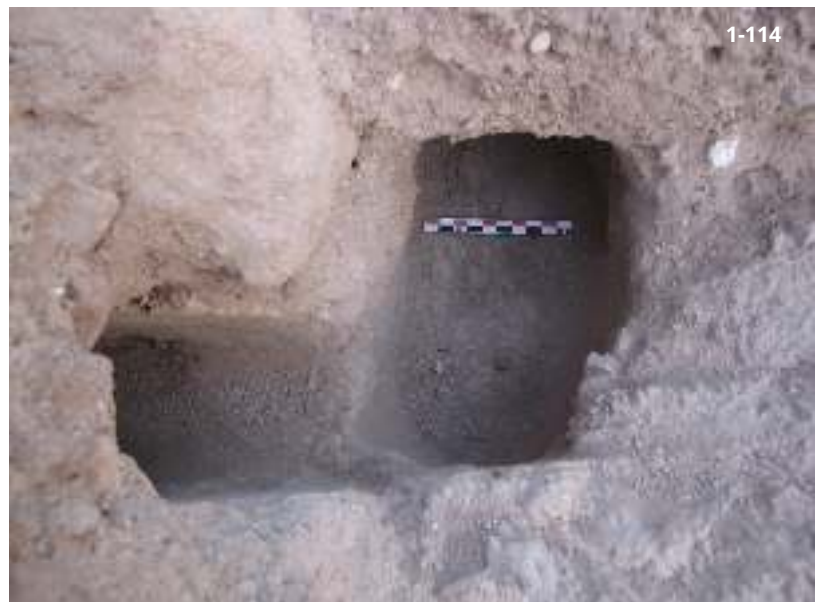
**Fig 1-114** : detailed view of the wooden pattern in the threshold B12-310

Beamholes were uncovered in the threshold B12-310, suggesting a particular wooden fitting to support the door and frame (**Fig 1-114**). A long transversal beamhole was found, crossing the entire length of the threshold and running inside the two jambs at their feet, 0.45m deep at east and 0.24m deep at west. This long beam was strengthened by the addition of two perpendicular beams at the foot of the jambs, whose function was undoubtedly to prevent a possible sliding of the wooden frame of the door which, according to the size of the gate, was probably really heavy. Disintegrated pieces of wood were found and sampled inside the beamholes and, as the mortar revealed the prints of some curves and fittings, it is possible that the wood was reused, maybe from a boat, and not necessarily cut especially to be used in the door-frame.

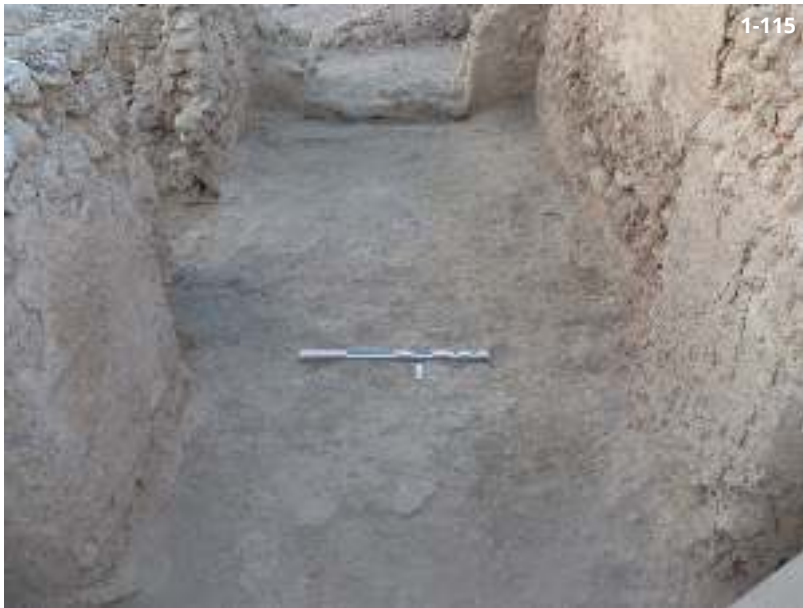
**Fig 1-115 :** view of the remains of the coated floor B12-306, with the south gate B12-379 in the background

The threshold B12-310 was associated with a floor made of gray beige mortar (**B12-306**) (**Fig 1-115**) which was observed in the main part of the corridor B12-B. This mortar floor is well-preserved at the foot of the walls and near the northern face of the upper step of the threshold while it is missing in the middle of the passageway, showing the underneath backfills.

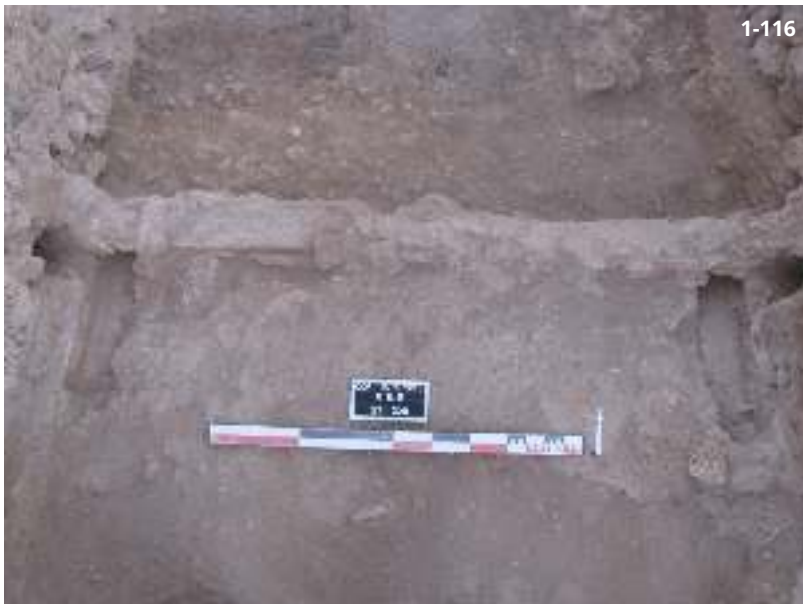
**Fig 1-116 :** the threshold B12-325

At the northern extremity of the corridor B12-B, the gate **B12-378** was uncovered during the previous season except for its bottom where a berm was left in place above the assumed threshold. Excavations during this season unearthed a threshold similar in shape to the one found in the southern extremity. The threshold **B12-325** (**Fig 1-116**), 2.06m long by 0.70m wide, is set between the two jambs made by the end of the wall B12-183 at west, and preserved for around 1.50m high, and by the end of the wall B12-29 at east, 0.75m wide and preserved for 1.20m high. The coating is not preserved.

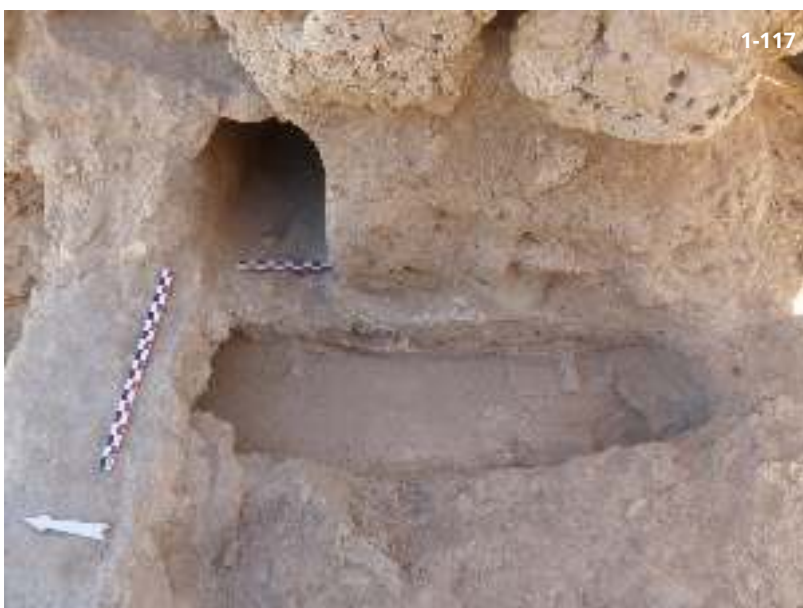
**Fig 1-117 :** detailed view of the wooden pattern in the threshold B12-325

Beamholes were also unearthed here, as in the threshold of the south end, with a long transversal beam, running for 0.40m inside the western jamb and for 0.27m inside the eastern one, with two smaller perpendicular beamholes at the foot of the jambs, around 0.35m long (**Fig 1-117**). The prints of the wood in the mortar also suggest that the wood was reused and the general pattern of the door is quite probably exactly the same as the southern one, except that the threshold here has no steps from the northern low courtyard. The threshold B12-325 is made by large limestone blocks covered by a gray mortar which is mostly missing in the middle and no strict connection was observed between the threshold and the coated floor observed southerly. There is however no reason to doubt that this two structures are contemporary, as they are in the south end of the corridor.
