## Qalhât Development Project, Season 2015B-2016A, Final Report

**QALHÂT (ASH-SHARQYJAH)**

**SEASON 2015B-2016A**

**FINAL REPORT**

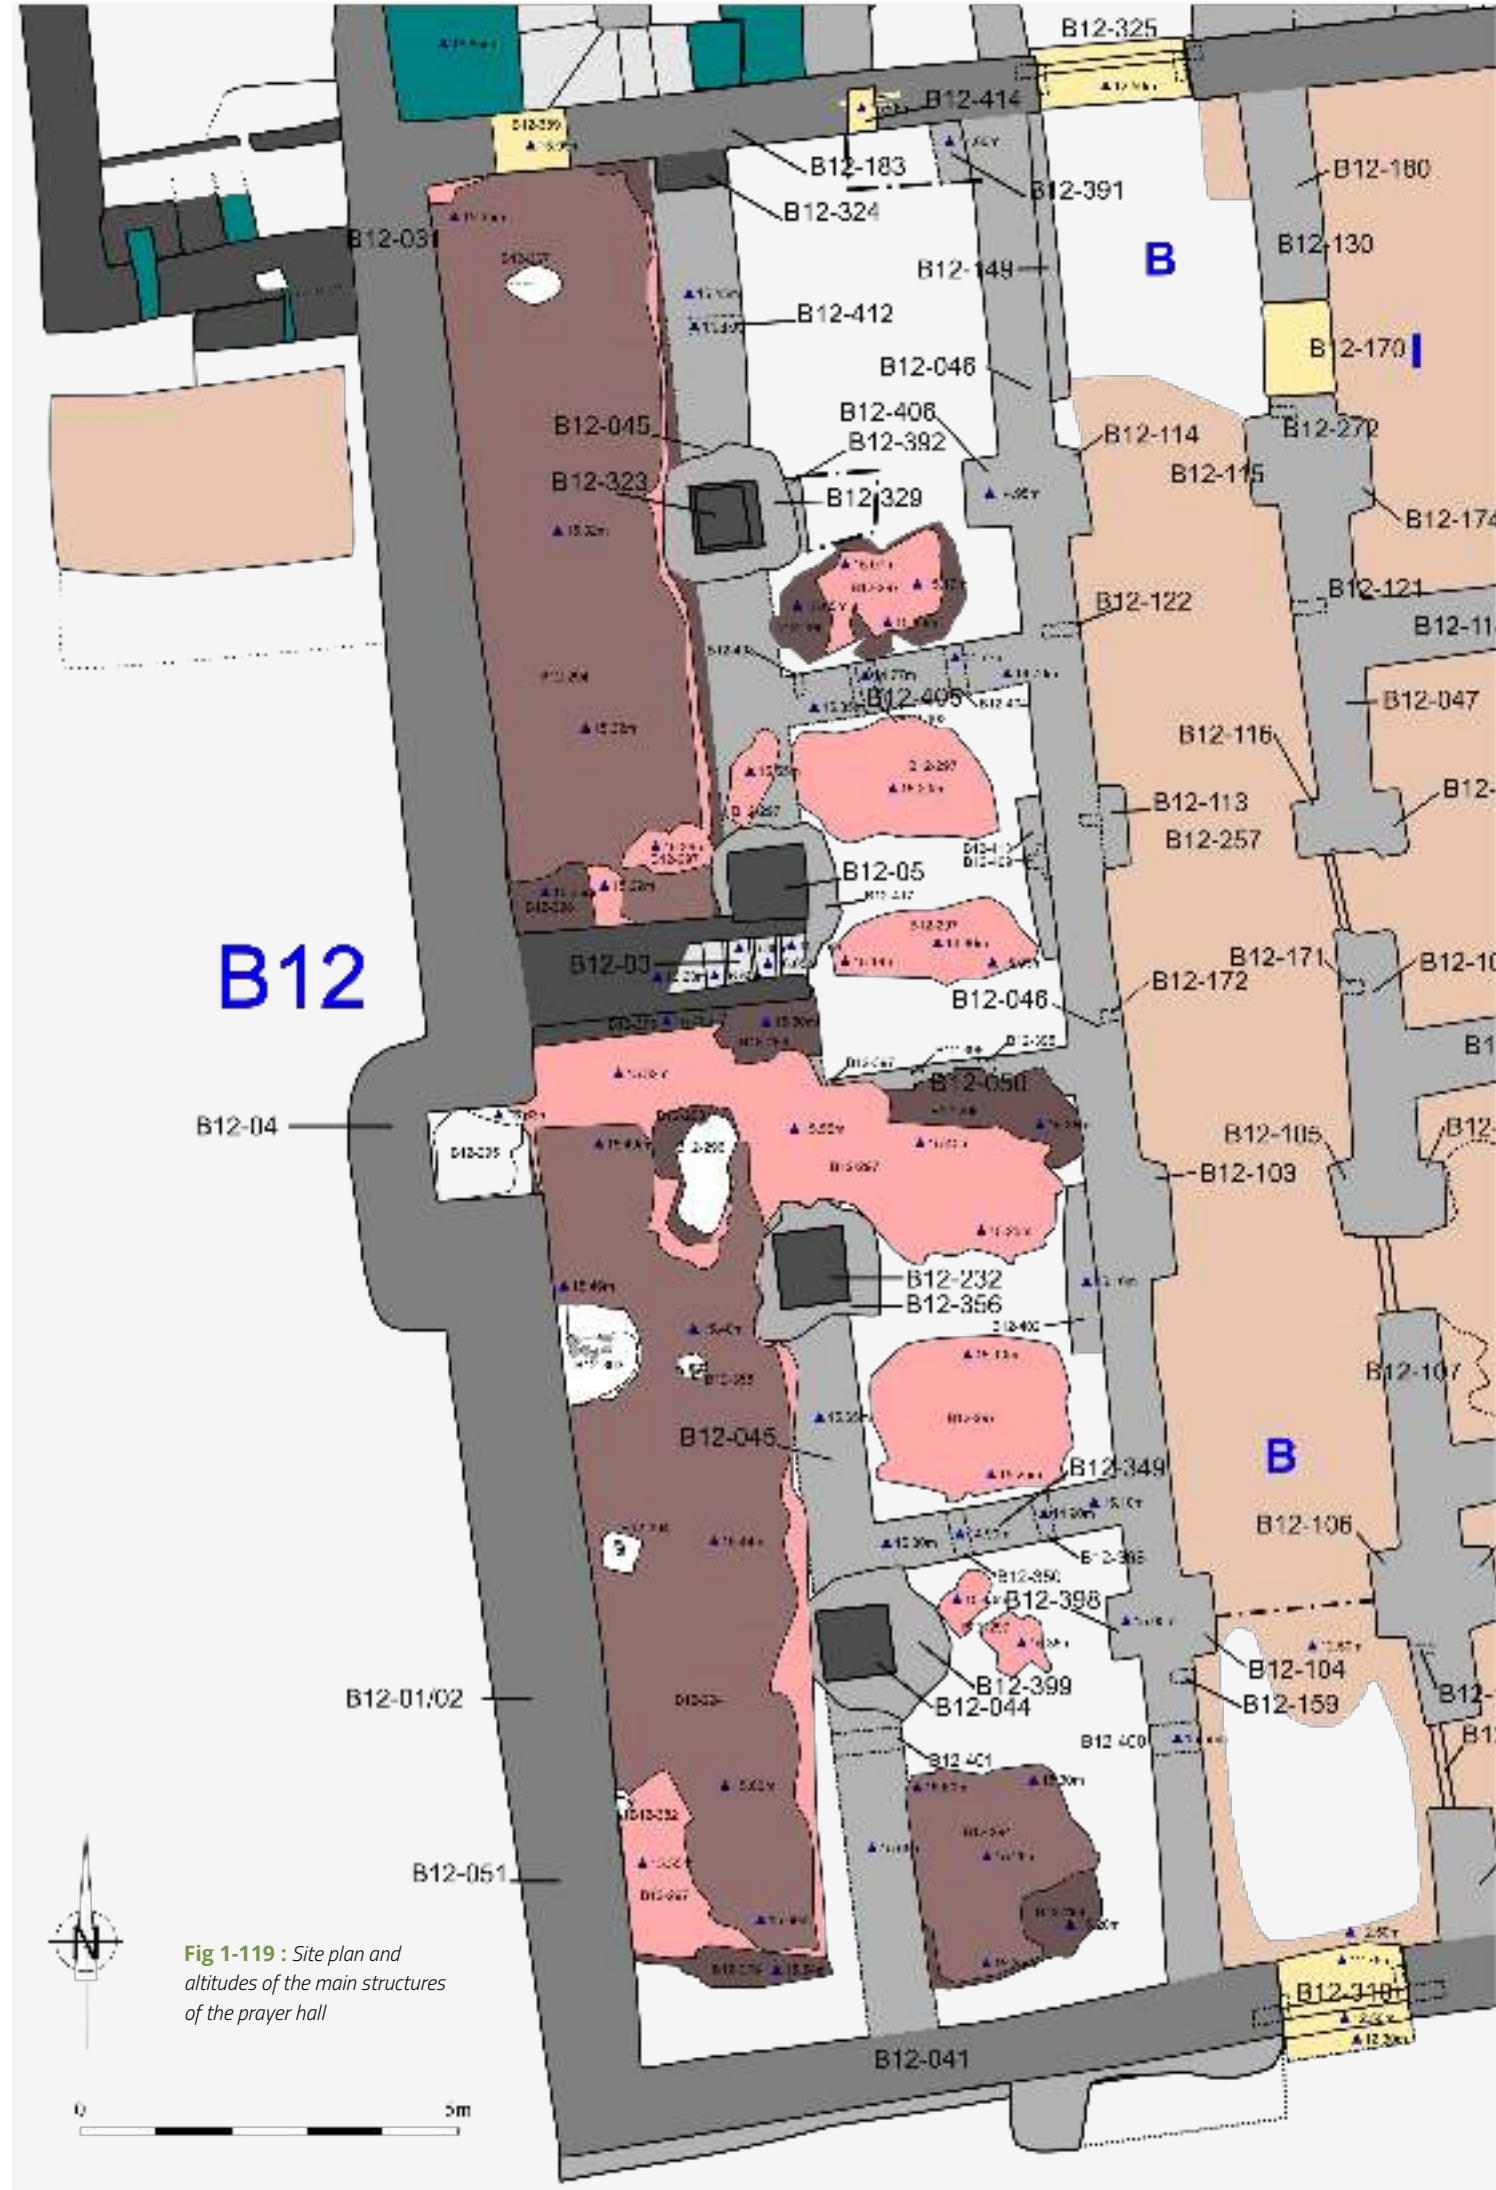
**Fig 1-119 :** Site plan and altitudes of the main structures of the prayer hall

Only the western part of the prayer hall proper, in the first floor of the mosque, is now preserved, against the qibla wall. As the two westernmost spans (5-6) of the basement were backfilled, the superstructures of the hall collapsed here on the floor, instead of down inside the empty other spans to the east (1-4). The floors and lower parts of the masonries were therefore protected. (FIG 1-119)

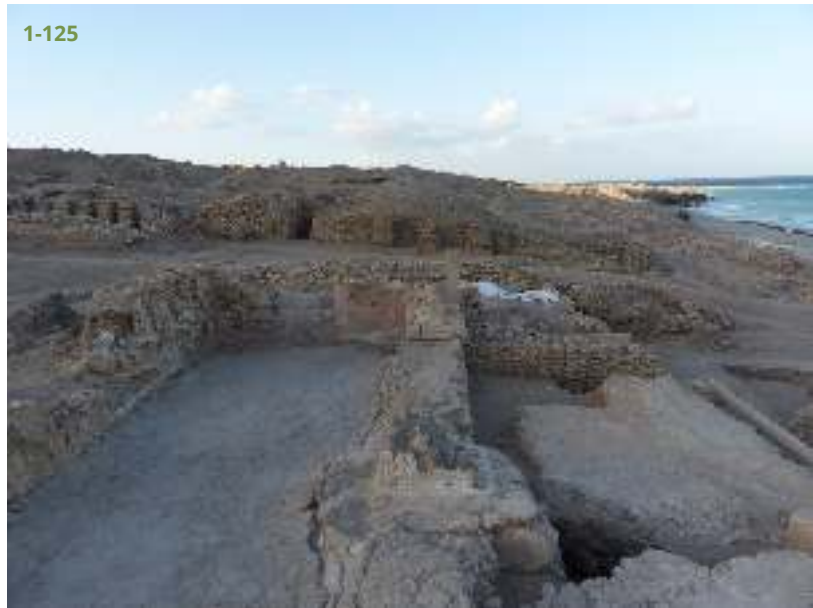
**Fig 1-125 :** view of the north wall B12-183

To the north, the north wall of the prayer hall **B12-183**, (**Fig 1-125**) against the north wing, is preserved up to 1.50m at its western extremity at the corner with the *qibla* wall, and totally eroded to the west the superstructures fallen into the basement and the low courtyard. The lower part of the wall, at basement level, is made mainly with large pebbles, while the corals are more present in the elevation of the first floor. A quite well preserved pink coating was observed on the internal face but no trace of decoration, even prints of it, was observed.

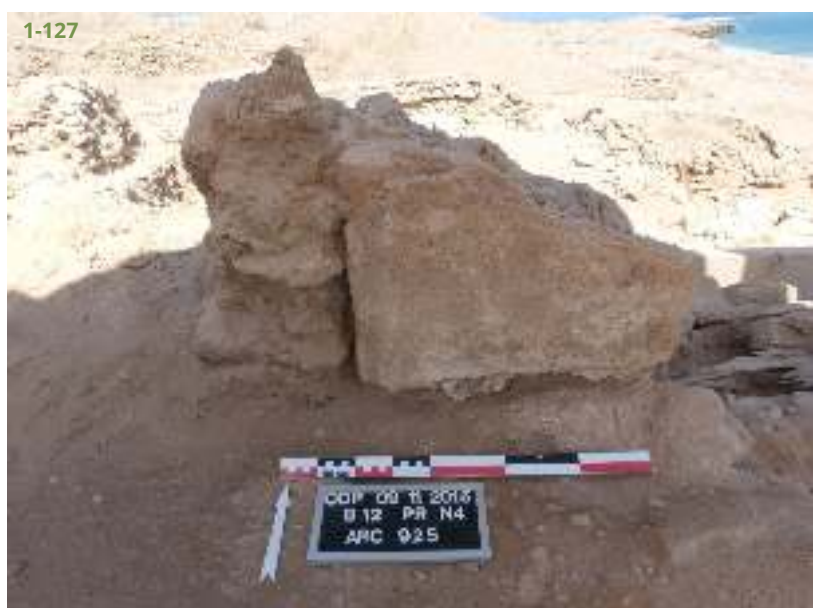
**Fig 1-127 :** remains of a possible opening with a late blocking at left

A second opening (**IsoArc925**) was also partially observed in the north wall B12-183, more or less in the middle of the span 5. It is not possible to clearly state if this opening is a gate, a windows or a niche, as only one jamb of this opening was found, incompletely preserved and having possibly slightly slide down from its original location. Parts of the jamb were found covered by a fine pinkish beige coating. A small curve at the rear of the coating might identify this structure as a niche but remains are too scarce to be affirmative. A gate or a window going to the floor can also be easily considered. In any case, this opening was blocked in a later refitting. **Fig 1-127**

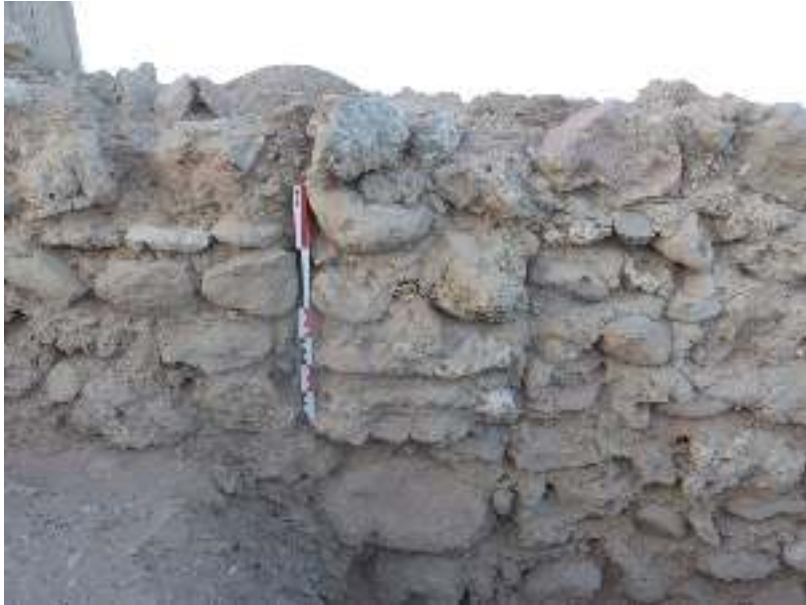
**Fig 1-128** : the blocked opening B12-414

Another particular fitting was observed right under this opening in the south face of the wall B12-183 and under the altitude of the floor of the prayer's hall. This fitting (**B12-414**) is visible in the facing of the wall by two vertical lines in the layout of the stones, joint by a horizontal line at their bottom (**Fig 1-128**). It seems reasonable to consider that an opening or a hole once stood here and was lately blocked. The structure blocked could be considered as a beamhole but it is not the most relevant hypothesize, firstly because of its shape. The opening before being blocked was about 0.40m wide and 0.60m high, which is a quite unusual height for a beam. Also the bottom of the cavity is nearly 0.90m below the floor of the prayer's hall, which would have so required to use a very large beam to support the floor. And moreover, the bottom of the structure B12-319 is nearly 0.20m lower than the others beam cavities observed elsewhere in the others walls of the basement visible under the prayer's hall, which is nonfunctional in a beam-framework. The best hypothesis is to consider this structure as a hole for aeration, crossing the entire width of the wall. Similar fittings were observed in other parts of the walls of the basement under the prayer's hall and it is possible that similar holes for aeration once stood in the upper part of the vanished walls of the basement, to bring fresh air into the rooms. Further hypothesis regarding the life and change of the building involved by the presence of those holes in the walls of the span 5 of the basement, yet entirely backfilled, will be described below.

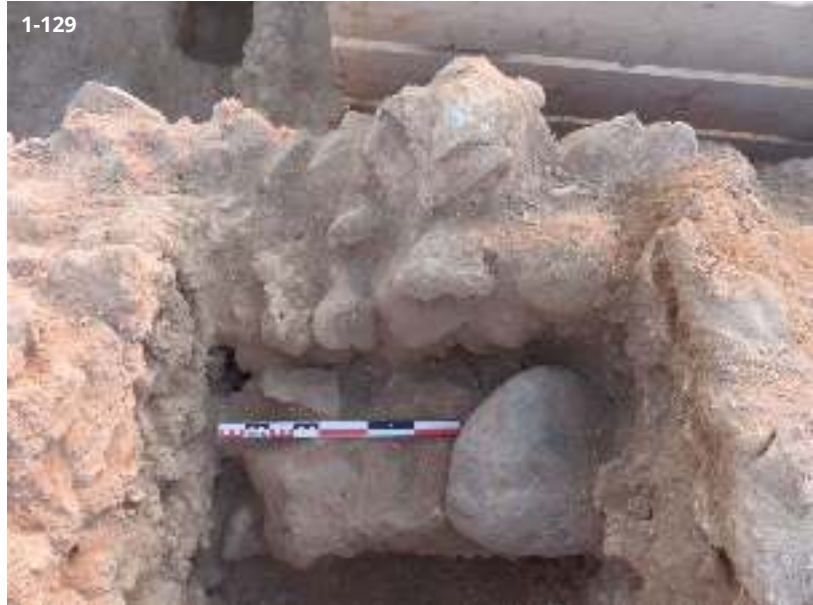
**Fig 1-129** : the thickening B12-391 (under the scale) of the wall B12-46 behind

Against the north wall B12-183, at the north-east corner of the preserved first floor, a sounding was opened into the backfill of the basement. It appeared that the wall B12-46 was strengthened by the addition of the thickening **B12-391** (**Fig 1-129**). This masonry, made of large corals and pebbles bonded with a beige mortar and built against the west facing of the wall B12-46, is 0.40m wide and was observed for 0.85m long (the length of the sounding) but it goes on southerly for an unknown distance.

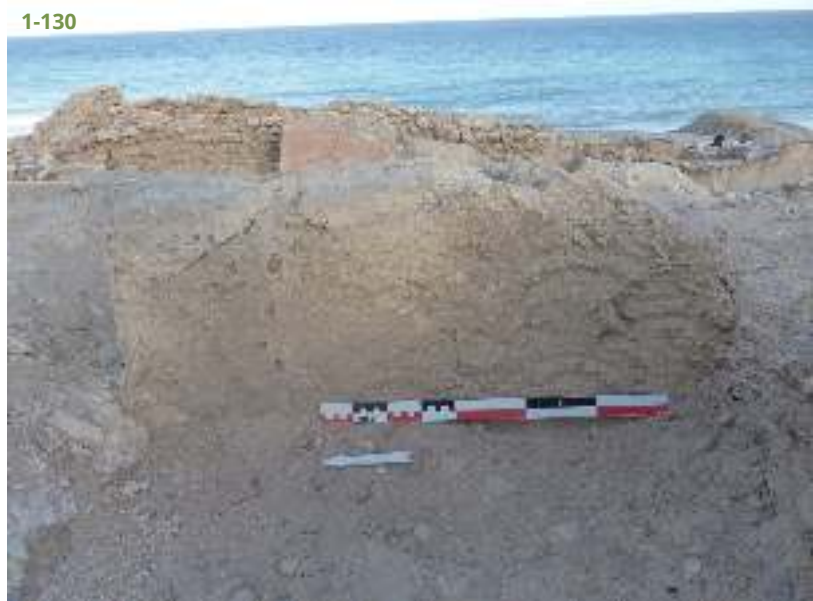
**Fig 1-130** : the buttress B12-406

Shortly to the south, the vacuum of the floor also permitted to observe the presence of a massive buttress (**B12-406**), 0.90m long by 0.50m wide for an unknown height as it was only unearthed in its upper part (**Fig 1-130**). It is made with corals and limestone blocks bonded with mortar and covered with a rough gray coating where fingerprints are still visible. Though badly preserved, it appears to be quoined with the wall B12-46 and, as it is built just opposite the buttress B12-114 in the corridor B12B, under the east-west alignment of the pillars of the prayer hall, its architectural function was obviously to support the heavy weight of the pillars and arches above.

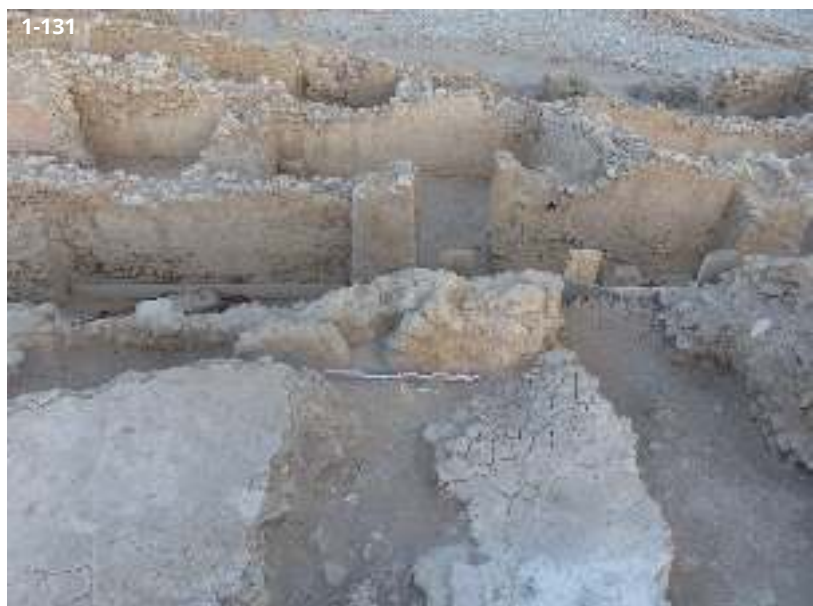
**Fig 1-131** : the buttress or thickening B12-413

Southerly again, the masonry **B12-413**, which was superficially uncovered, can be considered as a massive buttress or a thickening, or maybe both (**Fig 1-131**). It is a construction, at least 2.15m long by 0.30m wide, made with corals and medium limestone blocks bonded with beige mortar and apparently without coating. It seems to be quoined with the wall B12-46, at least in the northern part while it is less clear in the south part, because of the state of preservation. It is most probable that the north part of this structure, which north limit is in the same alignment than the easterly buttress B12-113, was used to support the pillar built above, but the south part can also be a later thickening, although its state of preservation and the presence of a preserved floor did not allow a certainty. At the top of the structure, a print (**B12-409**) was observed which can be the trace of a hole for a beam or for a strengthening wooden element (**Fig 1-132**).

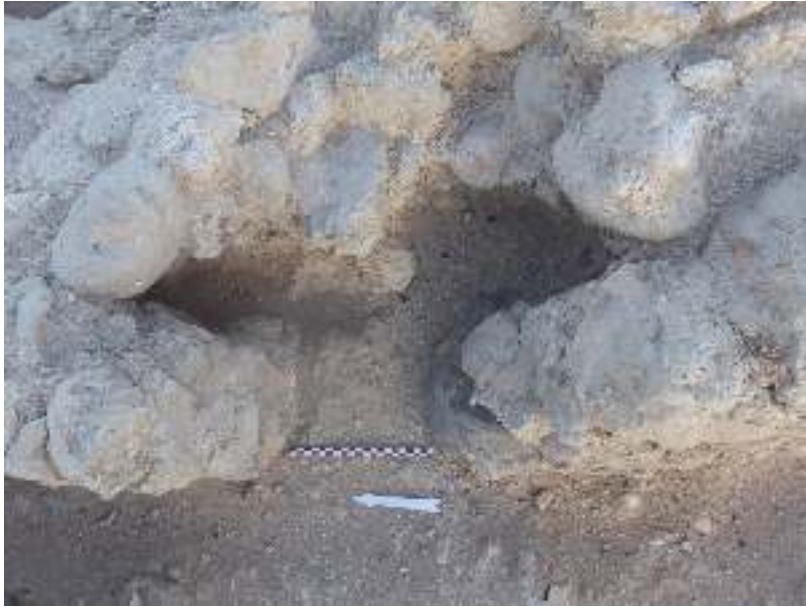
**Fig 1-132** : the print of a wooden steering B12-409

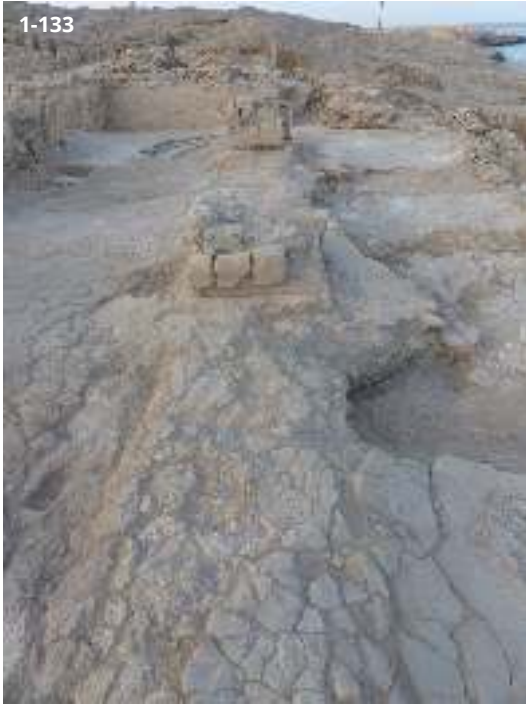
**Fig 1-133 :** the intermediary wall B12-45 under the row of pillars, visible by the cracks of the floors, in the south part

Parallel to the wall B12-46, the wall **B12-45**, which runs under the preserved row of pillars of the prayer hall, under the floor between the two backfilled spans 5 and 6, was partially observed where the floors have cracked or collapsed (**Fig 1-133** and **Fig 1-134**). It is 25m long for an assumed width around 1m, and was- observed for 0.50m high in average under the level of the floor. It is quoined with the wall B12-183 to the north and presumably with the wall B12-41 to the south, but the state of preservation is not good enough to be affirmative. The wall is made with medium pebbles, corals and limestone blocks bonded with a powdery brown mortar, apparently mainly made with soil. No trace of coating was observed. **Fig 1-135**

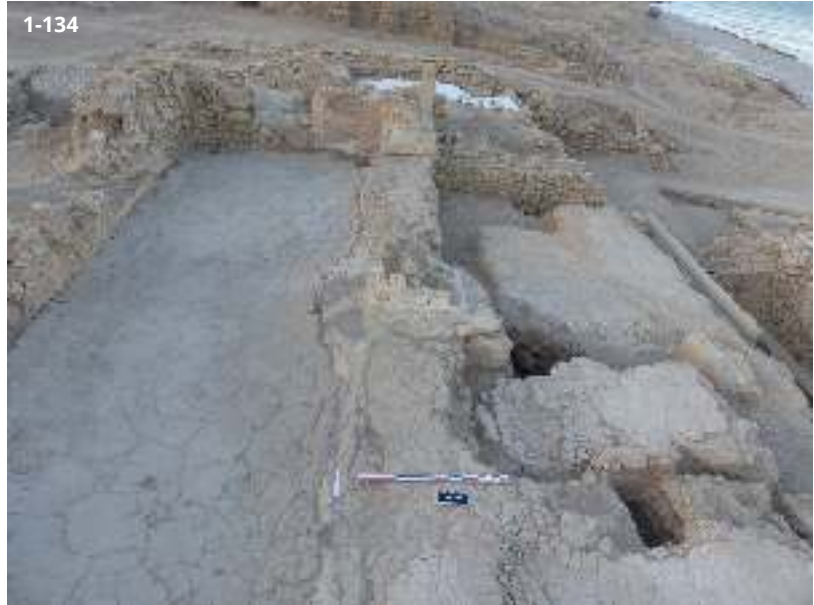
**Fig 1-134 :** the intermediary wall B12-45 under the row of pillars, visible by the cracks of the floors, in the north part

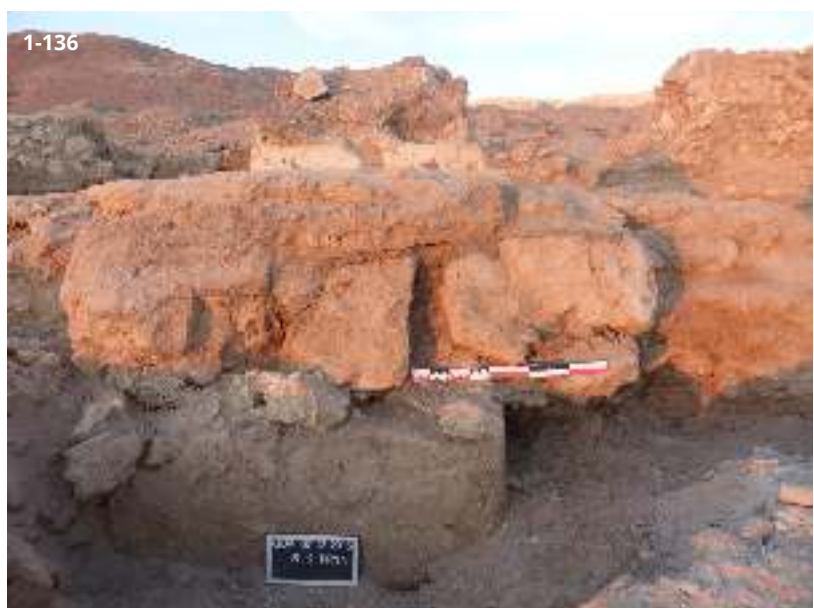
**Fig 1-136 :** the buttress B12-329, at the bottom, the upper part under the collapsed pillar, being a later addition

One buttress was found to the north, in front of the buttress B12-406, and other are strongly assumed under the other pillars but the excavations did not uncover them because of the need of conservation. The buttress **B12-329** is at least 0.90m long and at least 0.60m wide for an unknown height. It is similar to the buttress B12-406 in shape and components, with the same fingerprints visible on the coating (**Fig 1-136**). A rough masonry was built over it and similar constructions were observed under all the preserved pillars but, as it seems to be a later strengthening, they will be described below.

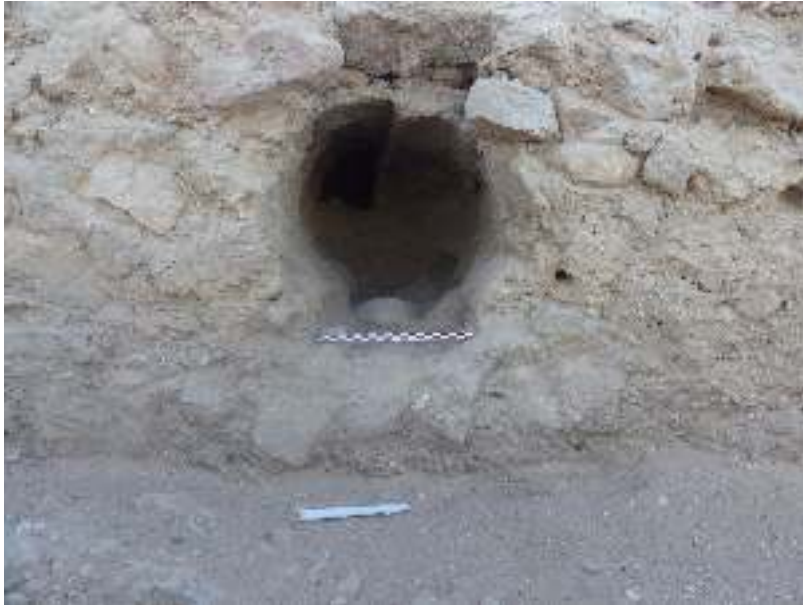
**Fig 1-137** : the beamhole  
B12-412

Two holes were observed in this wall, one in the northern part and the second one to the south. The northern one (**B12-412**) is 0.30m wide for 0.30m wide and runs for at least 1m inside the wall B12-45, the supposed width of this wall (**Fig 1-137**). The size and shape of this hole, and its location nearly halfway between two rows of pillars, suggest that it is a beam-hole that once hosted an east-west beam, but the corresponding beam-hole into the opposite wall B12-46 was not found. The state of preservation however can explain this lack. The southern hole (**B12-401**) is similar in size, 0.30m wide, at least 0.27m high and running for at least 0.90m inside the wall B12-45, and is probably also a beam-hole, and also without a corresponding in the wall B12-46. A small print (**B12-400**), 0.40m wide, was observed right at south of where the corresponding of B12-401 should have been. It is possible that the beam-hole in front of B12-401 has disappeared and that B12-400 would have hosted a second beam running east over the corridor B12-B.

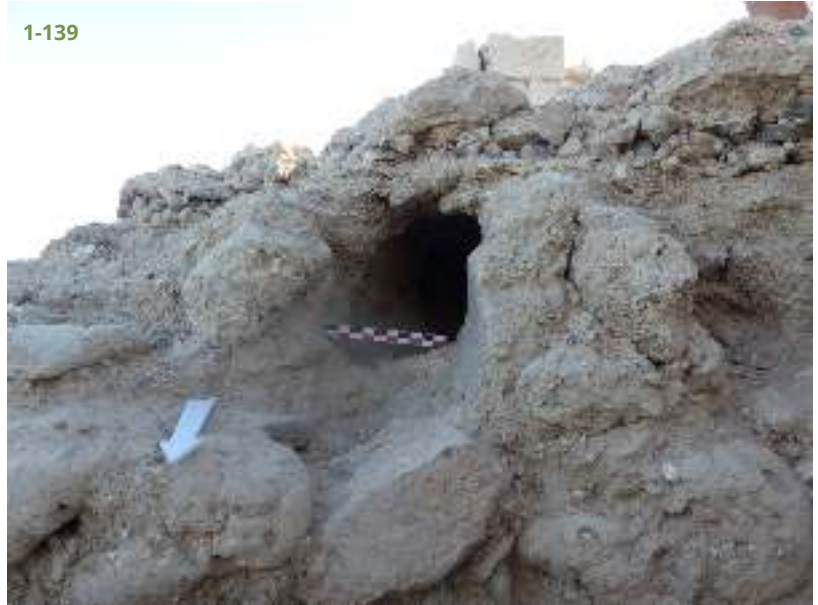
**Fig 1-139** : the assumed beamhole B12-408

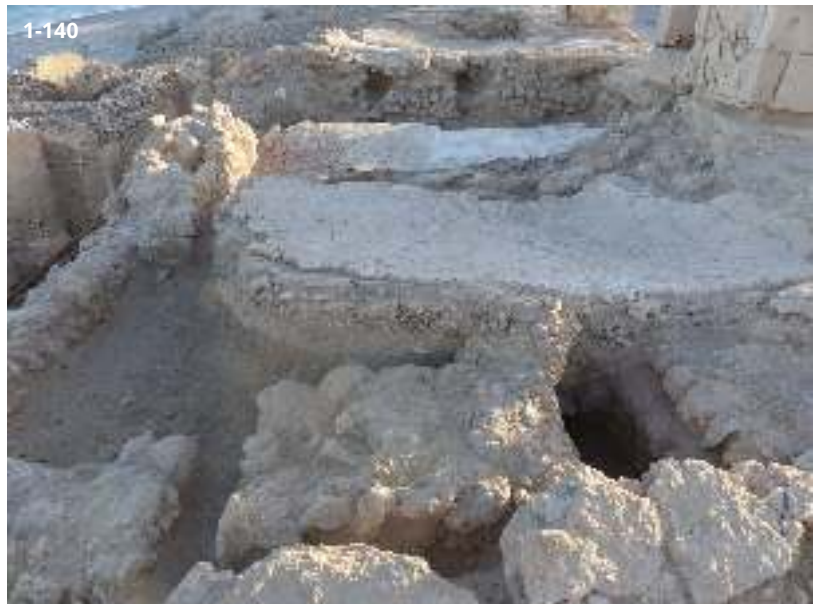
**Fig 1-140** : the openings B12-403 (at right) and B12-404 (at left) in the shear wall B12-405

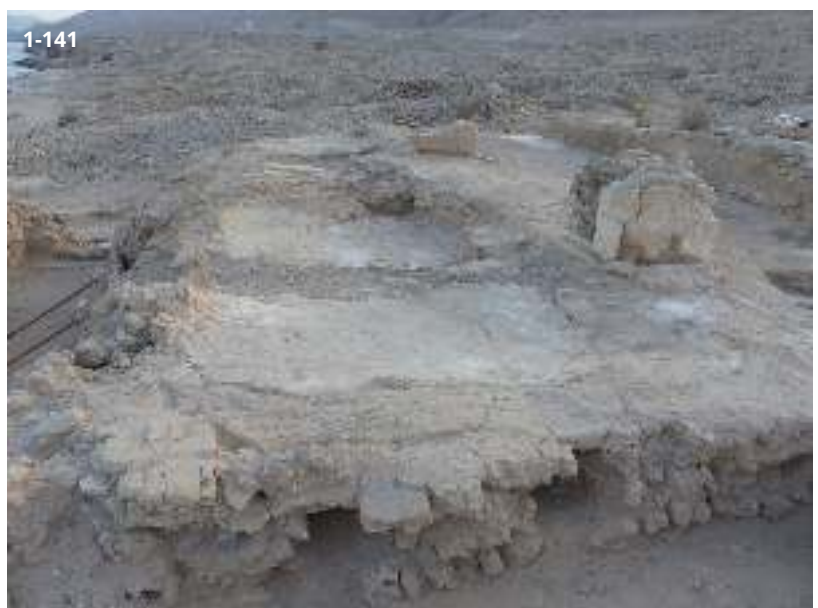
**Fig 1-141** : the shear wall B12-50 with the openings B12-395 (at left) and B12-396 (at right)

The same pattern was observed in the wall **B12-50**, which is built in the middle of the span and was already uncovered in the QP sounding. This wall, 3.25m long by 0.60m wide and uncovered for around 0.50m high, is made with medium corals and limestone blocks bonded with a powdery brown mortar and is quoined to the wall B12-45 and B12-46. Here also no coating was observed and three similar cavities were uncovered at the top of the wall. The westernmost, **B12-397**, set at the corner with the wall B12-45, is 0.10m wide and 0.13m high and, though not entirely unearthed, it does not seem to cross the entire length of the wall. Its function is not absolutely certain but it could be a little beam-hole. To the east however, the larger cavities **B12-395** and **B12-396** are more likely aeration holes. They are both 0.17m wide and around 0.40m high and they cross the entire width of the wall B12-50 (**Fig 1-141**).

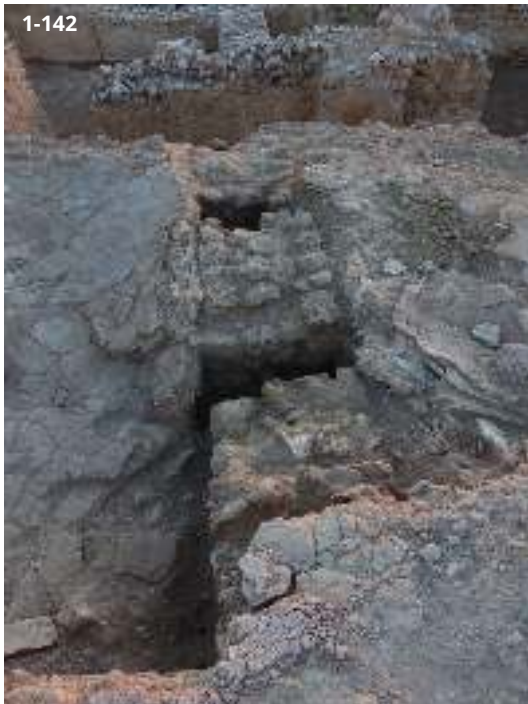
**Fig 1-142** : the shear wall  
B12-349 visible by the  
disappearance of the floors

Finally to the south, the third wall **B12-349** is similar to the previous one and shows the same fittings (**Fig 1-142**). This wall is 3.25m long by 0.60m wide and was uncovered for around 0.40m high. It is quoined with the walls B12-45 and B12-46 and made with medium corals and limestone blocks bonded with a powdery brown mortar. Scarce remains of a beige coating were observed on the south side, near the junction with the wall B12-46. The wall is also pierced at its top by two cavities, **B12-350** (**Fig 1-143**) and **B12-368** (**Fig 1-144**), crossing its entire width. They are both of the same size, around 0.20m wide for a minimal height of 0.40m as the top is not preserved. Some organic sediment were found inside those holes, which suggest that they were originally covered by small wooden planks. Here also, those cavities are more likely aeration holes rather than beam-holes.

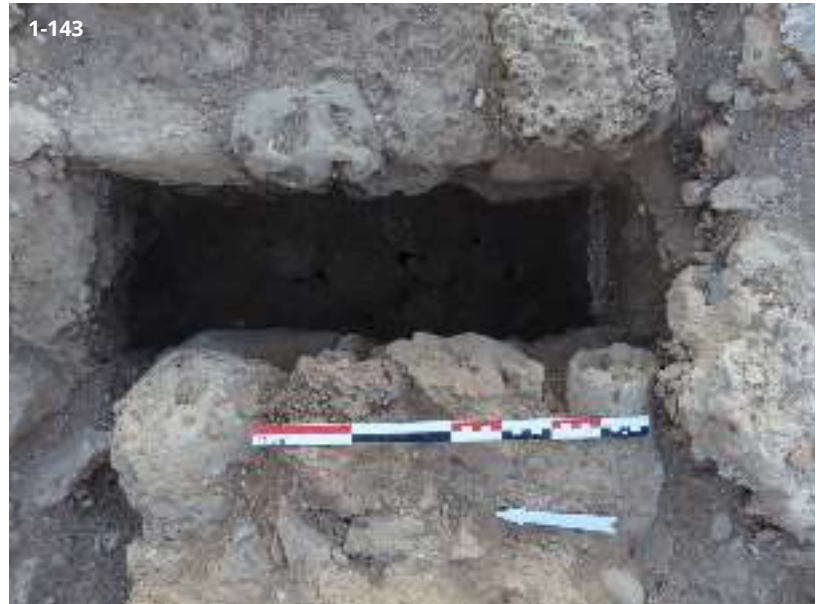
**Fig 1-143** : the opening  
B12-350

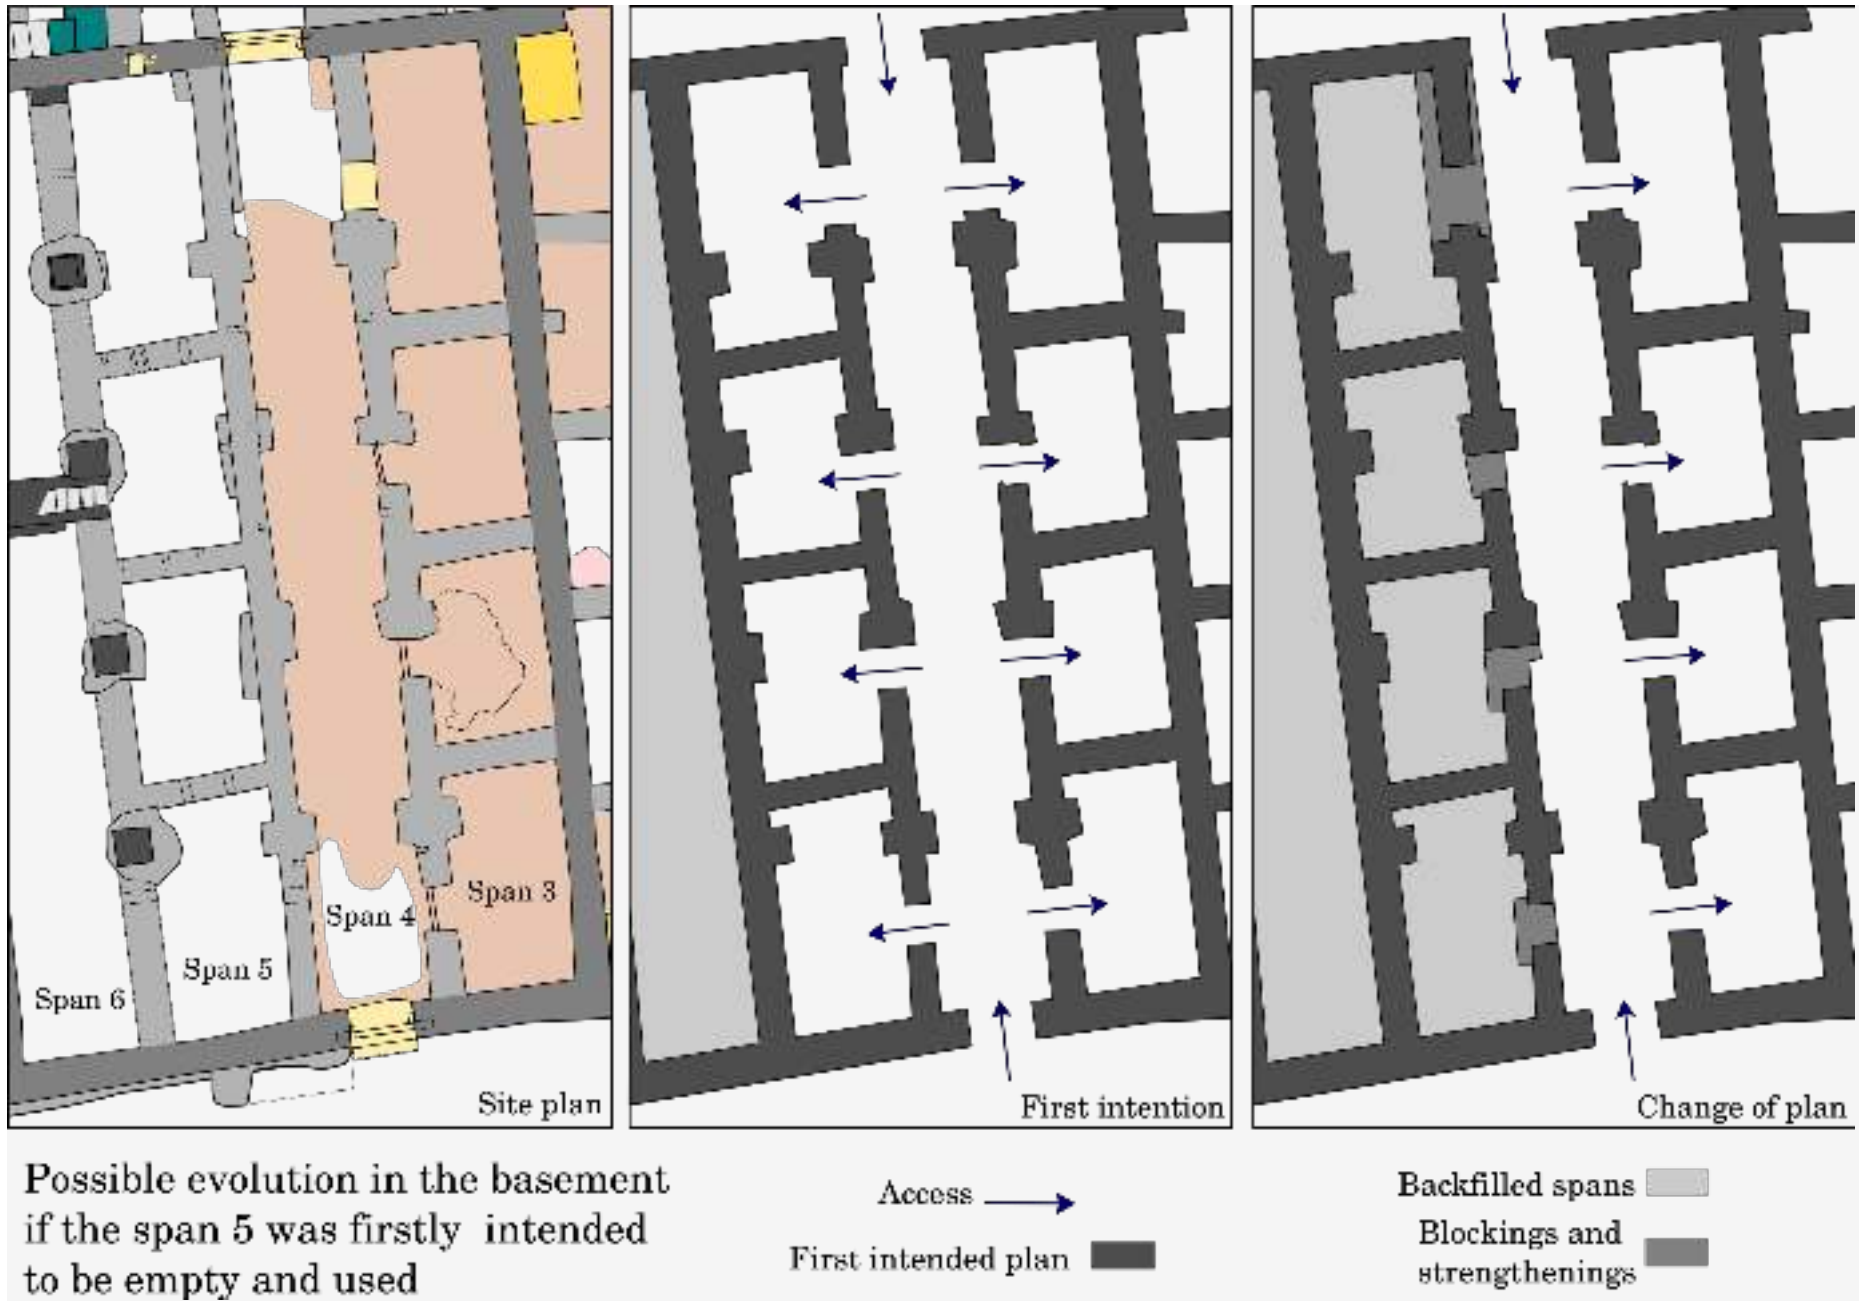
Fig 1-145 : possible evolution in the basement of the Mosque

It can be surprising that aeration holes were put in place in a span of the basement that was backfilled and so not reachable. One explanation could be that the top of the backfill and the bottom of the floor support above were separated by an empty space and that the aeration holes were used to ventilate this empty space and avoid the deterioration of the wooden beams. Nevertheless, it seems, as it will be detailed below, that the top of the backfill reached the level of the beams and that the floor support was set right above it and that no empty space ever existed between them. Another explanation could be that the span 5 of the basement was firstly intended to be left empty and used as rooms, as it is the case in the east part of the basement, and that the builders changed their mind during the course of construction and filled it. This hypothesis is based on the symmetry of the spans on each side of the corridor B12-B, which could have originally be set to give access to 8 rooms, 4 on each side, more or less similar in size. It can be objected that the walls B12-405, B12-50 and B12-349 are compartmentalization walls to maintain the backfill, but in that case it is also surprising than the span 6 of the basement was not built with the same compartmentalization walls, as none was observed or even deduced on the *qibla* side. It so seems that those perpendicular walls were not intended to maintain the backfill but to make separation between different rooms. This hypothesis is also enhanced by the presence of the aeration holes, which are all more or less in the same alignment, and which presence is more logical in case of empty rooms rather than backfilled compartments. It is also very likely that similar aeration holes originally existed in every rooms of the basement above the actual preserved elevation.

Moreover, the presence of the various thickenings against the west facing of the wall B12-46 could also be an argument to confirm this hypothesis. As mentioned above, the masonry B12-402 and B12-413 are located in front of the gates to the rooms B12-A and B12-C, where could have stood the accesses to the original assumed empty rooms in span 5. The southern extensions of those masonries may have been used to strengthen the blocking of the gates, which were walled up when it was decided that the span will not be accessible but backfilled, and built against or with the northern extremities which were architecturally used as buttresses. Similar inside blocking of possible gates could be in existence to the north, in the non excavated area in front of the gate to room B12-I, and to the south in front of the room B12-F where such kind of masonry was presumed, but not excavated. **Fig 1-145**

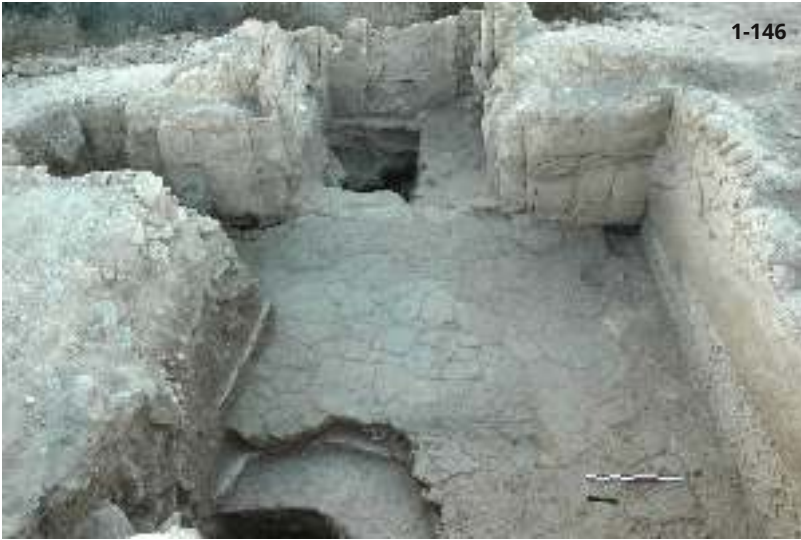
**Fig 1-146 :** the mihrab excavated during the QP soundings

The most characteristic structure of the prayer hall, the *mihrab*, was already excavated by the Qalhât Project and registered as **B12-04** at that time (**Fig 1-146**). Refitting was also assumed then and the observations made during the 2013b-2014a and 2015b-2016a seasons confirmed this hypothesis.

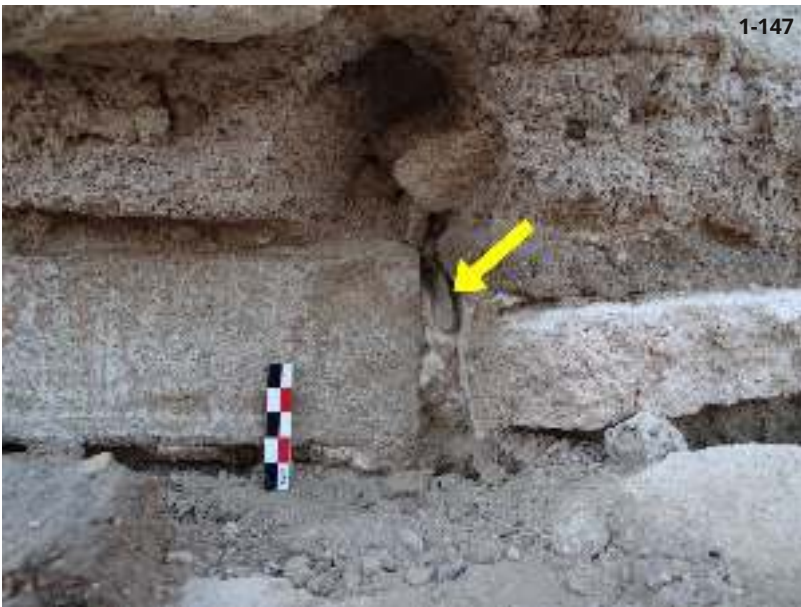
**Fig 1-147 :** the vertical profile of a tile (shown by arrow), probable element of decoration of the first stage of the mihrab

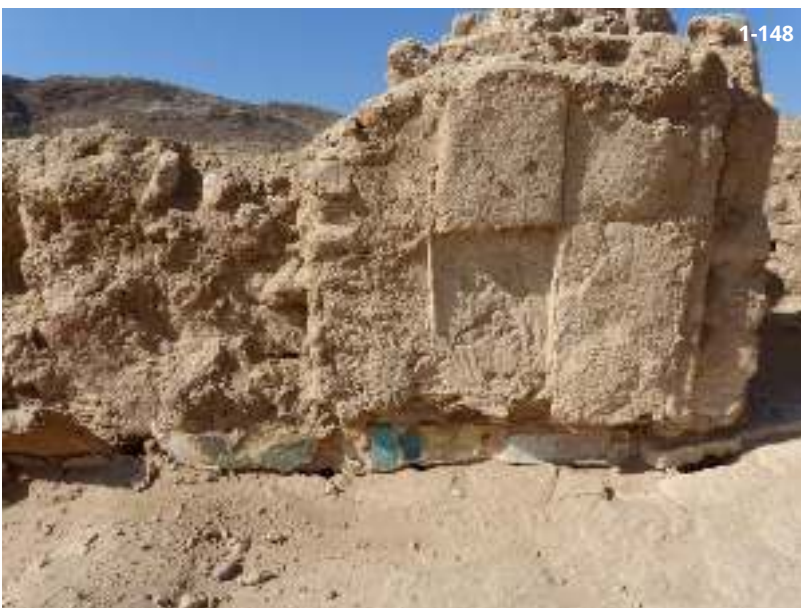
**Fig 1-148 :** the decoration of the first stage of the mihrab, including Kashan tiles, covered by the plaques of mortar of the second stage, south side

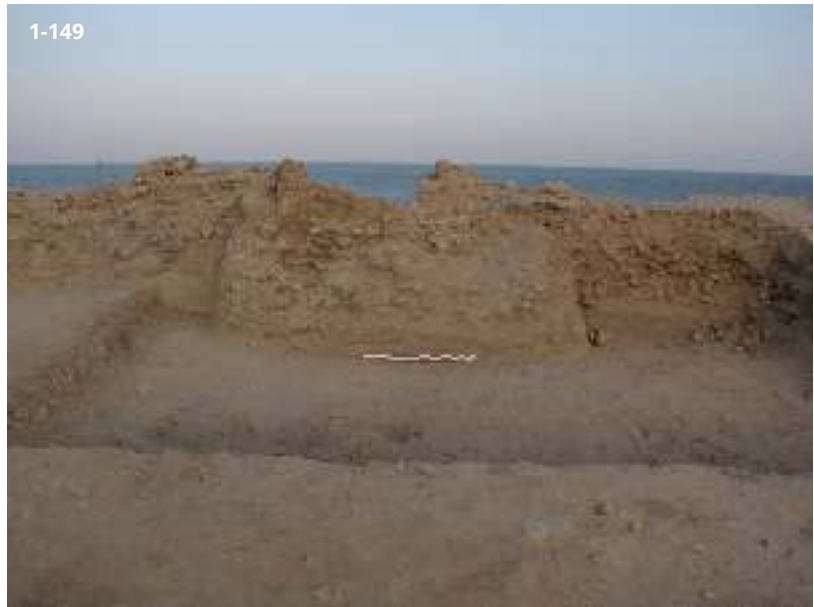
**Fig 1-149** : outside projection of the mihrab, last stage

The external projection of the *mihrab*, which is covered by a strong gray to black mortar, also belongs to the last stage of repair and the original projection may have been smaller and different in shape, but traces of it were not observed (**Fig 1-149**). The projection is rectangular in plan with roundish corners, 3.90m long and projecting from the *qibla* wall from 1.30m to the north to 0.90m to the south. The center of this projection is not aligned with the central axis of the niche of the *mihrab* inside, but it is shifted for around 0.60m to the south. In other words, the distance between the south internal face of the niche and the south external face of the projection is 0.60m longer than the distance between the north internal face of the niche and the north external of the projection. There are different possibilities to explain this little shift to the south. It could have an architectural purpose, for example to strengthen a weakness in the upper parts of the wall. It could also simply be a mistake of the builders about the exact location of the central axis. But this misalignment could also be intentional. Indeed, the south external side of the projection is 11m away from the south-west corner of the building, which is merely the same distance as the one between the north side of the projection and the junction of the *qibla* wall and the southern wall of the staircase B12-E which is built against the north-west corner of the building. So the projection was probably voluntarily extended to the south to compensate the presence of the room B12-E. If the projection would have been exactly aligned with the inside central axis of the *mihrab*, it would have looked from outside as off-centered, slightly shifted to the north. The southwards extension of the projection was probably decided to cancel this impression and let look like the *mihrab* was exactly centered.

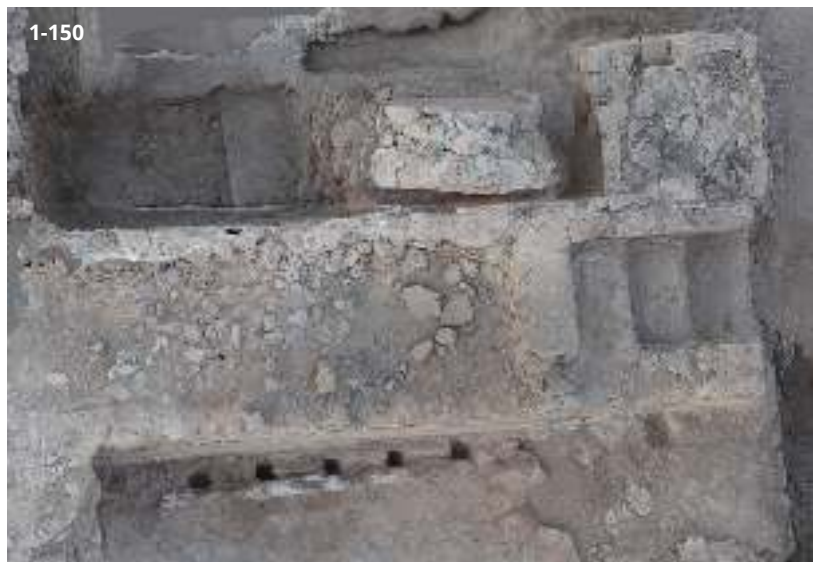
**Fig 1-150** : aerial view of the minbar B12-03 at the end of excavations

Around 1m north of the *mihrab* **B12-04** and leaning against the *qibla* wall **B12-01**, the yet visible *minbar* was already uncovered by the sounding of the QP, but the remains of a former one were found this season, and several stages of constructions of the actual one have been observed (**Fig 1-150**).

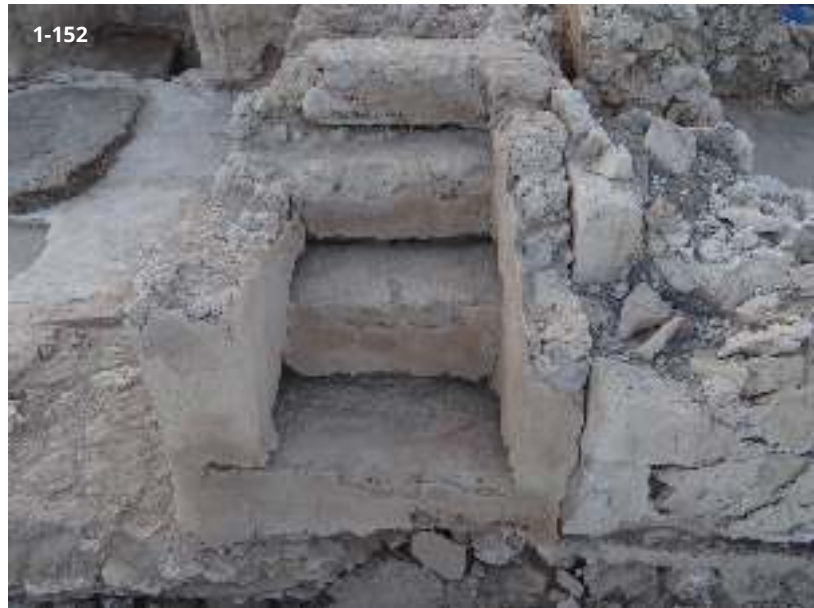
**Fig 1-152 :** *the remaining steps of the minbar B12-03, with the prints of wooden planks*

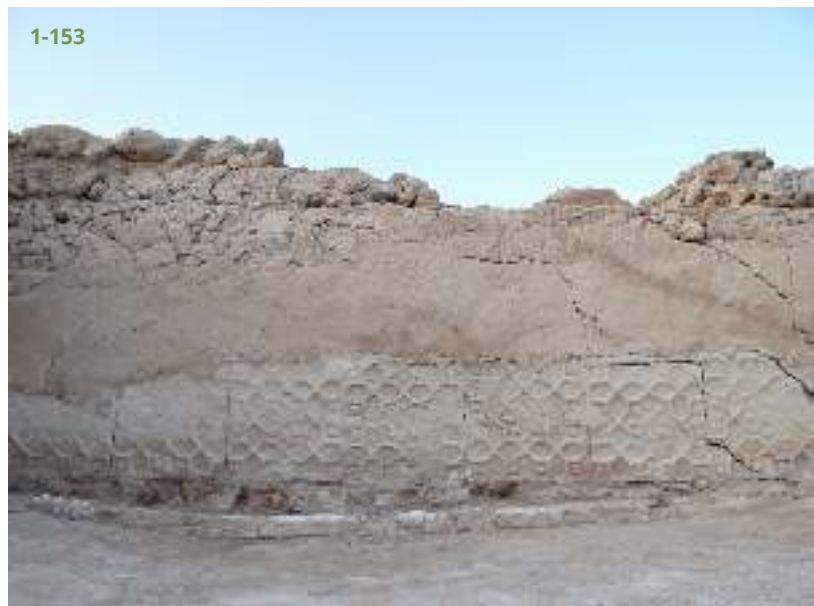
**Fig 1-153 :** *the frieze made of molded panels on the south side of the minbar B12-03*

The *minbar* is mainly made with corals bonded with a strong gray mortar and covered on all sides by a fine pinkish beige coating. The south face, on the *mihrab* side, is decorated by a frieze made of 8 panels of molded plaster, which is partially covered by the coating and does not extend until the eastern end of the *minbar* (Fig 1-153). It is also possible to distinguish, behind the groove of the third steps, a coated face with some glazed tiles. Those two elements strongly suggest that the *minbar* was originally shorter, probably as long as the preserved frieze, around 2.80m, which is also the distance between the *qibla* wall and the west face of the pillar right at north. The *minbar* was so afterward extended to the east by the addition of two more steps. This extension was built against the pillar to the north, whose south face is partially included into the masonry of the *minbar*. The yet visible coating was only applied afterward and partially covering the top of the molded panels, which were also at that time probably covered at their bottom by the raising of the last floor (see below). This last *minbar*, the one yet visible, was very simple, without decoration, and the general stratigraphy of the prayer hall suggest that it was made during the last stage of repair of the building, at the beginning of the 16<sup>th</sup> century (Fig 1-154). The assumed former masoned one underneath, which had replaced the first wooden *minbar*, appears to be more decorated, with molded panels and glazed tiles, and it is quite reasonable to consider that it was built during an important stage of repair that was observed elsewhere in the prayer hall and which seems to have occurred in the middle of the 15<sup>th</sup> century, but only the destruction of the actual *minbar* could confirm both its presence and dating.

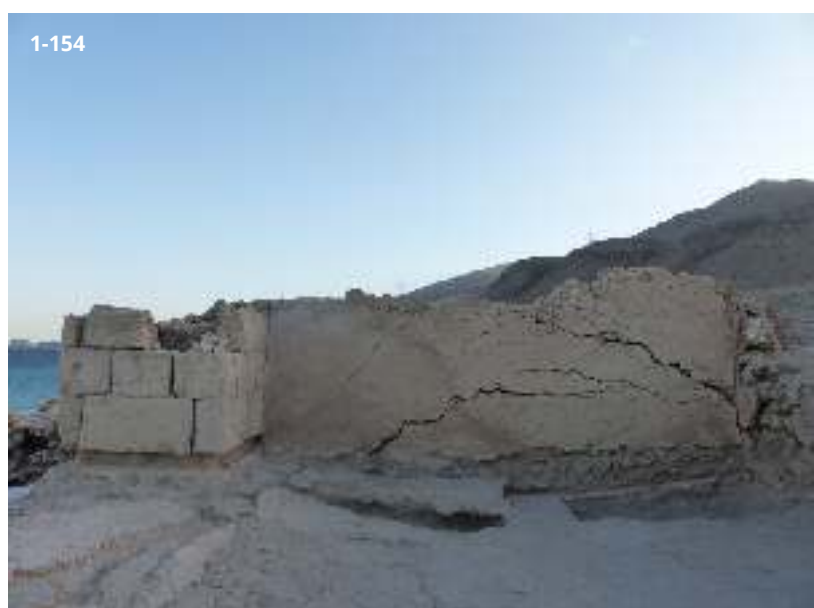
**Fig 1-154 :** *the north side of the minbar B12-03, last stage of use, without decoration*
