## Qalhât Development Project, Season 2015B-2016A, Final Report

**QALHÂT (ASH-SHARQYJAH)**

**SEASON 2015B-2016A**

**FINAL REPORT**

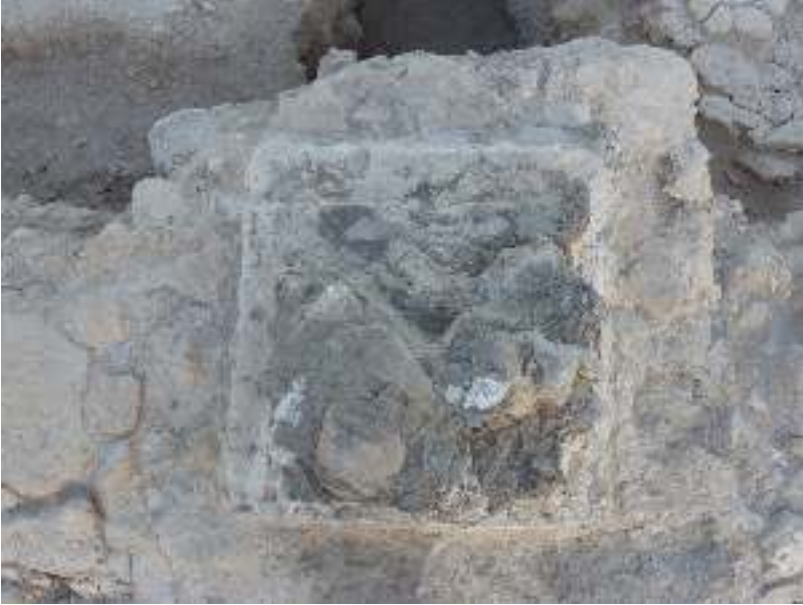
**Fig 1-155** : the internal core of the pillar B12-323 made with black mortar

The core of the preserved basis is made of medium rough corals and limestone blocks bonded with a very strong black mortar for most of them (Fig 1-155). The north, west and south facings are made with rectangular carved whitish limestone blocks, with no standard dimensions. The east facing, which is in front of the access from the forehall and facing the praying assembly, is treated differently. Only the bottom and the edges are made of carved limestone blocks, framing a mortar panel with inlaid crosses and stars glazed tiles. This decoration, very fragile, is not preserved everywhere and mainly the prints are now more or less visible.

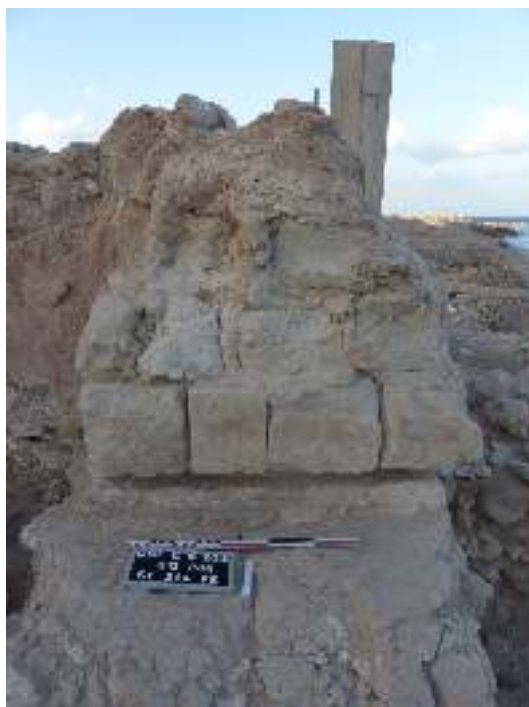
**Fig 1-157** : the northern pillar B12-324, half-engaged

The northernmost pillar (**B12-324**) is a half-pillar bonded to the wall B12-183, 0.90m long by 0.45m wide for a preserved elevation of around 0.90m (**Fig 1-157**). On the east facing, a whitish coating was observed, which extends northwards some centimeters beyond the assumed alignment of the south facing of the wall B12-183, suggesting that an opening or a niche was in existence immediately to the east of the pillars (**Fig 1-158**). It was probably associated with the masonry B12-414/IsoArc925, already described above. As already mentioned, it is impossible to firmly determine whether this fitting was a niche, a window or a gate. However, as elevated constructions might have stood in the north wing, on the other side of the wall, a window is unlikely. A gate could be a little more likely, giving access from the north wing, but as another access exists shortly to the west (B12-189) this hypothesis is not totally convenient. The proximity of the north main gate of the prayer hall could be an argument to identify this fitting as a niche, where holy books used for the prayer might have been stored.

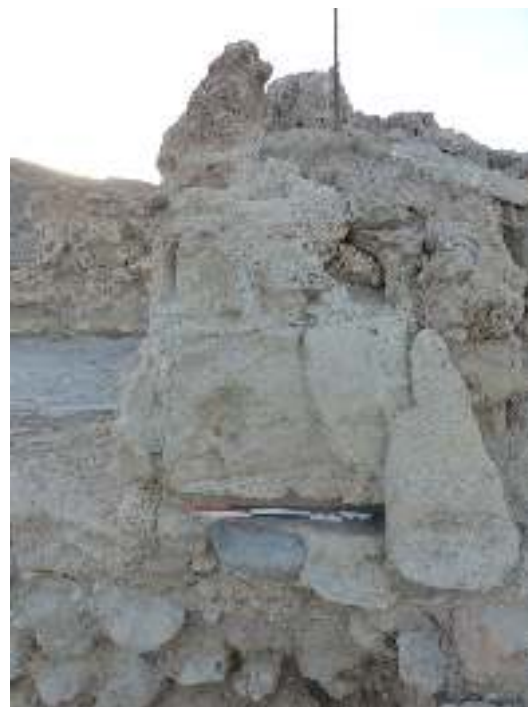
**Fig 1-158** : the exceeding with the coating on the east side of the pillar B12-324, at right of the scale

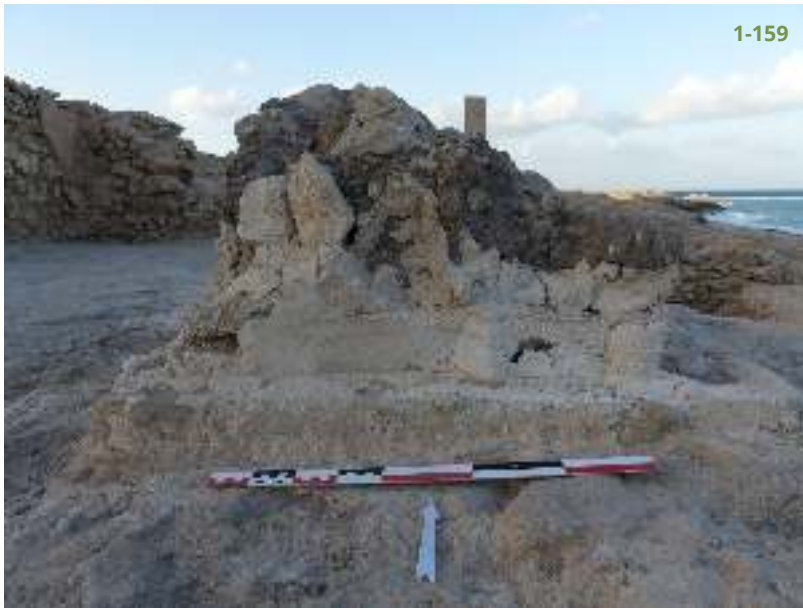
**Fig 1-159 :** the pillar B12-323, highly damaged

A little less than 4m to the south, the pillar **B12-323** is the less-preserved of all pillars of the row, most of its facing having collapsed around (**Fig 1-159**). The basis and the groove are preserved, 0.90m long and wide, but only the core of the pillar is preserved, for around 0.50m high. The third pillar, **B12-05**, was already uncovered by the sounding of the QP and it is one of the best preserved (**Fig 1-160**). As mentioned above, the eastern extension of the *minbar* was built against the south facing of the pillar which was so not visible, while its other facings are made with carved rectangular limestone blocks. Its width, length and preserved elevation are 0.90m. Around 4.10m further south, the fourth pillar **B12-232** is also well-preserved (**Fig 1-161**), especially on its east facing where the remains of decoration are the best visible. It is also 0.90m wide and long and preserved for around 0.70m high. Three nails (IsoMet27, 28 and 29) were found on the corners of the groove and they were obviously used to fix the wooden sticks together. As no nail was found elsewhere, it is possible that this setting only occurred in this basis of pillars and that, on the other ones, the fixing was made by using wooden nails. Finally, the last preserved pillar (**B12-44**), 4m south of the aforementioned one, was also partially uncovered by the QP soundings (**Fig 1-162**). It is quite similar to the other pillars, 0.90m wide and long for a preserved elevation around 0.80m, except that its east facing, probably decorated, has disappeared and that prints of tenons and dowels in the mortar in the groove might suggest that the assemblage of wooden sticks was probably made here with wooden elements rather than iron nails.

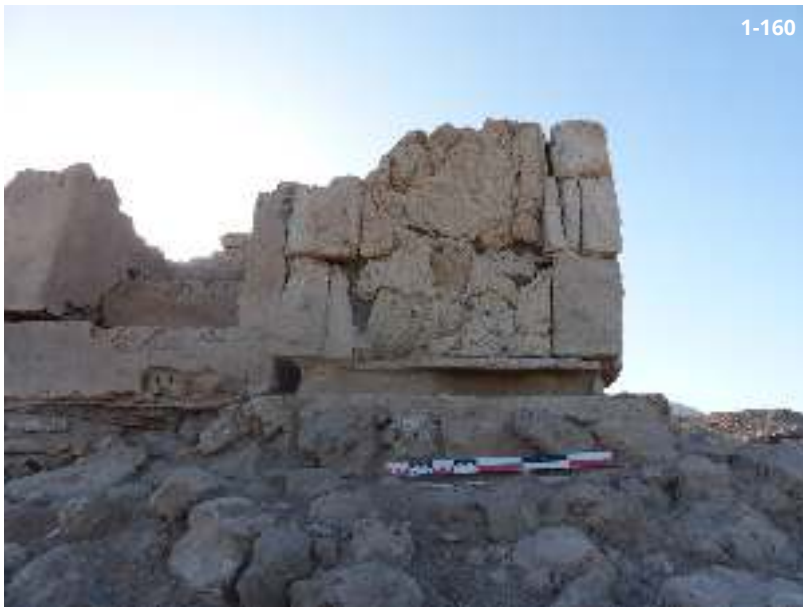
**Fig 1-160 :** the pillar B12-05, with the minbar at left

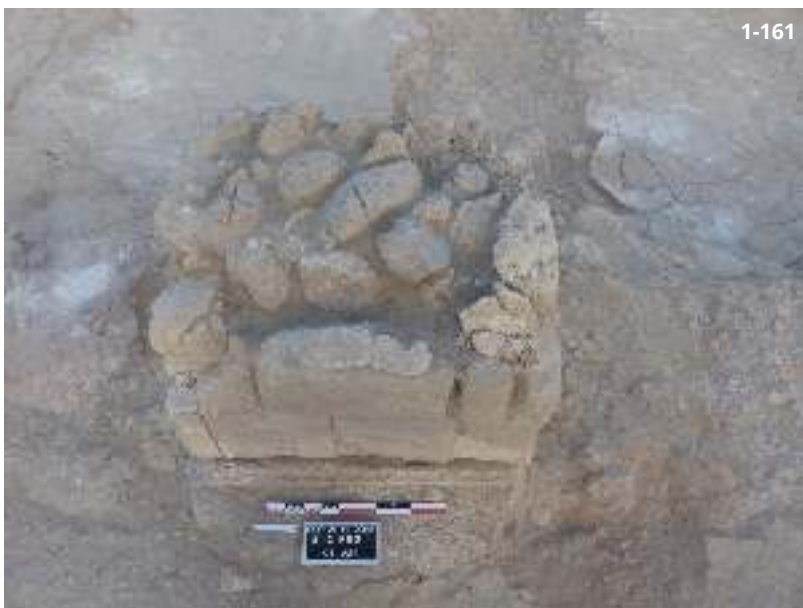
**Fig 1-161 :** the pillar B12-232

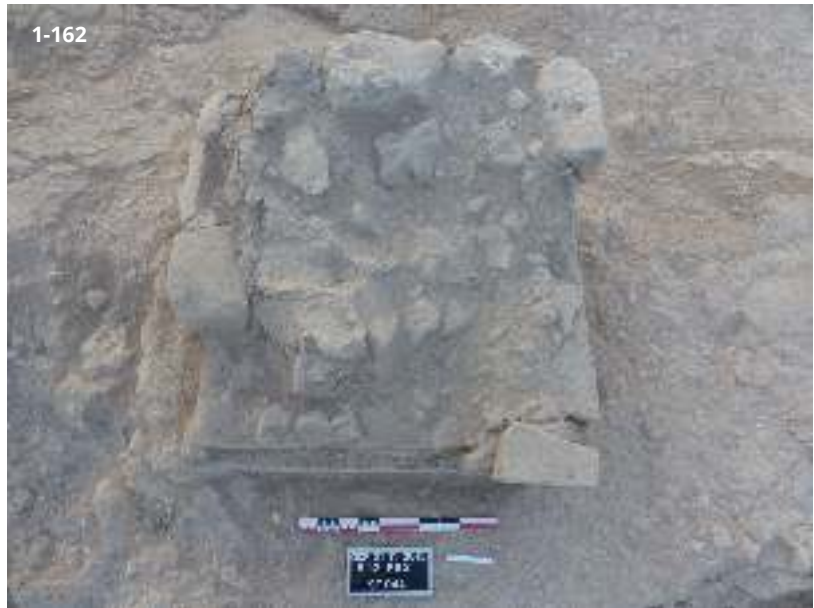
**Fig 1-162** : the pillar B12-44

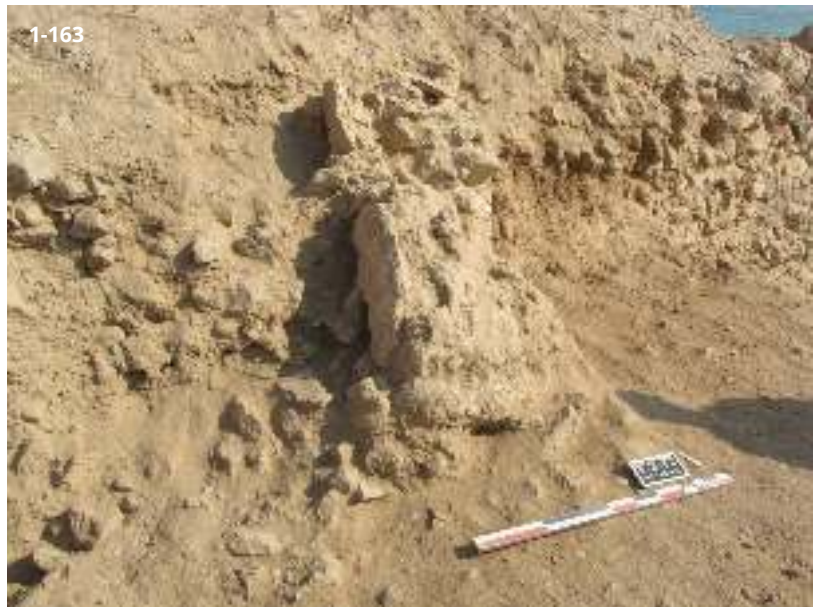
**Fig 1-163** : the architectural element IsoArc808 found in the south street, probable element of the southern half engaged pillar

To the south, the half-pillar that was bonded to the wall B12-41 was not preserved as the elevation above the floor level had fallen into the south street. A rectangular masonry found in this area (**Fig 1-163**), in the north-south axis of the row of pillars, probably came from it, but more likely from the upper part of the pillar and not from its basis, as the element was found covered with coating, which was not observed on any of the basis of the remaining pillars.

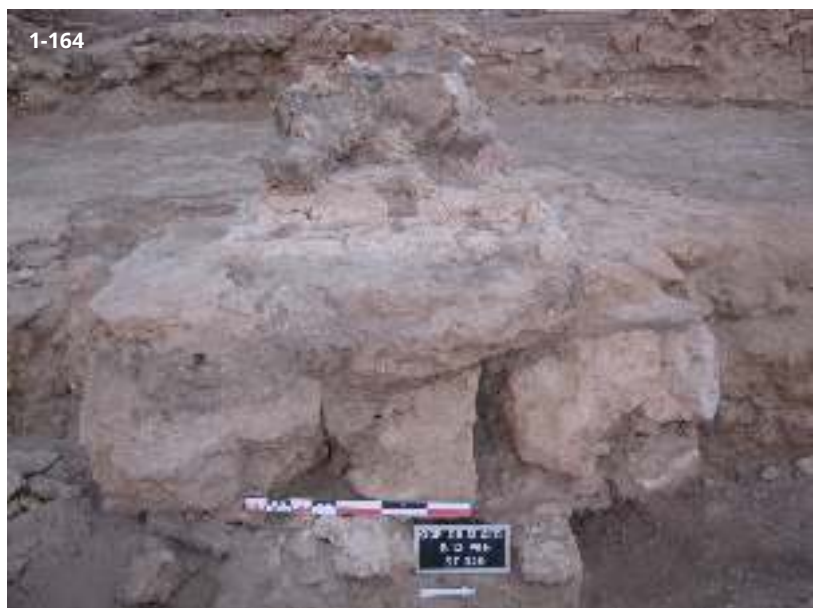
**Fig 1-164** : the reinforcement B12-329 under the pillar B12-323

Under all pillars, except the northern engaged one, a rough and quickly made reinforcement was observed, more or less circular in plan around the basis of pillars, and built over the wall B12-45 and the buttresses observed under most of the pillars. It is under the pillar B12-323 that this reinforcement (**B12-329**) was the best observed (**Fig 1-164**). The masonry, which is irregular, is mainly made with plaques of masoned floors and fragments of walls bounded with a strong gray mortar containing many small pebbles and fragments of ceramics. It is very likely that this reinforcement was made by cutting the masoned floors, digging a more or less circular pit around the basis of the pillar. It was afterward filled with this coarse masonry which was probably encompassing the underneath buttress B12-392 whose upper end was probably partially destroyed to allow a better fixing between it and the reinforcement. It is also possible that the above pillar was repaired at the same time. To the south, a similar reinforcement (**B12-417**), made in the same way, was also observed under the pillar B12-05, but mainly in plan as no major sounding was opened around it. The reinforcement **B12-356**, under the pillar B12-232, was better studied (**Fig 1-165**): in plan where the masoned floors were destroyed, and partially in elevation with a small sounding at its foot. It is made with large corals and rough limestone blocks, bounded with a compact gray mortar, and the fittings presented no facing, suggesting that the stones were put loose in a foundation pit. Finally, the reinforcement **B12-399**, under the pillar B12-44, was also mainly observed in plan and very partially in elevation. It is also a rough masonry made with all sizes corals and limestone blocks, bounded with a gray to black mortar.

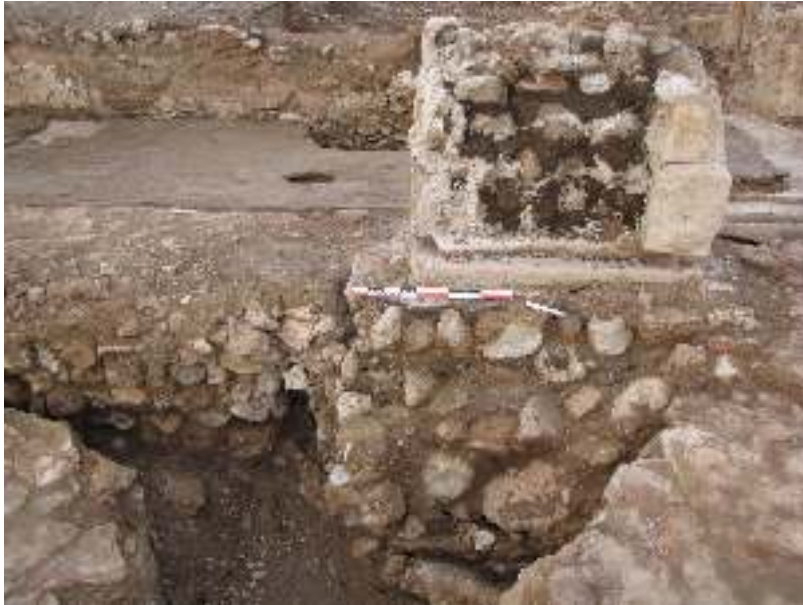
**Fig 1-165 :** the reinforcement B12-356 under the pillar B12-232

It is very unlikely that those reinforcements were made at the foundation of the Mosque, as the general construction is rather well-made, which is not the case of those masonry. It is more likely an underpinning, which was probably made to create a wider and more stable foundation for the high pillars above, to prevent a sliding or topple, which might have already started when the reinforcements were made. It is possible that the Mosque had known a weakness of construction, maybe because of the weight of the elevation that was greater than expected at the beginning, and that the pillars had started to move from their original axis. The reinforcements would have prevented the ongoing of this movement. But it is also possible that this stage of repair followed a damage due to a natural event, such as an earthquake, which could have destroyed some parts of the pillars, which then needed a strengthening for being efficiently repaired. It is yet impossible to state between this two hypotheses, neither to determinate if the above pillars were also repaired or rebuilt at that time, and on what scale if they did.

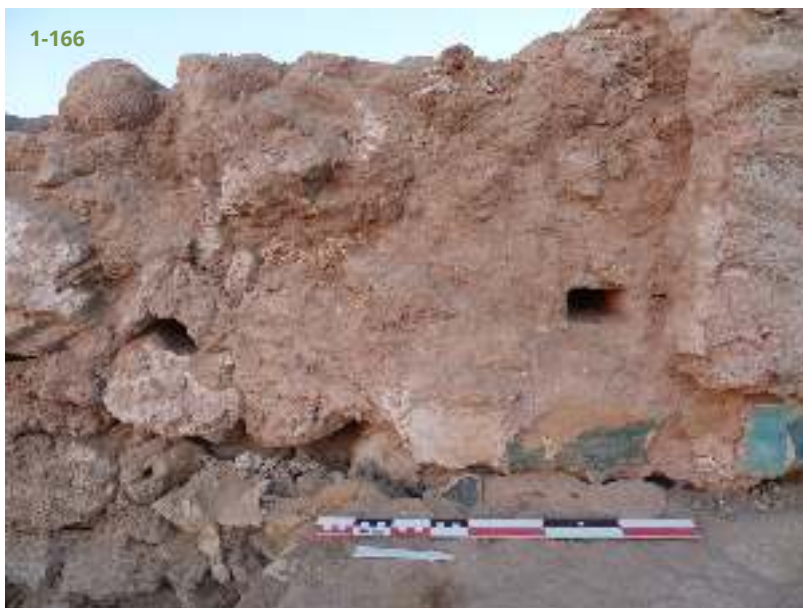
1-166

**Fig 1-166** : the two small beamholes B12-384 and B12-385, suggesting the presence of a half engaged pillar against the qibla wall

On the *qibla* wall B12/01, around 1m south of the south corner of the *mihrab*, two small rectangular holes (**B12-384** and **B12-385**) were observed. 0.60m apart, they are both 0.08 m long and 0.06 m high, and the northern one (B12-384) runs for 0.45m deep inside the wall, while the southern one (B12-385) goes for around 0.30m now, but originally for more than 0.40m when the original facing was in existence (**Fig 1-166**). Both at same altitude, they are built about 0.40m high over the original floor level. They are too small and too low to consider that they were used as holes for scaffolding and they must be part of an architectural fitting. As they are in the same general alignment than the pillar B12-232 to the east, and as the plaques of mortar which make the decoration of the late *mihrab* end vertically very close to them, the better explanation for these holes would be that they were used to strengthen the link between the *qibla* wall and a vanished engaged pillar, probably rectangular, supporting an east-west arcade between it and the eastern pillar B12-232.

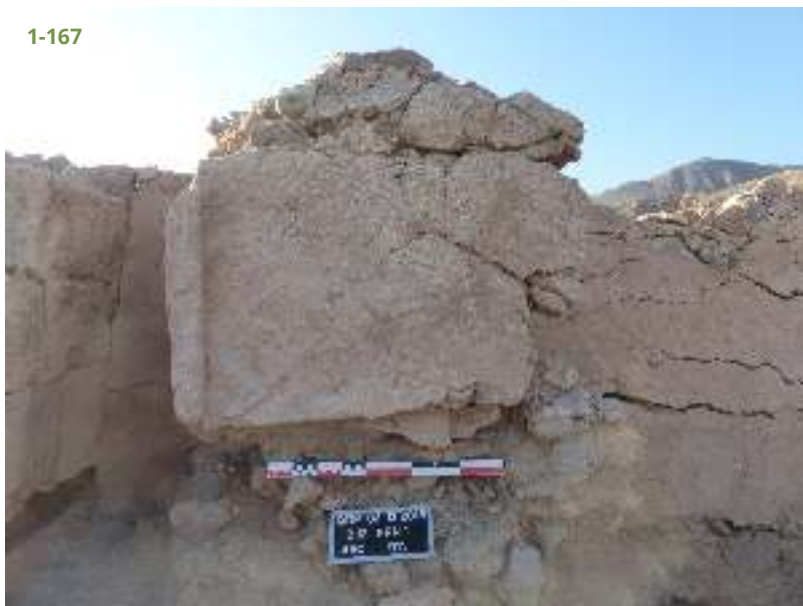
1-167

**Fig 1-167** : the architectural element IsoArc 911, remains of the upper part of an arch, against the north side of the minbar

An architectural element (**IsoArc911**), undoubtedly coming from the upper part of an arch and found against the north face of the *minbar* B12-03, in the alignment of the pillar B12-05, also suggests that an arcade once existed to the north (**Fig 1-167**). Though the proofs are very scarce, it is reasonable to assume that an east-west arcade once existed in the middle of the prayer hall, framing the *minbar* and *mihrab*, aligned with the pillar B12-05 to the north and the pillar B12-232 to the south, until the separating wall between the prayer hall and the forehall, where a door must have stood. This central nave had an architectural purpose by strengthening the four pillars that supported the central cupola, and also be part of the internal fitting by creating a decorated way between the main gate from the forehall and the *mihrab*, the focal point of the Mosque. This configuration meets some echoes with the description made by Bras de

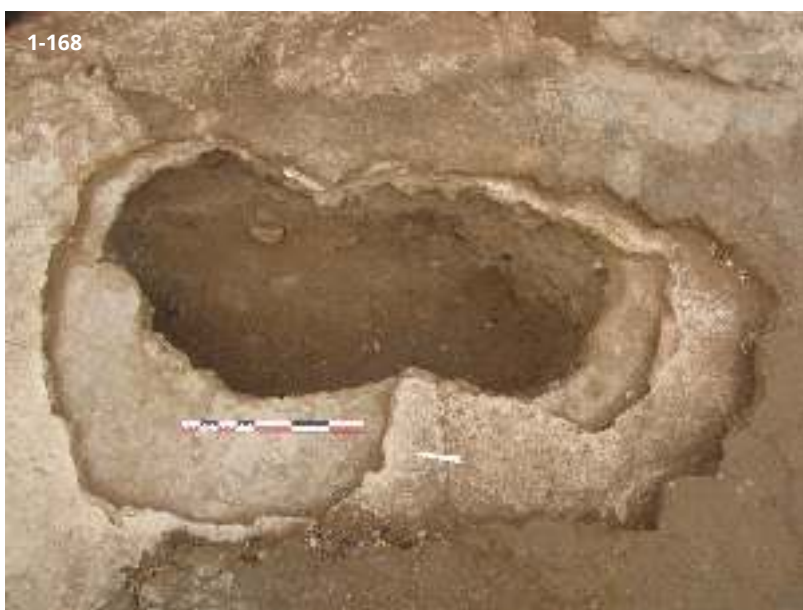
1-168

**Fig 1-168** : the floor support B12-298 (under the scale) visible in the pit B12-296

Built over the wooden beam-frame and the backfills of the basement, a floor support (B12-298) (Fig 1-168) is quite probably dated to the foundation of the Mosque, contemporary with the first stage of the *mihrab* (B12-386) and the original wooden *minbar* (B12-375). If this masonry once extended evenly over the spans 5 and 6, and also over the spans 3 and 4, it is now variously preserved. It is still preserved over the span 6, except to the south where it has fallen into the south street, but it is fragmentary over the span 5, and especially to the north where it has entirely disappeared. The floor support was made by spreading a strong beige mortar over a level of backfill made of ceramics and small pebbles, which covers the underneath earth backfill of the basement. This slab of mortar was afterward covered with a layer of small flat corals, bonded to the underneath mortar, and covered in turn with a third layer made of really strong gray mortar, which is nearly concrete.

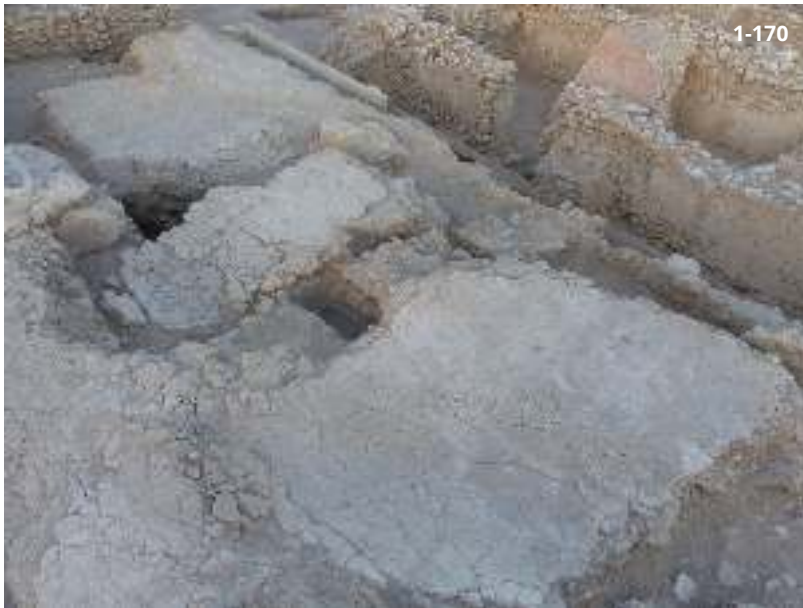
**Fig 1-170 :** *subsidiencies of the floors of the prayer hall, in north part*

This first floor B12-297 and the floor support B12-298 suffered a subsidence, probably due to the slight drop of the underneath backfill, which was more important to the east than to the west (Fig 1-170). In span 6, the subsidence is around 0.10m deep and, even if some cracks are visible, the floor is still more or less in good state. In span 5, the floor is far more cracked and the subsidence can reach 0.30m, the subsidence effects being well visible against the walls of the basement. Explanations for this difference of subsidence effects can be the quality of the backfill, which could have been rammed to the west and/or more airy to the east, or that some part of the backfill under the span 5 slowly infiltrated through the separating wall with the easterly corridor B12-B. In any way, the first floor was too damaged and irregular over span 5 to be properly used and a second masoned floor was made.

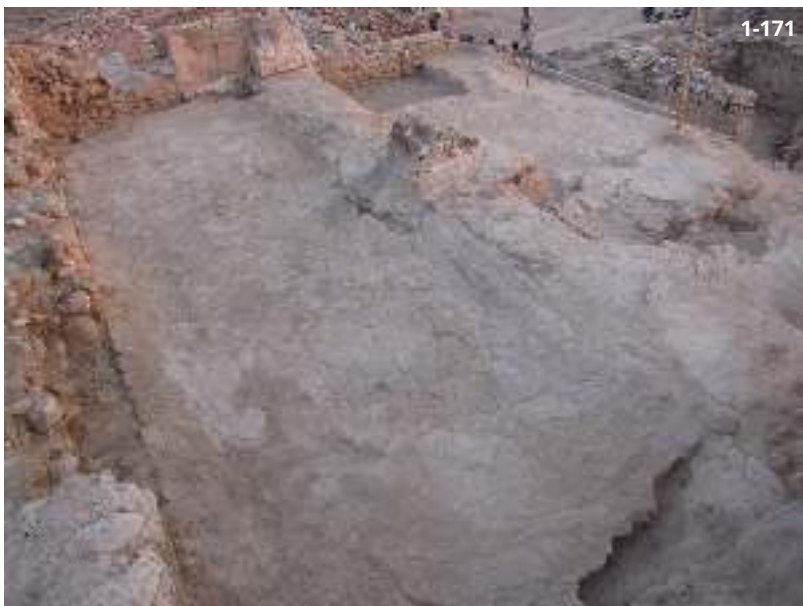
**Fig 1-171 :** *general view of the floor B12-294, in north part*

This second floor (B12-294), even if cracked, is still present over the main part of the span 6, covering most of the former floor and floor support, but preserved to the east, over span 5, only at the south extremity (Fig 1-171). The rest of it has disappeared, washed away by erosion or fallen into the basement in corridor B12. This second floor B12-294 is separated from the first floor B12-297 by a thin layer of small pebbles (Uf3839) leveling the subsidence of the lowest floor, inside which the material was too scarce to allow a dating. It is made by a rough gray mortar containing many small pebbles and its thickness varies from 0.03m to 0.11m, following the more or less importance of the subsidence of the underneath floor. As it is leaning against the north face of the first masoned *minbar*, it is very likely that this floor was put in place at the same time, in the course of the 14<sup>th</sup> century.

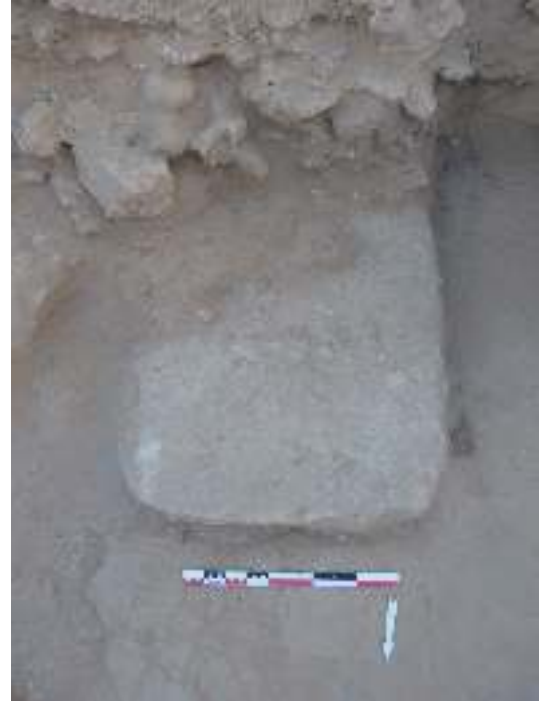
**Fig 1-174** : the late floor B12-293, made of plaster, in the south part (the shape is due to the excavations)

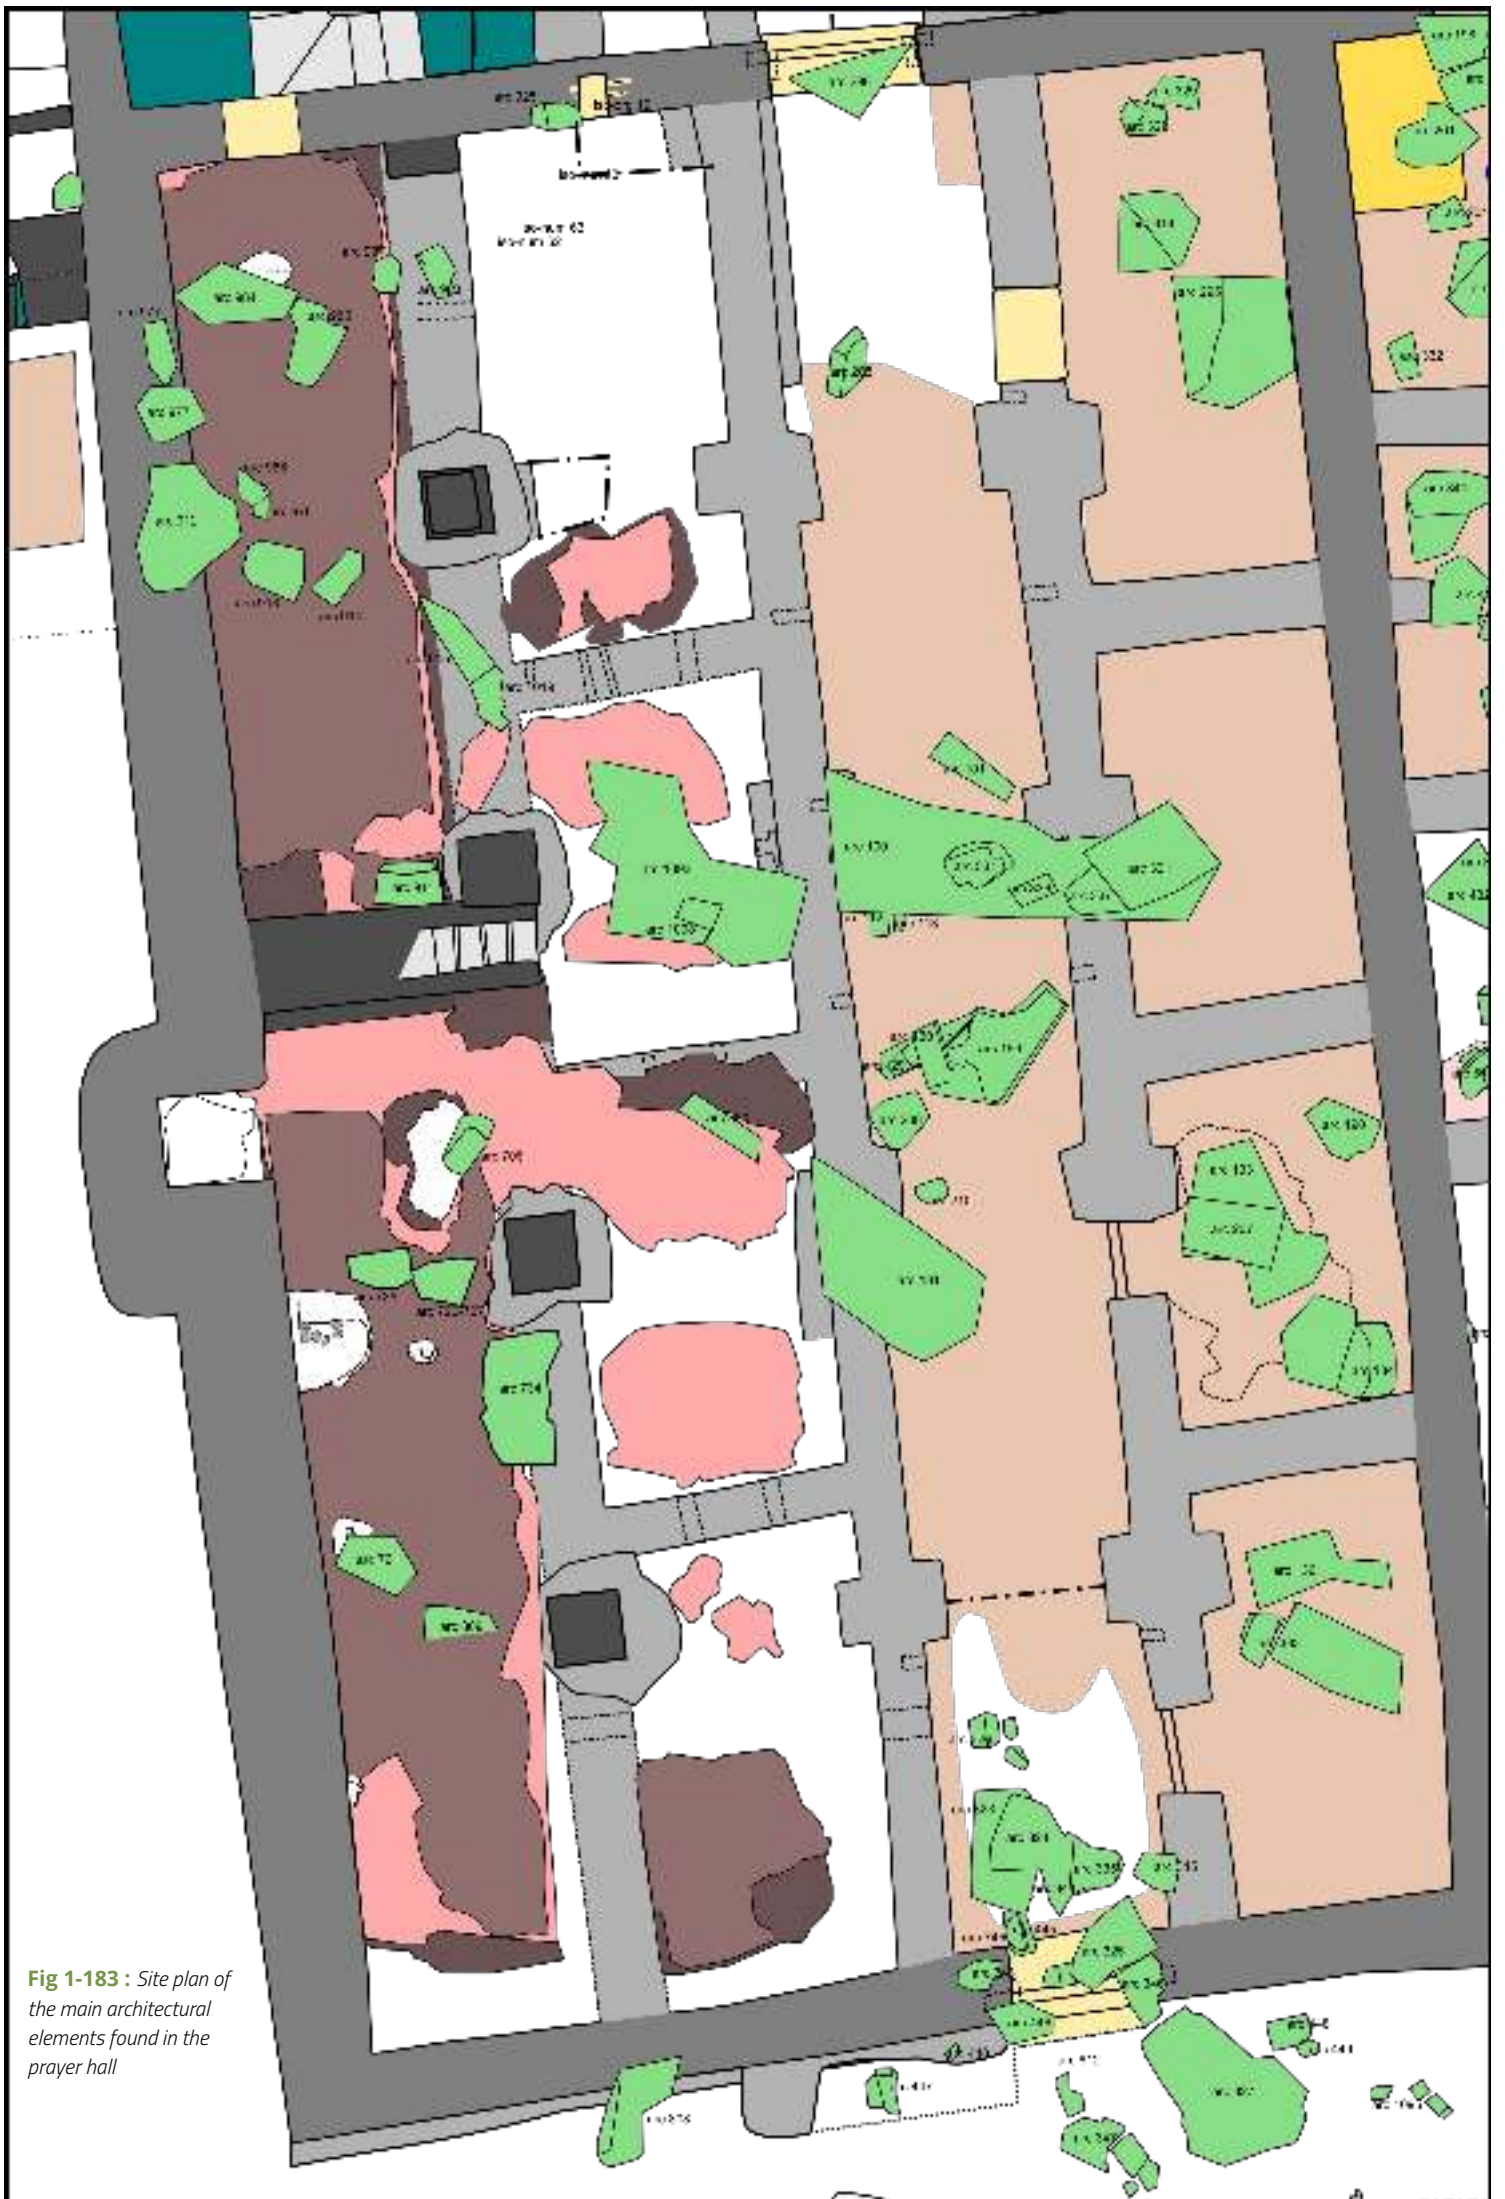
**Fig 1-183 :** Site plan of the main architectural elements found in the prayer hall

**Fig 1-183**

Many collapsed architectural elements were found in the prayer hall. Most of them were small isolated ones, such as square or rectangular carved stones or quaterfoils coming from the pillars or the arches, but many were enough preserved to allow guessing their original shape and provenance and to bring new information about the pattern of the prayer hall. Many remains of decoration were also uncovered, mainly isolated glazed tiles but also some fragments of ornamented panels still attached to the underneath masonry.

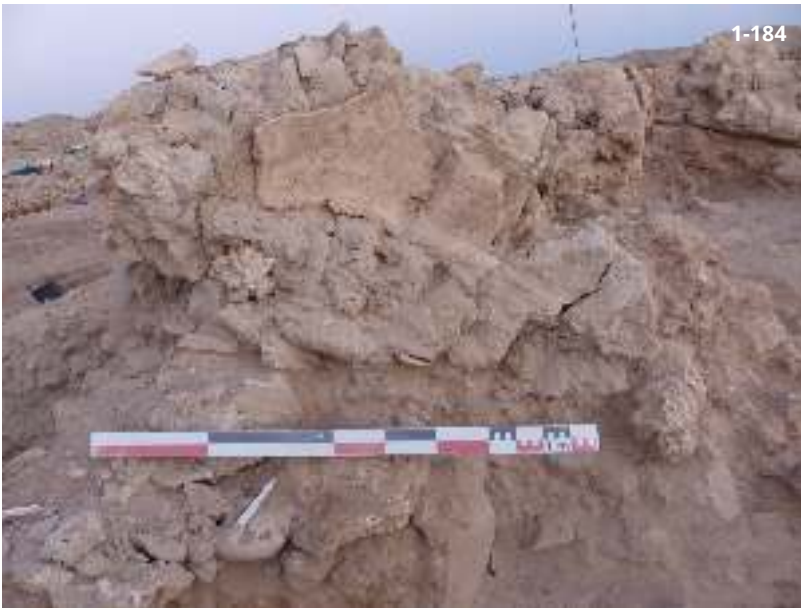
**Fig 1-184 :** the architectural element IsoArc912, remains of a niche

Found near or on the *qibla* wall, nearly halfway between the north-west internal corner and the north side of the *mihrab*, the **IsoArc912** and **IsoArc977** are remains of a niche (**Fig 1-184**). The first one, already seen by the QP, was showing one side, the rear face and the upper vault of the niche, with a small neck visible at the junction of the vault and the side face. The core of the masonry was made of medium corals and limestone blocks bonded with a beige mortar, and two stages of coating, one pinkish and the second whither, suggest that the niche was extended and refitted at one time. As the architectural element has slid down, the niche was most probably located very closed to where its remains were found. Shortly to the north, the second element also presented a curved side covered with pinkish coating and is probably also part of a niche. It is quite difficult however to state if this element came from the same niche as the first one, or from a second niche set north of the first one.

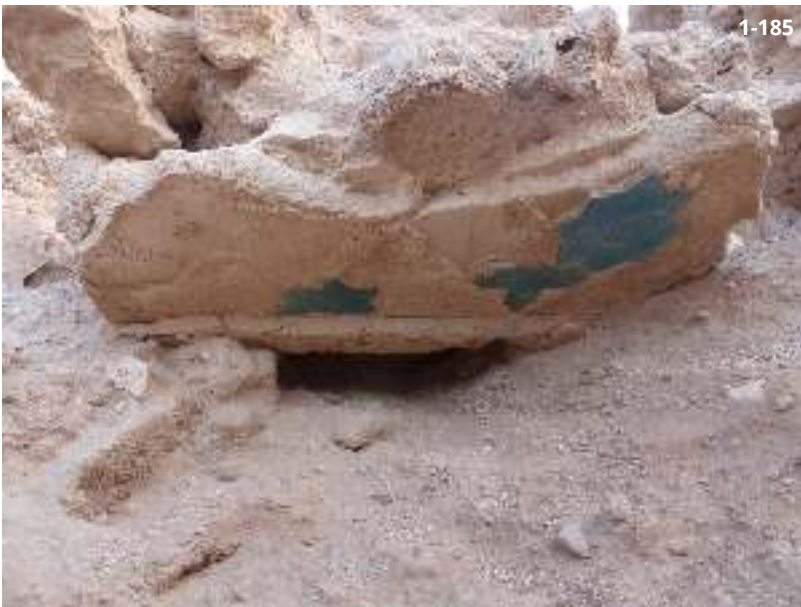
**Fig 1-185 :** the architectural element IsoArc913, in situ

Uncovered in the middle of the northern part of the span 6, the two architectural elements **IsoArc913** and **IsoArc914** present the same features, dimensions and decoration, and undoubtedly come from the same location (**Fig 1-185** and **Fig 1-186**). They both come from a rectangular engaged pillar with a decoration made of glazed tiles in the shape of crosses and stars, bonded with a beige mortar coating, while the fragment of the *qibla* wall attached to it is covered with a whither coating. On the **IsoArc914**, a small curve suggests the start of the intrados of the arch, and therefore that this element was originally located high on the *qibla* wall. As they were found nearly halfway between the *minbar* and the north wall near the pillar B12-323, they may have toppled from an important height and so felt at a certain distance from their original location. They so could have originally stood southerly, near the *minbar*, and have received the arch of the assumed central nave in front of the pillar B12-05. Already uncovered by the QP against the north side of the *minbar* and near the pillar B12-05, the **IsoArc911**, which was identified as a fragment of the upper part of an arch, could have been part of that central nave.

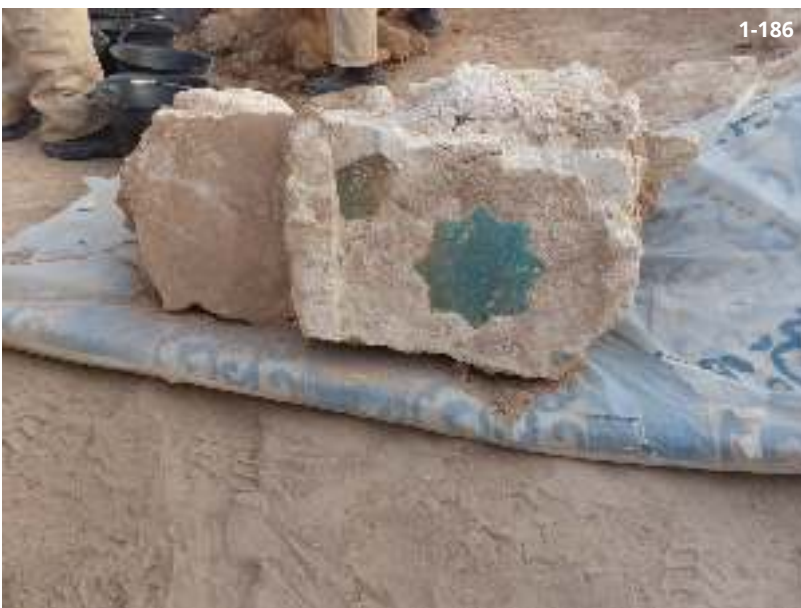
**Fig 1-186 :** the architectural element IsoArc914, after removal

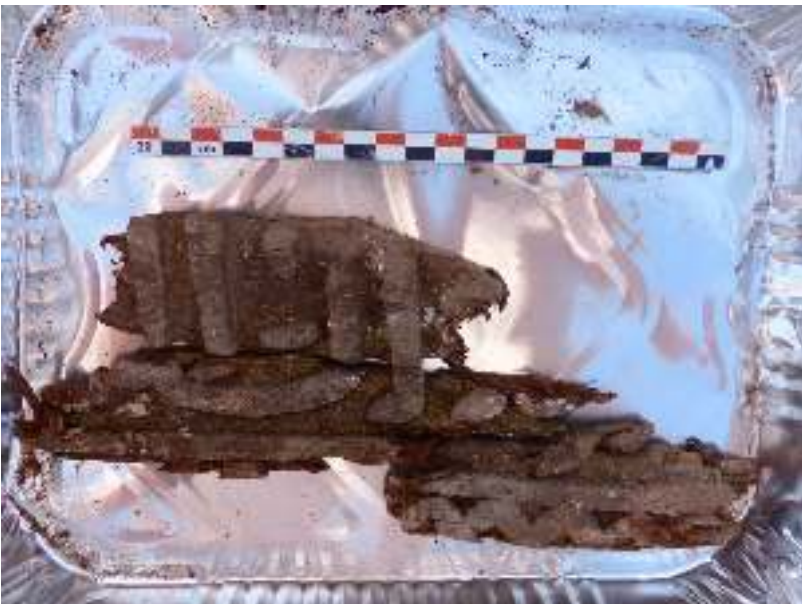
**Fig 1-196 :** fragment of carved and golden painted wood

Twelve pillars, and six engaged half-pillars to the north and south, supported three north-south lines of arcades and two east-west lines in the middle of the prayer hall, demarcating a central nave in front of the *mihrab*. The pillars of the central nave and the ones to the north and south were differently decorated and the same difference may have occurred in the upper part of the vaulting. The roof was supported by the arcades and by east-west beams linking the pillars and, according to the description by Bras de Albuquerque and the testimony of a single small fragment of wood decorated with carving and golden paint (Fig 1-196), these beams may have been carved and highly decorated.

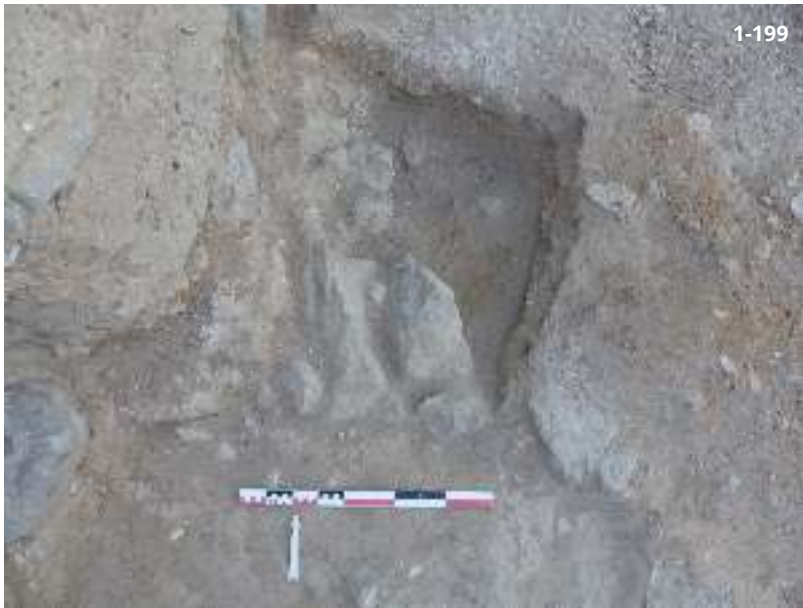
**Fig 1-199** : the scarce remains of the wall B12-479, under the retaining wall of the high courtyard

The southern wall, B12-479 (**Fig 1-199**), 0.60m wide and observed for 0.75m long, is made of large and medium limestone blocks and was probably associated to the easterly wall B12-75 with which it is aligned in the north side, both being on each side of the access to the corridor B12-B. The wall B12-75 (**Fig 1-200**), made of large and medium limestone blocks, was found under the structure B12-192 which was built above and extends westerly for an unknown distance as it is covered by later floors which were left in place. Though the connection between the two structures was not observed, it is very likely that it is the same wall, as the two parts are built in the same way and are apparently aligned. This wall could have been used as a step to compensate the difference of altitude, at least 0.50m and probably more, between the earlier floors of the low courtyard and the threshold of the room B12-B, and also to receive the south abutment of the arch.

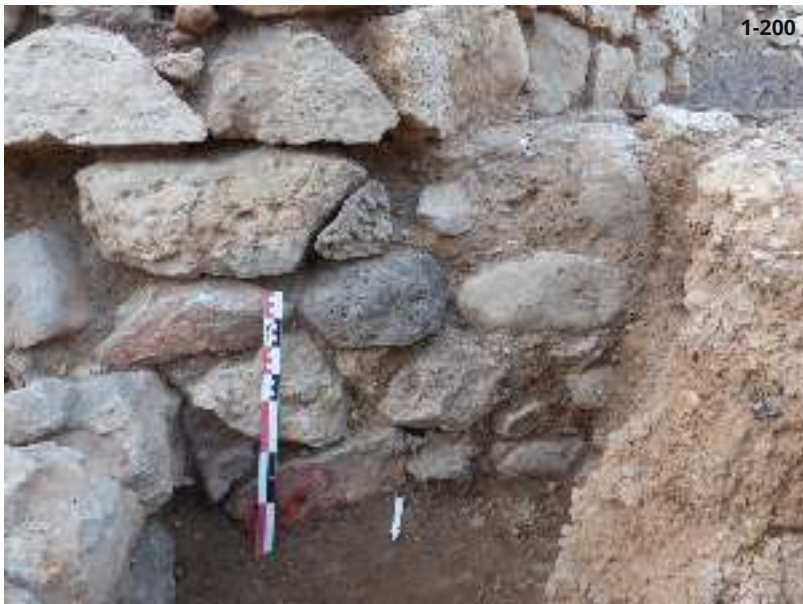
**Fig 1-200** : the wall B12-75 (behind the scale) under the staircase in area B12-N

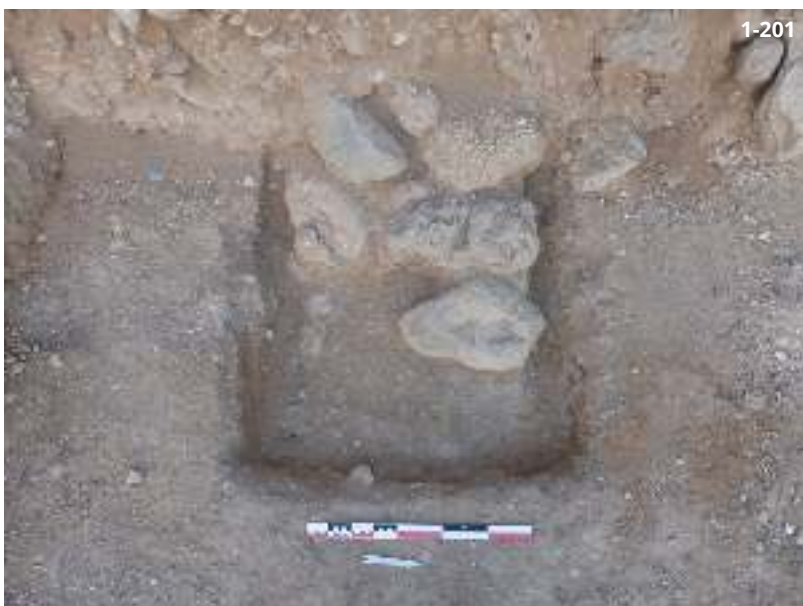
**Fig 1-201** : the scarce remains of the wall B12-477, under the retaining wall of the high courtyard

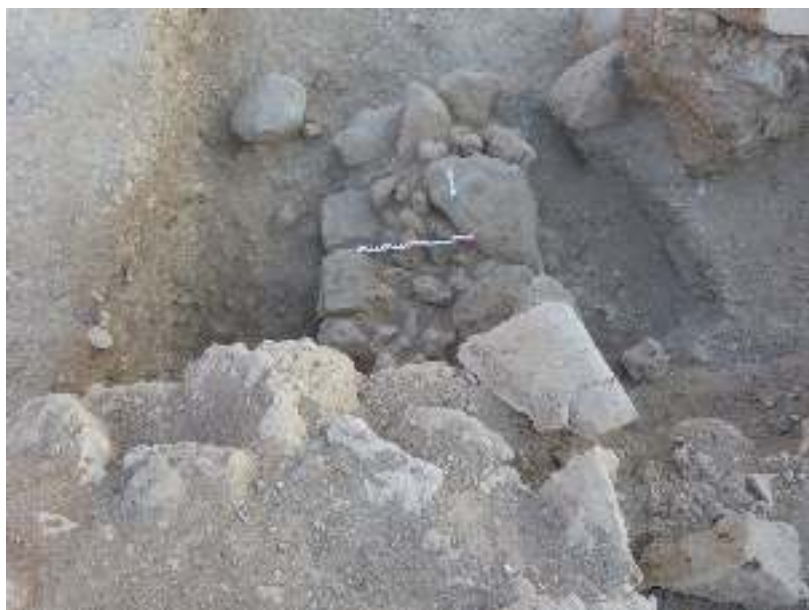
**Fig 1-202** : the remains of the wall B12-74, with the staircase in area B12-N in the foreground

Two other walls, covered by the late circulation floor, might also be part of the foundations of the terrace. Perpendicular to the wall B12-75 and apparently quoined with it, the wall B12-74 (**Fig 1-202**), about 1m wide and 0.40m high for a preserved length around 1.70m, is made of massive pebbles and limestone blocks, and could have been partially recovered at north. It could have been linking the missing parts of the walls B12-477 and B12-479, and be used to strengthen the foundations of the vaulted terrace.

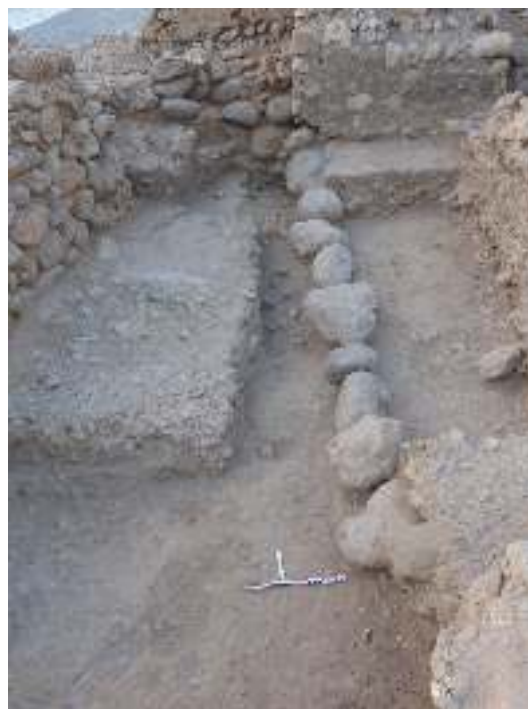
**Fig 1-203** : the remains of the wall B12-407, with a possible recovery trench at left and the north-east corner of the Mosque in the background

Set at the north-east corner of the Mosque and partially running under it, or at least under of thickening or a repair of the north wall of the building, the wall B12-407 (**Fig 1-203**) could have had the same use of strengthening the foundations. Made of massive pebbles and limestone blocks with no binder preserved, it is now 4m long by 0.50m wide but it appears that its eastern half was recovered to be reused. The fact that this wall is ending at north more or less in the same alignment that the north side of the wall B12-477 is in favor of this hypothesis. In this configuration, it is possible that the terrace was ending, at east, plumb with the line of the wall B12-407.
