## Qalhât Development Project, Season 2015B-2016A, Final Report

**QALHÂT (ASH-SHARQYJAH)**

**SEASON 2015B-2016A**

**FINAL REPORT**

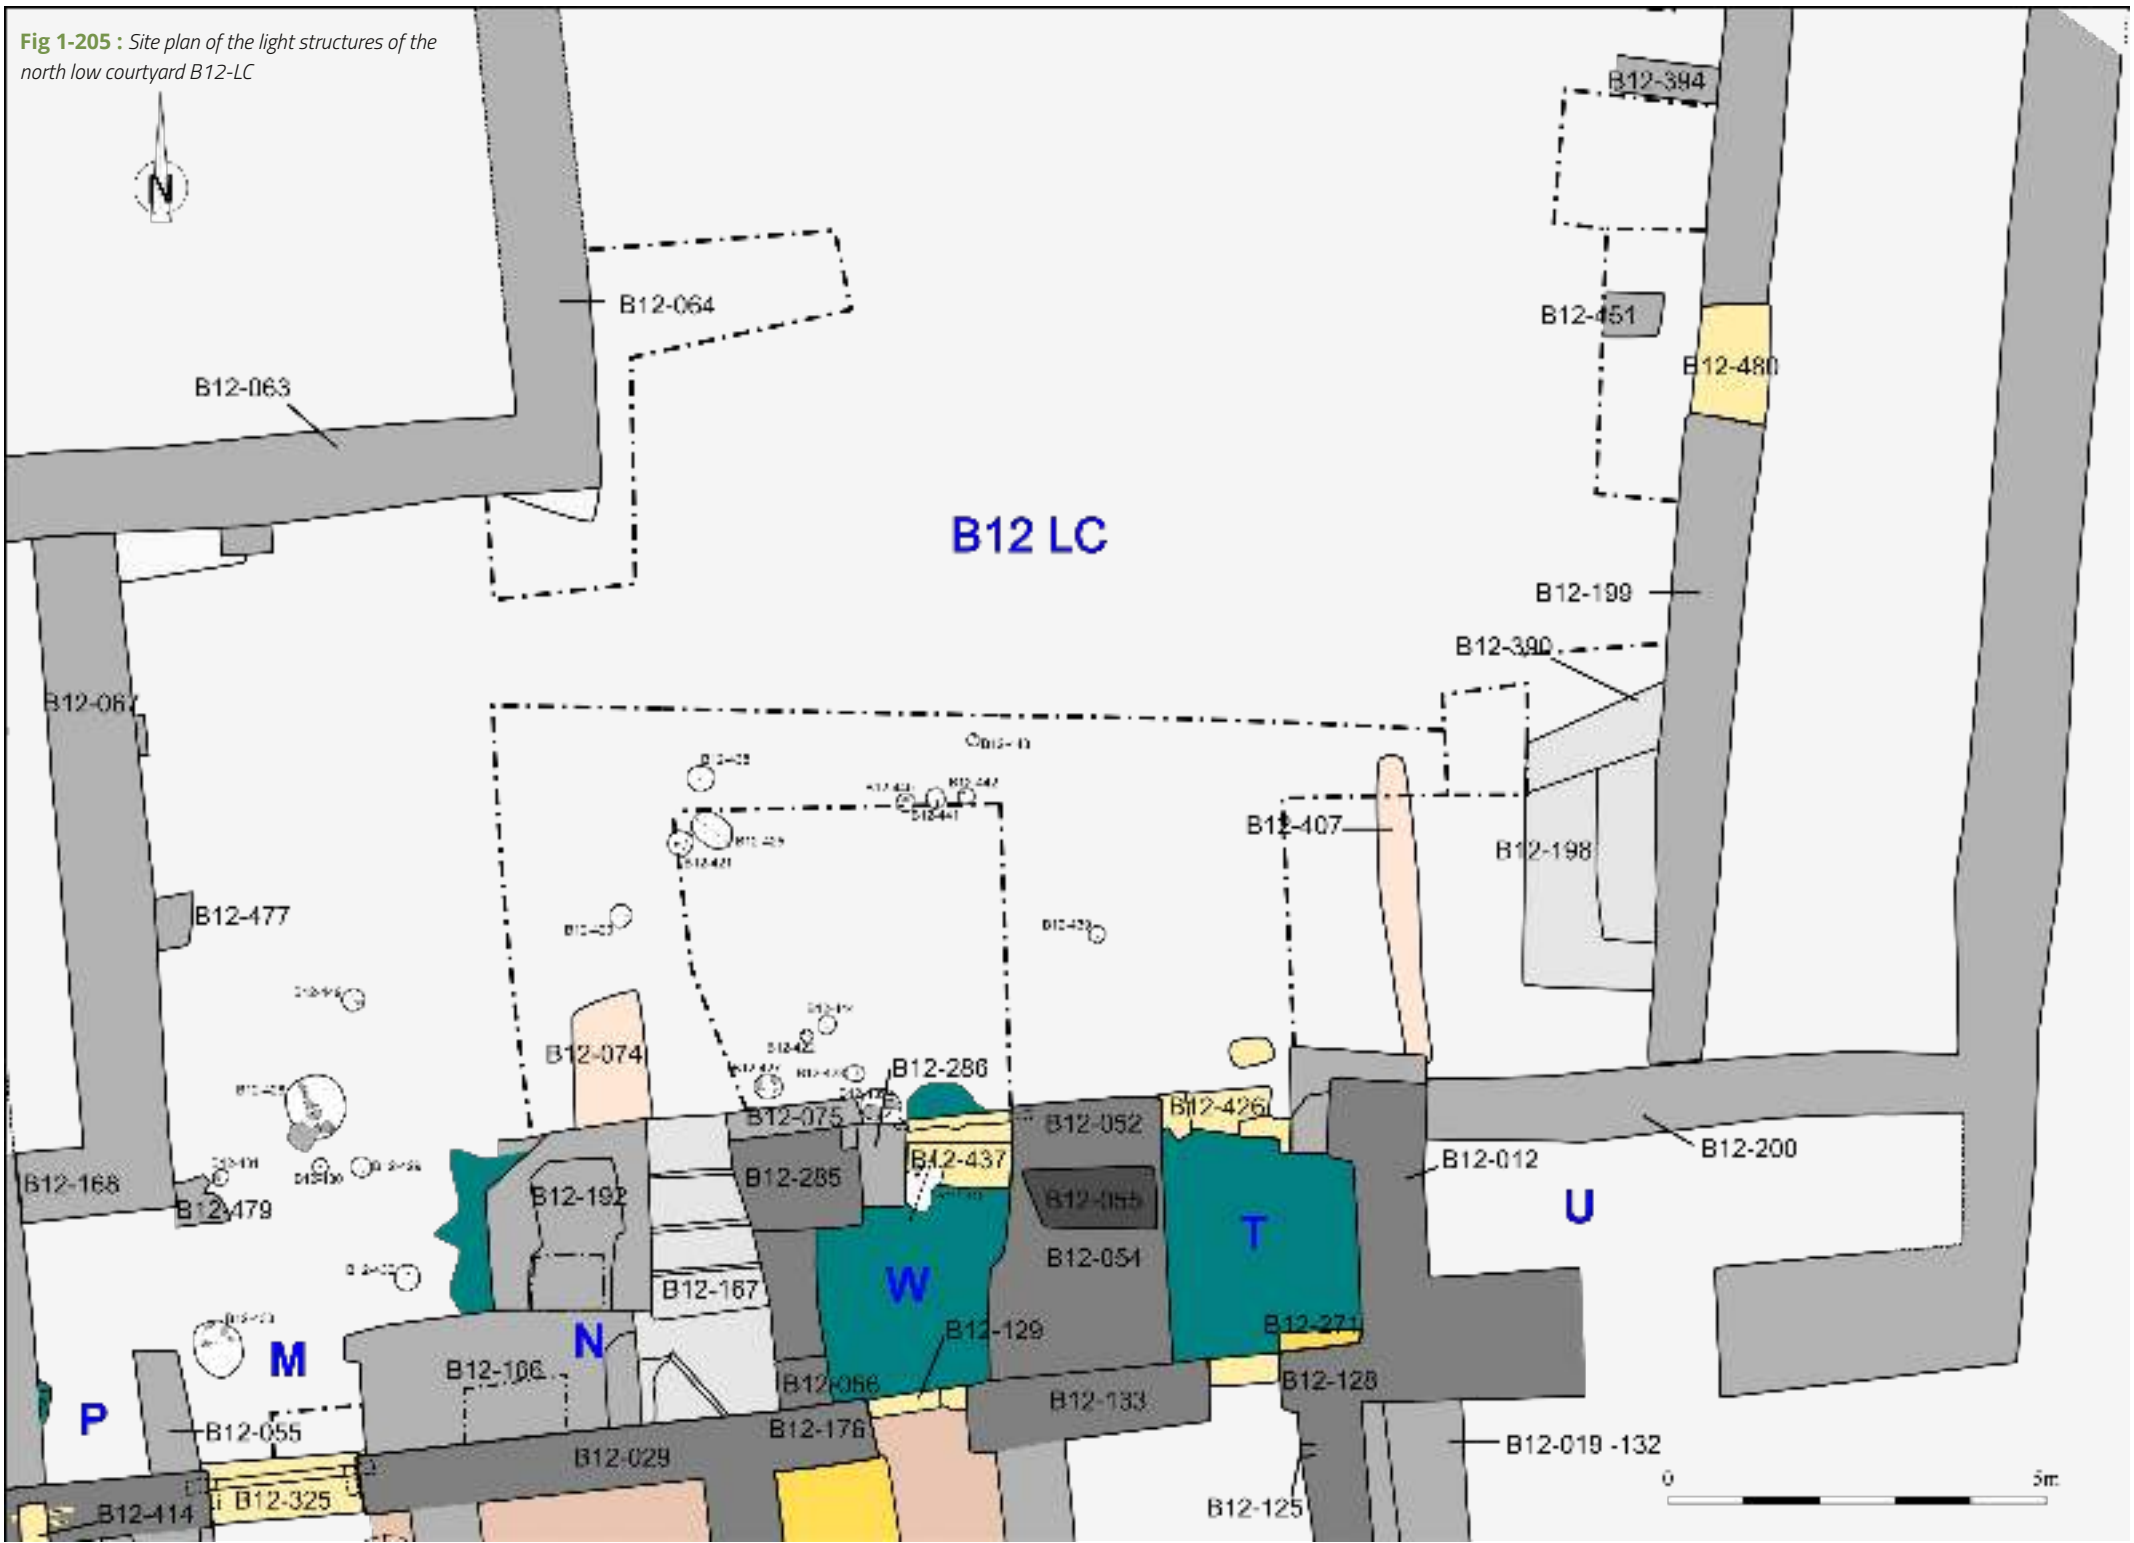
Fig 1-205 : Site plan of the light structures of the north low courtyard B12-LC

#### Fig 1-205

Though the ceramic material was too scarce to give a precise dating, the lowest floor observed in the soundings was quite probably in function in the first stage of the Mosque and the circulation floor used when the terrace was in use and not damaged. Observed at east along the wall B12-199, the floors **Uf5895 (Fig 1-206)** and **Uf5896 (Fig 1-207)** are earthen floors, with some small pebbles inserted into the floor which could be an infiltration from the upper layers. Built above these floors, the wall B12-451, 0.60m wide and observed for 0.75m long, probably belonged to the same stage of occupancy but its function is still unknown. It is only preserved for one course of stones but it could have been higher and the upper part recovered.

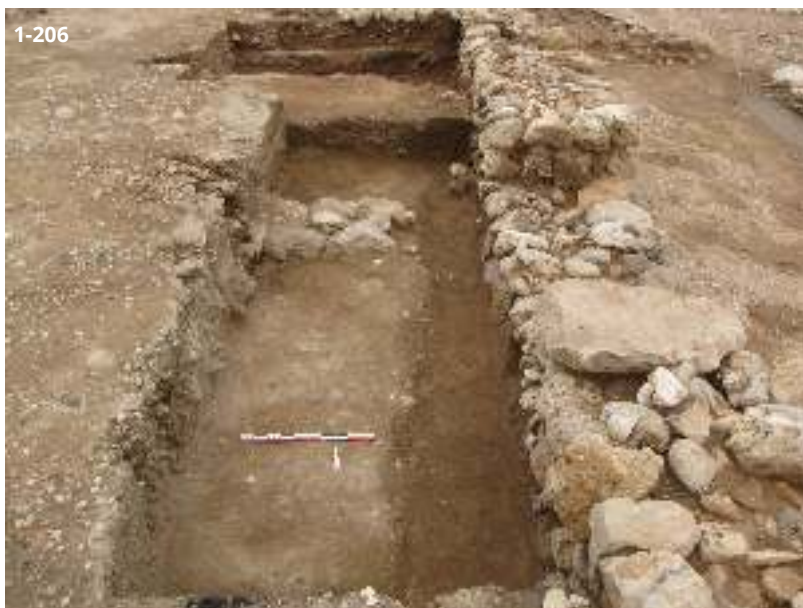
**Fig 1-206 :** the earthen floor Uf5895 (cut by the construction of the wall B12-199 at right) with the low wall B12-451 in the background

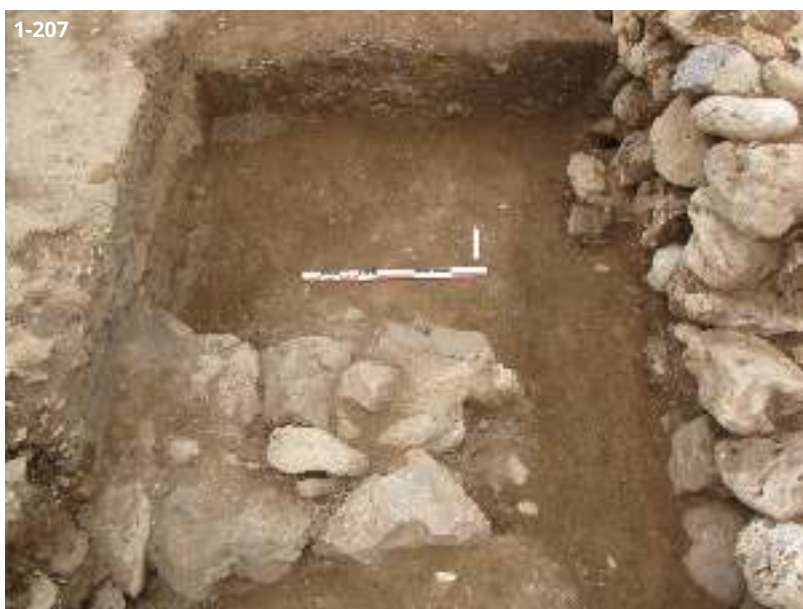
**Fig 1-207 :** the earthen floor Uf5896 (cut by the construction of the wall B12-199 at right) with the low wall B12-451 in the foreground

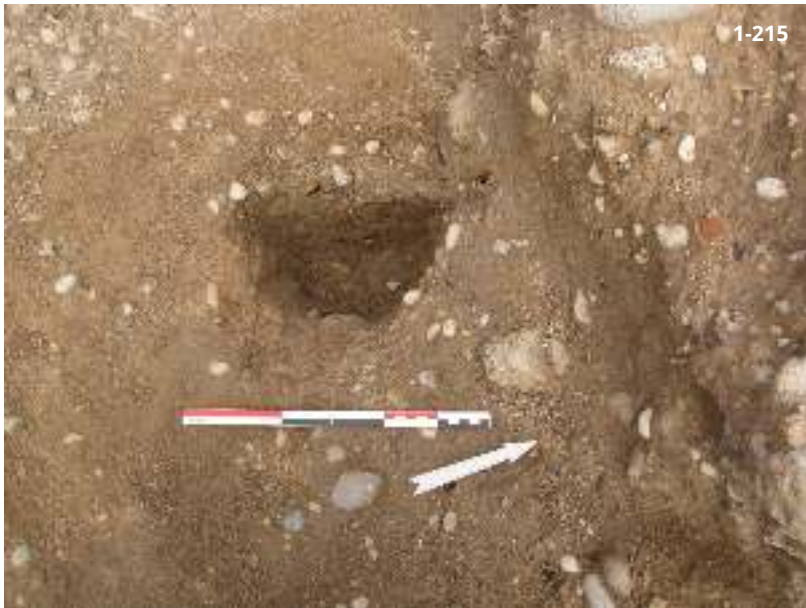
**Fig 1-215 :** the posthole B12-444, half excavated

Four other postholes were unearthed north-west of the gate to the room B12-W : **B12-427 (Fig 1-212)**, 0.35 m wide by 0.25 m deep, **B12-422 (Fig 1-213)**, 0.15m wide by 0.10m deep, **B12-423 (Fig 1-214)**, 0.25 m wide by 0.20 m deep and **B12-444 (Fig 1-215)**, 0.20m wide by 0.15m deep. For all of them, their use is unknown. On the contrary, the large posthole **B12-435 (Fig 1-216)**, around 0.40m wide by 0.30m deep, against the wall B12-286 and near the threshold B12-437 which give access to the room B12-W, was probably made to host the vertical pivot of the assumed door which closed the gate. Though it was dug through the earthen floor, it can also belong to a later stage of occupancy but its top was not seen in the upper layers.

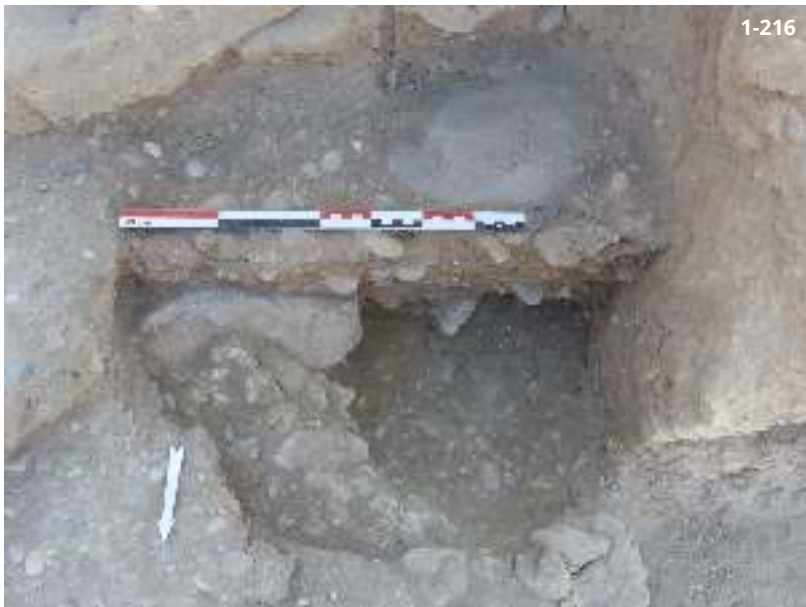
**Fig 1-216 :** the posthole B12-435, half excavated

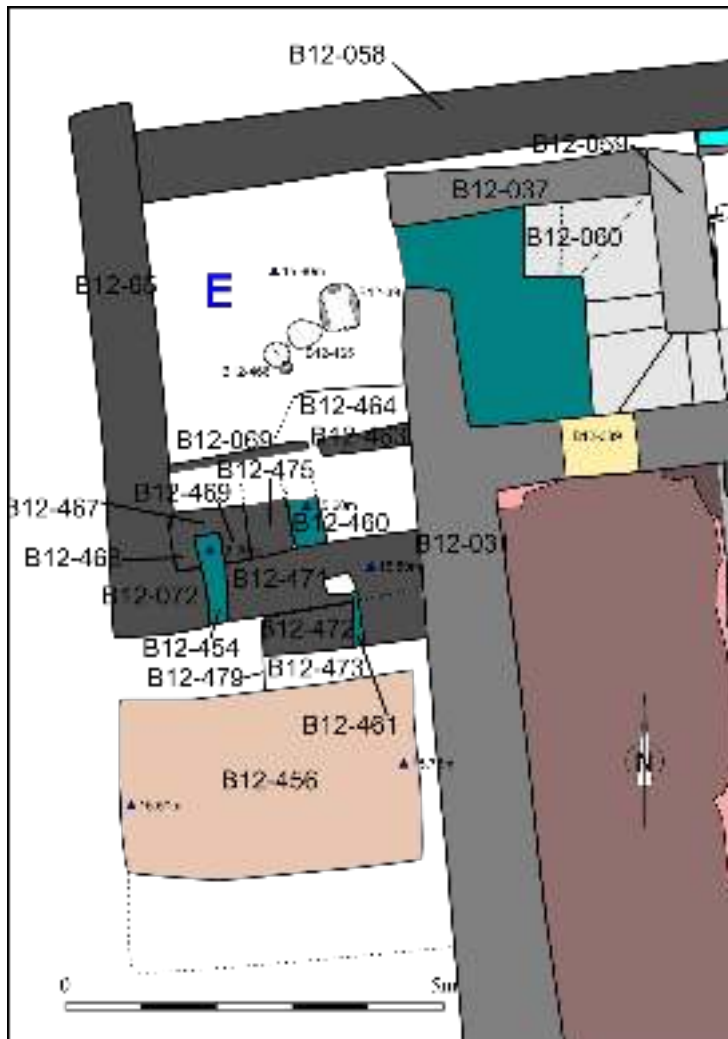
**Fig 1-236 :** Site plan and altitudes of the structures in the room B12-E

### I-F1. The ablution area in the high courtyard (Room B12-E) (Fig 1-236)

Set outside the north-west corner of the Mosque building and marking the western end of the north wing, the small room B12-E was already half excavated by the soundings of the QP and during the 2013-2014 season, and the discovery of small basins indicated the presence of an ablution area. The complete excavation during the 2015b-2016a season allowed to refine the plan of the room and the circulation but didn't solve all the questions about the use of this area.

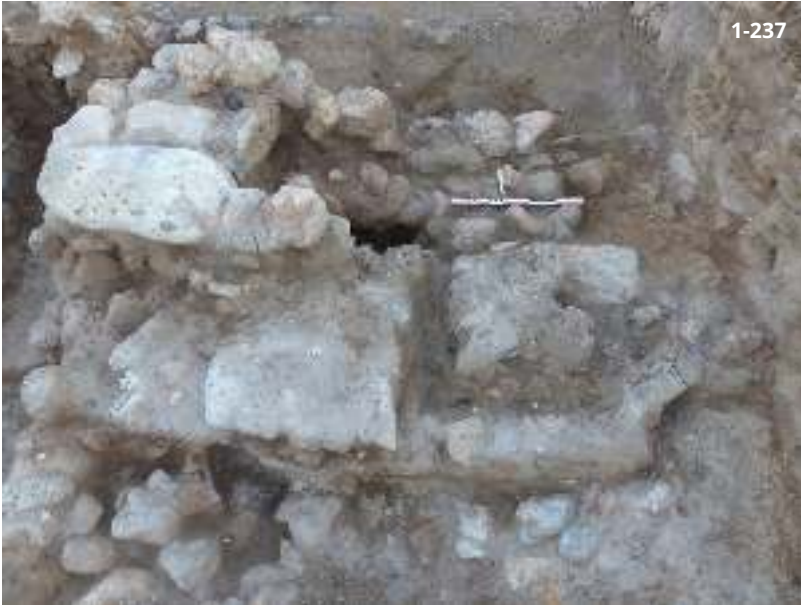
**Fig 1-237** : the wall B12-471, under the scale

The south limit of the room is made by the wall **B12-471 (Fig 1-237)**, which is leaning at east against the outside facade of the *qibla* wall (here registered as B12-31). It is very damaged and it is quite certain that a gate once stood here though no remain of threshold was preserved, as the general organization of the room and its surroundings indicates that the most convenient place for an access is here. The wall is now 2.60m long by 0.80m wide in average, for a maximal preserved elevation of 0.65m though some part of this elevation was originally not visible. It is made of medium limestone and corals blocks bonded with a badly preserved mortar and the internal core is very powdery. No coating was found in the south external face while the coating observed on the north internal face is linked with the northerly fittings (see below). Nearly in the middle of the wall, a gap in the masonry, though very badly preserved, could be the remain of an internal vertical gutter to drain the rainwater from the roof to the ground of the high courtyard. However, the remains are not well enough preserved to be affirmative.

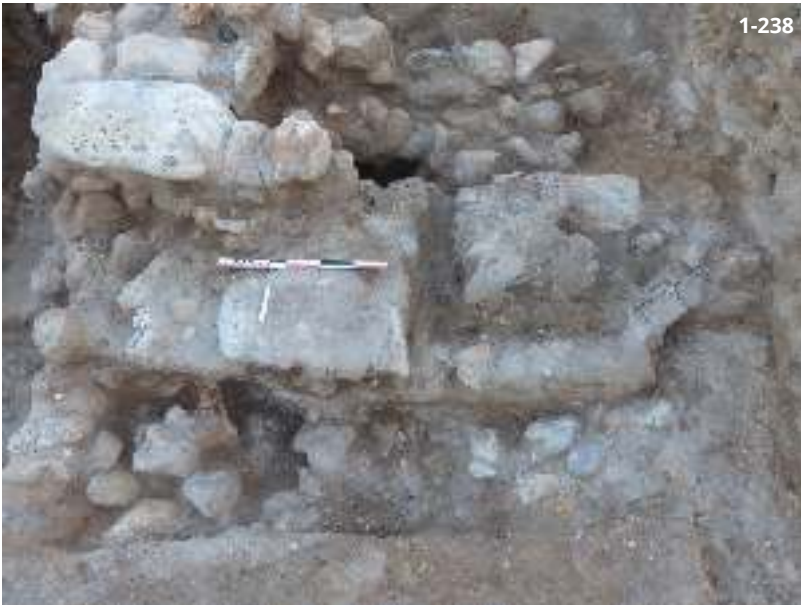
**Fig 1-238** : the wall B12-472, outlying the wall B12-471, with the groove B12-461 just at right of the scale

The wall B12-471 is outlined at south by the wall **B12-472 (Fig 1-238)** which is also leaning against the *qibla* wall. It is 2.20m long by 0.55m wide and only 0.15m high. It is very badly preserved especially at east where its limit with the wall B12-471 is nearly invisible. Nearly in the middle of the wall, a small groove (**B12-461**) with its bottom covered with strong gray coating, probably waterproof, was observed, crossing the width of the wall until the assumed vertical gutter in the wall B12-471, enhancing this interpretation. It is quite probable that the groove was originally covered and could so be interpreted as an internal canalization. The wall is also bordered at south by some kind of trench (**B12-473**) which could be a drain to evacuate the water.

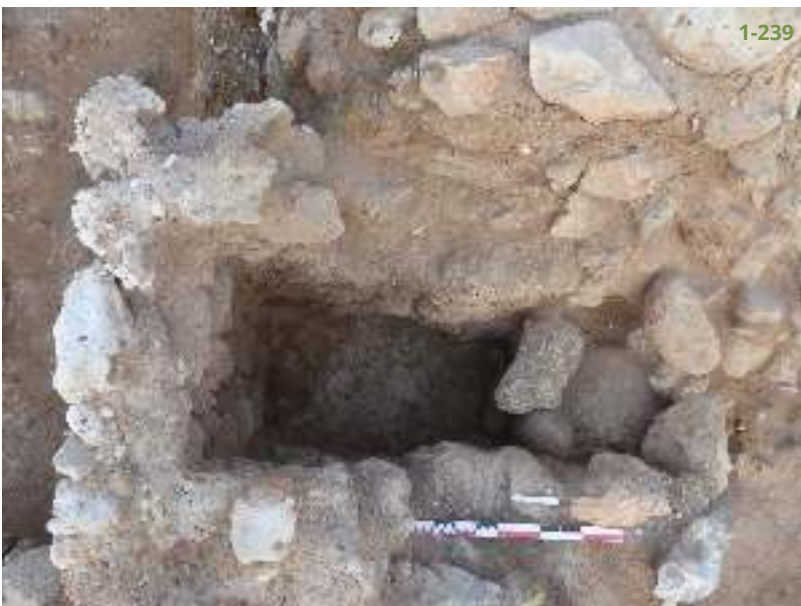
**Fig 1-239** : the groove B12-454, from above

The rest of the south limit on the south-west corner of the room B12-E is made by the masonry **B12-72**, linked with the western wall B12-65, already excavated and described in the previous report. The walls B12-471 and B12-72 are separated by a narrow groove (**B12-454 (Fig 1-239)**) which goes northerly inside a U-shaped masonry (**B12-467/468/469**) built in the internal south-west corner of the room. The wall B12-72 is 1.30m long by 0.75m wide and around 0.80m high and made with medium limestone and corals blocks bonded with earthen mortar and without external coating observed. The U-shaped masonry B12-467/468/469 is 1m long for a preserved elevation around 0.80m high and its width varies from 0.75m to 0.35m, the difference being the depth of the groove into the masonry. It is made of all sizes limestone and corals blocks bonded with yellowish mortar (**Fig 1-240**). The groove B12-454 is 1.20m long and its width varies from 0.35m to 0.25m and a strong with (white ?) grayish coating was found at the bottom of the structure. The most reasonable identification is a vertical gutter to evacuate the rainwater from the roof but it may look surprising that the evacuation was not at north to collect the rainwater for the ablation, as the water is lost in this configuration. Another identification could be a conduct for a latrine at first floor but it is problematical as the excrement would have fall on the floor level of the high courtyard and not into a sanitary pit, and very close to the *qibla* wall. If the presence of toilets is not impossible in the precinct of the Mosque, it is more problematic to set them so close to the most sacred place of the building. The inside of the gutter was filled with rubbish layers (**Uf5903**) suggesting that it was used as a rejection place, and by collapsed stones at south (**Uf5905**) which were undoubtedly covering the canalization between the wall B12-72 and B12-454 (**Fig 1-241**).

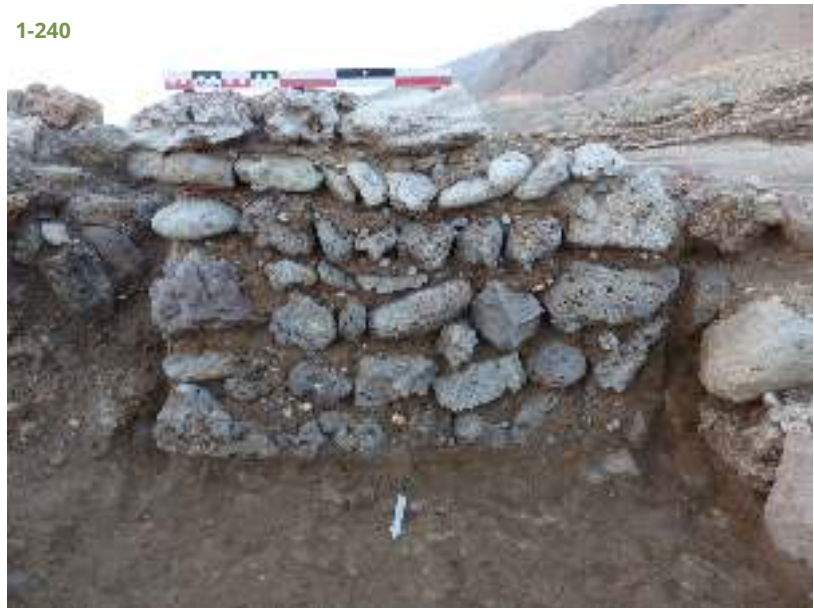
1-240

**Fig 1-240** : the north side of the wall B12-467, inside the room B12-E

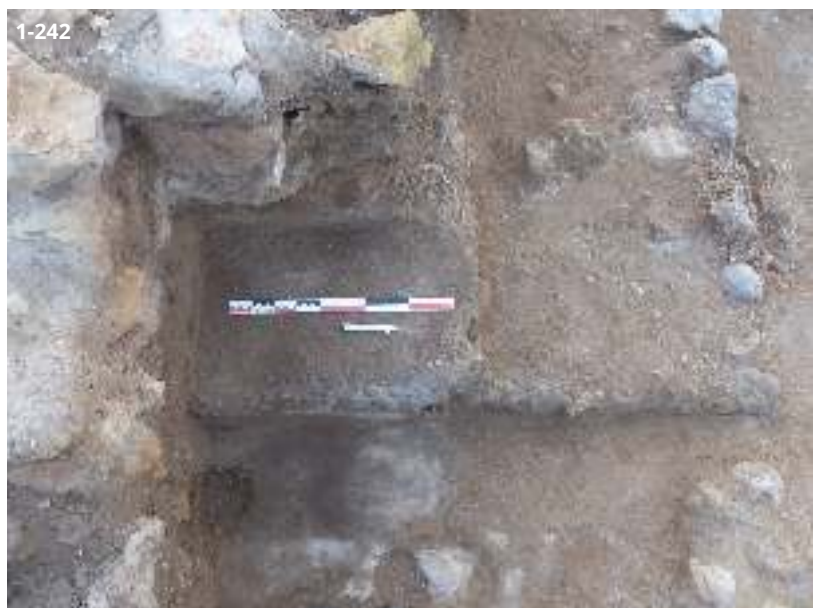
1-242

**Fig 1-242** : the step or bench B12-460, under the scale

In the south interior of the room, several damaged structures related with the northern remains of the basins were unearthed. The structure **B12-460 (Fig 1-242)**, 0.65m long by 0.40m wide and 0.15m high, is built against the south wall B12-471, around 1.20m west of the *qibla* wall. It is entirely covered with strong gray coating, probably waterproof, and can be identified as a step or more likely an edge of the basin, to receive the water for ablation and drain it to the north basin. It was associated with the structure **B12-475 (Fig 1-243)**, built at west against the masonry B12-467/468/469, made with various sized limestone and corals blocks bonded with a disintegrated mortar and covered, in the lower part, with the same strong gray coating as the structure B12-460. Preserved for 0.65m long by 0.60m wide and 0.60 high, the structure B12-475, though badly preserved, was quite undoubtedly a low bench, where people were sitting during the ablation.

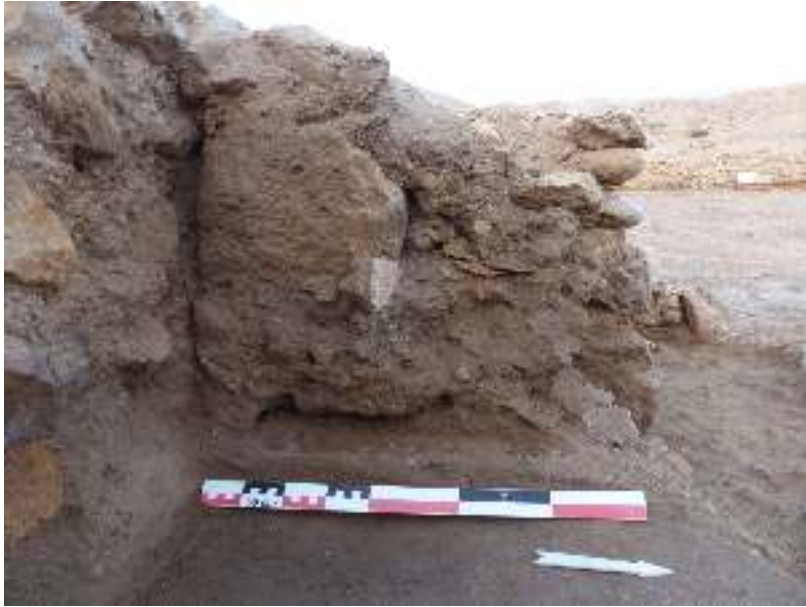
**Fig 1-243** : the structure B12-475, possible remains of bench

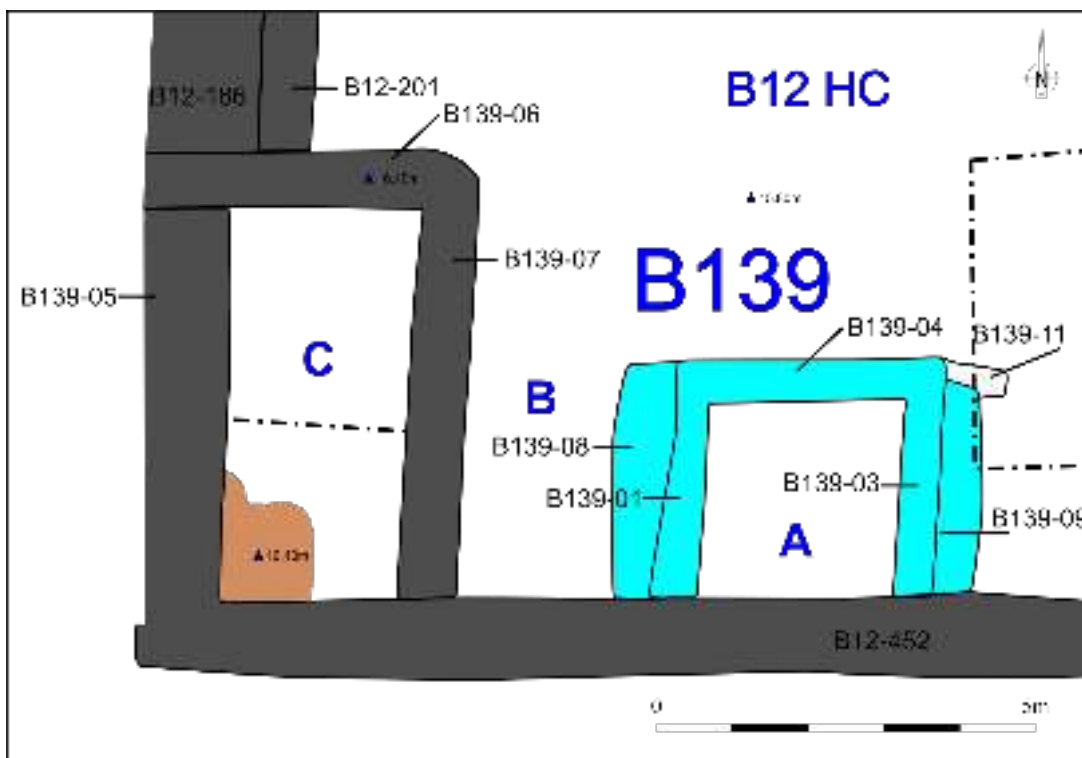
**Fig 1-249 :** Site plan and altitudes of the structures and floors of the building B139

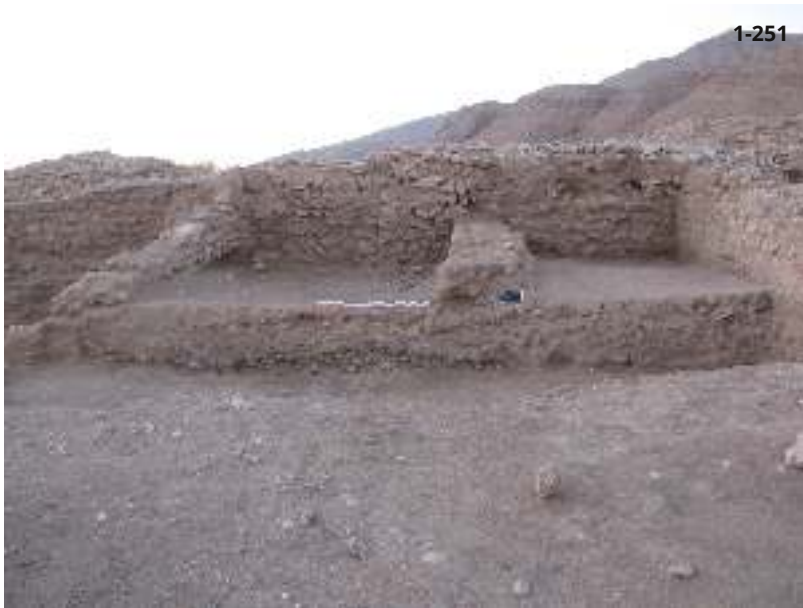
**Fig 1-251** : the sounding opened at north of the building B139, with the room B12-C at right

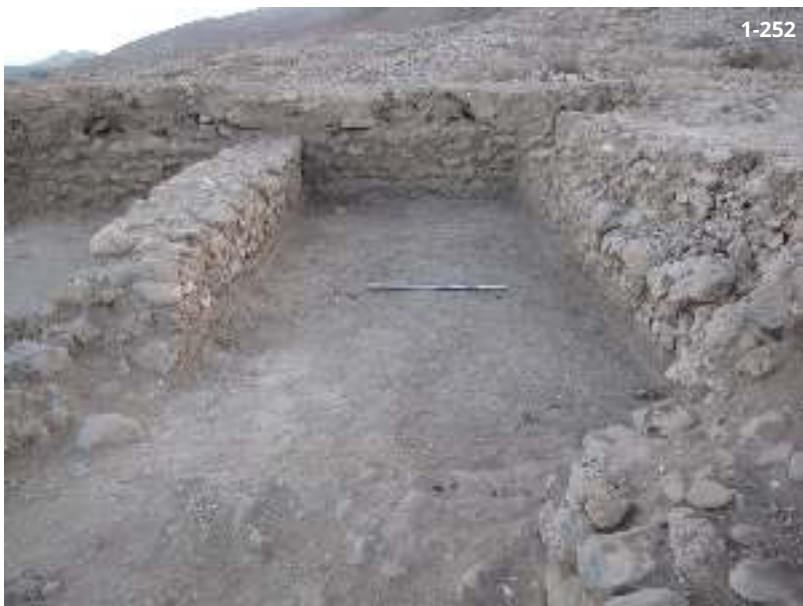
**Fig 1-252** : general view of the room B12-C at the end of excavations

At west (east ?), the wall **B139-07** is leaning against the wall B12-452 and built over the last layers of backfill. It is made with medium limestone and corals blocks bonded with earthen mortar and remains of a strong gray coating have been observed in its lower part. It is 5.90m long by 0.80m wide and a little more than 1m high, and though the wall is a little damaged and collapsed, the actual flat top of the wall could be original and intentional ,meaning that the upper part of the wall was possibly made of adobe. The earthen facies of the layers of collapse is in support of this hypothesis. Fig 1-252

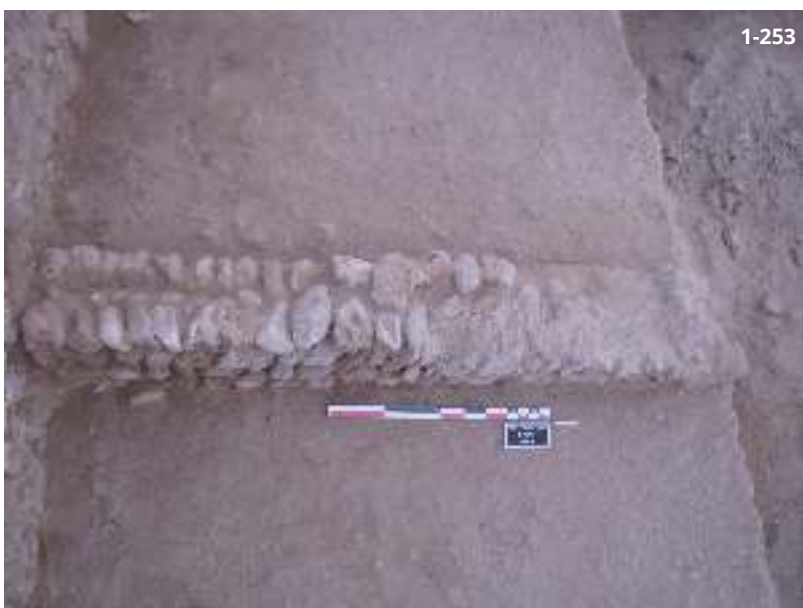
**Fig 1-253** : the wall B139-08

Two small walls were built over the sandy eolian levels, **B139-08** (Fig 1-253) around 2.70m east of the room B12-C and **B139-09** 3m east, whose foundation is not horizontal but follows the slope of the heap of sand accumulated against the south enclosure wall (Fig 1-254). They are both made with medium limestone and corals blocks bonded with earth, 3.10m and 2.80m long by 0.40m wide and between 0.40m to 0.30m high. The two walls created the first stage of the room B12-A, which was opened at north at this time and, according to the ceramic material found in the windy natural layers, the construction occurred in the course of the 16<sup>th</sup> century, a certain time after the abandonment of the Mosque.

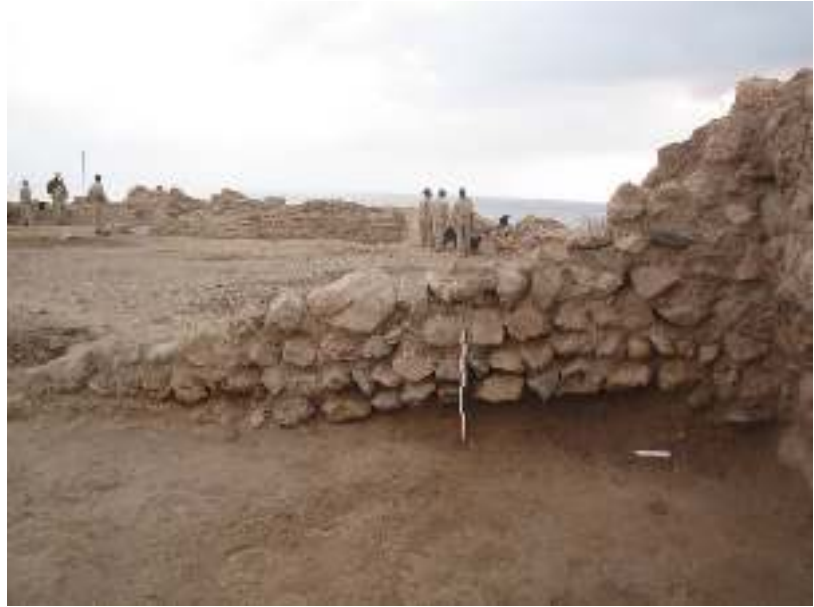
**Fig 1-254** : the wall B139-09 built over sand, visible behind the white arrow

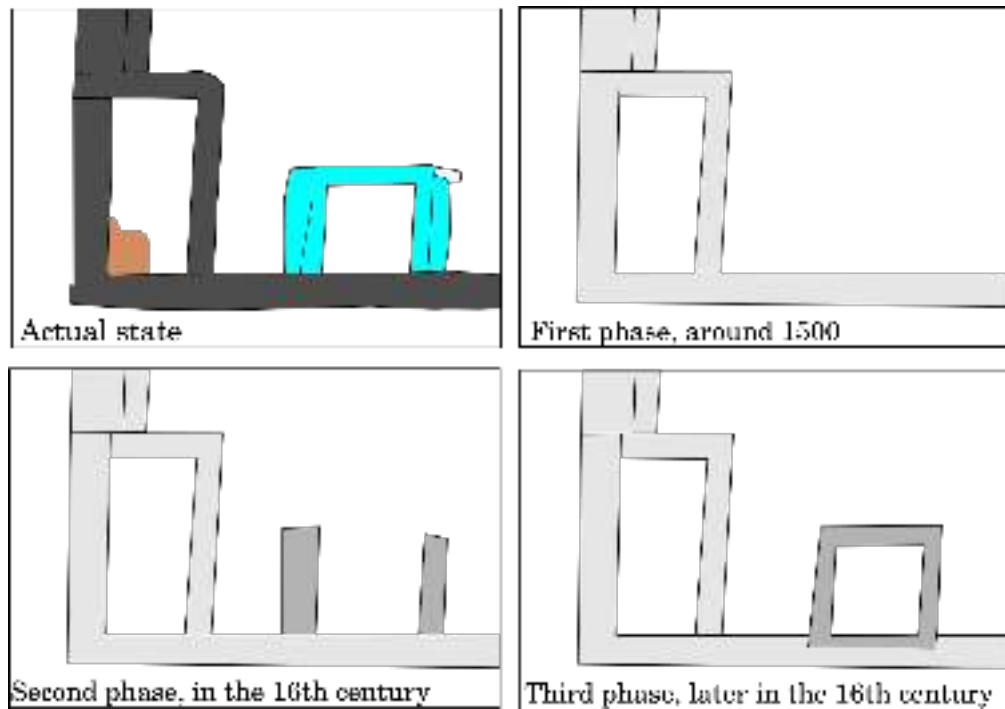
**Fig 1-255** : Hypothesis of evolution of the building B139

The second stage of the room B139-A occurred afterward by the construction of the walls B139-01, 03 and 04, already described in the previous report. They are built partly over the top of the walls of the first stage and partly over the natural accumulation of eolian sand and so followed a natural slope. According to the ceramic material, the second stage must have occurred also during the 16<sup>th</sup> century, most probably near its end.

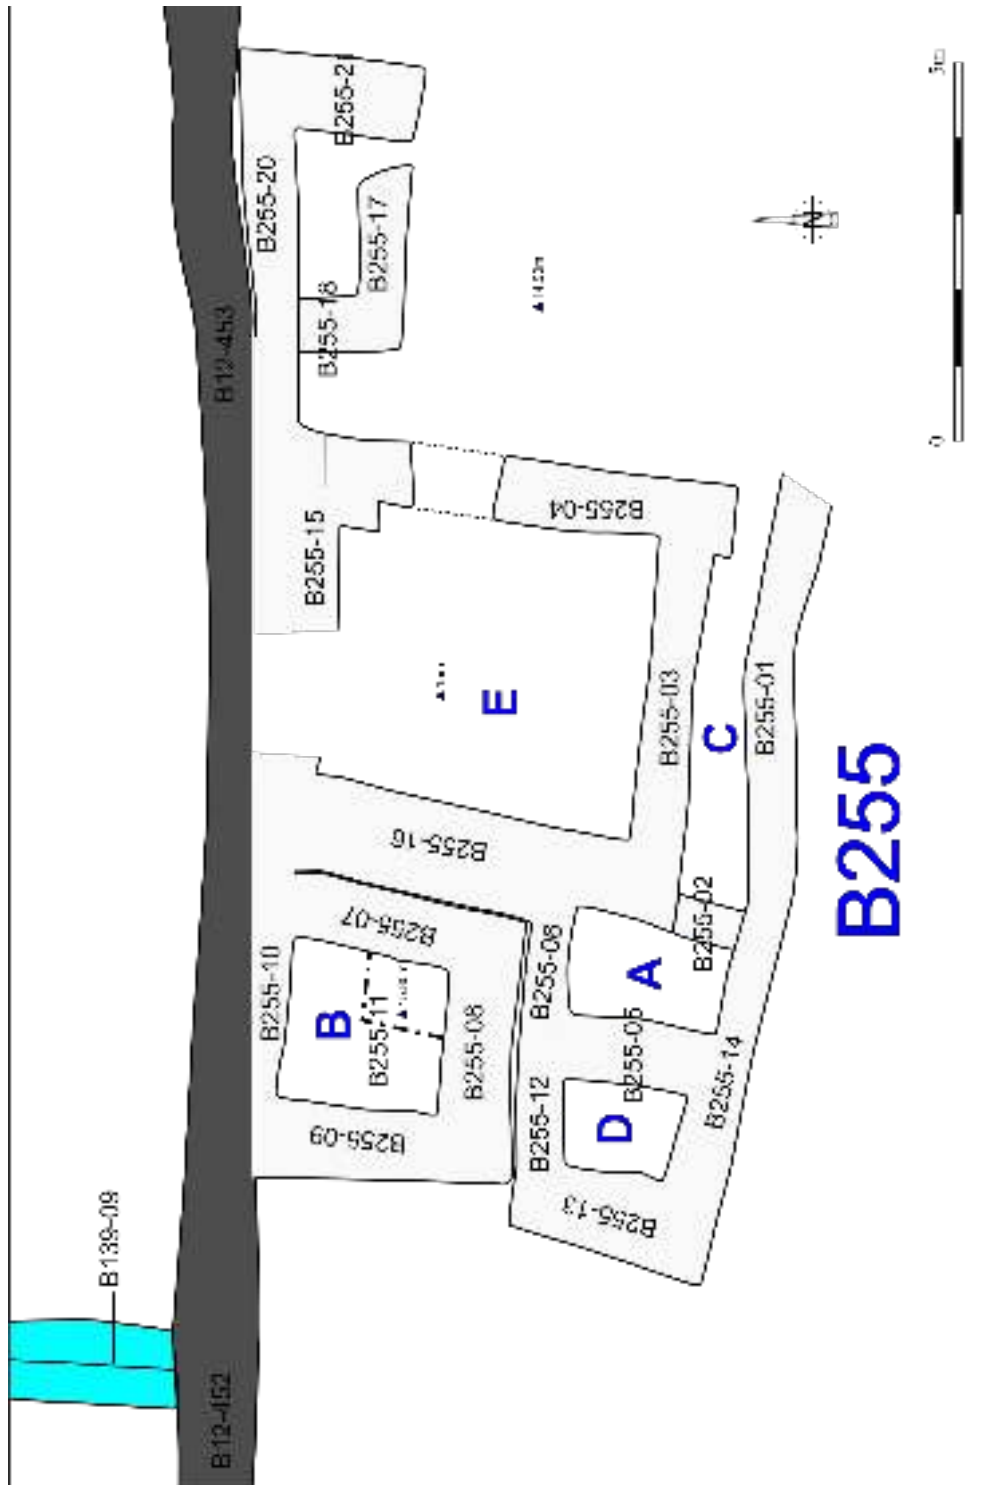
### Fig 1-256

Fig 1-256 : Site plan and altitudes of the building B255

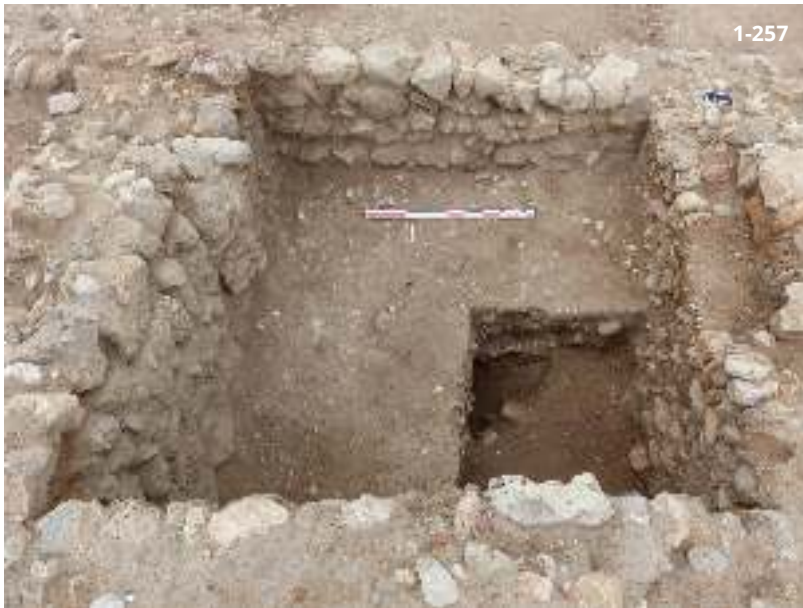
**Fig 1-257** : general view of the room B255-B

The largest room, B255-B (Fig 1-257), is internally just a little more than 4m<sup>2</sup> and no access was found, though the elevations are here best preserved than in the other rooms. It is delimited at north by the wall **B255-10**, which is apparently leaning against the enclosure wall B12-453, at east by the wall **B255-07** (Fig 1-258), at south by the wall **B255-08** (Fig 1-259) and at west by the wall **B255-09** (Fig 1-260). All walls are around 2m long internally and 3.40m externally for an average width of 0.90m and they were uncovered for at least 0.80m high. They are made with unorganized and variously sized limestone and corals blocks bonded with a strong mortar and no traces of coating were observed.

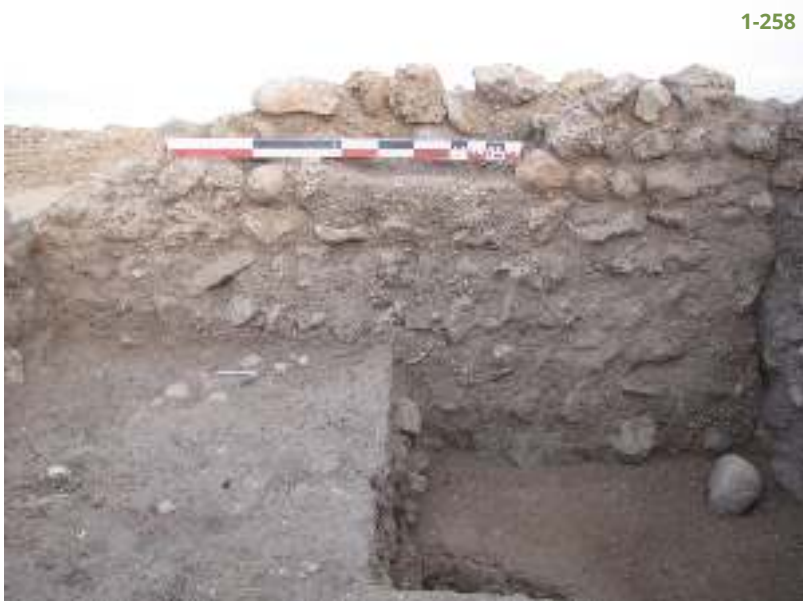
**Fig 1-258** : the wall B255-07, inside elevation

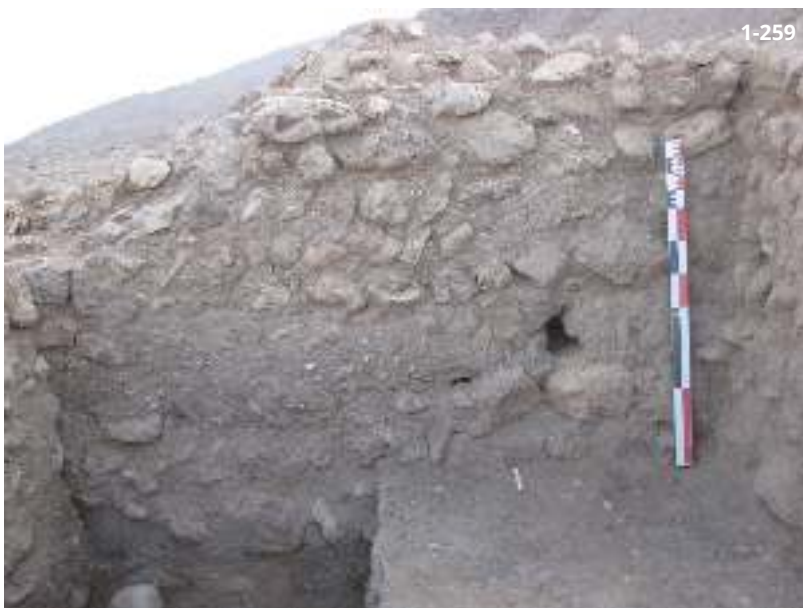
**Fig 1-259** : the wall B255-08, inside elevation

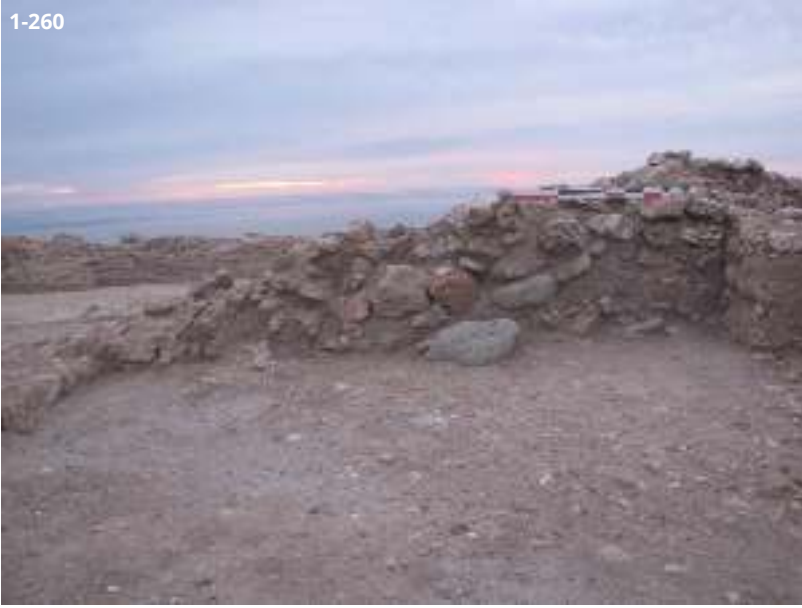
1-260

**Fig 1-260** : the wall B255-09, outside elevation

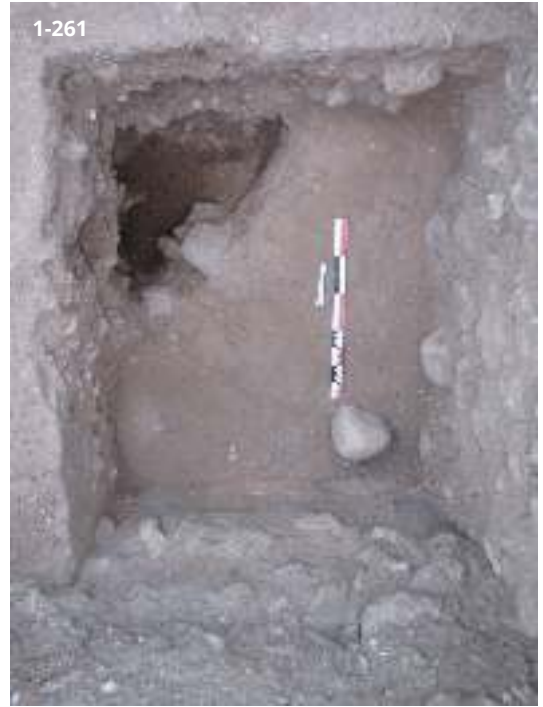
1-261

**Fig 1-261** : sounding in room B255-B with one quarter of the pit B255-11

The inside of the room B255-B was filled with a level of collapse (**Uf5603/5604**) around 1m thick. A sounding opened in its south-east corner revealed a brown indurated level made with silt mixed with small fragments of mortar and plaster which was probably a level of circulation for the room. One quarter of a central pit (**B255-11**) (Fig 1-261) around 1m wide was also excavated and its filling Uf5605 contained small fragments of decoration coming from the Mosque, including Kashan tile. It so seems that the building is at least contemporary of the last stage of use of the Mosque.

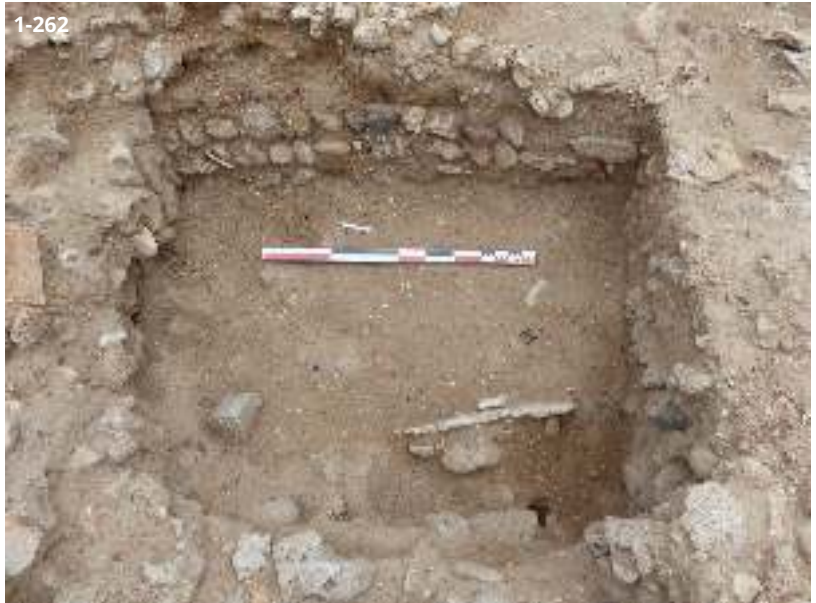
1-262

**Fig 1-262** : general view of the room B255-D

The western room B255-D (Fig 1-262) is delimited at north by the wall **B255-12** (Fig 1-263), 0.60 m wide and internally uncovered for around 0.20 m only, at west by the wall **B255-13** (Fig 1-264), 2.65 m long by 1 m to 1.20 m wide and externally excavated for more than 0.40m, and at south by the wall **B255-14** (Fig 1-265), common with room B12-A, around 5m long and 0.80m wide for the room B12-D and 0.60m for the room B12-A and uncovered for 0.60 to 1 m high. The rooms B255-D and B255-A are separated by the wall **B255-05** (Fig 1-266), 1.60 m long by 0.90 m wide and only uncovered for less than 0.40 m high in the room B12-D. All walls are made with medium limestone and corals blocks bonded with a nearly disintegrated beige mortar and remains of a strong dark coating have been found on the external facings of the wall B255-13. The internal useful space of the room B12-D is only 1.80m<sup>2</sup> and, as the internal facings were badly preserved, excavations stopped very early in the upper part of the collapse (**Uf5609**) while they went deeper externally into the collapse (**Uf5602**) as the external facings were best preserved.

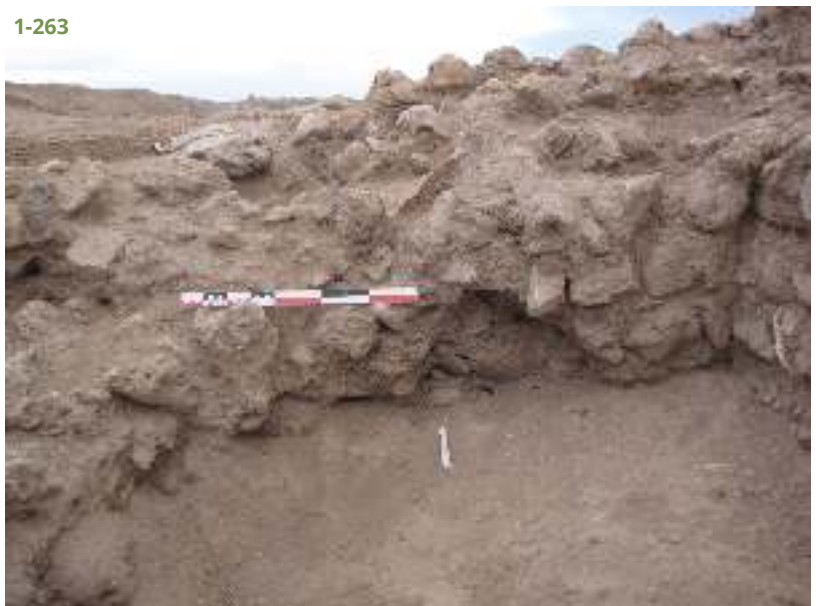
1-263

**Fig 1-263** : the wall B255-12, inside elevation

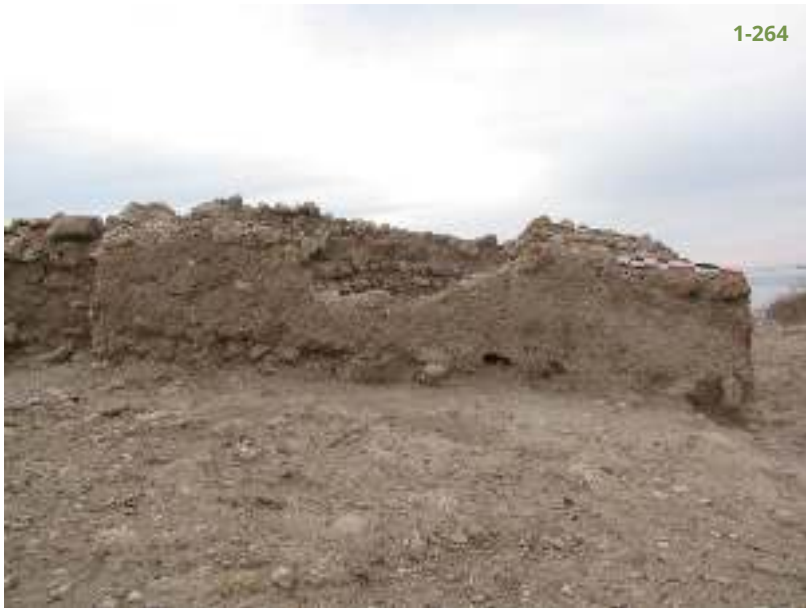
**Fig 1-264** : the wall B255-13, outside elevation

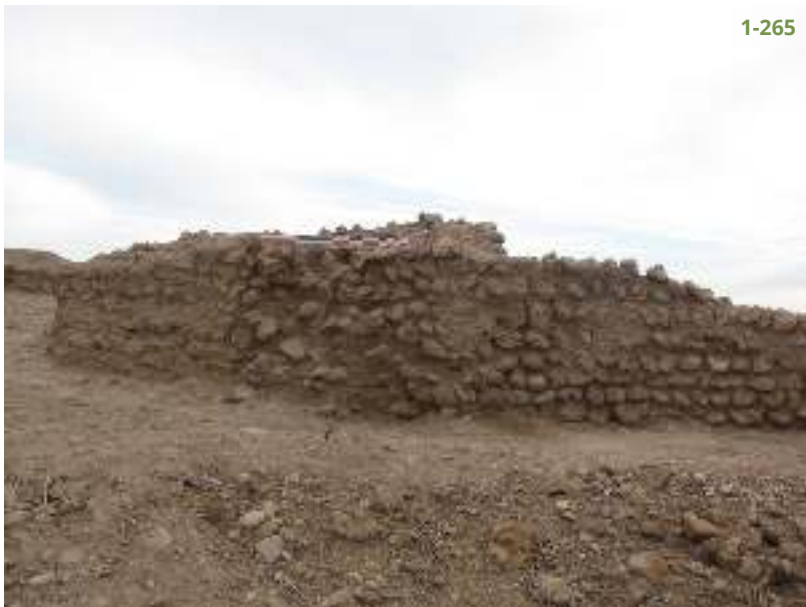
**Fig 1-265** : the wall B255-14, outside elevation

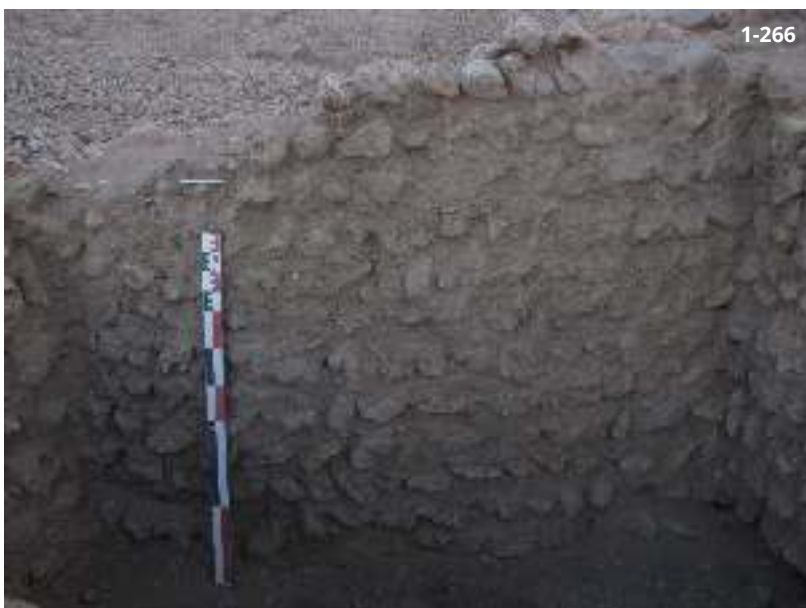
**Fig 1-266** : the wall B255-05, inside elevation in room B255-A
