## Qalhât Development Project, Season 2015B-2016A, Final Report

**QALHÂT (ASH-SHARQYJAH)**

**SEASON 2015B-2016A**

**FINAL REPORT**

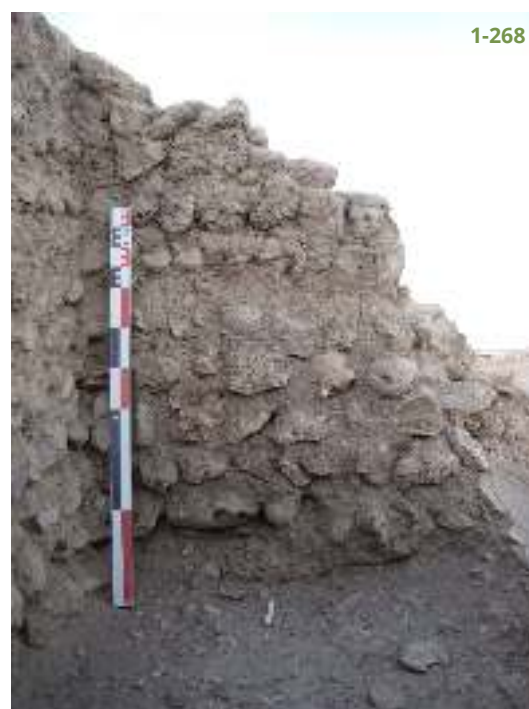
**Fig 1-267** : general view of the room B255-A

The eastern room B255-A (Fig 1-267) is delimited at south and west by the walls B255-14 and B255-05 already described, and at north by the wall **B255-06** (Fig 1-268), equal to the wall B255-12 and 0.50 m wide. At east, the limit is made northward by the wall **B255-16** (Fig 1-269), here 1.80 m long and 1m wide and high. A small access, 0.80m wide, might have existed to the south, before it was blocked by the construction of the wall **B255-02** (Fig 1-270), 0.80 m long by 0.50 m wide and around 0.60 m high. All walls are made with medium limestone and corals blocks bonded with a nearly disintegrated beige mortar. Important remains of a strong gray possibly waterproof coating were unearthed in the lower part of the inside of the room B255-A, which could indicate that the room was used as a cistern after the construction of the blocking B255-02. Around 2m long by 1.20 m wide, the use of the room B255-A remained unknown it its first stage. It was internally filled with a layer of collapse mixed with rubbish, including nearly complete ceramics and small fragments of the decoration of the Mosque (**Uf5600**).

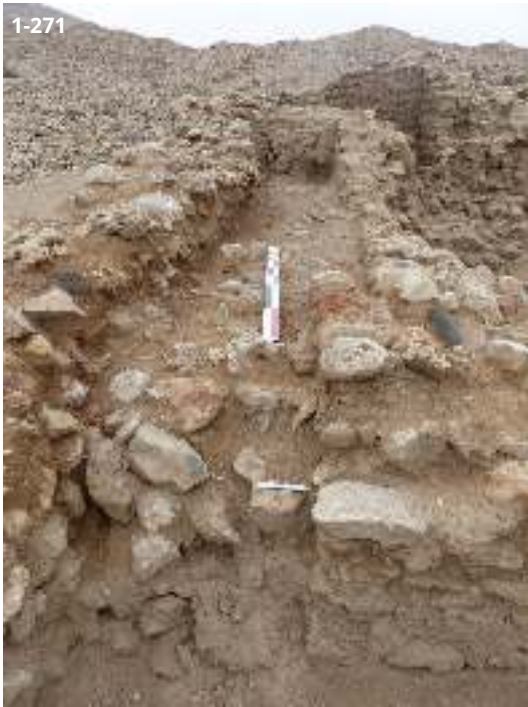
**Fig 1-271** : general view of the assumed corridor B255-C, unexcavated

The room B255-A was probably originally reachable by the winding narrow corridor B255-C (Fig 1-271), 0.60m to 0.90m wide, which is delimited at south by the wall **B255-01** (Fig 1-272), 6m long by 0.65m wide in average and externally uncovered for about 0.40m high, and at north by the wall **B255-03** (Fig 1-273), 4.50m long by 0.60m wide for an unearthed elevation of more than 1m at north. The inside of the corridor was only excavated down to the upper course of the walls and excavations were so stopped on artificial layers. The walls are made with small limestone and corals blocks bonded with a grayish mortar badly preserved and it is possible that their winding shape is accidental and due to the pressure of the collapse or possible backfills. The room B255-C was identified as a corridor because of its shape and location, but further excavations could reveal another identification, as a staircase for example.

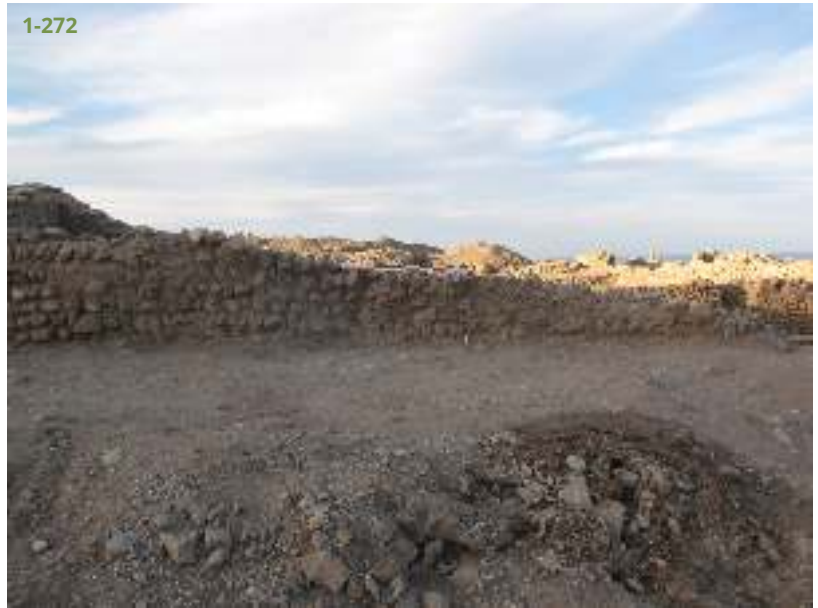
**Fig 1-272** : the wall B255-01, outside elevation

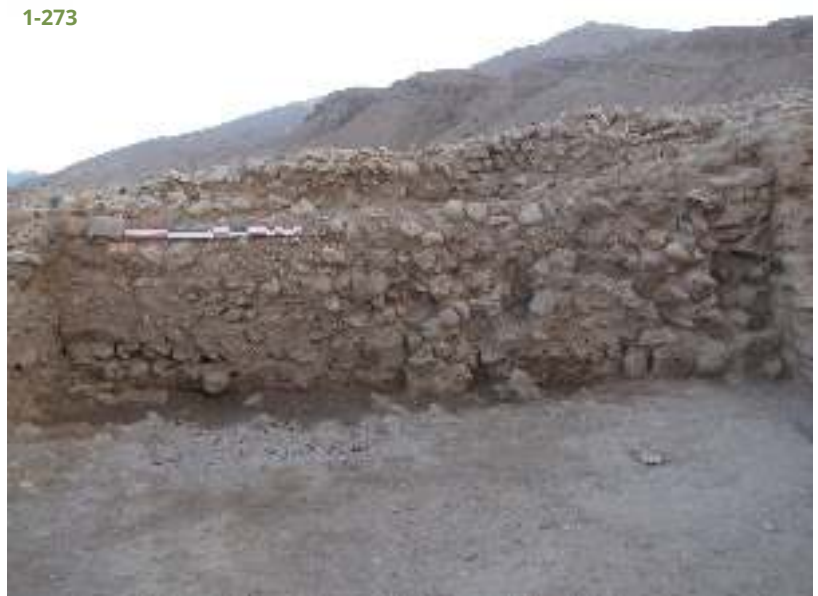
**Fig 1-273** : the wall B255-03, outside elevation in room B255-E

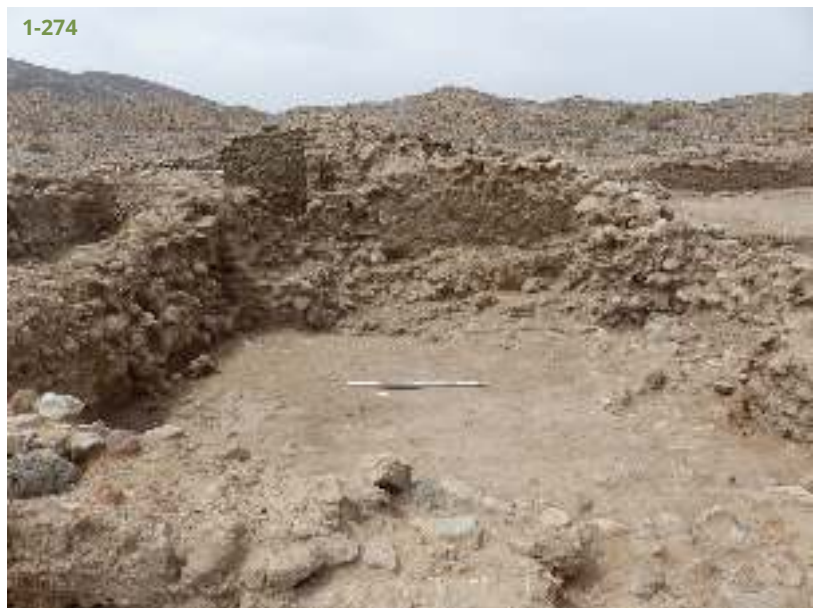
**Fig 1-274** : general view of the room B255-E

North of the corridor B255-C, the large room B12-E (Fig 1-274), 4.15m long north to south by 3.80m wide east to west, could possibly be the main room of the building B255, but it is also wide enough to be a small courtyard. Without further excavations, the precise identification of this space remains hypothetical.

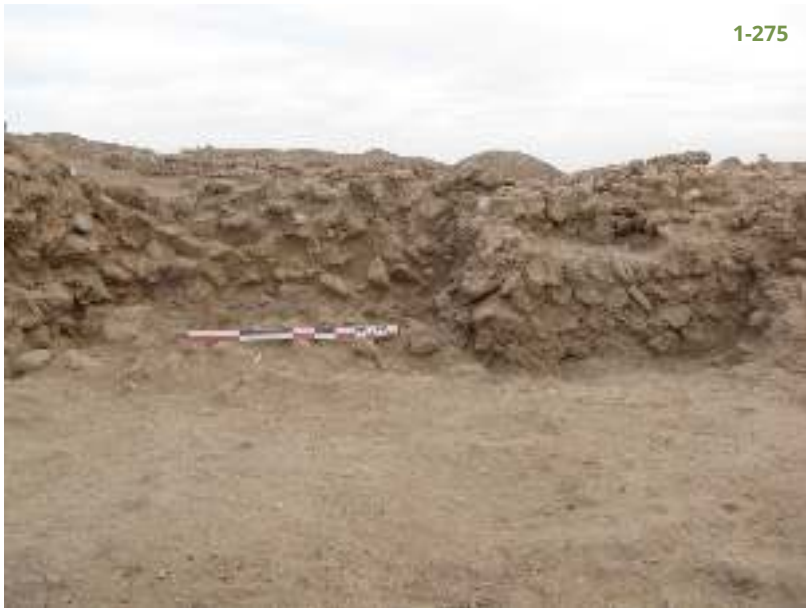
1-275

**Fig 1-275** : the badly preserved wall B255-15, inside elevation

The north limit is made by the wall **B255-15** (Fig 1-275) which is incompletely preserved, most of its facing having collapsed at west. It is built against the south enclosure wall of the Mosque B12-453 but the delimitation is very difficult to observe. It has been observed for 1.40m long by around 0.80m wide and a maximal preserved elevation of less than 0.90m.

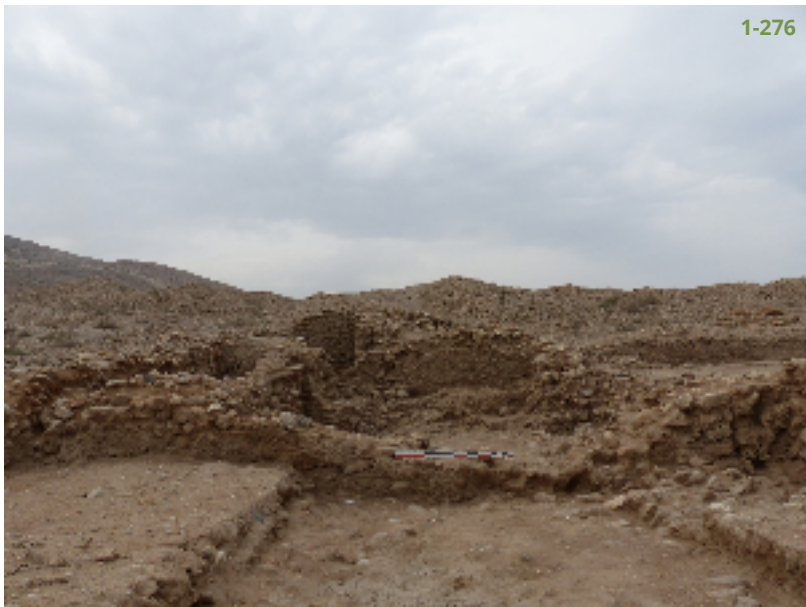
1-276

**Fig 1-276** : the wall B255-04, outside elevation

The south east limit of the room is made by the wall **B255-04** (Fig 1-276), 3.10m long by around 0.90m wide and uncovered for less than 1m high. At north, a gap in the masonry could be the remains of an opening or simply due to a baddest preservation.

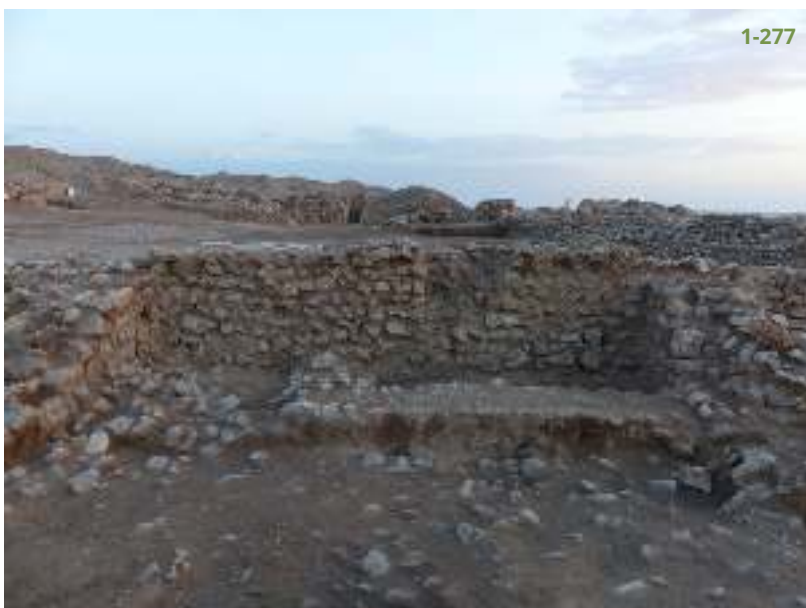
1-277

**Fig 1-277** : the walls B255-20 and B255-21 (in the background) and the walls B255-17 and B255-18 (in the foreground) which could belonged to another building

The building B255 was probably extending eastwards, where the uncovered wall B255-20 and B255-21 probably belonged to a fifth room. In the same area, the walls B255-17 and 18 have been observed on the ground and must be part of an internal fitting (Fig 1-277). As the building B255 appeared to be distinct from the Mosque Complex and was so no more a priority, the excavations did not continue here and the plan of this hypothetical room was not searched.

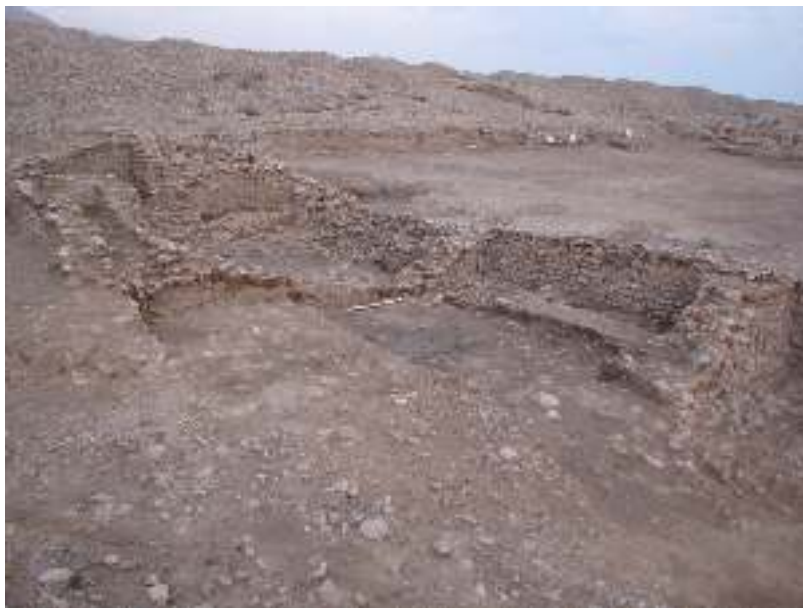
**Fig 1-278** : general view of the building B255 at the end of excavations

All the walls are made with medium sized limestone and corals blocks bounded with rough grayish mortar and no traces of coating were observed. The masonry is in general of a poor construction, with rough binder and winding walls and few right angles. It was so probably not an important building and, as some remains of decoration have been found in the rubbish layers of the fillings of the rooms B255-B and B255-A, it is very likely that the building was disused before the final abandonment of the Mosque. (Fig 1-278)

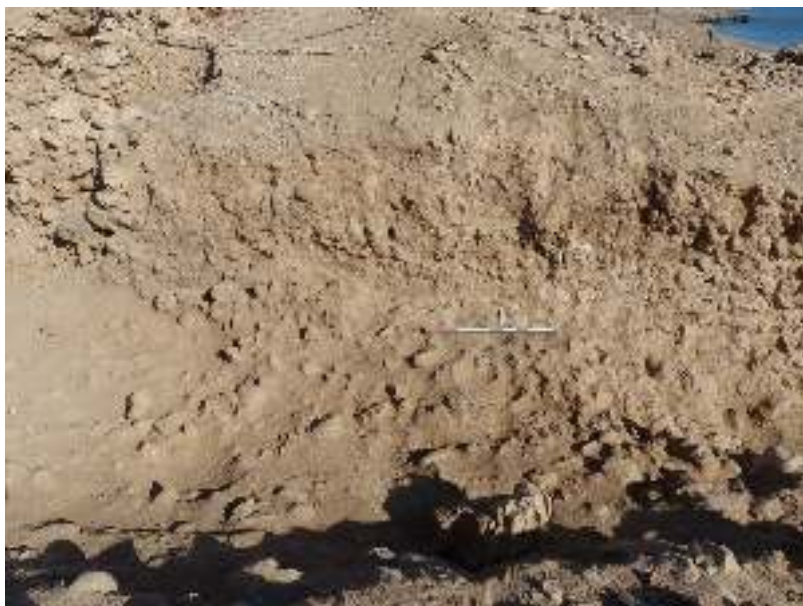
**Fig 1-279** : the south wall B12-41 of the Mosque, badly preserved, emerging from the collapse in the south street

In the western part of the area, west of the south gate to corridor B12-B, the south wall of the Mosque **B12-41** (Fig 1-279), already described with the prayer hall, is very badly preserved. No parts of the walls of the upper floor were preserved, and most of the external facing of the wall of the basement has also collapsed, probably because of the pressure of the backfills inside the basement. The facing is variously preserved, around 1m high at the south-west corner where it was not entirely unearthed, to more than 2m closed to the gate to the corridor B12-B, where the wall was uncovered until its foot. In the center however, only the lower courses of stones are still in place sometime only 0.30m above the final floor of abandonment.

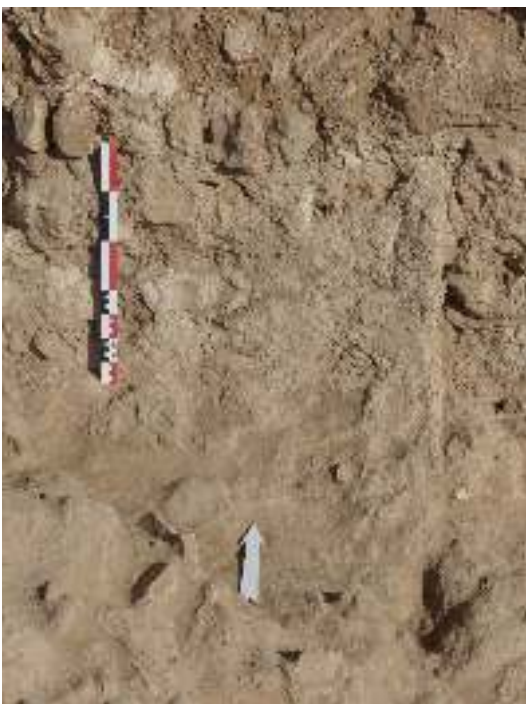
**Fig 1-280** : imprints in the mortar of the wall B12-41, suggesting the presence of a disappeared buttress

It is also possible that a massive buttress, around 3.60 m long by 1 m wide, may have existed right at west of the gate to the corridor B12-B. Protruding masoned stones and imprints in the mortar and coating of the wall strongly suggest that hypothesis (Fig 1-280) but it would have been necessary to excavate down to get more information about the lowest fittings of the wall. As already mentioned it was not possible to do so in proper state of safety without widely extending the excavations to the south.

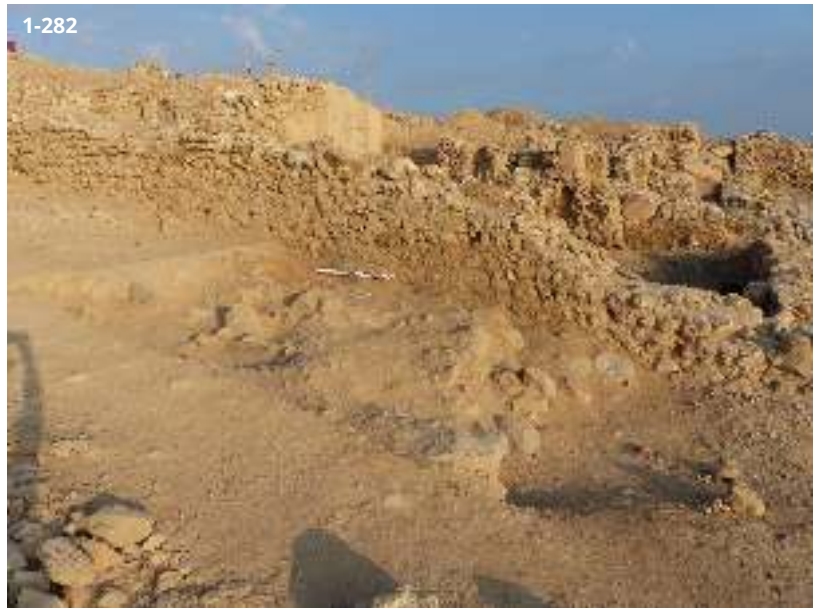
**Fig 1-282 :** the south wall  
B12-42/109 of the Mosque

In comparison, the south-east part of the wall **B12-42/109** is better preserved (**Fig 1-282**), as it did not had to support horizontal pressure from the north, where the rooms of the basement were empty. However, due to the natural weathering, the preserved elevation is more important at west, near the gate to the corridor B12-B, where it is around 2m high, than at east where it is only preserved for 0.60 m high.

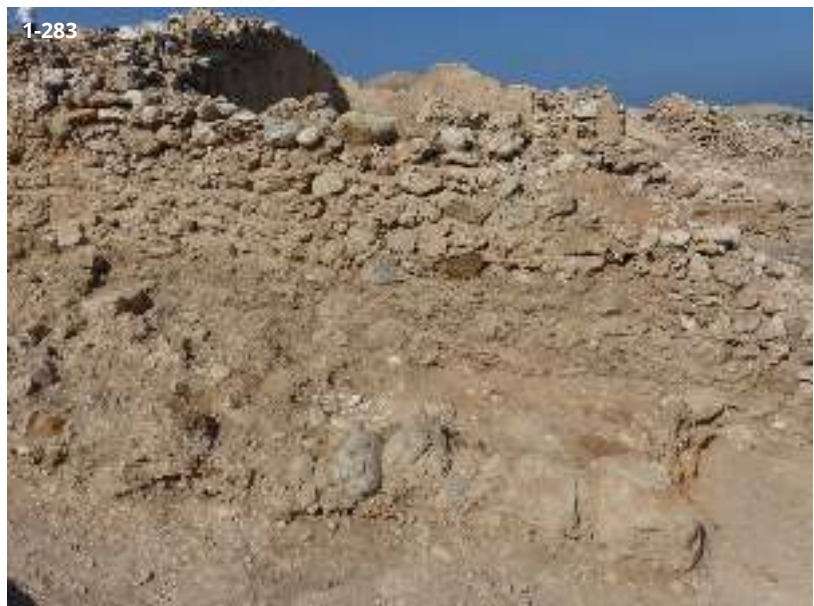
**Fig 1-283 :** the possible  
streetwalk B12-418

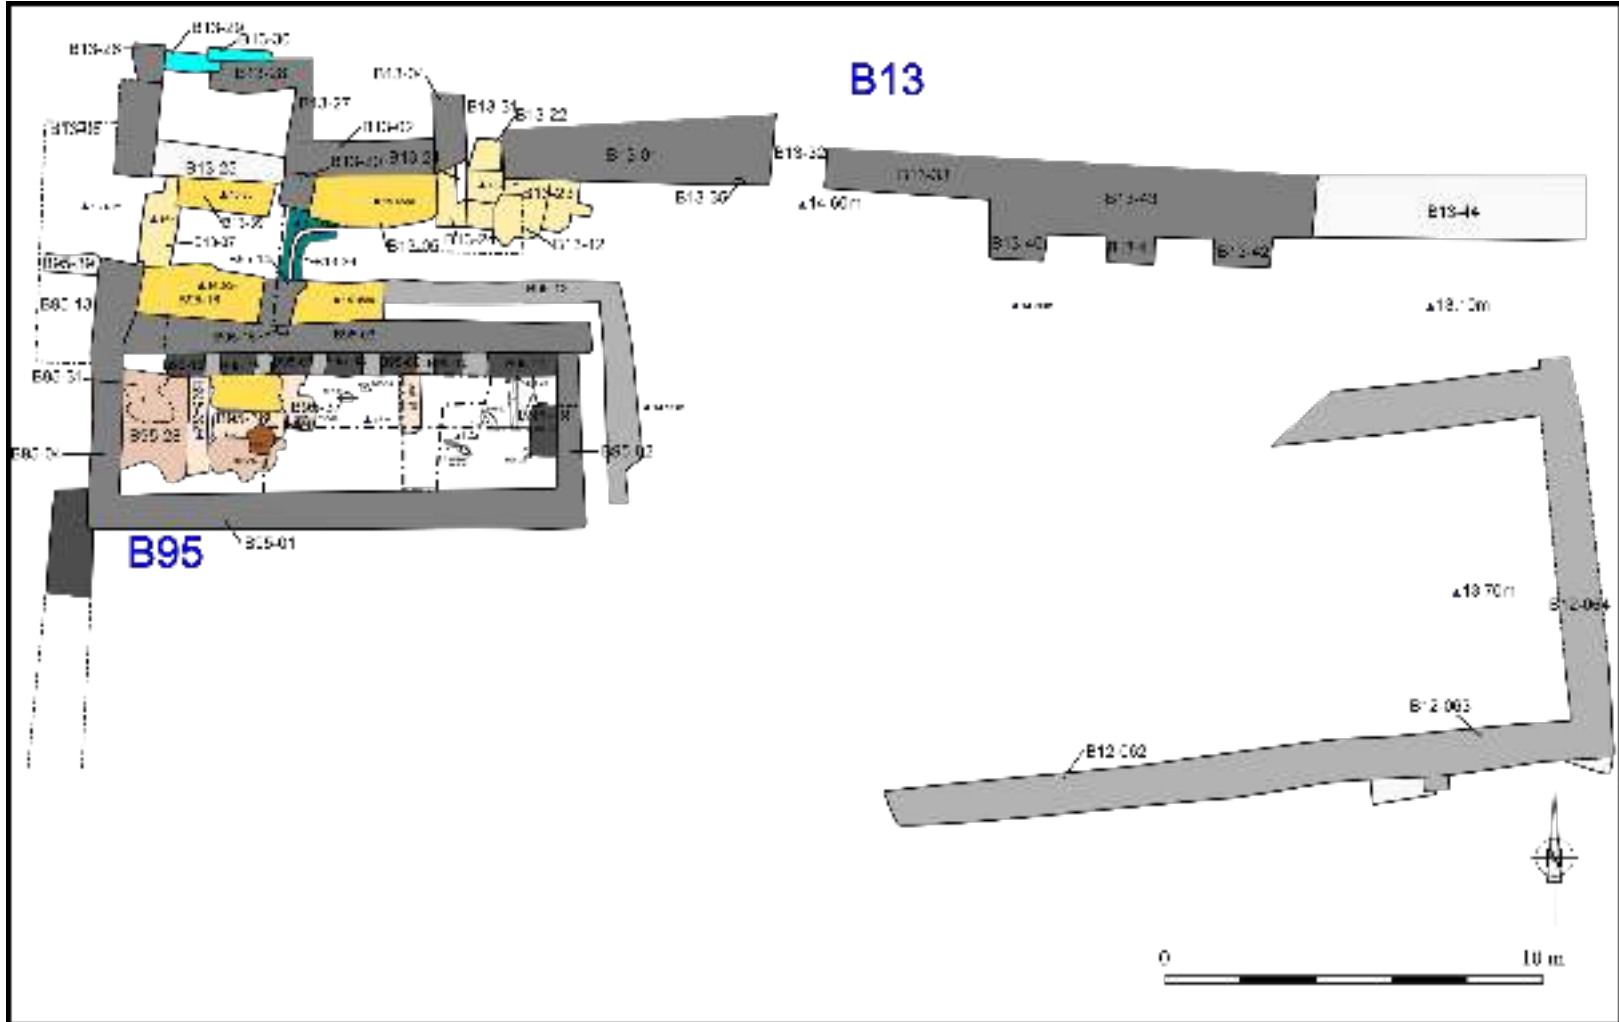
#### Fig 1-285

Fig 1-285 : Site plan and altitudes of the structures of the building B95,

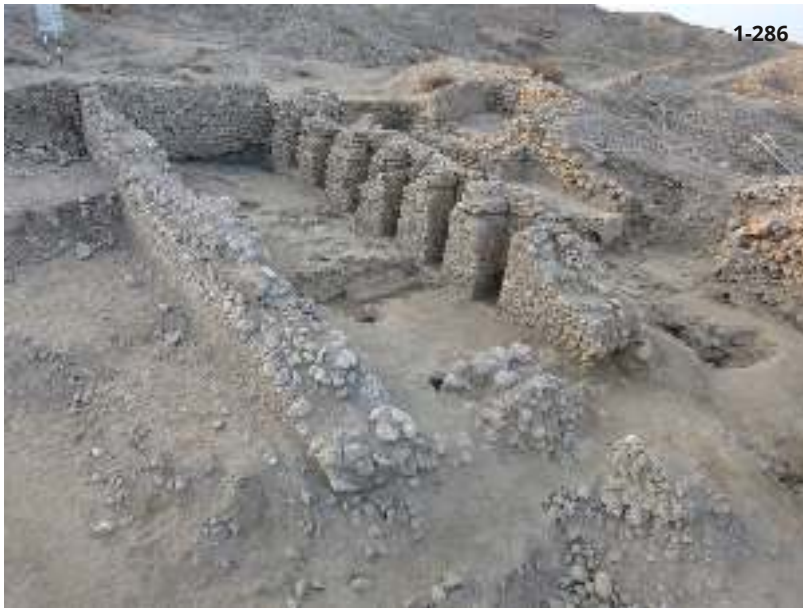
**Fig 1-286 :** general view of the building B95 at the beginning of the 2015b season

At the end of the 2013-2014 season, nearly the western two-third of the room B95 were excavated, down to the level of coated floors (B95-28 and B95-34), where appeared the levelling course of earlier walls (B95-32, B95-34 and B95-37) which were then believed to belonged to the internal fitting of the building. The last eastern third was uncovered until earthen floors (Uf3537, Uf3552, Uf3553 and Uf3557) which were only partially observed and excavated at that time. (Fig 1-286)

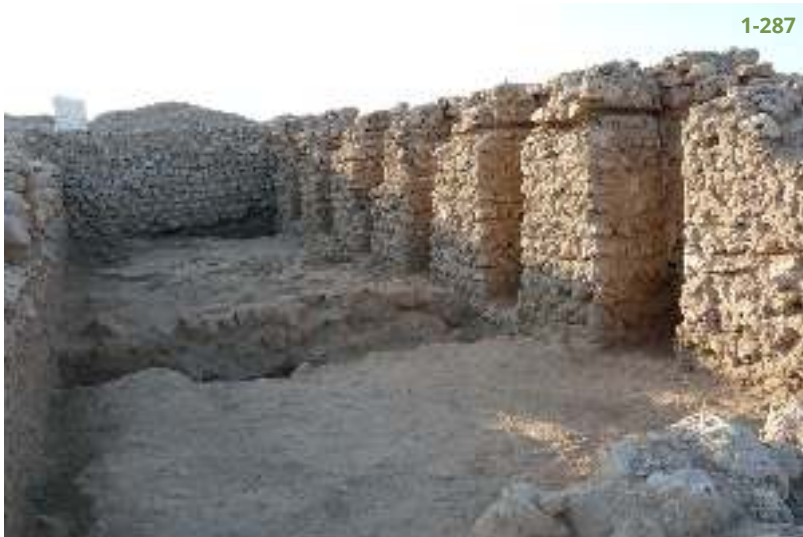
**Fig 1-287 :** general view of the row of pillars in the building B95

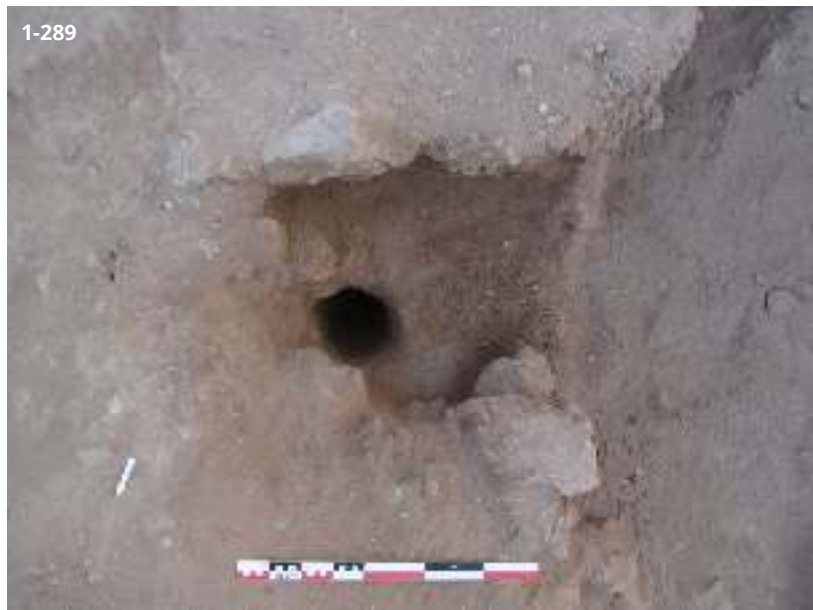
**Fig 1-289** : the pit B95-30, fully excavated

More than 1m to the west, the pit B95-30 (Fig 1-289), at least 0.60m long, 0.45m wide and 0.20m deep, was also dug through the earthen floor Uf3576 and partially cut by the sounding opened by the QP. This oval pit is surrounded by medium stones and filled by two different layers. The lowest one (Uf3578) is an organic orange brownish layer very loose and powdery and could be the natural deterioration of rejected natural material. This organic layer is covered by a level of small pebbles mixed with whitish silt (Uf3579) leveling the pit. It is so possible that the pit B95-30 was used as a rubbish deposit finally covered by a sanitary level made of small pebbles.

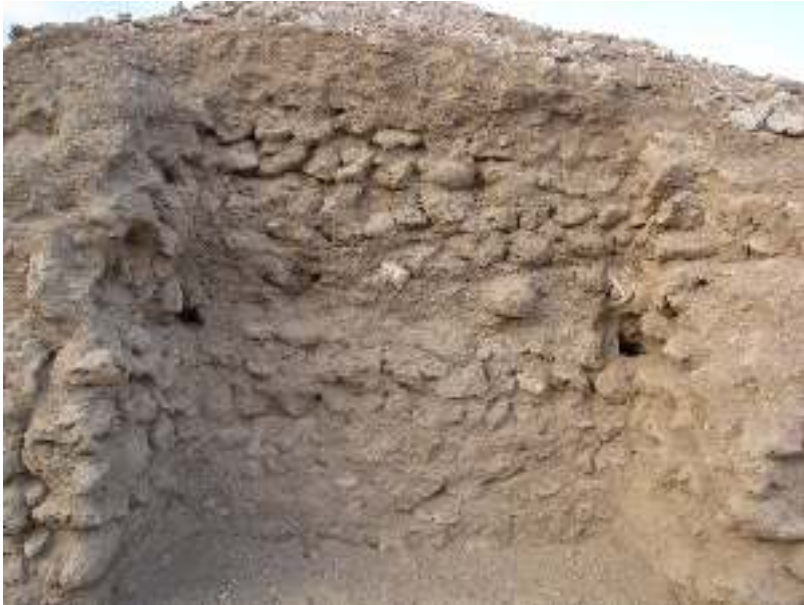
**Fig 1-301** : *the prints of the wood settings used to strengthen the walls*

All these walls are very-well made, with medium sized pebbles, limestone and corals blocks bonded with a strong beige mortar. If some parts of the facing has collapsed, the internal core is well visible and made by regular and well-made courses of pebbles and corals. No coating was found on the walls and no fragment was found in the collapse but as it was an outside wall, it is possible that the coating had entirely disappeared by the wind activity. An important wooden setting was also observed to strengthen the connection between the south wall B13-43 and its buttresses (Fig 1-301). Around 1m above the actual surface of the mosque courtyard, horizontal beam-holes were found on the east, south and west sides of the buttresses, making some kind of strapping around the masonry. The beams were also entering for around 0.50 m into the internal core of the south wall B13-43, making a really strong construction. It is also possible that the south wall was also strengthened by horizontal beams between the buttresses but the facings are not enough preserved to be strictly affirmative.

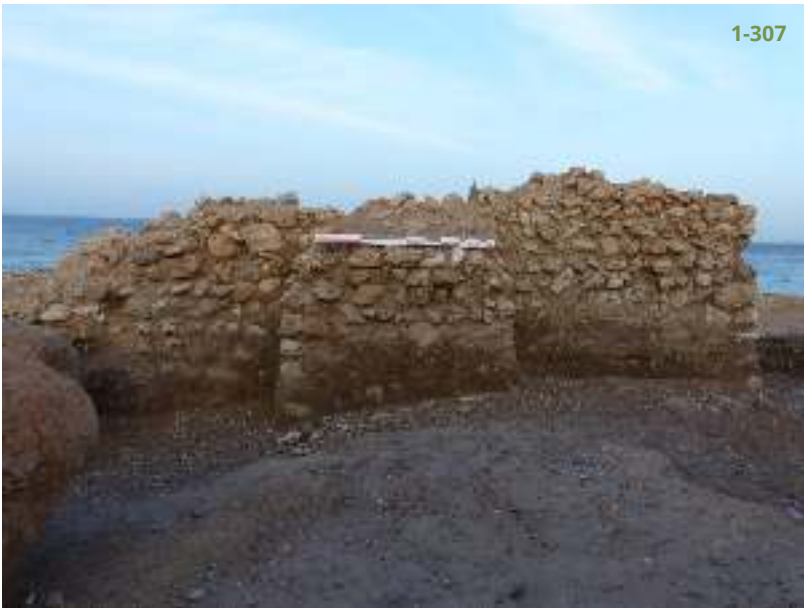
**Fig 1-307 :** the wall B197-04 (under the scale) with the walls B197-02 at right and B197-03 at left

Between the walls B197-02 and B197-03, the structure **B197-04 (Fig 1-307)** is a rectangular construction protruding for around 0.50m from the alignment of the westerly limit of the basement. It is 1.30m long and preserved for a little more than 1m high, and is made with medium corals and limestone blocks bonded with beige mortar. The same coating is preserved in the lowest part, hiding the connections between the walls, while it has disappeared in the upper part, showing that the wall B197-04 is leaning against the walls B197-02 and B197-03. It is so probable that these two walls make in fact a single wall, against which was later built the projection B197-04, probably shortly later.

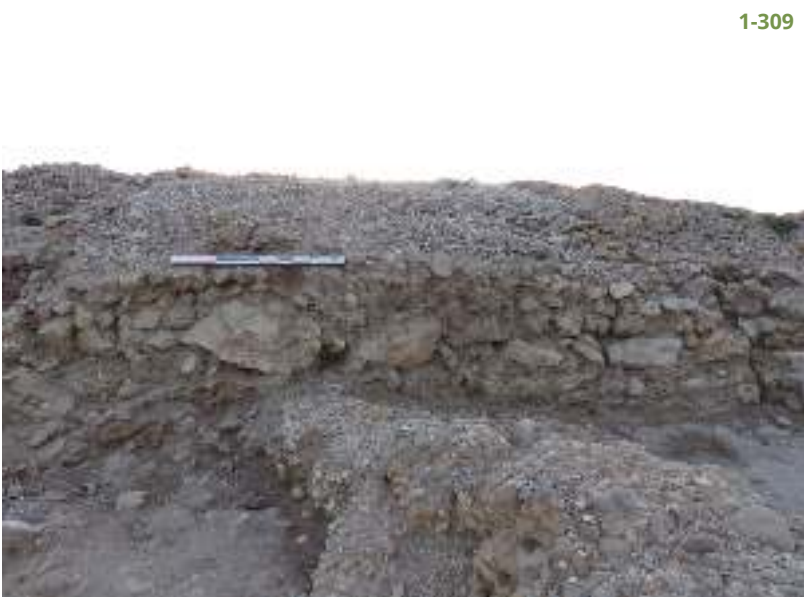
**Fig 1-309 :** the wall B197-06

The east side is made by the wall **B197-06 (Fig 1-309)**, 4.90m long for a maximal preserved elevation of 0.90m and an unknown width as its west facing was not uncovered. It is badly preserved, especially at

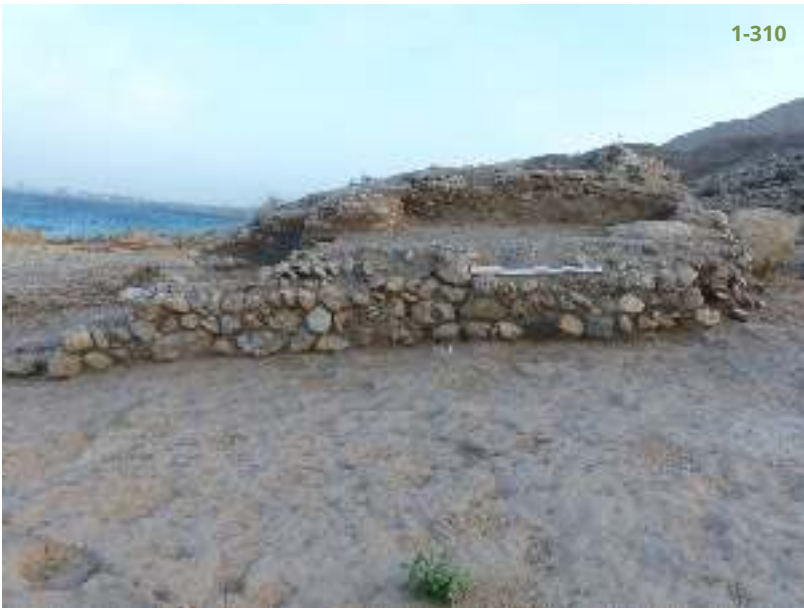
**Fig 1-310 :** the wall B197-07, in the foreground

The north side of the stairs is made by the wall **B197-07 (Fig 1-310)**, nearly parallel to the wall B197-05, 5m long by 0.50m wide for a maximal preserved elevation of 0.70m high. It is made with large to medium corals and limestone blocks, bonded with earthen mortar, and no trace of coating was observed. Its west end, at the junction with the wall B197-08, is unfortunately destroyed.

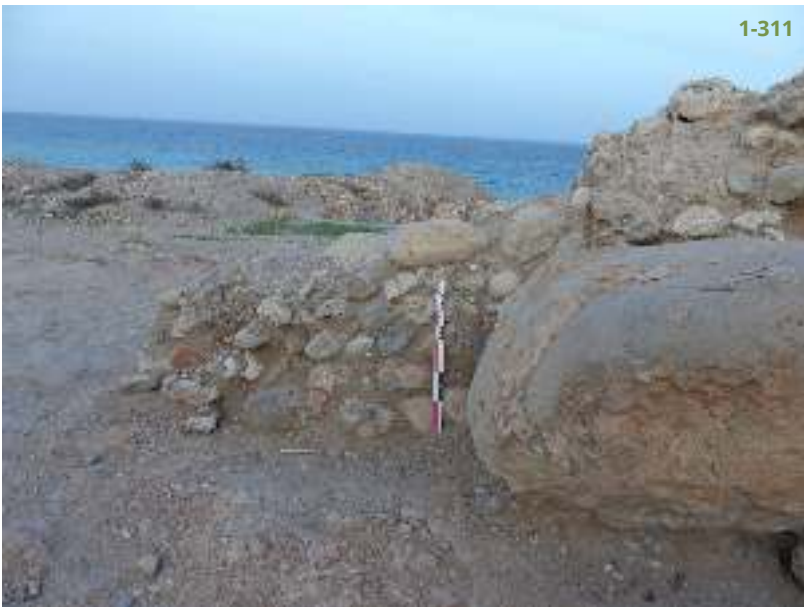
**Fig 1-311 :** the wall B197-08, with the massive natural pebble at right

The west wall **B197-08 (Fig 1-311)**, poorly preserved, is built against a very massive natural pebble which has detached from the puddingstone cliff edge and has rolled down the slope. It is in fact quite impossible to state if the stair was built against the large stone or if it has later detached from the cliff and has rolled against the wall. It is 1.46m long and around 0.50m wide in average with a maximal preserved elevation of 0.70m, made of large to medium unorganized corals and limestone blocks bounded with earthen mortar and without coating. Though the presence of the large stone did not help the observation, it seems that the wall B197-08 is leaning against the corner of the walls B197-03 and B197-05, and could so be a later addition.

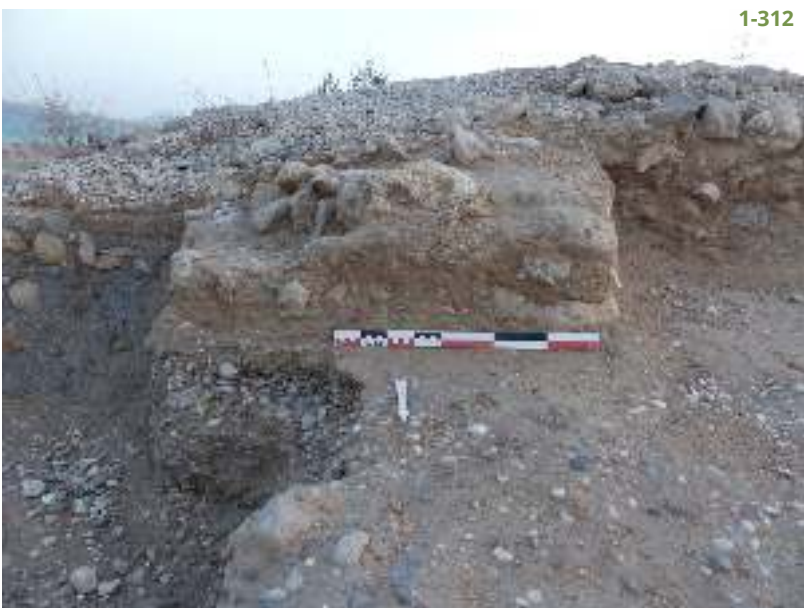
**Fig 1-312 :** the assumed step B197-05

In the east part, built against the wall **B197-05 (Fig 1-312)**, the construction B197-09 is 1m long by 0.55m wide for a preserved elevation of 0.35m high, and is entirely covered by a strong grayish beige coating. It has been interpreted as the final step of the stair, reaching the circulation level of the southerly main building. Other much damaged steps are guessable at east and it is very likely that the west part was occupied by a small terrace or a high bench.

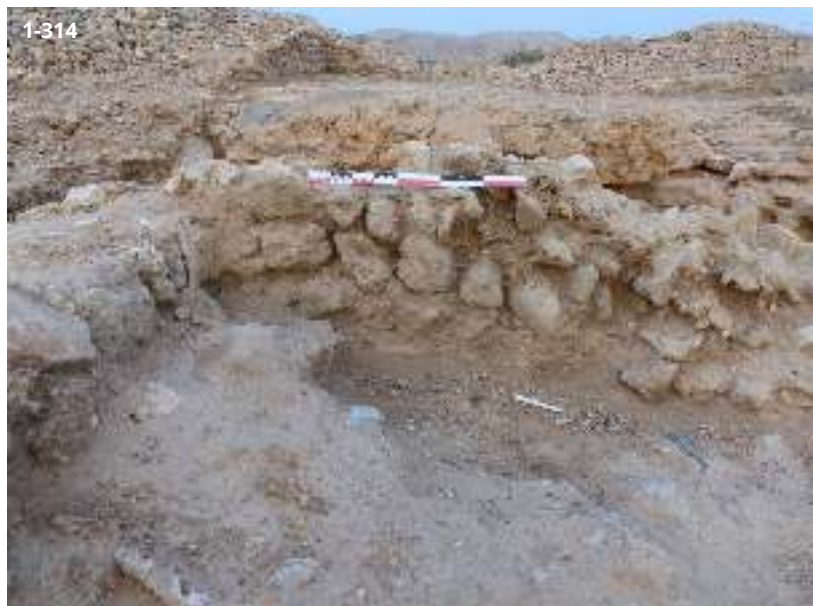
**Fig 1-314** : the internal corner of the walls B197-02 and B197-03 with a small remains of coating which could mark the original level of the floor

The internal facing of the walls B197-03 and B197-02 have only be observed for 0.20m and 0.30m high, made by irregular courses of small corals and limestone blocks with no preserved coating. At the south-west internal corner, a small trace of coating was observed against the walls B197-02 and B197-01, with a small projection possibly marking the delimitation between the backfill and the pebbles floor (**Fig 1-314**).

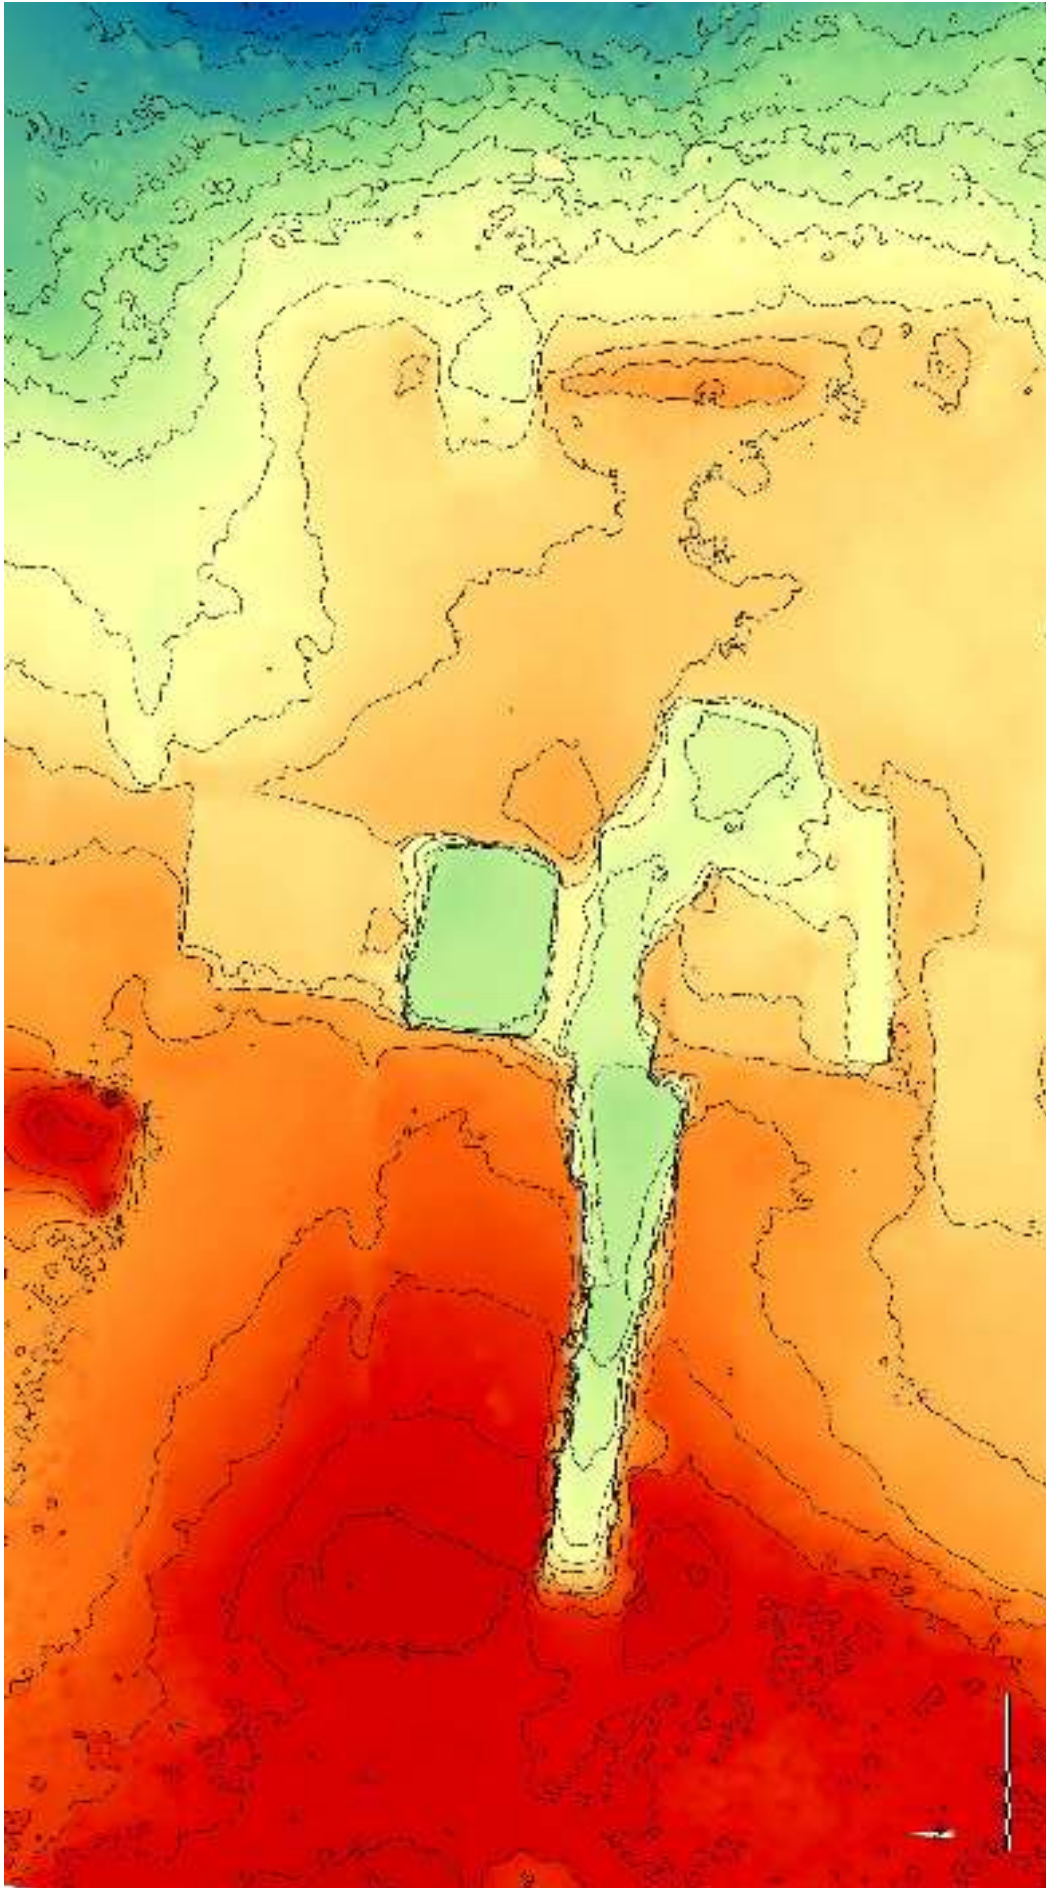
Fig A-21 : Digital Elevation Model of B4 1 (06/02/16)

The workshop B41 is located between different buildings, B285 to the north, B284 to the west, B40 to the south. Before the excavation started, the sector of the factory was approximately levelled (Altitude between 32m and 31.40m) (Fig A-21). There was a depression to the east of the area (Altitude 29.6m). To the west, building B284 forms a promontory (Altitude 33m). At the end of the excavations, the highest point was at 32.4m and the lower point was at 28.65m at the bottom of structure 45 (Fig A-22).

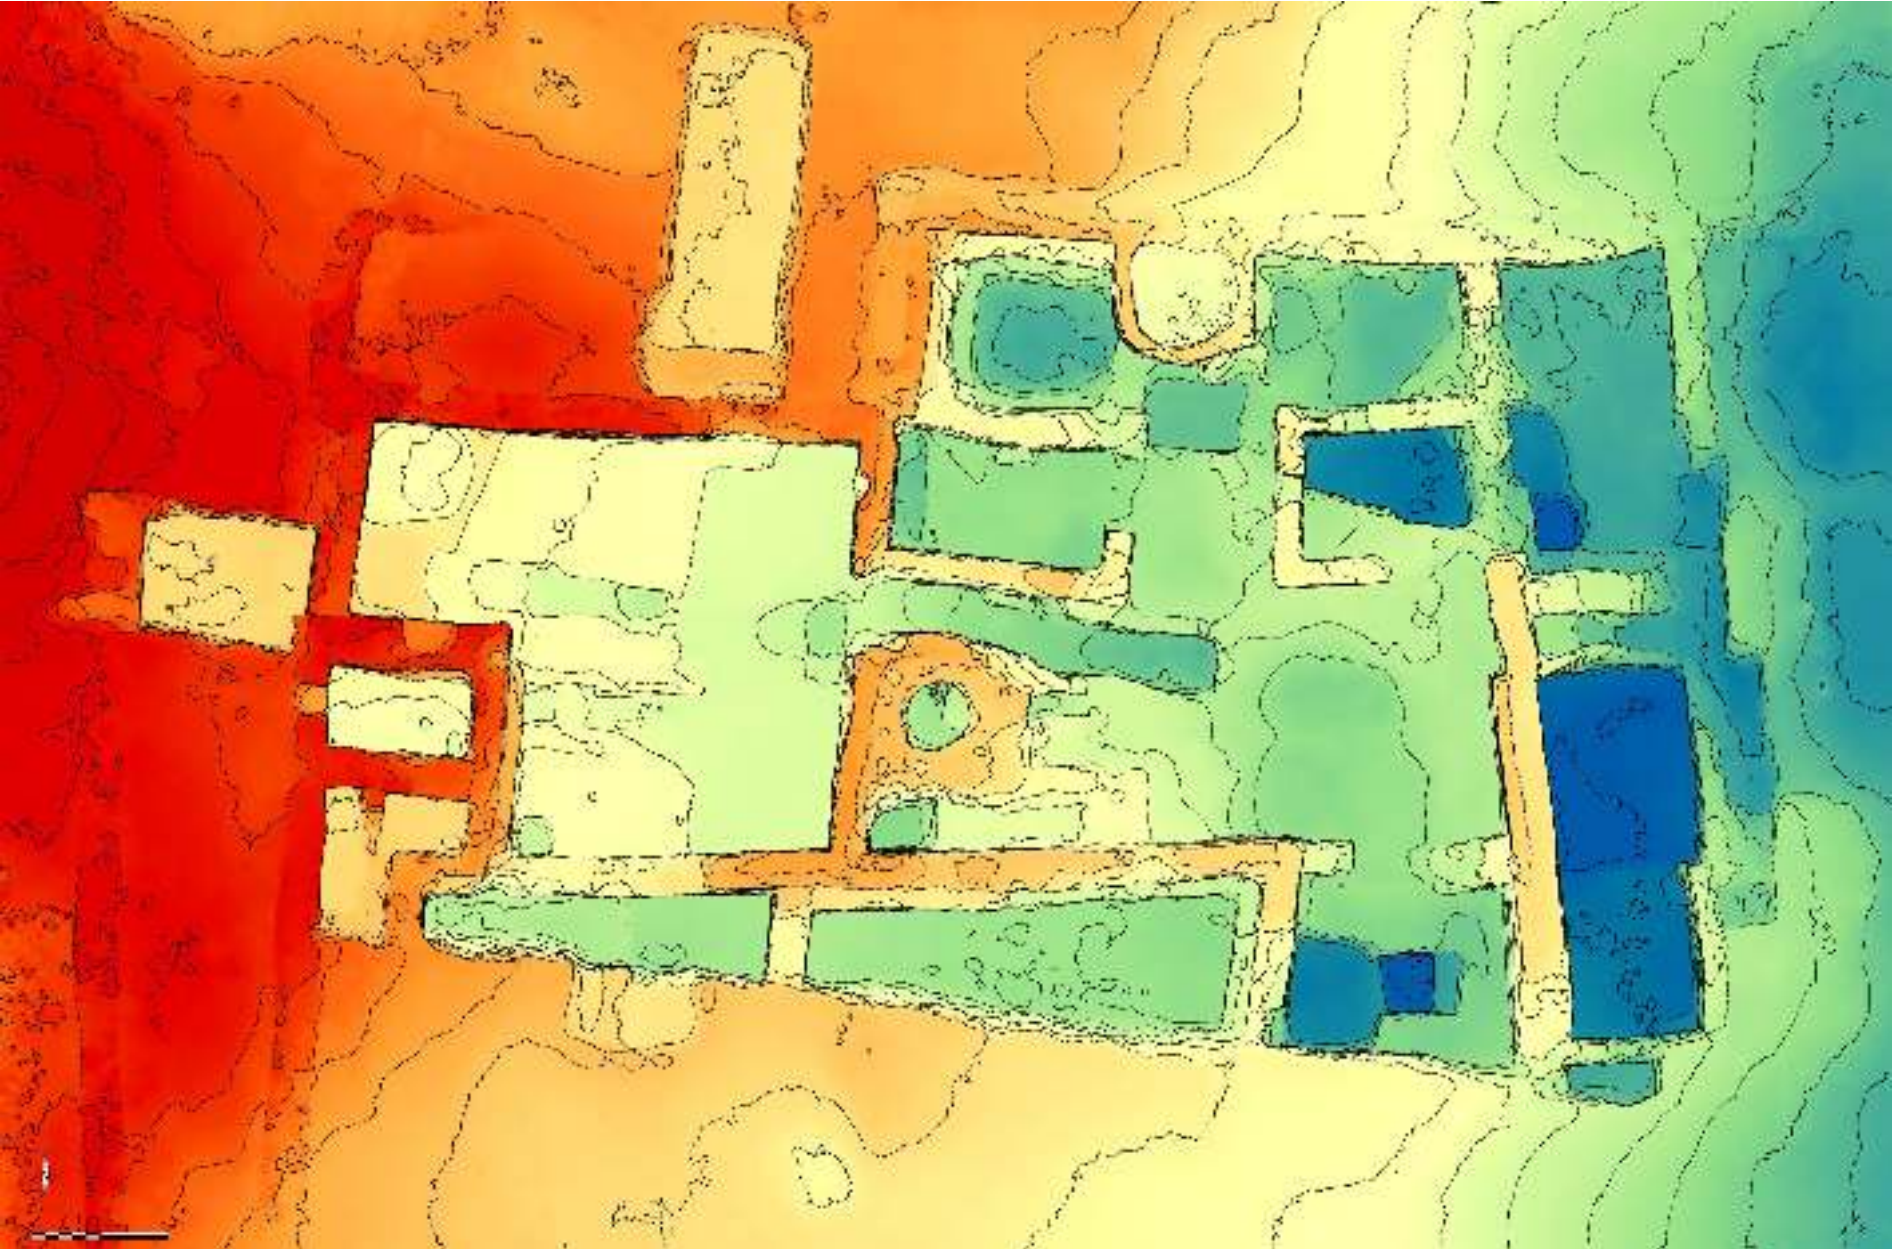
Fig A-22 : Digital Elevation Model of B41 (24/03/16)

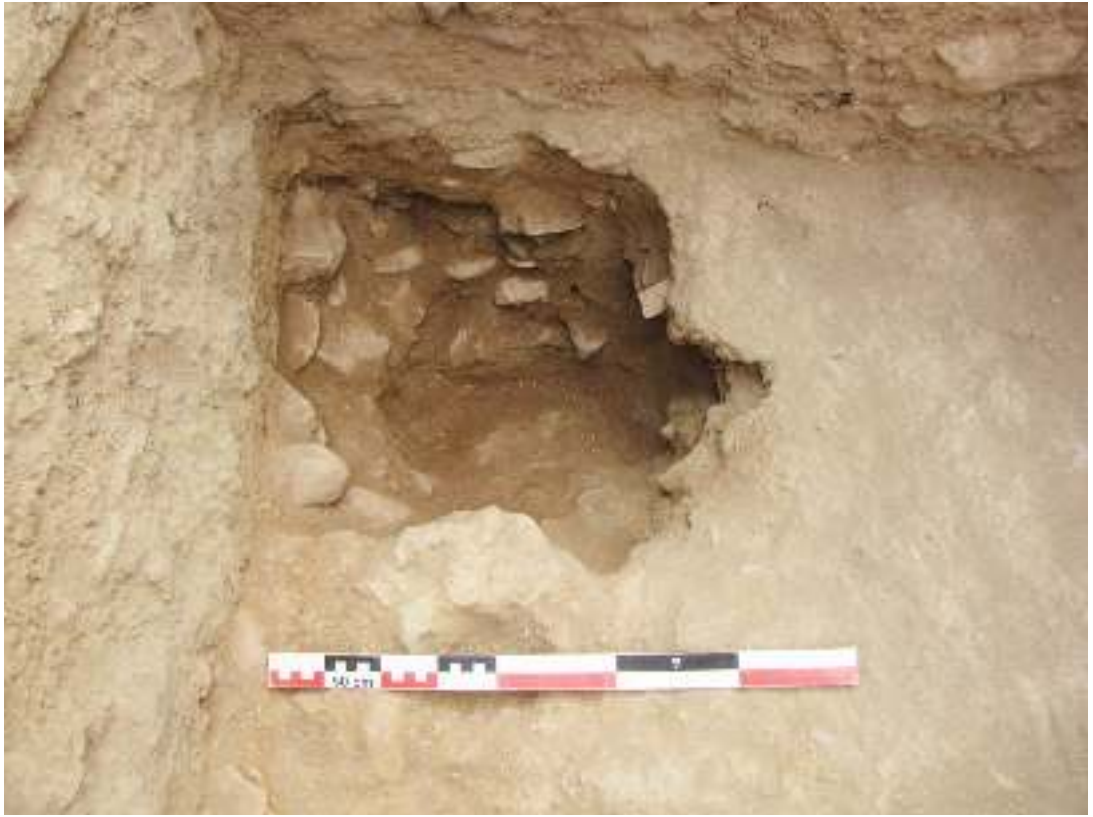
Fig A-26 : Phase 1 of B41
