## Qalhât Development Project, Season 2015B-2016A, Final Report

**QALHÂT (ASH-SHARQYJAH)**

**SEASON 2015B-2016A**

**FINAL REPORT**

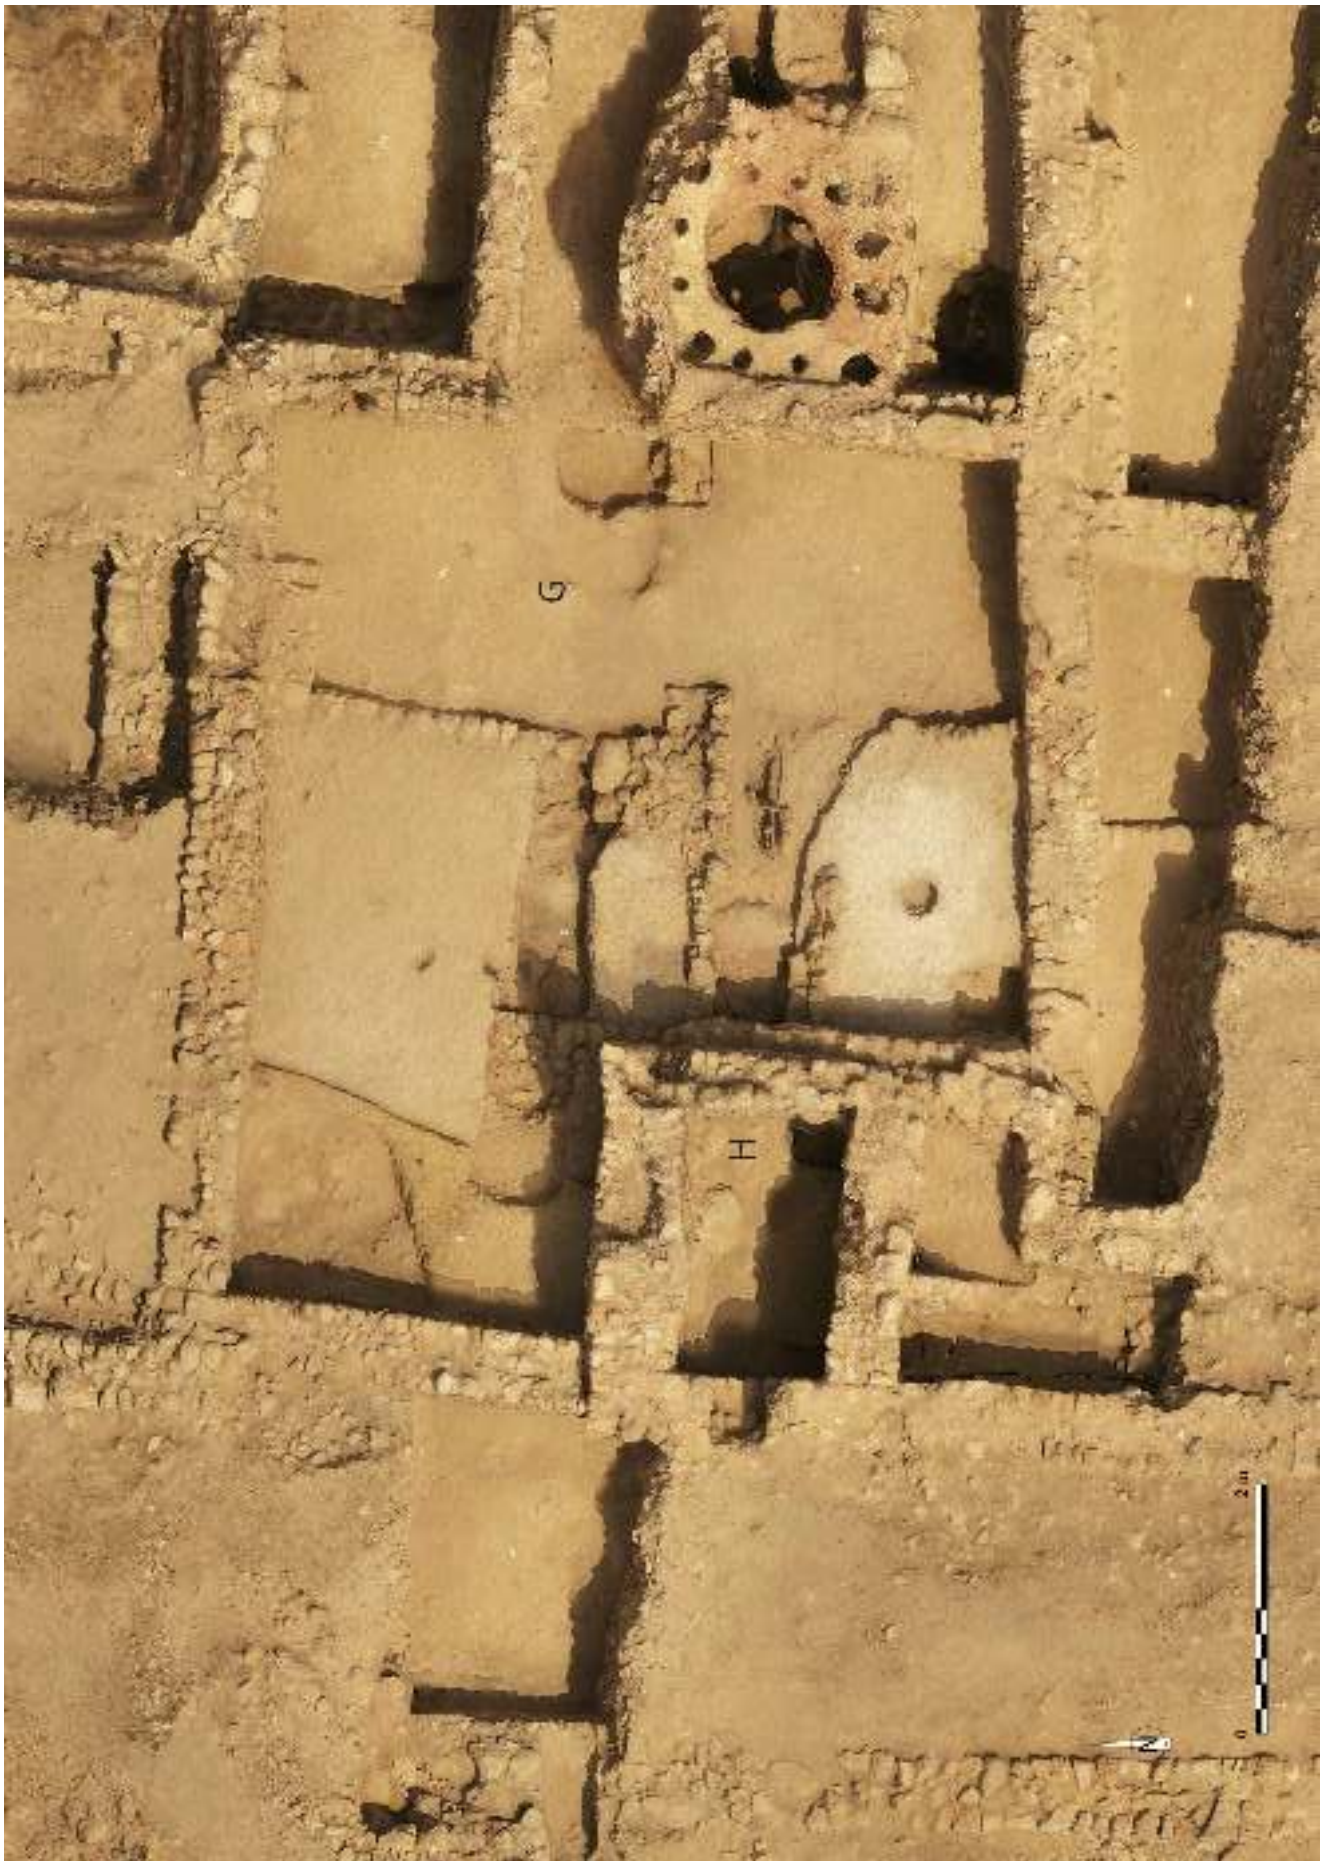
Fig A-28 : Room H and space G

Wall B41-14 is in the same axis as B41-30 but the connection between these two structures is unclear because of refurbishments that took place at their junction. It is founded directly over the bedrock and measures 3.55m long, 0.55m wide and 1m high. Wall B41-08 is oriented east-west; it is leaning on B41-14 and delimits the workshop to the north side. It was erected over the bedrock and measures 7.52m long, 0.47m wide and its maximum height preserved is 1.56m. It has an outward opening including a step, structure B41-56, which is 1m long, 0.44m wide and 0.19m high (Altitude 30.65m). It is linked with wall B41-06 oriented north-south which in its first phase measures 1.06m long 0.42m wide and 2.20m high. Its western side has a niche of 0.47m long by 0.75m high. It underwent refurbishments, which will be detailed in the section dedicated to the third phase of the workshop. Wall B41-05 is in the same axis as wall B41-06 but it is leaning perpendicularly on wall B41-02. It measures 3.04m long, 0.45m wide and 1.60m high. Wall B41-18 is built over the bedrock and is oriented north-south. It measures 1.40m long, 0.43m wide and 0.30m high and is built against wall B41-50. These walls create an enclosed space (Room G) (*Fig A-28*).

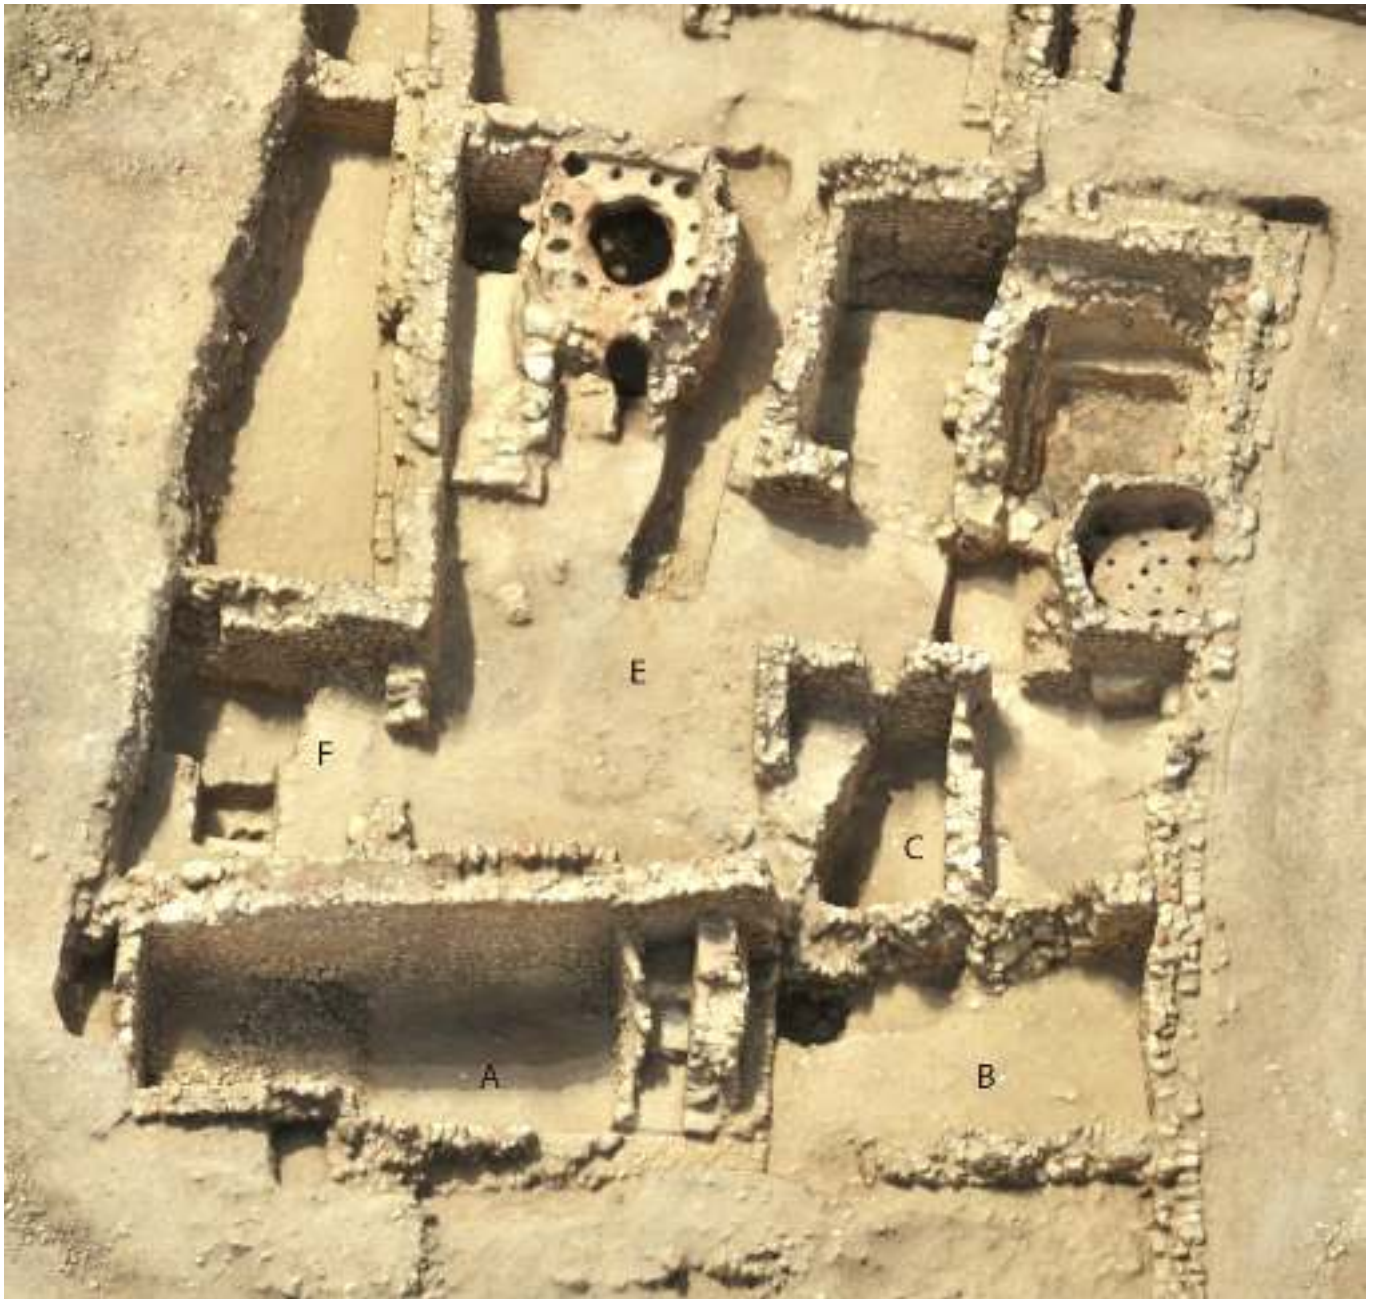
Fig A-29 : General view of space E

Wall B41-40 is perpendicular and is leaning on wall B41-41. It measures 2.63m long, 0.40m wide and 0.80m high. It is endowed with an opening across the total width of the masonry and measuring 0.37m long. Its height is not known since the upper parts of the wall are not preserved. It is built over large blocks of the bedrock. Wall B 41-37 is perpendicular and leaning on it, it measures 2.75m long, 0.40m wide and 1.05m high. Another niche was built measuring 0.28m wide at its base, and 0.48m at the level of destruction of the wall. Wall B41-33 is perpendicular to B41-37 on which it is leaning, and parallel to B41-40. It measures 1.26m long, 0.40m wide and 0.77m high. This set of three walls creates an enclosed space inside Room E (Room C) whose function is still to be determined (*Fig A-29*).

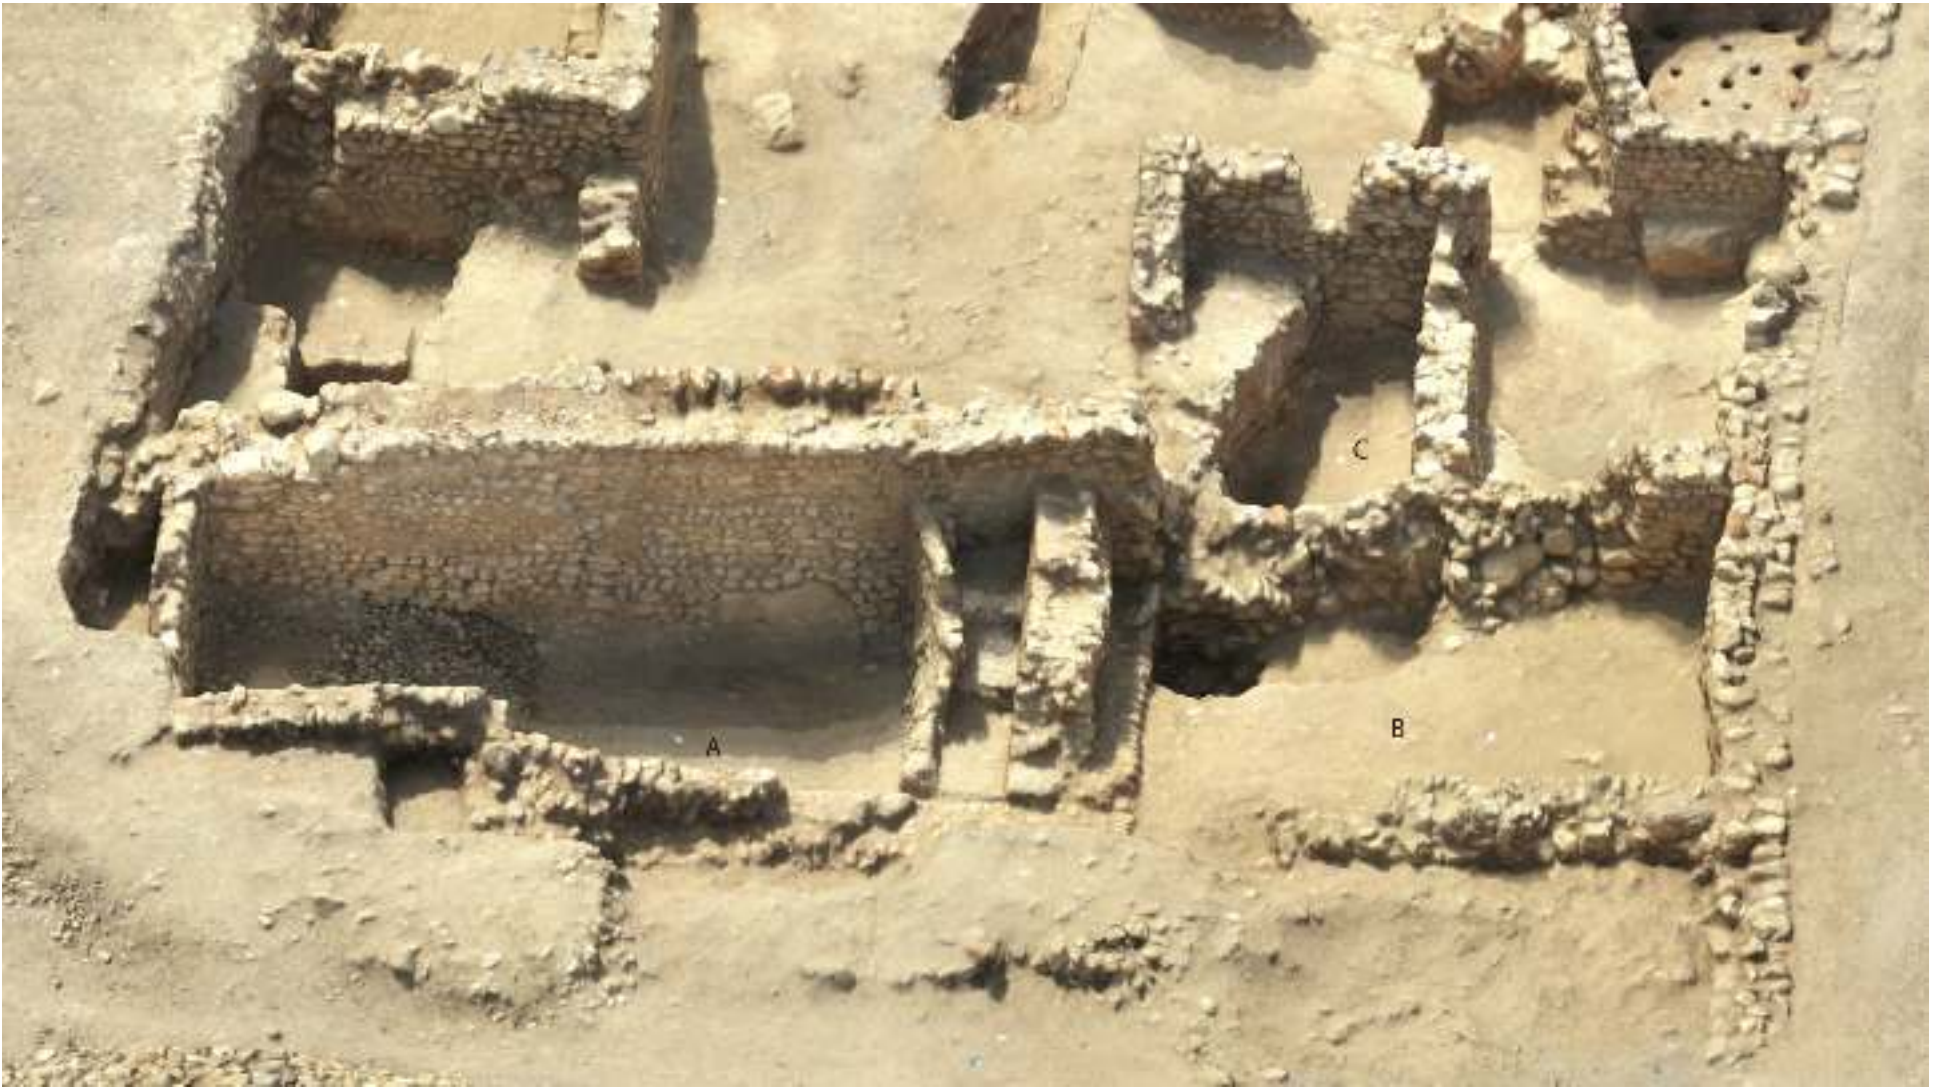
Fig A-30: detailed view of rooms A, B and C

Inside the workshop, the opening between areas E and F is not closed but only narrowed with the construction of B41-28, which is built perpendicular to wall B41-27. It is facing B41-46, but unlike wall 46, which is connected to wall 12, B41-28 is leaning on wall 27. It measures 0.68m long, 0.45m wide and 0.65m high (Fig A-30).

B41-24 is the support of two perpendicular walls B41-41 and B41-63 which enclose room B to the east and west. The first one measures 3m long, 0.60m wide and 1.30m high. Its facing has partially collapsed. The foundation is irregular, large blocks from the bedrock are for instance used for the base. B41-63 is parallel to it ; it is oriented north-south, measuring 3.29m long, 0.48m wide and 0.55m high. It operated with B41-26 which is built in the same axis. A space measuring 1.05m between them creates an opening which gave access to the workshop (Fig A-30).

The phase 3.1 also involved the addition of walls and the closure of some access (**Fig A-30**).

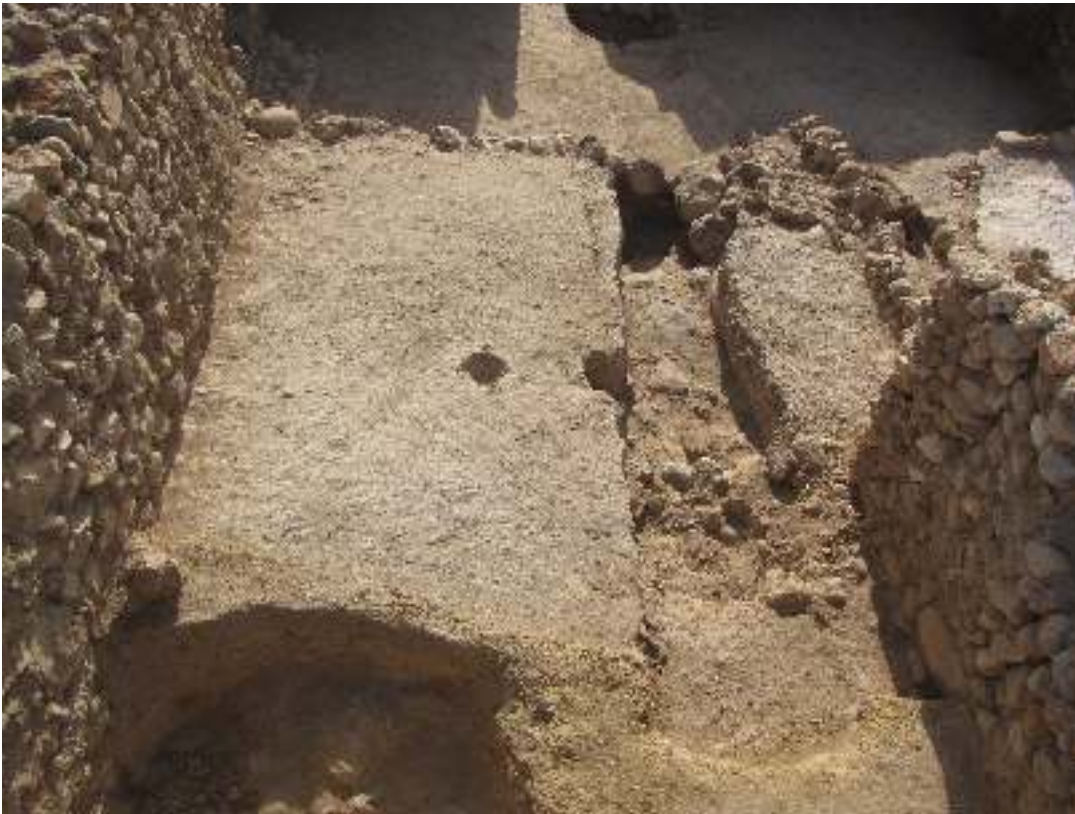
**Fig A-33 :** *Structure B41-17*

The ongoing assumption concerning B41-17 (**Fig A-33**) suggests work and / or storage of clay area. It is built directly over the bedrock, and leaning on walls B41-56, B41-50, B41-08 and B41-18 which closes the platform to the west (Altitude 30.83m). It measures 3.70m long, 4.85m wide and 0.30m high. The platform itself is made of a homogeneous light grey compact indurated mortar (UF 6117). It contains some ceramics and gravels. This structure is sealed by a layer of crushed, yellow to green clay (UF 6118, max Altitude 31.20m). Very locally against the wall B 41-08 there is a compact heap of brown clay (UF 6228) above UF 6118.

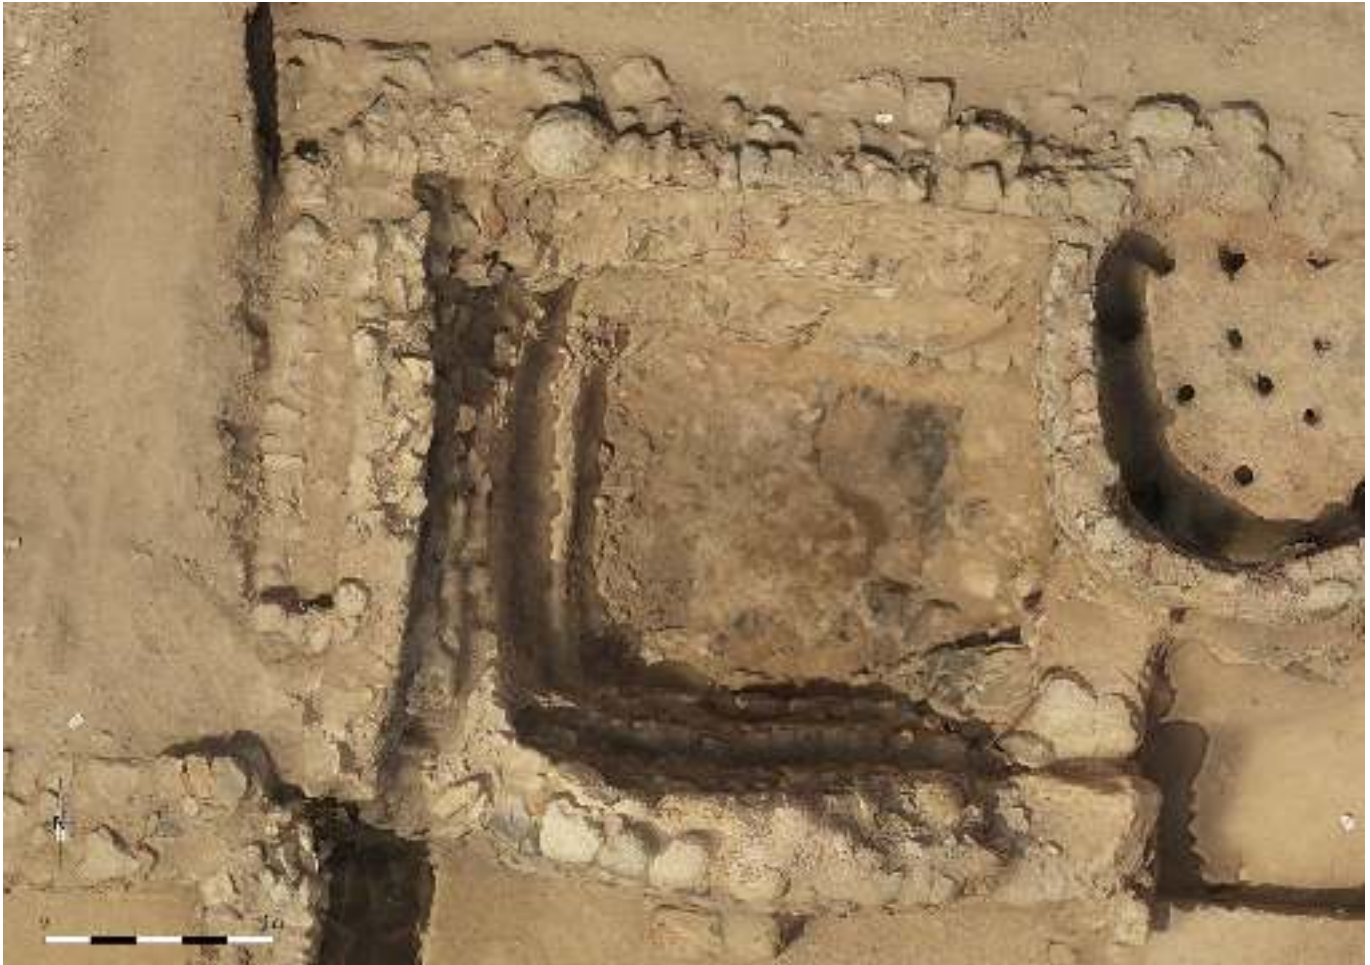
Fig A-35 : *Kiln B41-10*

In room E, kiln B41-10 was built during this phase (min Altitude 29.51m). It was built along walls B41-09 and B41-24. Its plan is rectangular. It is seriously damaged. The heating room of the kiln is the only part remaining. Its external dimensions are 3.27m long and 3.06m wide. It is preserved over a height of 2.20m. The heating room measures 2.00m long and 1.40m wide. It was built with medium to large blocks of stones directly over the bedrock. Along the western wall of the chamber, there is a vitrified bench. There is no trace of any support or floor (**Fig A-35**).

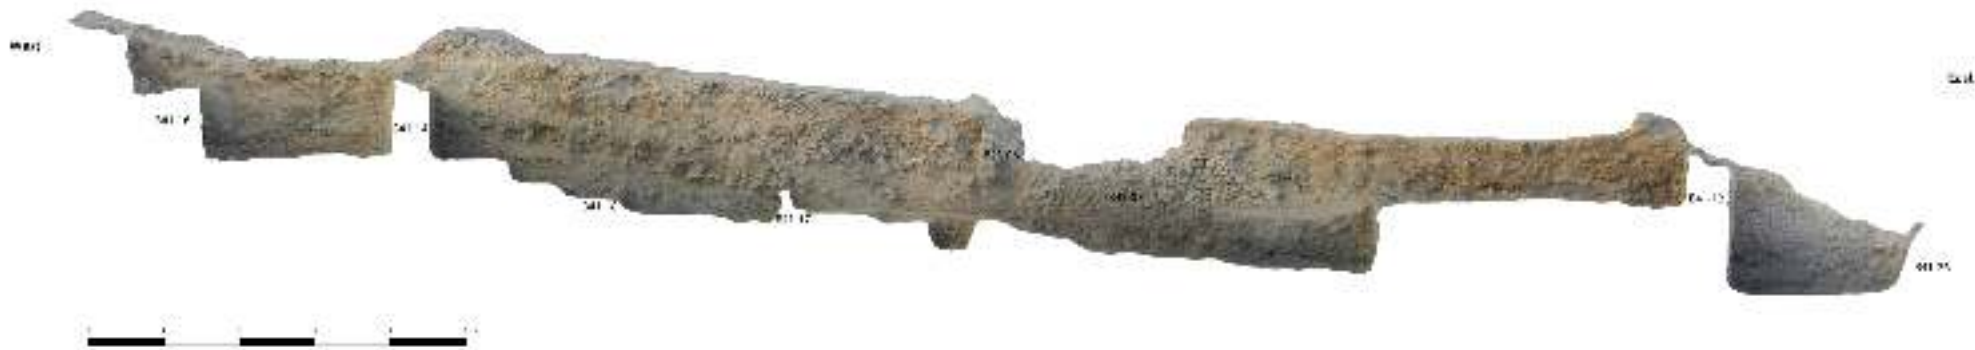
Fig A-53 : Longitudinal west–east trench

As from the sequence 3.3, the room G becomes a dumping ground for the workshops. There is a stack of layers (UF 6127, UF 6146, UF 6223, UF 6224, UF 6227) containing many ceramics, wastes, slags and burnt fish bones. These UF correspond to artificial passes UF 6014, UF 6020, UF 6163, UF 6333, UF 6335, UF 6350, and UF 6359 (Fig A-53).

At first, room G is a dumping ground of another potter's workshop (**Fig A-69**). In the northern part of the room, there is a stack of layers of wastes, slags, kiln pieces of wall, burnt fish bones (UF 6138, UF 6147, UF 6148, UF 6149, UF 6150 and UF 6151). These UF correspond to artificial passes UF 6156, UF 6323, UF 6328, and UF 6356. Then, wall B41-02 was destroyed. The UF 6230 and UF 6128 correspond to demolition levels south of the room. These UF correspond to artificial passes UF 6130, UF 6158, UF 6348, UF 6349 and UF 6351. At the end of the phase there are very mixed levels (UF 6001, UF 6002 and UF 6342), probably related to a late reoccupation of the area (B41-32) (**Fig A-53**).

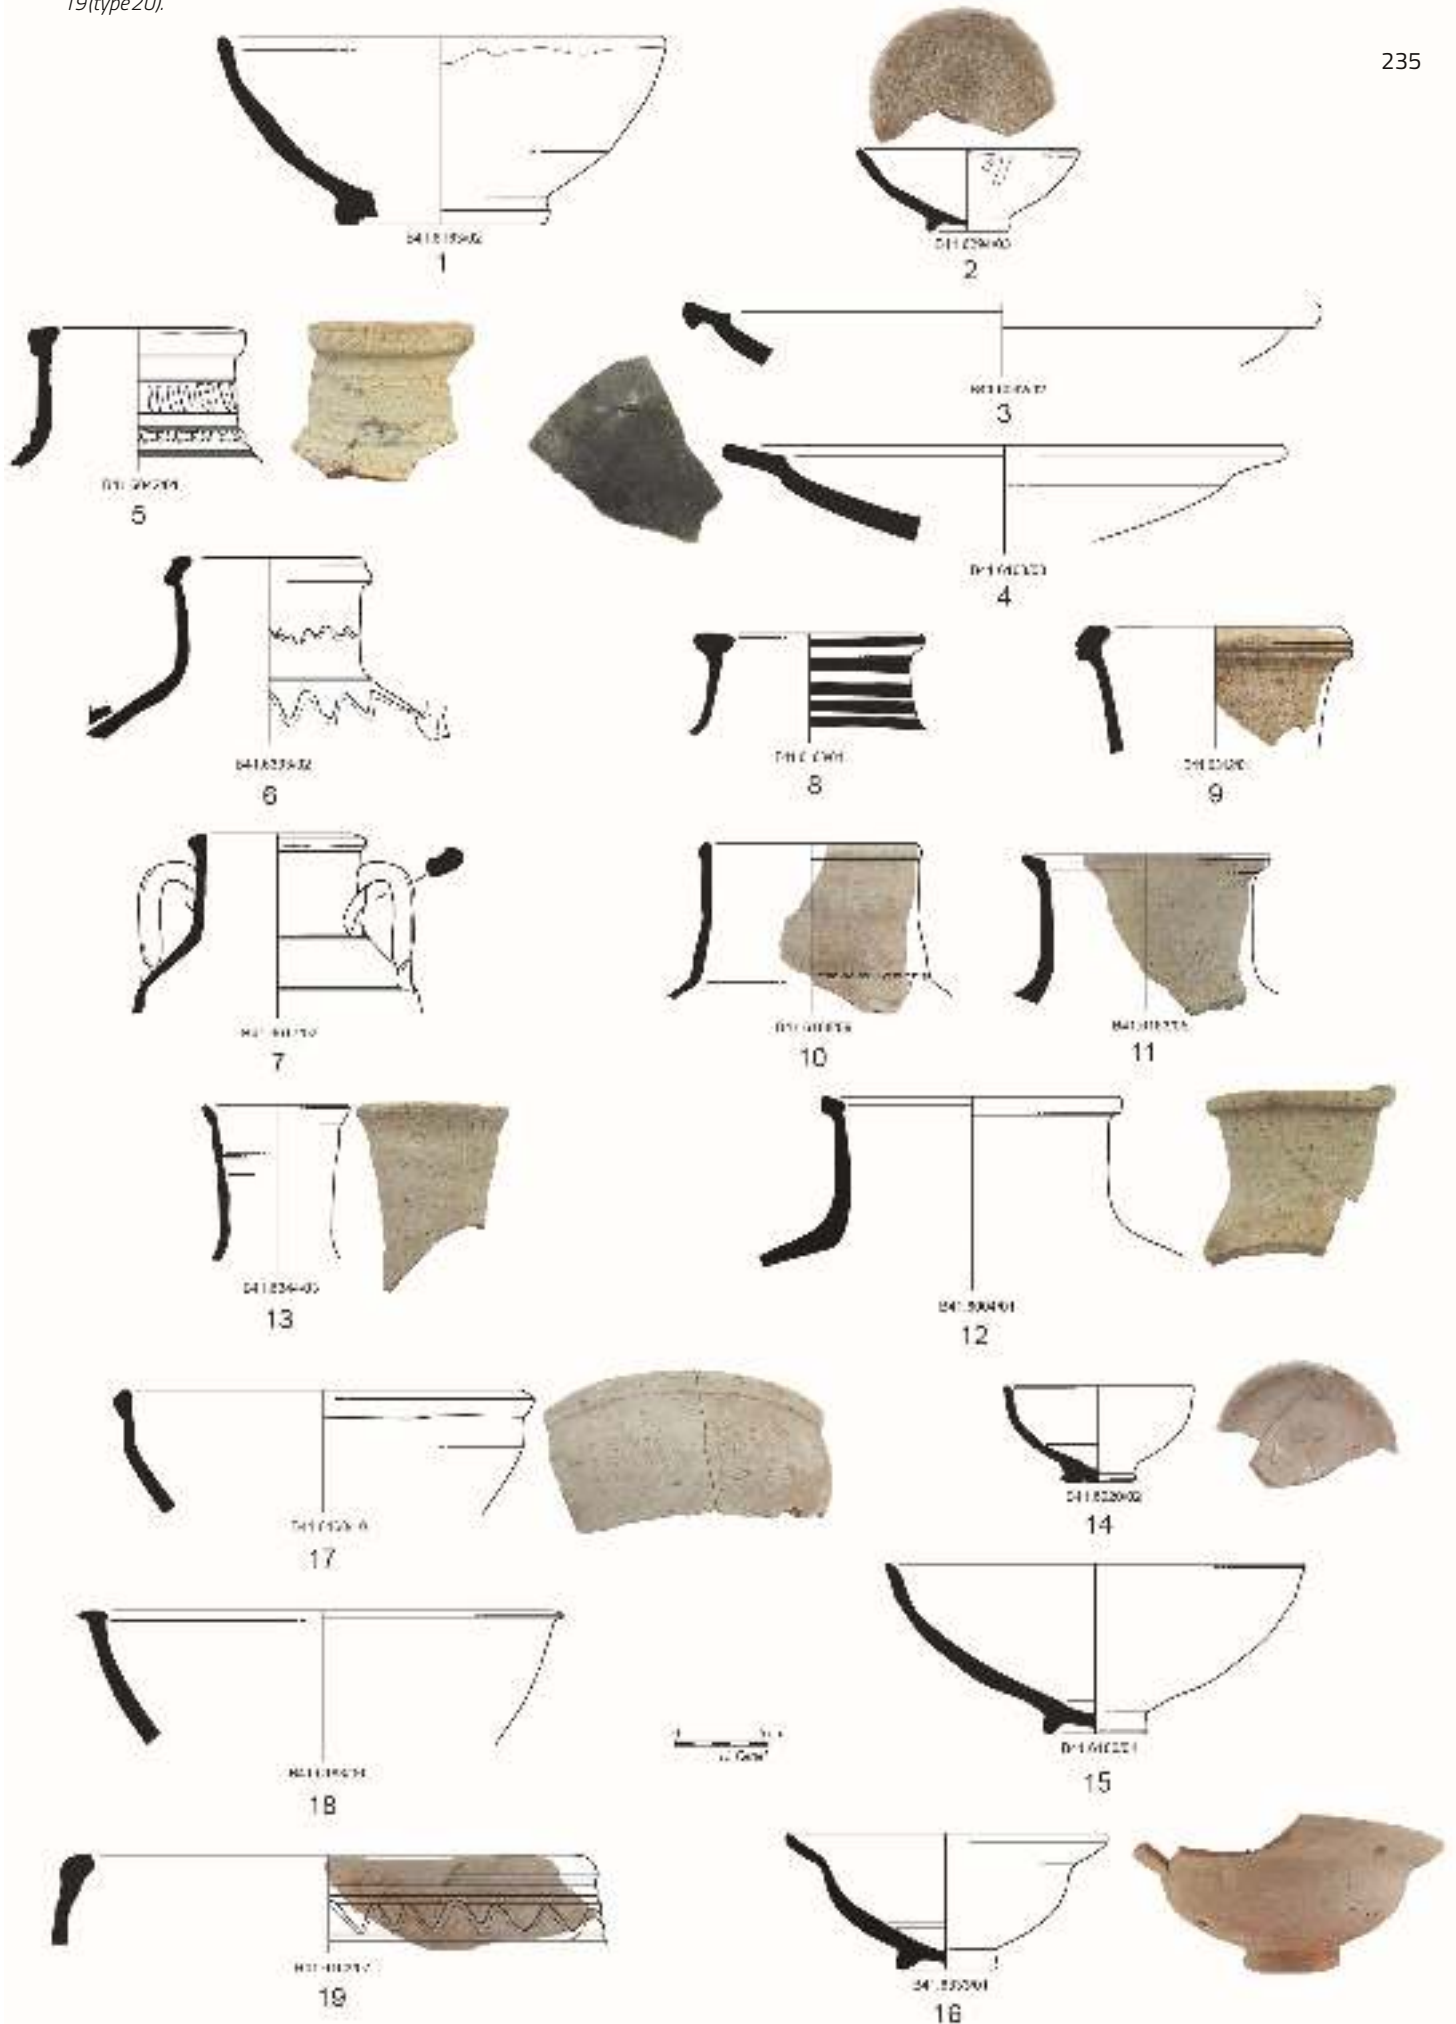
**Fig A-58** : Phase 3 : local production. Glazed bowls : n° 1-2 (type 1D), n° 3 (type 1H), n° 4 (type 1G); large jars : n° 5-6 (type 1A), n° 8 (type 2N), n° 9 (type T1); n° 10 (type 2D), n° 11 (type 2X), n° 12 (type 2I); jar: n° 7 (type 1C); jug: n° 13 (type 2M); unglazed bowls: n° 14-15 (type 2H), n° 16: (type 2V); basins: n° 17, 18 (type 2T), 19 (type 2U).

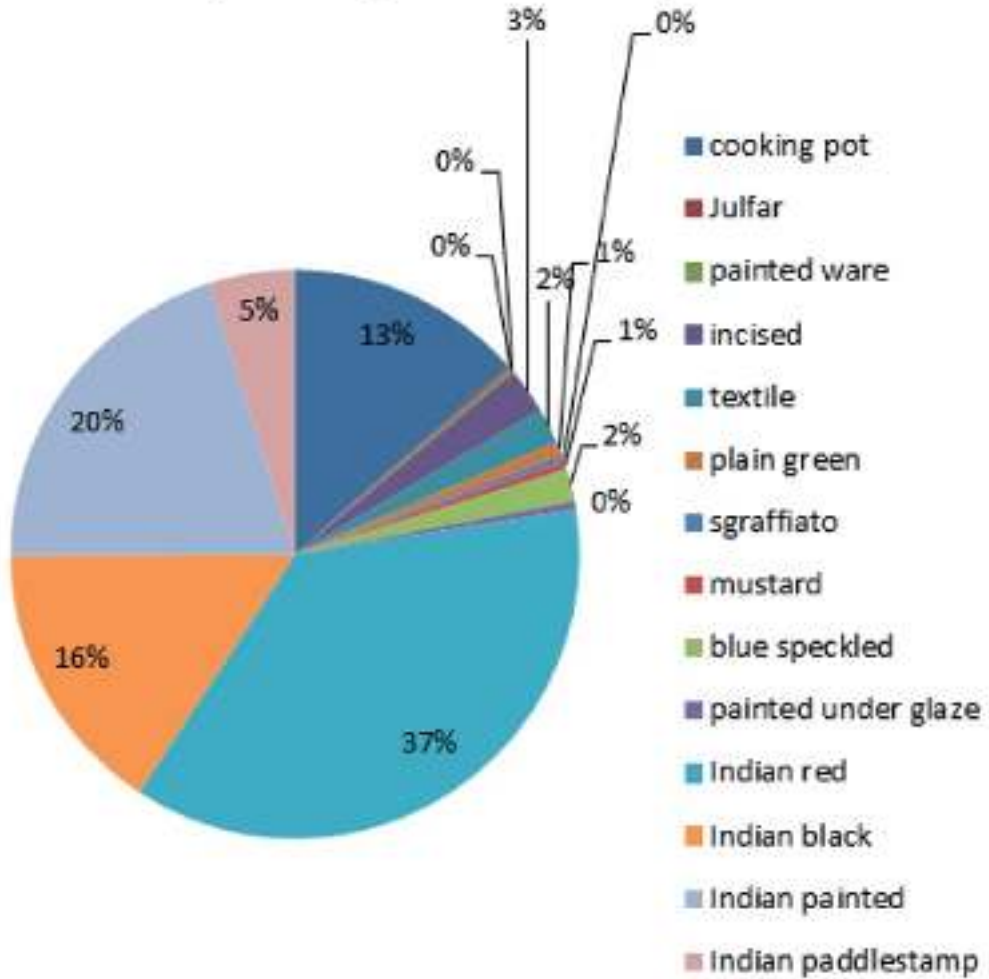
**Fig A-64:** Imported ceramic phase 4. N°1: plain green glazed bowl; n°2: iranian painted underglazed ware; n° 3-5 : cooking pots; n° 6-7: indian black cooking pots; n°8-9: indian red ware.

The « mustard » bowls, common between 1250 and 1350, disappear. The few examples are residuals, founded principally in rubbish levels. Whereas some productions dated from the 14<sup>th</sup> century appear: the bowls with turquoise glaze so-called "blue speckled", bowls with black painting patterns under light pinkish glaze (Fig A-64: 2) and the plain or painted under glazed fritware.

A new shape of cooking pot is present in the levels of the 4<sup>th</sup> phase (Fig A-64: 4-5) next to the cooking pots coming from Julfar (Fig A-64: 3). This new shape is globular with everted rim and combed decoration on the shoulder. It is uncommon in the levels of the houses of Qalhât, some pieces are found in levels dated to the late 14<sup>th</sup> century. Their origin remains unknown for the moment. The importations from India change with a decline of painted jars and the frequency of cooking pots in red or light brown fabric with orange slip (Fig A-64: 8-9).

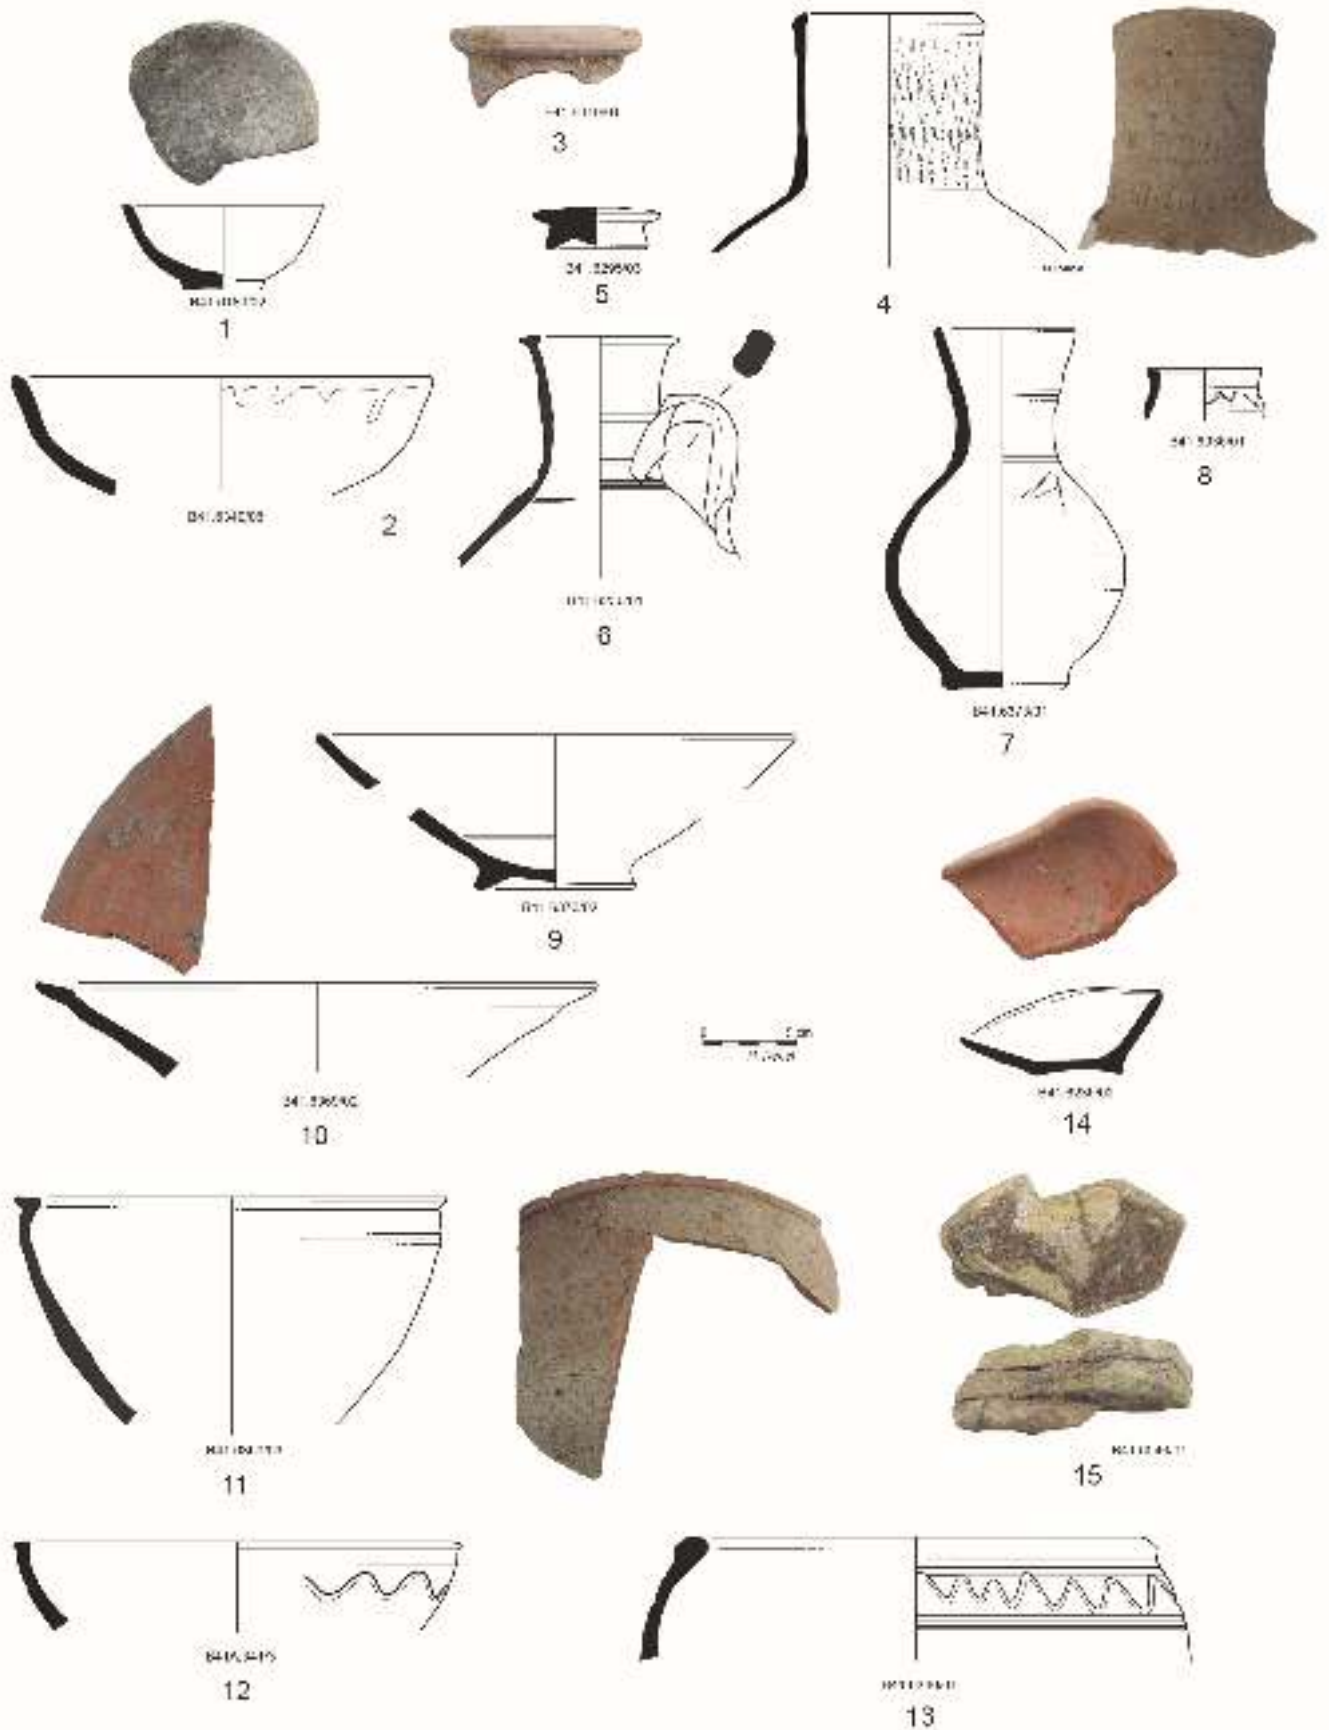
**Fig A-68** : Phase 4: local production Glazed bowls: n° 1-2 (type 1D); large jars : n° 3 (type 1A), n° 4 (type T4); jugs: n° 5-6 (type 2O); bottle: n° 7; pot: n° 8 (type 2S); unglazed bowls : n° 9 (type 2H), n° 10 (type 2V); oil lamp: n° 14 (type 2W); basins: n° 11 (type 2T), n° 12 (type 2K), n° 13 (type 2U, ) tiles: n° 15.

In fact, the forms represented, glazed and unglazed, are equal and produced in the same proportions as during the phase 3 (Fig A-65). We note the confirmation of the reduction in glazed bowls with everted rim (type 1F) and the significant increase of basins (type 2K; Fig A-68: 12). Ascendancy which will be confirmed during the 15<sup>th</sup> and the 16<sup>th</sup> centuries.

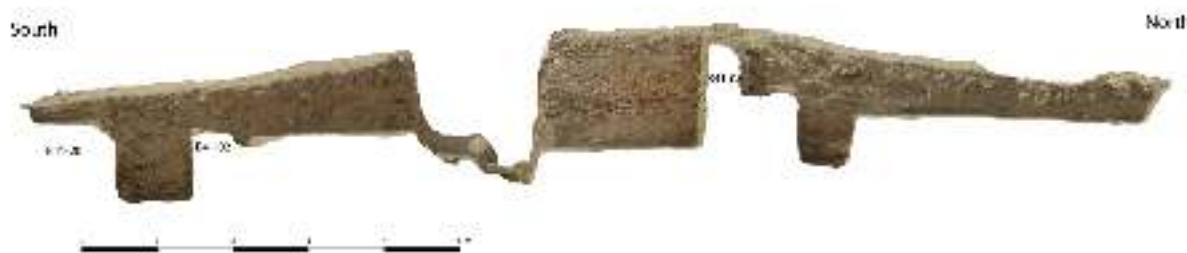
**Fig A-70** : West view of the trench south-north

The northern area outside of room G underwent major redevelopment during this phase. 0.25 m behind B41-67, wall B41-21 was unearthed in trench E oriented north-south. This wall is built on the new floor level of the north street (B41-22, Altitude 31.14 m), it was cleared over a length of 1.94 m and a width of 0.48 m but continues on either side of the trench. In the continuation of B41-14 wall, a dry stones wall B41-32 was built (Altitude 32.21 m). The end of the occupation of this sector has led to the development of several levels of collapse, abandonment and burning (UF 6211, UF 6212, UF 6213, UF 6214, UF 6216, UF 6219, 6220, UF 6221 and UF 6222). These layers were made of homogeneous beige sandy silt. They contain many stones, ceramics, charcoals and gravels. These UF correspond to artificial passes UF 6051, UF 6086, UF 6093, UF 6103, UF 6111, UF 6113, UF 6131, UF 6132 and UF 6154 (**Fig A-70**).

The southern area outside the workshop was filled during this phase. Between wall B41-64, B41-65 and wall B41-66, filling was made of stones and ceramics included in homogeneous loose beige sandy silt (UF 6182, UF 6192, UF 6207, UF 6229, UF 6237, UF 6238, UF 6246 and UF 6247). Between wall B41-64, B41-02 and wall B41-39, demolition levels of room G extends into this area (UF 6128, UF 6232 and UF 6233). These UF correspond to artificial passes UF 6050, UF 6085, UF 6090, UF 6112, UF 6355, UF 6362, UF 6363, UF 6368, UF 6370 and UF6390 (**Fig A-70**).

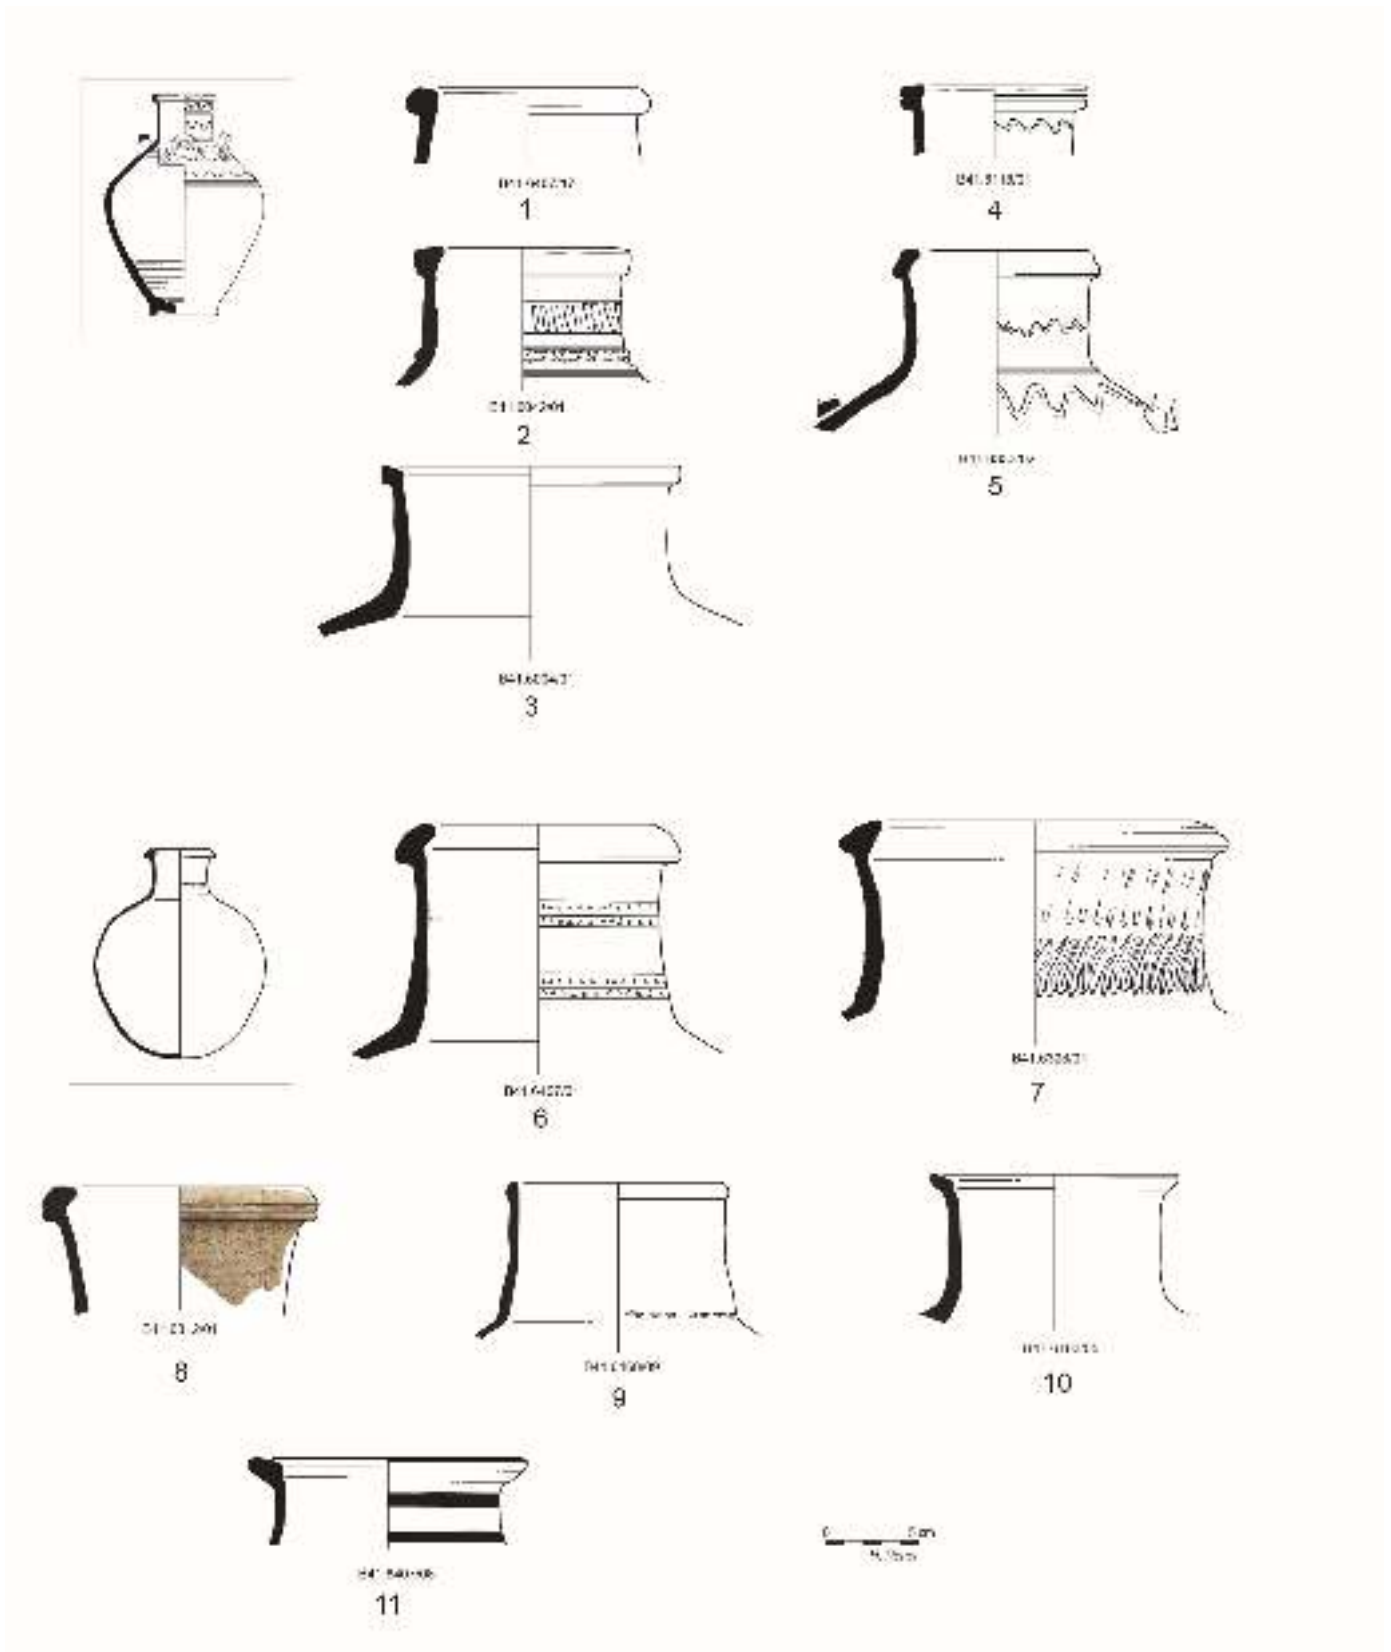
**Fig A-72** :Local production : large jars. glazed large jars : type 1A (n°1, 2, 4, 5); type 1H : n°3; unglazed large jars: type 2B (n°6-7); type T1 (n°8); type 2D (n°9); type 2X (n°10); type 2N (n°11).

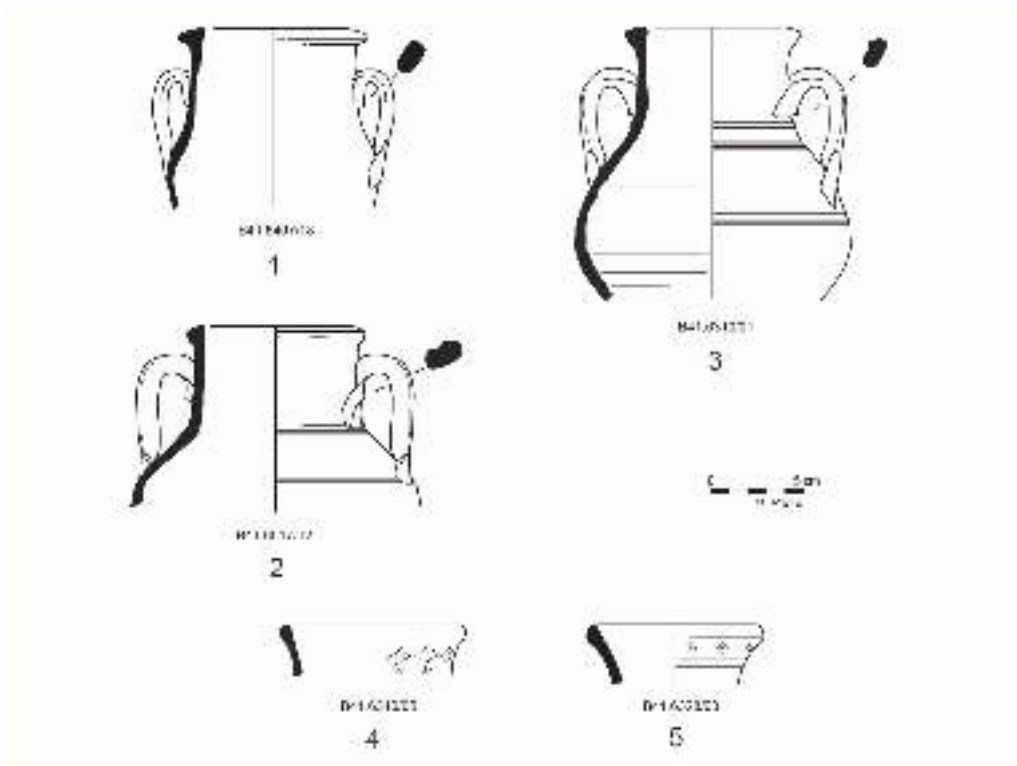
**Fig A-75 :** Local production : jars. type 1C/2C (n° 1-3); type T4 (n° 4-5).

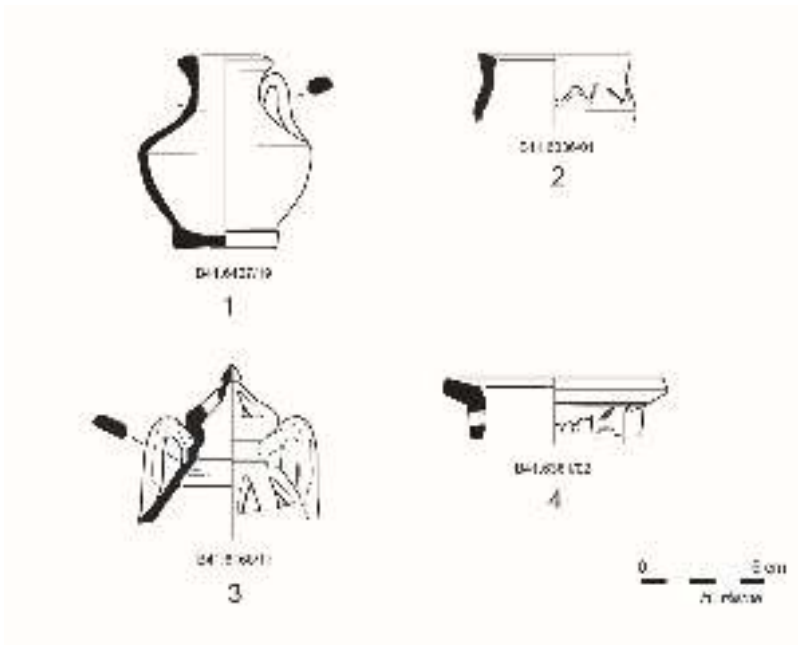
**Fig A-79 :** Local production :  
pots and incense burners.  
type 2S (n°2); type 2J (n°3-4).

The globular pots decorated with incised horizontal and wavy lines on the shoulders (Fig A-79: 2) were produced from the second half of the 13<sup>th</sup> century to the 16<sup>th</sup> century but in few quantities.

The excavation of the refuses of the workshop brought to light some sherds of incense burners. Unfortunately the sherds are too small for a complete description of the shape (Fig A-79: 3-4). Their production is continuous between the 13<sup>th</sup> and the 16<sup>th</sup> centuries.
