## Qalhât Development Project, Season 2015B-2016A, Final Report

**QALHÂT (ASH-SHARQYJAH)**

**SEASON 2015B-2016A**

**FINAL REPORT**

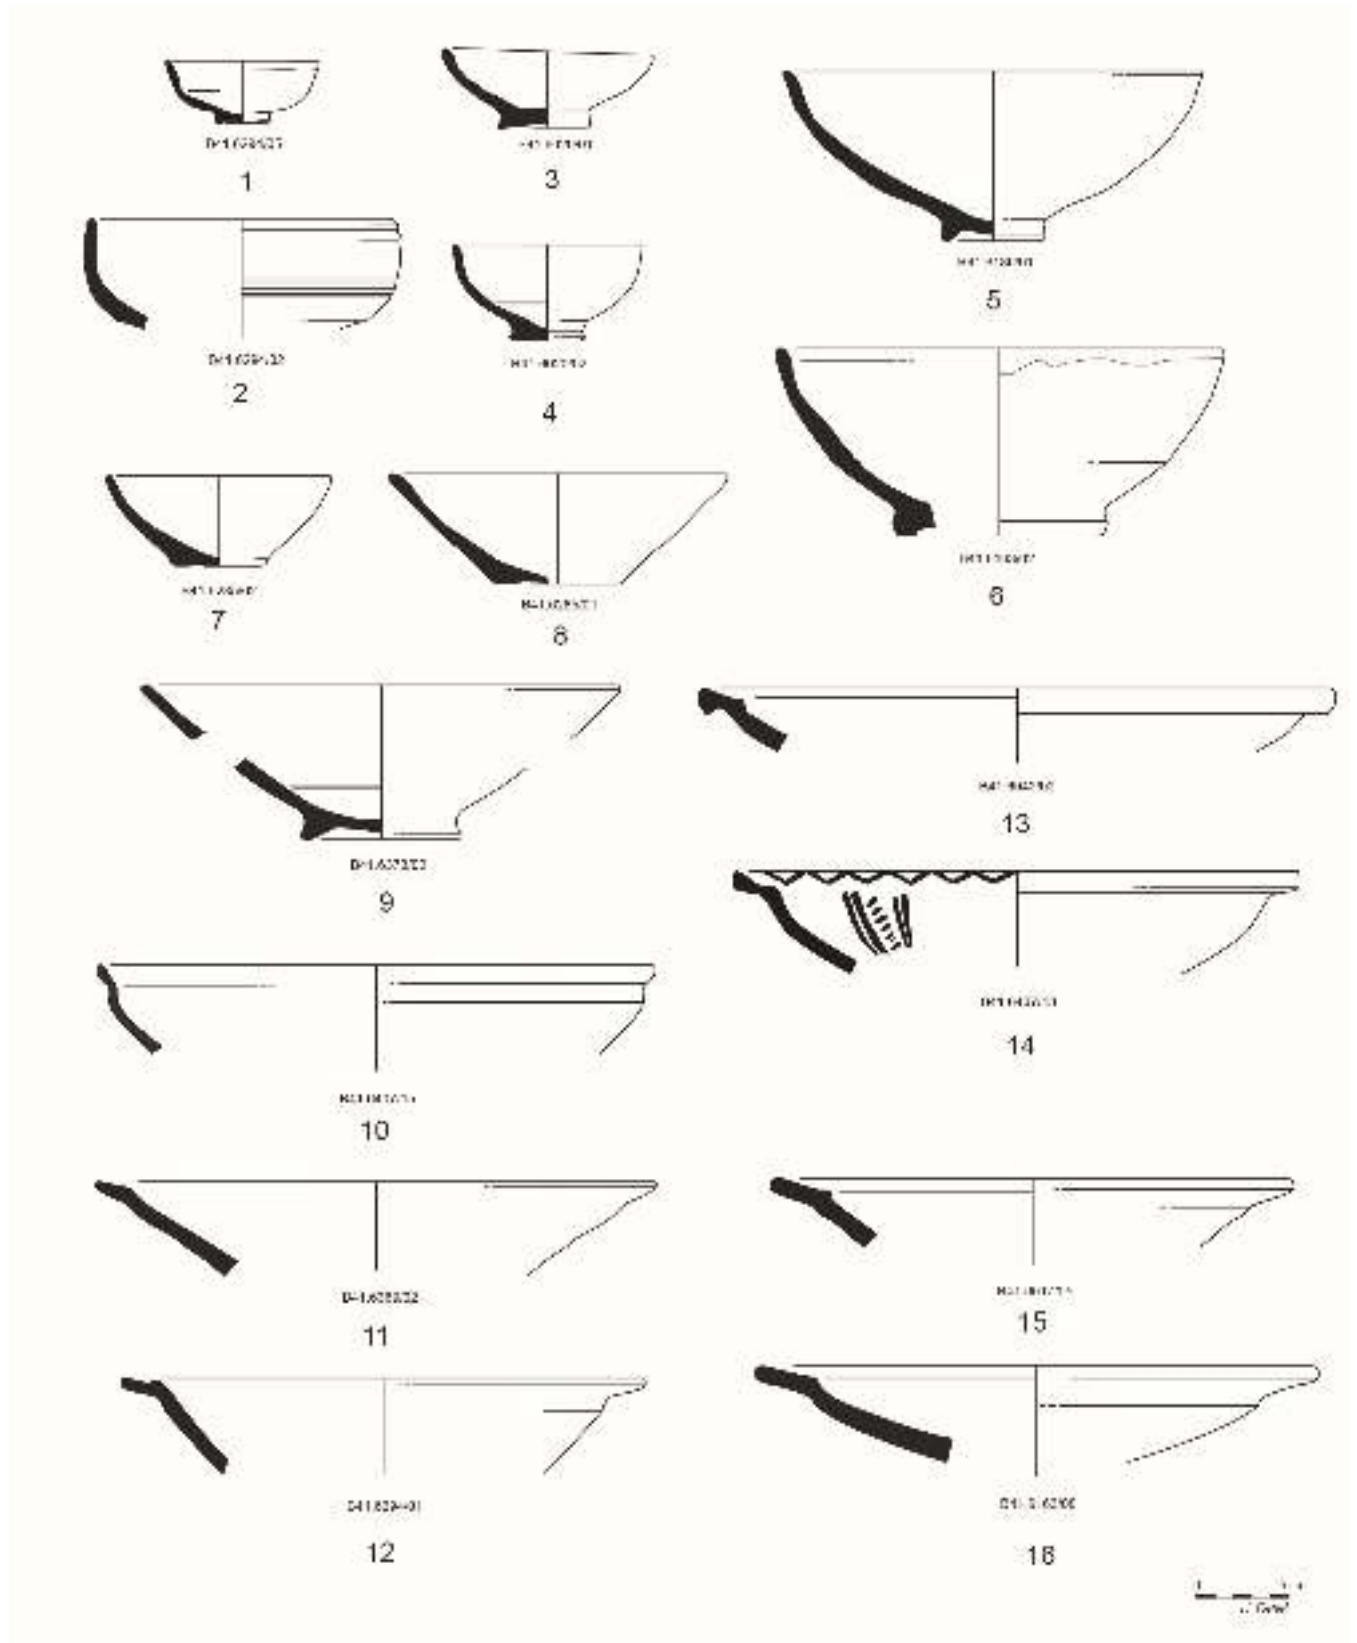
**Fig A-80** :Local production : bowls. type 1E (n°1-2), type 2D/1H (n°4-9), type 1H/2R (n°13-14); type 1F/2V (n°10-12); type 1G (n°15-16).

- Hemispherical bowls with a flaring rim and a ring base (**Fig A-80: 10-12**). They are also glazed (type 2V) or unglazed (type 1F). The glazed shape is predominant during the second half of the 13<sup>th</sup> century and declines from the first half of the 14<sup>th</sup> century (phase 3), replaced by the hemispherical shape.

- The hemispherical bowls with a flattening and molded rim (type 1M; fig.14: 13-14). Some sherds have a painted decoration under pale green glaze (**Fig A-80: 14**). Like the previous type, a few pieces are unglazed but founded only in housing contexts.

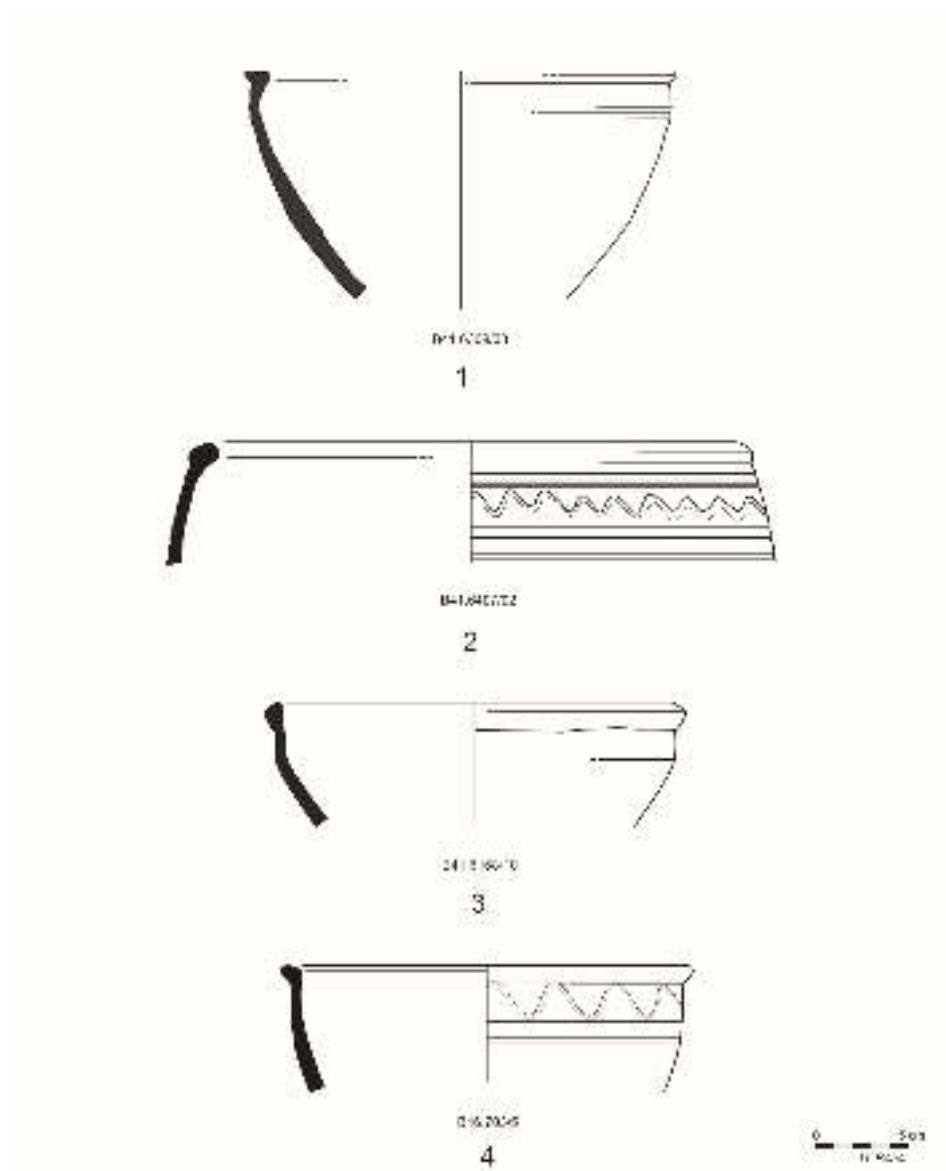
**Fig A-82 :** Local production : basins. type 1T (n° 1); type 2U (n° 2); type 2K (n° 4).

- A new shape was brought to light during this campaign. The sides are slightly carinated with a thickened rim triangular in section (**Fig A-82: 3**). Only four sherds were found in phase 3.

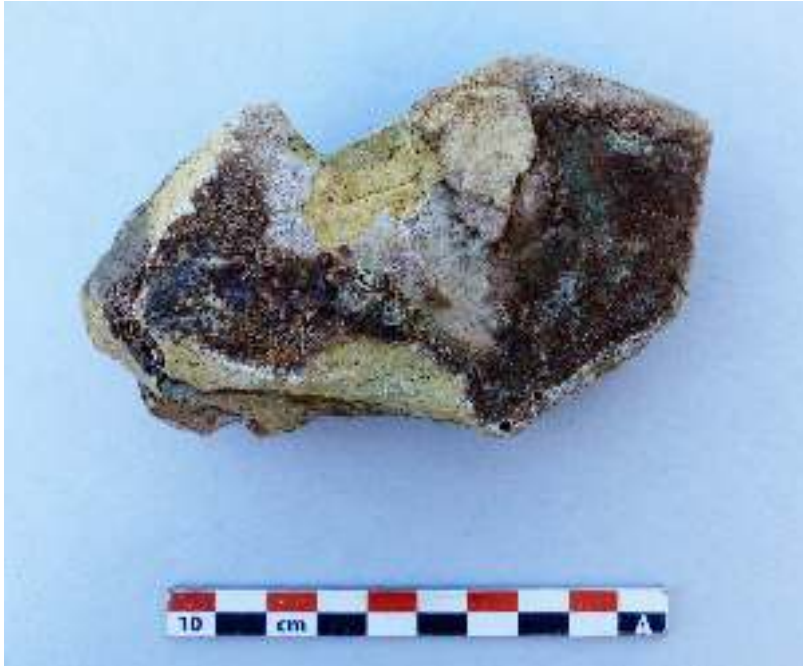
**Fig A- 85:** *Waste of cross*  
(UF 6046 B41-15)

Two fragments of green glazed tiles in shape of cross were found in the workshop. This indicates that from the beginning of the 14<sup>th</sup> century, it produced decoration elements of the Great Mosque at Qalhat.

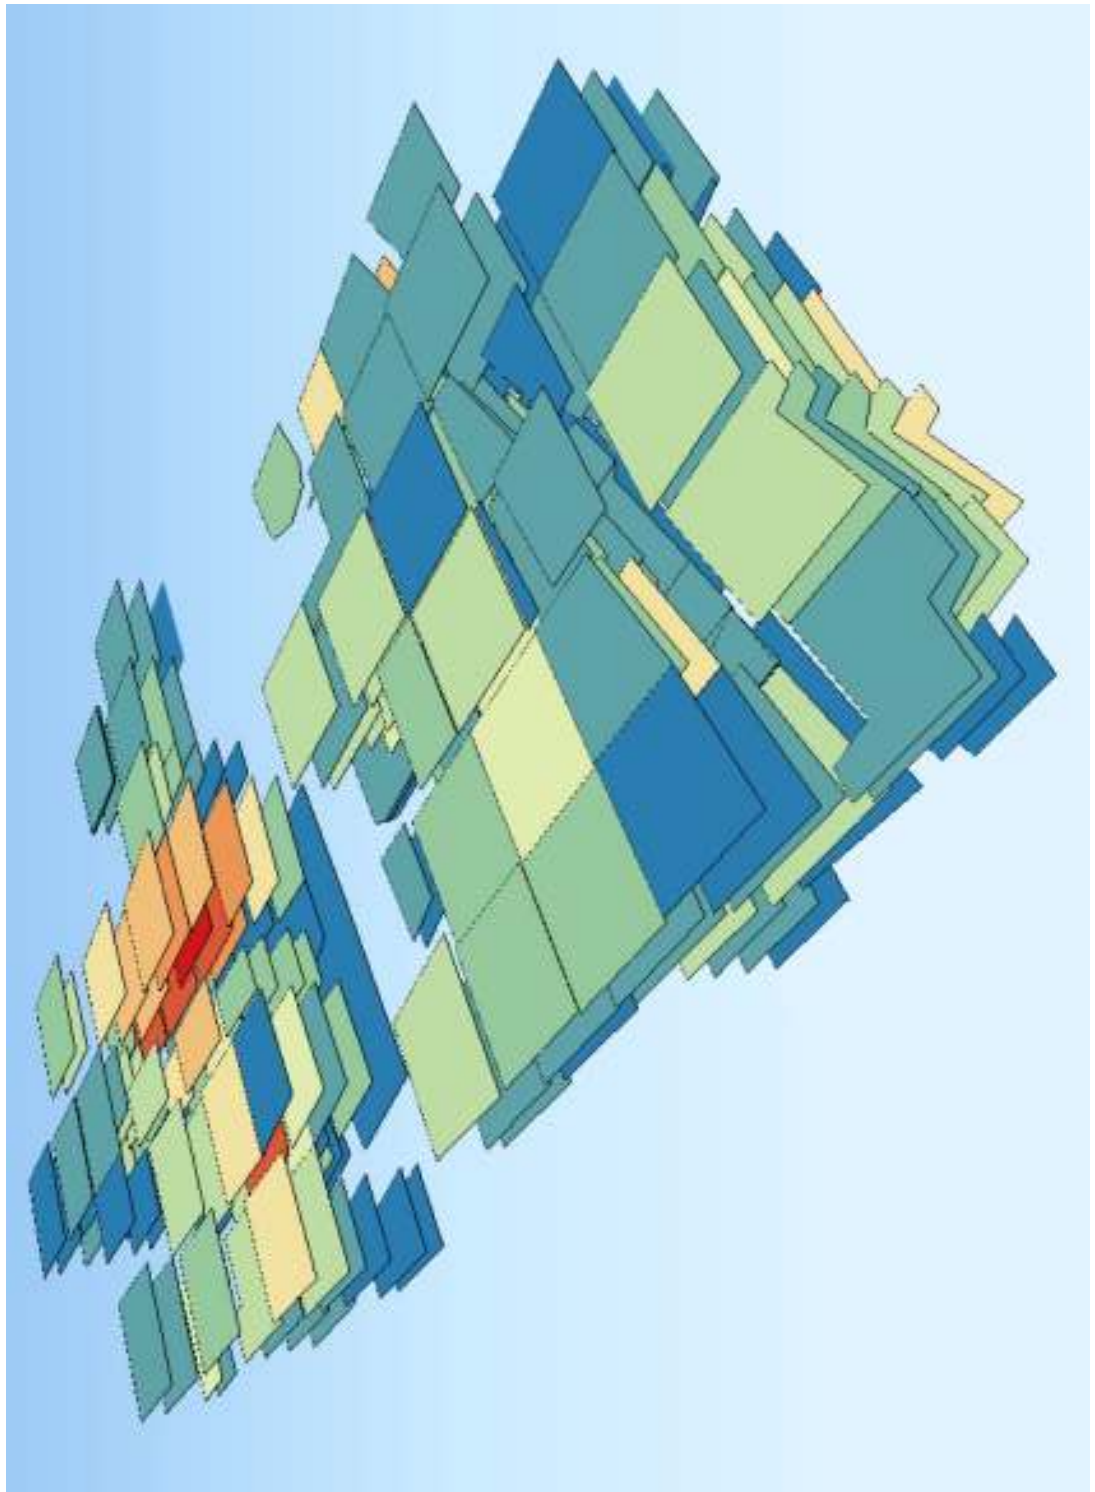
**Fig A-86:** 3D distribution of the over-firing in B4 1

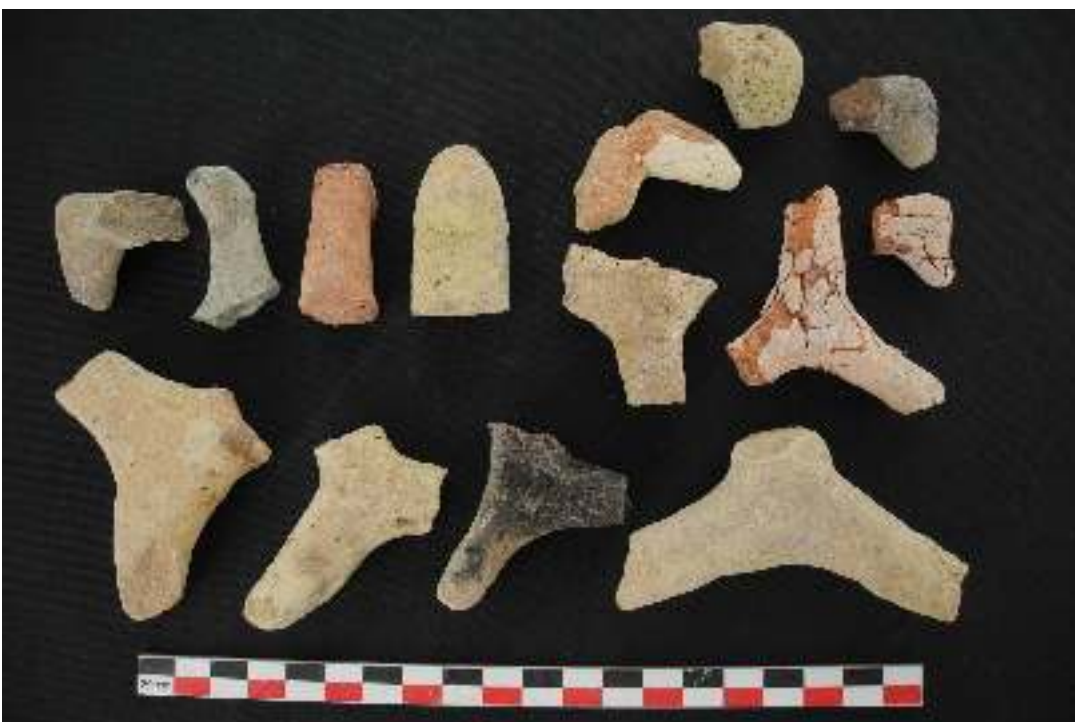
**Fig A-88:** Tripods (UF 6236 B41-14)

The agglomerates of ceramics (**Fig A-87**) or tripods (**Fig A-88**) are clues of firing techniques. Tripods were found in bowls agglomerates. Comparing the evolution of the number of tripods by phases with glazed bowls and unglazed bowls, it was observed that the tripods are always used with glazed bowls (**Fig A-89**). Different sizes of tripods correspond to the diameters and thicknesses of the various types of bowls. So that the glazed bowls do not stick, potters put tripods between each piece. An agglomerate of large jars shows that they were superimposed by neck in the firing room.

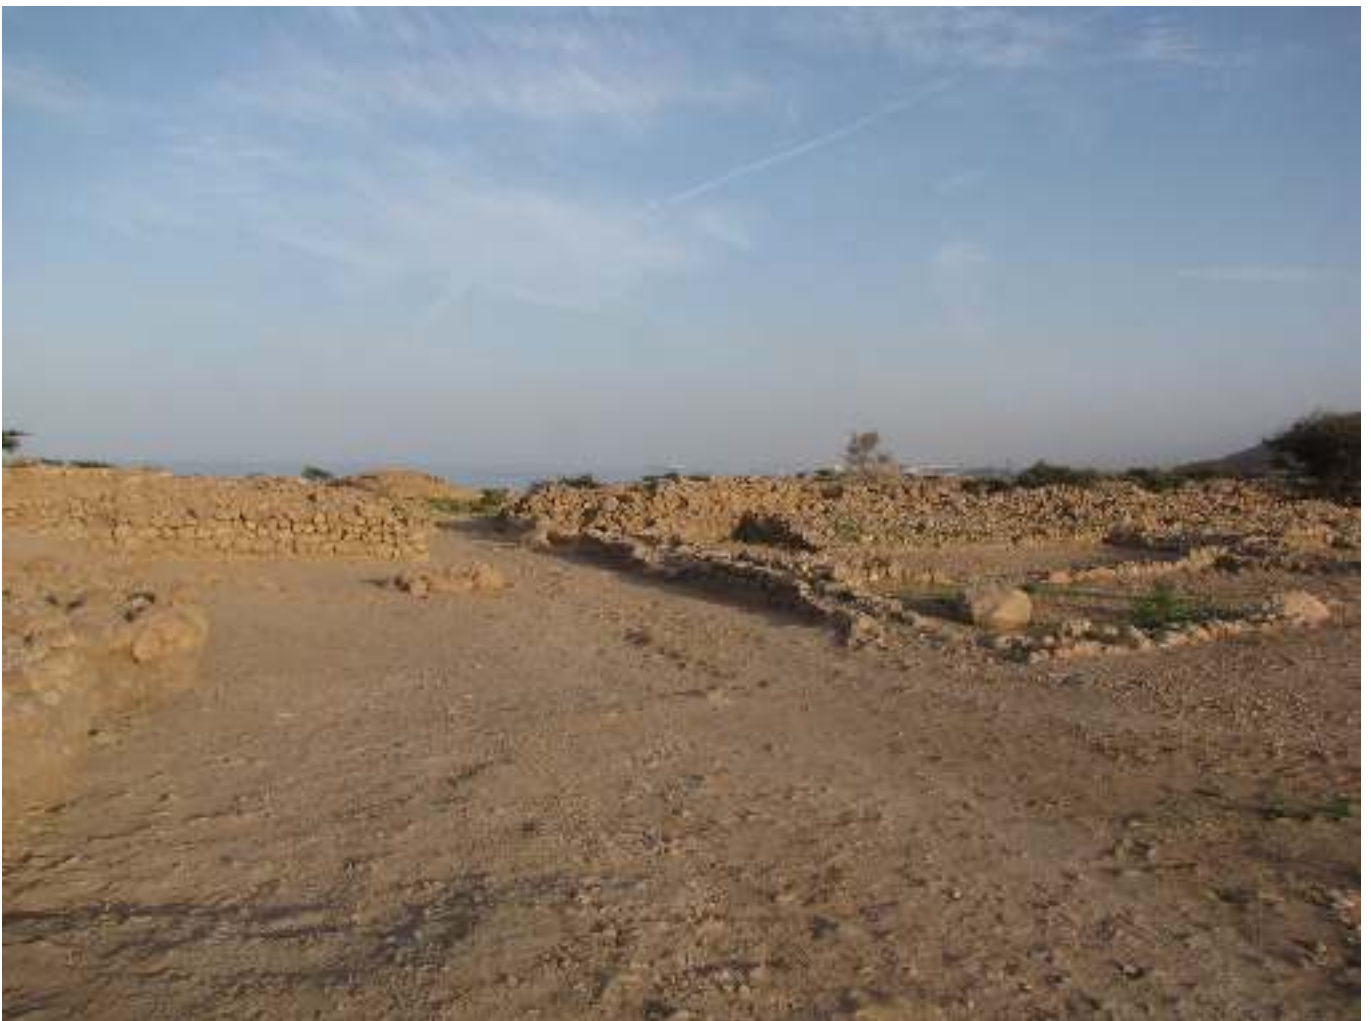
**Fig 3-1** : general view of the west gate (B31), from the outside of the city

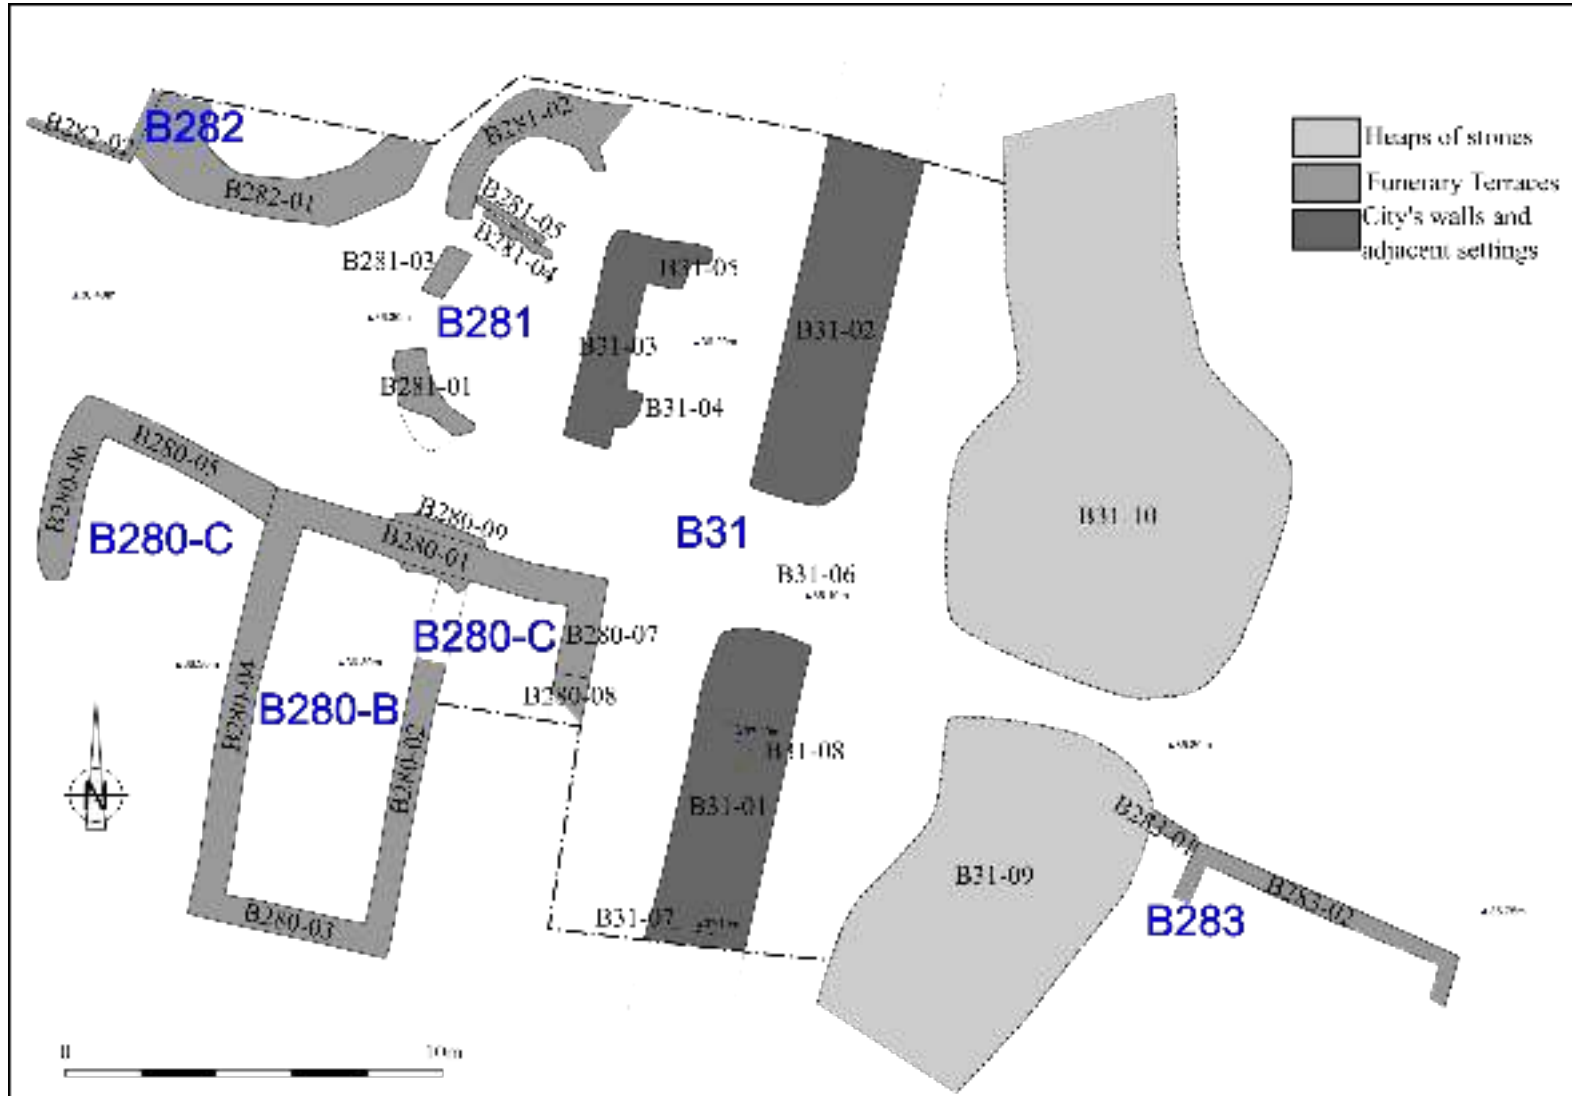
Fig 3-2 : site plan of the west gate (B31) and associated constructions

Located in front of the Bibi Maryam mausoleum, the area B31 gathers the west gate of the city (B31-06) set between two sections of the fortification wall B6 (registered as B31-01 for the south section of the wall and B31-02 for its northern part), four adjacent buildings (B280, B281 and B282 at west and B283 at east) which were interpreted as funerary terraces, and two massive heaps of stones (B31-09 and B31-10) : they are located at rear of the gate, in both sides of the passageway.

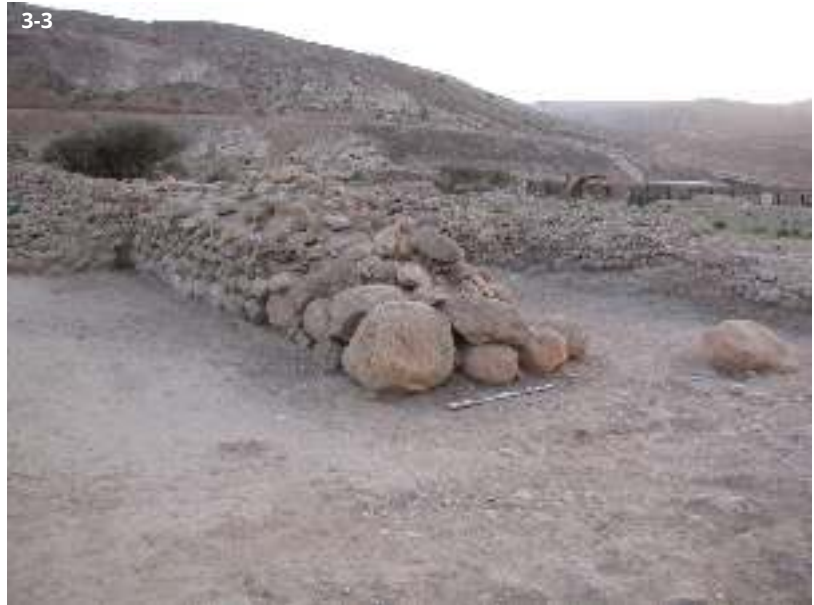
**Fig 3-3 :** the south fortification wall B31-01

The east facing of the south wall B31-01 (Fig 3-3) is now preserved for around 1.23 m high, a little less on the west facing, both being built the same way. The lowest course is made of massive pebbles or limestone blocks, very large, some of them being around 1m wide and probably coming from the Wadi downhill as they look to have been polished by water. They are sometimes lying over a backfill and sometimes directly on the underneath bedrock.

The faces of the four upper courses preserved are mostly made with pebbles and limestone blocks which are smaller than the ones used for the foundations. Very small pebbles and corals or limestone pieces are also used to wedge the massive stones, a way of construction observed everywhere else in the city walls and now used by the Conservation Component.

The internal core is made of small and medium corals and limestone blocks bonded by earth rather than mortar. No remains of coating was observed. The way of construction of the facing strongly suggest that this wall was never coated.

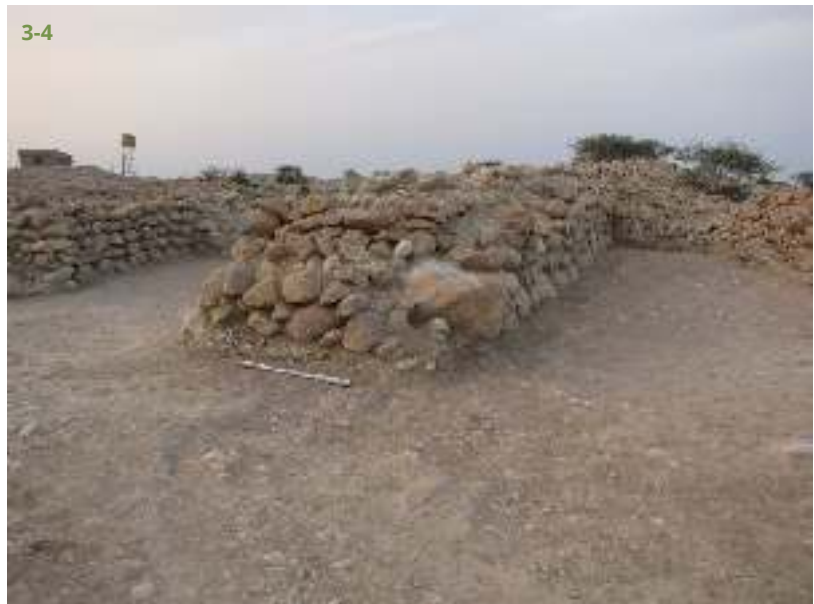
**Fig 3-4 :** the north fortification wall B31-02

The east facing of the north wall B31-02 (Fig 3-4) is now preserved for around 1.30 m high and a little less at west. It is made exactly the same way as the south wall B31-01, with larger stones on foundations and smaller blocks used for wedging. The upper elevation is a little more well-preserved but, as the binder was made of earth, it is very difficult to distinguish the collapse from the preserved structure in the absence of facing.

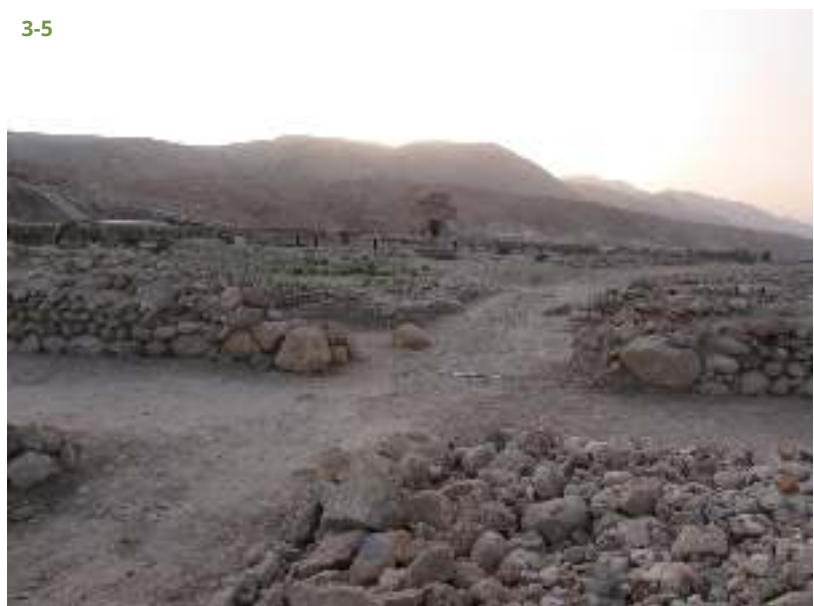
**Fig 3-5 :** the gate B31-06, with the mausoleum of Bibi Maryam in the background

The extremities of the walls B31-01 and B31-02 were also the jambs of the west gate B12-06 which is now 3.50 m wide (Fig 3-5). The south jamb is now only made of four very large limestone blocks while the north jamb is made of three courses of smaller stones, both jambs being preserved for around 0.80 m high. The different way of construction of the north jamb and the fact that its bottom is higher than the bottom of the wall and built above a thicker layer of backfill strongly suggest that the gate was lately reduced by the addition of the actual north jamb. Material was too scarce to give a dating for this refitting of the west gate, which could have been originally 4 m wide.

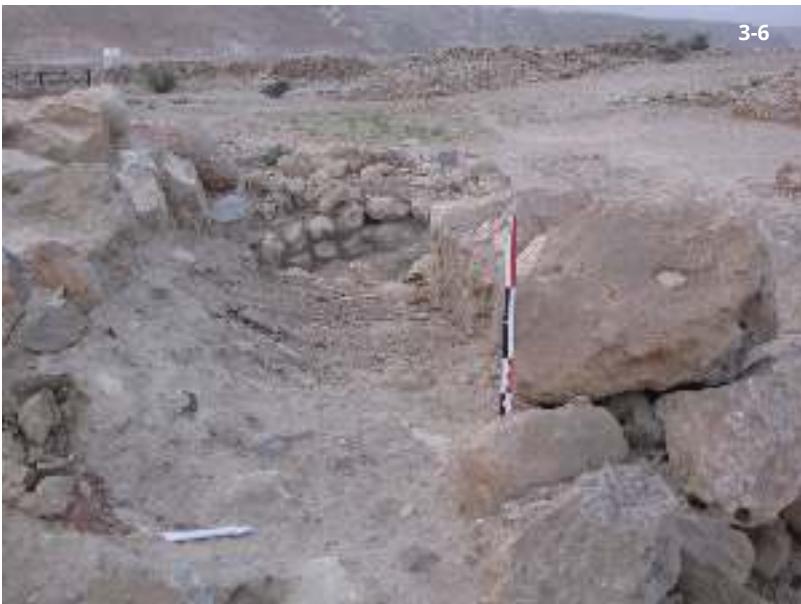
**Fig 3-6 :** the crossing hole B31-08

Two rectangular holes crossing the wall were observed in the south wall B31-01, and others similar fittings were observed elsewhere in the fortification wall B6. The north one, B31-08, (Fig 3.6) is set around 2.60 m south of the south jamb of the gate B31-06. The south side of the crossing hole is partially collapsed, the bottom is very damaged and the top has disappeared. The structure is actually preserved for no more than 0.20 m high and its width varies from 0.36 m at west to 0.56 m at east. Its actual length is 1.10 m, the east and south extremities having collapsed but it was originally as long, like the width of the wall.

The functions of those holes is yet unclear. As their bottom is about 1.40 m to 1.5 m higher than the ground, they can have been used as scaffolding holes, or beamholes to support the assumed walkway for the guards. They can also be interpreted as arrow or gun loops but their asymmetrical setting and the fact that the western buildings were obstructing the view are not in support of this interpretation. Maybe further excavations of the others holes visible in the fortification wall could bring an answer to this question.

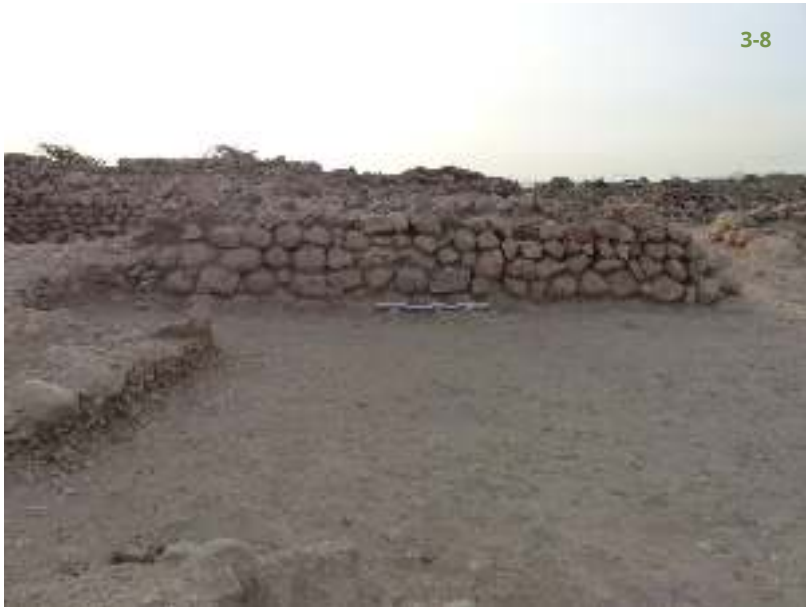
**Fig 3-8 :** *the wall B31-03, outside elevation*

West of the south extremity of the north wall B31-02, some upside-down L-shaped walls with a buttress were uncovered. The longest one, B31-03, (Fig 3-8) is parallel to the wall B31-02, 3.90 m at west. It is 5.70m long by 1.10m wide and its height varies from 0.40 m to 1.20 m. This wall is made of medium corals and limestone blocks bonded with earth. The way of construction is similar to the fortification wall though the stones used are a little bit smaller. Its south end is well preserved and a facing can be observed, while the north end is very damaged.

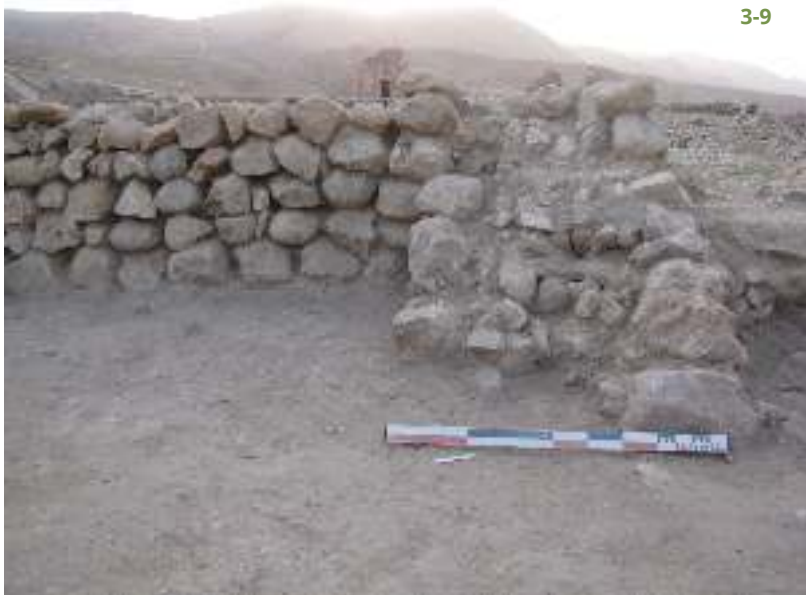
**Fig 3-9 :** *the damaged wall B31-05*

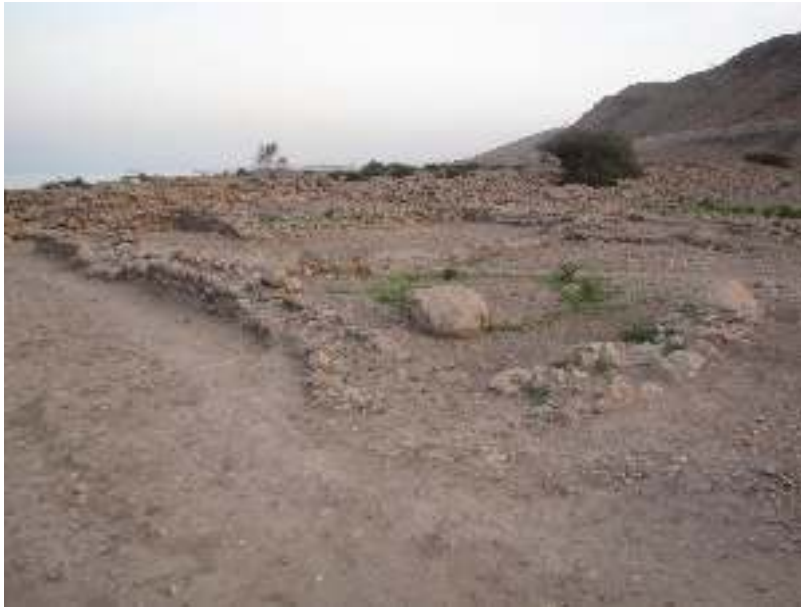
**Fig 3-11** : general view of the building B280

West of the fortification wall B31-01, the building B280 was excavated for about 126 m<sup>2</sup> and three different spaces, registered as rooms B280-A, B and C from west to east, were identified. Remains are very low, sometimes preserved for only the lowest courses of stones and few collapse was removed. Although some part of collapse may have been recovered and reused, it is quite probable that most of the walls were very low, no more than 1m and more probably around 0.50 m high.

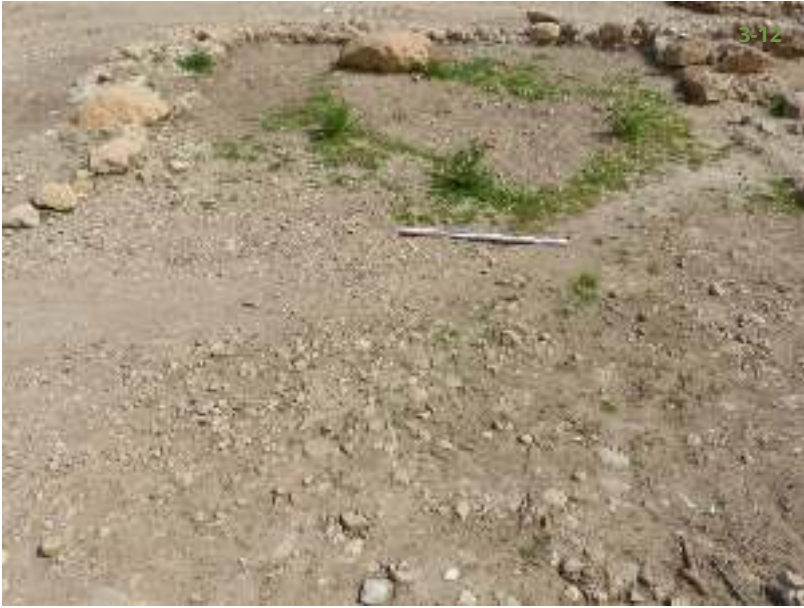
**Fig 3-12 :** general view of the room B280-A

The room B280-A, west of the building, is delimited by walls B280-05 at north, B208-06 at west and B280-04, which is common with room B280-B, at east. This room was apparently opened southward. (Fig 3-12)

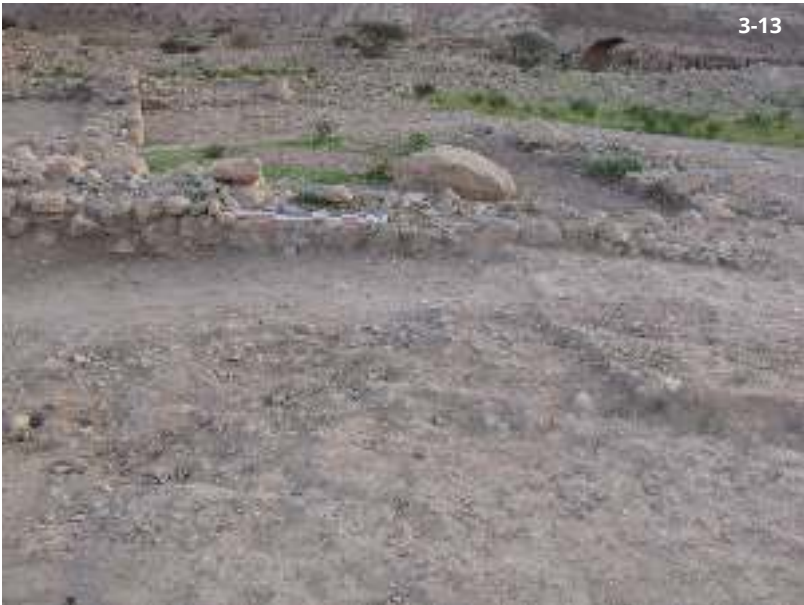
**Fig 3-13 :** the wall B280-05, outside elevation

The north wall B280-05 (Fig 3-13) is 5.70m long for a width which varies from 0.70m to 0.95m and preserved from one to two courses of stones. The wall is not linear as the north-west corner widens, probably because the facing of the wall has slowly slid. It is made of small to medium corals and limestone blocks bonded with earth. The west wall B280-06 (Fig 3-14) is 5m long and its width varies from 0.85m to 1m and preserved for one course of stones. The wall is slightly curved and made by large limestone blocks and it is leaning, at south, against a massive limestone block which is probably a natural resurgence of the underneath bedrock.

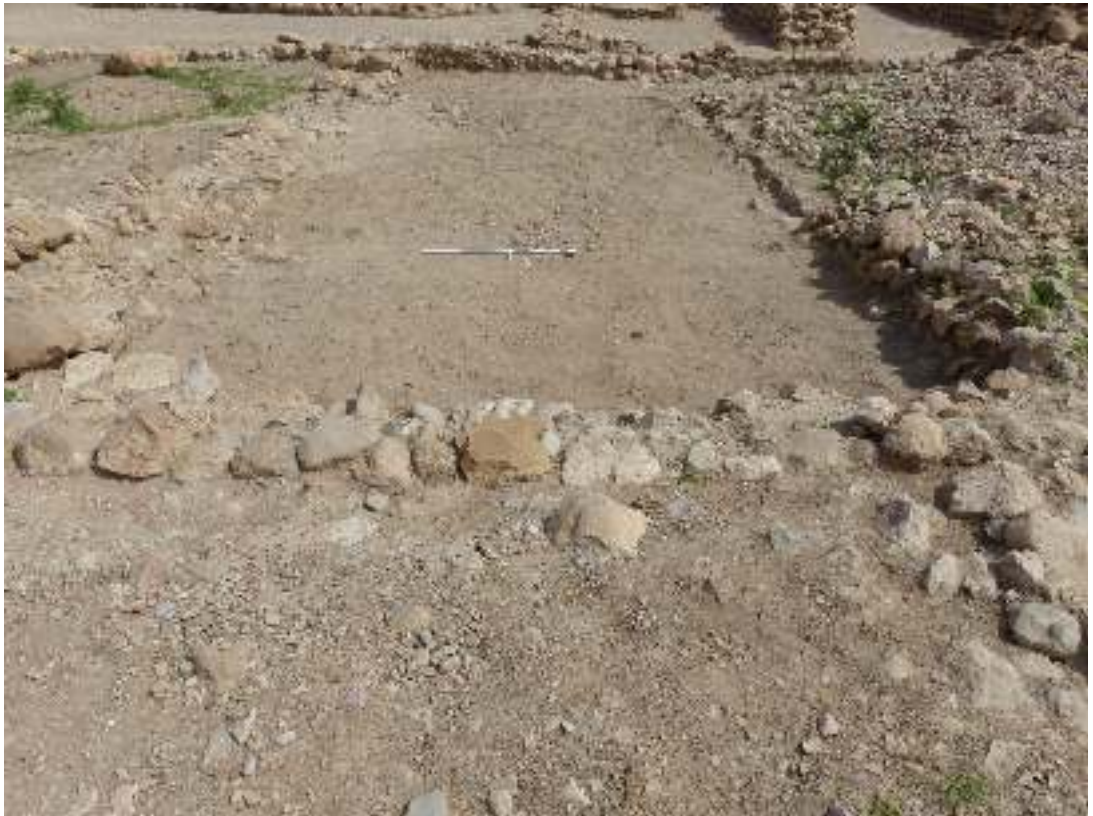
**Fig 3-15** : general view of the room B280-B

The room B280-B, 10m long by 3.75m wide in average, is a north-south oriented rectangular room located in the center of the building, covering an area around 38m<sup>2</sup>. (Fig 3-15)

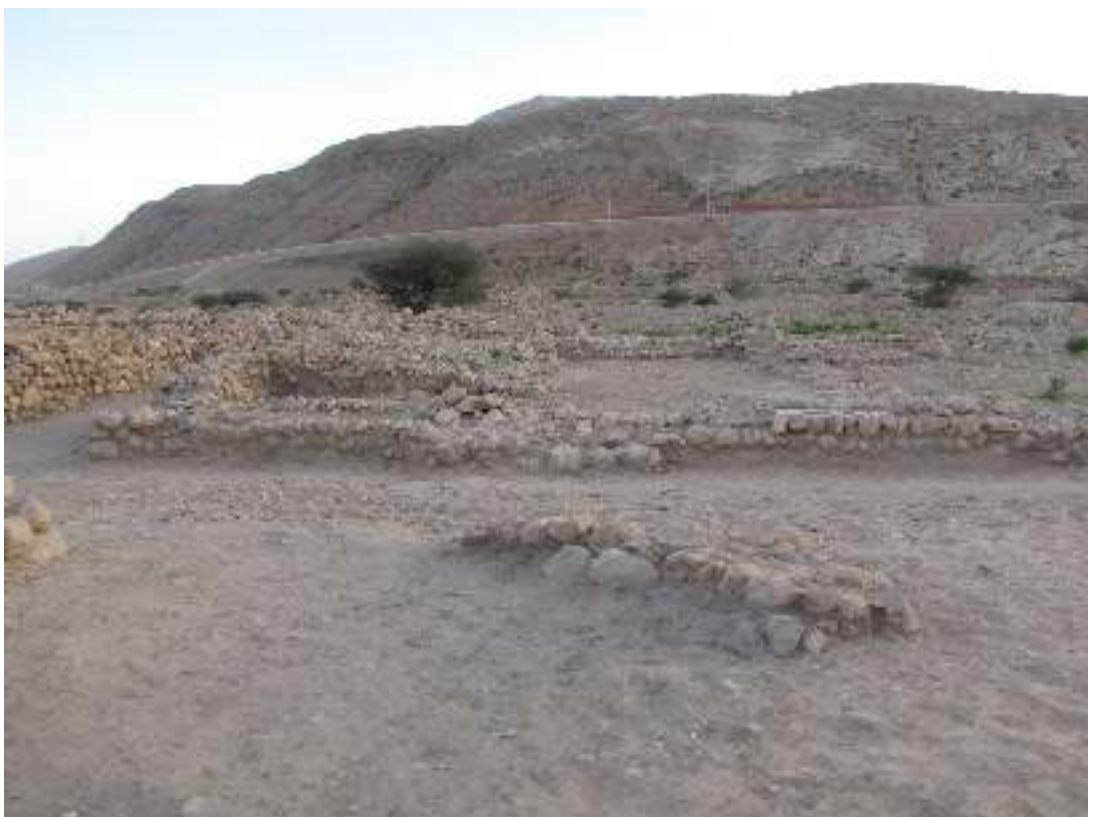
**Fig 3-16** : the wall B280-01, outside elevation

At north, the delimiting wall B280-01 (Fig 3-16) continues at east to the room B280-C for a total length of 9m. Its maximal width is around 0.80m and it is preserved for 0.45m high, from two to three courses of stones. Its internal core is made by small blocks bonded with earth and the facings are made with medium

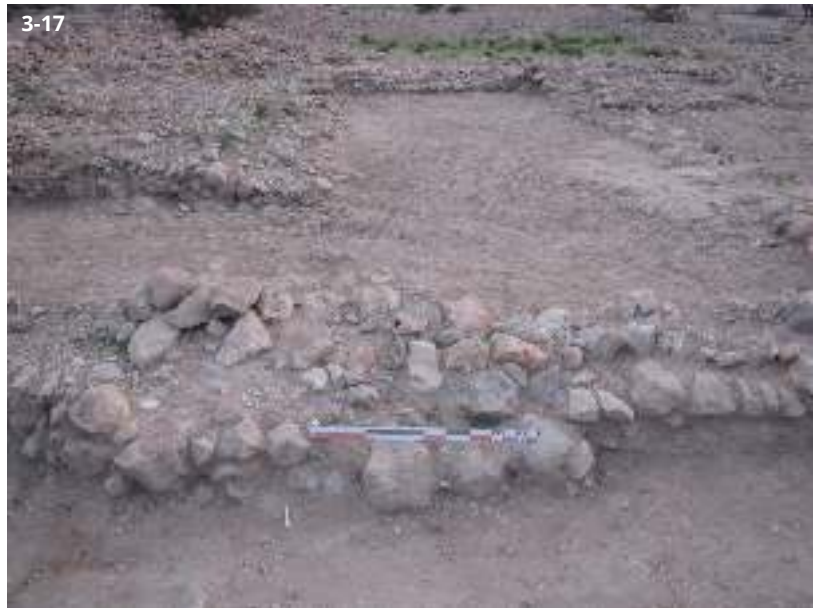
**Fig 3-17** : the possible threshold B280-09

limestone blocks with some small corals for wedging. In the middle of the wall, a rectangular concentration of stones on each sides of the wall may be the remains of a very damaged stepped threshold (B208-09) (Fig 3-17) which is around 2.50m by 1.50m wide. Unfortunately, the structures are not enough preserved to confirm this hypothesis as no preserved steps or traces of jambs of a gate were seen.

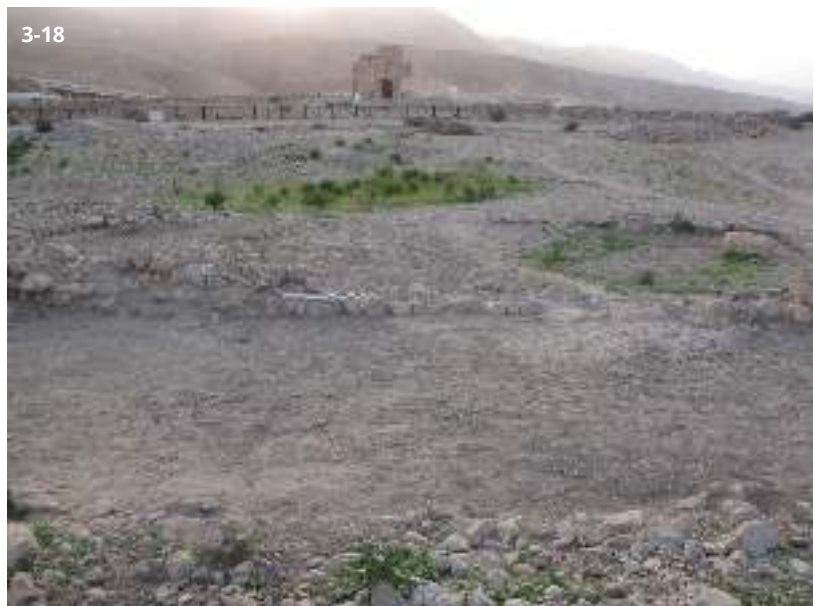
**Fig 3-18** : the wall B280-04, inside elevation

Linked with the wall B280-01, the west wall B280-04 (Fig 3-18) separates the room B280-B ad the room B280-A. It is not linear but slightly curved in the center, where an access may have existed. Externally 11.50m long, its width varies from 0.80m to 1m, probably because of a sliding of the external facing, and its maximal preserved elevation is around 0.45m high. The internal core is strongly disorganized and the facings are irregulars, some stones being missing.

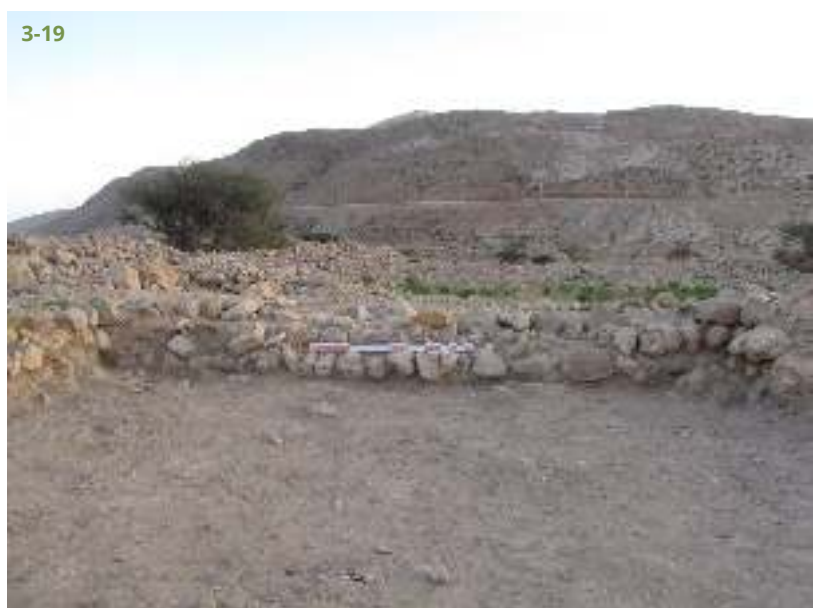
**Fig 3-19** : the wall B280-03, inside elevation

At south, the delimiting wall B280-03 (Fig 3-19) is linked with the western wall B280-04 and the eastern B280-02. Its is externally 5.40m long by 0.70m wide and 0.35m high, excavated for two courses of stones internally but only for the upper course externally at south, where the facing may continues down under. The internal core is made of disorganized small blocks bonded with earth while the facing are better built, using medium limestone blocks.

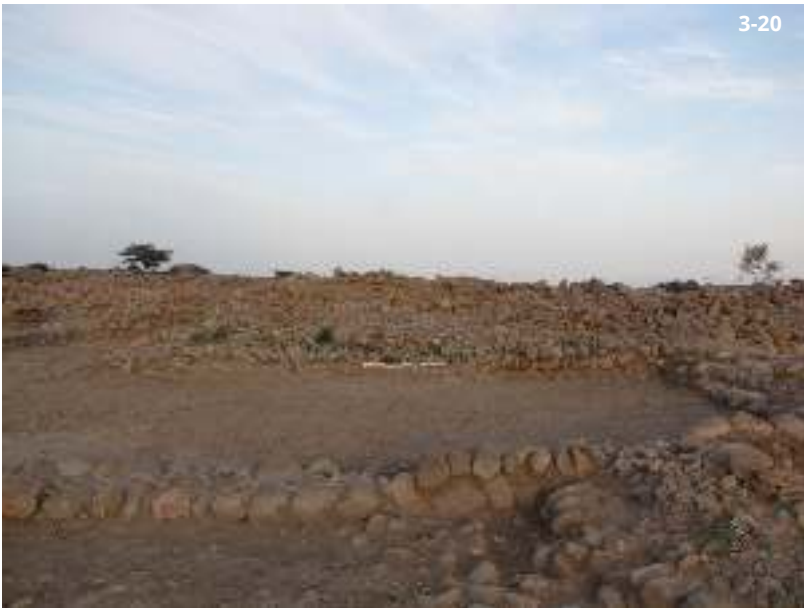
**Fig 3-20 :** the wall B280-02, inside elevation

The eastern limit of the room B280-B is made by the wall B208-02 (Fig 3-20) which is common to the room B280-C. It is around 0.70m wide and preserved for a maximal height of 0.40m. Well preserved for 7.15m long from the south-east corner, the wall disappeared about 2.30m from the north wall B280-01. It is not possible to state if the wall has disappeared or if a highly damaged gate once stood here. As the eastern room B280-C was probably filled with small pebbles to create a terrace, the hypothesis of a gate is unlikely. The facings are poorly made, or badly preserved, with medium limestone blocks more or less organized and not always aligned.

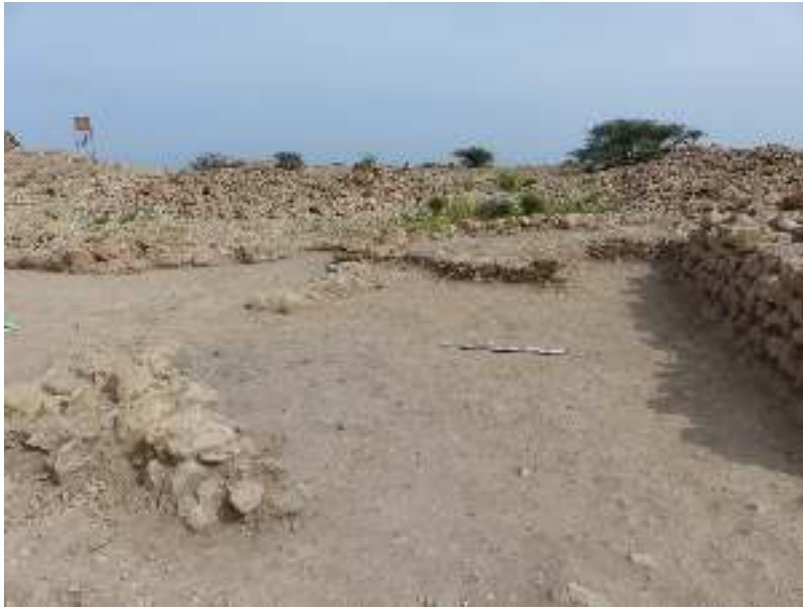
**Fig 3-23** : general view of the building B281

The building B281 is located at west of the wall B31-03, north of the building B280 on the other side of the access road, and gathered several different structures which were gathered as a unit even if they are not connected, for an average surface around 40 m<sup>2</sup>. The structures are very damaged and not entirely excavated toward the north where the building might continue.

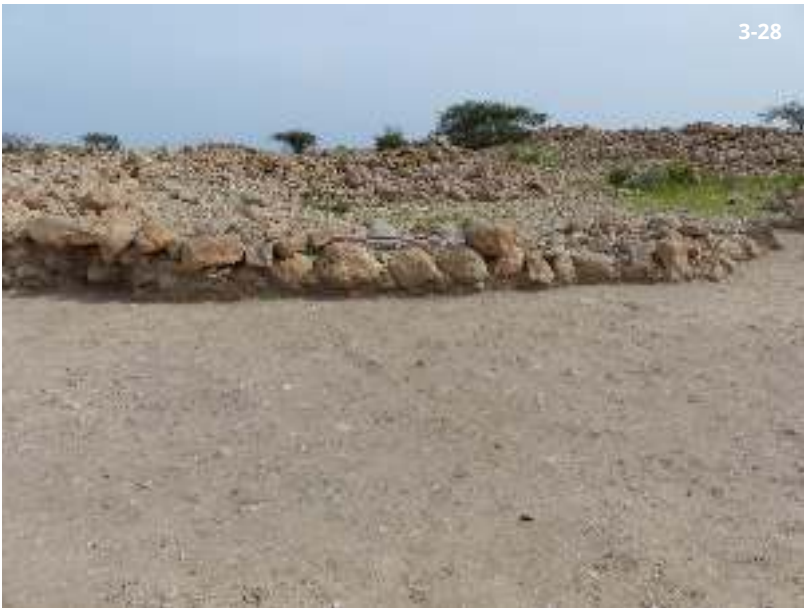
**Fig 3-28 :** the wall B282-01, outside elevation

The wall B282-01 (**Fig 3-28**) is curved, nearly half-oval, for a maximal length of 7.30m and a width from 0.90m to 1.30m, for a maximal preserved elevation of 0.85m high. The south external facing is made with medium to large limestone blocks without proper binder and the north internal facing is visible on the ground but not excavated, as the level of small pebbles reached is a backfill level and not a collapse layers.

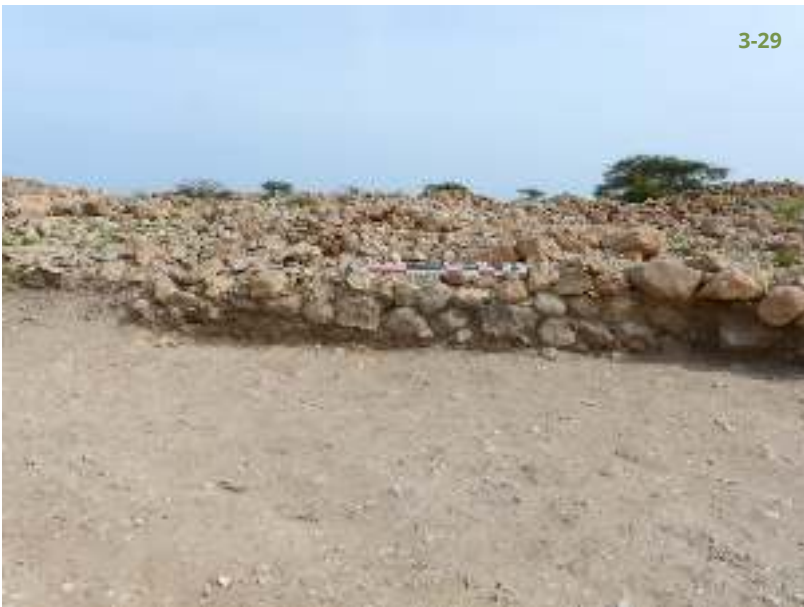
**Fig 3-29 :** the wall B282-02, outside elevation

The wall B282-02 (**Fig 3-29**) is more linear and misaligned with the wall B282-01, excavated for a maximal length of nearly 3m and a preserved elevation about 0.60 m high. Its width is still unknown and a possible perpendicular return may be guessed at east, along and under the wall B282-01. From two to three courses of stones were unearthed on the south side. They are made of medium limestone blocks poorly bonded with earth. This wall probably extends westward but this area was not excavated.
