## Qalhât Development Project, Season 2015B-2016A, Final Report

**QALHÂT (ASH-SHARQYJAH)**

**SEASON 2015B-2016A**

**FINAL REPORT**

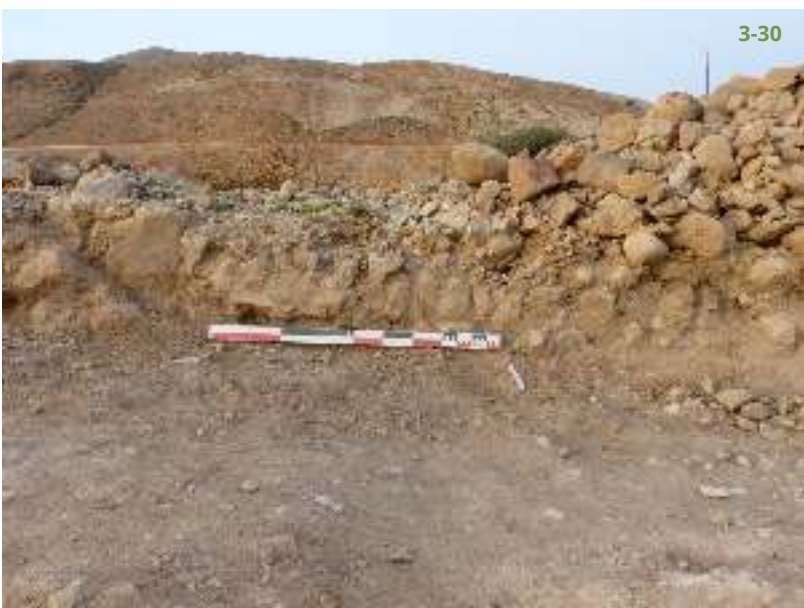
**Fig 3-30 :** the wall B283-01, outside elevation

The wall B283-01 (**Fig 3-30**) represent the west part of the northern limit, with an external facing made of one course of small corals and limestone blocks, poorly bonded with earth, and presenting remains of a damaged coating of pinkish plaster. It has been observed for 2 m long but extend westerly under the heap B31-09, and its width is unknown, like its southern extension remains uncovered.

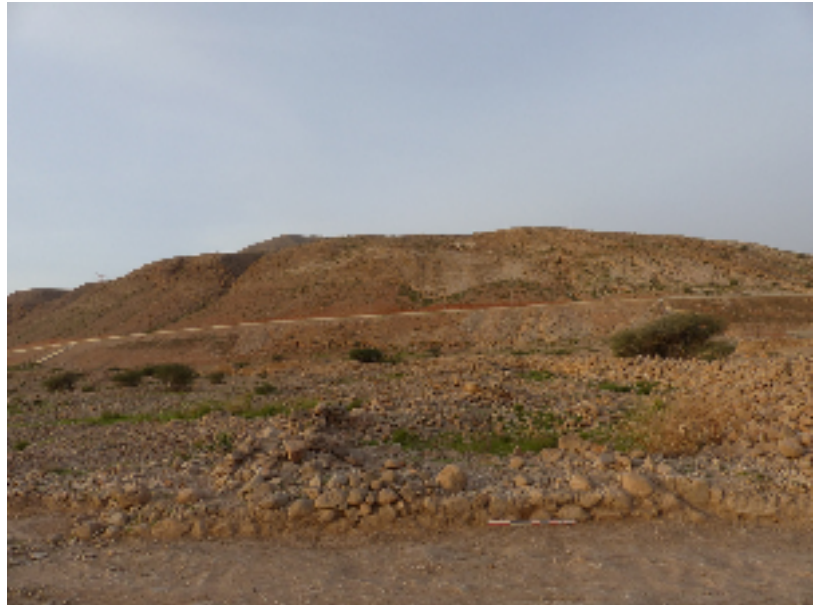
**Fig 3-31 :** *the wall B283-02, outside elevation*

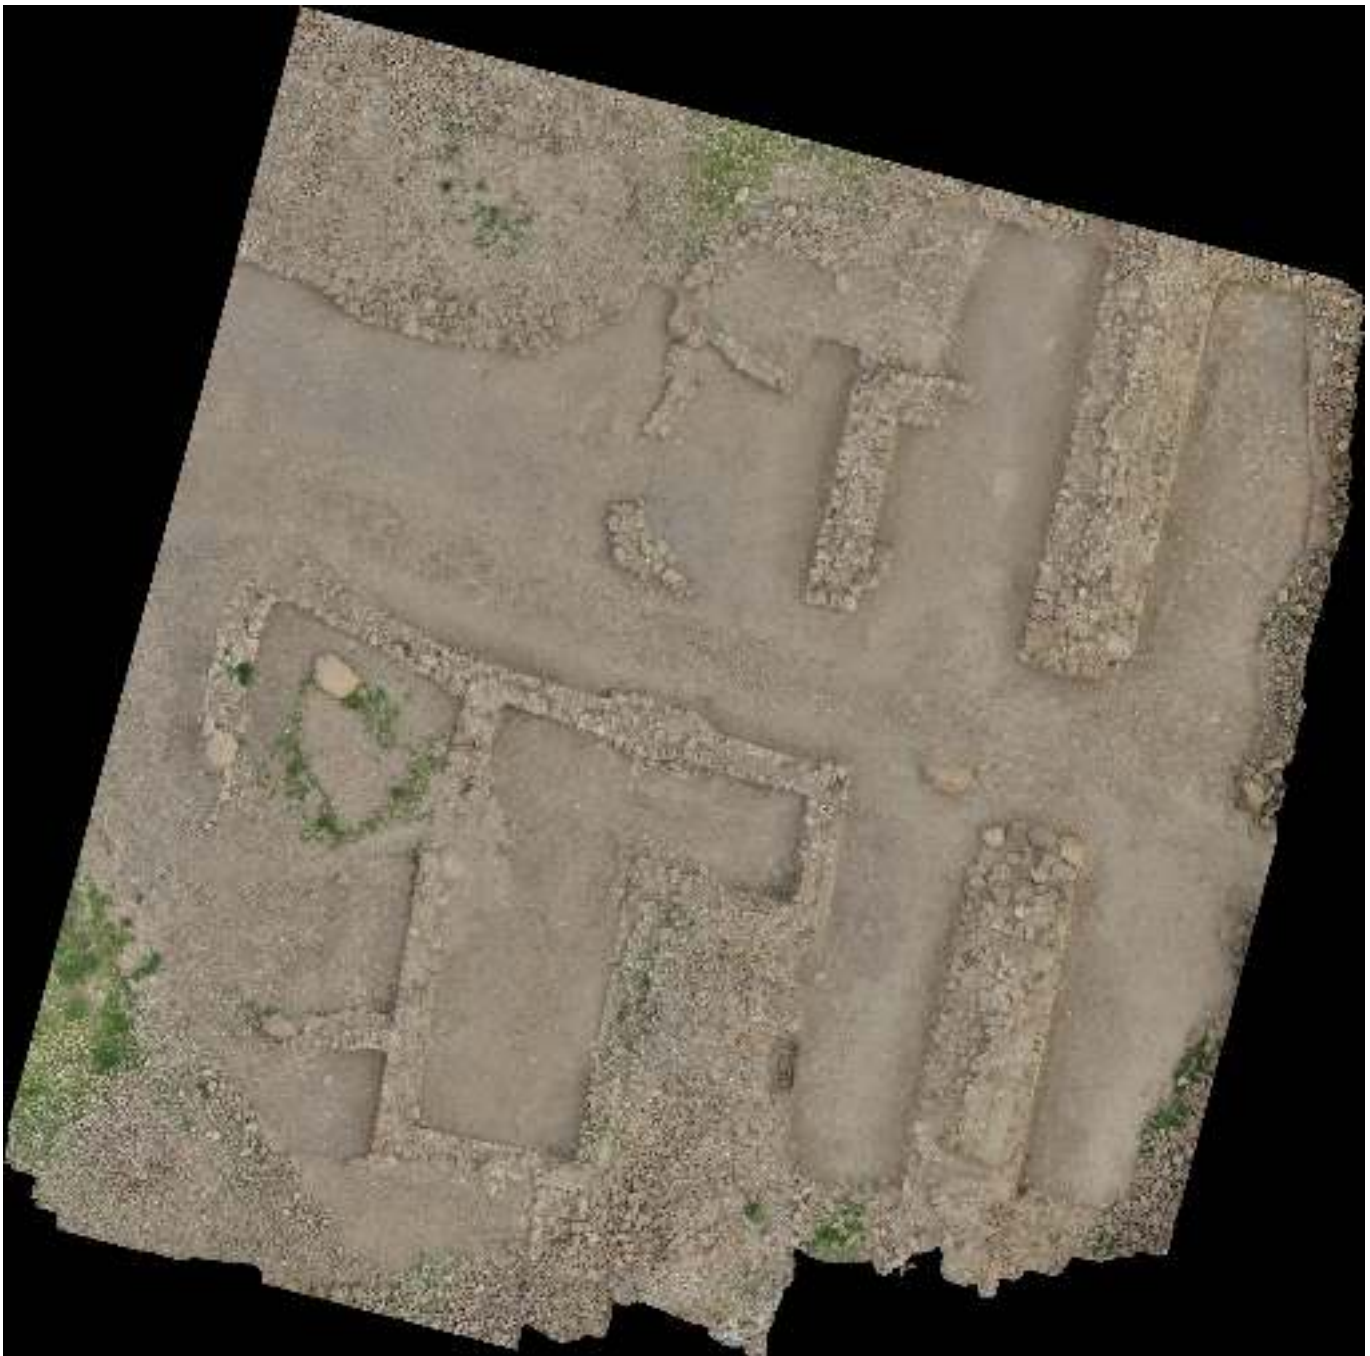
**Fig 3-32 :** *photogrammetry of the west gate and associated constructions*

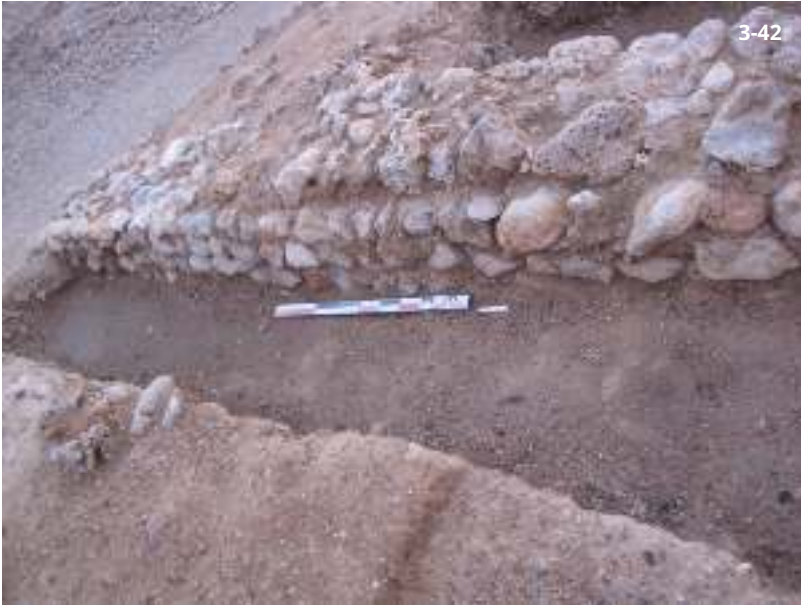
**Fig 3-42 :** the wall B29-04, partially visible in the sounding SD4

The east limit of the room B29-A is made by the wall B29-04 and the dividing wall B29-30 built above it, both separating the room B29-A from the room B29-B. The wall **B29-04** (Fig 3-42) was observed on the surface, 6.40m long by 0.90m wide, and also partially on both sides in the soundings SD4 and SD5. The wall is leaning on the wall B29-02 to the north and B29-03 to the south; it is made with medium pebbles and limestone blocks bonded with earthen mortar. No coating was observed and, as the wall was not intended to be visible, it is obvious that there never was any. The wall **B29-30** (Fig 3-43) is built over the wall B29-04 more or less in its south half. It appears that the main function of the wall B29-04 was to support the wall B29-30 which was rising at first floor and so dividing the main building into the two rooms B29-A and B29-B. The dividing wall B29-30, which is the only remain of the elevation at first floor, is preserved for 2.60m long by 0.60m wide and only 0.20m high. It is made by medium limestone blocks with earthen mortar and no remain of coating was observed, but several fragments found in the nearby soundings suggest that it was covered with white plaster (Fig 3-44). The north edge of the wall is quite probably the jamb of the gate leading from the room B29-B to the room B29-A and a similar wall was undoubtedly in existence above the northern half of the wall B29-04 but it has entirely collapsed. In this hypothesis, the gate was so not exactly in the middle of the wall.

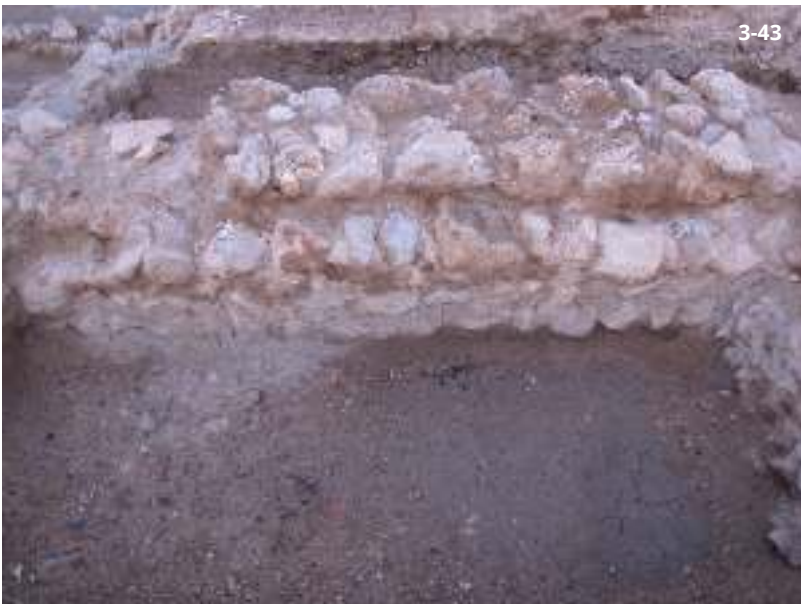
**Fig 3-43 :** the dividing wall B29-30, built above the wall B29-04

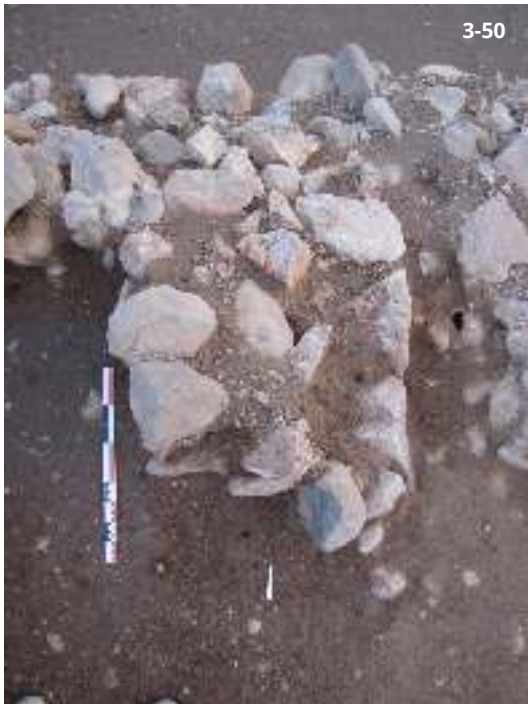
**Fig 3-50 :** *the small wall B29-27*

To the north, the small wall **B29-27 (Fig 3-50)**, only preserved for 0.80 m long, 0.75 m thick and 0.20 m high, is quite probably the counterpart of the wall B29-05 but less preserved, because of the collapse of the north-east corner of the building. The same gallery must so be considered north of the stair.

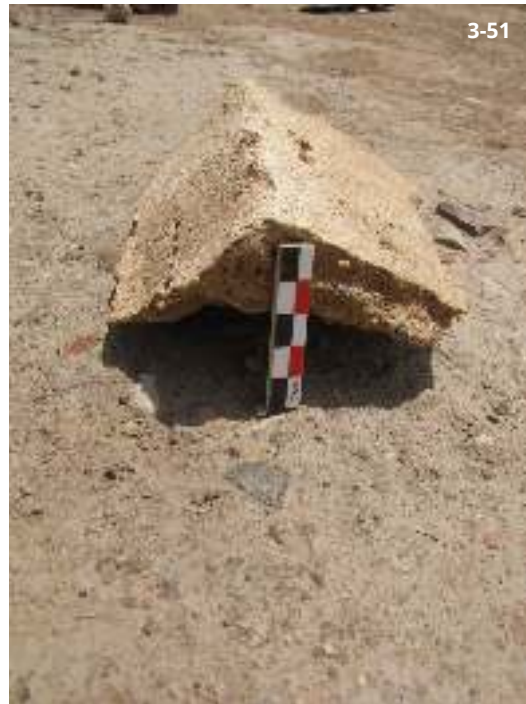
**Fig 3-51 :** *the assumed masoned shrine B29-28*

In the center of the room B29-B, a more or less rectangular masonry **B29-28 (Fig 3-51)** was visible since the beginning of excavation. It is a very damaged construction, 2.70 m long by 0.75 m to 1.30 m wide, made with large and medium pebbles and limestone blocks bonded with earthen mortar. The construction was at least 0.20 m higher than the floor and the collapse of the backfill eastwards has shown that it continues for at least for 0.50 m under the floor level. Though it cannot be proved without further excavations, the dimensions of the structure, its location and appearance, and the general pattern of the area, strongly suggest that it is a masoned grave. A small fragment of coating (**IsoArc1166, Fig 3-52**) found in the collapse south of the building could come from the cover of the grave, which could so have been of trapezoidal or pyramidal section, but it is difficult to be affirmative.

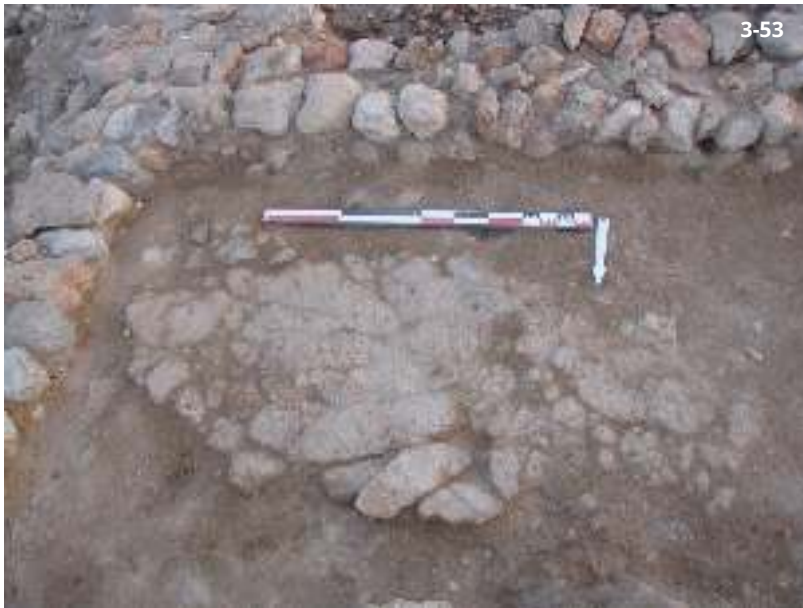
**Fig 3-53 :** the remains of coated floor B29-29

South of the grave B29-28, a small piece of coated floor **B29-29 (Fig 3-53)** was found, above the earthen floor, for 1.70 m long by 0.70 m wide. Absolutely no other remain of coated floor was observed anywhere in the main building and it can be exaggerated to assume that the whole room B29-B was covered with coated floor. Though the coating is not exactly waterproof, a small area for ablution might be considered and the remains of floor could in fact be the bottom of a basin.

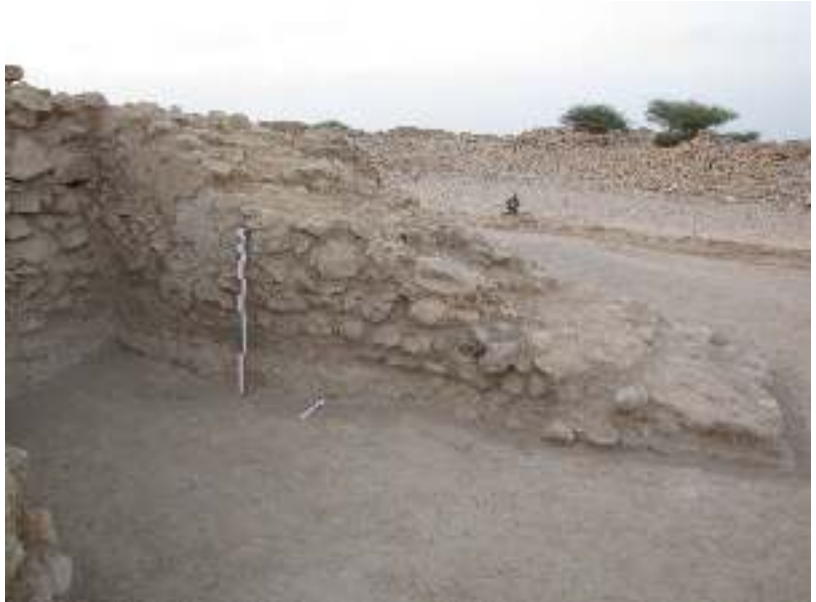
**Fig 3-56** : the south side of the stair B29-33, with the beige coating on top at left, the gray coating at feet and the disturbed facing at right

Several remains of coating were observed on both sides of the stair, with a beige one on the upper part and a strong gray one, similar to cement, all around its foot. The north and south sides have also suffered a pressure, due to the internal filling, which has pushed the elevation to the outside and some of the stones from the facing have either collapsed or slide, explaining why the facings are not yet strictly vertical and some stones are missing (**Fig 3-56**).

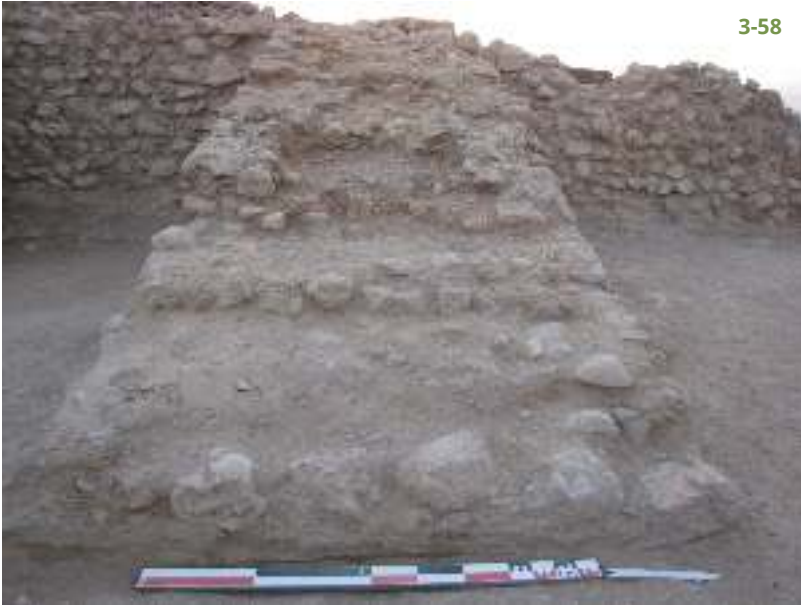
**Fig 3-58 :** the first two steps (in the foreground) and the upper steps (guessable in the background) of the stair B29-33

The upper steps are more damaged and it is difficult to be affirmative about them (**Fig 3-58**). They were apparently bounded at north and south by a handrail, which is very badly preserved, and so were smaller than the low steps, about 0.80m long by 0.60m wide. They could also have been higher, probably 0.50m but five steps about 0.30m high were probably enough to reach the east upper gallery, where one large step or two small ones were sufficient to reach the floor of the room B29-B.

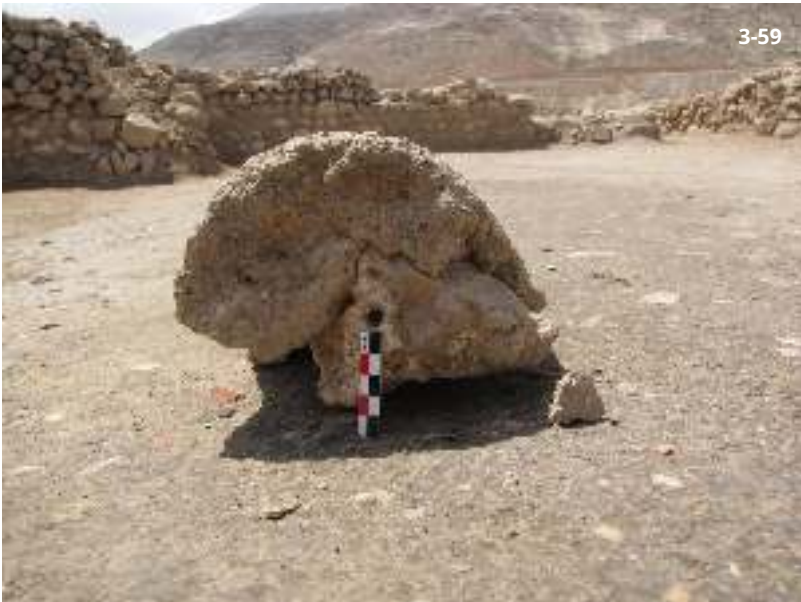
**Fig 3-59 :** lateral view of the possible remains of a handrail (IsoArc 1165)

In the layer of collapse (**Uf5531**) excavated around the stair B29-33, a fragment of masonry with a half-round face covered with strong gray coating (**IsoArc1165** ; **Fig 3-59**) was found. According to its location, it could be the remains of the handrail outlying the upper steps, the top of which was half-round. This handrail could have been very low, no more than 0.50m high, as some examples of stairs with low handrail are still visible today in the oldest houses of the actual village of Qalhât. The handrail could have extended until the walls B29-05 and B29-27 and have the same height; in this configuration, the access to the upper gallery in front of the room B29-B was blocked by the pursuit of the handrail, and was so probably not used as a passageway.

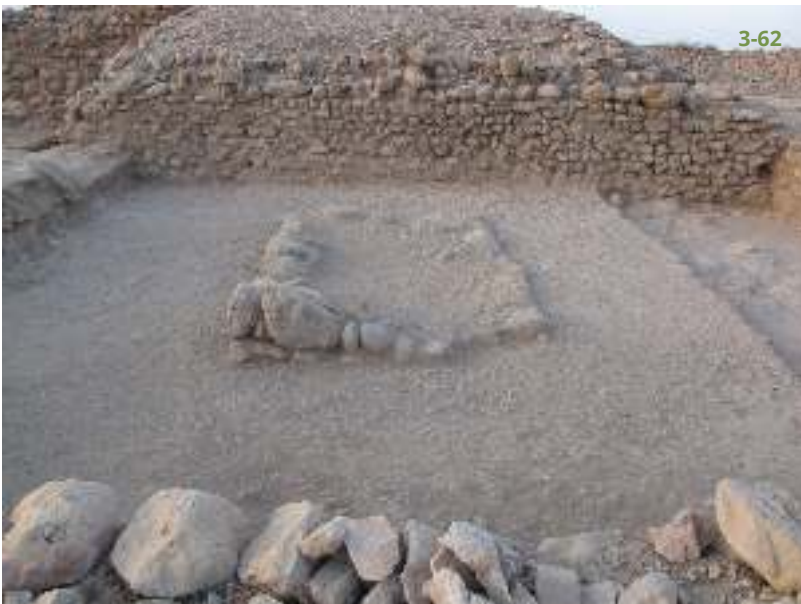
**Fig 3-62 :** the wall B29-08, in the background

The south limit is made by the wall **B29-08 (Fig 3-62)** which is common with room B29-D. It is here 6.30m long and 0.65m thick for a preserved elevation of 0.80m in average, made with medium pebbles and limestone blocks bonded with earthen mortar and few remains of beige coating were observed in the lower parts of the wall.

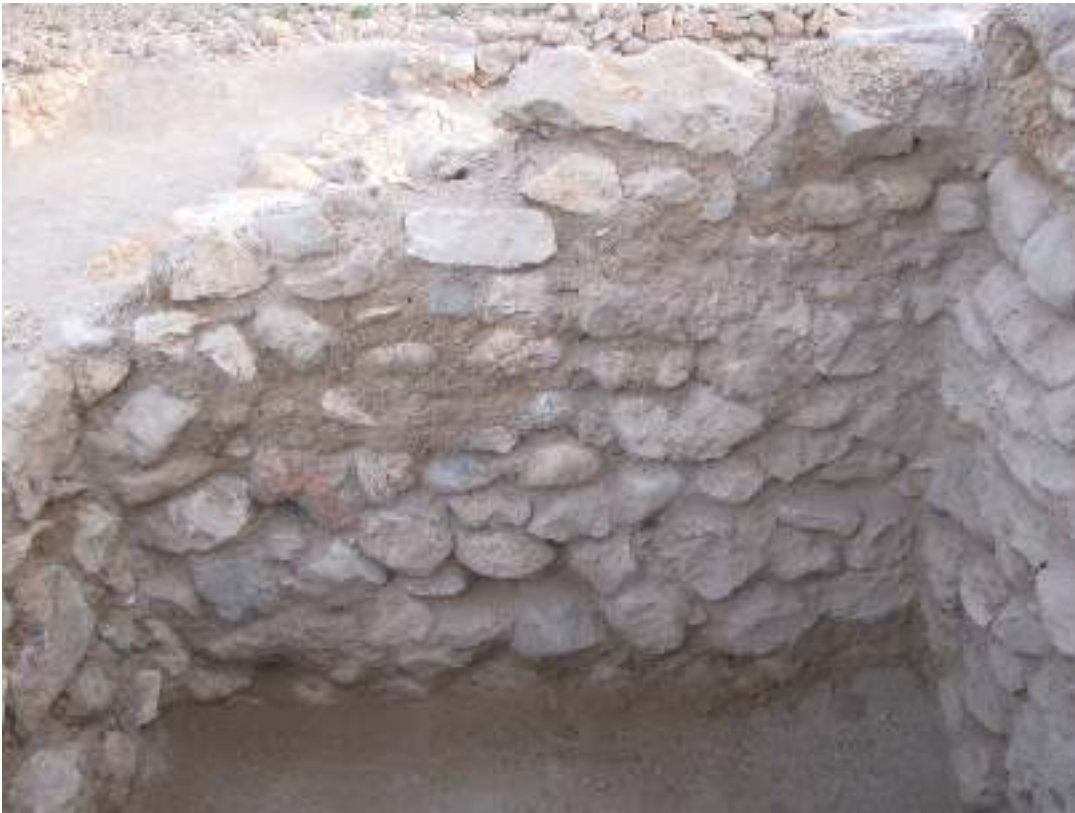
**Fig 3-67** : the internal elevation of the wall B29-08 in room b29-D

The south room B29-D is now 1.70m long by 1.30m wide and is reachable at east by a very narrow gate. The south limit is made by the wall B29-08, common with room B29-C and which is here 1.30 m long internally and 0.70m thick for a maximal preserved elevation of around 1.30m (**Fig 3-67**). The west limit is made by the wall **B29-07 (Fig 3-68)** which is also the east wall of the room B29-C. It is 1.60m long and 0.55m thick for a maximal preserved elevation of 1.80m; it is made with large and medium pebbles and limestone blocks poorly bonded with earthen mortar and without any remain of coating.

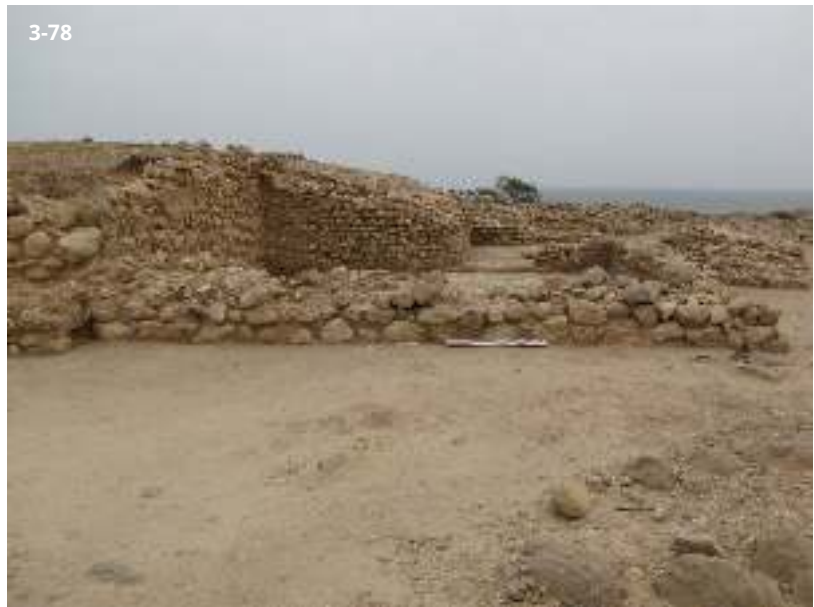
**Fig 3-78 :** *the wall B29-10, outside elevation*

The south-west courtyard, 6.50m long by 5m wide, is set against the south side of the prayer hall B29-A and the high terrace B29-C to the east. The west limit is made by the wall **B29-10** (Fig 3-78), 7.30 m long and 0.75 m thick, 0.60 m high in average, built with large pebbles and limestone blocks bonded by earth. No coating was found on the outside face, but the internal elevation is partly covered with the strong gray mortar (Fig 3-79).

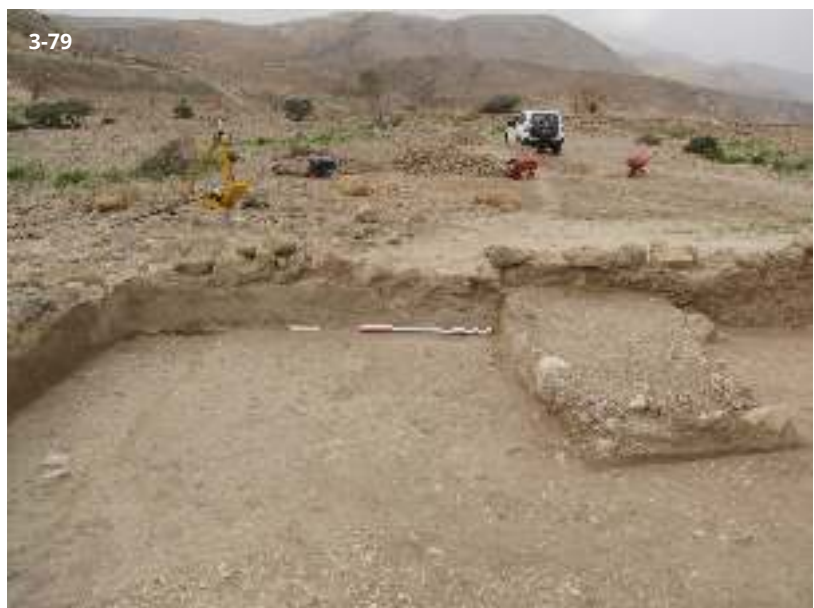
**Fig 3-79 :** *the wall B29-10, inside elevation*

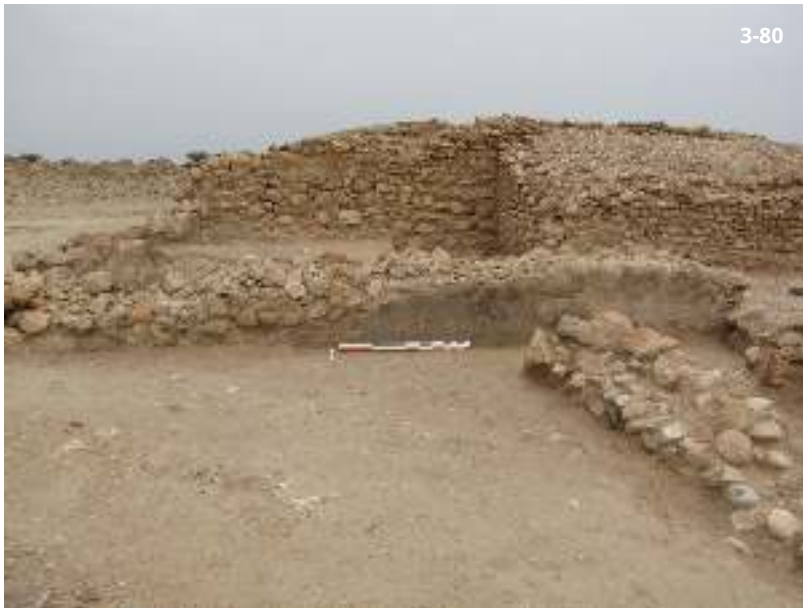
**Fig 3-80 :** the wall B29-16, outside elevation

The south limit is made by the wall **B29-16**, 6.50 m long by 0.80 m thick and 0.60 m high, also made with large pebbles and limestone blocks bonded with earth and entirely covered by strong gray coating only on the internal face and partly on its external side (Fig 3-80). A sounding (SD6) opened along the internal face of this wall also showed that this gray cement was also put above the bedrock and its leveling, at least in the south part of the courtyard. It is very unlikely however that the entire floor of the courtyard was ever cemented.

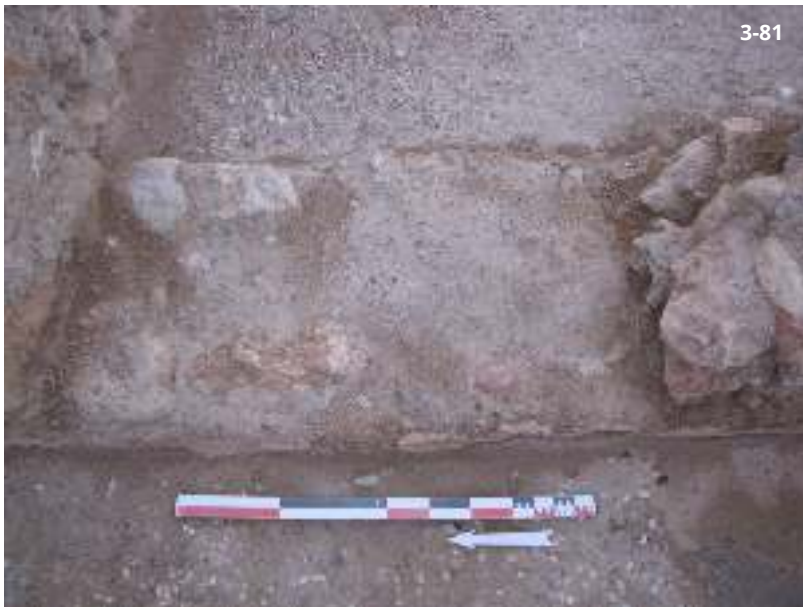
**Fig 3-81 :** the threshold B29-19

The south-west courtyard was reachable from the east, through the south-east courtyard, by the threshold **B29-19** (Fig 3-81), which is set right at the foot of the south-west corner of the high terrace. This threshold, 1.30m long by 0.80m wide, is made with large and flat pebbles, partially polished, bonded with earth and partially covered by a strong mix of plaster, mortar and small pebbles, which was probably the circulation level.

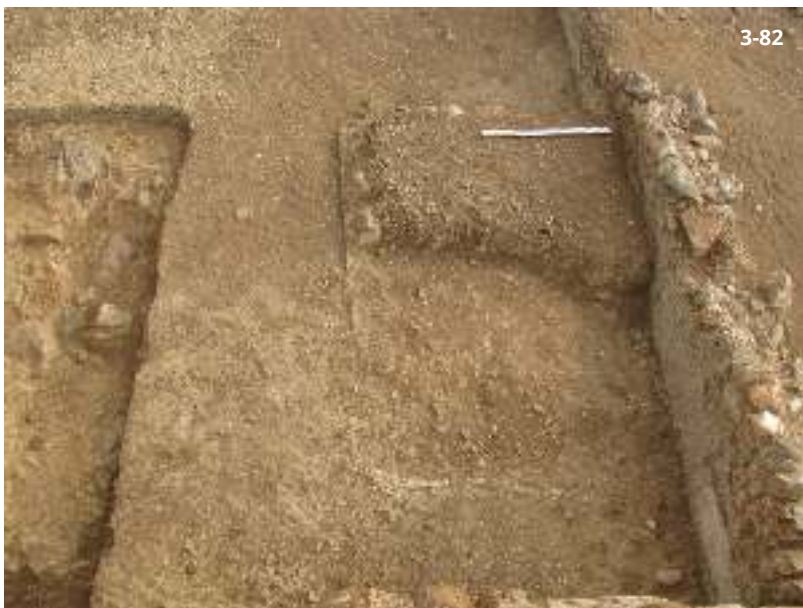
**Fig 3-82 :** the grave B29-18, with its imprints visible on the ground

Along the west wall B29-10, a large rectangular grave (**B29-18** ; Fig 3-82) was found, with its north half heavily destroyed by the collapse of the wall B29-03 but the extent of which is still visible by the imprints on the floor. The construction was originally 3 m long by 2.10 m wide and probably around 0.40 m high. It was made with a rectangular formwork made of large pebbles and limestone blocks bonded with mortar and covered with strong gray coating to the south and apparently white plaster to the north. The inside of the masoned formwork was afterwards filled in with gravels and small pebbles until its top, which could have been coated, though no remain was found. According to its shape and location, it is possible to identify this structure as a rectangular masoned grave.

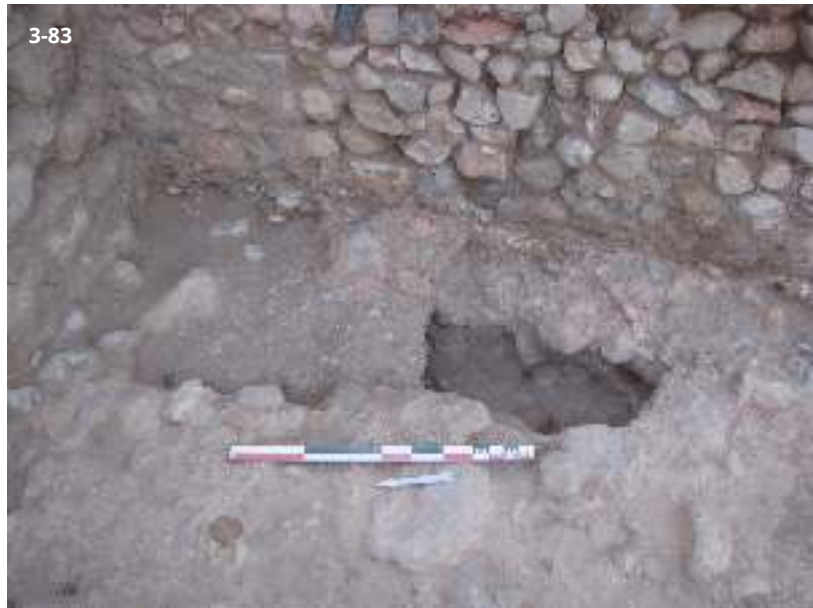
**Fig 3-83 :** the oval pit B29-32 in the sounding SD, half excavated

In the middle of the sounding SD2, an irregular oval pit was also uncovered (**B29-32** ; Fig 3-83). Around 2 m long by 0.40 m wide and 0.60 m deep, it was probably a failed attempt to dig a sepulchral pit, and the grave B29-32 could be the successful attempt.

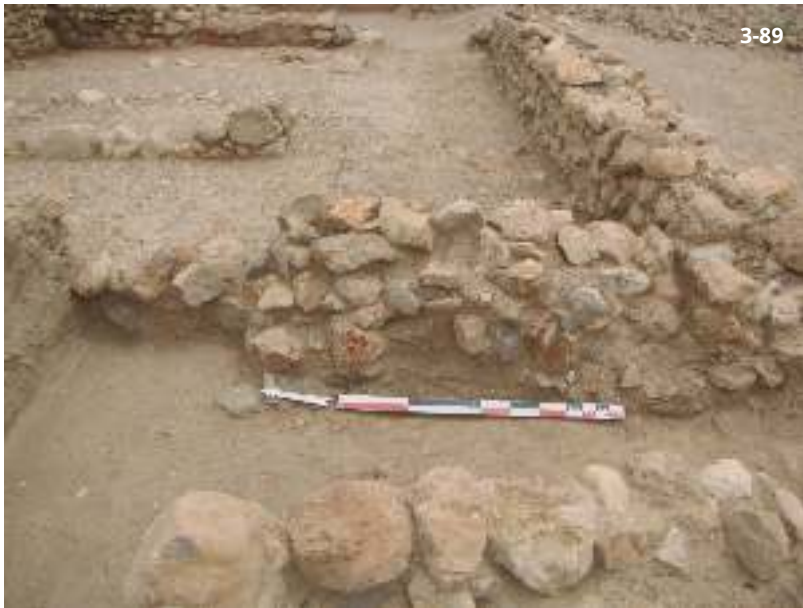
**Fig 3-89** : the wall B29-14, outside view

To the west, the limit is made by the wall **B29-14 (Fig 3-89)**, which is leaning on the south wall B29-13 of the south-east courtyard and on the south wall B29-16 of the south-west courtyard and has only one internal facing. It is possible that this wall is a later addition related with the wall B29-31 to the west (see below) and that the passage was originally opened.

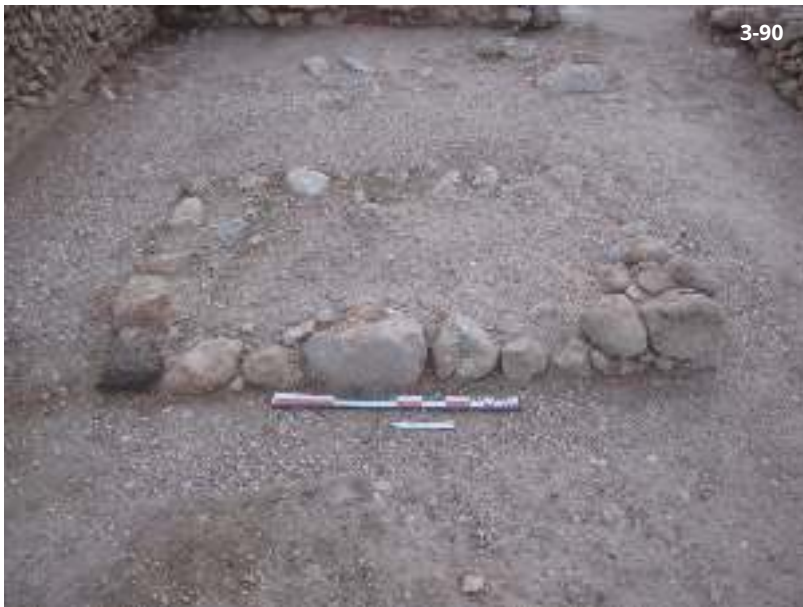
**Fig 3-90** : the grave B29-17

Nearly in the center of the south-east courtyard, a rectangular structure (**B29-17; Fig 3-90**) was also unearthed. The structure, 2.80m long by 1.90m wide, was damaged by the collapse and some of it was accidentally removed during excavations before its identification. The south-west corner is however well preserved and the structure was originally at least 0.40m high. As for the grave B29-18, the structure B29-17 was made with a formwork of massive pebbles and limestone blocks, nearly without binder, and afterwards filled with small pebbles and gravels. No remain of coating was here observed. According to its location and shape, this structure must also be identified with a masoned grave, similar to the western one but simpler made.

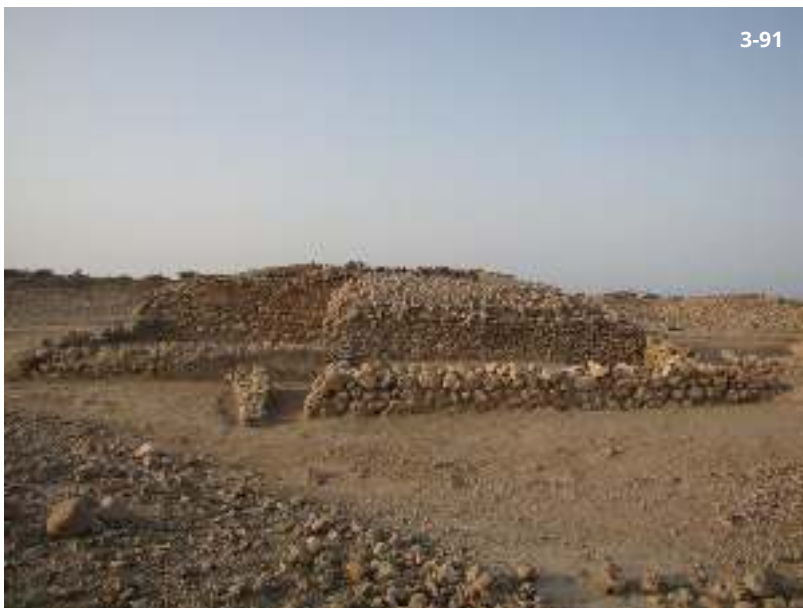
**Fig 3-91** : general view of the south side of the building B29

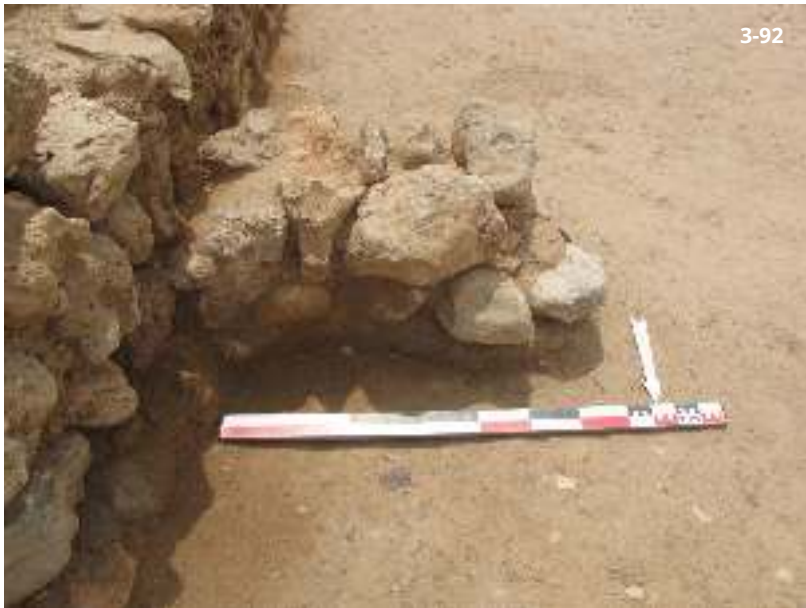
**Fig 3-92 :** *the small wall B29-36*

To the west, a very small wall (**B29-36 ; Fig 3-92**) was found, built against the wall B29-12. It is now only 0.75m long, 0.50m thick and 0.40m high and, as it is built above the circulation floor and not over the bedrock, it could reasonably be considered as a late addition and its function remains unknown.

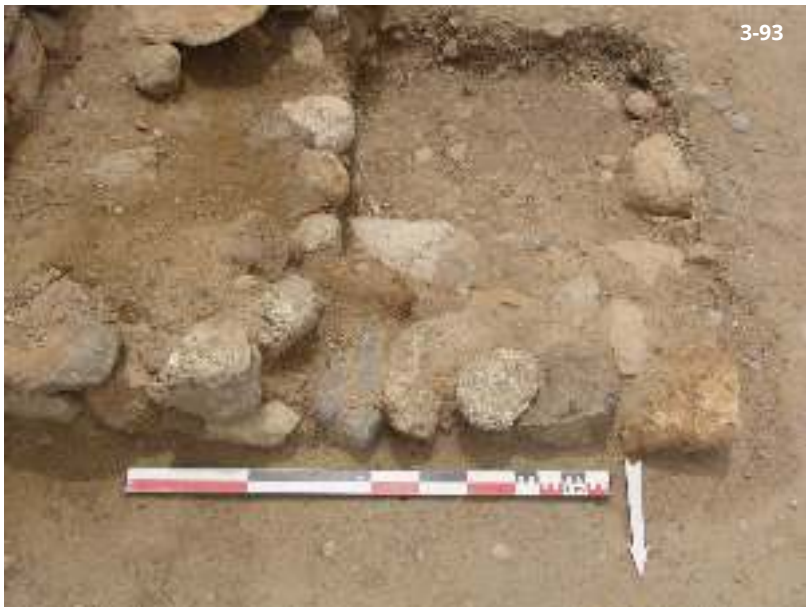
**Fig 3-93 :** *the low wall B29-35*

To the north, the low wall **B29-35 (Fig 3-93)** is also problematical. It was observed for 1.60m by 0.70m wide and is preserved for one to two courses of stones, made by large and medium pebbles and limestone blocks bonded with mortar and partially covered by the circulation floor. It might extend westward and, to the east, it goes under the wall B29-12 and the corner of the walls B29-01 and B29-02, with which it is perfectly aligned. It could so be part of a former building entirely leveled and of which nothing visible remains. It can also participate to the original setting of the building. The wall B29-35 might have been built first, not much higher than it is today, to indicate the direction of Mekka, and it was shortly after used by the builders to make the whole building, following the orientation given by the low wall. This is only a hypothesis but there is no much better explanation.

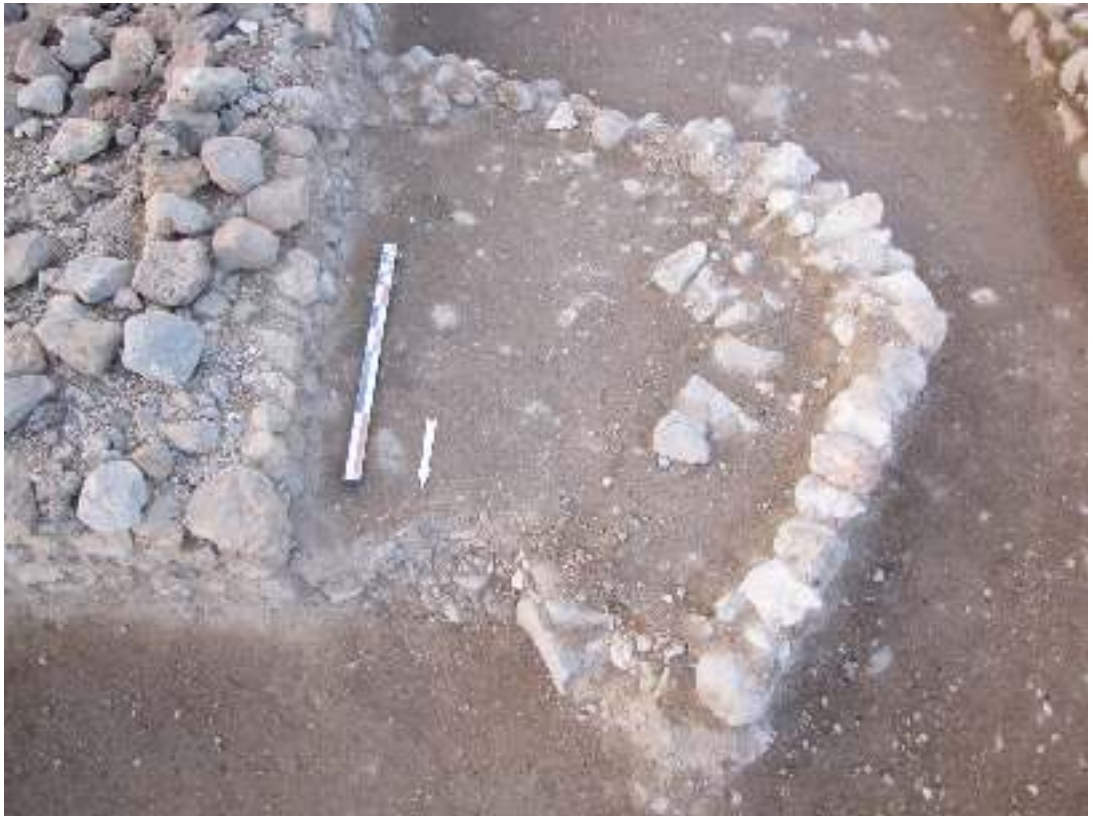
**Fig 3-95** : general view of the structure B29-F

About 3.30 m east of the south-west courtyard, a more or less U-shaped wall was observed, which could belong to a building, a courtyard, or even a funerary terrace. In this narrow passageway, a nearly circular structure was uncovered (**B29-F ; Fig 3-95**), made with medium pebbles and limestone blocks without binder and built over collapse. It is obviously a late structure which was made when the building B29 has started to fall into decay but it looks too small to be an enclosure for goats. It could also be a late grave, set here when the sacred use of the building B29 was still clearly visible.

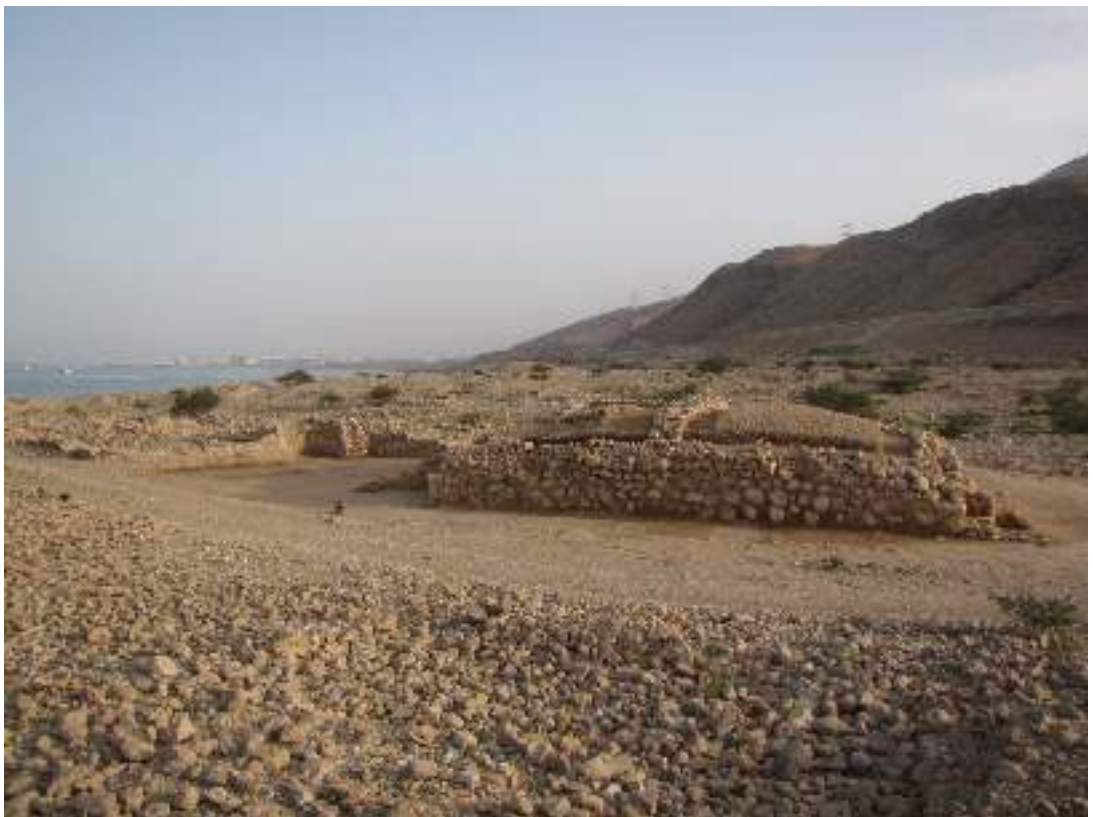
**Fig 3-96** : general view of the building B29 at the end of excavations, with the city square at left

More to the west, about 9.75m far from the rooms B29-D/E, a corner of wall was also partly uncovered, belonging to a medieval building extending south-east. Two late walls, made of drystones and built over an important layer of collapse and colluvium, were observed. They were both made after the abandonment of the city and quite probably used as enclosures. If the open space which is bordering the east side of the building B29, and which could be named as a city square, is now about 10m wide, it may have extended originally eastwards for several meters more. (**Fig 3-96**)

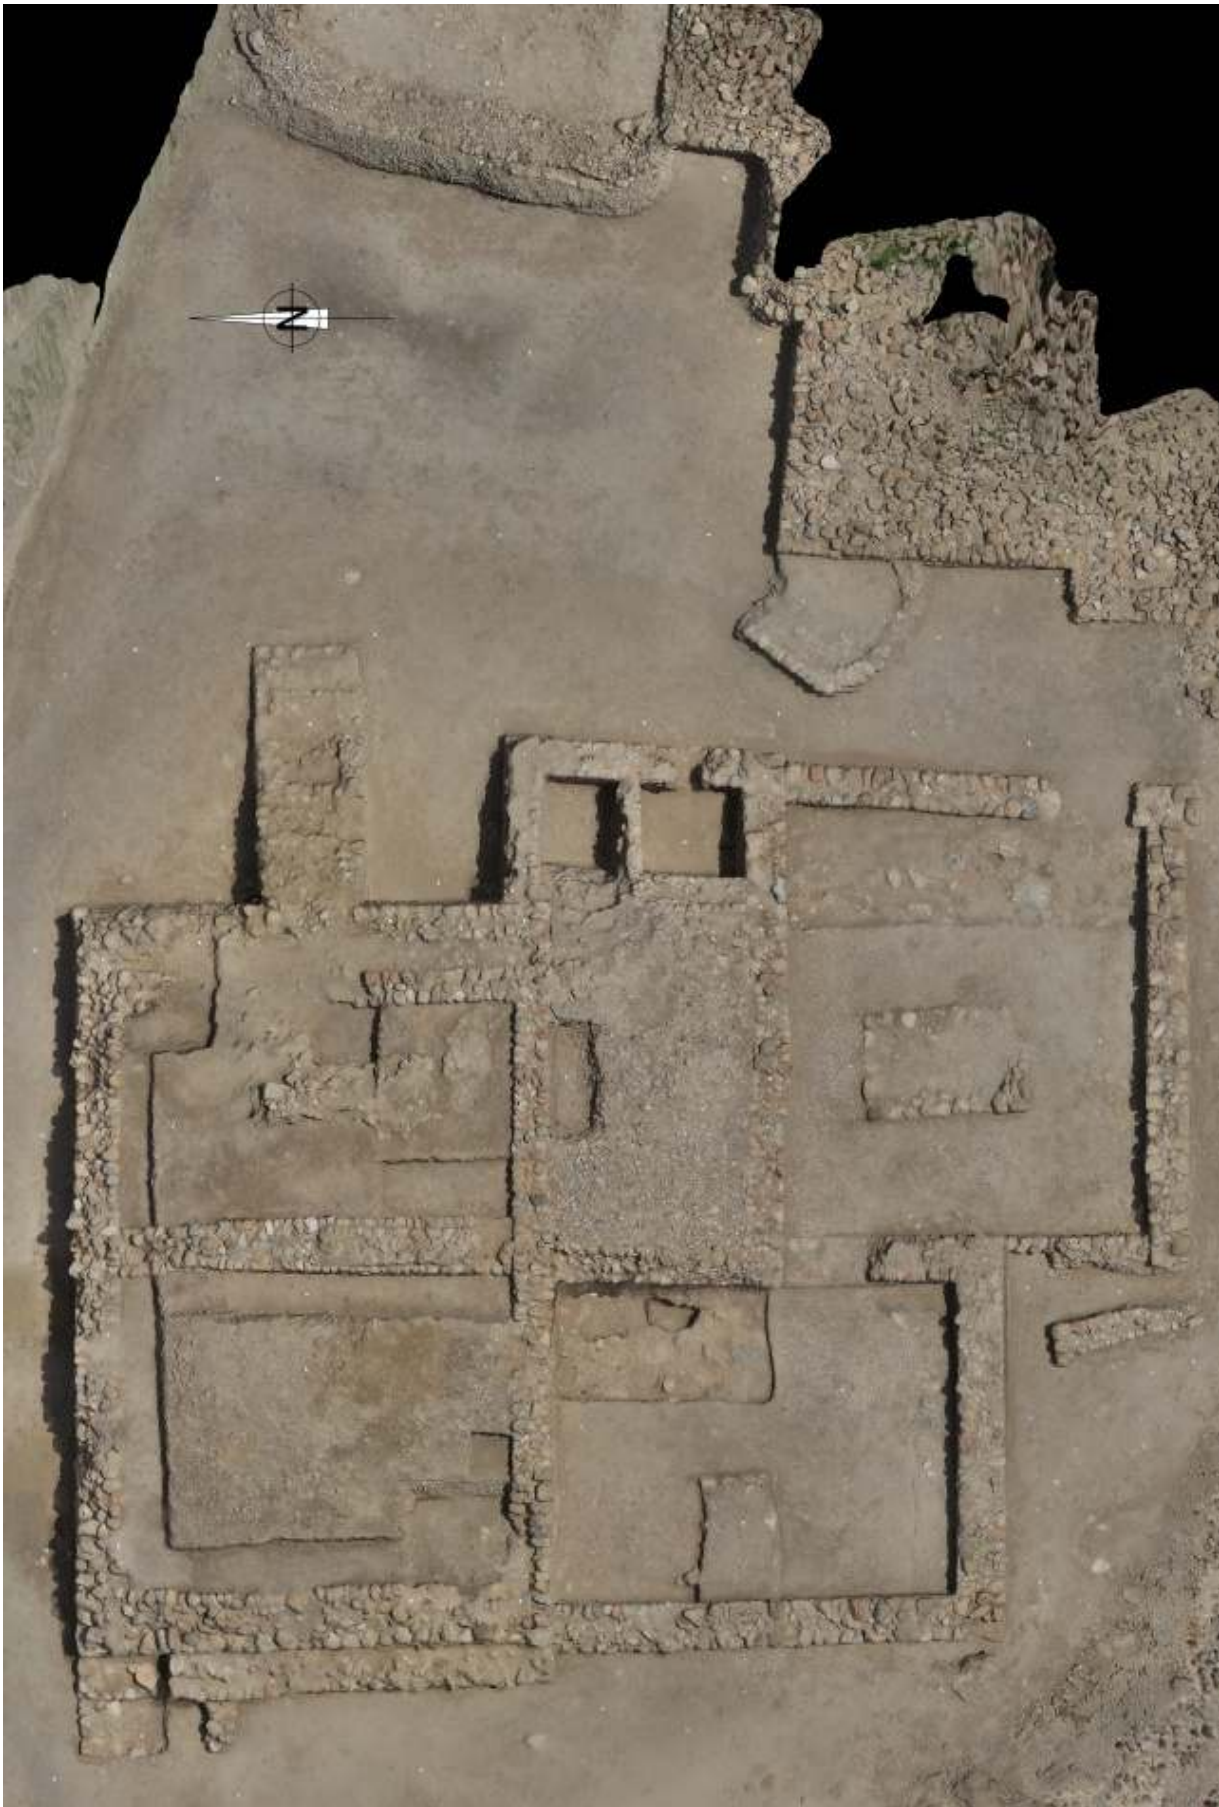
**Fig 3-97** : photogrametry of the building B29 and its surroundings
