## Qalhât Development Project, Season 2015B-2016A, Final Report

**QALHÂT (ASH-SHARQYJAH)**

**SEASON 2015B-2016A**

**FINAL REPORT**

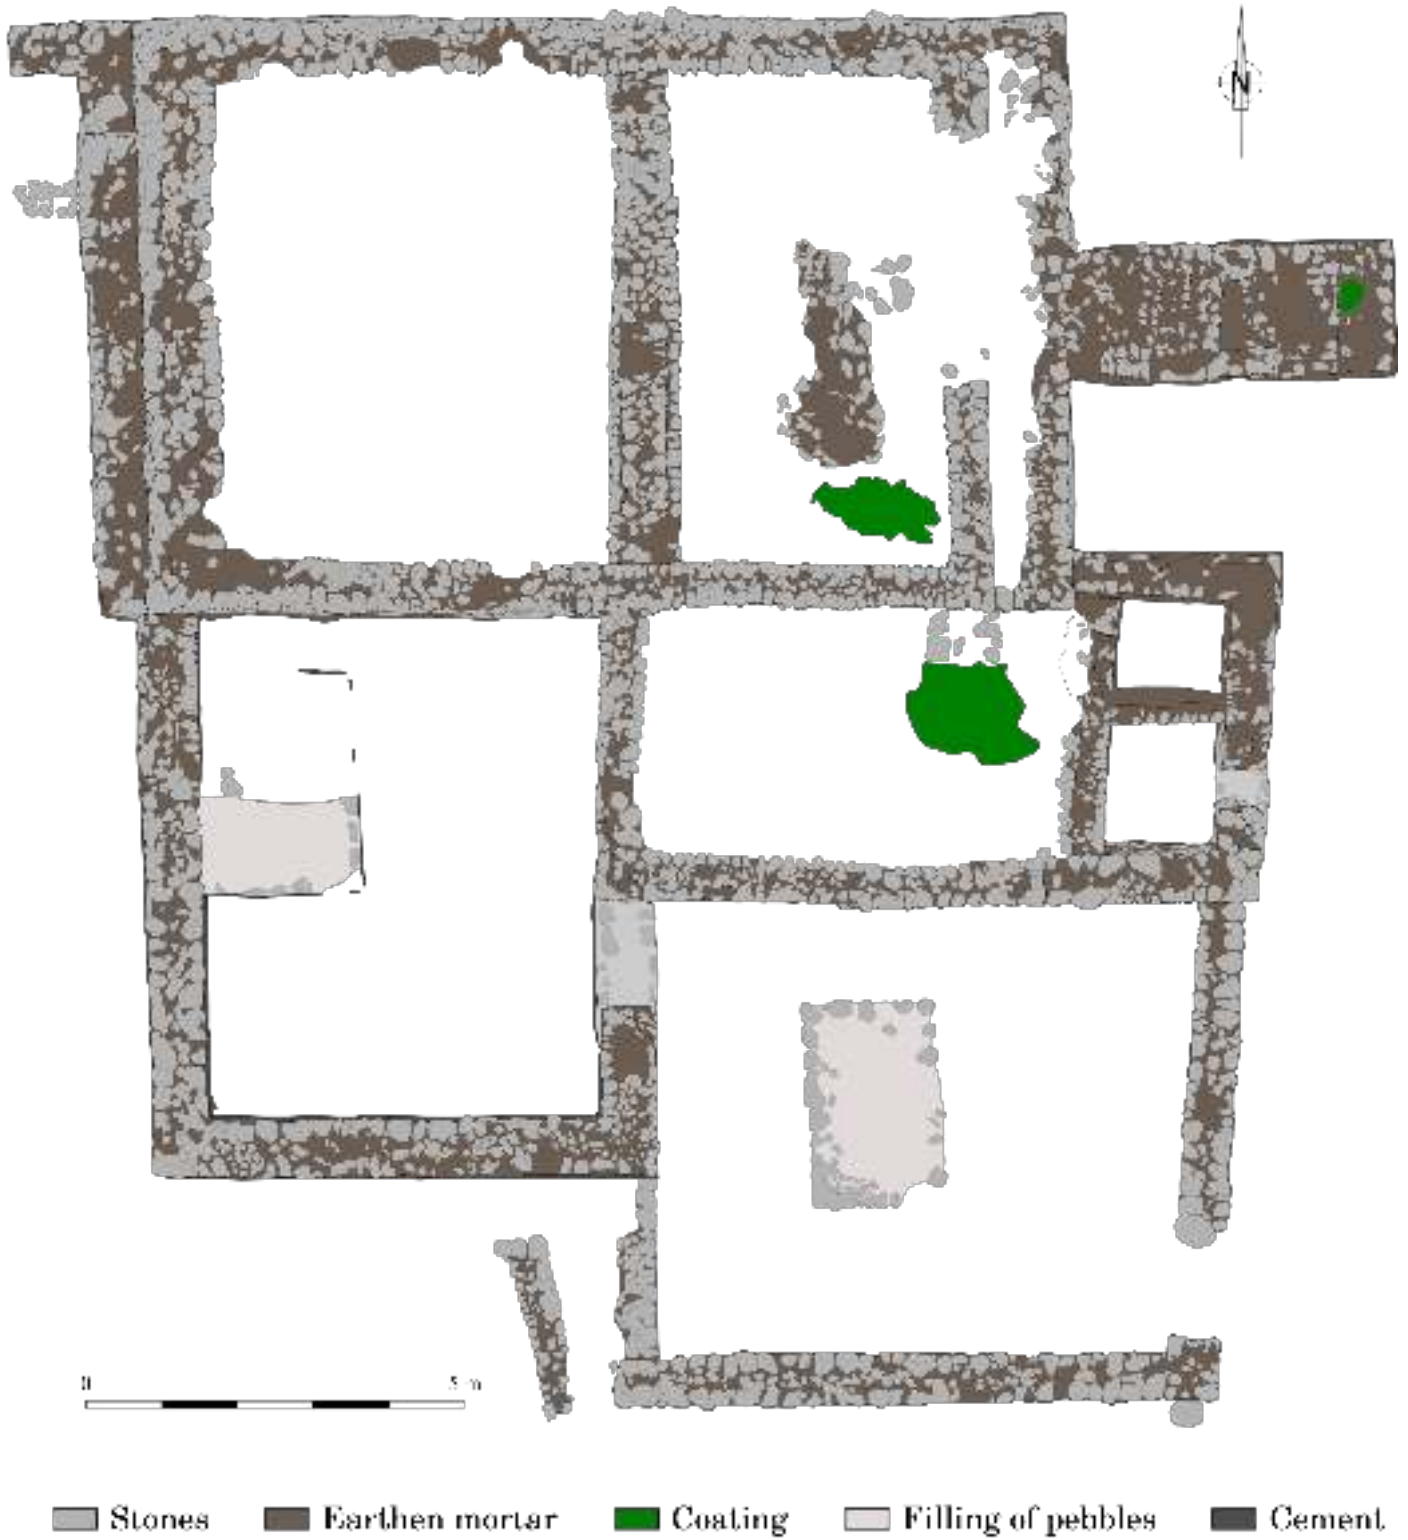
Fig 3-98 : archaeological site plan of the building B29

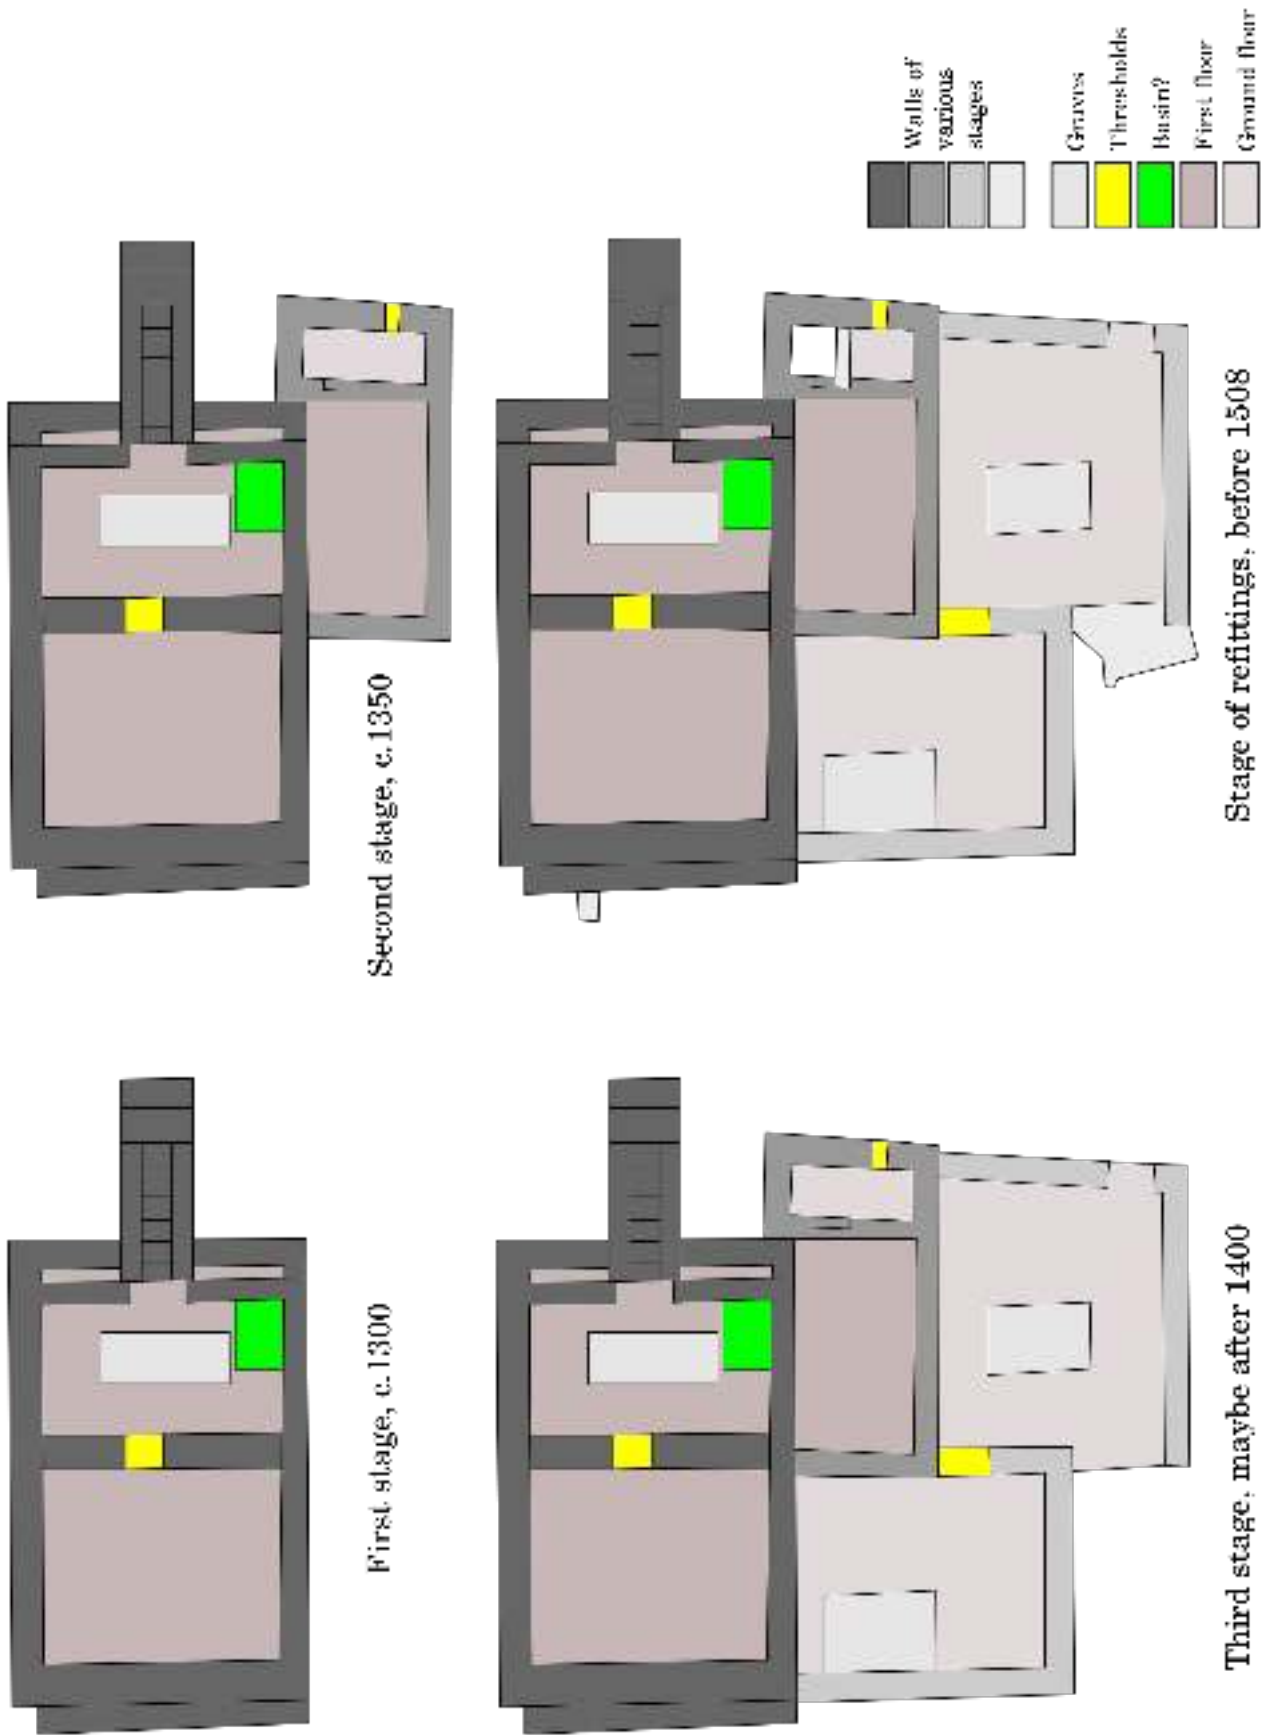
**Fig 3-99**

Fig 3-99 : stages of evolution of the building B29

The first stage of the building B29 dates back to the turn of the 13<sup>th</sup> century to the 14<sup>th</sup> century, probably during the reign of Ayaz of shortly after. It was firstly a rectangular construction, made as a mausoleum built on a platform. The first floor was reachable by a stair on the east side, climbing to the high terrace (B29-B) occupied by a masoned grave, from where a small prayer hall (B29-A) was accessible west, through a vaulted gate. The prayer hall was apparently very simple, without decoration, and quite probably covered by a roof, while the high terrace could have been at open sky and only bounded by low walls. The east facade of the building was outlined by a high gallery while a bench could have existed west at the foot of the *qibla* wall.

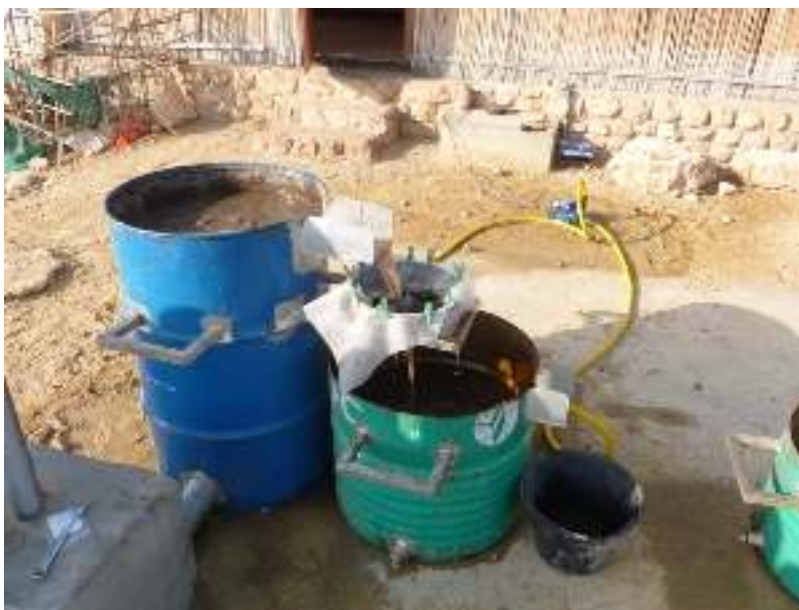
**Figure 1:** Flotation-machine

The aim of the flotation method is to sieve excavated sediment in a water bath, in order to allow the organic material to float to the surface. So, a flotation-machine built during the 2014a campaign has been used. (fig. 1).

The sediment, sampled in different types of archaeological contexts, is added in the main barrel. By doing so, the big fraction of the sediment and other heavy material (ceramic, glass, metal, pearls) are recovered on a bottom sieve (meshes: 1mm), while the less dense organic material (charred seeds, charcoals, bones) float to the surface. The material that floats to the top, called light fraction is recovered with a sieve (meshes: 0.3mm). After drying the light fraction, the macro-botanical remains (seeds, fruits, charcoals) are sorted out by looking with a binocular loupe (Nikon SMZ 1000).

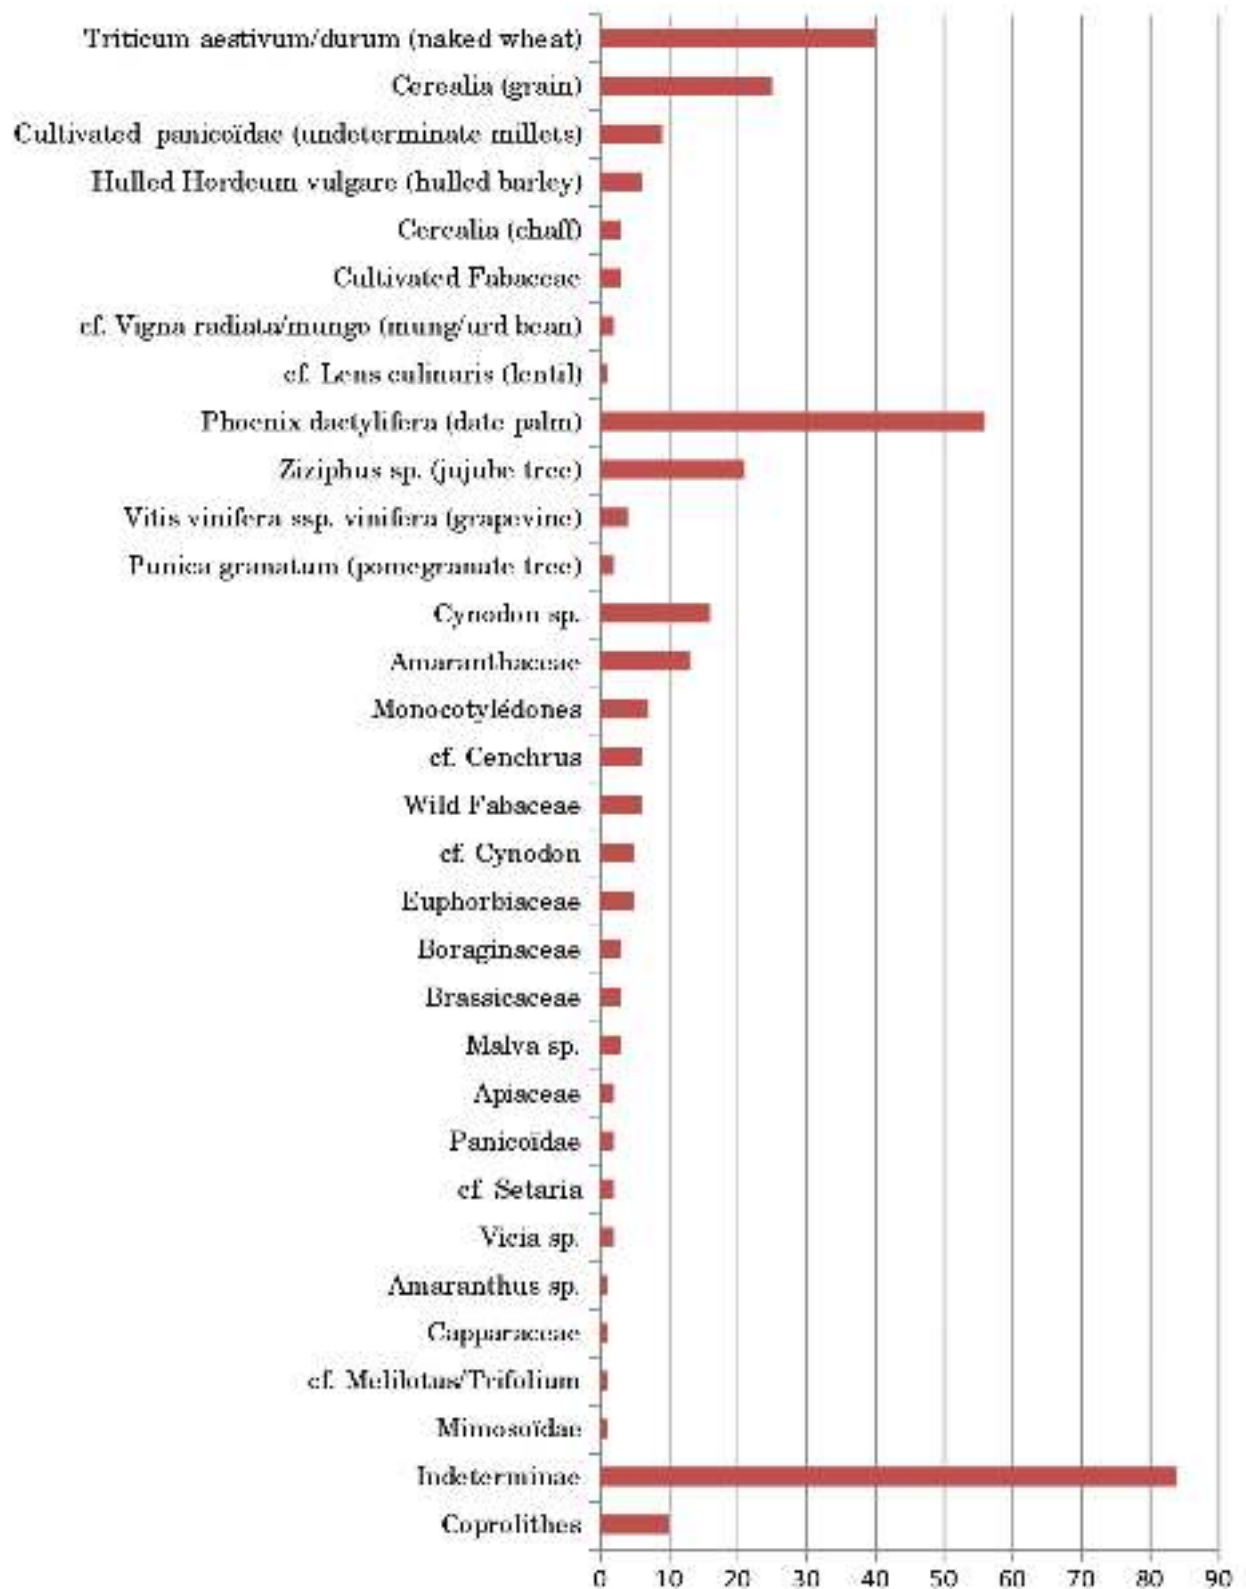
Figure 2: Composition of the whole seeds and fruit assemblage from B94 and B21

All in all, 683 seeds and fruit remains have been counted corresponding to a minimum of 356 individuals (fig. 2). They are mainly preserved by carbonisation but also by dessication (1) and mineralization (4). According to the general results, we can notice the predominance of both cereals and fruit trees. For the first category, we can see that the naked wheat (*Triticum aestivum/durum*) is dominant compare to the hulled barley (*Hulled Hordeum vulgare*). Some millets (*Panicoidae*) have been found but, due to their morphological diversity, their identification remains unclear. Further analysis will be undertaken in order to precise their identification. Concerning the fruit trees, we can point out that they are mainly represented by the date palm (*Phoenix dactylifera*) then by the jujube tree (*Ziziphus sp.*)(fig.3). Other fruit trees are present in few quantities such as grapevine (*Vitis vinifera ssp. vinifera*)(fig.4) and pomegranate tree (*Punica granatum*). Pulses are very poor numerically: most of them doesn't have sufficient morphological and anatomical features to be identified more precisely. Nevertheless, a hypothesis have been given for some of them, one may correspond to lentil (*Lens culinaris*) and others to mung/urd bean (*Vigna radiata/mungo*) which originate from the Indian sub-continent. Several weedy taxa have been identified in the assemblage. Among them, we can note the presence of wild taxa which are common in arid environment as this of Qalhât such as *Amaranthaceae*, *Malva*, or even *Cenchrus* ; the most represented weed is quackgrass (*Cynodon sp.*) which characterizes irrigated fields. Finally, some rodents and goats dung have been retrieved in several samples. The undeterminate will be analysed more precisely to try to identify them.
