Qalhât Development Project, Season 2015B-2016A, Final Report

Excavations on the Ceramic Workshop B41

I-B. The 2015b-2016a season - 1. Excavations of the southeast part of the Mosque (Spans 1 and 2)

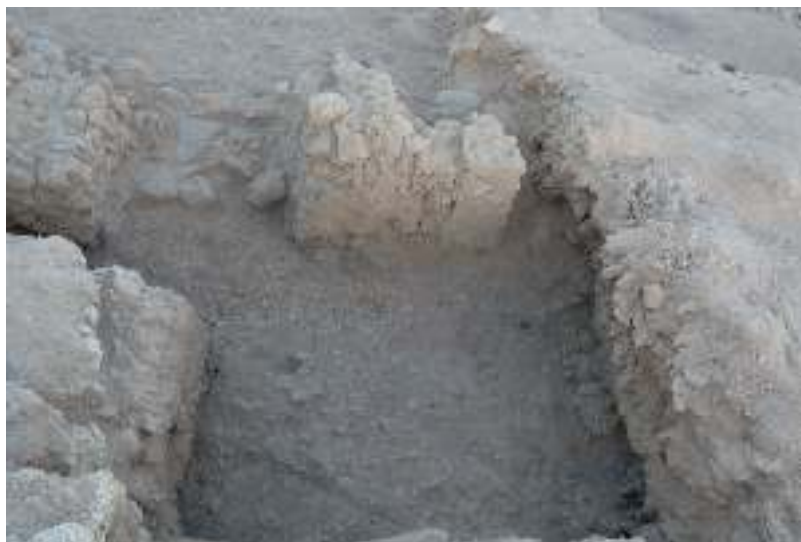
Fig 1-12 : the abutment B12-301 from the west

The abutment **B12-301** (Fig 1-12) is a rather square construction, 1.90m long and from 1.75m to 1.50m wide, now preserved for about 0.90m high. It frames the threshold B12-300 to the south, opposite the abutment B12-184. Further south, the abutment **B12-308** (Fig 1-13), separated from the previous one by the threshold B12-360, measures 1.70m long by 1.50m wide for a maximal preserved elevation of 0.80m. The southernmost abutment **B12-311** (Fig 1-14), framing the threshold B12-359 with the aforementioned wall B12-308, is 1.70m by 1.60m wide for an actual elevation of 0.85m. South of it, the threshold B12-372 is framed to the south by the external wall B12-16, uncovered and registered during the soundings made by the QP. All those square jambs for the gates are made in the same way with medium coral and limestone blocks, carefully built, and bounded with gray mortar mixed with small pebbles, charcoals and fragments of ceramics. The coating is variously preserved, in a better way to the north than to the south where it shows important gaps on the wall B12-311. Two types of coating were also observed, the first one being similar to the coating observed elsewhere in the basement, though a little grayer, and the second one being a darker coating of the same type as the one observed in some part of the north wing and suggesting a possible later repairing.

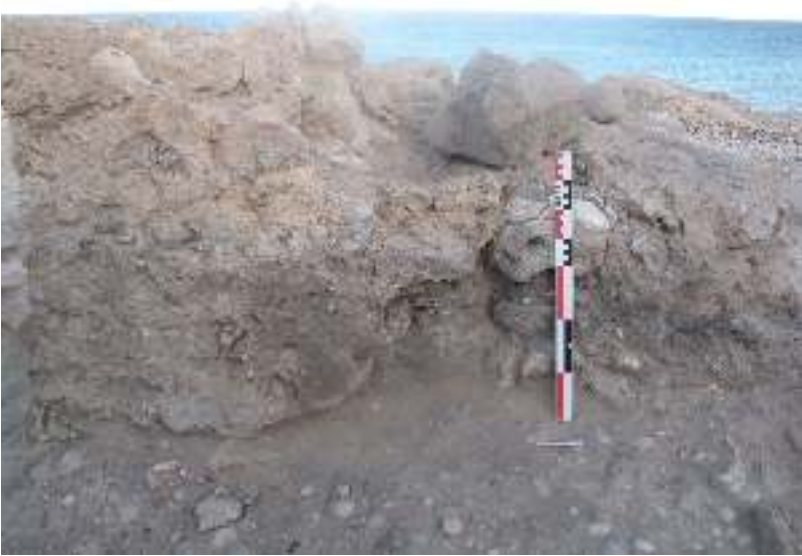
Fig 1-13 : the abutment B12-308 from the west

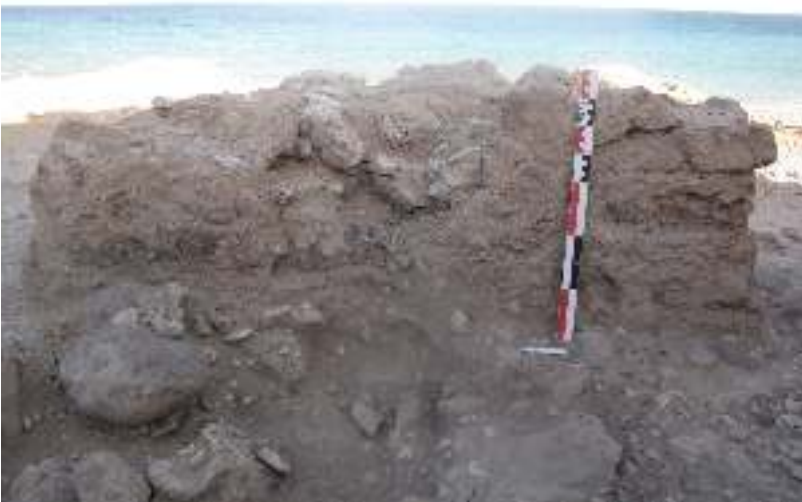
Fig 1-14 : the abutment B12-311 from the west

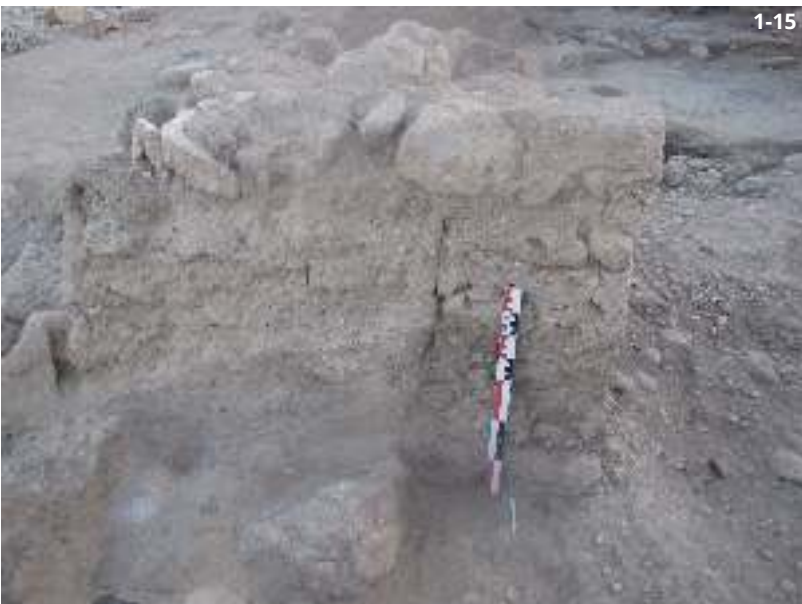
Fig 1-15 : the line (at left of the scale) suggesting a former widening

Those abutments also show traces of a western widening in their lower part, a vertical line being visible between the original west facing and a doubling wall. But this line does not show in the upper part (Fig 1-15). It seems therefore very likely that the jambs of the gates were firstly built in a smaller scale before being enlarged during the construction phase, quite probably because the first dimensions were considered too small to support the walls above, including the wall of the entrance hall on the first floor that was facing the sea. In the actual state of knowledge, there is no indication about the original height of the gates and abutments. They could go up to the roof between the ground floor and the first floor or be lower, as no architectural remains found can suggest if the top of the gates were made by masoned arches, or lintels, or by simple beams. There are also no traces of door-frames or visible hinges and, though it seems quite unusual, these gates might have no doors at all.

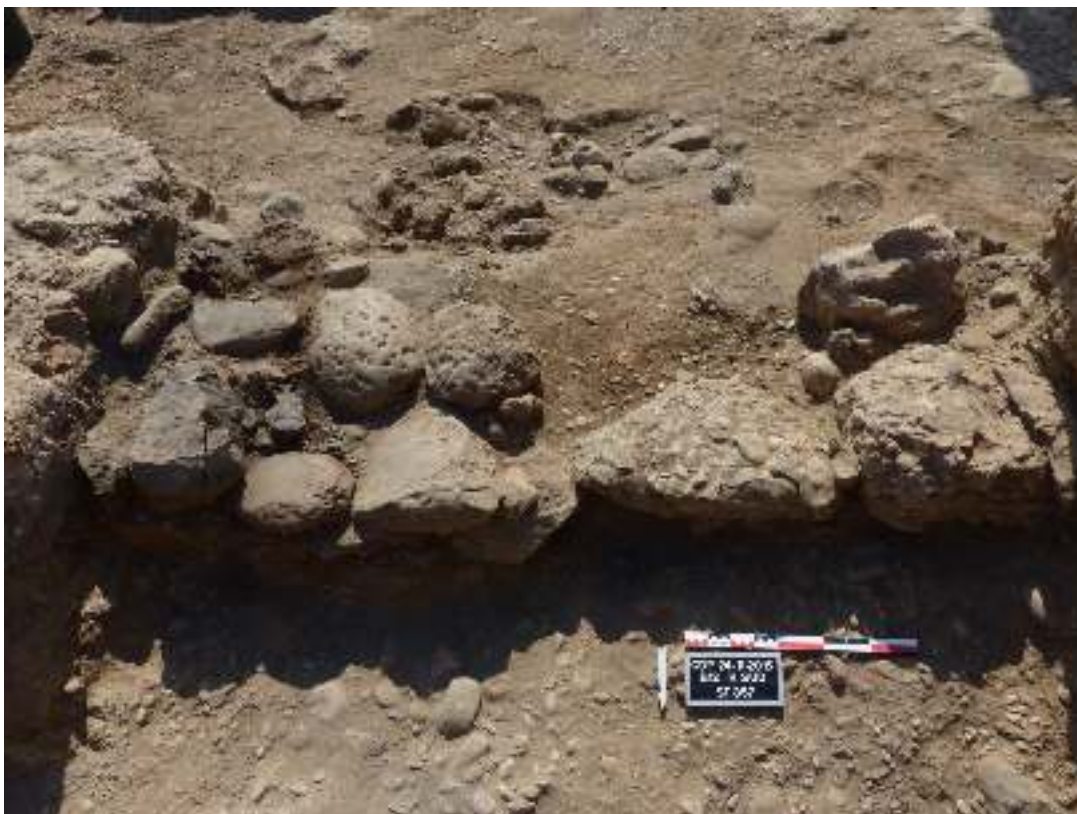
Fig 1-24 : the low partition wall B12-357

Covering those levels, the **UF3886** and **UF3869** seem to be both ground of rammed earth, the first one made with compact beige silt mixed with small pebbles, charcoals and fragments of plaster, while the second one is similar by its components but a little darker. Those two levels could be former floors, before the fitting of the last occupancy floor observed (UF3830, see below) but could also be levels of backfill to compensate the irregularities of the bedrock and to raise the level of the floor, in accordance with the height of the thresholds. Though it is not possible to be affirmative as the area was not excavated down, because of the will to let in place the most remarkable archaeological levels for conservation purpose, it is very likely that those two backfill levels were used as the foundation for the low partition wall **B12-357** (Fig 1-24) which divides the room B12-K in two nearly symmetrical halves. This east-west wall is built against the buttress B12-322 to the west and the abutment B12-308 to the east, in the same alignment than the wall separating the rooms B12-S and B12-L in the adjacent span 2. It is 2.20m long by 0.65m wide for a preserved height of 0.40m and, although one course of stones might have been accidentally removed during the excavations, it was never much higher, no more than 0.50m high and easy to climb over. It is made mainly with medium limestone and corals blocks with two facing but no mortar coating, and with an internal blocking of medium and small pebbles bounded with sandy gray-brown silt. The construction is rather rough and simple compared with other walls, but it can be easily explained by the fact that this low wall never intended to raise high and support the roof or any kind of structures.

Considering the difference of altitude between the floor made of small pebbles to the north and the floor made of rammed earth UF3830 to the south, which is leaning against the low wall B12-357 and clearly associated with it, this low wall was most probably made to create a platform in the south half of the room 21K, 0.50/0.60m high and easy to climb over, probably testifying of two different functions. As the excavations were not completed down there because of the conservation need, it is not possible to state that this separation was intended since the original construction of the Mosque. But considering that the levels of backfill under the floor UF3830 could be earlier floors, also that the low wall B12-357 is not built on the bedrock and that it is leaning against the coating of the abutment B12-308 and the buttress B12-322, it is very possible that this fitting occurred in a later stage, though the internal division in two spaces with two different uses could date back from the very beginning.

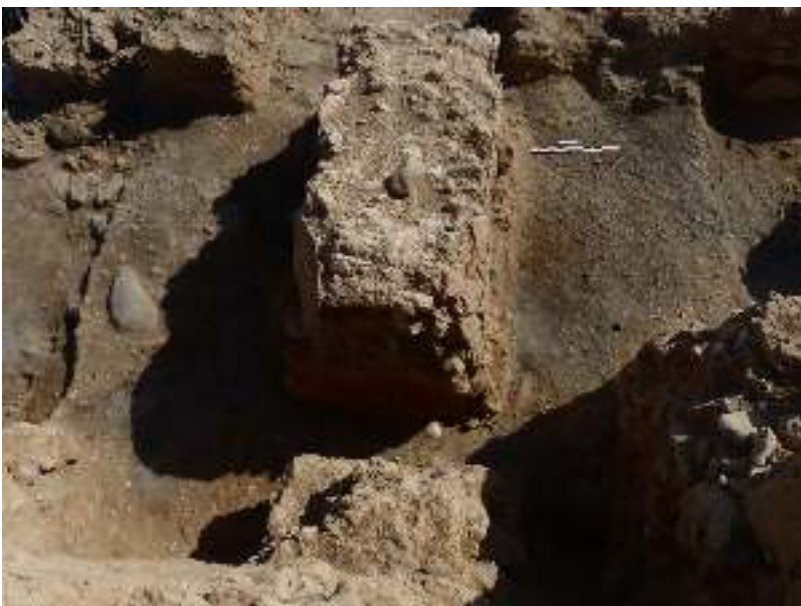
Fig 1-27 : the earthen floor
Uf3824

Above the sanitary level UF3825, remains of a second rammed earth floor **UF3824 (Fig 1-27)** was partially observed next to the gate to room B12-L, south of the low wall B12-357 and next to the thresholds B12-308 and B12-311. It is possible that this thin floor once covered the whole southern half and was damaged by the later occupancy and collapse. This layer is made by indurated brown sandy silt mixed with charcoals, ashes and fragments of plaster. In the northern half, the backfill **UF3831** made of brown to beige sandy silt seems to be contemporary. As the ceramics found in those levels belong to the first half of the 16th century and seem to be a little later than the year 1508, it is a possibility that those layers were put in place shortly after the seize of the city by the Portuguese. Also, the presence of some small elements of collapse found in this level seems to confirm that the fitting was made when the building has started to slowly collapse. This fitting could then either be an attempt to restore the Mosque or be the first stage of reoccupation after the abandonment of the building as a religious edifice. During this stage of occupancy, the low wall B12-357 was still in use and apparently still made a symbolic division between the two halves of the room B12-K. As the ceramic material is very mixed and the backfills very similar, all made with brown silt and small pebbles, it is in fact very difficult to link those levels with the occupancy prior to the arrival of the Portuguese when the Mosque was in use, or to the occupancy after this arrival when the Mosque is assumed to be abandoned. However, the location of this area in front of the seashore makes quite obvious the will to maintain this place in a reasonable state of use, either by the Portuguese occupants, if they stayed here for a certain time, or by the late Qalhâti, even if they did not try to fully restored the building for a religious use.

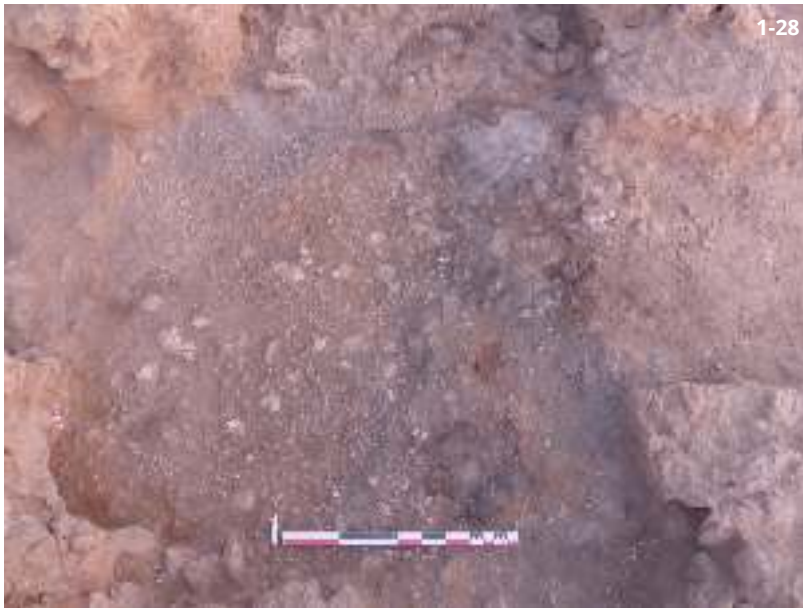
Fig 1-28 : the sanitary floor
Uf3814

Afterward, a sanitary floor made quite exclusively of pebbles mixed with a little bit of brown silt and ashes (**UF3814**) (**Fig 1-28**) was spread over nearly all the southern half, the reoccupation of the northern half being less visible. Right above this level, an important quantity of oyster's shells were found. Those remains can be linked to a craft activity (pearl production?) or simply to a food production and seems to clearly state that the Mosque was no longer in use when this layer was put in place, as both activities didn't suit to a religious building. A layer of ashes (**UF3815**), which can be considered as a damaged hearth, was found nearby above the sanitary floor UF3814, between the gate to room B12-L and the threshold B12-359, and could have been used to cook the oysters before their consumption, and so giving more credit to the hypothesis of a food production. Other concentrations of ashes were also observed above the floor UF3814, but they were not well-preserved enough to determine if they were remains of hearths or simply parts of the backfills or rubbish rejection.

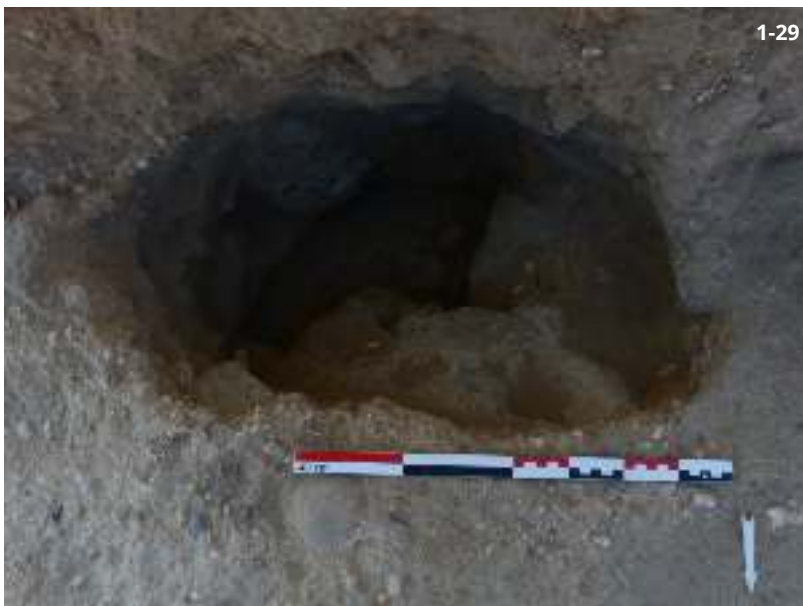
Fig 1-29 : the pit B12-374
fully excavated

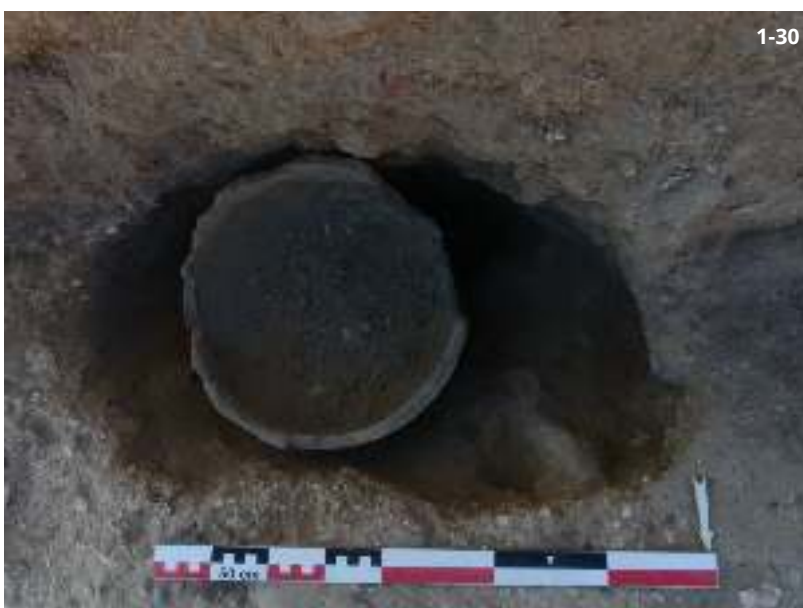
Fig 1-30 : the pit B12-374
with the upside down jar
used as a brazier

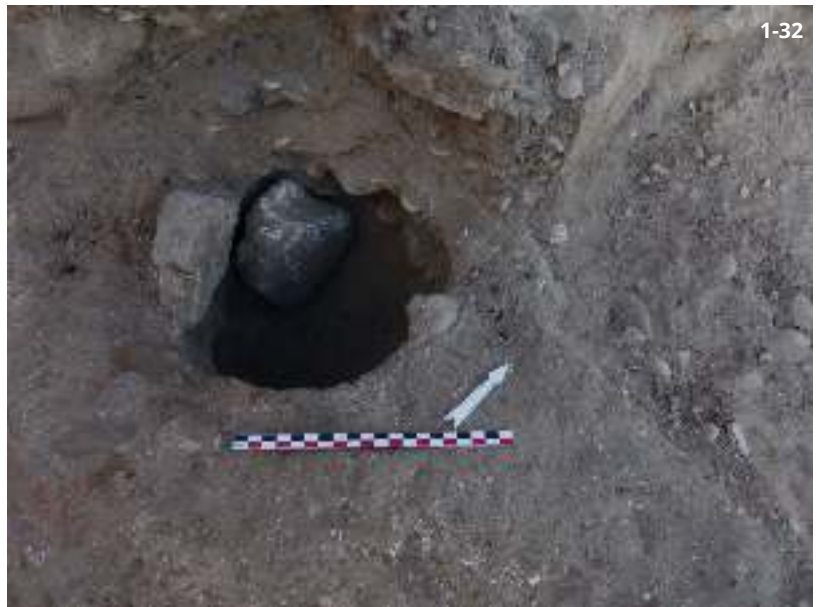
Fig 1-32 : *the posthole B12-361*

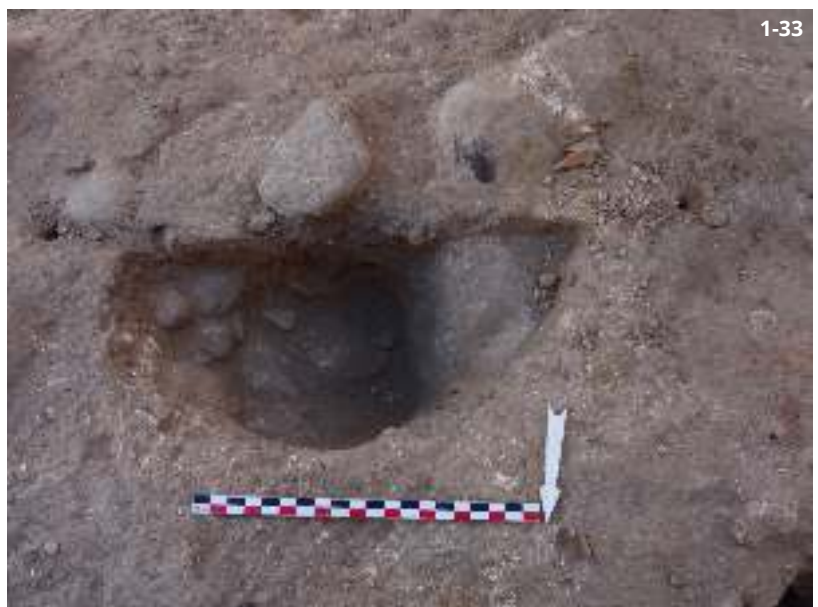
Fig 1-33 : *the posthole B12-362*

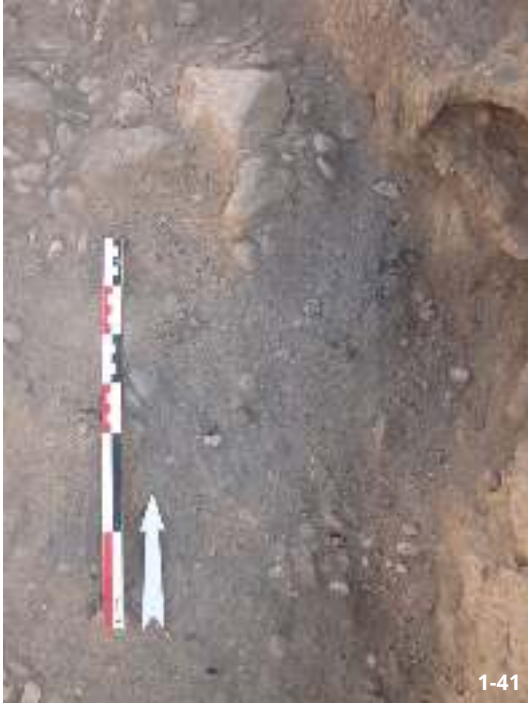
Fig 1-41 : *the possible hearth B12-351*

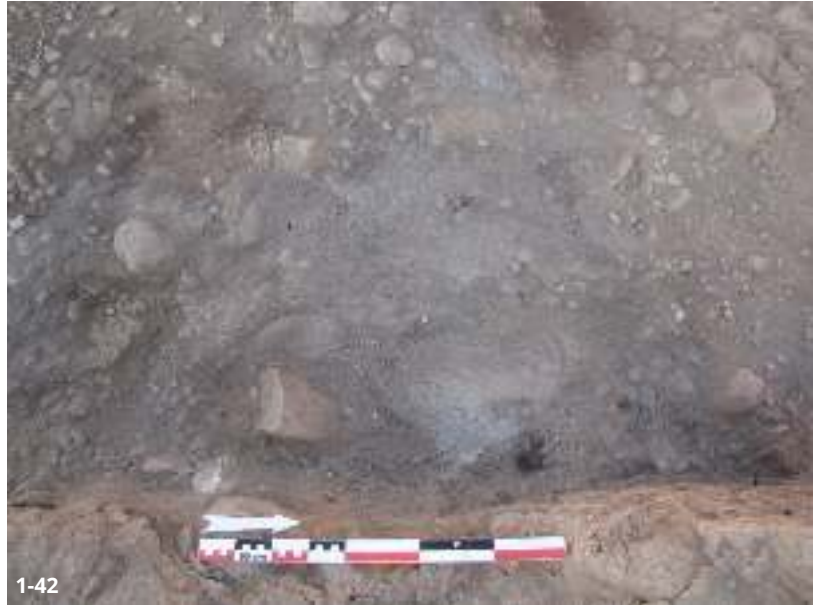
Fig 1-42 : *the possible hearth B12-352*

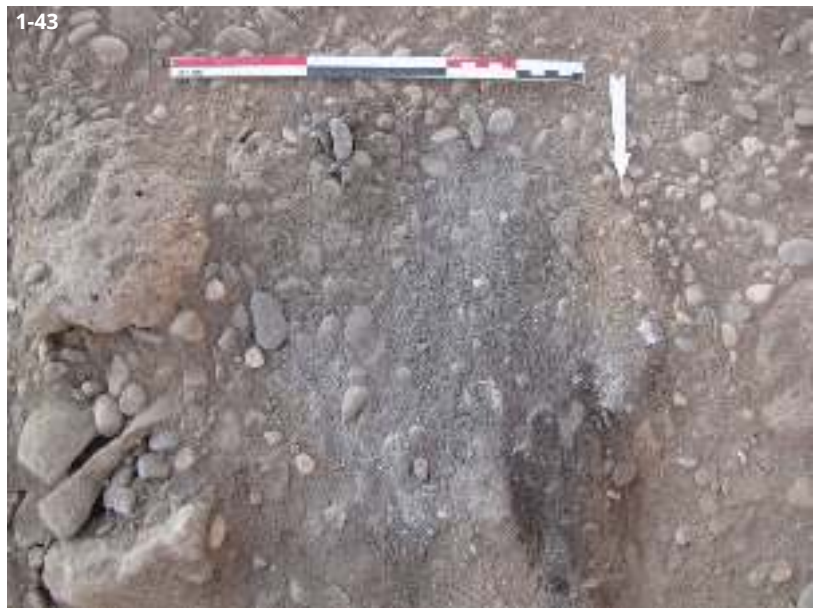
Fig 1-43 : *the hearth B12-353*

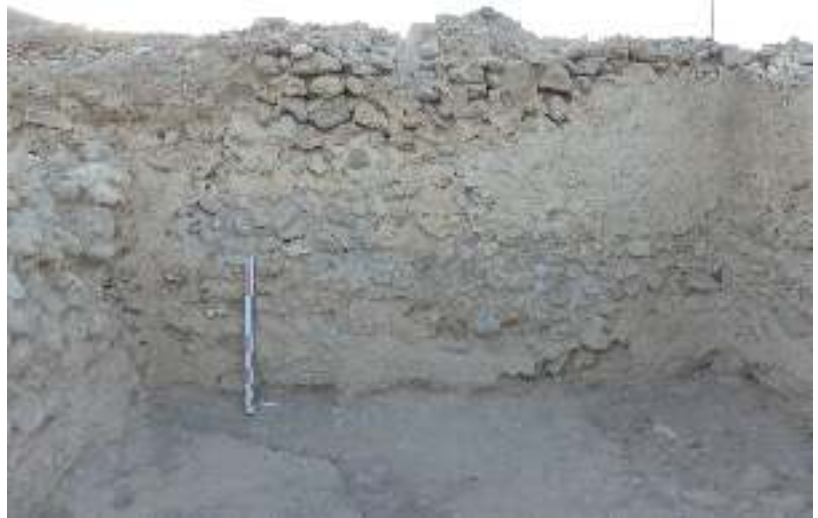
Fig 1-54 : the wall B12-188 in room B12-S

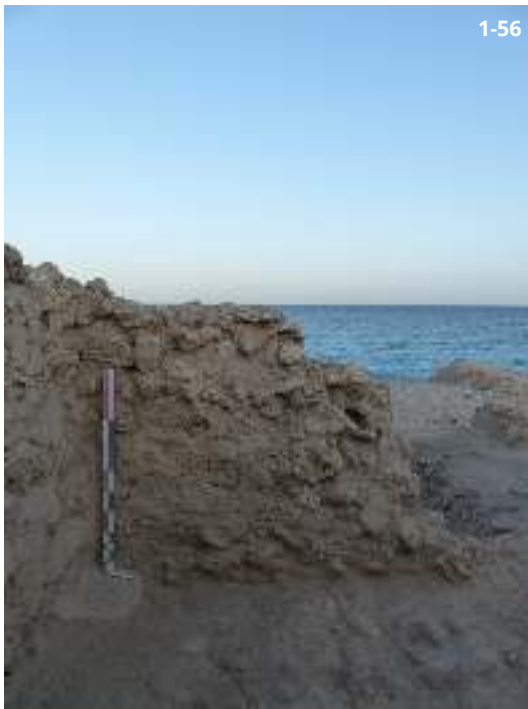
Fig 1-56 : the wall B12-213 in room B12-S

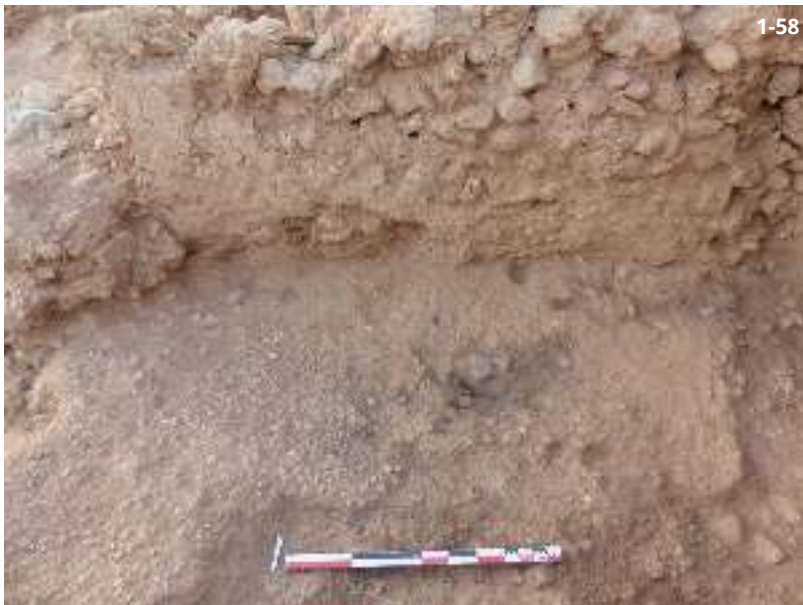
Fig 1-58 : the foundation layer Uf3648

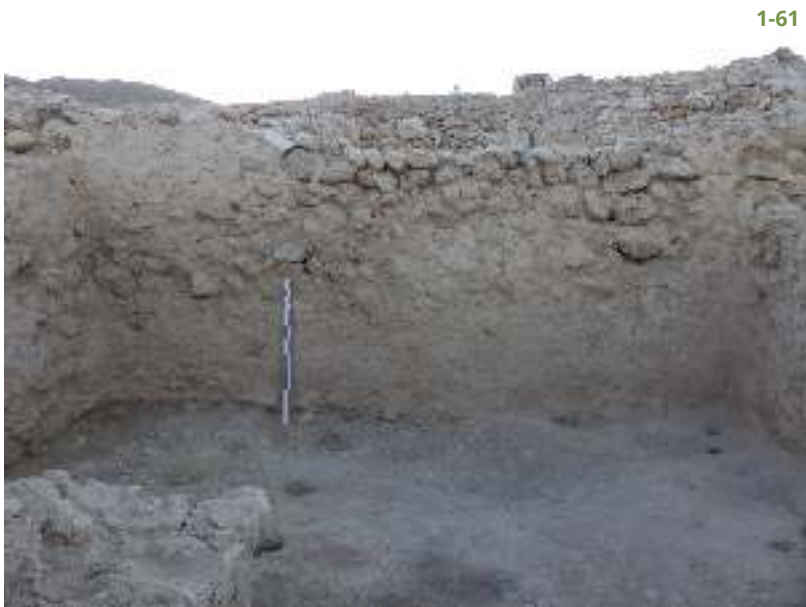
Fig 1-61 : the wall B12-110 in room B12-L

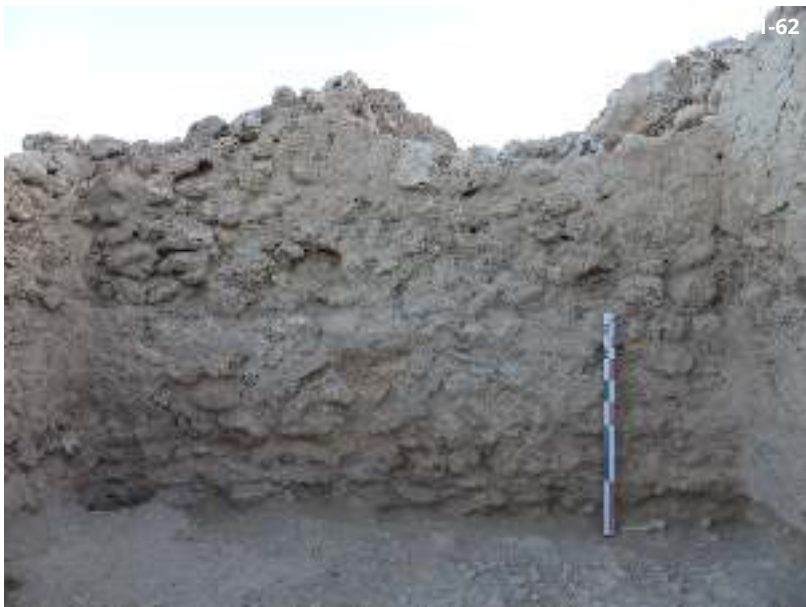
Fig 1-62 : the wall B12-278 in room B12-L

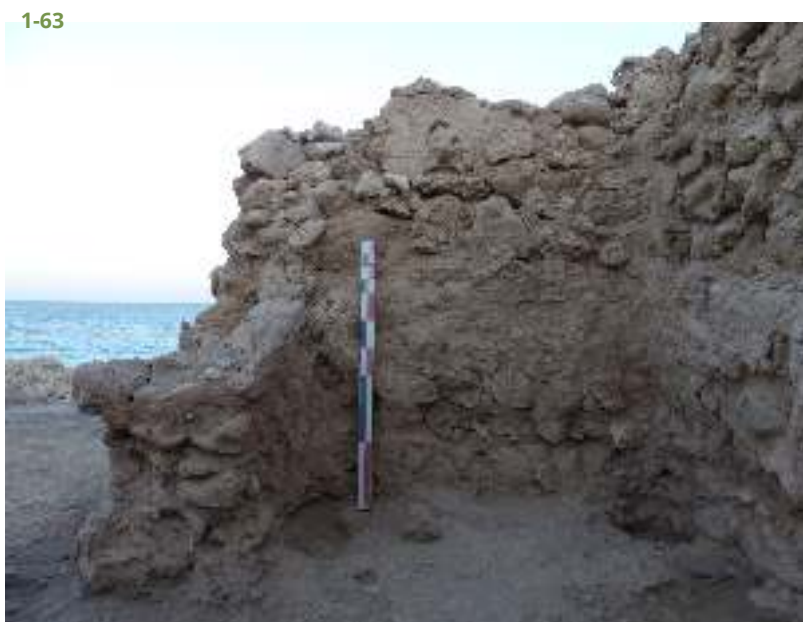
Fig 1-63 : the wall B12-281 in room B12-L

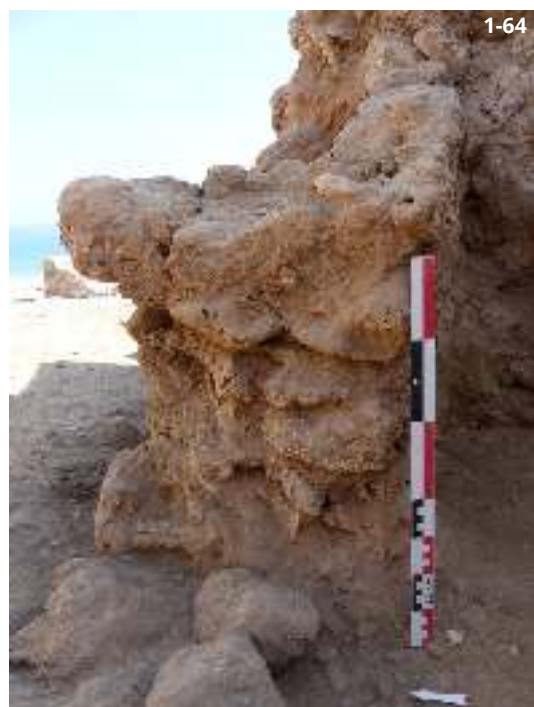
Fig 1-63 bis : the gate to the room B12-L

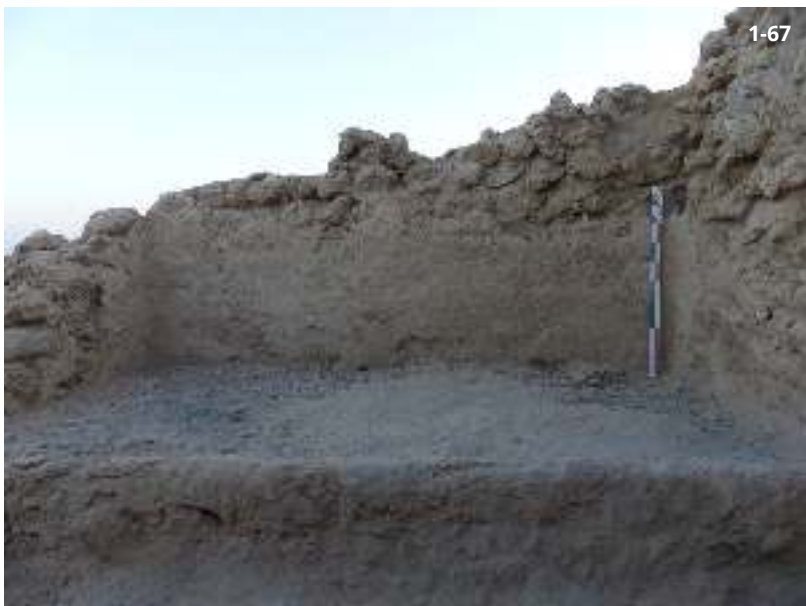
Fig 1-67 : the wall B12-42 in room B12-R

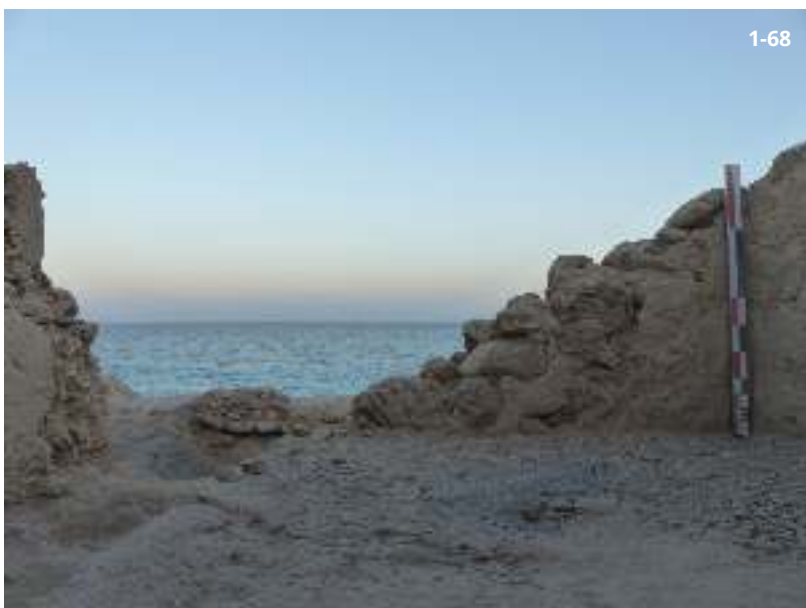
Fig 1-68 : the wall B12-276 in room B12-R

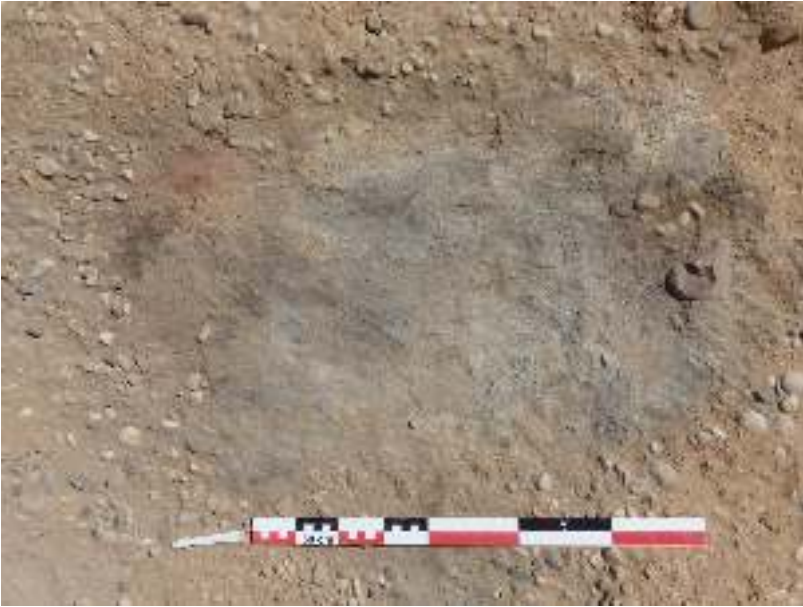
Fig 1-95 : *the hearth B12-312, before excavations*

A third and last phase of reoccupation was observed in the room B12-L, which occurred when the building was partially falling into decay. The level **UF3663** (**Fig 1-94**) is made by small pebbles mixed with reddish soil which is quite probably coming from the disintegration of the coating and mortar of the walls. This reoccupation can be very close in time to the previous one, as the ceramic material dates it from the 16th century also. One hearth (**B12-312**, 0.80m long by 0.45m wide) (**Fig 1-95**) is probably contemporary with this final occupation.

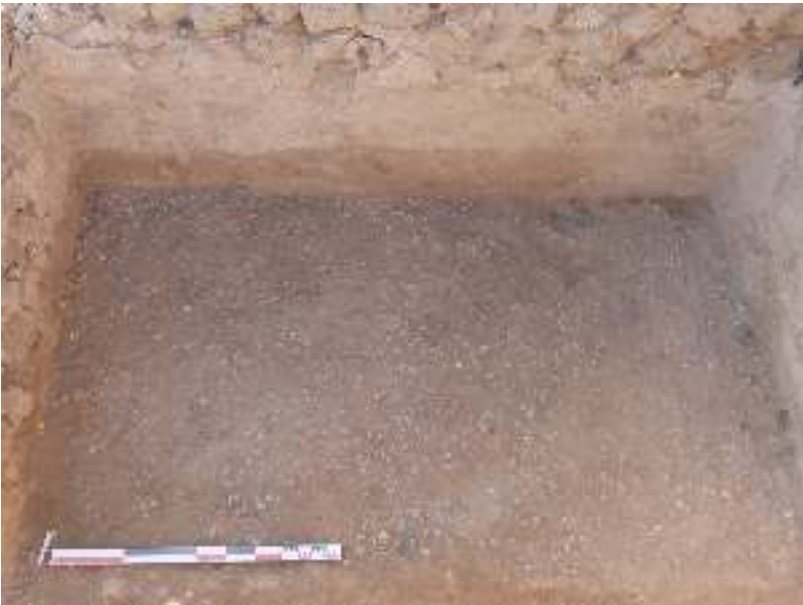
Fig 1-96 : *the sanitary floor Uf 3697 above the bench B12-326*

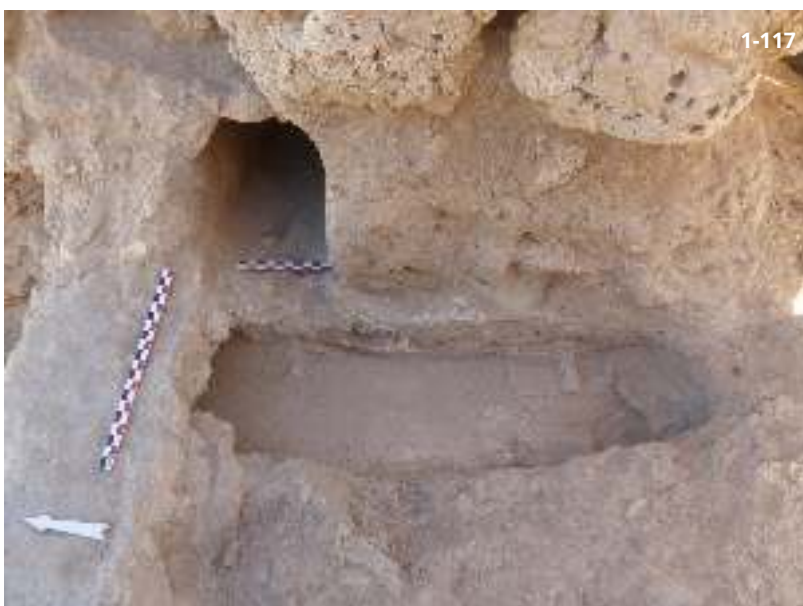
Fig 1-117 : detailed view of the wooden pattern in the threshold B12-325

Beamholes were also unearthed here, as in the threshold of the south end, with a long transversal beam, running for 0.40m inside the western jamb and for 0.27m inside the eastern one, with two smaller perpendicular beamholes at the foot of the jambs, around 0.35m long (**Fig 1-117**). The prints of the wood in the mortar also suggest that the wood was reused and the general pattern of the door is quite probably exactly the same as the southern one, except that the threshold here has no steps from the northern low courtyard. The threshold B12-325 is made by large limestone blocks covered by a gray mortar which is mostly missing in the middle and no strict connection was observed between the threshold and the coated floor observed southerly. There is however no reason to doubt that this two structures are contemporary, as they are in the south end of the corridor.

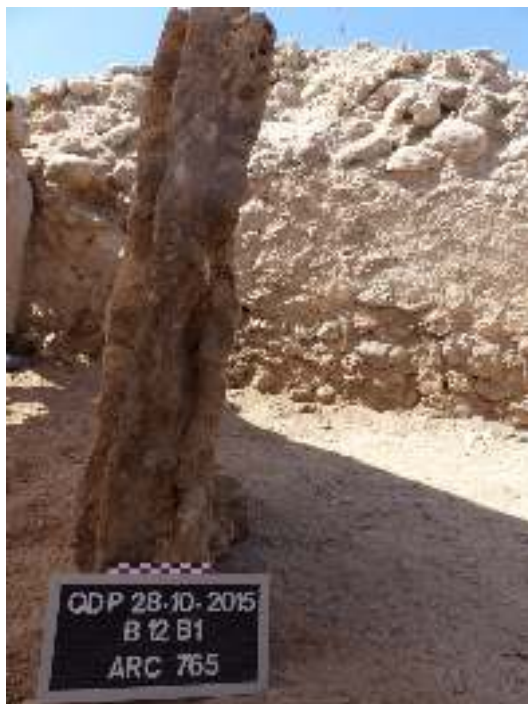
Fig 1-118 : fragment of floor of the prayer hall fallen into the basement room B12-B

Few architectural elements were found in the south end of the corridor B12-B, while none was found in the north end where the excavations area was very small. In the south part, the most interesting ones are the large remains of the decorated spandrels (**IsoArc325, 335 and 346**), mainly already unearthed during the previous season. After the careful removal of the decoration made by molded panels of plaster, those elements were destroyed as they were too fragile to be moved without cracking. Apart from this decorated remains, the others architectural elements uncovered in this area are only rectangular carved stones coming from the pillars and large fragments of floors and walls (**Fig 1-118**).

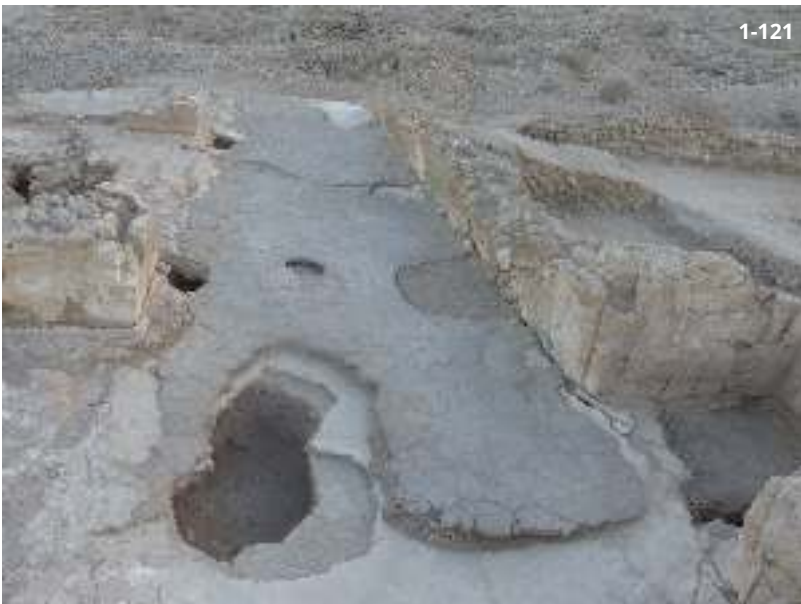
Fig 1-121 : general view of the qibla wall, south part with the mihrab at right

▪ The west qibla wall (Fig 1-121 and 1-122)

The *qibla* wall is made with large corals and limestone blocks and some large pebbles, bonded with different types of mortar, from beige to black in color, presumably because of repairs. To the west, on its external face, the wall B12-01 is covered by a coating made of a strong dark gray mortar which probably dates back to the last phase of repair. Its eastern internal face is covered by a beige coating with some whitish parts, presumably resulting from the fact that the inside was covered with a white plaster now disappeared. The remains of a frieze (Fig 1-123) made of glazed tiles in the shape of stars and crosses fixed at the base of the wall are preserved on the north and south parts of the wall, the tiles having mostly vanished and being only visible by their prints in the mortar. The frieze originally rose around 1m high, at least in some places. Highly eroded and not well attached to the wall, this frieze is still partly visible to the south, but in the north it has fallen down during the course of excavations. Remains have been taken and stored for a possible later display. Fig 1-124

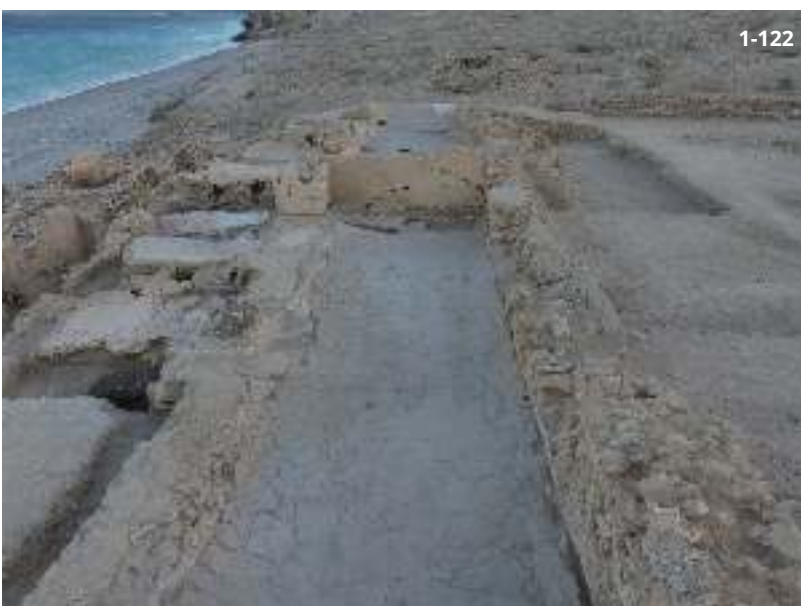
Fig 1-122 : general view of the qibla wall, north part at right, with the minbar in the background

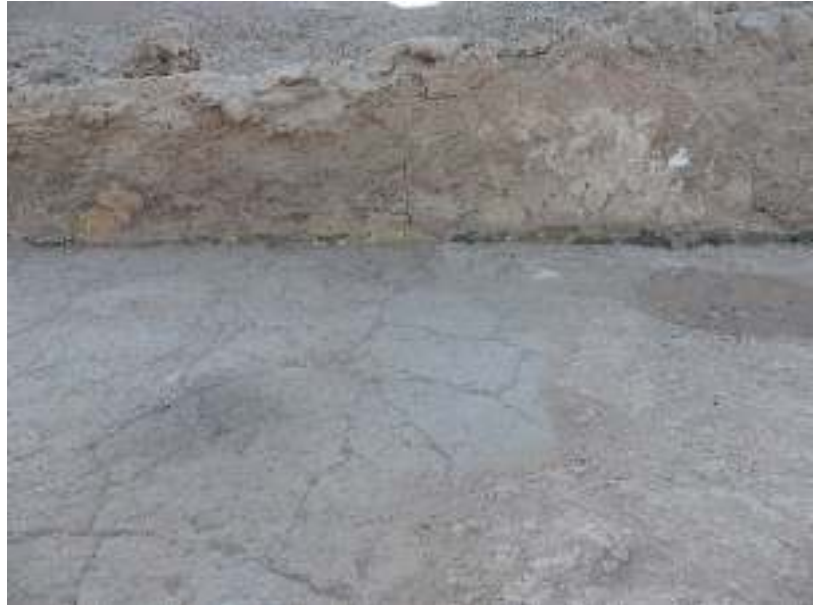
Fig 1-123 : remains of the frieze of the qibla wall, south part

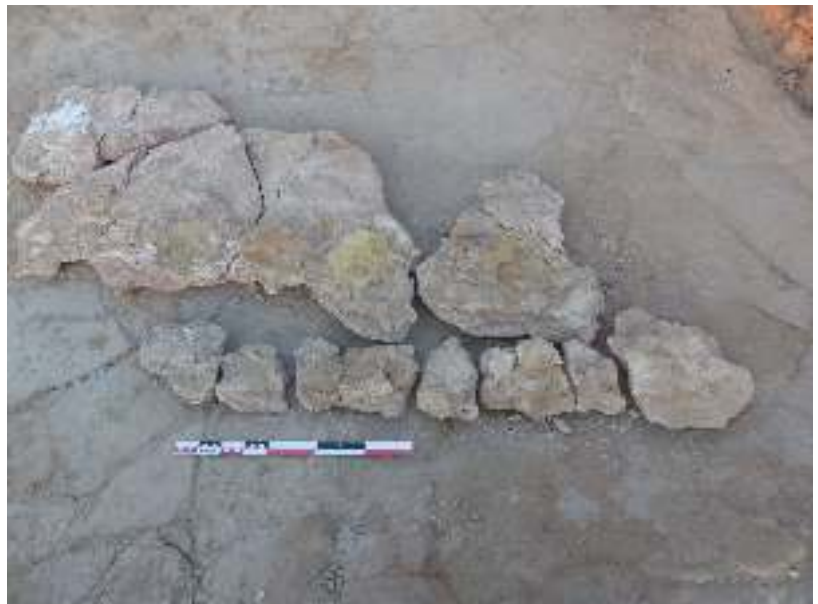
Fig 1-124 : remains of the frieze of the qibla wall, north part, after its fall

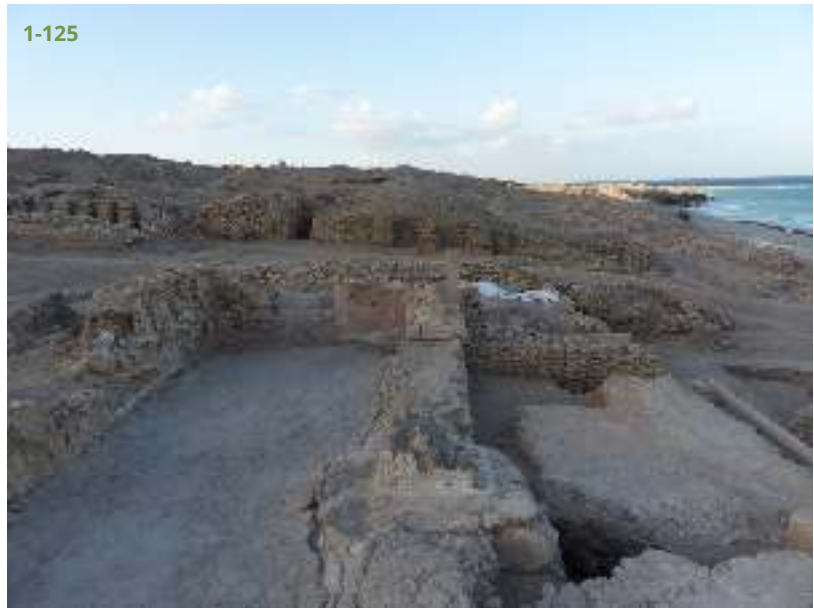
Fig 1-125 : view of the north wall B12-183

To the north, the north wall of the prayer hall **B12-183**, (**Fig 1-125**) against the north wing, is preserved up to 1.50m at its western extremity at the corner with the *qibla* wall, and totally eroded to the west the superstructures fallen into the basement and the low courtyard. The lower part of the wall, at basement level, is made mainly with large pebbles, while the corals are more present in the elevation of the first floor. A quite well preserved pink coating was observed on the internal face but no trace of decoration, even prints of it, was observed.

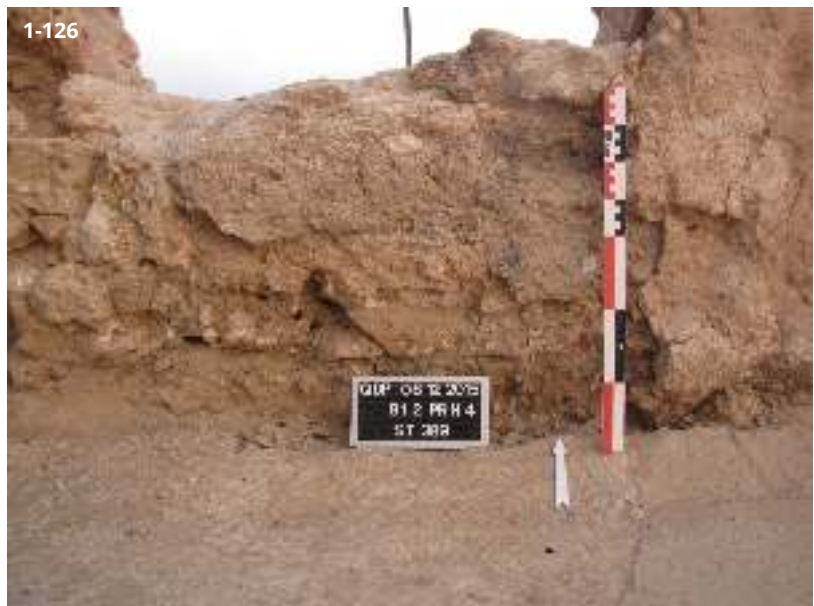
Fig 1-126 : the stepped opening B12-389

The wall B12-183 is interrupted, more or less in the middle of the span 6, by an opening (**B12-389**) (**Fig 1-126**), which is 1m long by 0.75m wide and gave access to the prayer hall from the tower B12-J, which is occupied by a staircase. The two jambs of the opening are badly preserved, 0.75m high on the west side and 0.60m high to the east, and the possible coating has disappeared. To the north, the western half of the threshold is at the same level than the top of the staircase while its eastern half is overhanging the void, the lower steps of the staircase being more than 2m below. This strongly suggests that the stair landing was originally extended by a wooden floor which has disappeared. To the south, the threshold is about 0.50m higher than the floor of the prayer hall, and it is possible that steps once stood here but no remains of them have been observed. A wooden fitting might also be considered.

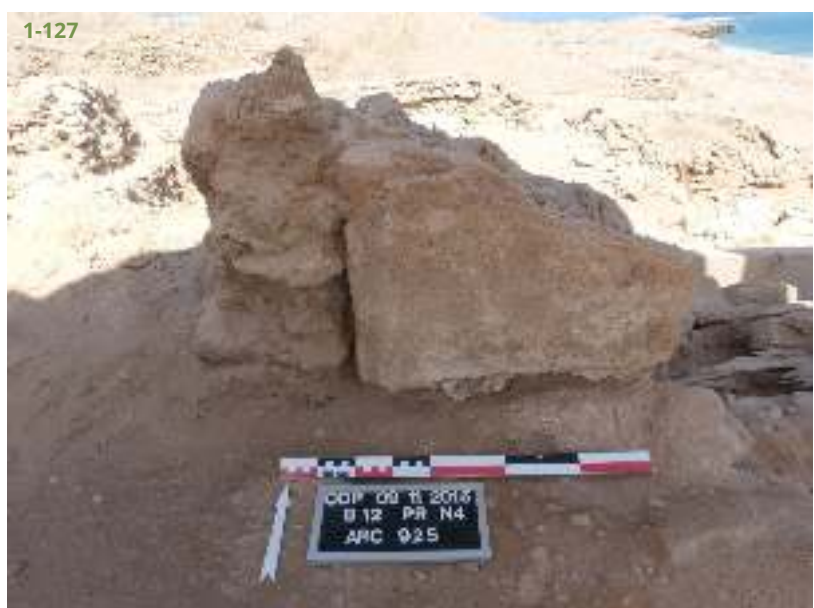
Fig 1-127 : remains of a possible opening with a late blocking at left

A second opening (**IsoArc925**) was also partially observed in the north wall B12-183, more or less in the middle of the span 5. It is not possible to clearly state if this opening is a gate, a windows or a niche, as only one jamb of this opening was found, incompletely preserved and having possibly slightly slide down from its original location. Parts of the jamb were found covered by a fine pinkish beige coating. A small curve at the rear of the coating might identify this structure as a niche but remains are too scarce to be affirmative. A gate or a window going to the floor can also be easily considered. In any case, this opening was blocked in a later refitting. **Fig 1-127**

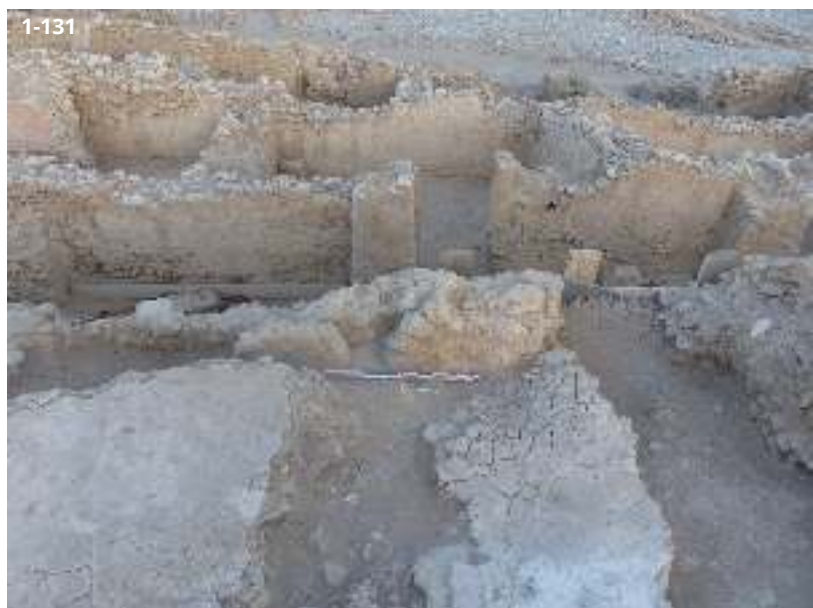
Fig 1-131 : the buttress or thickening B12-413

Southerly again, the masonry **B12-413**, which was superficially uncovered, can be considered as a massive buttress or a thickening, or maybe both (Fig 1-131). It is a construction, at least 2.15m long by 0.30m wide, made with corals and medium limestone blocks bonded with beige mortar and apparently without coating. It seems to be quoined with the wall B12-46, at least in the northern part while it is less clear in the south part, because of the state of preservation. It is most probable that the north part of this structure, which north limit is in the same alignment than the easterly buttress B12-113, was used to support the pillar built above, but the south part can also be a later thickening, although its state of preservation and the presence of a preserved floor did not allow a certainty. At the top of the structure, a print (**B12-409**) was observed which can be the trace of a hole for a beam or for a strengthening wooden element (Fig 1-132).

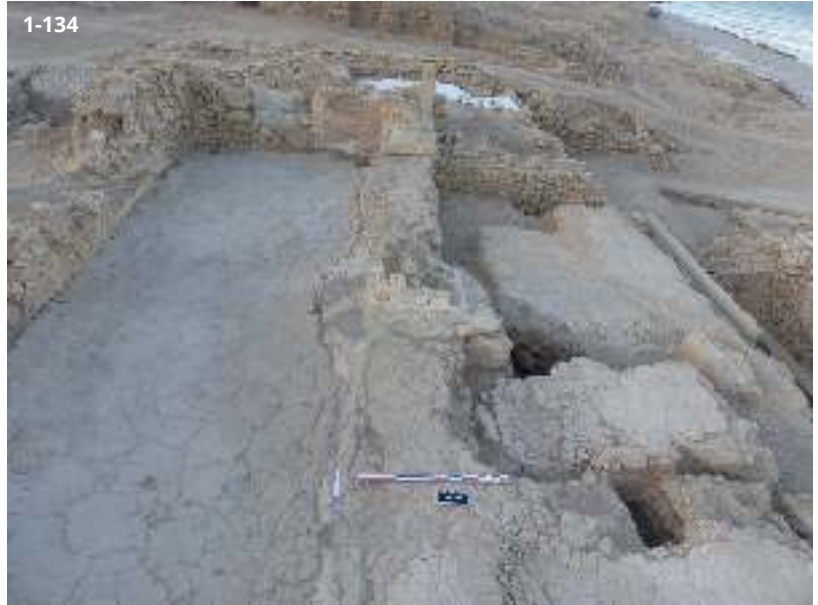
Fig 1-134 : the intermediary wall B12-45 under the row of pillars, visible by the cracks of the floors, in the north part

Parallel to the wall B12-46, the wall **B12-45**, which runs under the preserved row of pillars of the prayer hall, under the floor between the two backfilled spans 5 and 6, was partially observed where the floors have cracked or collapsed (**Fig 1-133** and **Fig 1-134**). It is 25m long for an assumed width around 1m, and was- observed for 0.50m high in average under the level of the floor. It is quoined with the wall B12-183 to the north and presumably with the wall B12-41 to the south, but the state of preservation is not good enough to be affirmative. The wall is made with medium pebbles, corals and limestone blocks bonded with a powdery brown mortar, apparently mainly made with soil. No trace of coating was observed. **Fig 1-135**
