Qalhât Development Project, Season 2015B-2016A, Final Report

Excavations on the Ceramic Workshop B41

I-B. The 2015b-2016a season - 1. Excavations of the southeast part of the Mosque (Spans 1 and 2)

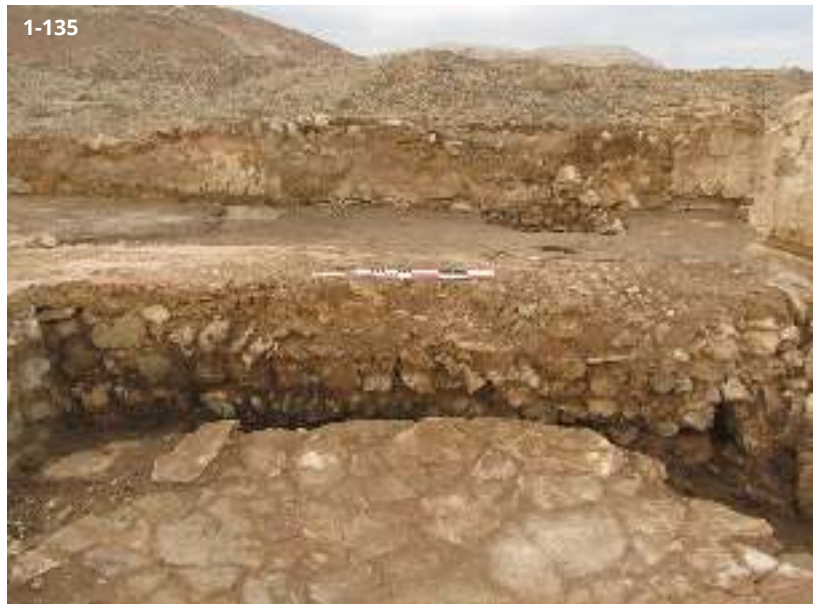
Fig 1-135 : visible elevation of the intermediary wall B12-45, in the south part

Parallel to the wall B12-46, the wall **B12-45**, which runs under the preserved row of pillars of the prayer hall, under the floor between the two backfilled spans 5 and 6, was partially observed where the floors have cracked or collapsed (**Fig 1-133** and **Fig 1-134**). It is 25m long for an assumed width around 1m, and was- observed for 0.50m high in average under the level of the floor. It is quoined with the wall B12-183 to the north and presumably with the wall B12-41 to the south, but the state of preservation is not good enough to be affirmative. The wall is made with medium pebbles, corals and limestone blocks bonded with a powdery brown mortar, apparently mainly made with soil. No trace of coating was observed. **Fig 1-135**

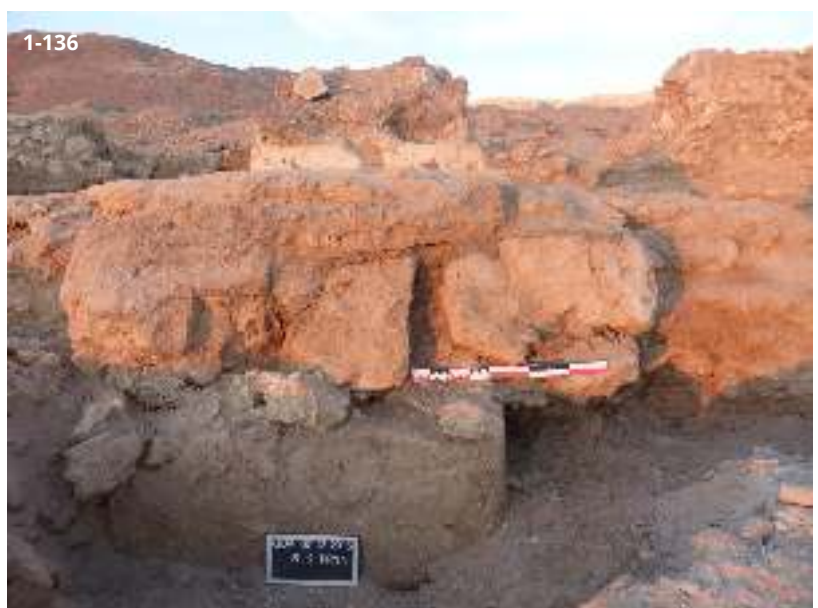
Fig 1-136 : the buttress B12-329, at the bottom, the upper part under the collapsed pillar, being a later addition

One buttress was found to the north, in front of the buttress B12-406, and other are strongly assumed under the other pillars but the excavations did not uncover them because of the need of conservation. The buttress **B12-329** is at least 0.90m long and at least 0.60m wide for an unknown height. It is similar to the buttress B12-406 in shape and components, with the same fingerprints visible on the coating (**Fig 1-136**). A rough masonry was built over it and similar constructions were observed under all the preserved pillars but, as it seems to be a later strengthening, they will be described below.

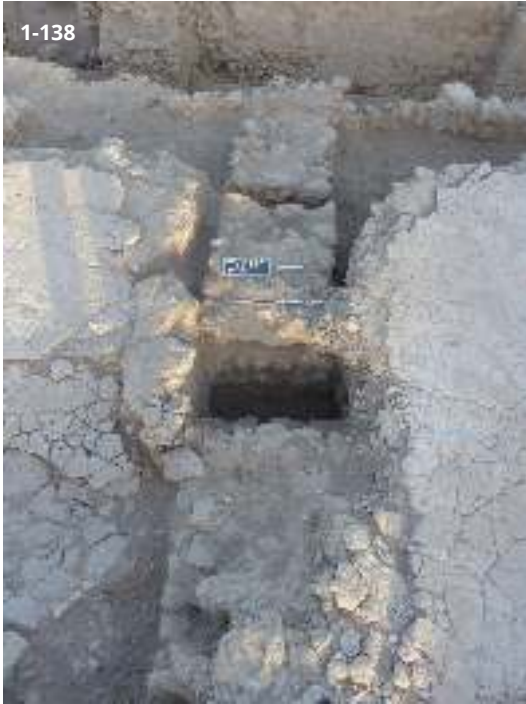
Fig 1-138 : the shear wall B12-405 visible by the disappearance of the floors

To the north, the wall **B12-405** is 3.45m long by 0.60m wide and was uncovered for 0.50m wide (**Fig 1-138**). It is quoined to the walls B12-45 and B12-46 and made with medium corals and limestone blocks bonded with powdery brown mortar and no coating was observed. It is pierced in its upper part by three holes which do not seem to have the same function. The westernmost, **B12-408**, is 0.15m wide and high and runs into the wall for 0.40m, meaning it does not cross the entire width of the wall (**Fig 1-139**). Its shape and size, the organic sediment found inside it and some wood prints observed on the mortar clearly suggest that this hole is a beam-hole. It was probably not the case for the two easterly holes, **B12-403** and **B12-404**, which are both crossing the wall and where no organic sediment or wood prints were observed (**Fig 1-140**). They are both of the same size, 0.25m wide and around 0.30m high. At the top of B12-403, prints of small wood planks were observed, which were quite probably used to cover the top of the cavity. Similar fittings must have been in existence over the cavity B12-404, and presumably over the other similar structures observed in the other walls, but they probably vanished following the dilapidation of the building. It is very likely that those cavities were used as aeration holes.

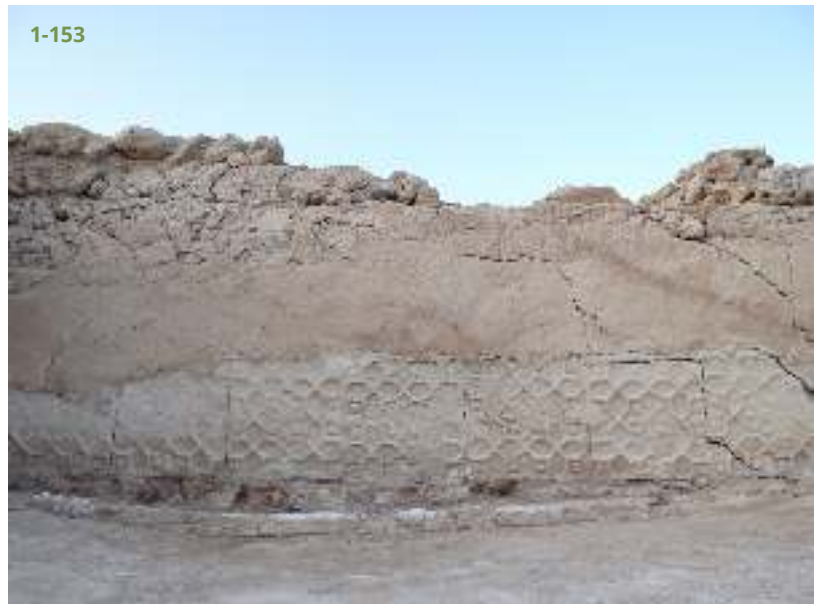
Fig 1-153 : *the frieze made of molded panels on the south side of the minbar B12-03*

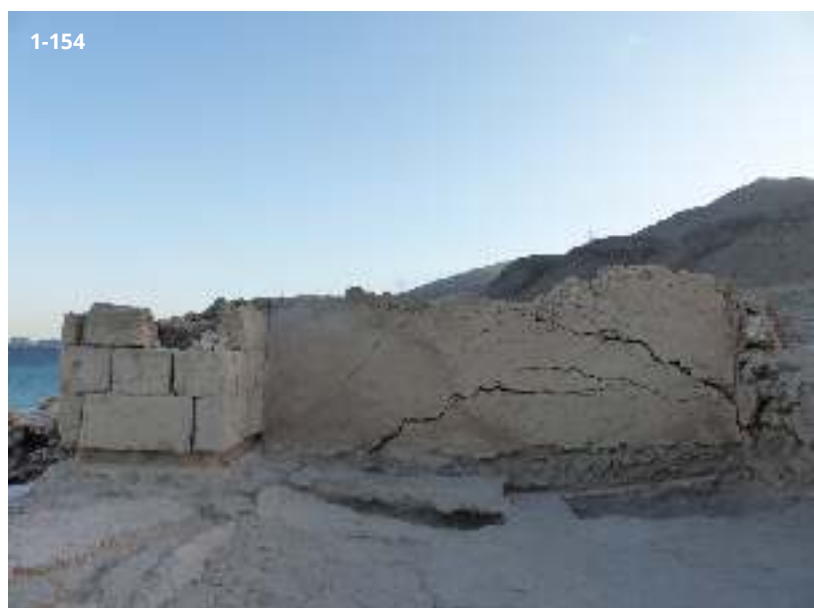
Fig 1-154 : *the north side of the minbar B12-03, last stage of use, without decoration*

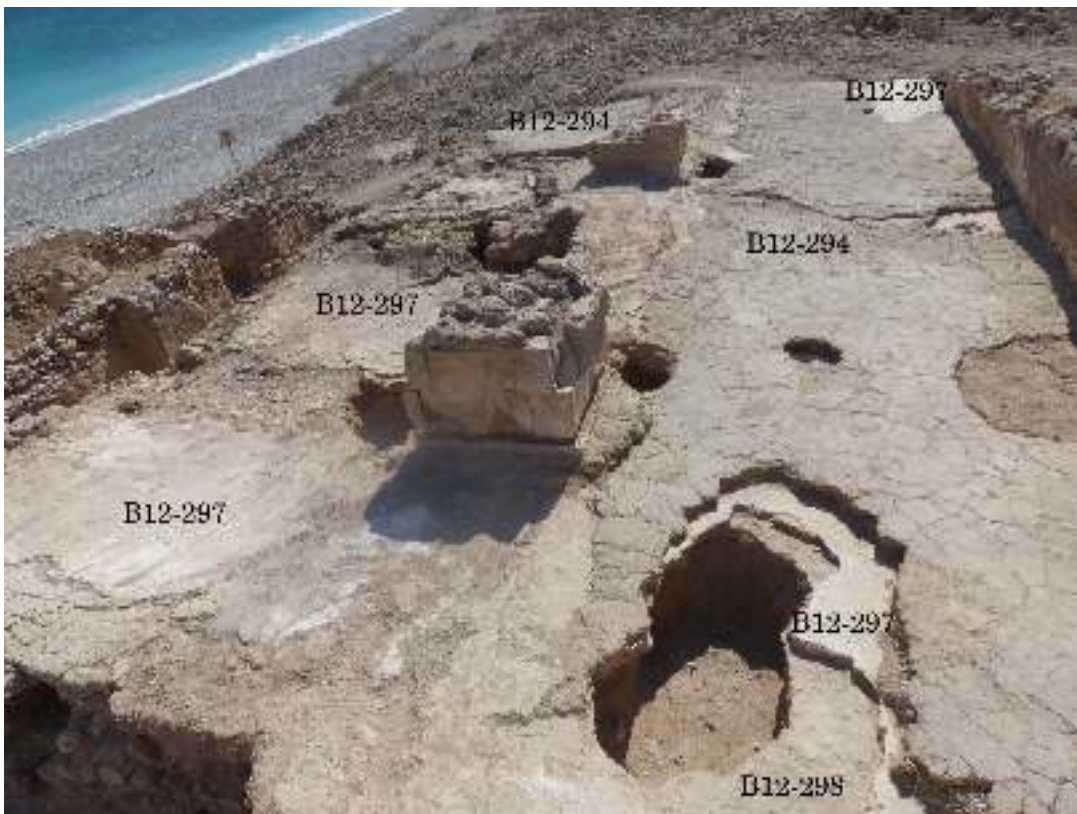
Fig 1-169 : the floor B12-297 partially visible under the floor B12-294, in south part

This very strong floor support made of three layers of material, some fragments of which were found collapsed into the basement to the east, was used to support the first floor of the Mosque (B12-297) made of a strong pinkish-white mortar, only 0.04m thick (Fig 1-169). It is the original floor and it was associated with the wooden *minbar* B12-375 as it is leaning against its plinth, and with the first *mihrab* B12-386 as it goes under the plaques of mortar of the second *mihrab* B12-04. It was so made at the very beginning of the 14th century and has remained in use until the destruction of the first wooden *minbar*, as small traces of fire observed near the actual *minbar* could testify of the fire that destroyed it later in the same century.

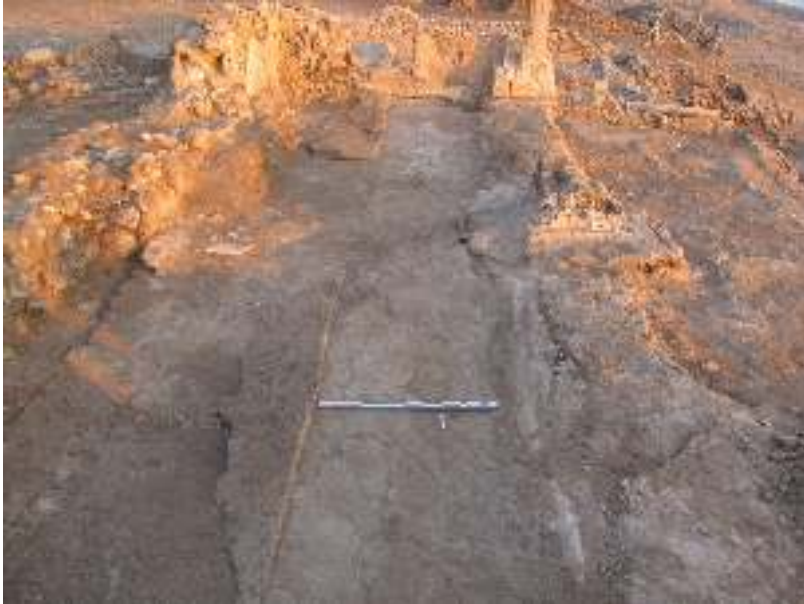
Fig 1-173 : the earthen floor Uf3950, half excavated, above the floor B12-294

To the north was uncovered a flat and indurated level (Uf3725) made of compacted brown orange silt, containing small charcoals and gravels. It was also observed elsewhere to the north and registered as Uf3950, and in the south half of the prayer hall where it was registered as Uf3746, 3799, 3800 and 3801. This level is probably an earthen floor made after the large refitting of the Mosque, or the circulation level contemporary of it (Fig 1-173).

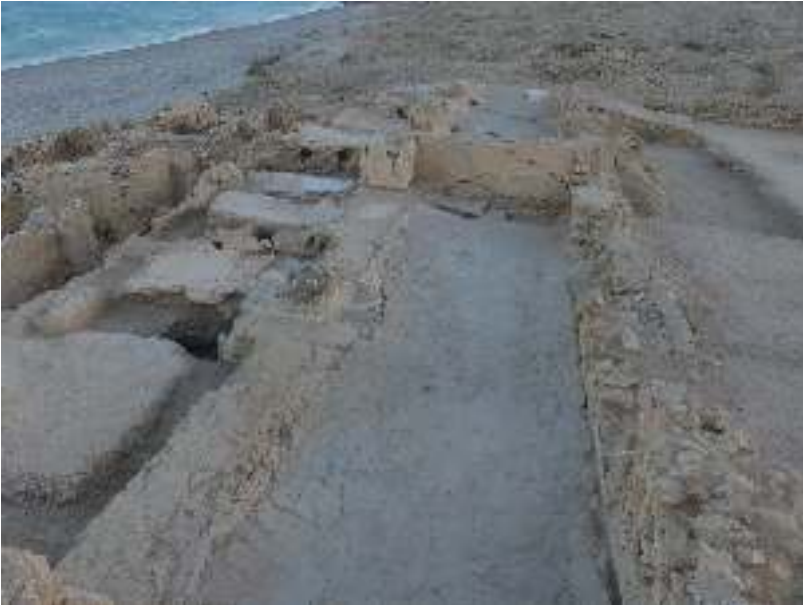
Fig 1-195 : General view of the prayer hall at the end of excavations

Fig 1-195

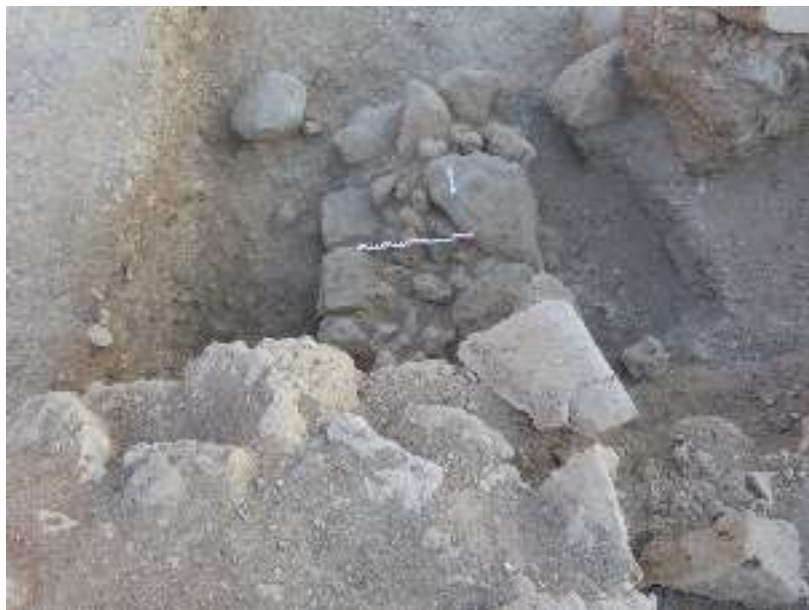
Fig 1-202 : the remains of the wall B12-74, with the staircase in area B12-N in the foreground

Two other walls, covered by the late circulation floor, might also be part of the foundations of the terrace. Perpendicular to the wall B12-75 and apparently quoined with it, the wall B12-74 (**Fig 1-202**), about 1m wide and 0.40m high for a preserved length around 1.70m, is made of massive pebbles and limestone blocks, and could have been partially recovered at north. It could have been linking the missing parts of the walls B12-477 and B12-479, and be used to strengthen the foundations of the vaulted terrace.

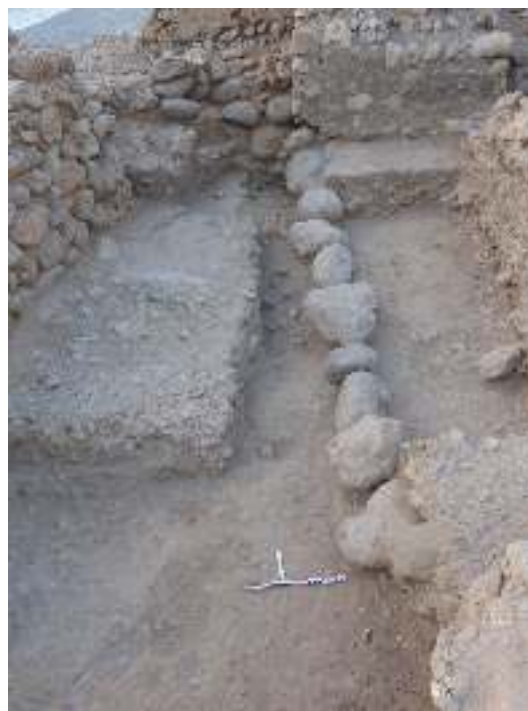
Fig 1-203 : the remains of the wall B12-407, with a possible recovery trench at left and the north-east corner of the Mosque in the background

Set at the north-east corner of the Mosque and partially running under it, or at least under of thickening or a repair of the north wall of the building, the wall B12-407 (**Fig 1-203**) could have had the same use of strengthening the foundations. Made of massive pebbles and limestone blocks with no binder preserved, it is now 4m long by 0.50m wide but it appears that its eastern half was recovered to be reused. The fact that this wall is ending at north more or less in the same alignment that the north side of the wall B12-477 is in favor of this hypothesis. In this configuration, it is possible that the terrace was ending, at east, plumb with the line of the wall B12-407.

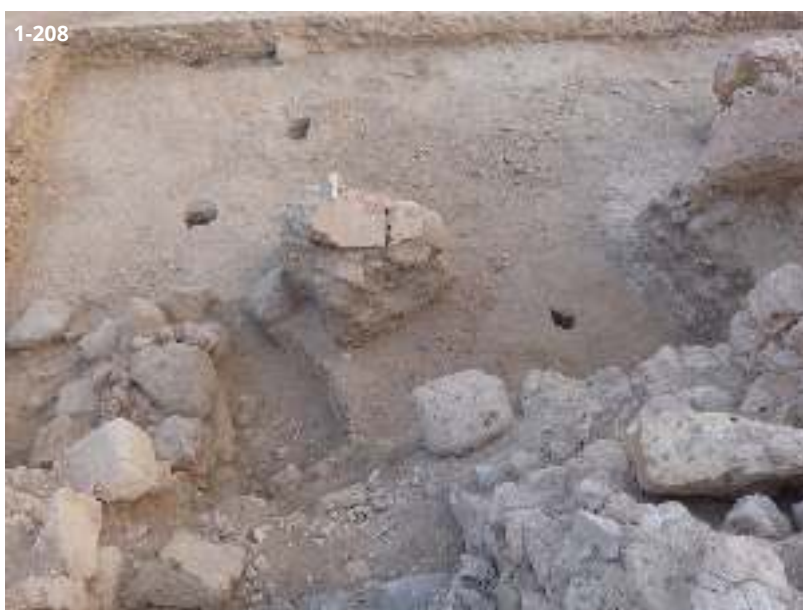
Fig 1-208 : the earthen floors Uf5822 and Uf5823, pierced by several postholes

North of the rooms B12-T and B12-W, the earthen floors **Uf5822** and **Uf5823** probably belonged to the same stage and must be the same floors as Uf5895/5896, though their connection was not excavated (**Fig 1-208**). Many postholes were found in this sounding, probably belonging to the same stage. Three of them are aligned, **B12-440 (Fig 1-209)**, **B12-441 (Fig 1-210)** and **B12-442 (Fig 1-211)**, all around 0.30 m wide and 0.20m deep and, as they are more or less aligned with the wall B12-477, they could have been part of the settings of the terrace, for scaffolding or strengthening. North of them, the smaller posthole **B12-443**, 0.15m wide and 0.15m deep, was dug through the same level and could belong to the same stage, but its function is more problematical.

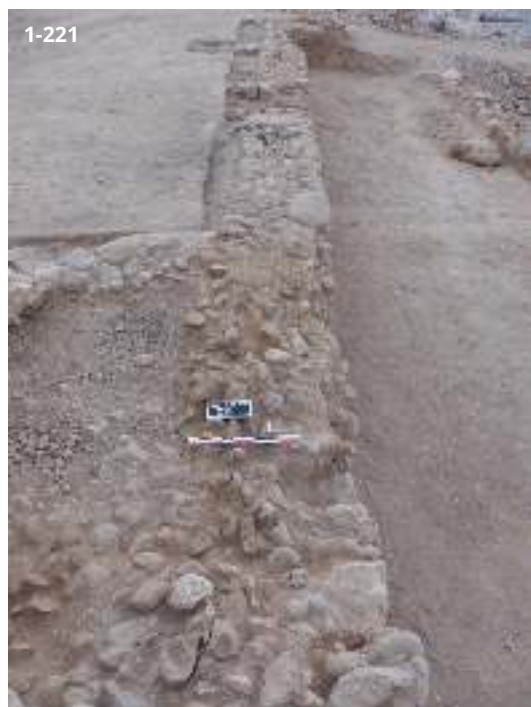
Fig 1-221 : the wall B12-199

The second stage of floors was apparently set after the partial destruction of the terrace as the backfills and the level of floor covered the foundation walls and their removal. At east, it is probably at that time that the wall **B12-199 (Fig 1-221)** and its probable threshold **B12-480 (Fig 1-222)** were built, as they were made by cutting the previous floor and backfills (**Fig 1-223**). It is so a possibility that the low courtyard originally extended at east until the wall B12-11 and that it was afterward reduced. As the stair B12-198/390 is partially quined with the wall B12-199 and built over the backfills covering the wall B12-407, it was obviously built at this time, probably to create an access to the terrace from the east. Though there is no remain to be affirmative, it is possible to imagine that a former stair once stood nearby, maybe related with the southern room B12-U.

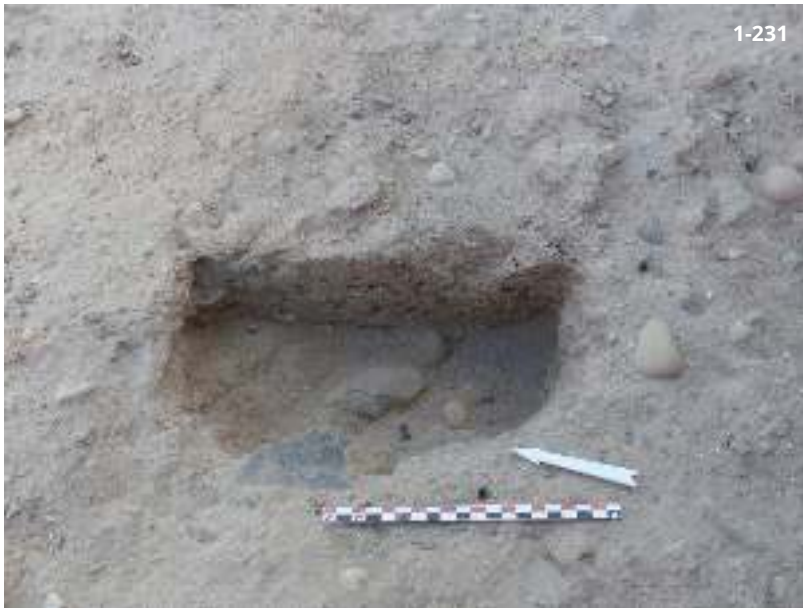
Fig 1-231 : the posthole B12-432, half excavated

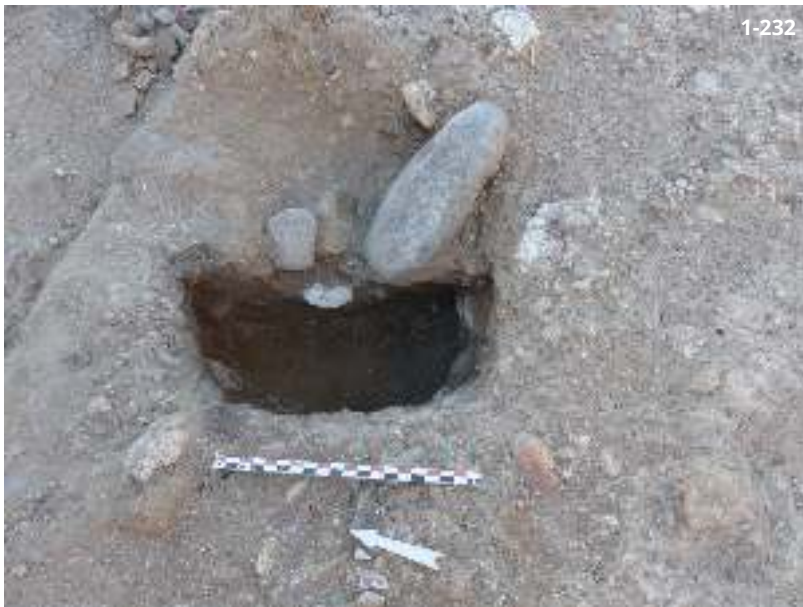
Fig 1-232 : the posthole B12-449, half excavated

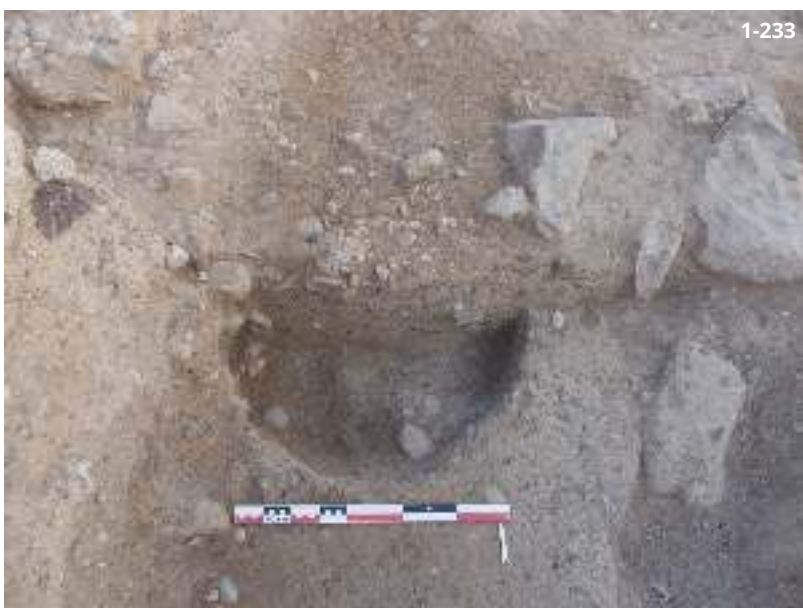
Fig 1-233 : the pit B12-433, half excavated

The two pits dug through the floor Uf3999 are more problematical. The first one, **B12-433** (Fig 1-233), 0.75m long by 0.60m wide and 0.50m deep, is located in area M, in the passageway to the corridor B12-B and, if it was in existence during the use of the basement, it would have greatly reduced the size of the entrance. The second one, **B12-428** (Fig 1-234), 0.80m wide and 0.25m deep, is located just at north of the aligned postholes B12-429, B12-430 and B12-431, were it was also greatly blocking the circulation. They could so have been dug after the abandonment of the Mosque, but their use and function will remain unexplained.

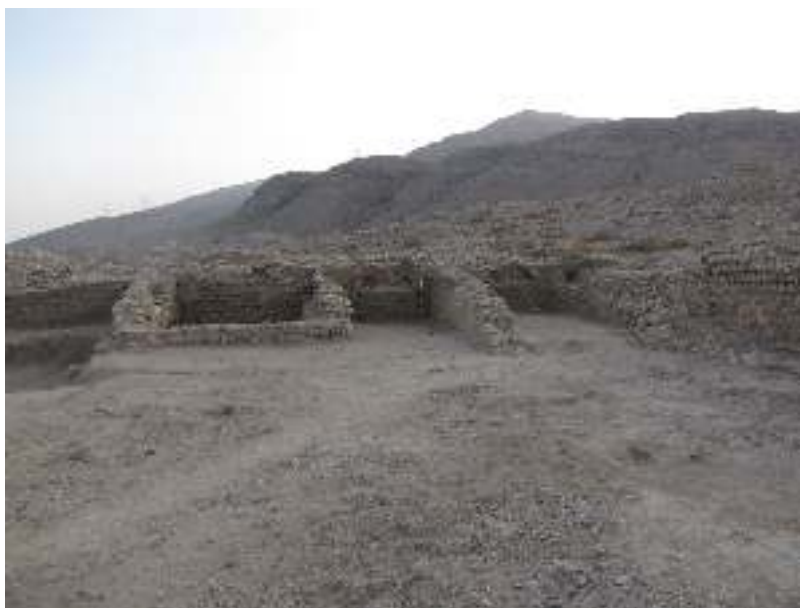
Fig 1-250 : general view of the building B139 at the beginning of excavations during the 2015b season

During the 2014–2015 season, three different areas have been observed in the building B-139 and described, the rectangular room B12-C in the south-west corner of the high courtyard and a nearly square room B139-A at south, made with low walls built against the south enclosure wall and over a sandy level, both being separated by a narrow recess B139-B. (Fig 1-250)

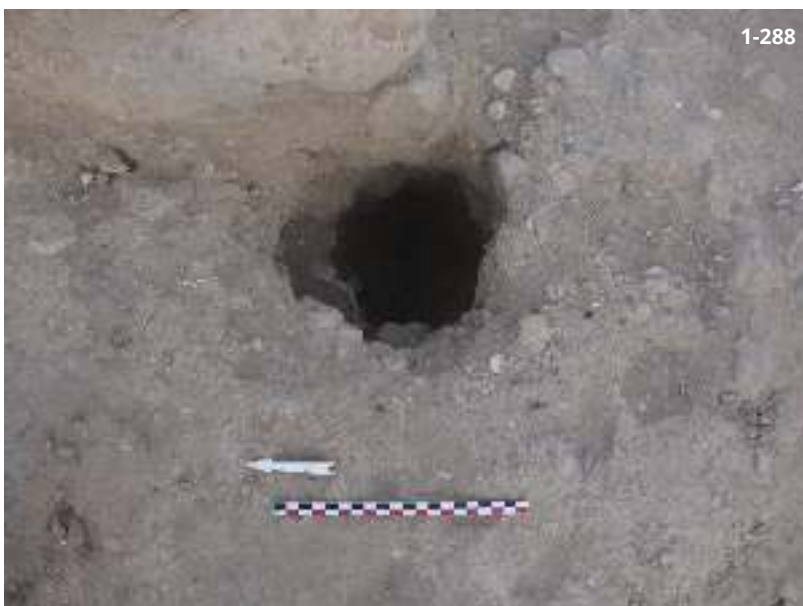
Fig 1-288 : the posthole B95-29, fully excavated

Only two occupancy structures were found over the floor Uf3576. At east, dug through the floor and against the pillar B95-19, the small posthole B95-29 (Fig 1-288), 0.20m wide and 0.35m deep, could have been part of shelves, or for an hypothetical door if there was any gate in the south east-corner of the room.

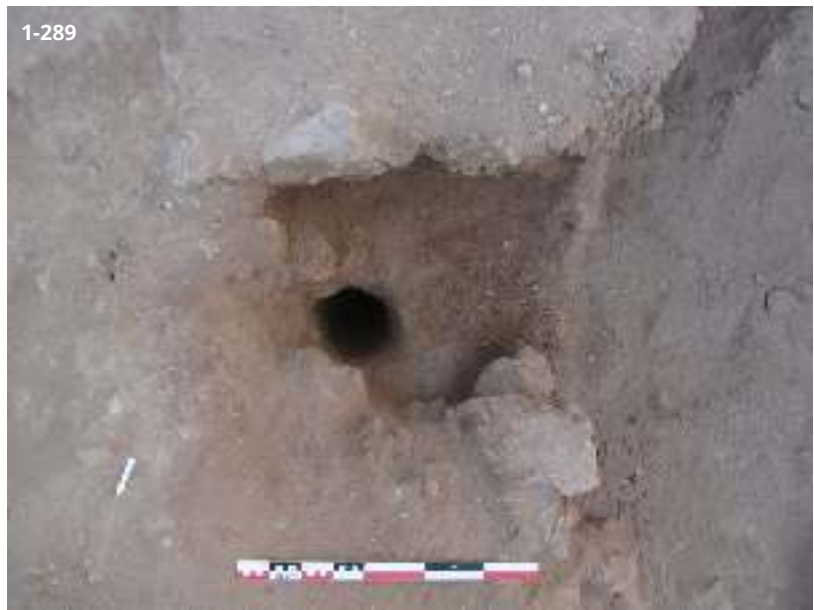
Fig 1-289 : the pit B95-30, fully excavated

More than 1m to the west, the pit B95-30 (Fig 1-289), at least 0.60m long, 0.45m wide and 0.20m deep, was also dug through the earthen floor Uf3576 and partially cut by the sounding opened by the QP. This oval pit is surrounded by medium stones and filled by two different layers. The lowest one (Uf3578) is an organic orange brownish layer very loose and powdery and could be the natural deterioration of rejected natural material. This organic layer is covered by a level of small pebbles mixed with whitish silt (Uf3579) leveling the pit. It is so possible that the pit B95-30 was used as a rubbish deposit finally covered by a sanitary level made of small pebbles.

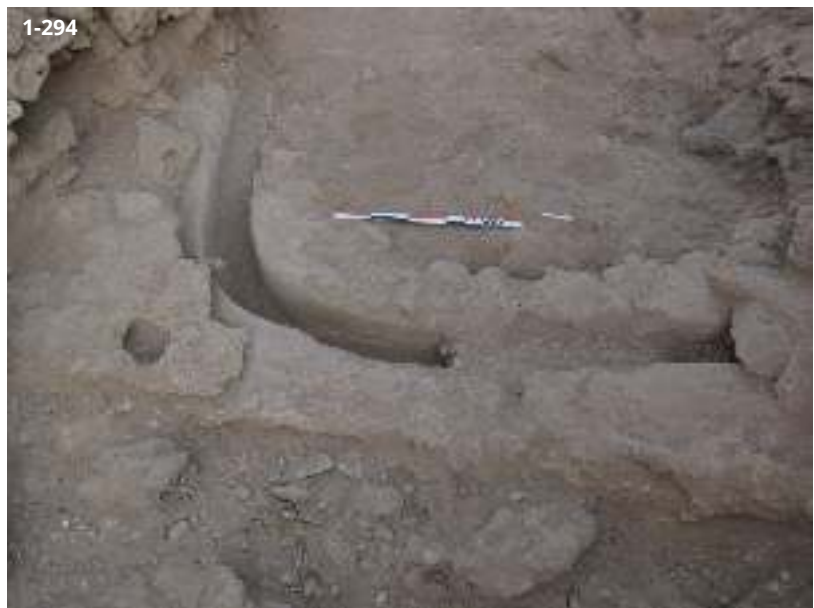
Fig 1-294 : the threshold with canalization B13-36, partly excavated

The eastern threshold (**B13-36**) (Fig 1-294) is more likely a canalization than a threshold properly said. It is a narrow L-shaped gutter, 0.10 m wide and 0.15 m deep in average, molded into a step made with strong grey waterproof mortar and corals blocks bonded with brown mortar. The plaque of mortar is now around 2.40 m long by 0.60 m wide and must have originally extended eastward, as the eastern end of the gutter is not preserved. The buttress B95-14 at south and the buttress B13-20 and the bench B13-05 are built over the canalization B13-36, which so belonged to an earlier stage of use. As a matter of fact, the course of the gutter is aligned with the vertical gutter B95-15 which is set in the wall B95-03 and was afterward disused by the construction of the buttress B95-14.

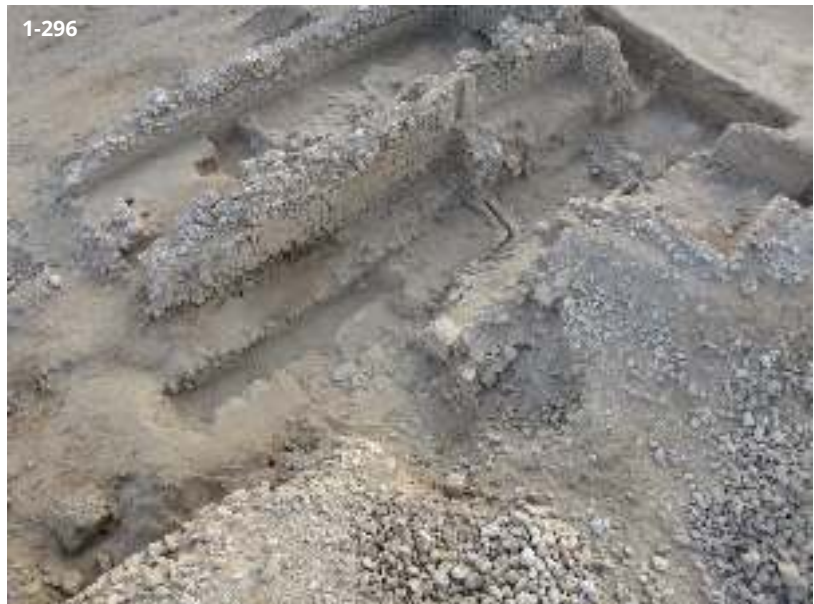
Fig 1-296 : general view of the passageway B95/B13, nearly at the end of excavations

Covering the poor remains of the eastern steps of the west threshold B13-37 and leaning against the west face of the east threshold or canalization B13-36, the layer **Uf3573** is made of small pebbles and few small corals mixed with a brown silt and was the last level of floor in the passageway, apparently spread above the leveled bedrock Uf3546. The central gutter of the canalization B13-36 was filled by the **Uf3581**, also made of small pebbles mixed with beige silt, which was undoubtedly put in place when the passageway was reduced by the building of the benches and buttresses, when the gutter was disused and leveled. It is however strongly possible that the plaque of mortar was still visible on the ground and part of the circulation level, though the gutter was no longer in use. (Fig 1-296)

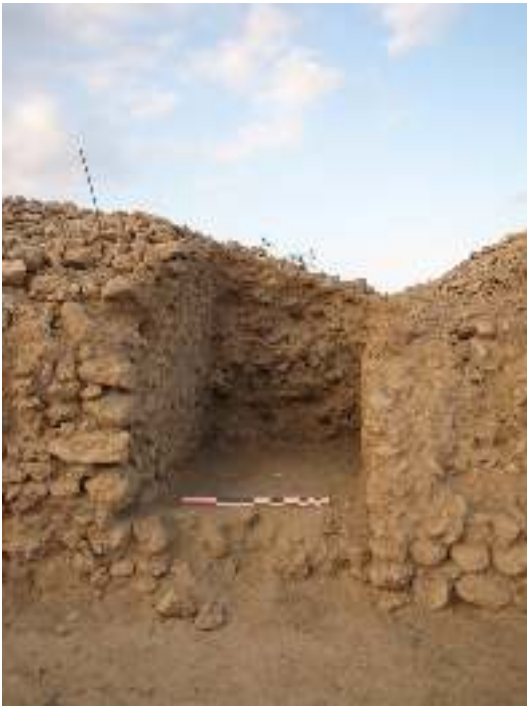
Fig 1-299 : the gate B13-32, partially excavated

One gate to B13 (B13-31) (Fig 1-298) was already known since the QP soundings in the passageway, and a second one was partially observed during the previous season, about 7 m east of the first one. The gate **B13-32** (Fig 1-299), a little less than 1.50m wide, is lined by the wall B13-01 on its western side and by the wall B13-33 to the east. The west wall, partially described in previous reports, is well preserved, being more than 2m high inside the gate. It was cleared for nearly 2 m long, until the north end of excavation, but it continues northerly and is probably the external wall of a room or a building.

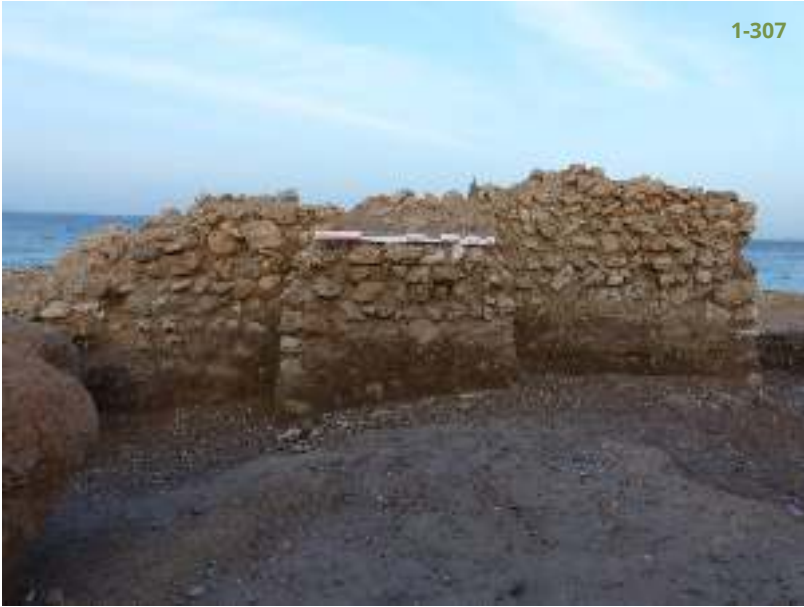
Fig 1-307 : the wall B197-04 (under the scale) with the walls B197-02 at right and B197-03 at left

Between the walls B197-02 and B197-03, the structure **B197-04 (Fig 1-307)** is a rectangular construction protruding for around 0.50m from the alignment of the westerly limit of the basement. It is 1.30m long and preserved for a little more than 1m high, and is made with medium corals and limestone blocks bonded with beige mortar. The same coating is preserved in the lowest part, hiding the connections between the walls, while it has disappeared in the upper part, showing that the wall B197-04 is leaning against the walls B197-02 and B197-03. It is so probable that these two walls make in fact a single wall, against which was later built the projection B197-04, probably shortly later.

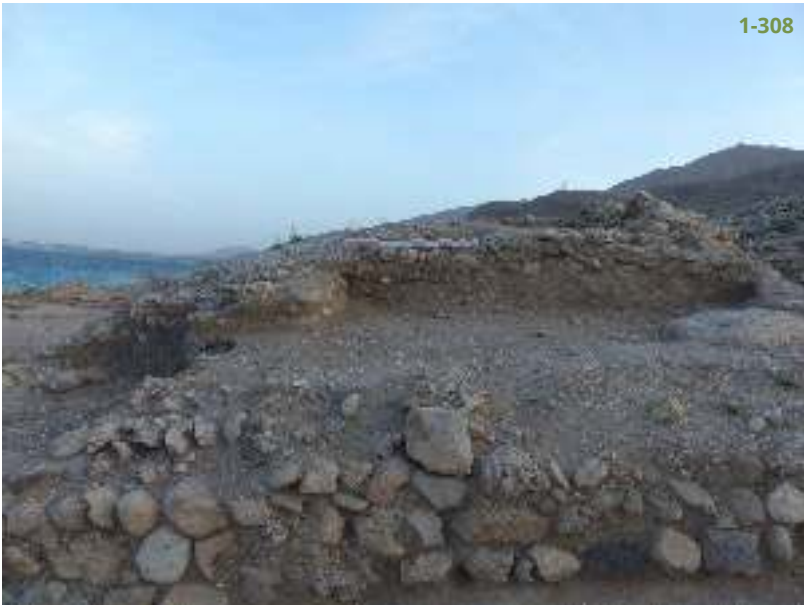
Fig 1-308 : the wall B197-05, in the background under the scale

The north side of the main building is made by the wall **B197-05 (Fig 1-308)**, around 5.70m long by 0.50m wide. As the stair was built against it, it has only been observed for 0.60m high, until the reaching of the backfill levels of the stair which were left in place. According to what have been observed, the north facing is made of small to medium corals and limestone blocks bonded with beige mortar, and small remains of the brown coating were observed, especially at east.

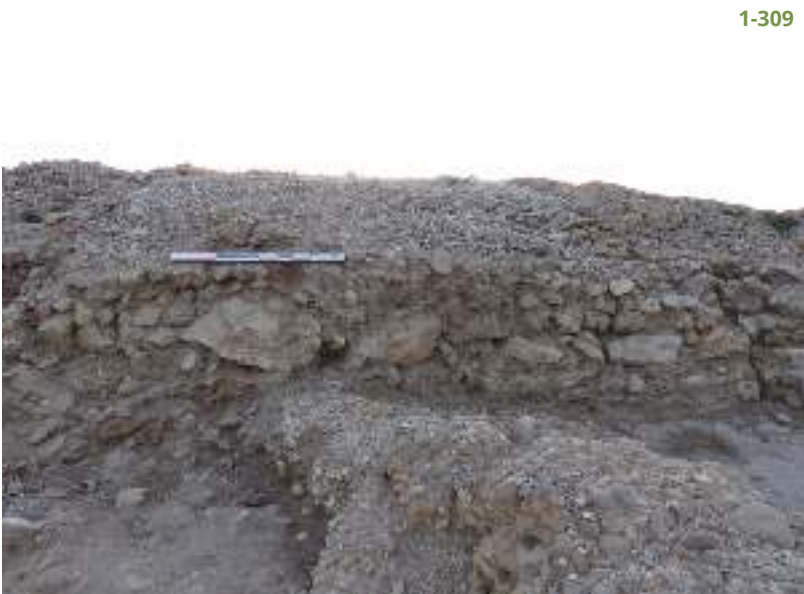
Fig 1-309 : the wall B197-06

The east side is made by the wall **B197-06 (Fig 1-309)**, 4.90m long for a maximal preserved elevation of 0.90m and an unknown width as its west facing was not uncovered. It is badly preserved, especially at

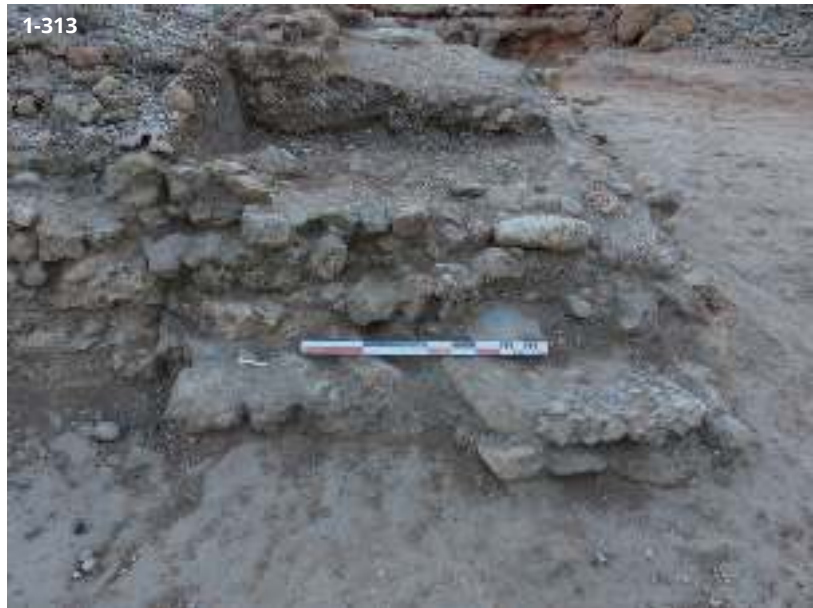
Fig 1-313 : the steps B197-10

At east, the construction **B197-10 (Fig 1-313)** is very badly preserved but several lines of stones might be the remains of damaged steps. The lowest one, leaning against the wall B197-06, is made with plaques of bedrock, protruding for around 0.50m from the alignment of the wall B197-06. A second step can be seen above by the alignment of few medium limestone blocks and a third one can more be guessed than observed and the other ones have entirely disappeared.

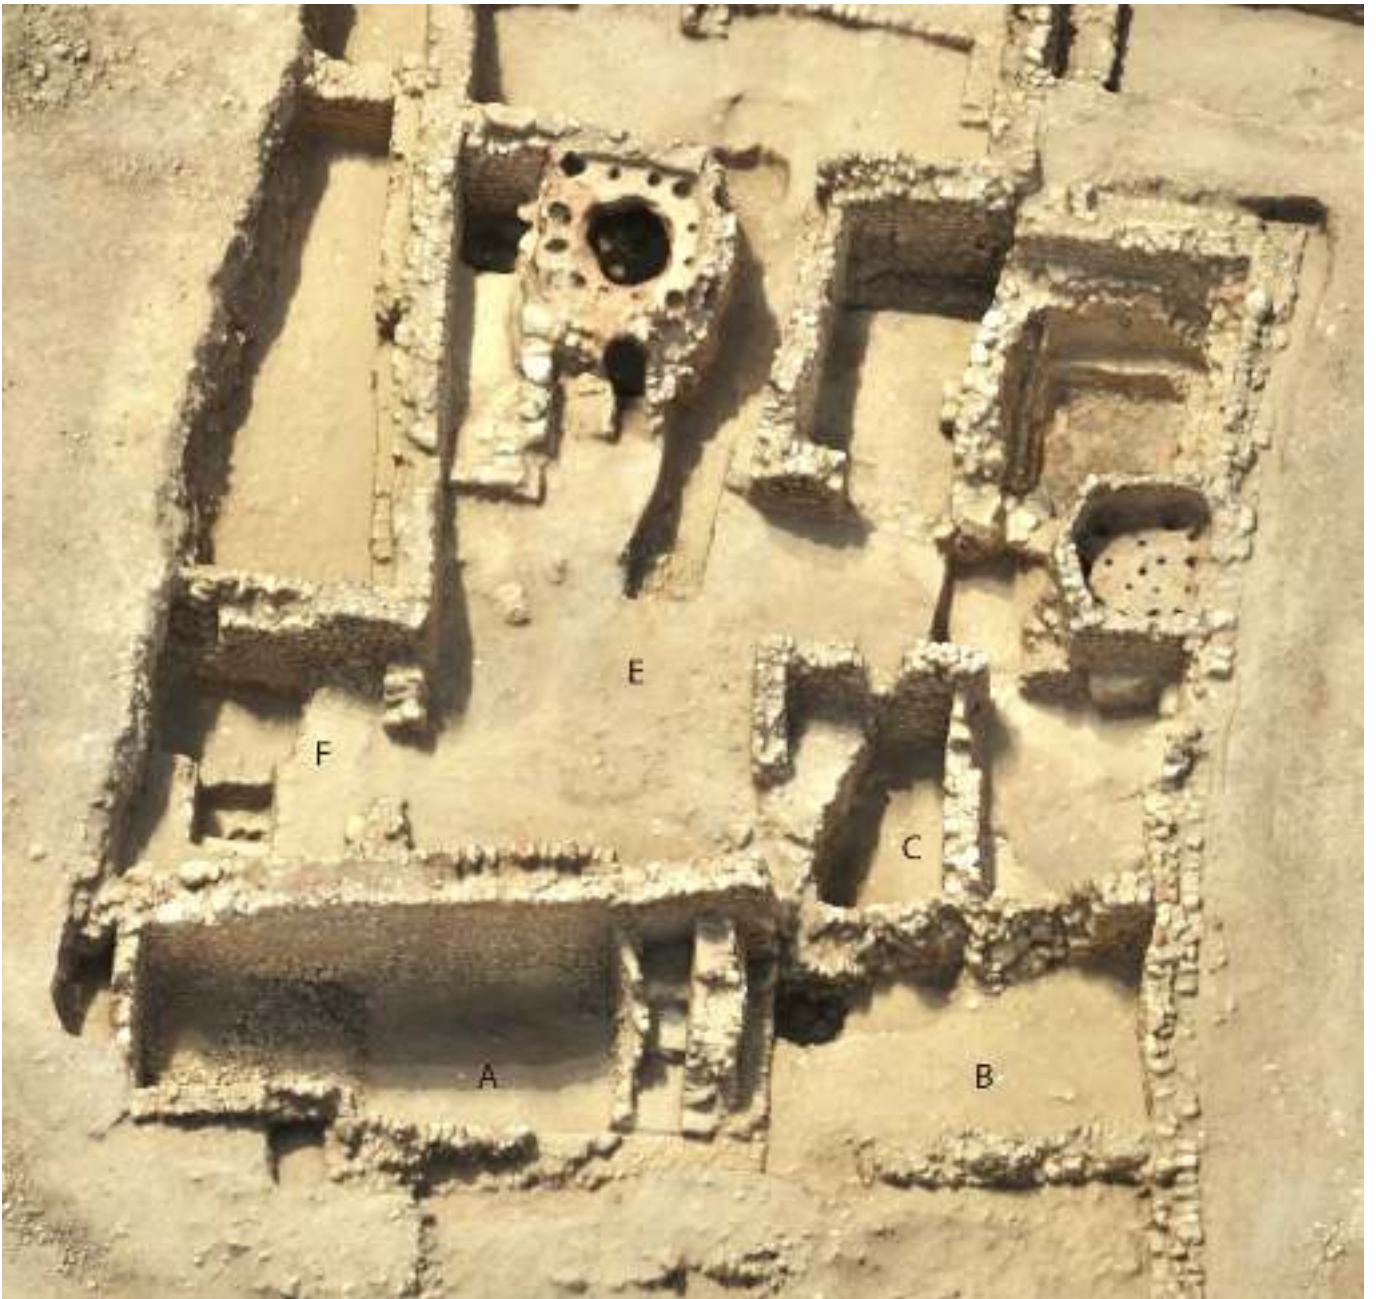
Fig A-29 : General view of space E

Wall B41-40 is perpendicular and is leaning on wall B41-41. It measures 2.63m long, 0.40m wide and 0.80m high. It is endowed with an opening across the total width of the masonry and measuring 0.37m long. Its height is not known since the upper parts of the wall are not preserved. It is built over large blocks of the bedrock. Wall B 41-37 is perpendicular and leaning on it, it measures 2.75m long, 0.40m wide and 1.05m high. Another niche was built measuring 0.28m wide at its base, and 0.48m at the level of destruction of the wall. Wall B41-33 is perpendicular to B41-37 on which it is leaning, and parallel to B41-40. It measures 1.26m long, 0.40m wide and 0.77m high. This set of three walls creates an enclosed space inside Room E (Room C) whose function is still to be determined (*Fig A-29*).

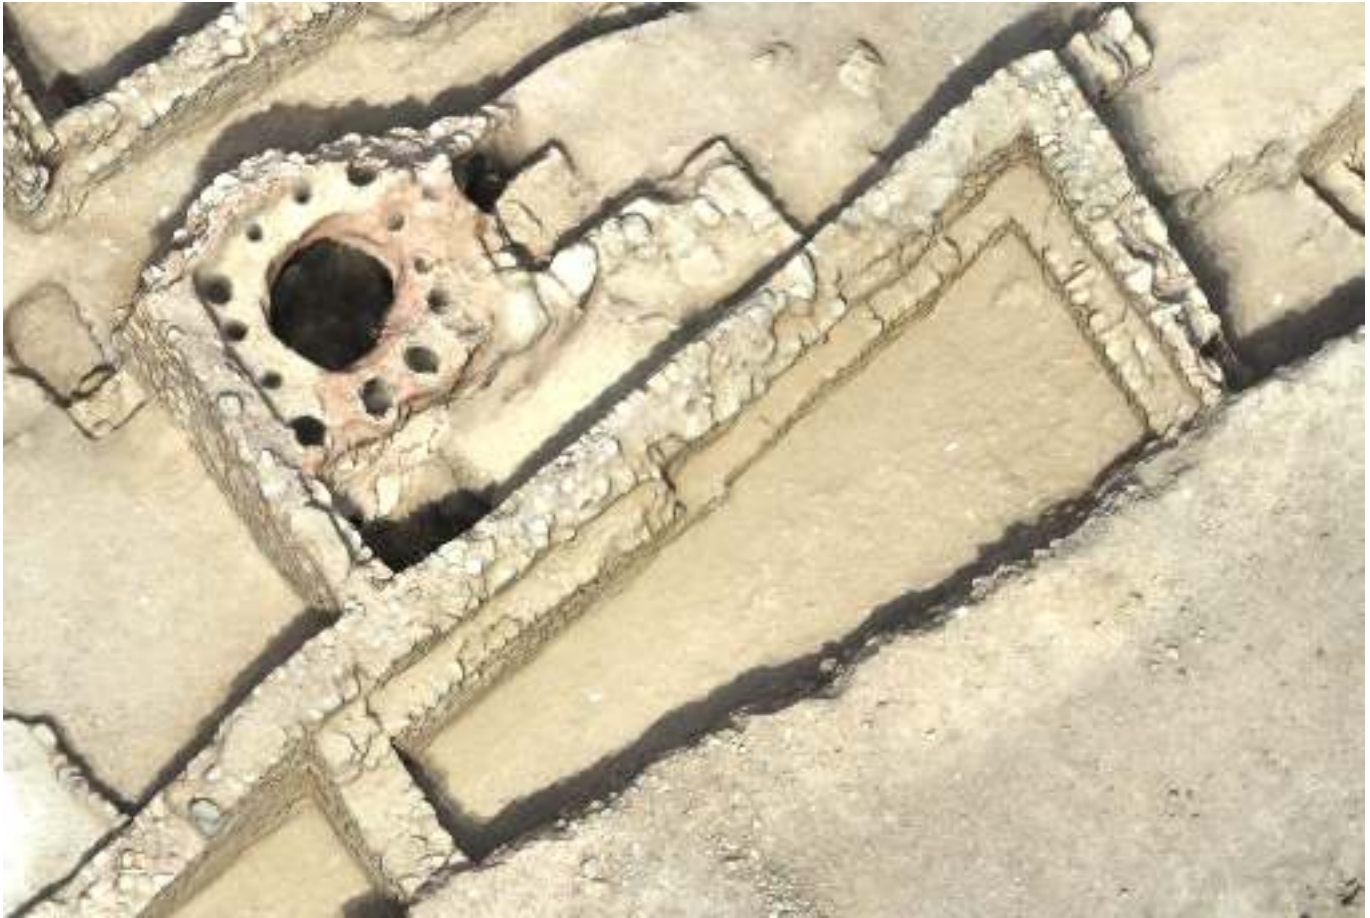
Fig A-61 : Wall B41-65 and B41-66

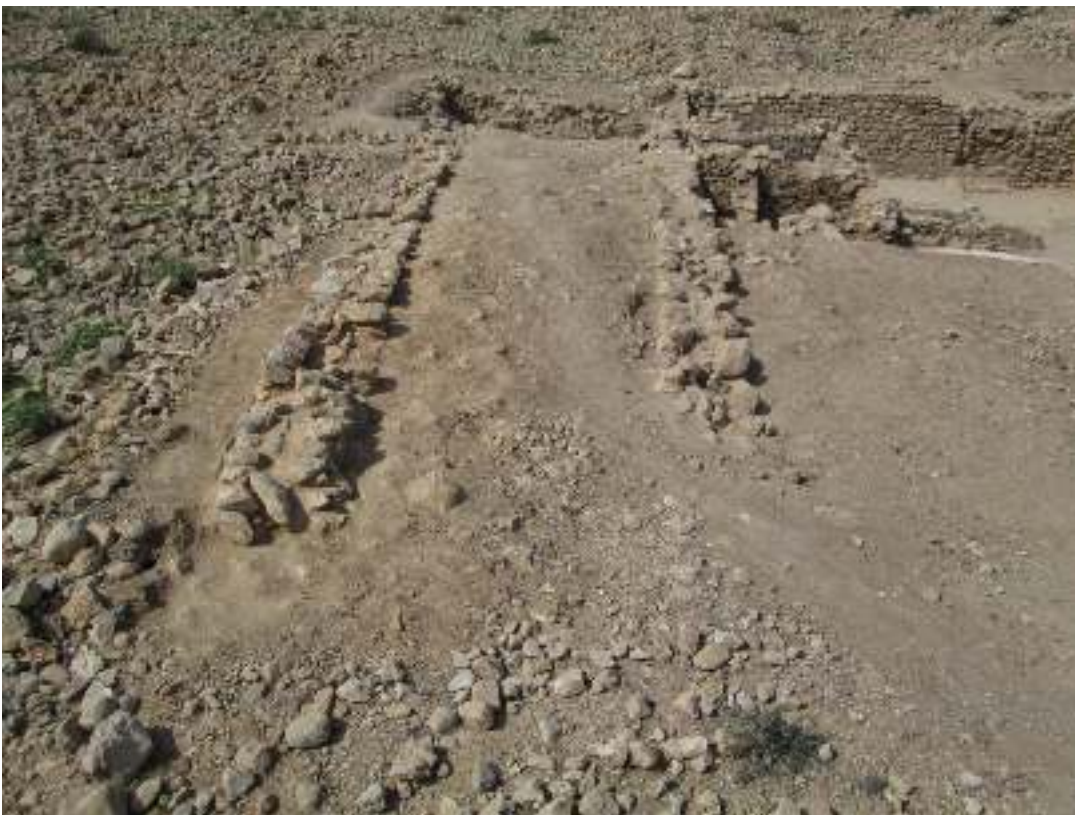
Fig A-71 : *West Street overlooking north*

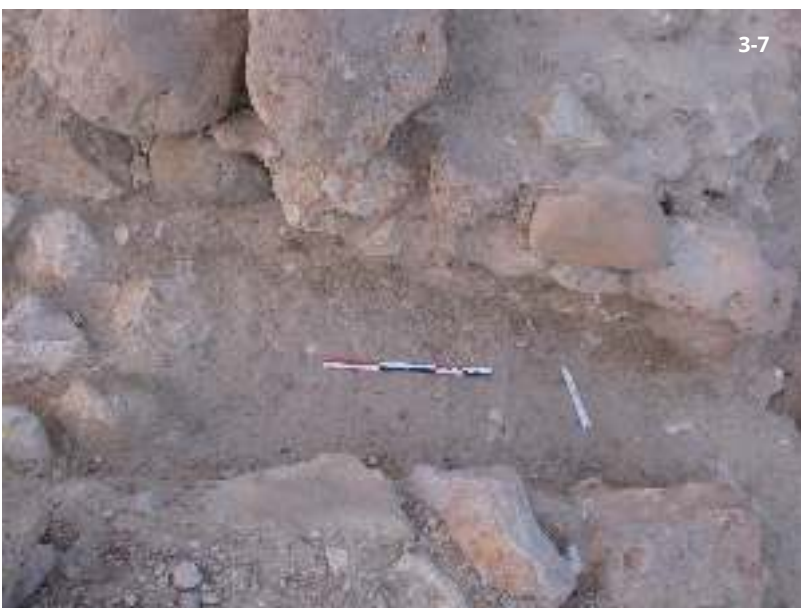
Fig 3-7 : the crossing hole B31-07

The south hole B31-07, (Fig 3-7) around 4.5 m south of the north one, is preserved for a little more height, around 0.45 m for two courses of stones and its width also varies from 0.47 m at west to 0.27 m at east, asymmetrically of the north hole B31-08. Its actual length is along 1.35 m but it was also originally around 2.60 m, as the width of the wall.

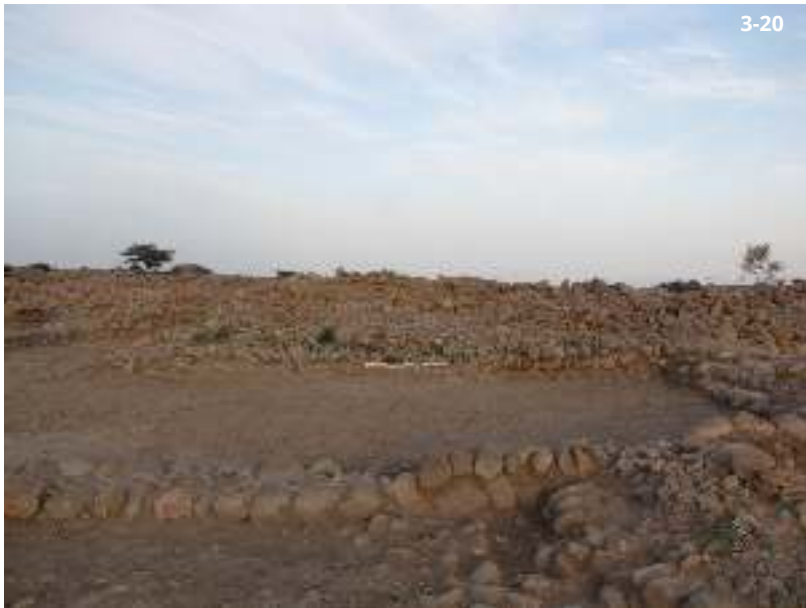
Fig 3-20 : the wall B280-02, inside elevation

The eastern limit of the room B280-B is made by the wall B208-02 (Fig 3-20) which is common to the room B280-C. It is around 0.70m wide and preserved for a maximal height of 0.40m. Well preserved for 7.15m long from the south-east corner, the wall disappeared about 2.30m from the north wall B280-01. It is not possible to state if the wall has disappeared or if a highly damaged gate once stood here. As the eastern room B280-C was probably filled with small pebbles to create a terrace, the hypothesis of a gate is unlikely. The facings are poorly made, or badly preserved, with medium limestone blocks more or less organized and not always aligned.

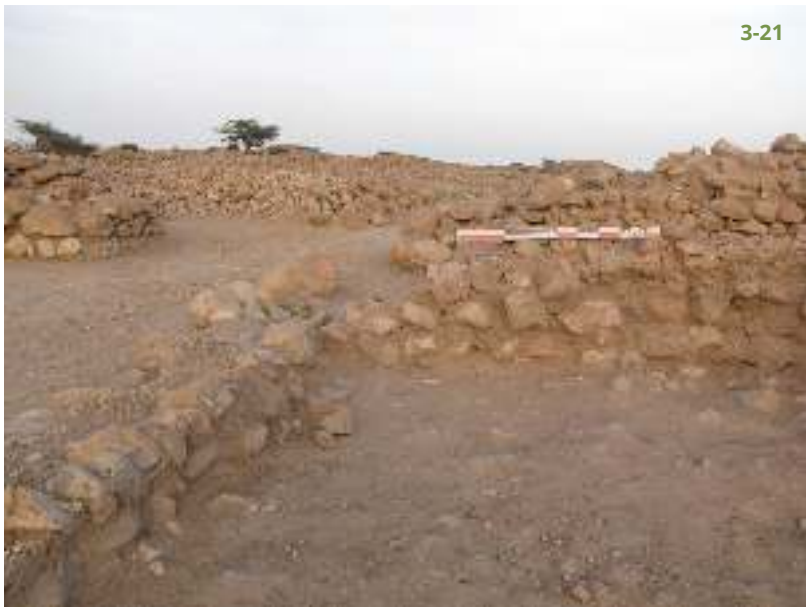
Fig 3-21 : the wall B280-07, inside elevation

The north limit is made by the wall B280-01 and the eastern limit is made by the connected wall B280-07 and the wall B280-08 leaning against it. The wall B280-07 (Fig 3-21) is 2.65m long by 0.80m wide for a preserved elevation of 0.80m high, made of four regular courses of medium limestone blocks bounded with earth.
