Qalhât Development Project, Season 2015B-2016A, Final Report

Excavations on the Ceramic Workshop B41

I-B. The 2015b-2016a season - 1. Excavations of the southeast part of the Mosque (Spans 1 and 2)

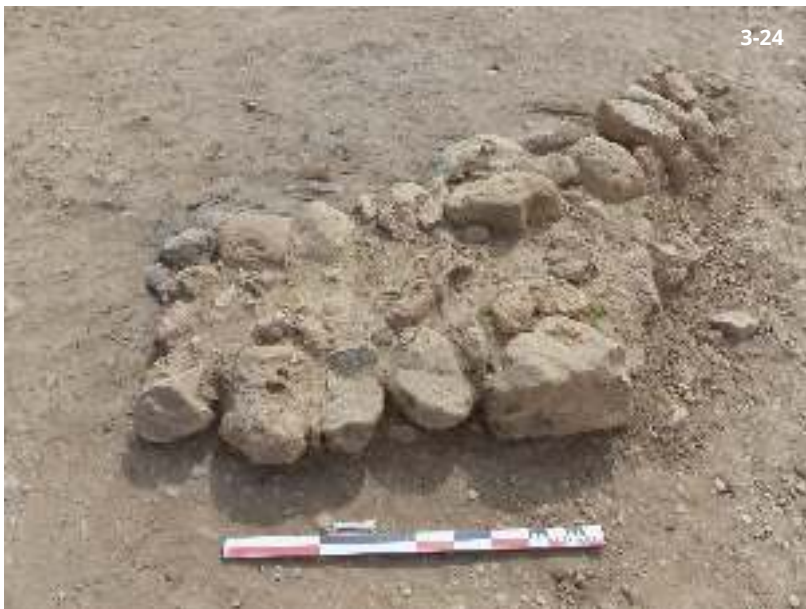
Fig 3-24 : the curved wall B281-01

The curved wall B281-01 (Fig 3-24) bound both the south and east limits of the building. It is still 1.50 m long and from 0.90 to 1m wide, and only preserved for 0.20 m high. It is built with medium limestone blocks for facing and smaller rocks and pebbles for the core, all bonded with earth. It could have originally extended southerly and have been destroyed by the circulation on the access way, or can also have been voluntary destroyed to increase the width of this passageway.

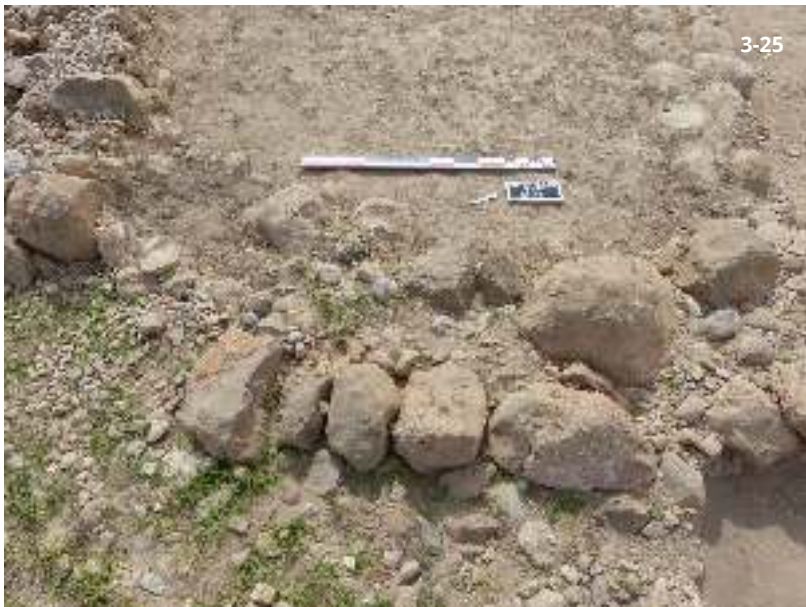
Fig 3-25 : the wall B281-02

The north and west known limits of the building are made with the curved wall B281-02, (Fig 3-25) which plan is very confused. Its width deeply varies from 0.60m at south to 1.70m at east and its preserved elevation is around 0.30m high. Different stages of construction may have occurred but the state of preservation was not good enough to observe them. The wall is made of small unorganized small rocks of pebbles for the core and medium to large limestone blocks for the facing, all bonded with earth.

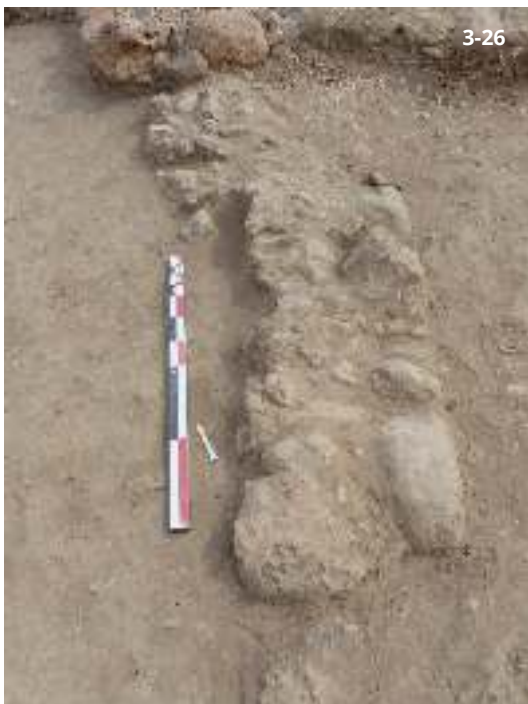
Fig 3-26 : the wall B281-03

The small wall B281-03 (Fig 3-26) is built in the aforementioned gap but is not in the alignment of the walls B281-01 and B281-02. It is around 1.40 m long by 0.55 m wide and only preserved for 0.20 m high. The east and west facings are made of an alignment of medium limestone blocks without any clearly visible core. The northern and southern ends are irregular, suggesting that the wall may have originally extended. In fact, this wall may belong to a former building that was destroyed or reused when the walls B280-01 and B280-02 were built.

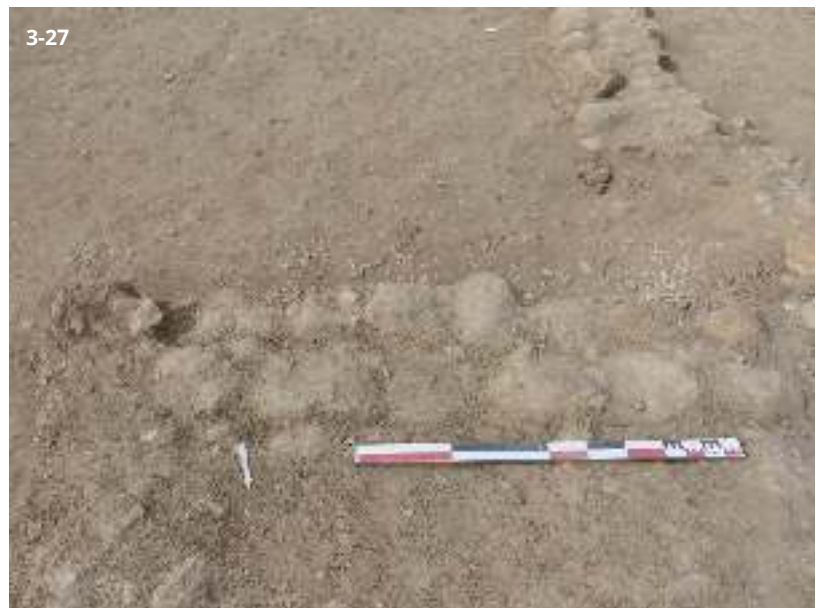
Fig 3-27 : the two walls B281-04 and B281-05

It can also be the case for the walls B281-04 and B281-05, which are two small parallel alignments which function is unclear. The southern alignment B281-04 is 2.20 m long by 0.30 m wide for a preserved elevation of only 0.20 m high, made by one row of medium limestone blocks without binder and apparently built over a layer of backfill. The missing of a south facing might indicate that it was used as a retaining wall for southerly backfill. The northern alignment B281-05 is similar in components and sizes, though a little bit smaller, and could be a later refitting to strengthen or replace the former retaining wall B281-04. (Fig 3-27)

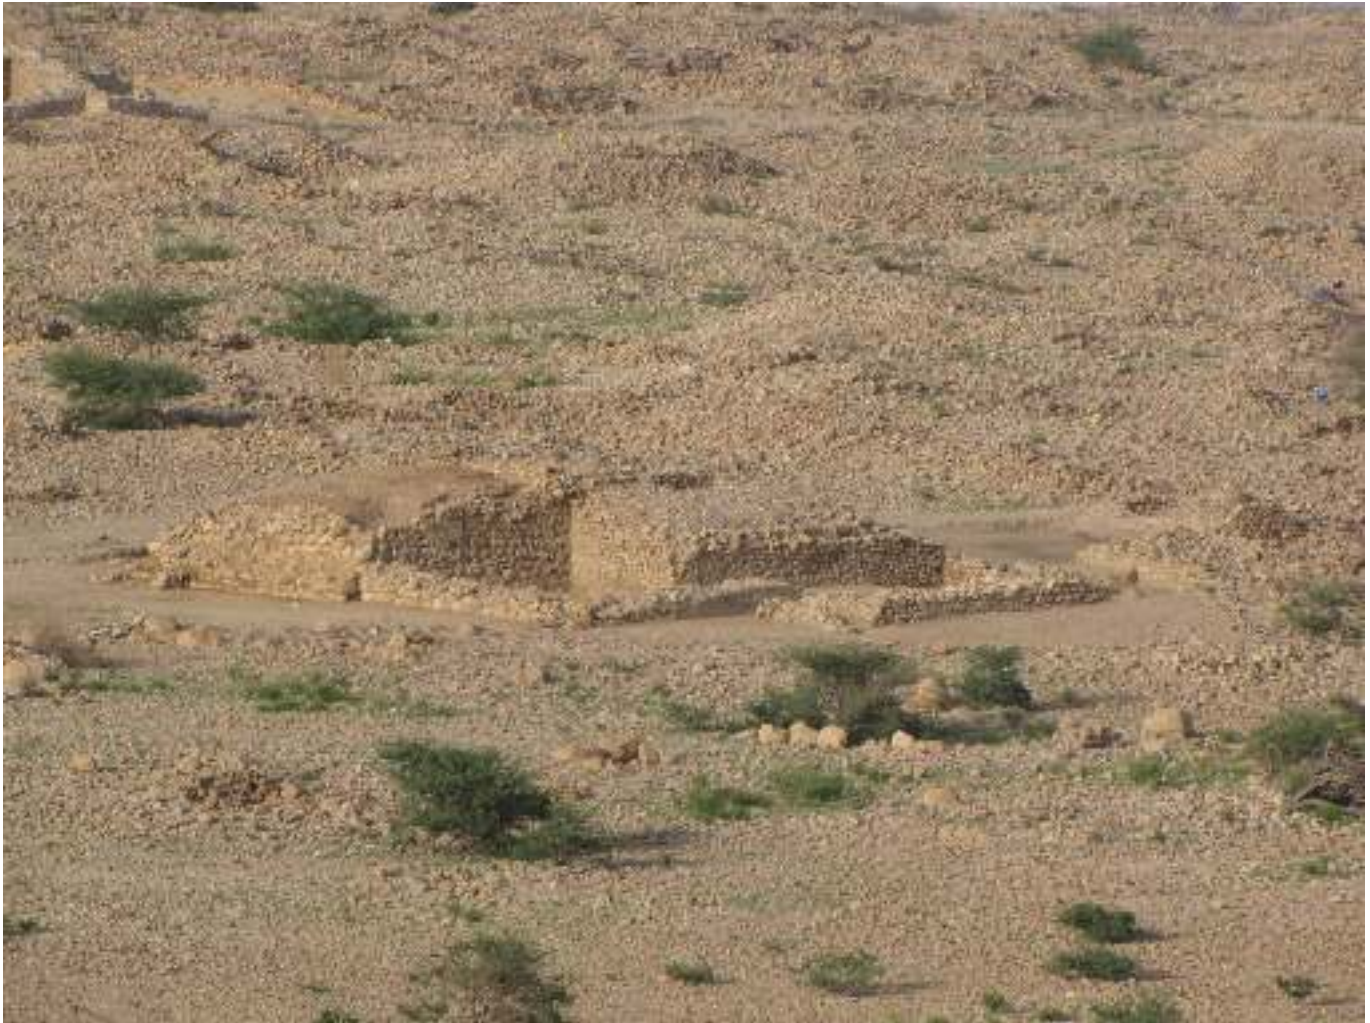
Fig 3-33 : *general view of the building B29 from the motorway*

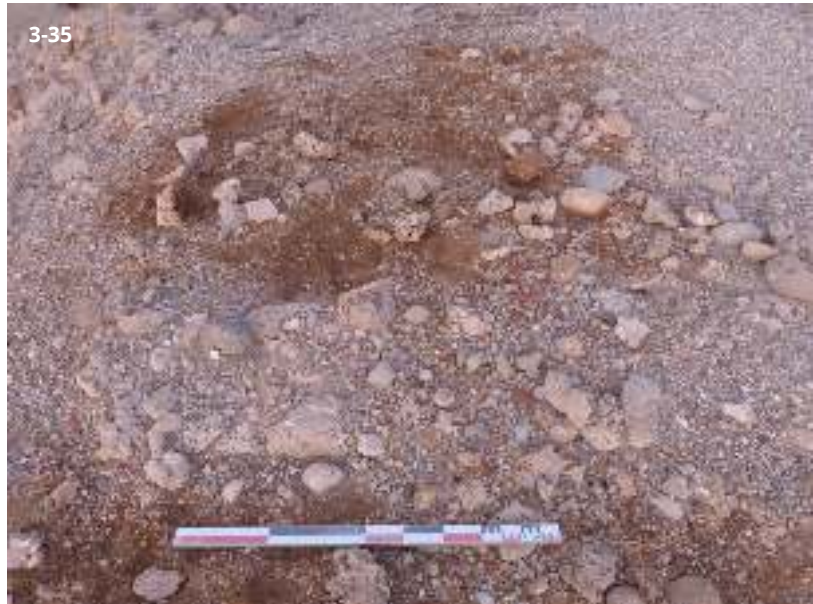
Fig 3-35 : the wall B29-30 emerging from the level of small pebbles, at the beginning of excavations

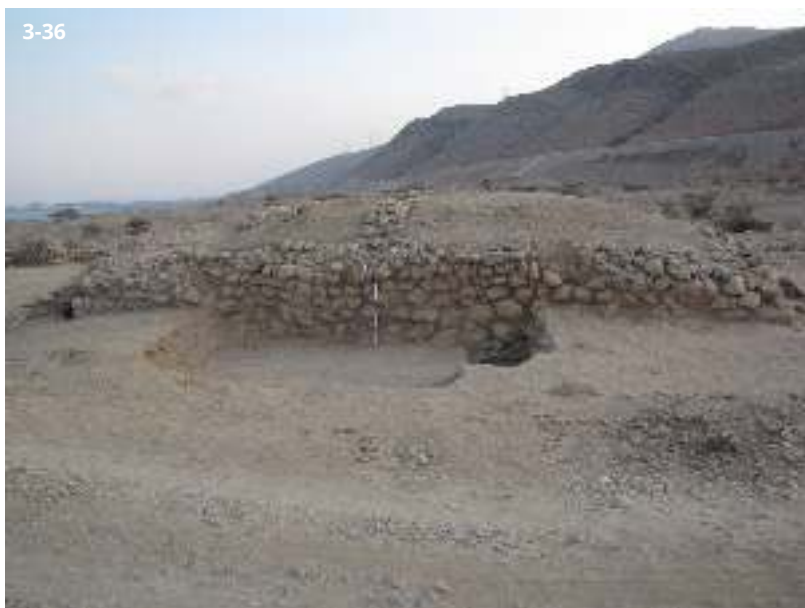
Fig 3-36 : the wall B29-02 partially excavated, with the room B29-A at right

The west room B29-A measures approximately 7.80 m (n-s) x 7.00m (w-e). It is bounded north by the wall B29-02 and south by the wall B29-03, both extending eastwards to bound the room B29-B. In the room B29-A, the wall **B29-02 (Fig 3-36)** is 0.75 m thick in average and has a preserved elevation of 1 m to 1.50 m, which is less than the original height of the first floor. It is made in its lower part in massive pebbles and limestone blocks and in the higher part in medium ones, bonded by grayish earthen mortar; some very scarce remains of gray coating were observed. This wall was buried on the outer side by its own collapse, which was registered as **Uf5501** to the east and **Uf5502** to the west and which contained comparatively less corals blocks than in the Great Mosque and other excavated buildings. A sounding (SD1) opened at its feet revealed that it is built above a small layer of backfill (**Uf5507**), made of brown silt mixed with rocks and gravels and around 0.40m thick, which is leveling the underneath bedrock (Fig 3-37). The top of this backfill can be considered as the surrounding circulation level.

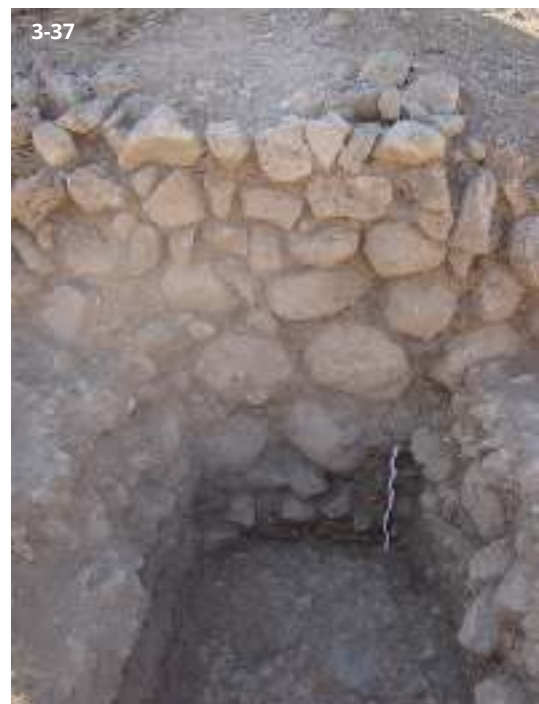
Fig 3-37 : the sounding SD1, with the backfill UF5507 (nearly until the top of the scale) and the wall B29-02 (starting with the massive pebbles) and the natural bedrock (down the sounding)

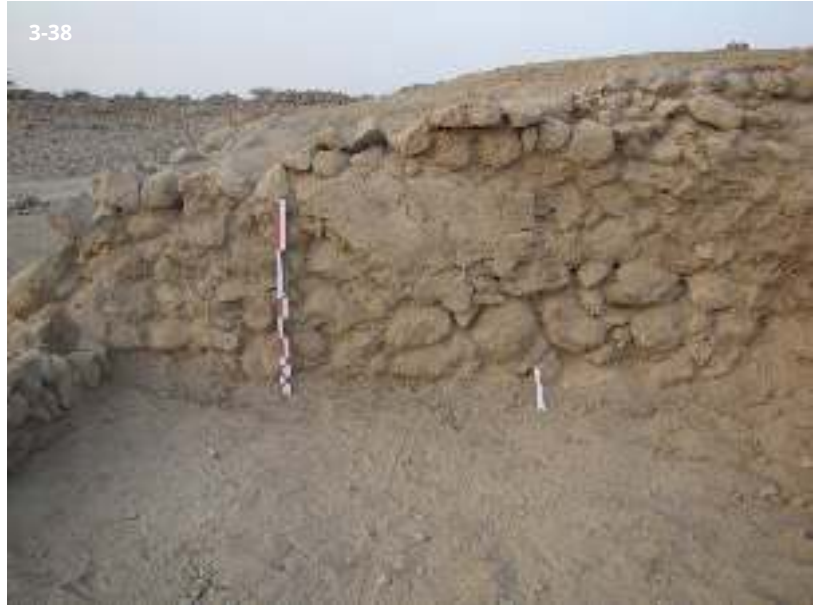
Fig 3-38 : the wall B29-03, partially excavated, with its remains of coating

The south wall **B29-03** (Fig 3-38) is also common with the room B29-B but it is here hidden by the south terrace B29-C (*infra*). In the room B29-A, the wall is internally 5m long by 0.75m wide in average for a preserved elevation of 1.50m to more than 2m near the corner with the room B29-C. It is also made with massive pebbles and limestone blocks in the lower courses and medium ones in the upper ones, bonded with grayish earthen mortar. A large plaque of grayish coating was also found still preserved on the wall. The layer of collapse **Uf5504**, which was covering the wall, contained few corals and remains of coating and plaster which could come, according to the location, from the wall at first floor. A sounding (SD2) was opened in the corner between the main building and the south terrace, which showed that the wall B29-03 is partially built directly over the bedrock and partially over a very thin layer of backfill (maybe from natural origin) which is leveling it (Fig 3-39).

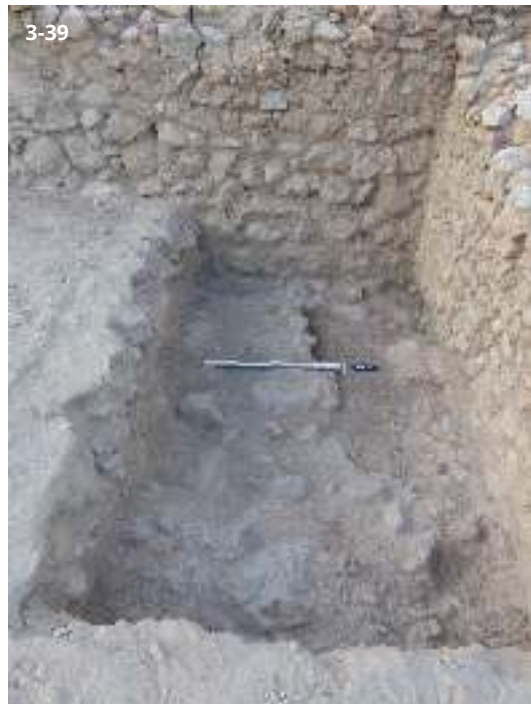
Fig 3-39 : the sounding SD2, with the wall B29-03 (in the background) built over the bedrock

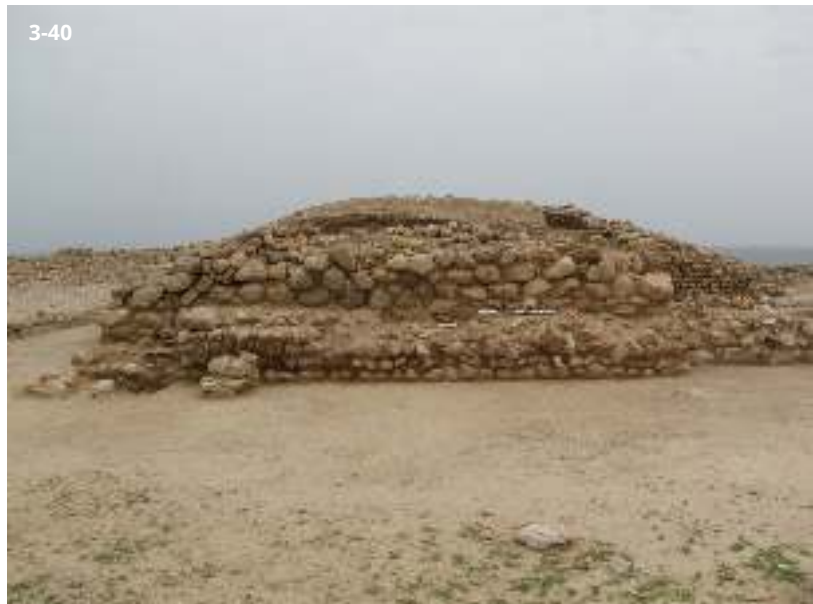
Fig 3-40 : the wall B29-01, in the background behind the scale

The west limit of the room B29-A is made by the wall **B29-01** (Fig 3-40) which is externally 7.80m long by 1m wide for a preserved elevation of almost 2m. The lower part is now hidden behind an outlying wall B29-12 but is probably also made with massive pebbles and limestone blocks; medium ones are visible in the upper part, bonded with grayish earthen mortar. No remains of coating were observed on the visible parts of the wall but many remains were found in the collapse (**Uf 5505** and **Uf5506**), which can in fact also come from the elevation of the wall at first floor.

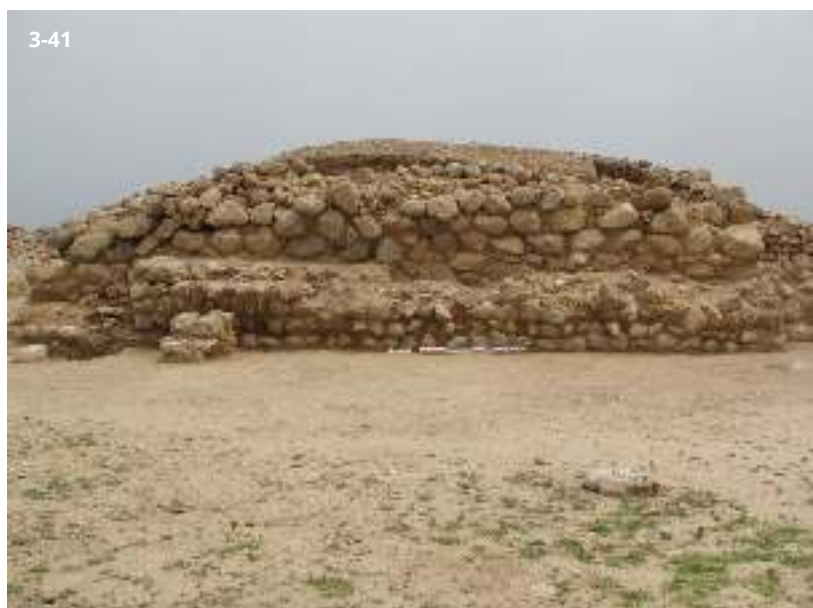
Fig 3-41 : the outlying wall B29-12, at bottom behind the scale

The wall B29-01 is bonded to the west by the outlying wall **B29-12** (Fig 3-41), the function of which is problematical. It is 7.20m long, and so does not outline the wall B29-01 on its entire length, and 0.75m thick for a preserved elevation around 0.80m maximum. Though the top of the wall is badly preserved in its middle and south parts, a flat level to the north might be the original elevation of the wall, which was therefore not as high as the wall B29-01 behind. The wall B29-12 is mainly made with medium limestone blocks and few corals or pebbles and only bonded by earth and no remains of coating were observed. The shape and dimensions of this construction suggest an identification as a high bench but, as the wall B29-01 is believed to be a *qibla* wall, the location of this bench is rather unusual. There is however no better interpretation.

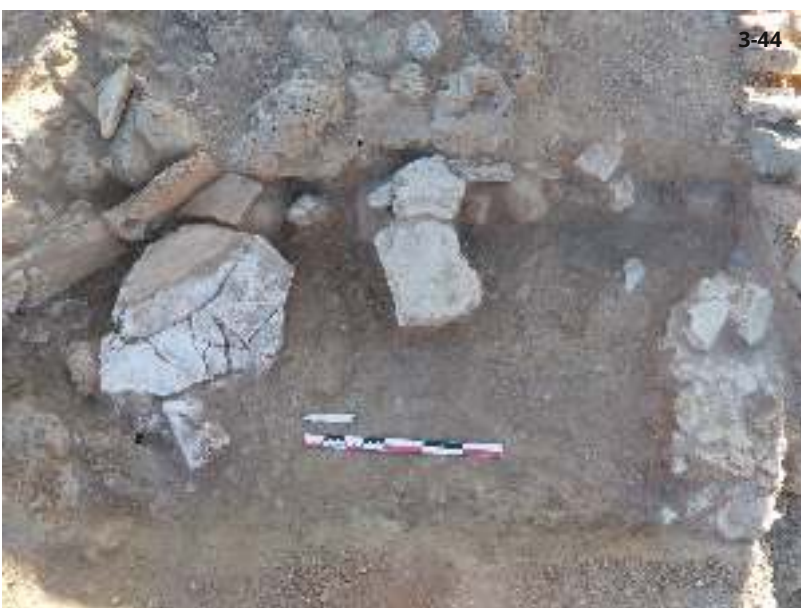
Fig 3-44 : remains of plaster found near the wall B29-30 (at right)

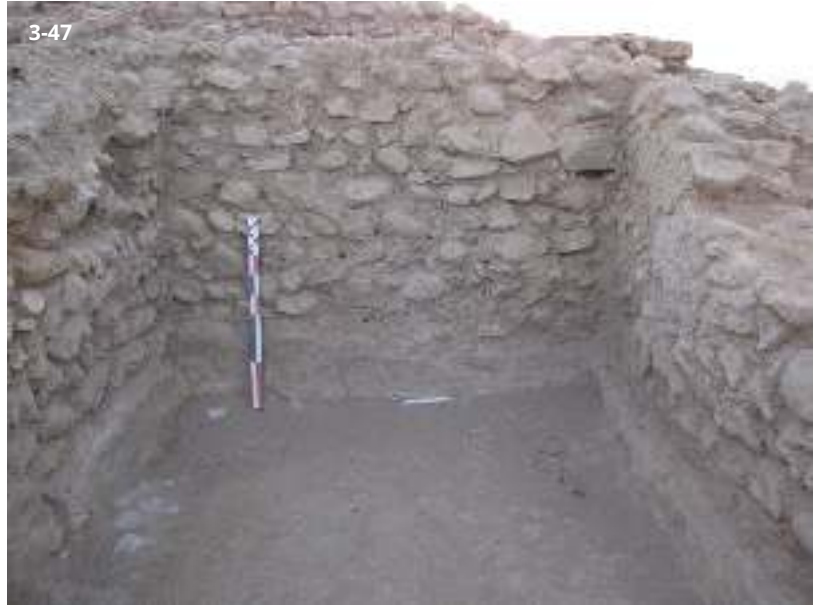
Fig 3-47 : *the wall B29-26; with the room B29-E at left and the stair B29-33 at right*

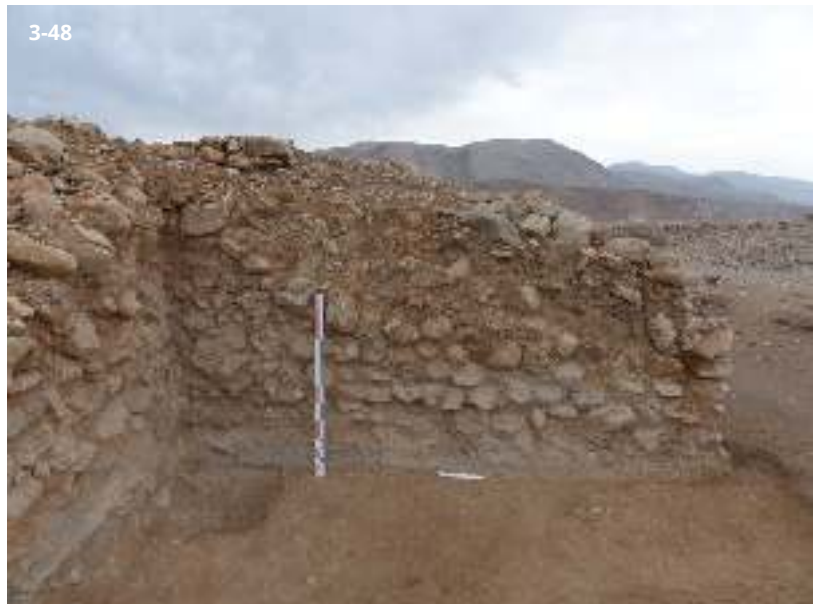
Fig 3-48 : *the wall B29-34, with the stair B29-33 at left*

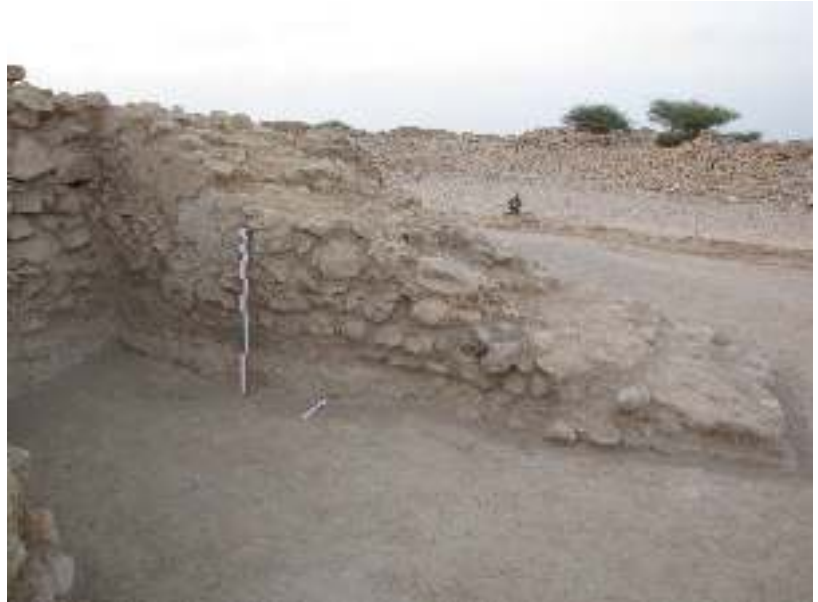
Fig 3-56 : the south side of the stair B29-33, with the beige coating on top at left, the gray coating at feet and the disturbed facing at right

Several remains of coating were observed on both sides of the stair, with a beige one on the upper part and a strong gray one, similar to cement, all around its foot. The north and south sides have also suffered a pressure, due to the internal filling, which has pushed the elevation to the outside and some of the stones from the facing have either collapsed or slide, explaining why the facings are not yet strictly vertical and some stones are missing (**Fig 3-56**).

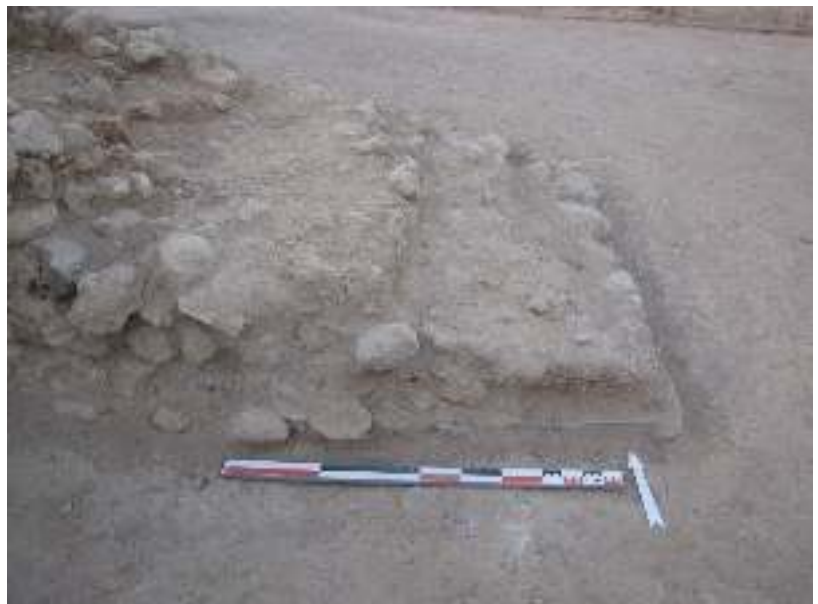
Fig 3-57 : the first two steps of the stair B29-33

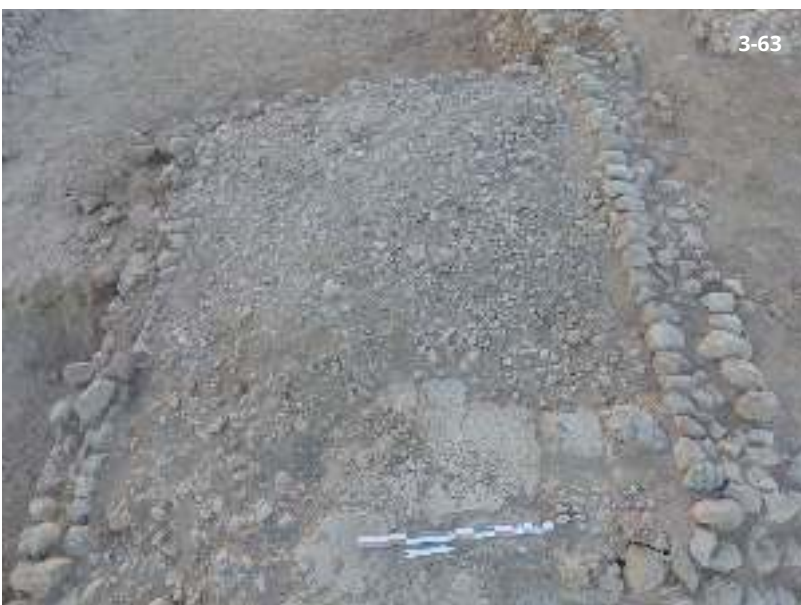
Fig 3-63 : general view of the room B29-C with the level of backfill Uf5510, mainly made of rocks

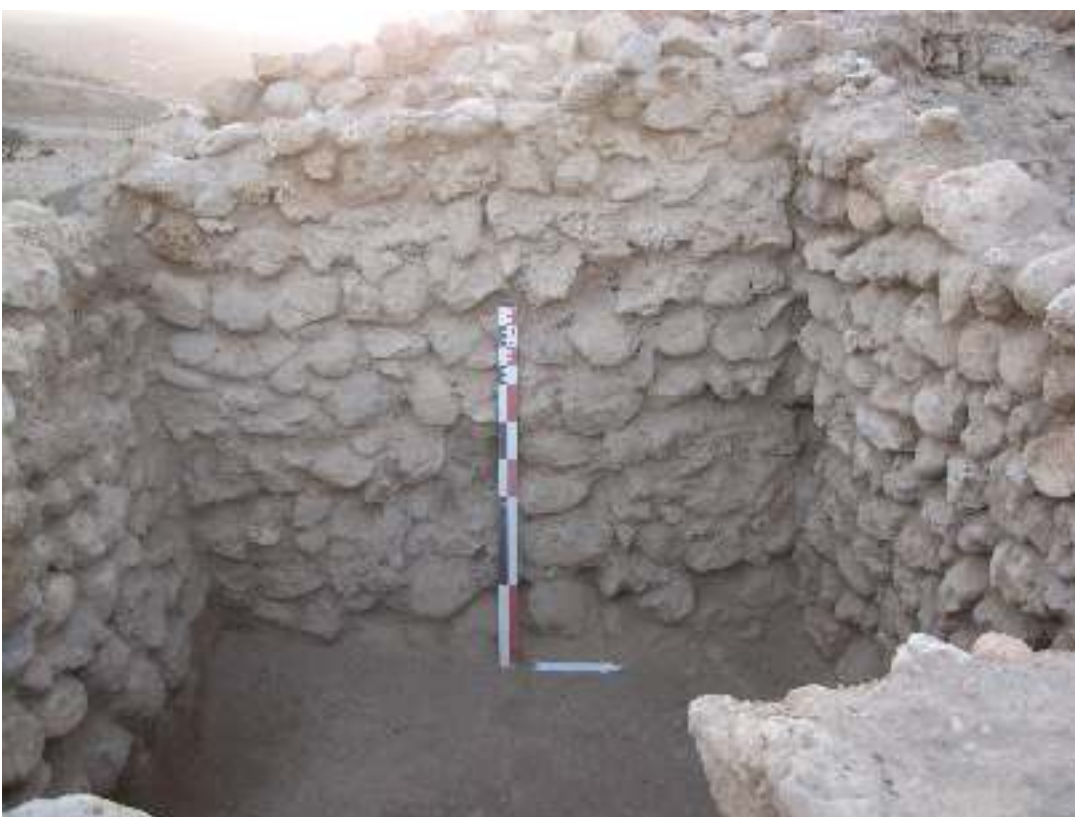
Fig 3-68 : the wall B29-07 in room B29-D

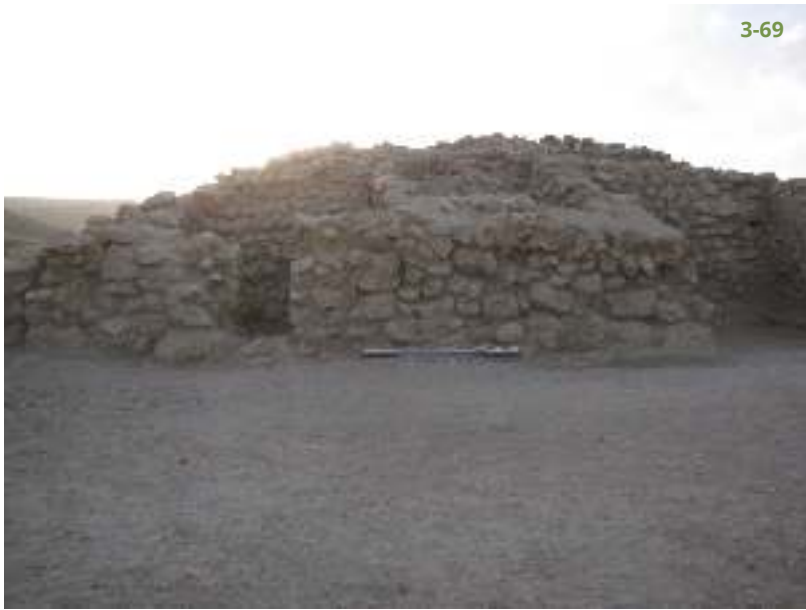
Fig 3-69 : general view of the east side of the rooms B29-D and B29-E, with the wall B29-20, the threshold B29-21 and the wall B29-22 from left to right

To the east, the limit is made by the wall **B29-20**, which is 1.30m long externally and 0.70m thick for a maximal preserved elevation of 0.80m, and by the wall **B29-22**, common with room B29-E and which is here 0.60m long internally by 0.75 m thick for a preserved elevation less than 0.80m, both being separated by the threshold **B29-21**, which is only 0.35m wide (**Fig 3-69**). The walls are made with large limestone blocks and medium pebbles bonded with earthen mortar. The same strong gray coating was found at the foot of the walls, mainly north of the wall B29-22. The threshold B29-21 (**Fig 3-70**) is made with medium pebbles partially polished and apparently only bonded with earth. As the south jamb of the gate has a little slide, it is possible that the gate was originally a little bit wider than it is today, but in any case no more than 0.40m wide.

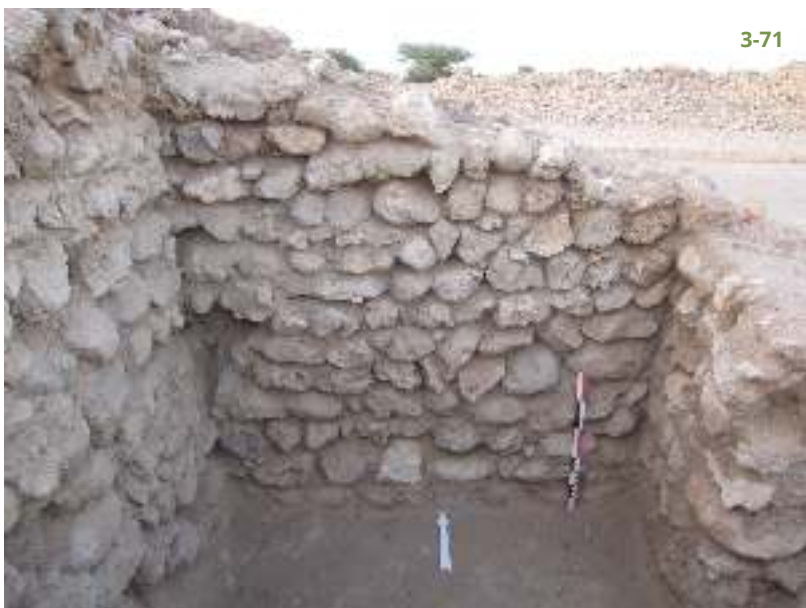
Fig 3-71 : the wall B29-23 in the room B29-D

Considering the strongly probable voluntary filling of the room B29-E and the fact that it has no access, it is very likely that the area B29-E was never a room but a reduction of the room B29-D. Originally the room B29-D was extended until the north wall B29-25 and was so about 3.20m long by 1.30m wide with probably a niche on the west side. At a certain time, the niche collapsed and instead of repairing it, the northern half of the room was closed by the wall B29-23 and filled.

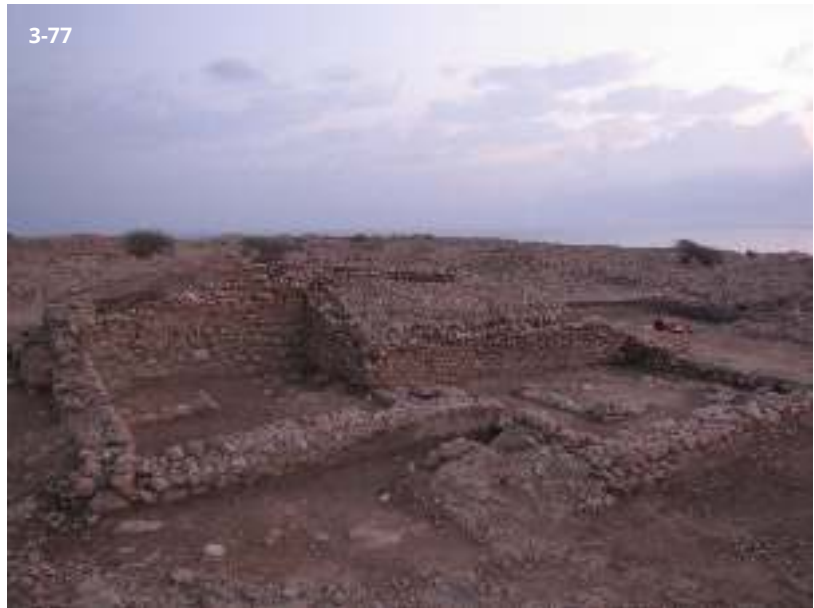
Fig 3-77 : *general view of the south courtyards, under excavations*

Fig 3-78 : *the wall B29-10, outside elevation*

Fig 3-79 : *the wall B29-10, inside elevation*

Two courtyards were found south of the building B29, bounded with low walls leaning against the main building or the high terrace (Fig 3-77). West and south, the collapse were removed down to the level of the actual ground, while to the north some parts of the late colluvium were removed until the actual track, which marks the north limit of excavation. A more important space was excavated to the east, where some walls were visible and partially excavated, in order to create a coherent visual ensemble.

The south-west courtyard, 6.50m long by 5m wide, is set against the south side of the prayer hall B29-A and the high terrace B29-C to the east. The west limit is made by the wall **B29-10** (Fig 3-78), 7.30 m long and 0.75 m thick, 0.60 m high in average, built with large pebbles and limestone blocks bonded by earth. No coating was found on the outside face, but the internal elevation is partly covered with the strong gray mortar (Fig 3-79).

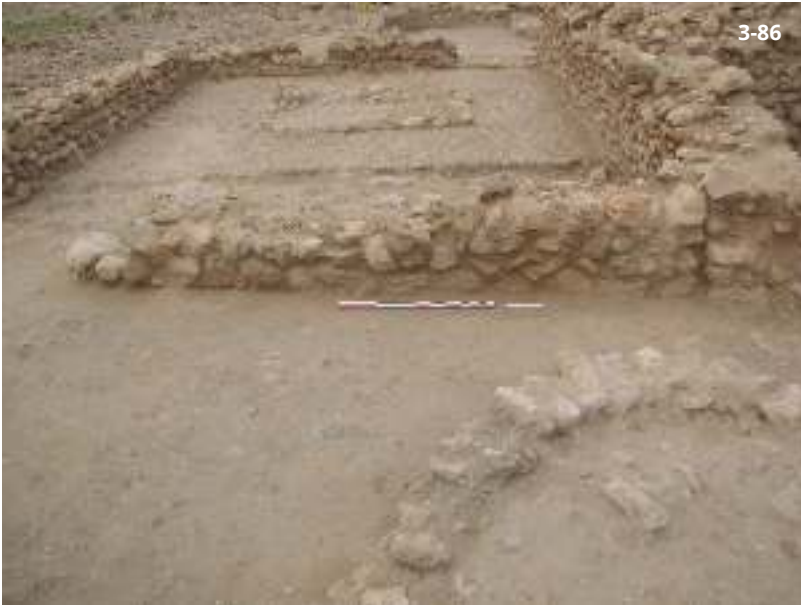
Fig 3-86 : the wall B29-15,
outside elevation

The east limit is made by the wall **B29-15** (Fig 3-86), 4.40m long, 0.70m thick and 0.50m high in average, leaning on the high terrace to the north and made with large pebbles and limestone blocks bonded with earth. The south limit is made by the wall **B29-13** (Fig 3-87), 8m long, 0.65m wide and 0.50m high in average, built in the same way. Between these two walls, in the south-east corner of the courtyard, an opening without any particular fitting is the access to the south-east courtyard and beyond to the south-west one (Fig 3-88).

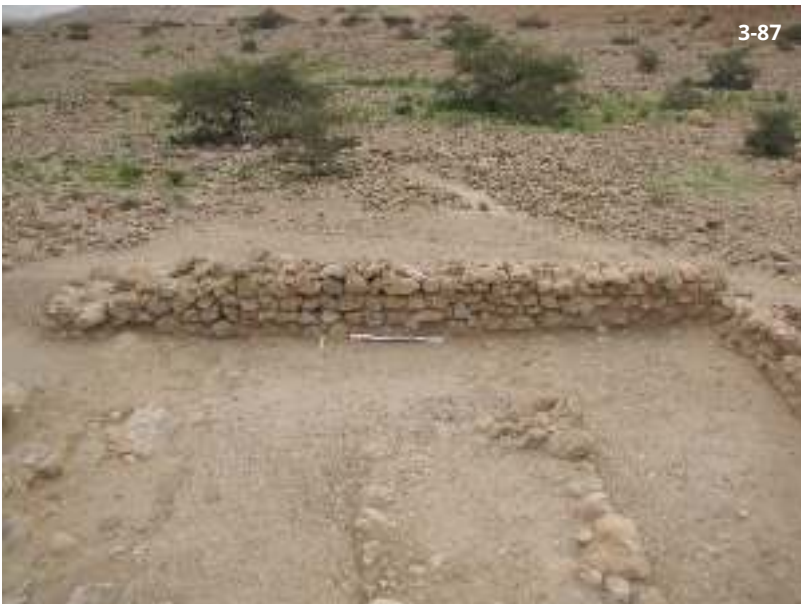
Fig 3-87 : the wall B29-13,
inside elevation

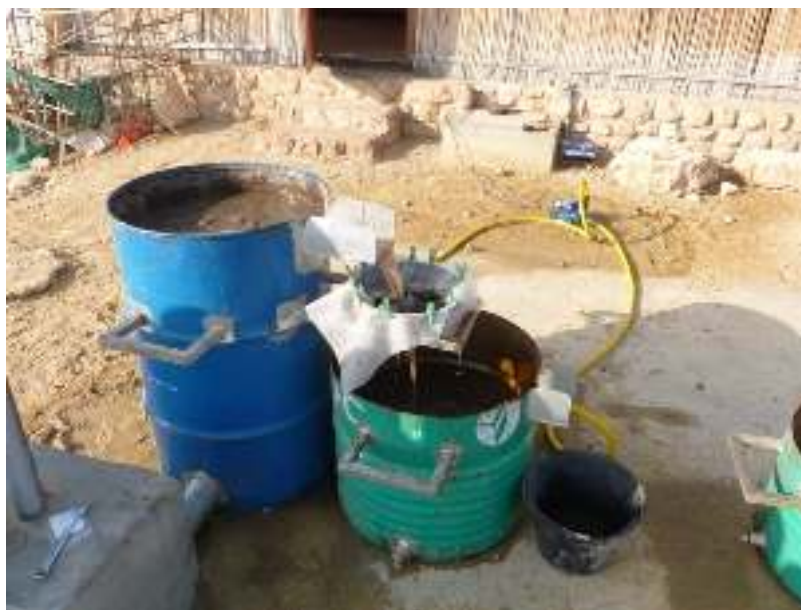
Figure 1: Flotation-machine

The aim of the flotation method is to sieve excavated sediment in a water bath, in order to allow the organic material to float to the surface. So, a flotation-machine built during the 2014a campaign has been used. (fig. 1).

The sediment, sampled in different types of archaeological contexts, is added in the main barrel. By doing so, the big fraction of the sediment and other heavy material (ceramic, glass, metal, pearls) are recovered on a bottom sieve (meshes: 1mm), while the less dense organic material (charred seeds, charcoals, bones) float to the surface. The material that floats to the top, called light fraction is recovered with a sieve (meshes: 0.3mm). After drying the light fraction, the macro-botanical remains (seeds, fruits, charcoals) are sorted out by looking with a binocular loupe (Nikon SMZ 1000).

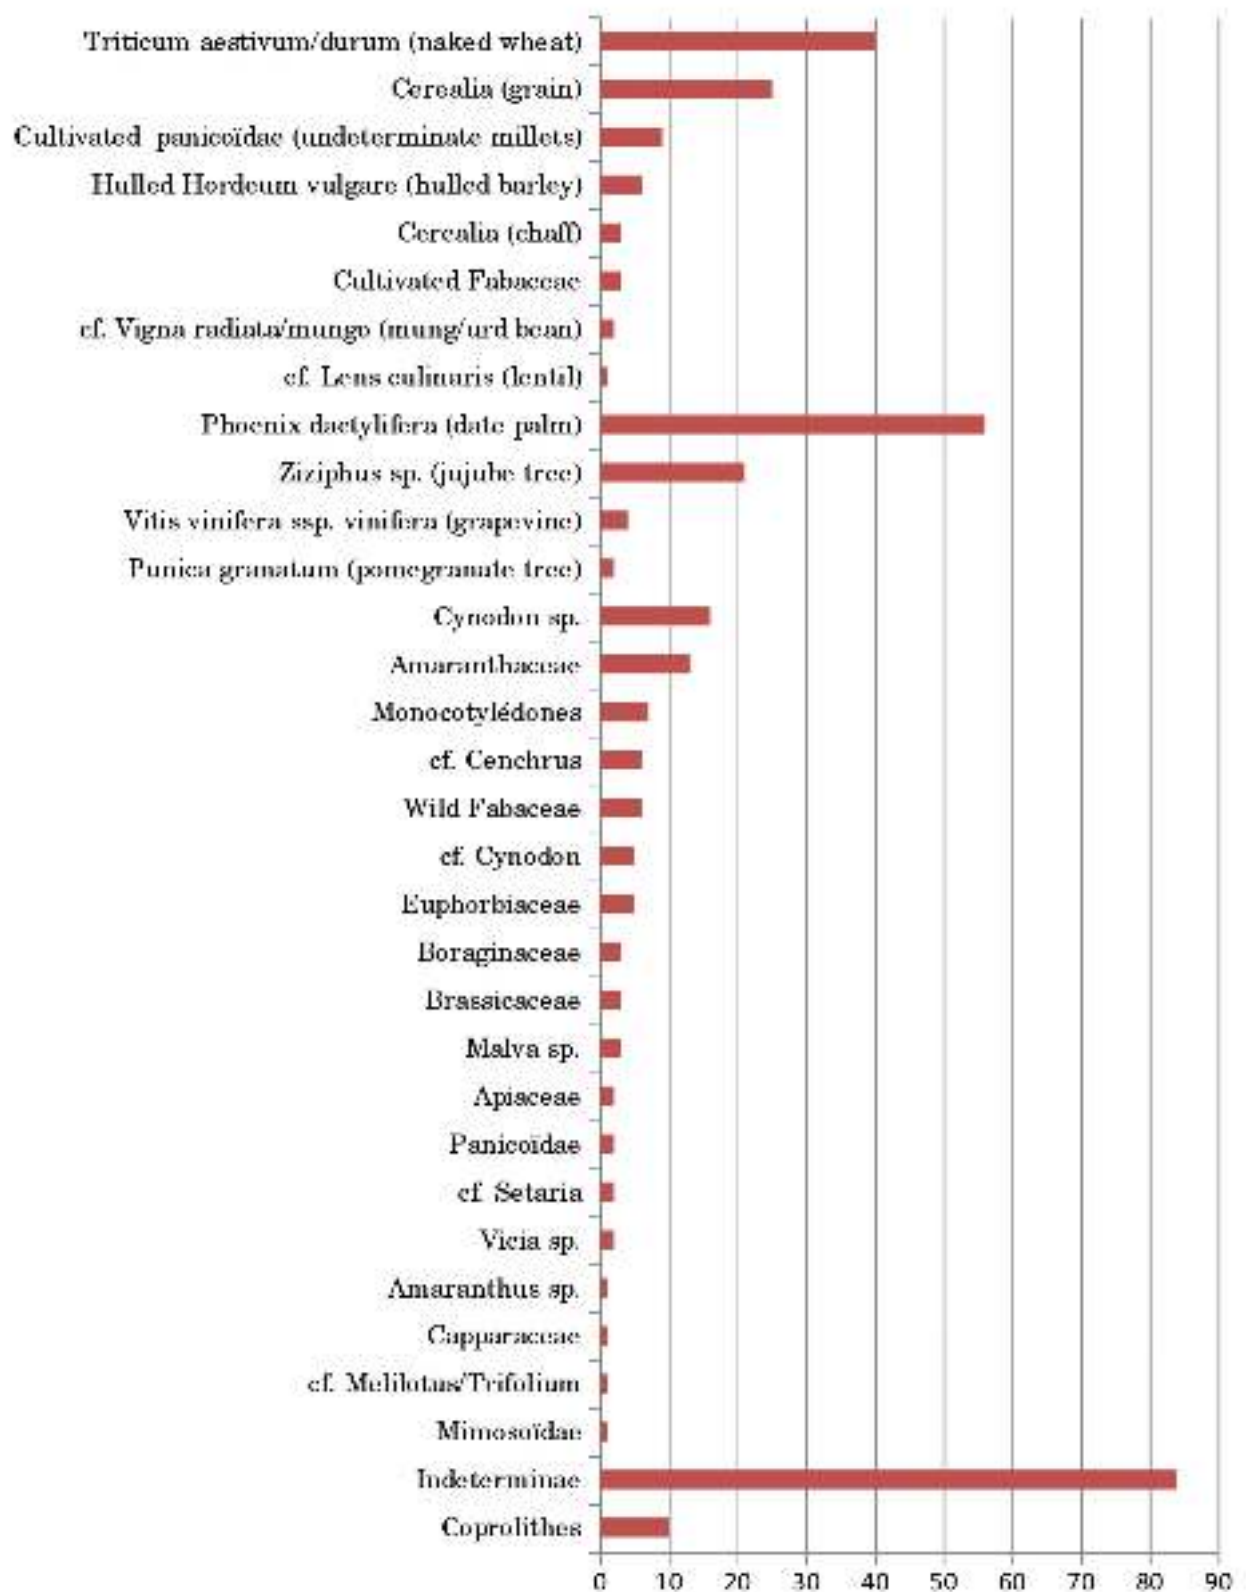
Figure 2: Composition of the whole seeds and fruit assemblage from B94 and B21

All in all, 683 seeds and fruit remains have been counted corresponding to a minimum of 356 individuals (fig. 2). They are mainly preserved by carbonisation but also by dessication (1) and mineralization (4). According to the general results, we can notice the predominance of both cereals and fruit trees. For the first category, we can see that the naked wheat (*Triticum aestivum/durum*) is dominant compare to the hulled barley (*Hulled Hordeum vulgare*). Some millets (*Panicoidae*) have been found but, due to their morphological diversity, their identification remains unclear. Further analysis will be undertaken in order to precise their identification. Concerning the fruit trees, we can point out that they are mainly represented by the date palm (*Phoenix dactylifera*) then by the jujube tree (*Ziziphus sp.*) (fig.3). Other fruit trees are present in few quantities such as grapevine (*Vitis vinifera ssp. vinifera*) (fig.4) and pomegranate tree (*Punica granatum*). Pulses are very poor numerically: most of them doesn't have sufficient morphological and anatomical features to be identified more precisely. Nevertheless, a hypothesis have been given for some of them, one may correspond to lentil (*Lens culinaris*) and others to mung/urd bean (*Vigna radiata/mungo*) which originate from the Indian sub-continent. Several weedy taxa have been identified in the assemblage. Among them, we can note the presence of wild taxa which are common in arid environment as this of Qalhât such as *Amaranthaceae*, *Malva*, or even *Cenchrus*; the most represented weed is quackgrass (*Cynodon sp.*) which characterizes irrigated fields. Finally, some rodents and goats dung have been retrieved in several samples. The undeterminate will be analysed more precisely to try to identify them.
