Qalhât Development Project, Season 2015B-2016A, Final Report

SEASON 2015B-2016A

FINAL REPORT

Excavations on the Ceramic Workshop B41

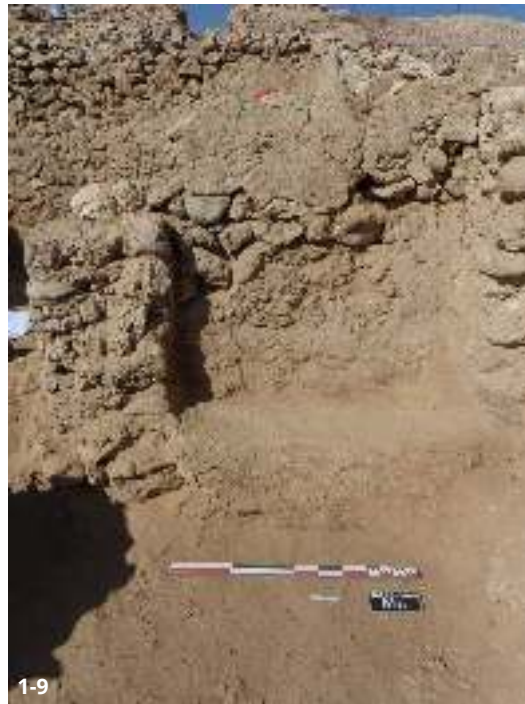
Fig 1-9 : the buttress B12-376, at left of the bench B12-299

Apart from those two massive buttresses that have an architectural use, smaller ones were also uncovered which were certainly not used as a support for an above construction. To the north, the buttress **B12-376** (Fig 1-9), 0.70m long by 0.35m wide, is built right against the gate that gave access to the room B12-S and could either be used as a jamb for the gate or, more probably, as a border for the bench B12-299 that was found next to it. North of the massive buttress B12-247, the smaller one **B12-320** (Fig 1-10), 0.50m long by 0.35m wide and 1.90m high, is built against the wall B12-281 at 0.50m south of the gate to room B12-L. It is badly preserved, especially at its north-east angle where it is only preserved for around 1m high. It is made the same way as other buttresses with a quite well made gray mortar and its coating, which is linked with the coating of the wall B12-281, is also well preserved. In comparison, the small buttress **B12-321** (Fig 1-11) is very badly preserved. It is located about 0.50m north of the gate to room B12-S against the wall B12-277. Only the upper part of it, around 1.50m above the floor where the buttress measures 0.55m long by 0.38m wide, is preserved and it has slipped down from its original location, all its lower part having collapsed. It is made the same way as the other construction but bounded with a poorly made mortar containing many sand. The use of this badly mixed mortar is quite obviously responsible of its poor state of conservation and a security bench has to be let in place to prevent a complete decay of its remains.

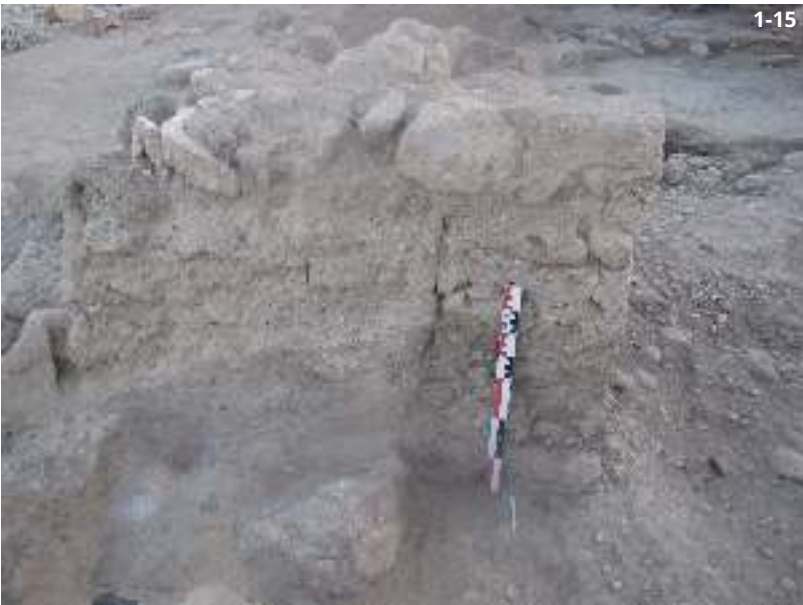
Fig 1-15 : the line (at left of the scale) suggesting a former widening

Those abutments also show traces of a western widening in their lower part, a vertical line being visible between the original west facing and a doubling wall. But this line does not show in the upper part (Fig 1-15). It seems therefore very likely that the jambs of the gates were firstly built in a smaller scale before being enlarged during the construction phase, quite probably because the first dimensions were considered too small to support the walls above, including the wall of the entrance hall on the first floor that was facing the sea. In the actual state of knowledge, there is no indication about the original height of the gates and abutments. They could go up to the roof between the ground floor and the first floor or be lower, as no architectural remains found can suggest if the top of the gates were made by masoned arches, or lintels, or by simple beams. There are also no traces of door-frames or visible hinges and, though it seems quite unusual, these gates might have no doors at all.

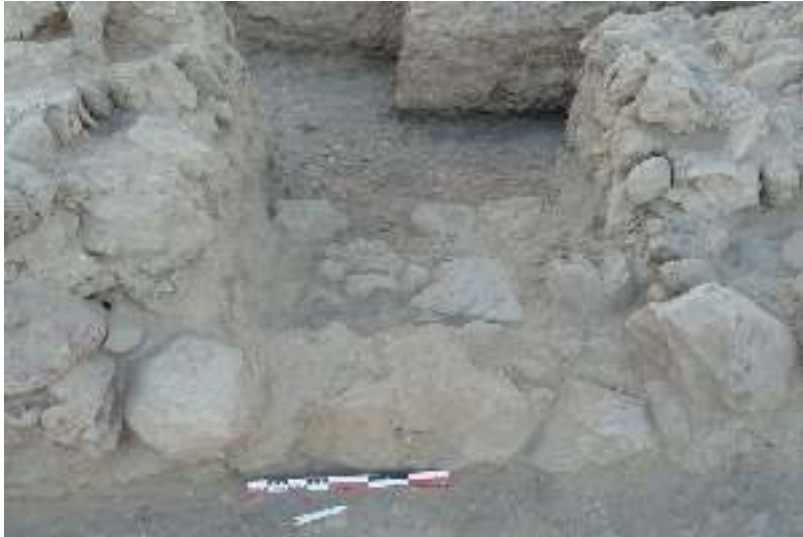
Fig 1-16 : the threshold
B12-300

The threshold **B12-300** (Fig 1-16) of the following gate, between the abutments B12-184 and B12-301, is 1m wide between the two jambs and 1.60m long from the outside to the inside. It is about 0.50m high from the outside floor (which is the natural bedrock) and it shows a small step more or less in its middle, as the northerly threshold. But this particular fitting, which can be considered as a plinth, was not observed in the other thresholds to the south and it is not possible to know whether this small step is a late addition or an original fitting.

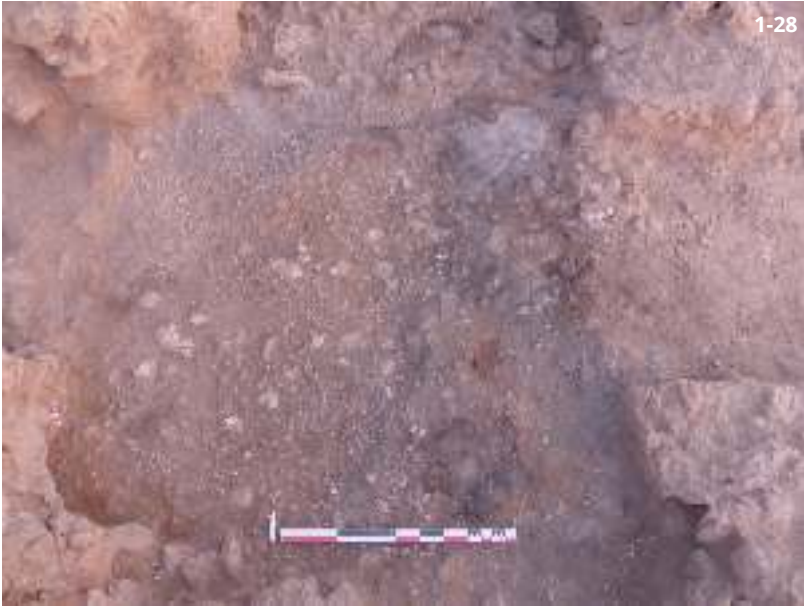
Fig 1-28 : the sanitary floor Uf3814

Afterward, a sanitary floor made quite exclusively of pebbles mixed with a little bit of brown silt and ashes (**UF3814**) (**Fig 1-28**) was spread over nearly all the southern half, the reoccupation of the northern half being less visible. Right above this level, an important quantity of oyster's shells were found. Those remains can be linked to a craft activity (pearl production?) or simply to a food production and seems to clearly state that the Mosque was no longer in use when this layer was put in place, as both activities didn't suit to a religious building. A layer of ashes (**UF3815**), which can be considered as a damaged hearth, was found nearby above the sanitary floor UF3814, between the gate to room B12-L and the threshold B12-359, and could have been used to cook the oysters before their consumption, and so giving more credit to the hypothesis of a food production. Other concentrations of ashes were also observed above the floor UF3814, but they were not well-preserved enough to determine if they were remains of hearths or simply parts of the backfills or rubbish rejection.

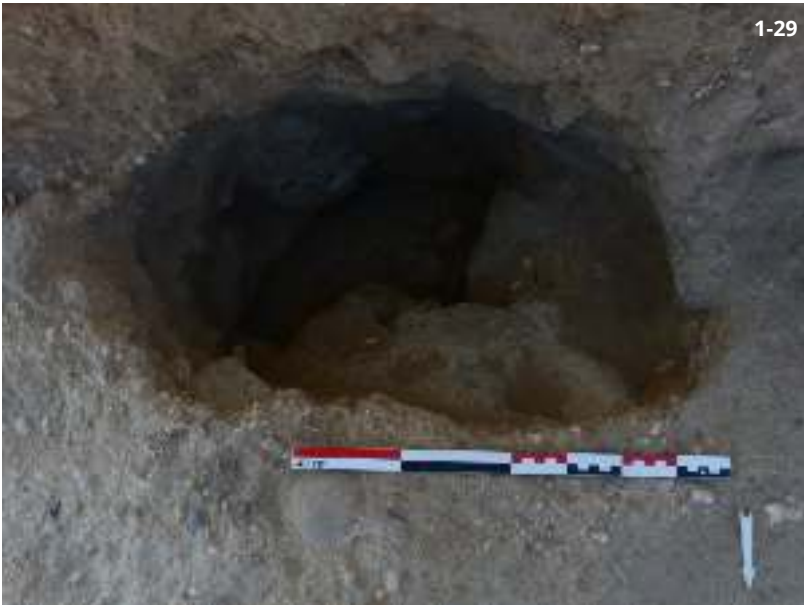
Fig 1-29 : the pit B12-374 fully excavated

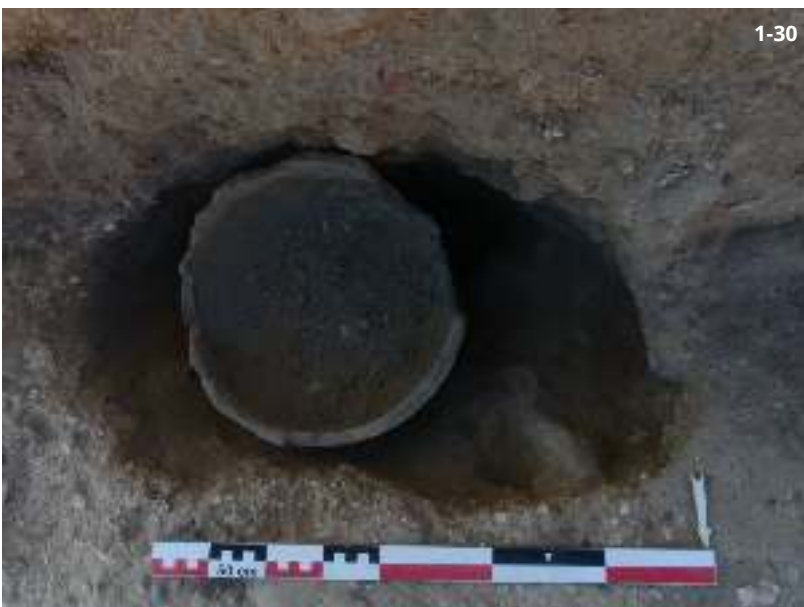
Fig 1-30 : the pit B12-374 with the upside down jar used as a brazier

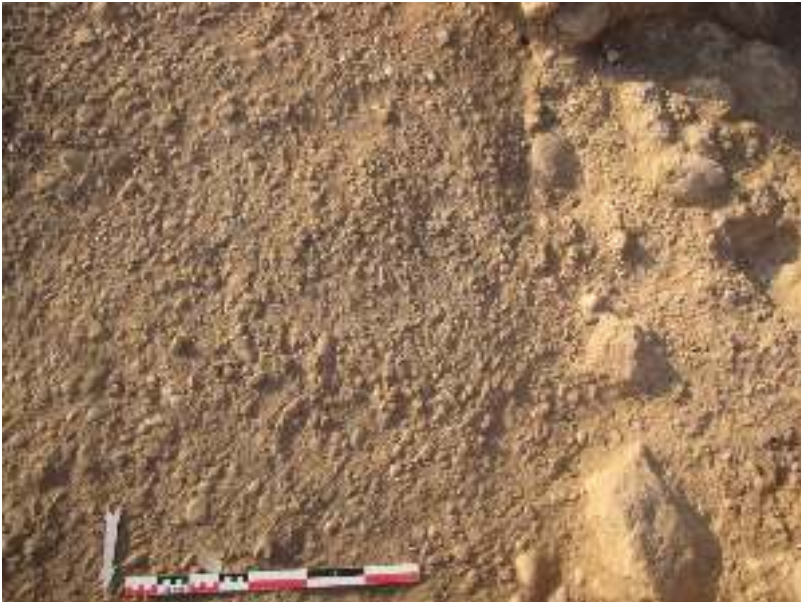
Fig 1-40 : the sanitary floor
Uf3684

A final stage of occupancy was observed above the aforementioned one, mainly concentrated in the middle of room B12-K. A new level of floor (**UF3684**) (**Fig 1-40**), made again of small pebbles mixed with a beige sandy silt, was uncovered, well-preserved next to the eastern accesses B12-359 and B12-360, more disturbed in the middle where the collapse had greatly damaged this layer. Three hearths were found above this level. The first one, **B12-351** (**Fig 1-41**), 0.60m long by 0.50m wide and 0.07m deep, was set against the wall B12-311 which western facing was partially cut, probably by the settler or by the fire activity. The second one, **B12-352** (**Fig 1-42**), 0.85m long by 0.60m wide and 0.10m deep, was set against the wall B12-308 and also slightly damaged its western facing. Some stones probably coming from the collapse were reused in the bottom of this hearth to circumvent the fire and maybe prop a container. The last one, **B12-353** (**Fig 1-43**), 0.30 wide and 0.08m deep, was set near the gate to room B12-S. All the hearths were observed filled with ashes and charcoals and small fishbones and shells were found nearby, clearly suggesting that they were made by fishermen who were occasionally squatting the abandoned building when it was slowly starting to fall into decay. No major fittings were observed related to that late reoccupation and it can be assumed that the human presence only occurred for a short time, no more than several days.

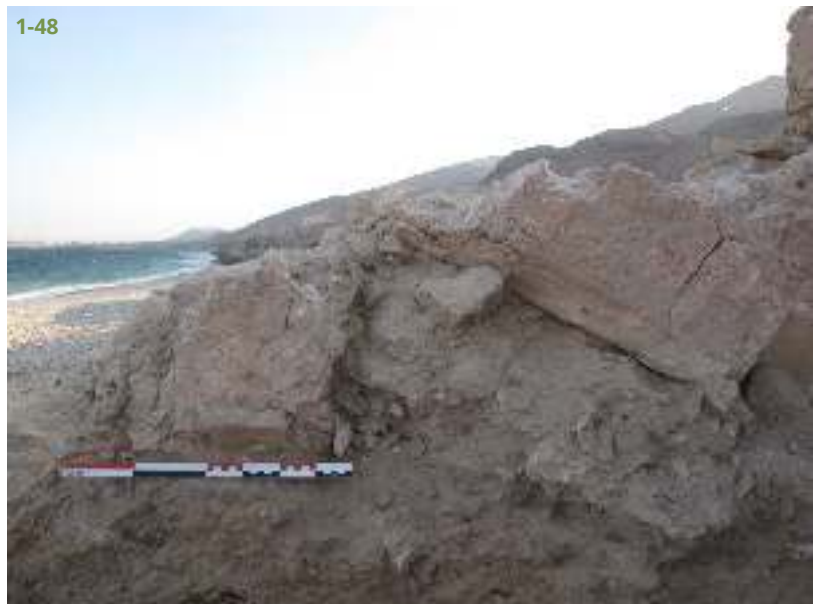
Fig 1-48 : the architectural element IsoArc 924, square basis and octagonal tambour of a pillar from the first floor

It is simpler with the **IsoArc924 (Fig 1-48)**, more at south, which is enough preserved to be affirmative, the cubic basis and two fragments of the octagonal drum being preserved and clearly visible. It was found at the foot of the massive buttress B12-347 above which it was originally standing. The column did not strictly toppled from its original location but slipped down from it as the top of the buttress collapsed. Indeed, if the column had toppled, the basis would be closed to the buttress and the drum to the east, as it is the case of the IsoArc251/285 in room B12-H; but in this case the drum is near the buttress B12-347 and the basis further east. The same effect of slipping was observed in the prayer hall, especially in the south side near the south gate of B12-B with the engaged column B12-327.

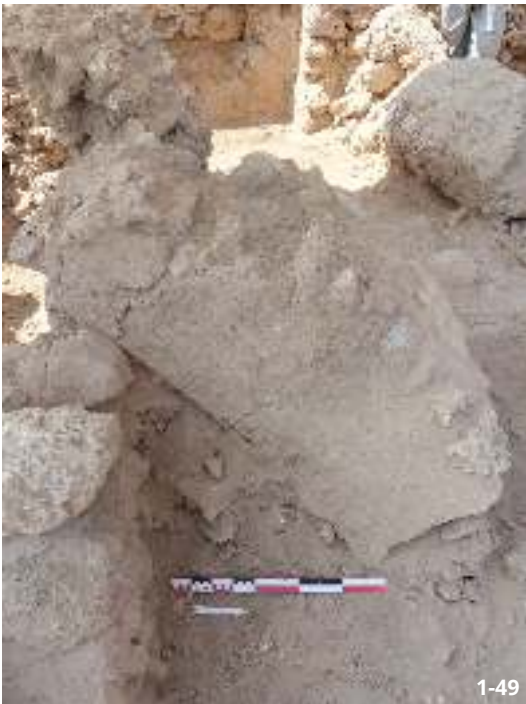
Fig 1-49 : the architectural element IsoArc 692, fragment of arch

Found in the immediate proximity of the threshold B12-300, the **IsoArc692 (Fig 1-49)** is the remain of an arch and the only remain of this kind unearthed in the room. It is very tempting, due to its location, to assume that the arch was originally at the top of the gate that gave access to the room from the beach but it can also come from another place of the Mosque and has followed the slope of the collapse. If the arch really came from the top of the gate, its size and curve might suggest that the gates in front of the beach were topped by segmented arches.

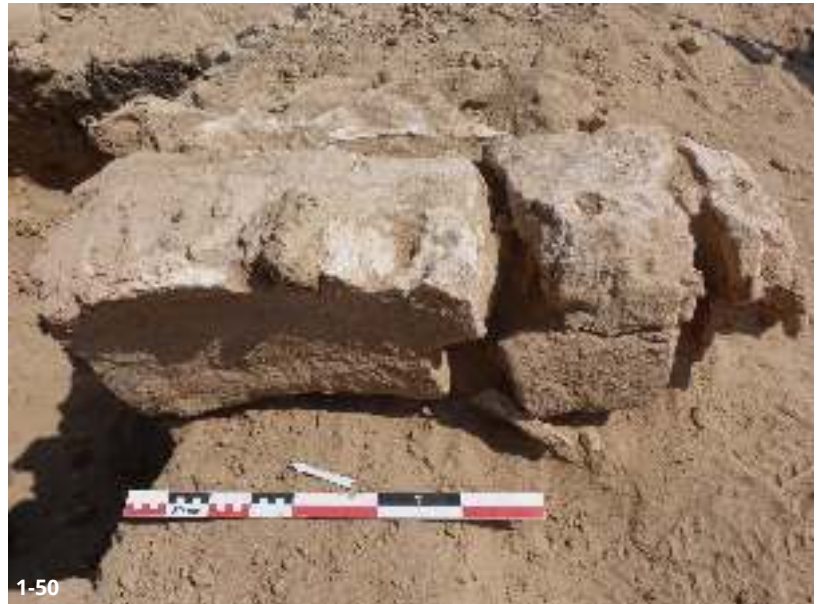
Fig 1-50 : the architectural element IsoArc 705, possible fragment of niche

Unearthed right in front of the gate to room B12-S, nearly in the exact center of the span, the **IsoArc705 (Fig 1-50)** is a fragment of a wall showing a curve on its rear coating and a possible vertical bow, the remains being too fragmented to be affirmative for this last identification. It is very possible that this fragment is a remain of a vaulted opening (gate or window) or more likely a shallow niche. This fragment undoubtedly came from the wall that was dividing the first floor into prayer hall and entrance hall, above the long uninterrupted wall between the spans 2 and 3 where the architectural elements unearthed during the 2013b-2014a season had allowed to assume the presence of gates, niches (which could be considered as *mihrab*) and windows (see previous report and drawn restitution for further details). The **IsoArc829 (Fig 1-51)**, which is a fragment of an engaged pilaster, also comes from the dividing wall on the first floor, the same kind of fitting having been observed during the previous season. Those two architectural elements have slipped down following the slope made by the collapse. As they have slipped over the remains of the walls of the eastern part of the basement, it so means that most part of the

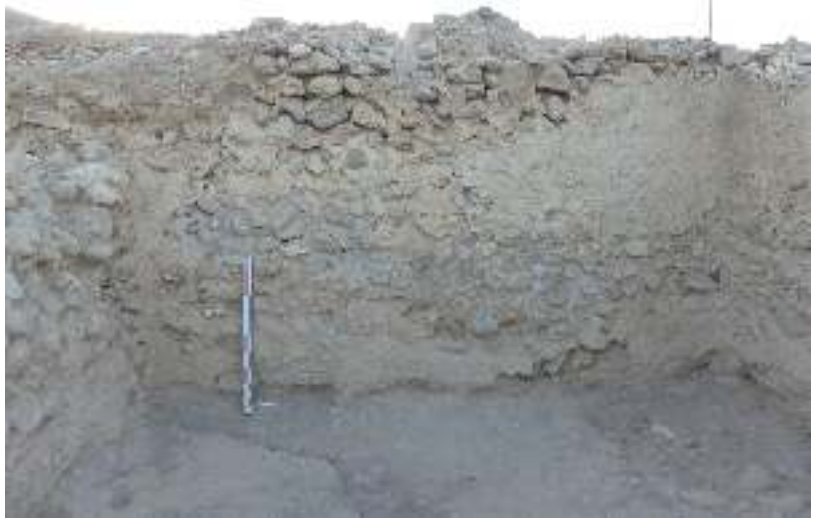
Fig 1-53 : the wall B12-110 in room B12-S

The room B12-S has an internal length of 3.75m and an internal width of 2.90m, the useful space of the room thus being a little more of 11m², access excluded. It is delimited, to the west, by the long uninterrupted wall **B12-110 (Fig 1-53)** which is here preserved up to around 2.50m high, to the north by the wall **B12-188 (Fig 1-54)**, 3m long by 0.80m wide and 2.30m high which separated the room B12-S from the northern room B12-Q, and at south by the section of wall **B12-292 (Fig 1-55)**, 3m long by 0.70m wide and 1.30m high. To the east, where is the gate from the room B12-K, the delimitation is made by the walls **B12-213 (Fig 1-56)**, 1.70m long by 0.80m wide and 1.30m high, and **B12-309**, which is more likely a jamb and very damaged, on both sides of the gate, in front of the eastern external gate with the threshold B12-360, which is now 1.60m wide but was probably originally narrower, the two jambs of the gate being destroyed nearly to the bottom. As this side is particularly badly preserved, it is impossible to give the original size of the gate, but according to the others gates of the span, it was probably around 1m. In the same way, it is very likely that the gate once presented a stepped threshold but nothing of it was enough preserved to suggested its original shape. All the walls are apparently bonded and built in the same way, with large limestone blocks at the bottom, sometimes with some large pebbles, and smaller limestone blocks and coral blocks of all sizes in the upper part, bonded by a gray mortar containing many small pebbles. All walls were also covered by a rough gray to beige coating which is variously preserved: in general, it is well-preserved in the lower and upper parts and missing in the middle, but it is also nearly all gone on the east side, due to the poor state of conservation of the walls.

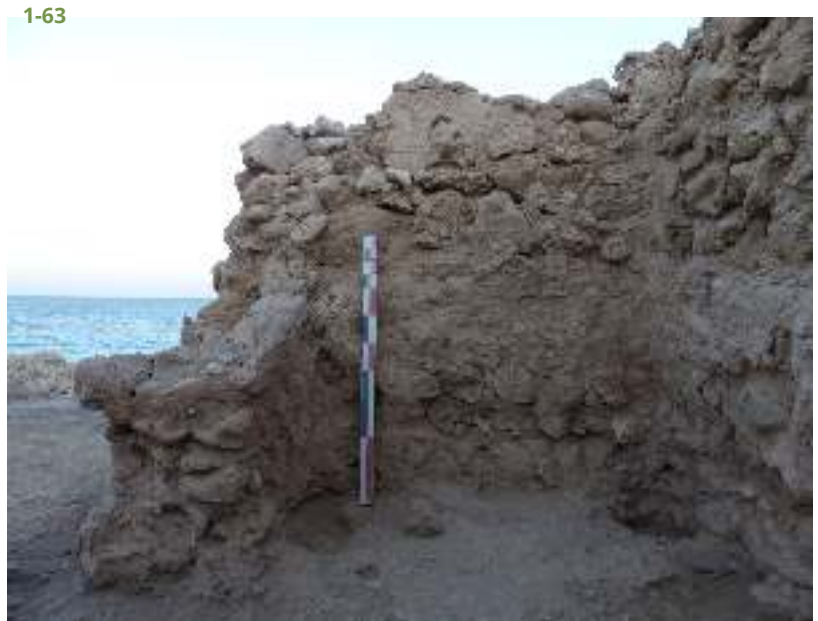
Fig 1-61 : the wall B12-110 in room B12-L

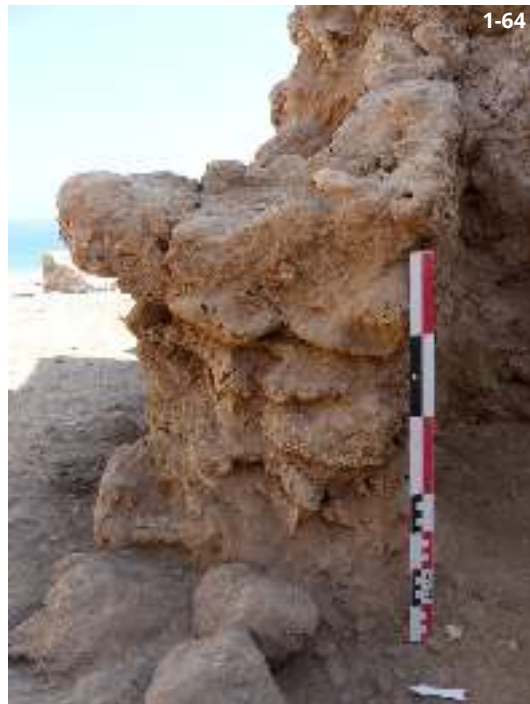
Fig 1-62 : the wall B12-278 in room B12-L

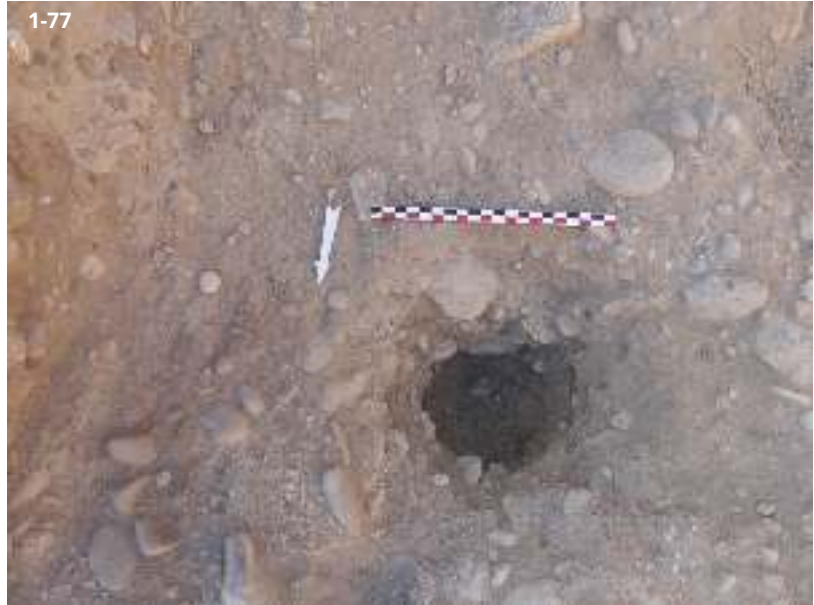
Fig 1-77 : the posthole
B12-336, fully excavated

The three postholes **B12-328** (Fig 1-75), **B12-335** (Fig B1-76), and **B12-336** (Fig 1-77), all seizing around 0.25m for 0.20m deep, seem to work all together and most probably belong to the occupancy of the room. It is surely the case for B12-336, which was covered by a later low wall, and for B12-335 which was filled by the layer of the later reoccupation. It is less clear for B12-328, but as the three postholes are aligned together and also aligned with the small buttress B12-305, the four structures may have been used to create a separation in the room, nearly in its southern half. It is possible to imagine that those postholes were used to hang curtains for creating a private area but surely not to support some rows of shelves as they are not located along the walls. Located between the postholes B12-335 and B12-336 but slightly misaligned, the posthole **B12-318** (Fig 1-78), 0.20m wide and 0.15m deep, could also belong to the same fitting but evidences to link it to the phase of occupancy are doubtful.

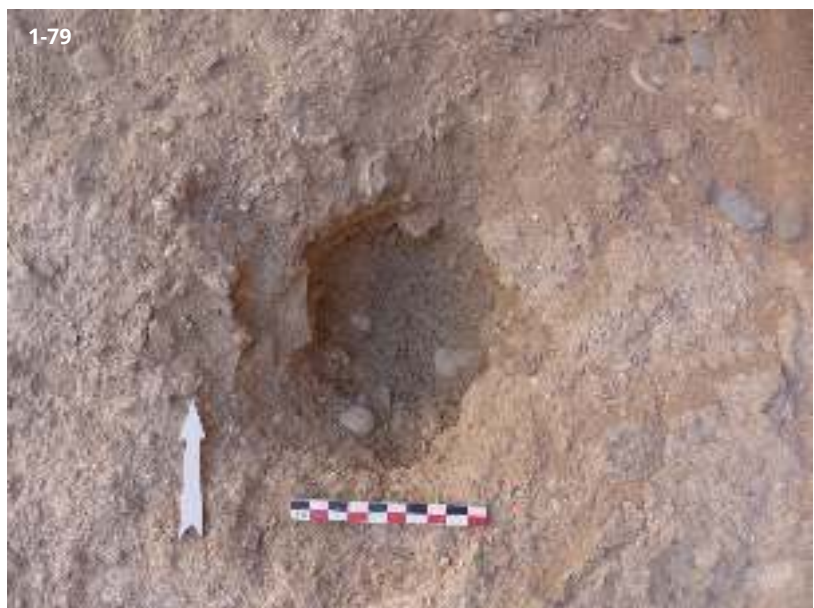
Fig 1-79 : the posthole
B12-332, fully excavated

In the southern part of the room B12-L, the postholes **B12-332** (Fig 1-79), 0.15m wide by 0.10m deep, and **B12-334** (Fig 1-80), 0.20m wide and 0.15m deep, seem also to belong to the phase of occupancy as they were covered by the level of the next phase of reoccupation, but their function is less explainable than the aforementioned postholes. The first one is problematical because its location would have hindered the fitting of the assumed shelves along the wall B12-281 while the second one might have worked with the postholes B12-328/335/336 as it is creating a right angle with their alignment, but cannot be conveniently explained. In any way, the presence of the small buttress B12-305 and of several postholes located alongside the walls is a reminder of the room B12-Q where similar fitting were observed. In that case also, the presence of shelves was strongly assumed. It must also be noted that in the room B12-L, the presence of the usual sanitary floor made of some pebbles over the coated floor was not observed, to the contrary of most other rooms in the basement.

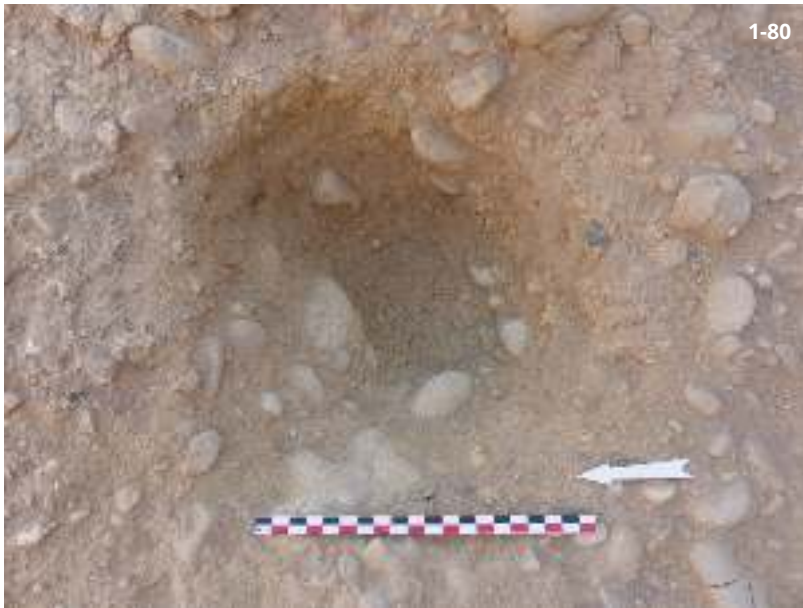
Fig 1-80 : the posthole
B12-334, fully excavated

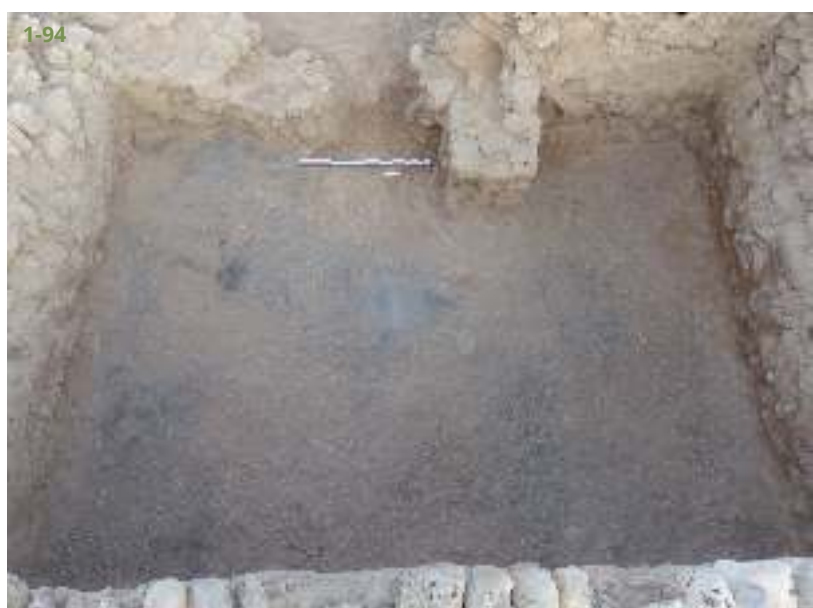
Fig 1-94 : *the earthen floor*
Uf3663

A third and last phase of reoccupation was observed in the room B12-L, which occurred when the building was partially falling into decay. The level **UF3663** (**Fig 1-94**) is made by small pebbles mixed with reddish soil which is quite probably coming from the disintegration of the coating and mortar of the walls. This reoccupation can be very close in time to the previous one, as the ceramic material dates it from the 16th century also. One hearth (**B12-312**, 0.80m long by 0.45m wide) (**Fig 1-95**) is probably contemporary with this final occupation.

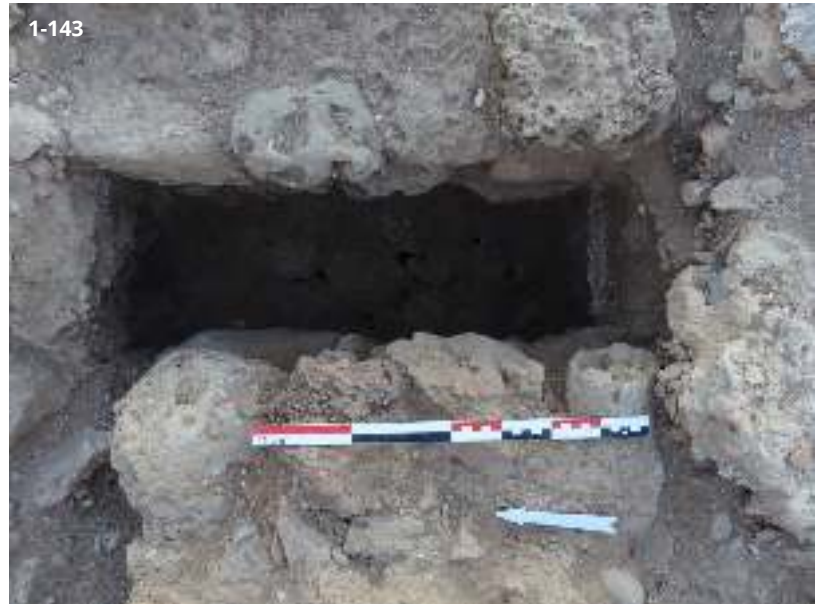
Fig 1-143 : the opening
B12-350

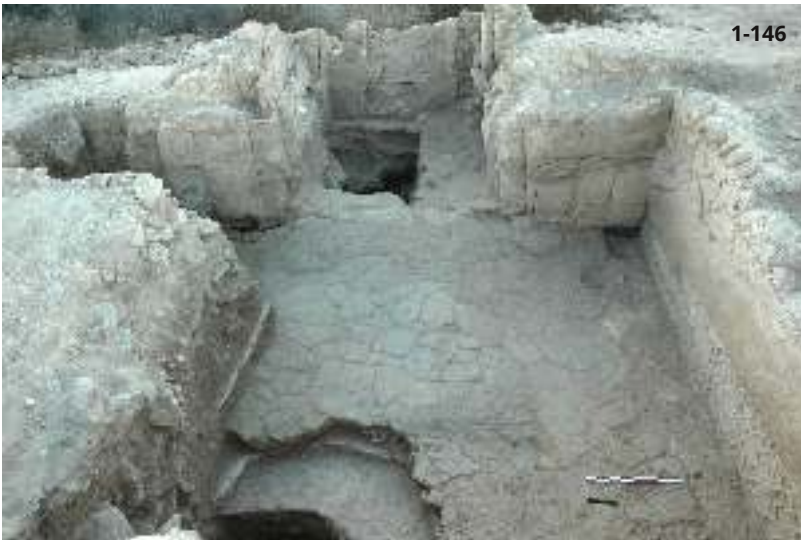
Fig 1-146 : the mihrab excavated during the QP soundings

The most characteristic structure of the prayer hall, the *mihrab*, was already excavated by the Qalhât Project and registered as **B12-04** at that time (**Fig 1-146**). Refitting was also assumed then and the observations made during the 2013b-2014a and 2015b-2016a seasons confirmed this hypothesis.

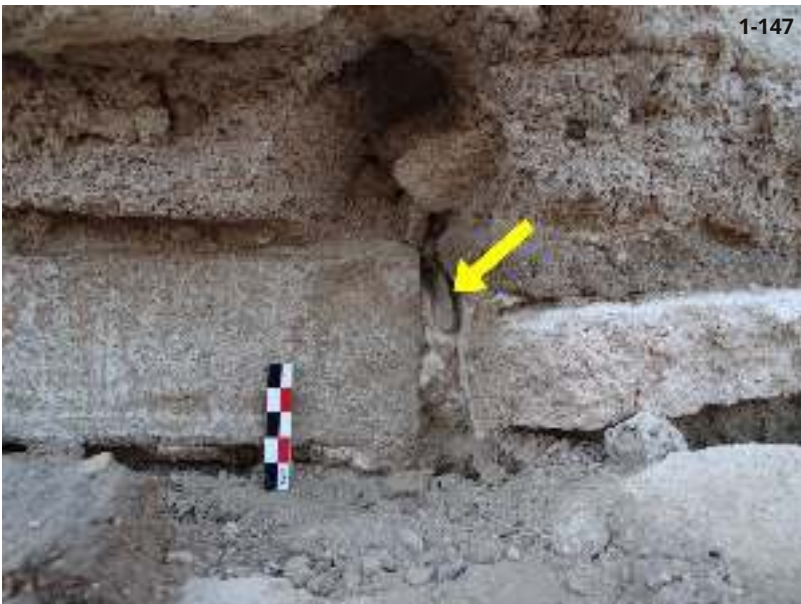
Fig 1-147 : the vertical profile of a tile (shown by arrow), probable element of decoration of the first stage of the mihrab

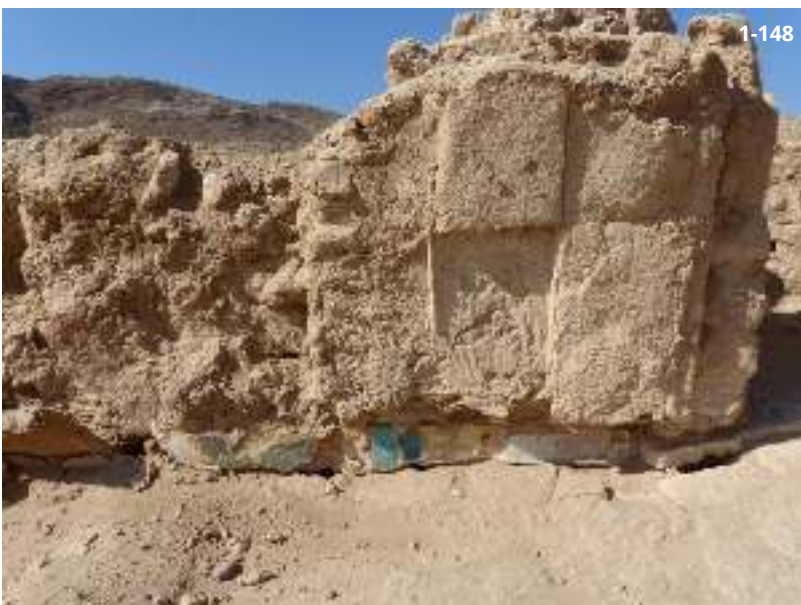
Fig 1-148 : the decoration of the first stage of the mihrab, including Kashan tiles, covered by the plaques of mortar of the second stage, south side

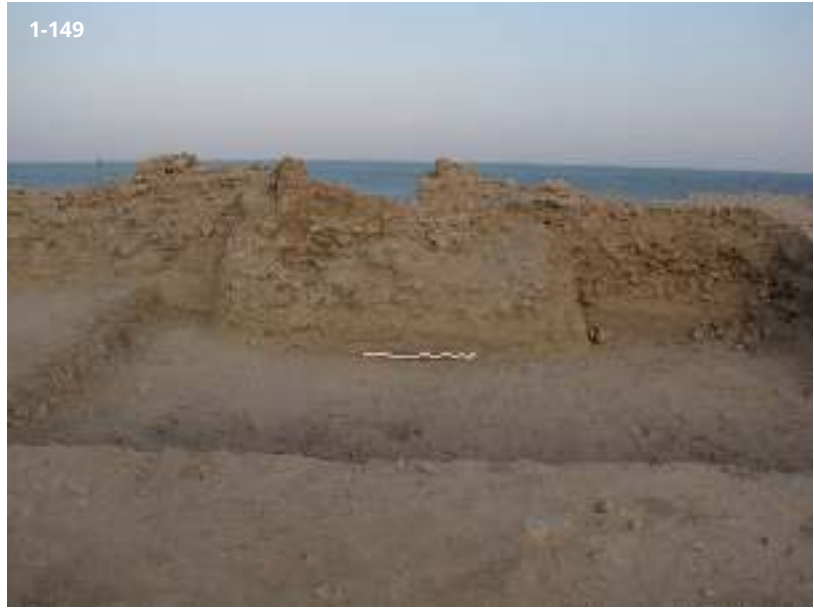
Fig 1-149 : outside projection of the mihrab, last stage

The external projection of the *mihrab*, which is covered by a strong gray to black mortar, also belongs to the last stage of repair and the original projection may have been smaller and different in shape, but traces of it were not observed (**Fig 1-149**). The projection is rectangular in plan with roundish corners, 3.90m long and projecting from the *qibla* wall from 1.30m to the north to 0.90m to the south. The center of this projection is not aligned with the central axis of the niche of the *mihrab* inside, but it is shifted for around 0.60m to the south. In other words, the distance between the south internal face of the niche and the south external face of the projection is 0.60m longer than the distance between the north internal face of the niche and the north external of the projection. There are different possibilities to explain this little shift to the south. It could have an architectural purpose, for example to strengthen a weakness in the upper parts of the wall. It could also simply be a mistake of the builders about the exact location of the central axis. But this misalignment could also be intentional. Indeed, the south external side of the projection is 11m away from the south-west corner of the building, which is merely the same distance as the one between the north side of the projection and the junction of the *qibla* wall and the southern wall of the staircase B12-E which is built against the north-west corner of the building. So the projection was probably voluntarily extended to the south to compensate the presence of the room B12-E. If the projection would have been exactly aligned with the inside central axis of the *mihrab*, it would have looked from outside as off-centered, slightly shifted to the north. The southwards extension of the projection was probably decided to cancel this impression and let look like the *mihrab* was exactly centered.

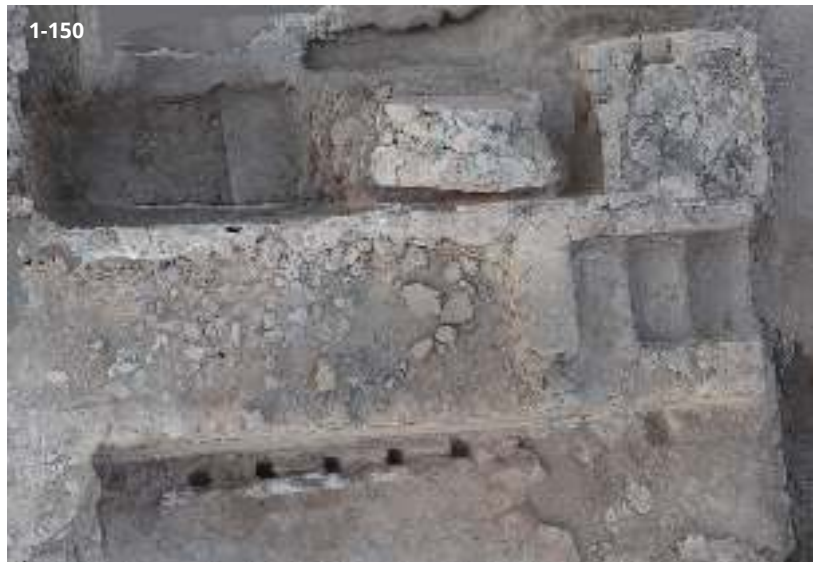
Fig 1-150 : aerial view of the minbar B12-03 at the end of excavations

Around 1m north of the *mihrab* **B12-04** and leaning against the *qibla* wall **B12-01**, the yet visible *minbar* was already uncovered by the sounding of the QP, but the remains of a former one were found this season, and several stages of constructions of the actual one have been observed (**Fig 1-150**).

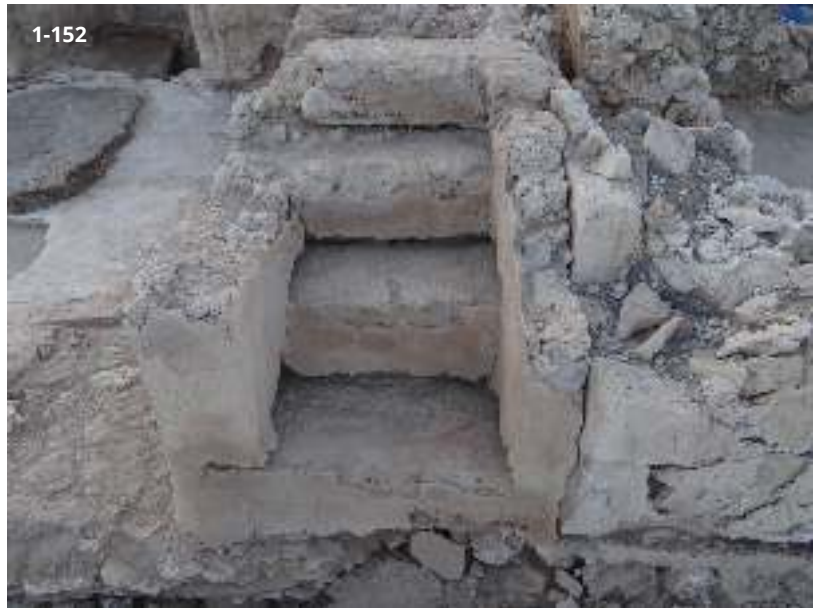
Fig 1-152 : *the remaining steps of the minbar B12-03, with the prints of wooden planks*

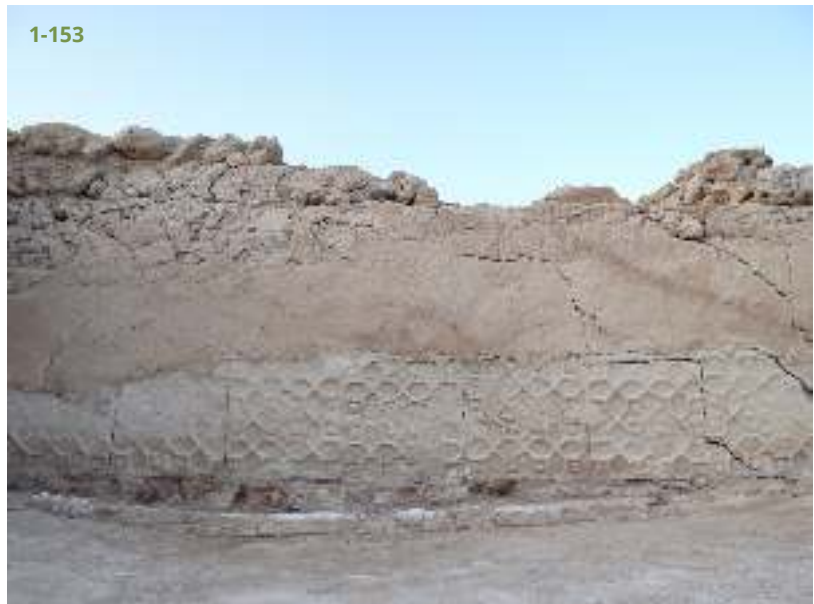
Fig 1-153 : *the frieze made of molded panels on the south side of the minbar B12-03*

The *minbar* is mainly made with corals bonded with a strong gray mortar and covered on all sides by a fine pinkish beige coating. The south face, on the *mihrab* side, is decorated by a frieze made of 8 panels of molded plaster, which is partially covered by the coating and does not extend until the eastern end of the *minbar* (Fig 1-153). It is also possible to distinguish, behind the groove of the third steps, a coated face with some glazed tiles. Those two elements strongly suggest that the *minbar* was originally shorter, probably as long as the preserved frieze, around 2.80m, which is also the distance between the *qibla* wall and the west face of the pillar right at north. The *minbar* was so afterward extended to the east by the addition of two more steps. This extension was built against the pillar to the north, whose south face is partially included into the masonry of the *minbar*. The yet visible coating was only applied afterward and partially covering the top of the molded panels, which were also at that time probably covered at their bottom by the raising of the last floor (see below). This last *minbar*, the one yet visible, was very simple, without decoration, and the general stratigraphy of the prayer hall suggest that it was made during the last stage of repair of the building, at the beginning of the 16th century (Fig 1-154). The assumed former masoned one underneath, which had replaced the first wooden *minbar*, appears to be more decorated, with molded panels and glazed tiles, and it is quite reasonable to consider that it was built during an important stage of repair that was observed elsewhere in the prayer hall and which seems to have occurred in the middle of the 15th century, but only the destruction of the actual *minbar* could confirm both its presence and dating.

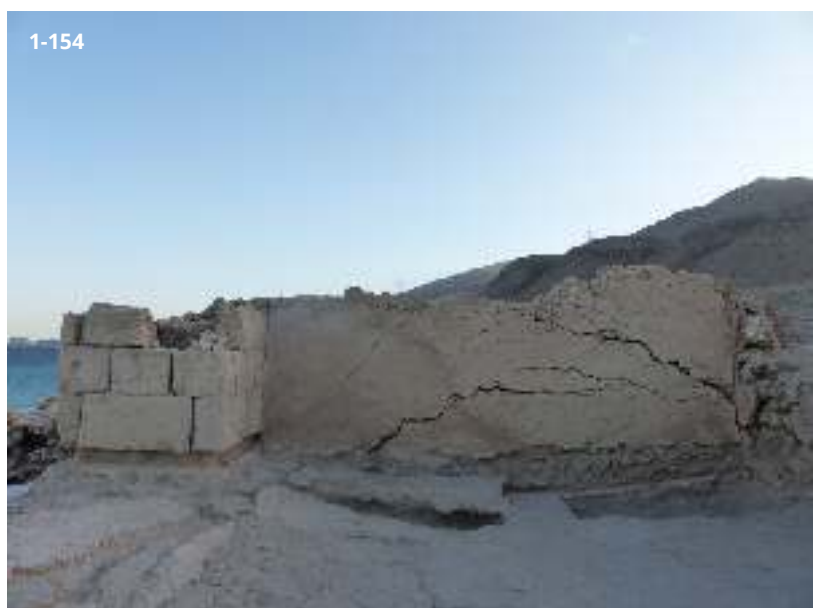
Fig 1-154 : *the north side of the minbar B12-03, last stage of use, without decoration*

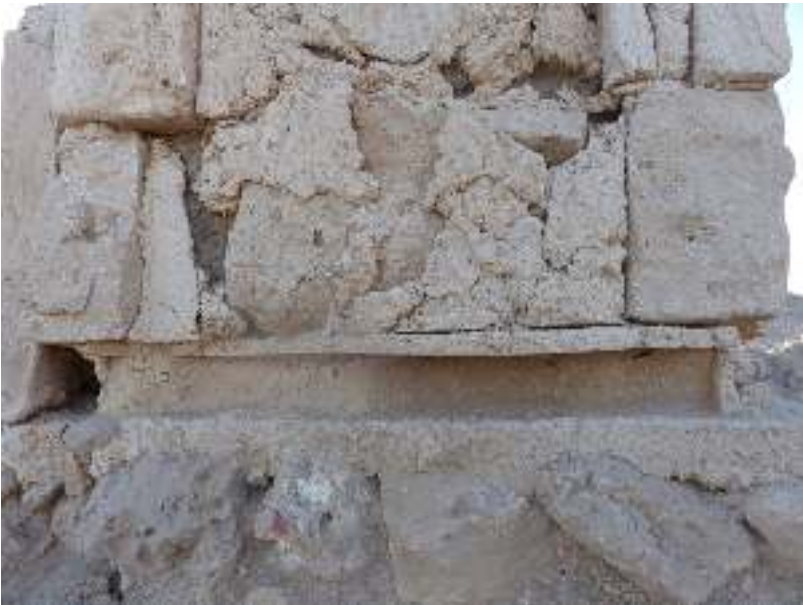
Fig 1-156 : moldings and prints visible in the groove, at the bottom of the pillar B12-05

The bottom of all pillars shows a groove, around 0.10m high, that runs around the base under the four facings. Moldings and wood prints in the mortar indicate that these grooves originally hosted wooden sticks, more or less square in section, which were jointed together by nails at the four angles of the basis, some nails having been found in some grooves. Curved and rectangular prints observed in the mortar also indicate that the internal side of the sticks, facing the core of the pillars, were not straight and flat but irregular (Fig 1-156). It is possible that these irregularities are due to the fact that the wooden sticks were

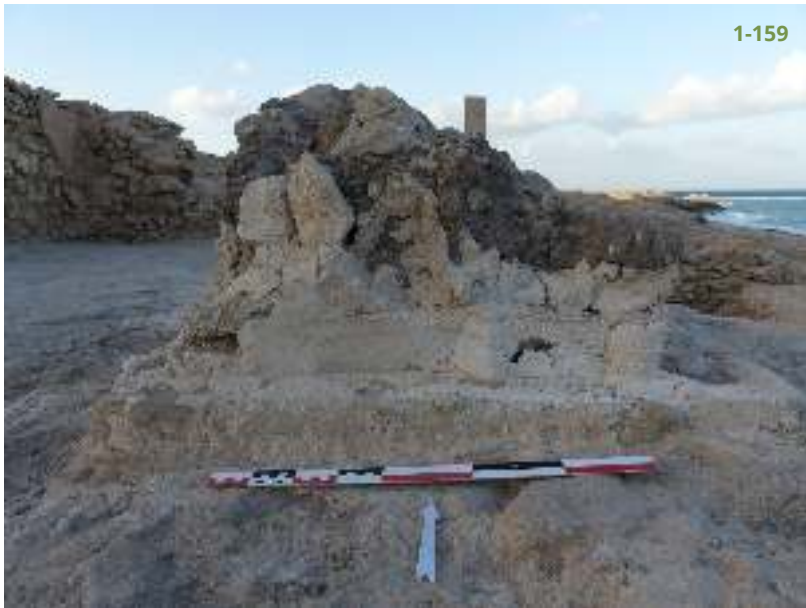
Fig 1-159 : the pillar B12-323, highly damaged

A little less than 4m to the south, the pillar **B12-323** is the less-preserved of all pillars of the row, most of its facing having collapsed around (**Fig 1-159**). The basis and the groove are preserved, 0.90m long and wide, but only the core of the pillar is preserved, for around 0.50m high. The third pillar, **B12-05**, was already uncovered by the sounding of the QP and it is one of the best preserved (**Fig 1-160**). As mentioned above, the eastern extension of the *minbar* was built against the south facing of the pillar which was so not visible, while its other facings are made with carved rectangular limestone blocks. Its width, length and preserved elevation are 0.90m. Around 4.10m further south, the fourth pillar **B12-232** is also well-preserved (**Fig 1-161**), especially on its east facing where the remains of decoration are the best visible. It is also 0.90m wide and long and preserved for around 0.70m high. Three nails (IsoMet27, 28 and 29) were found on the corners of the groove and they were obviously used to fix the wooden sticks together. As no nail was found elsewhere, it is possible that this setting only occurred in this basis of pillars and that, on the other ones, the fixing was made by using wooden nails. Finally, the last preserved pillar (**B12-44**), 4m south of the aforementioned one, was also partially uncovered by the QP soundings (**Fig 1-162**). It is quite similar to the other pillars, 0.90m wide and long for a preserved elevation around 0.80m, except that its east facing, probably decorated, has disappeared and that prints of tenons and dowels in the mortar in the groove might suggest that the assemblage of wooden sticks was probably made here with wooden elements rather than iron nails.

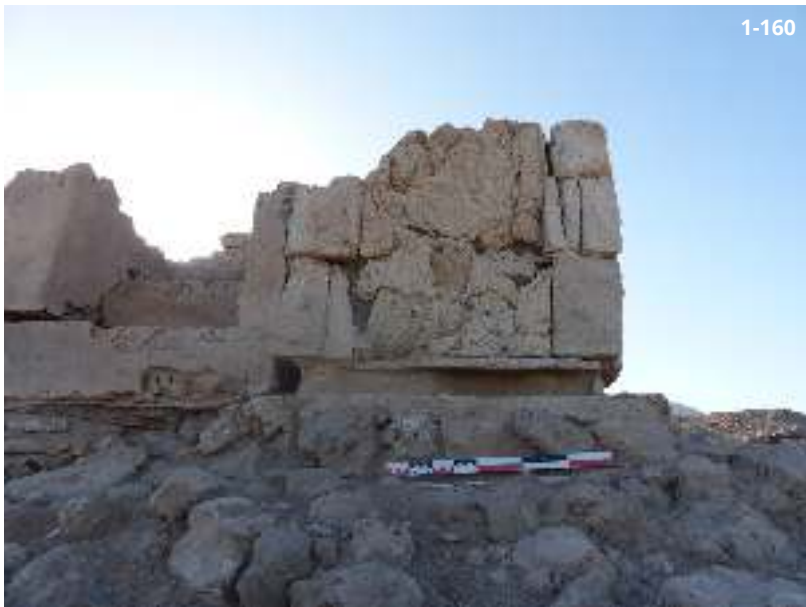
Fig 1-160 : the pillar B12-05, with the minbar at left

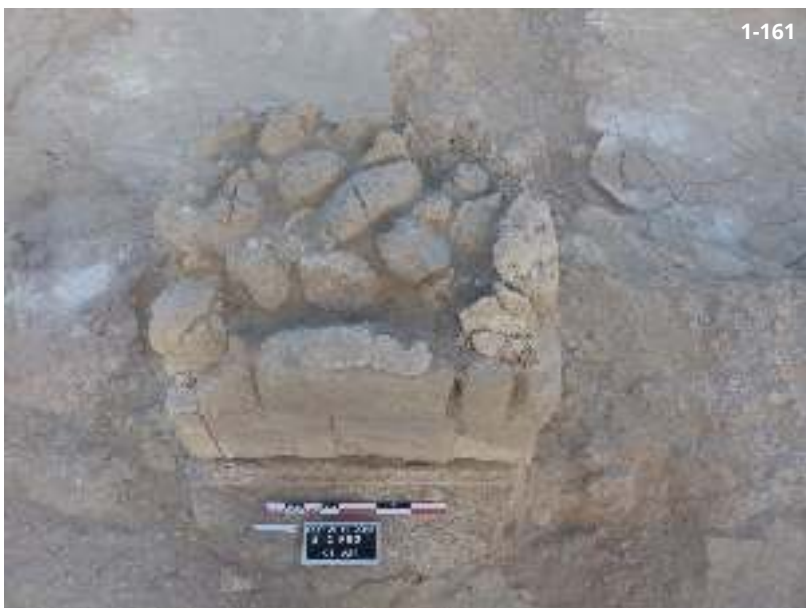
Fig 1-161 : the pillar B12-232

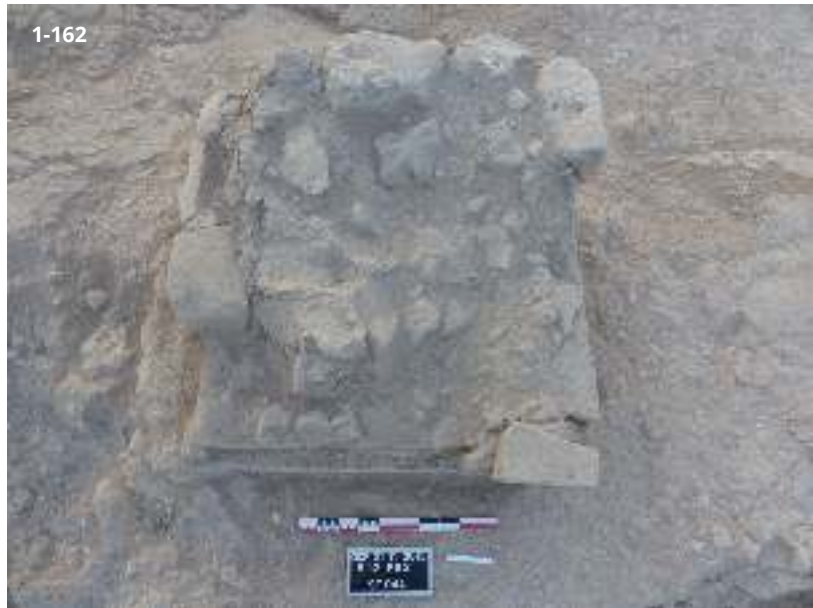
Fig 1-162 : the pillar B12-44

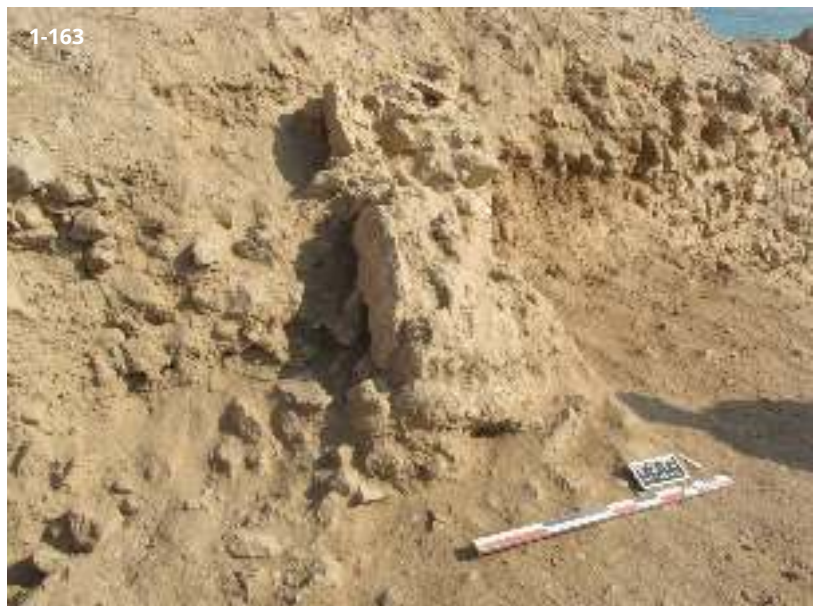
Fig 1-163 : the architectural element IsoArc808 found in the south street, probable element of the southern half engaged pillar

To the south, the half-pillar that was bonded to the wall B12-41 was not preserved as the elevation above the floor level had fallen into the south street. A rectangular masonry found in this area (**Fig 1-163**), in the north-south axis of the row of pillars, probably came from it, but more likely from the upper part of the pillar and not from its basis, as the element was found covered with coating, which was not observed on any of the basis of the remaining pillars.

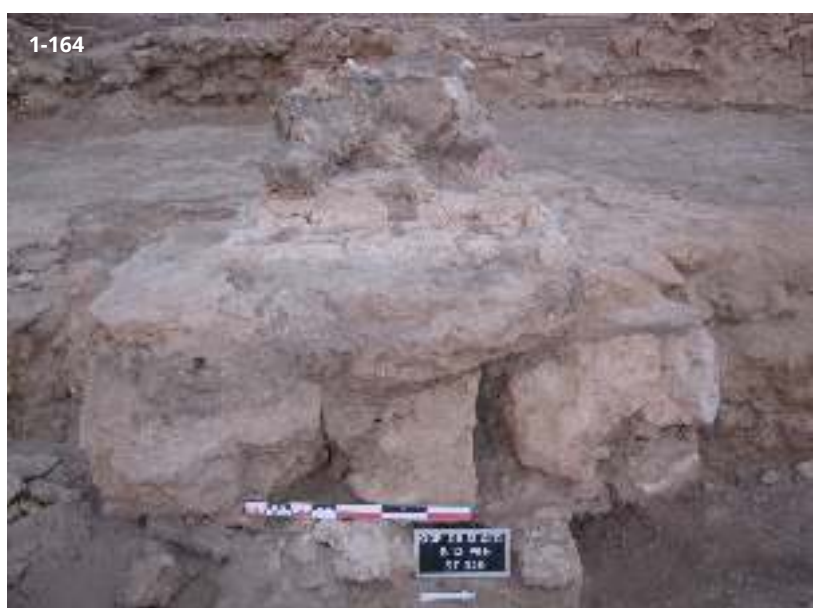
Fig 1-164 : the reinforcement B12-329 under the pillar B12-323

Under all pillars, except the northern engaged one, a rough and quickly made reinforcement was observed, more or less circular in plan around the basis of pillars, and built over the wall B12-45 and the buttresses observed under most of the pillars. It is under the pillar B12-323 that this reinforcement (**B12-329**) was the best observed (**Fig 1-164**). The masonry, which is irregular, is mainly made with plaques of masoned floors and fragments of walls bounded with a strong gray mortar containing many small pebbles and fragments of ceramics. It is very likely that this reinforcement was made by cutting the masoned floors, digging a more or less circular pit around the basis of the pillar. It was afterward filled with this coarse masonry which was probably encompassing the underneath buttress B12-392 whose upper end was probably partially destroyed to allow a better fixing between it and the reinforcement. It is also possible that the above pillar was repaired at the same time. To the south, a similar reinforcement (**B12-417**), made in the same way, was also observed under the pillar B12-05, but mainly in plan as no major sounding was opened around it. The reinforcement **B12-356**, under the pillar B12-232, was better studied (**Fig 1-165**): in plan where the masoned floors were destroyed, and partially in elevation with a small sounding at its foot. It is made with large corals and rough limestone blocks, bounded with a compact gray mortar, and the fittings presented no facing, suggesting that the stones were put loose in a foundation pit. Finally, the reinforcement **B12-399**, under the pillar B12-44, was also mainly observed in plan and very partially in elevation. It is also a rough masonry made with all sizes corals and limestone blocks, bounded with a gray to black mortar.
