Qalhât Development Project, Season 2015B-2016A, Final Report

SEASON 2015B-2016A

FINAL REPORT

Excavations on the Ceramic Workshop B41

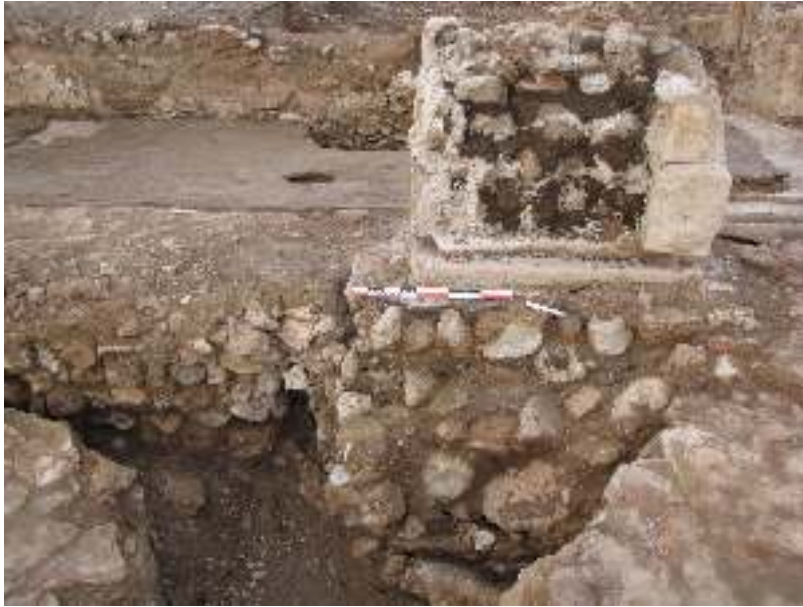
Fig 1-165 : the reinforcement B12-356 under the pillar B12-232

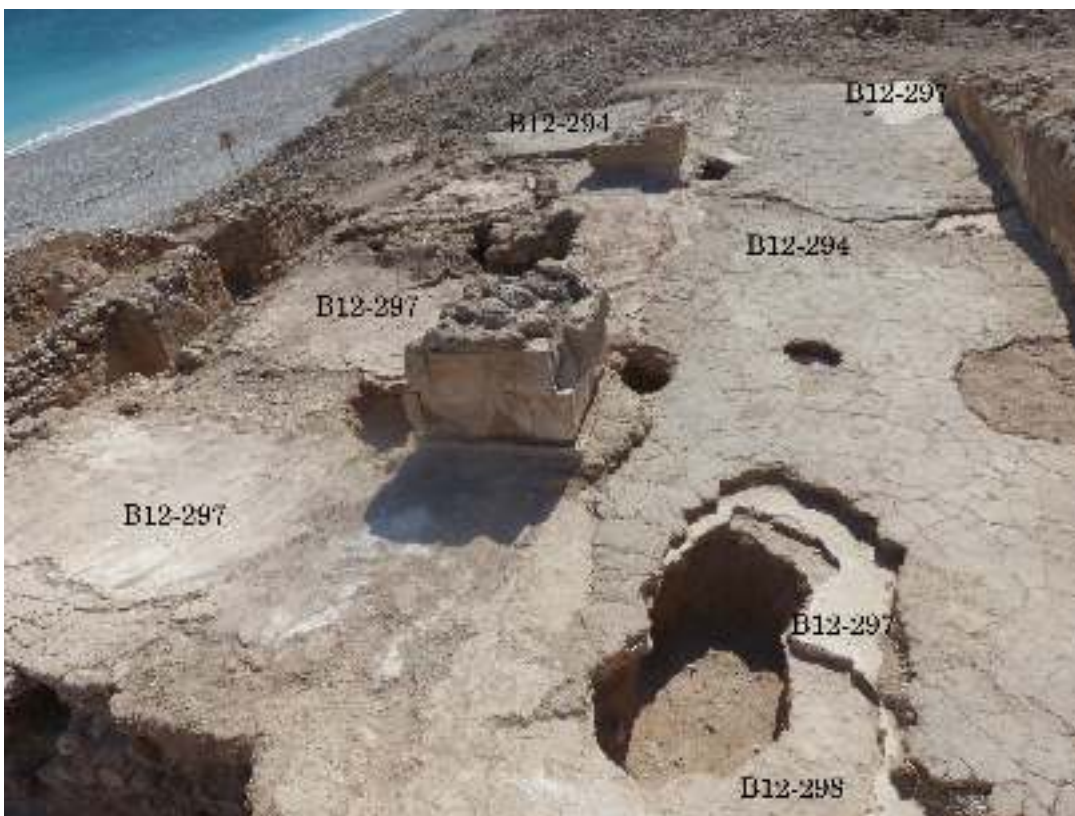
Fig 1-169 : the floor B12-297 partially visible under the floor B12-294, in south part

This very strong floor support made of three layers of material, some fragments of which were found collapsed into the basement to the east, was used to support the first floor of the Mosque (B12-297) made of a strong pinkish-white mortar, only 0.04m thick (Fig 1-169). It is the original floor and it was associated with the wooden *minbar* B12-375 as it is leaning against its plinth, and with the first *mihrab* B12-386 as it goes under the plaques of mortar of the second *mihrab* B12-04. It was so made at the very beginning of the 14th century and has remained in use until the destruction of the first wooden *minbar*, as small traces of fire observed near the actual *minbar* could testify of the fire that destroyed it later in the same century.

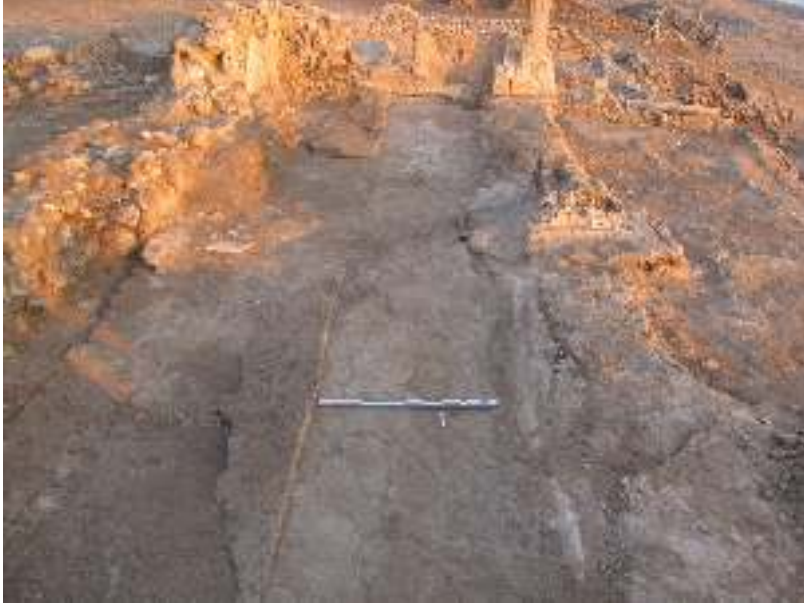
Fig 1-173 : the earthen floor Uf3950, half excavated, above the floor B12-294

To the north was uncovered a flat and indurated level (Uf3725) made of compacted brown orange silt, containing small charcoals and gravels. It was also observed elsewhere to the north and registered as Uf3950, and in the south half of the prayer hall where it was registered as Uf3746, 3799, 3800 and 3801. This level is probably an earthen floor made after the large refitting of the Mosque, or the circulation level contemporary of it (Fig 1-173).

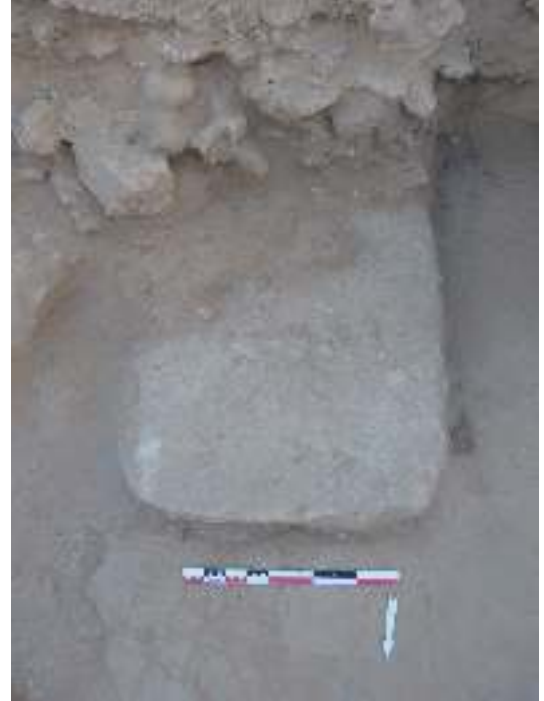
Fig 1-174 : the late floor B12-293, made of plaster, in the south part (the shape is due to the excavations)

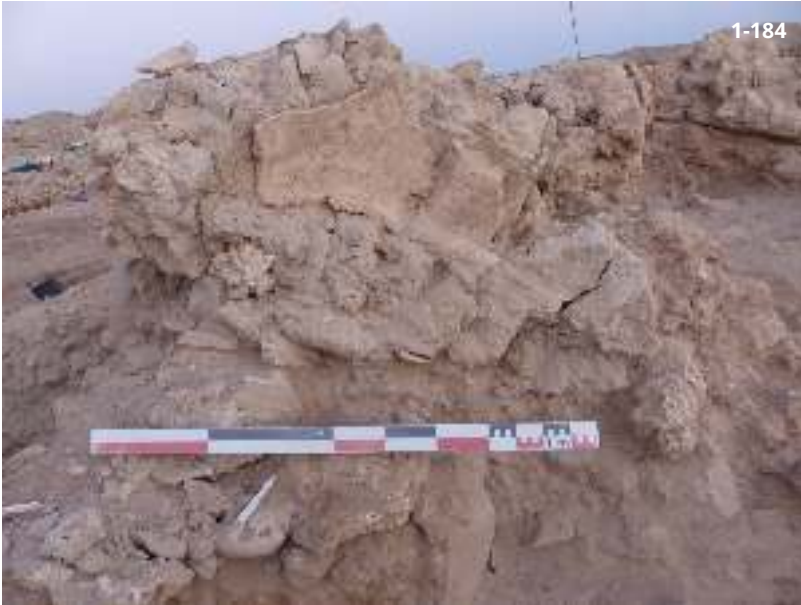
Fig 1-184 : the architectural element IsoArc912, remains of a niche

Found near or on the *qibla* wall, nearly halfway between the north-west internal corner and the north side of the *mihrab*, the **IsoArc912** and **IsoArc977** are remains of a niche (**Fig 1-184**). The first one, already seen by the QP, was showing one side, the rear face and the upper vault of the niche, with a small neck visible at the junction of the vault and the side face. The core of the masonry was made of medium corals and limestone blocks bonded with a beige mortar, and two stages of coating, one pinkish and the second whither, suggest that the niche was extended and refitted at one time. As the architectural element has slid down, the niche was most probably located very closed to where its remains were found. Shortly to the north, the second element also presented a curved side covered with pinkish coating and is probably also part of a niche. It is quite difficult however to state if this element came from the same niche as the first one, or from a second niche set north of the first one.

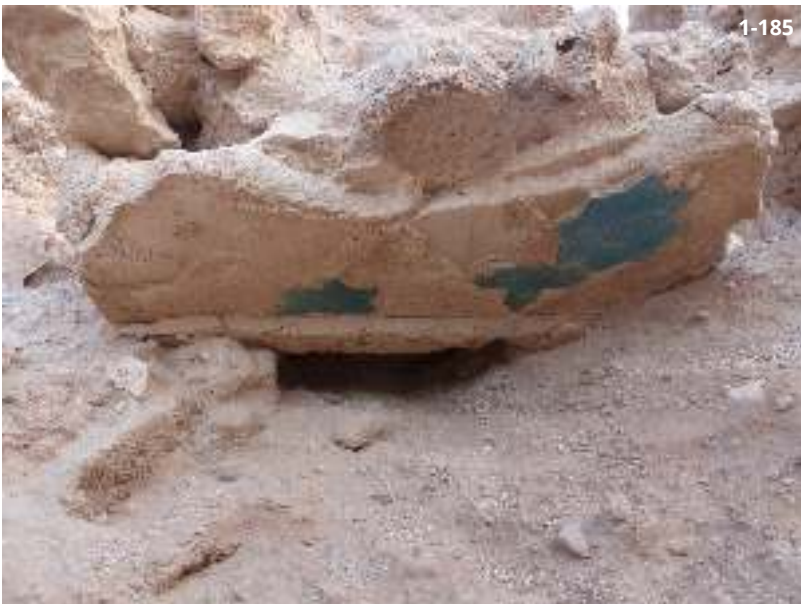
Fig 1-185 : the architectural element IsoArc913, in situ

Uncovered in the middle of the northern part of the span 6, the two architectural elements **IsoArc913** and **IsoArc914** present the same features, dimensions and decoration, and undoubtedly come from the same location (**Fig 1-185** and **Fig 1-186**). They both come from a rectangular engaged pillar with a decoration made of glazed tiles in the shape of crosses and stars, bonded with a beige mortar coating, while the fragment of the *qibla* wall attached to it is covered with a whither coating. On the **IsoArc914**, a small curve suggests the start of the intrados of the arch, and therefore that this element was originally located high on the *qibla* wall. As they were found nearly halfway between the *minbar* and the north wall near the pillar B12-323, they may have toppled from an important height and so felt at a certain distance from their original location. They so could have originally stood southerly, near the *minbar*, and have received the arch of the assumed central nave in front of the pillar B12-05. Already uncovered by the QP against the north side of the *minbar* and near the pillar B12-05, the **IsoArc911**, which was identified as a fragment of the upper part of an arch, could have been part of that central nave.

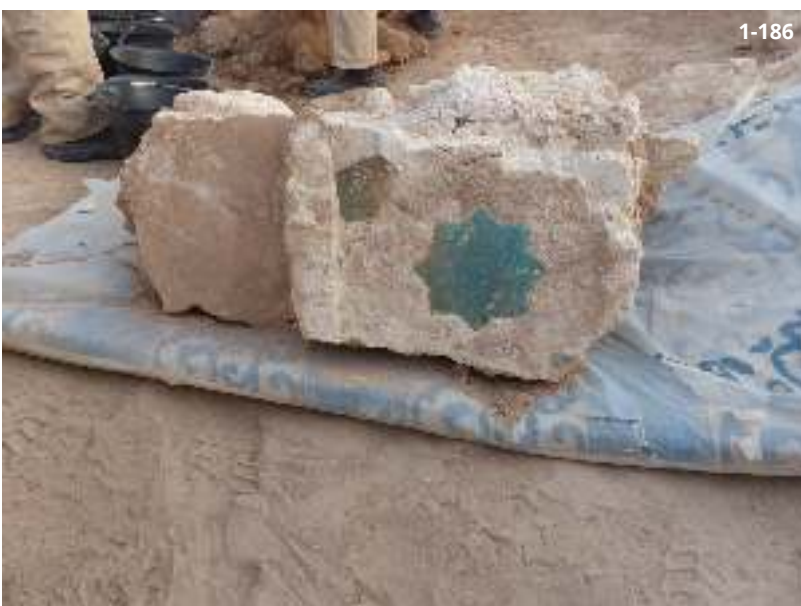
Fig 1-186 : the architectural element IsoArc914, after removal

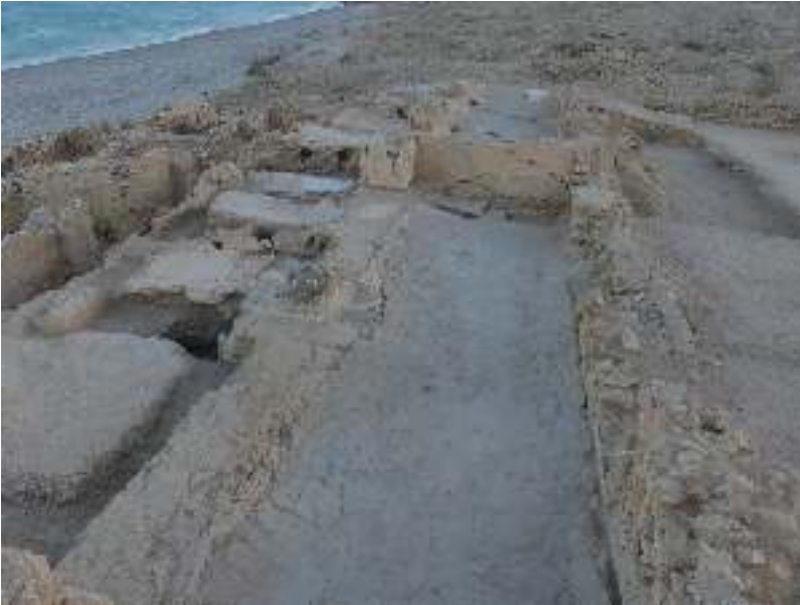
Fig 1-195 : General view of the prayer hall at the end of excavations

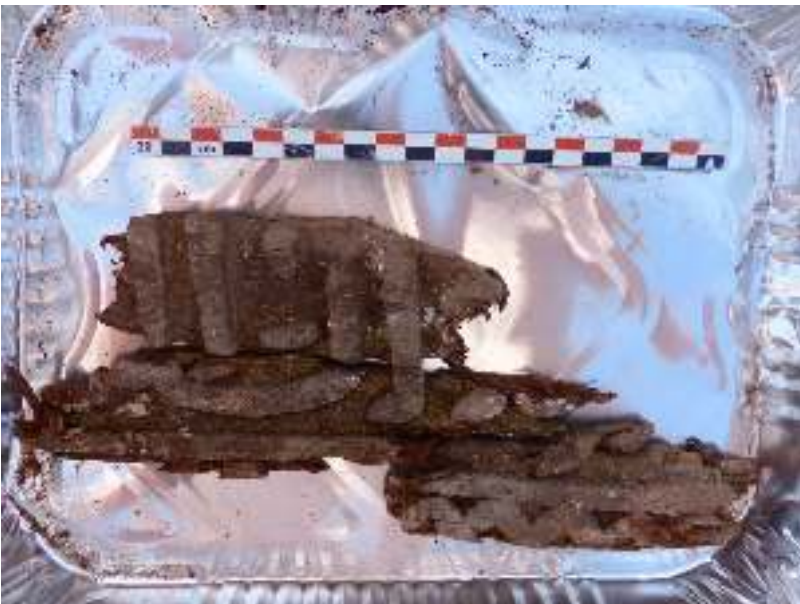
Fig 1-196 : fragment of carved and golden painted wood

Twelve pillars, and six engaged half-pillars to the north and south, supported three north-south lines of arcades and two east-west lines in the middle of the prayer hall, demarcating a central nave in front of the *mihrab*. The pillars of the central nave and the ones to the north and south were differently decorated and the same difference may have occurred in the upper part of the vaulting. The roof was supported by the arcades and by east-west beams linking the pillars and, according to the description by Bras de Albuquerque and the testimony of a single small fragment of wood decorated with carving and golden paint (Fig 1-196), these beams may have been carved and highly decorated.

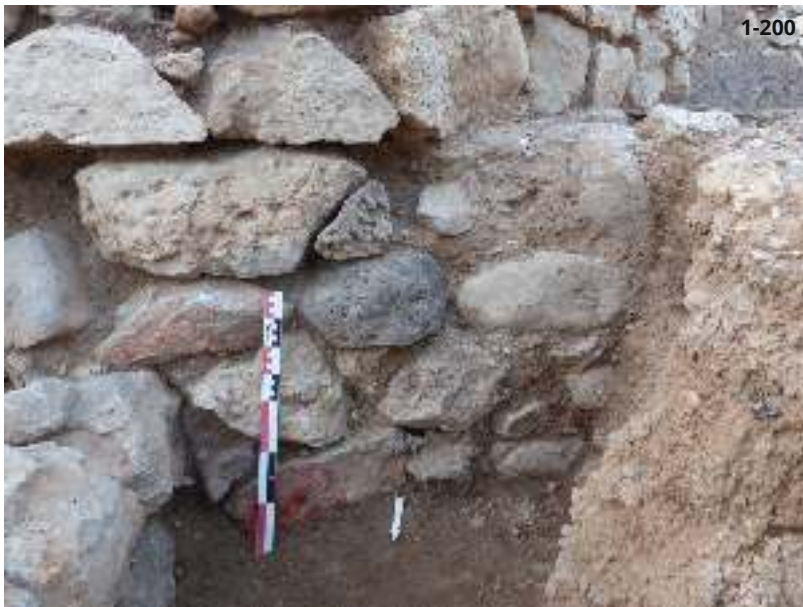
Fig 1-200 : the wall B12-75 (behind the scale) under the staircase in area B12-N

The southern wall, B12-479 (**Fig 1-199**), 0.60m wide and observed for 0.75m long, is made of large and medium limestone blocks and was probably associated to the easterly wall B12-75 with which it is aligned in the north side, both being on each side of the access to the corridor B12-B. The wall B12-75 (**Fig 1-200**), made of large and medium limestone blocks, was found under the structure B12-192 which was built above and extends westerly for an unknown distance as it is covered by later floors which were left in place. Though the connection between the two structures was not observed, it is very likely that it is the same wall, as the two parts are built in the same way and are apparently aligned. This wall could have been used as a step to compensate the difference of altitude, at least 0.50m and probably more, between the earlier floors of the low courtyard and the threshold of the room B12-B, and also to receive the south abutment of the arch.

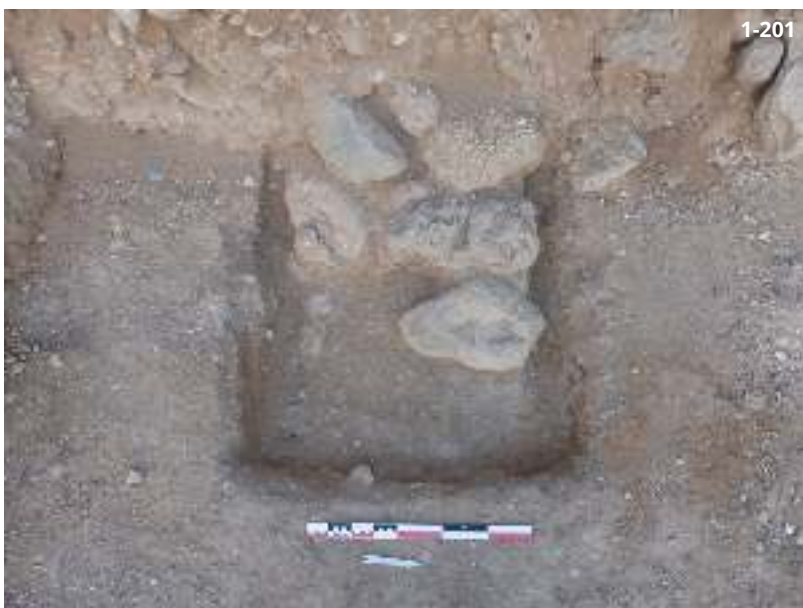
Fig 1-201 : the scarce remains of the wall B12-477, under the retaining wall of the high courtyard

Around 3m north of the wall B12-479, the small remains of wall B12-477 (**Fig 1-201**), about 0.70m wide, is also running under the wall B12-67 and, though it was only partially unearthed for only 0.50m long, it seems to be parallel with the wall B12-479. As it was not found in the sounding opened in the middle of the low courtyard, it is very likely that most of its material was recovered, but it originally probably extended easterly, at least until the north-east corner of the Mosque building.

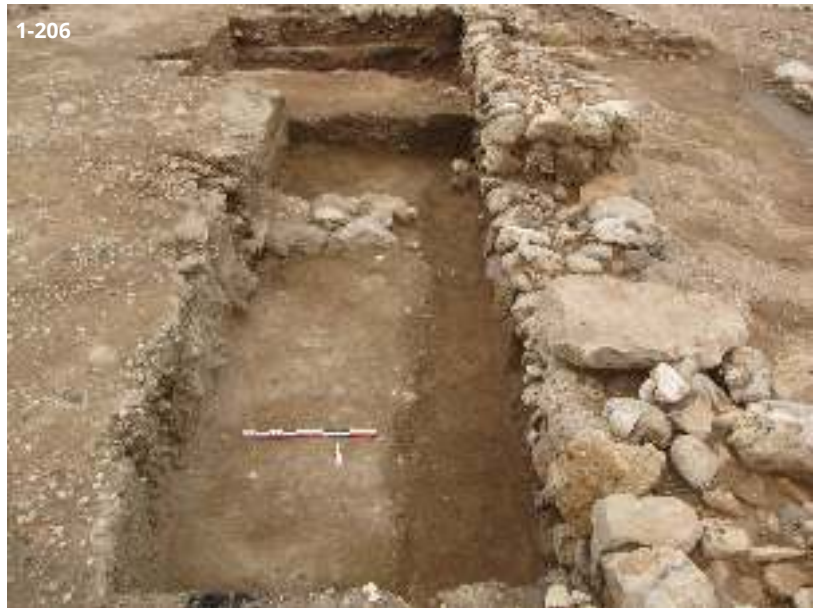
Fig 1-206 : the earthen floor Uf5895 (cut by the construction of the wall B12-199 at right) with the low wall B12-451 in the background

Though the ceramic material was too scarce to give a precise dating, the lowest floor observed in the soundings was quite probably in function in the first stage of the Mosque and the circulation floor used when the terrace was in use and not damaged. Observed at east along the wall B12-199, the floors **Uf5895 (Fig 1-206)** and **Uf5896 (Fig 1-207)** are earthen floors, with some small pebbles inserted into the floor which could be an infiltration from the upper layers. Built above these floors, the wall B12-451, 0.60m wide and observed for 0.75m long, probably belonged to the same stage of occupancy but its function is still unknown. It is only preserved for one course of stones but it could have been higher and the upper part recovered.

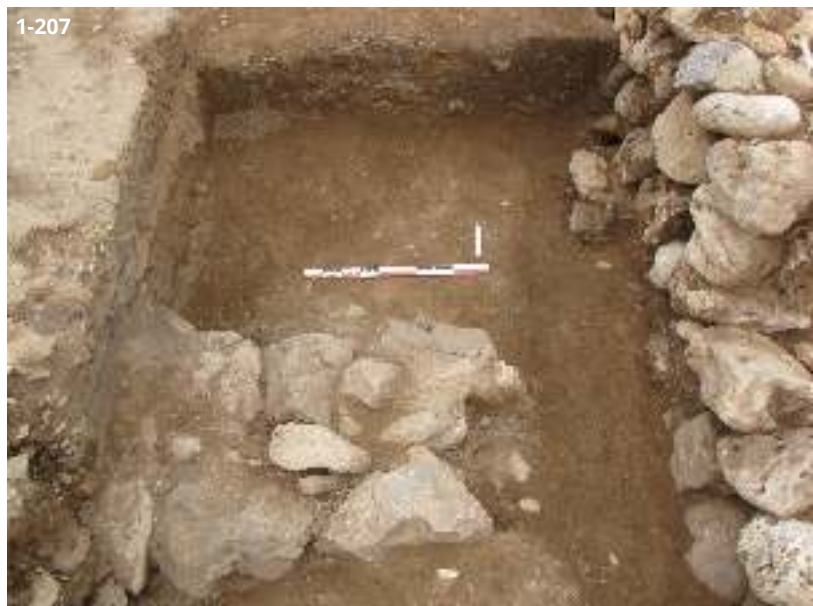
Fig 1-207 : the earthen floor Uf5896 (cut by the construction of the wall B12-199 at right) with the low wall B12-451 in the foreground

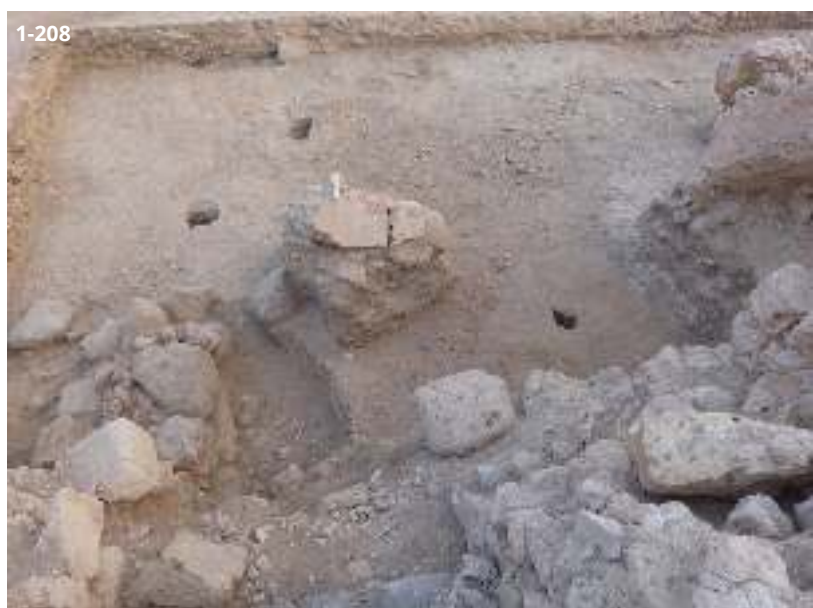
Fig 1-208 : the earthen floors Uf5822 and Uf5823, pierced by several postholes

North of the rooms B12-T and B12-W, the earthen floors **Uf5822** and **Uf5823** probably belonged to the same stage and must be the same floors as Uf5895/5896, though their connection was not excavated (**Fig 1-208**). Many postholes were found in this sounding, probably belonging to the same stage. Three of them are aligned, **B12-440 (Fig 1-209)**, **B12-441 (Fig 1-210)** and **B12-442 (Fig 1-211)**, all around 0.30 m wide and 0.20m deep and, as they are more or less aligned with the wall B12-477, they could have been part of the settings of the terrace, for scaffolding or strengthening. North of them, the smaller posthole **B12-443**, 0.15m wide and 0.15m deep, was dug through the same level and could belong to the same stage, but its function is more problematical.

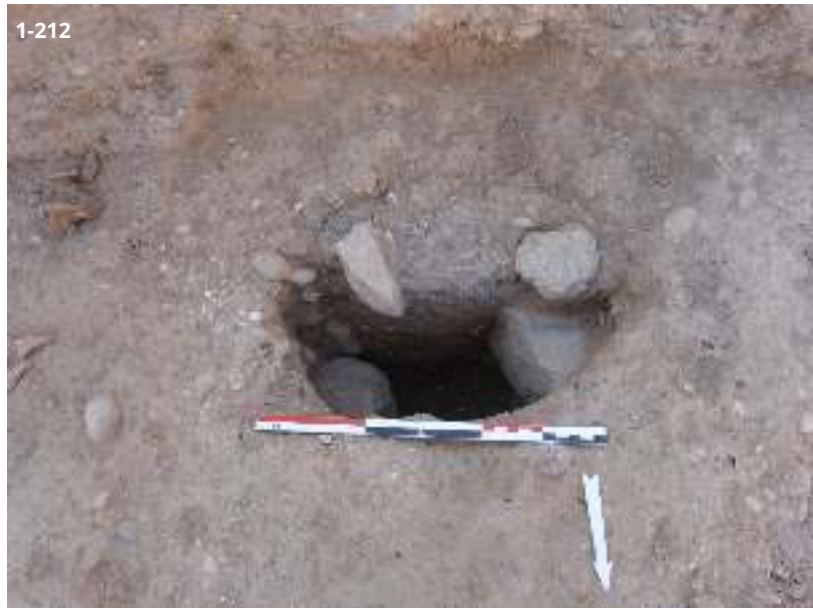
Fig 1-212 : the posthole
B12-427, half excavated

Four other postholes were unearthed north-west of the gate to the room B12-W : **B12-427 (Fig 1-212)**, 0.35 m wide by 0.25 m deep, **B12-422 (Fig 1-213)**, 0.15m wide by 0.10m deep, **B12-423 (Fig 1-214)**, 0.25 m wide by 0.20 m deep and **B12-444 (Fig 1-215)**, 0.20m wide by 0.15m deep. For all of them, their use is unknown. On the contrary, the large posthole **B12-435 (Fig 1-216)**, around 0.40m wide by 0.30m deep, against the wall B12-286 and near the threshold B12-437 which give access to the room B12-W, was probably made to host the vertical pivot of the assumed door which closed the gate. Though it was dug through the earthen floor, it can also belong to a later stage of occupancy but its top was not seen in the upper layers.

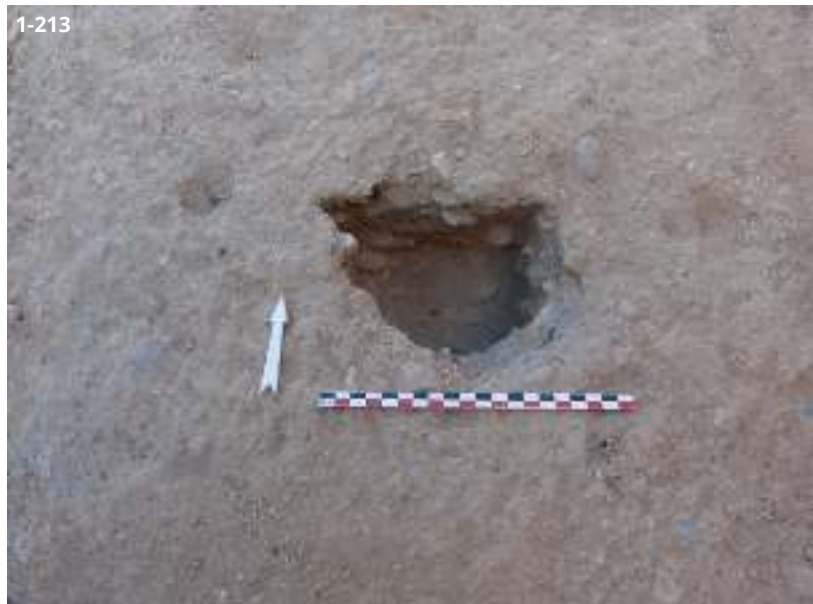
Fig 1-213 : the posthole
B12-422, half excavated

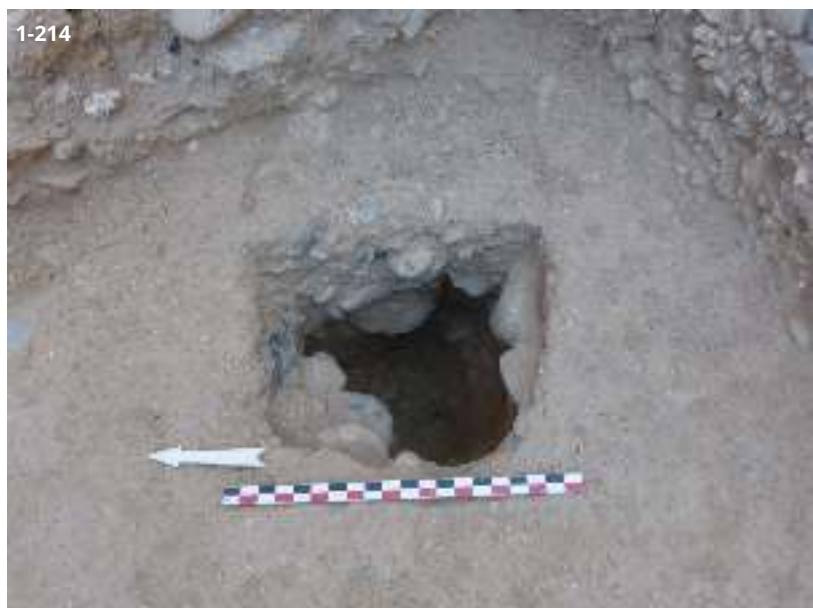
Fig 1-214 : the posthole
B12-423, half excavated

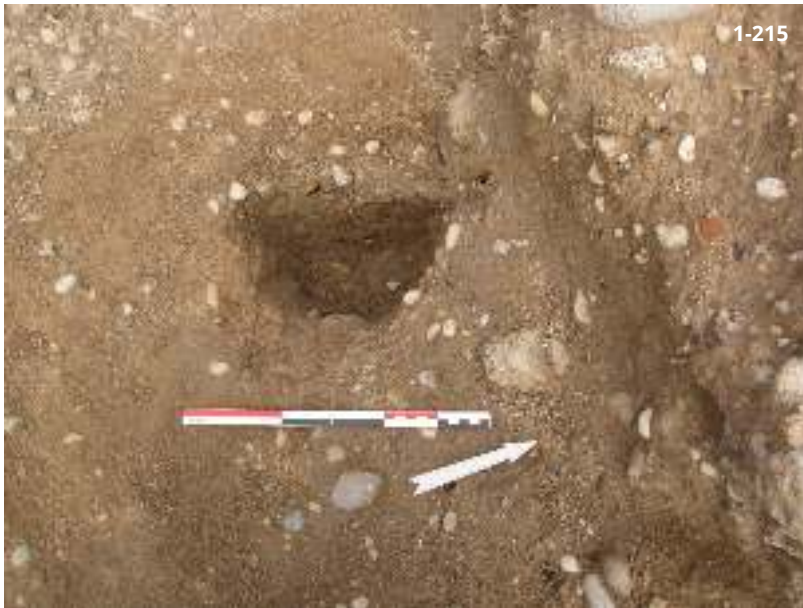
Fig 1-215 : the posthole B12-444, half excavated

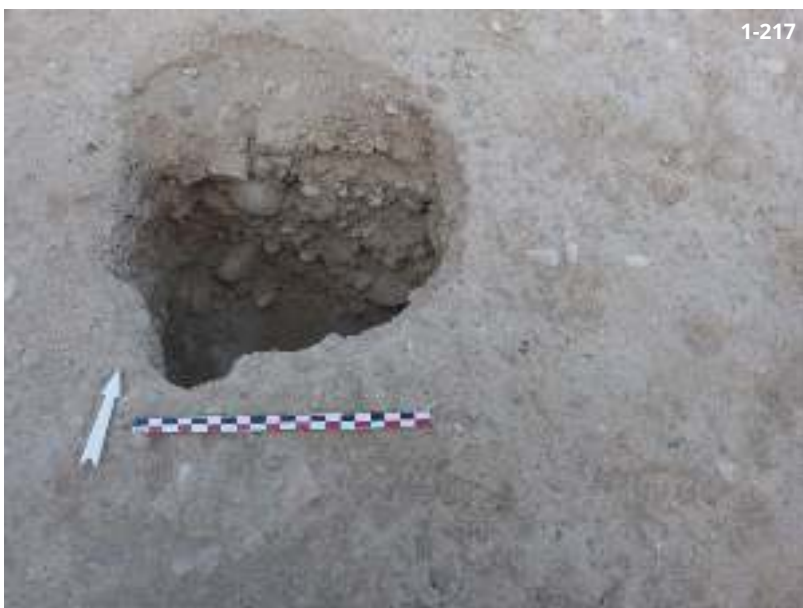
Fig 1-217 : the posthole B12-420, half excavated

Finally, north of the staircase B12-167, three postholes (**B12-420 (Fig 1-217)**, 0.30m wide by 0.20m deep, **B12-421 (Fig 1-218)**, of the same size and **B12-438 (Fig 1-219)**, around 0.35m wide and 0.05m deep) and an oval pit (**B12-425 (Fig 1-220)**, 0.60m long by 0.40m wide and deep) were also dug through the earthen floor, but here also their functions remained unknown.

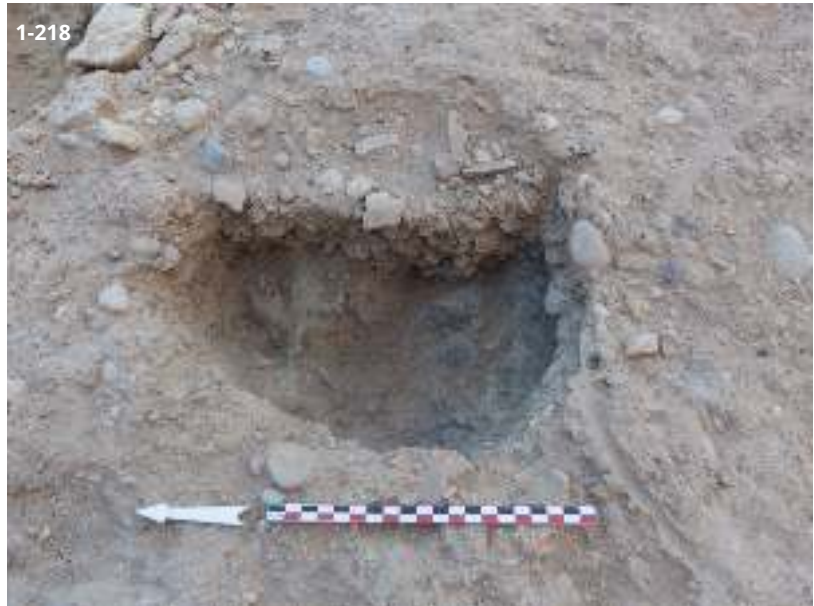
Fig 1-218 : the posthole B12-421, half excavated

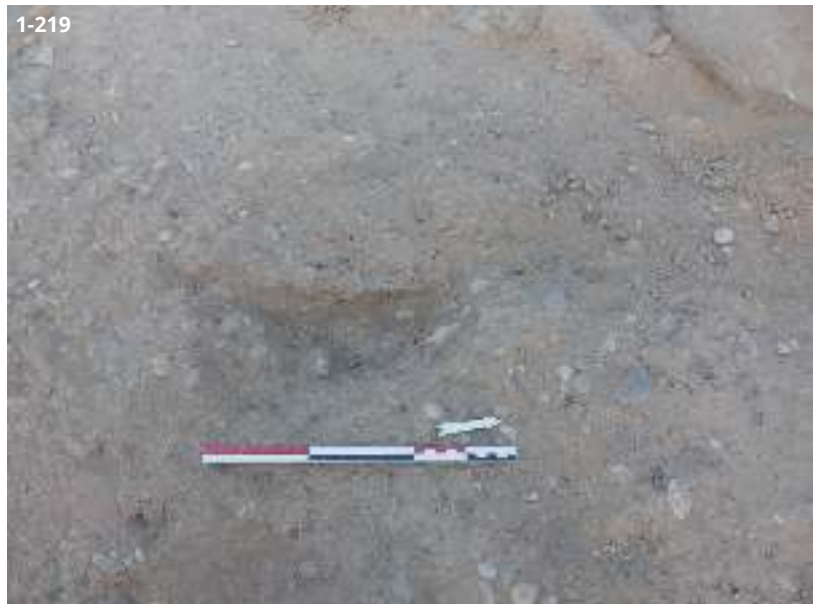
Fig 1-219 : the posthole B12-438, half excavated

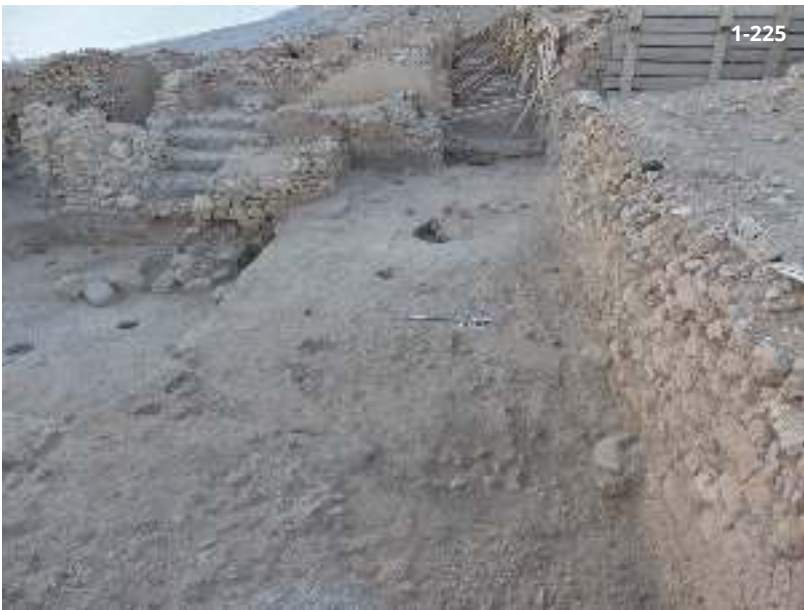
Fig 1-225 : the mortar floor Uf3999 pierced by several postholes, with the corridor B12-B in the background

At east, in front of the opening to the corridor B12-B, the floor **Uf3999** (Fig 1-225), made of a thin layer of gray mortar above rammed soil, is the last circulation floor of the low courtyard. An iron cannonball (Fig 1-226) was found over this floor and, as the iron cannonballs are supposed to be of European origin while the Arabic ones were of stone, it is very likely that this floor was the one in existence at the arrival of the Portuguese. Five postholes and two pits were unearthed above this floor. Three of them are aligned (**B12-430** (Fig 1-227) and **B12-431** (Fig 1-228), around 0.20m wide and deep and **B12-429** (Fig 1-229), around 0.30m wide and 0.20m deep) and located between the walls B12-479 and B12-75. Their location might indicate that they were used for wooden posts to support the above terrace which was presumably here repaired with wood (Fig 1-230). It might also be the case for the posthole **B12-432** (Fig 1-231), around 0.35m wide and 0.10m deep, located near the corner of the staircase B12-166 and the construction B12-192 but this is less obvious. At north, the posthole **B12-449** (Fig 1-232), 0.30m wide by 0.20m deep, could also be the trace of a repair of the northern part of the terrace but could either be an isolated structure not related with the others.

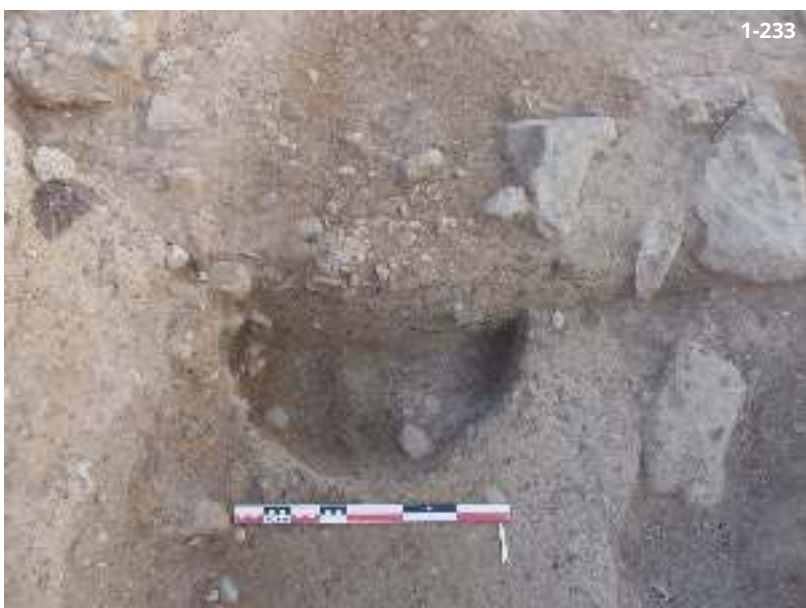
Fig 1-233 : the pit B12-433, half excavated

The two pits dug through the floor Uf3999 are more problematical. The first one, **B12-433** (Fig 1-233), 0.75m long by 0.60m wide and 0.50m deep, is located in area M, in the passageway to the corridor B12-B and, if it was in existence during the use of the basement, it would have greatly reduced the size of the entrance. The second one, **B12-428** (Fig 1-234), 0.80m wide and 0.25m deep, is located just at north of the aligned postholes B12-429, B12-430 and B12-431, were it was also greatly blocking the circulation. They could so have been dug after the abandonment of the Mosque, but their use and function will remain unexplained.

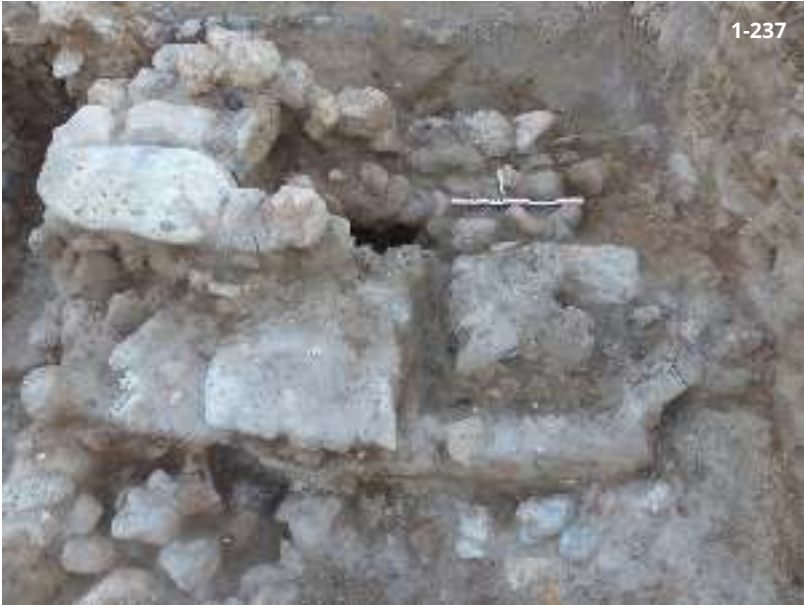
Fig 1-237 : the wall B12-471, under the scale

The south limit of the room is made by the wall **B12-471 (Fig 1-237)**, which is leaning at east against the outside facade of the *qibla* wall (here registered as B12-31). It is very damaged and it is quite certain that a gate once stood here though no remain of threshold was preserved, as the general organization of the room and its surroundings indicates that the most convenient place for an access is here. The wall is now 2.60m long by 0.80m wide in average, for a maximal preserved elevation of 0.65m though some part of this elevation was originally not visible. It is made of medium limestone and corals blocks bonded with a badly preserved mortar and the internal core is very powdery. No coating was found in the south external face while the coating observed on the north internal face is linked with the northerly fittings (see below). Nearly in the middle of the wall, a gap in the masonry, though very badly preserved, could be the remain of an internal vertical gutter to drain the rainwater from the roof to the ground of the high courtyard. However, the remains are not well enough preserved to be affirmative.

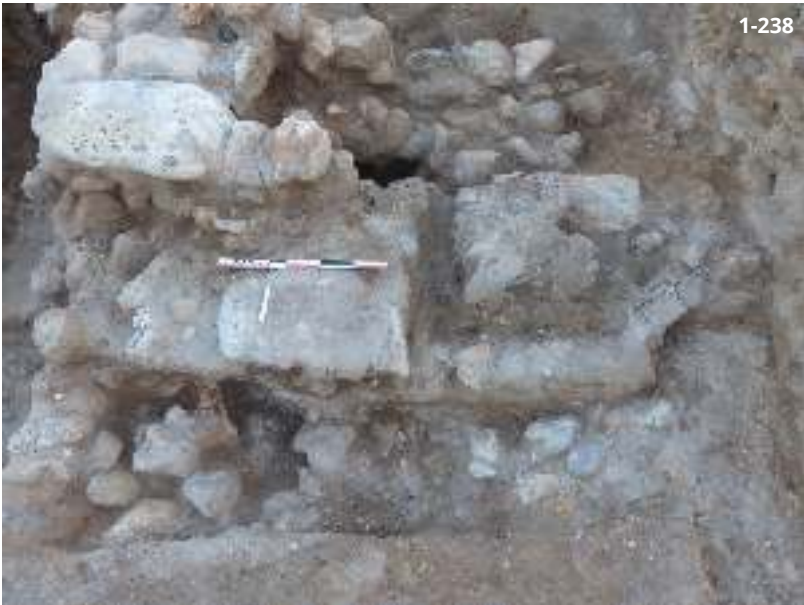
Fig 1-238 : the wall B12-472, outlying the wall B12-471, with the groove B12-461 just at right of the scale

The wall B12-471 is outlined at south by the wall **B12-472 (Fig 1-238)** which is also leaning against the *qibla* wall. It is 2.20m long by 0.55m wide and only 0.15m high. It is very badly preserved especially at east where its limit with the wall B12-471 is nearly invisible. Nearly in the middle of the wall, a small groove (**B12-461**) with its bottom covered with strong gray coating, probably waterproof, was observed, crossing the width of the wall until the assumed vertical gutter in the wall B12-471, enhancing this interpretation. It is quite probable that the groove was originally covered and could so be interpreted as an internal canalization. The wall is also bordered at south by some kind of trench (**B12-473**) which could be a drain to evacuate the water.

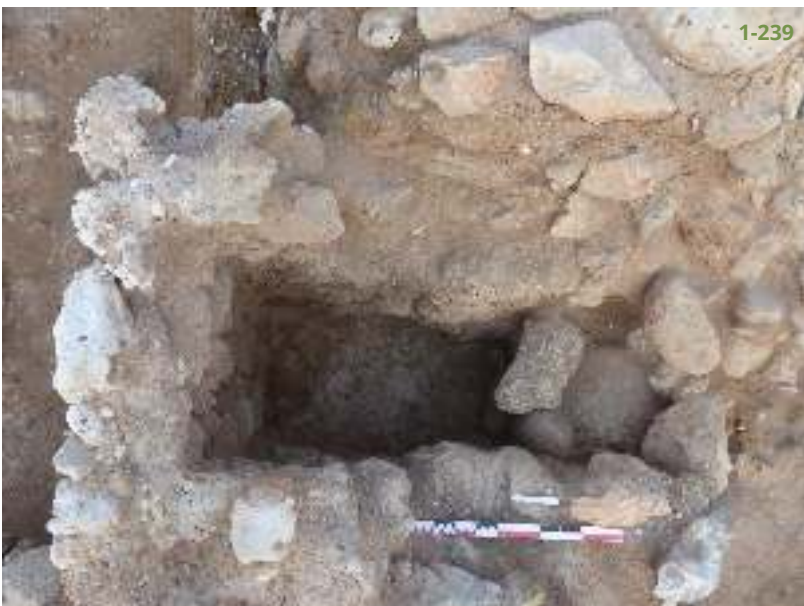
Fig 1-239 : the groove B12-454, from above

The rest of the south limit on the south-west corner of the room B12-E is made by the masonry **B12-72**, linked with the western wall B12-65, already excavated and described in the previous report. The walls B12-471 and B12-72 are separated by a narrow groove (**B12-454 (Fig 1-239)**) which goes northerly inside a U-shaped masonry (**B12-467/468/469**) built in the internal south-west corner of the room. The wall B12-72 is 1.30m long by 0.75m wide and around 0.80m high and made with medium limestone and corals blocks bonded with earthen mortar and without external coating observed. The U-shaped masonry B12-467/468/469 is 1m long for a preserved elevation around 0.80m high and its width varies from 0.75m to 0.35m, the difference being the depth of the groove into the masonry. It is made of all sizes limestone and corals blocks bonded with yellowish mortar (**Fig 1-240**). The groove B12-454 is 1.20m long and its width varies from 0.35m to 0.25m and a strong with (white ?) grayish coating was found at the bottom of the structure. The most reasonable identification is a vertical gutter to evacuate the rainwater from the roof but it may look surprising that the evacuation was not at north to collect the rainwater for the ablation, as the water is lost in this configuration. Another identification could be a conduct for a latrine at first floor but it is problematical as the excrement would have fall on the floor level of the high courtyard and not into a sanitary pit, and very close to the *qibla* wall. If the presence of toilets is not impossible in the precinct of the Mosque, it is more problematic to set them so close to the most sacred place of the building. The inside of the gutter was filled with rubbish layers (**Uf5903**) suggesting that it was used as a rejection place, and by collapsed stones at south (**Uf5905**) which were undoubtedly covering the canalization between the wall B12-72 and B12-454 (**Fig 1-241**).

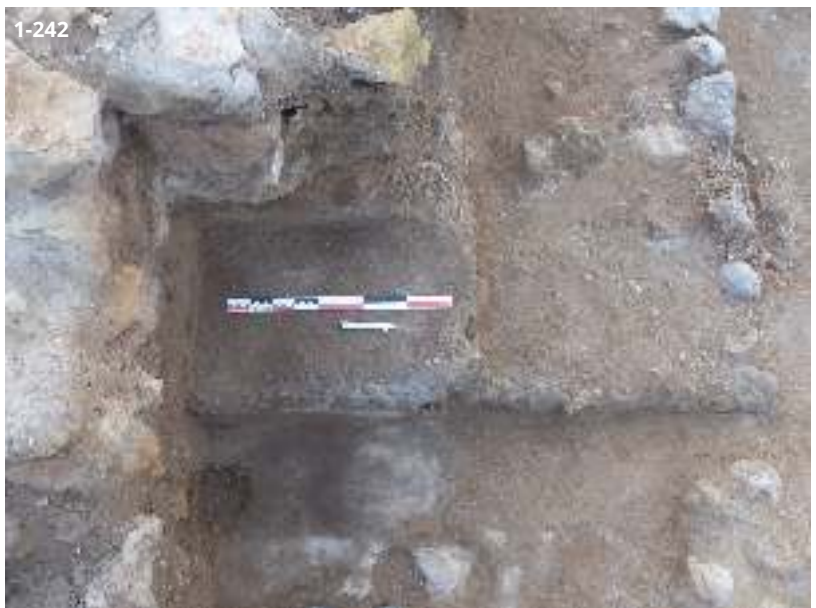
Fig 1-242 : the step or bench B12-460, under the scale

In the south interior of the room, several damaged structures related with the northern remains of the basins were unearthed. The structure **B12-460 (Fig 1-242)**, 0.65m long by 0.40m wide and 0.15m high, is built against the south wall B12-471, around 1.20m west of the *qibla* wall. It is entirely covered with strong gray coating, probably waterproof, and can be identified as a step or more likely an edge of the basin, to receive the water for ablation and drain it to the north basin. It was associated with the structure **B12-475 (Fig 1-243)**, built at west against the masonry B12-467/468/469, made with various sized limestone and corals blocks bonded with a disintegrated mortar and covered, in the lower part, with the same strong gray coating as the structure B12-460. Preserved for 0.65m long by 0.60m wide and 0.60 high, the structure B12-475, though badly preserved, was quite undoubtedly a low bench, where people were sitting during the ablation.

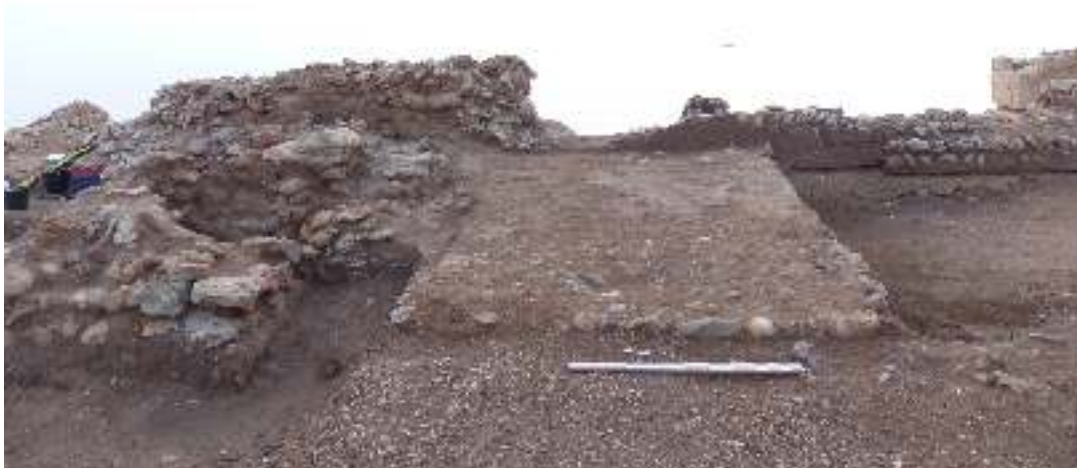
Fig 1-244 : the large plaque of mortar B12-456, with the *qibla* wall in the background

South of the room B12-E, a large plaque of mortar **B12-456** (Fig 1-244), nearly 4m long and between 3.75m to 2.50m wide, was found under the layers of collapse of the *qibla* wall. A single course of medium limestone and corals blocks without binder, set in the alignment of the west wall of the room B12-E, was retaining a backfill layer which was covered by a strong gray mortar containing many small pebbles and gravels and partially covered with a yellowish coating. This surface presents an important slope from west to east and was quite probably used as a ramp to reach the room B12-E from the level of the courtyard. It was destroyed at east by the trench B12-474 which was made for the last stage of repair of the *qibla* wall and it is separated from the room B12-E by the trench B12-473 which was probably in use to evacuate the rainwater coming from the gutters B12-454 and B12-461.

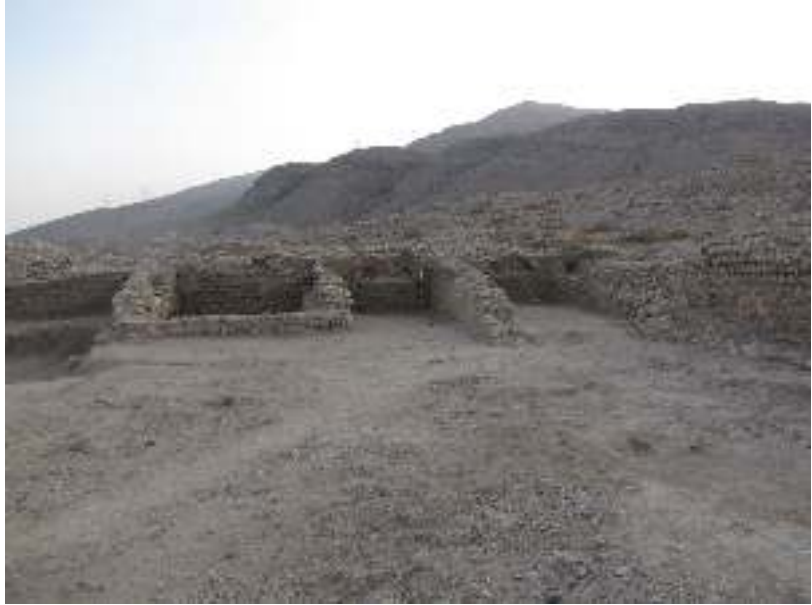
Fig 1-250 : general view of the building B139 at the beginning of excavations during the 2015b season

During the 2014–2015 season, three different areas have been observed in the building B-139 and described, the rectangular room B12-C in the south-west corner of the high courtyard and a nearly square room B139-A at south, made with low walls built against the south enclosure wall and over a sandy level, both being separated by a narrow recess B139-B.. (Fig 1-250)

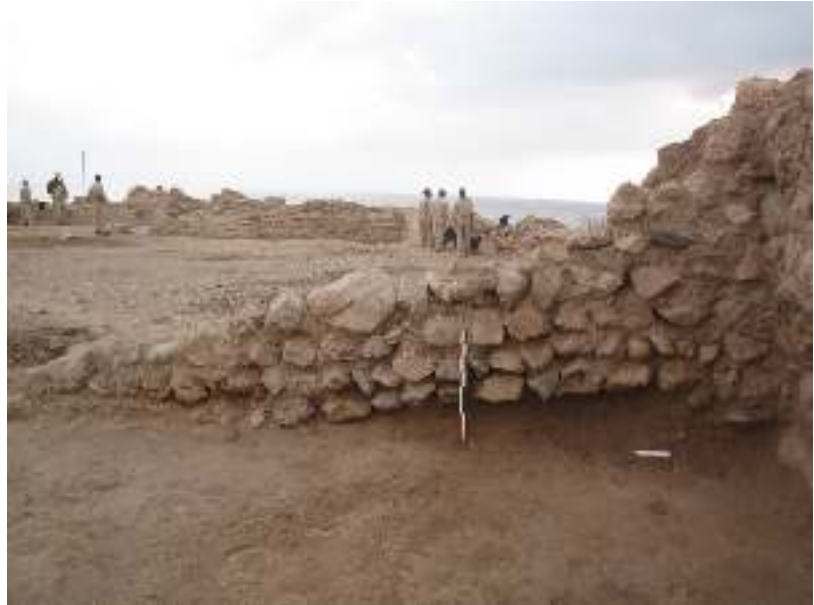
Fig 1-254 : the wall B139-09 built over sand, visible behind the white arrow

Two small walls were built over the sandy eolian levels, **B139-08** (**Fig 1-253**) around 2.70m east of the room B12-C and **B139-09** 3m east, whose foundation is not horizontal but follows the slope of the heap of sand accumulated against the south enclosure wall (**Fig 1-254**). They are both made with medium limestone and corals blocks bonded with earth, 3.10m and 2.80m long by 0.40m wide and between 0.40m to 0.30m high. The two walls created the first stage of the room B12-A, which was opened at north at this time and, according to the ceramic material found in the windy natural layers, the construction occurred in the course of the 16th century, a certain time after the abandonment of the Mosque.

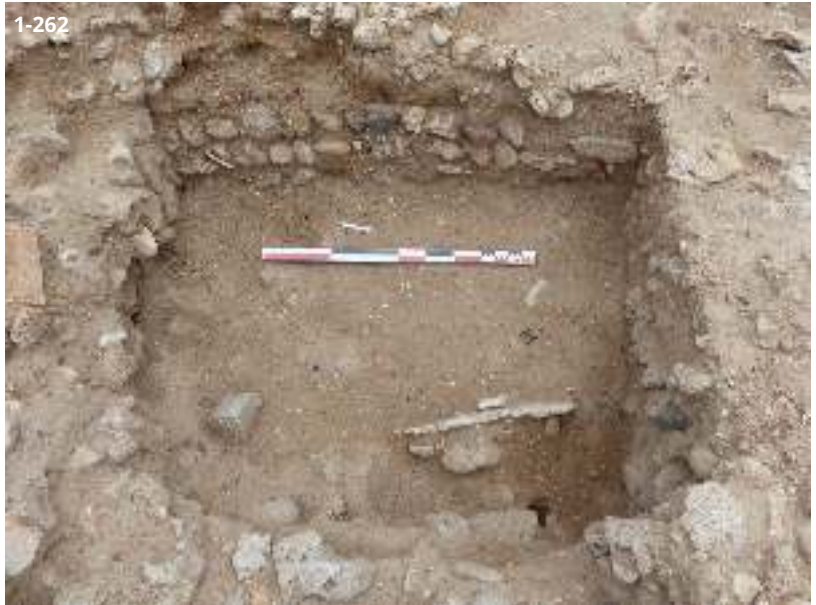
Fig 1-262 : general view of the room B255-D

The western room B255-D (Fig 1-262) is delimited at north by the wall **B255-12** (Fig 1-263), 0.60 m wide and internally uncovered for around 0.20 m only, at west by the wall **B255-13** (Fig 1-264), 2.65 m long by 1 m to 1.20 m wide and externally excavated for more than 0.40m, and at south by the wall **B255-14** (Fig 1-265), common with room B12-A, around 5m long and 0.80m wide for the room B12-D and 0.60m for the room B12-A and uncovered for 0.60 to 1 m high. The rooms B255-D and B255-A are separated by the wall **B255-05** (Fig 1-266), 1.60 m long by 0.90 m wide and only uncovered for less than 0.40 m high in the room B12-D. All walls are made with medium limestone and corals blocks bonded with a nearly disintegrated beige mortar and remains of a strong dark coating have been found on the external facings of the wall B255-13. The internal useful space of the room B12-D is only 1.80m² and, as the internal facings were badly preserved, excavations stopped very early in the upper part of the collapse (**Uf5609**) while they went deeper externally into the collapse (**Uf5602**) as the external facings were best preserved.

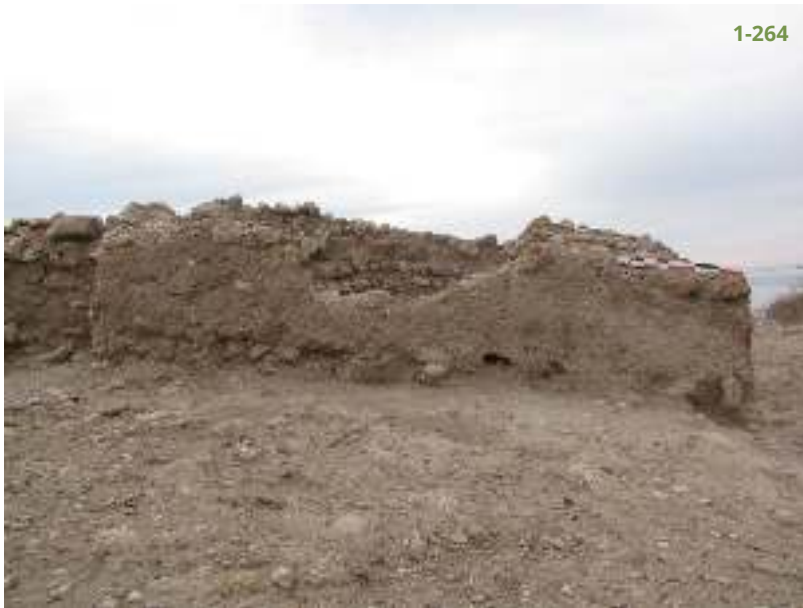
Fig 1-264 : the wall B255-13, outside elevation

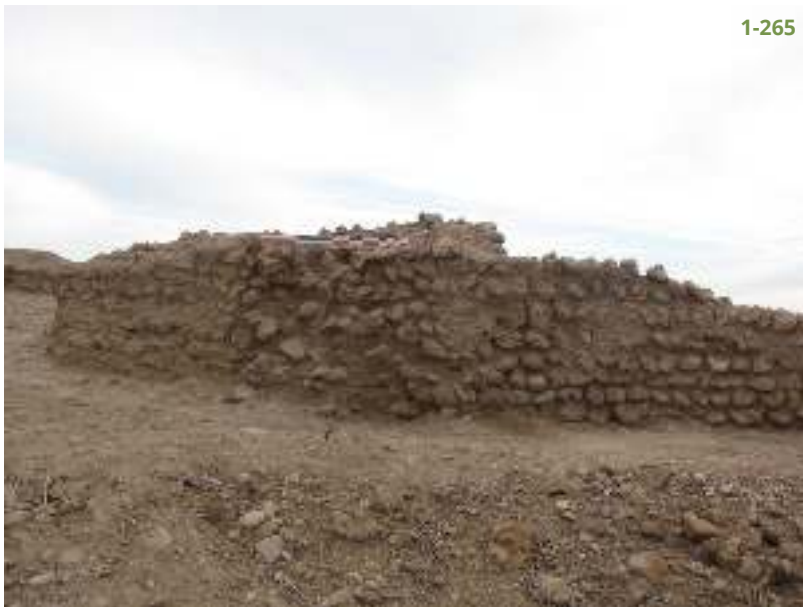
Fig 1-265 : the wall B255-14, outside elevation

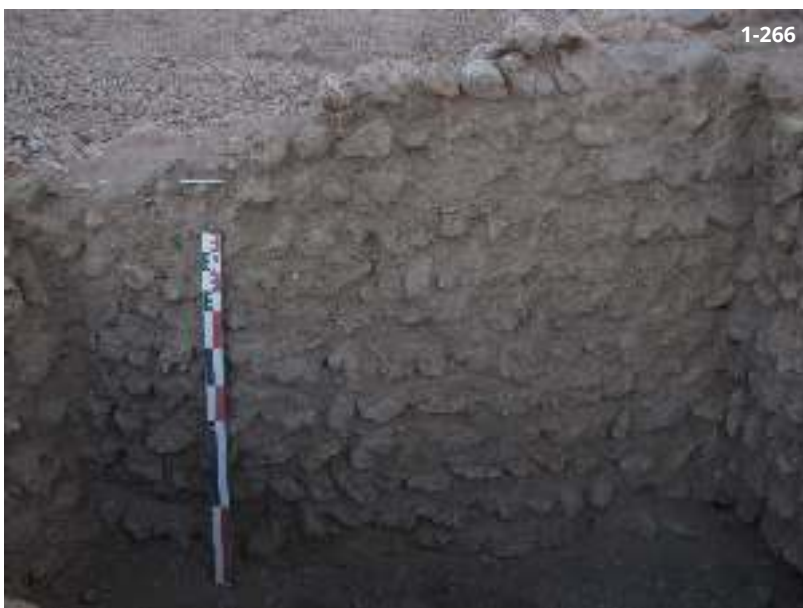
Fig 1-266 : the wall B255-05, inside elevation in room B255-A
