Qalhât Development Project, Season 2015B-2016A, Final Report

SEASON 2015B-2016A

FINAL REPORT

Excavations on the Ceramic Workshop B41

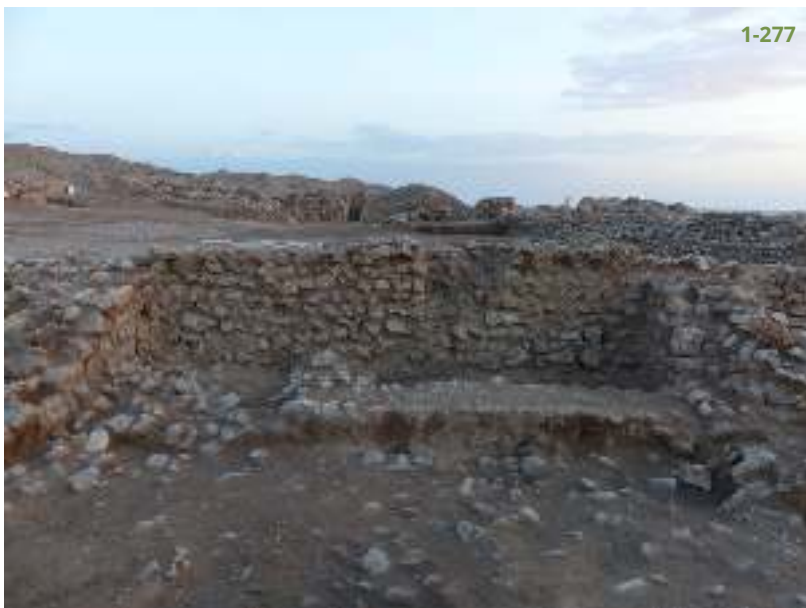
Fig 1-277 : the walls B255-20 and B255-21 (in the background) and the walls B255-17 and B255-18 (in the foreground) which could belonged to another building

The building B255 was probably extending eastwards, where the uncovered wall B255-20 and B255-21 probably belonged to a fifth room. In the same area, the walls B255-17 and 18 have been observed on the ground and must be part of an internal fitting (Fig 1-277). As the building B255 appeared to be distinct from the Mosque Complex and was so no more a priority, the excavations did not continue here and the plan of this hypothetical room was not searched.

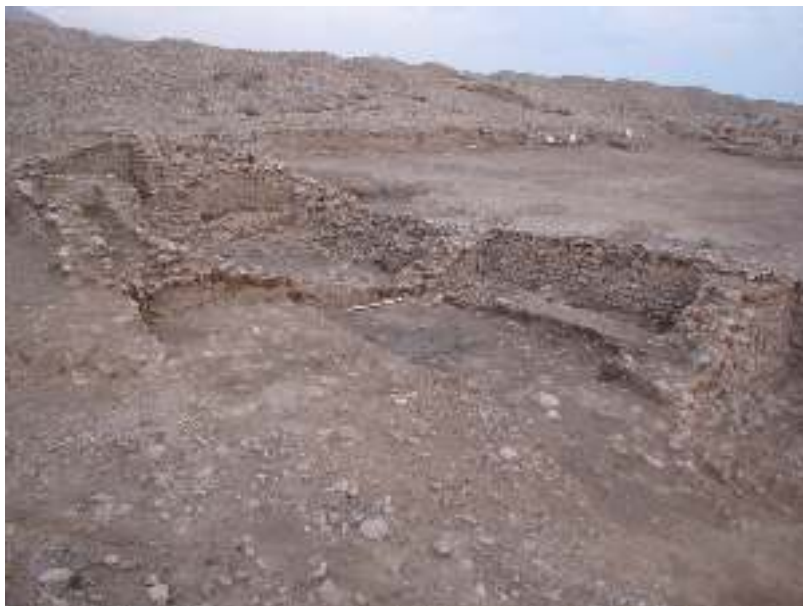
Fig 1-278 : general view of the building B255 at the end of excavations

All the walls are made with medium sized limestone and corals blocks bounded with rough grayish mortar and no traces of coating were observed. The masonry is in general of a poor construction, with rough binder and winding walls and few right angles. It was so probably not an important building and, as some remains of decoration have been found in the rubbish layers of the fillings of the rooms B255-B and B255-A, it is very likely that the building was disused before the final abandonment of the Mosque. (Fig 1-278)

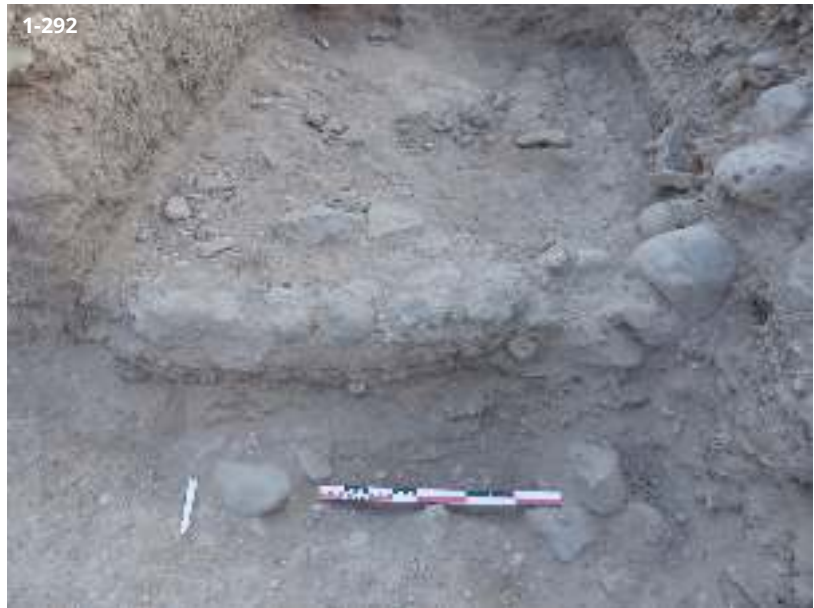
Fig 1-292 : the wall B95-39, with the entrance at left

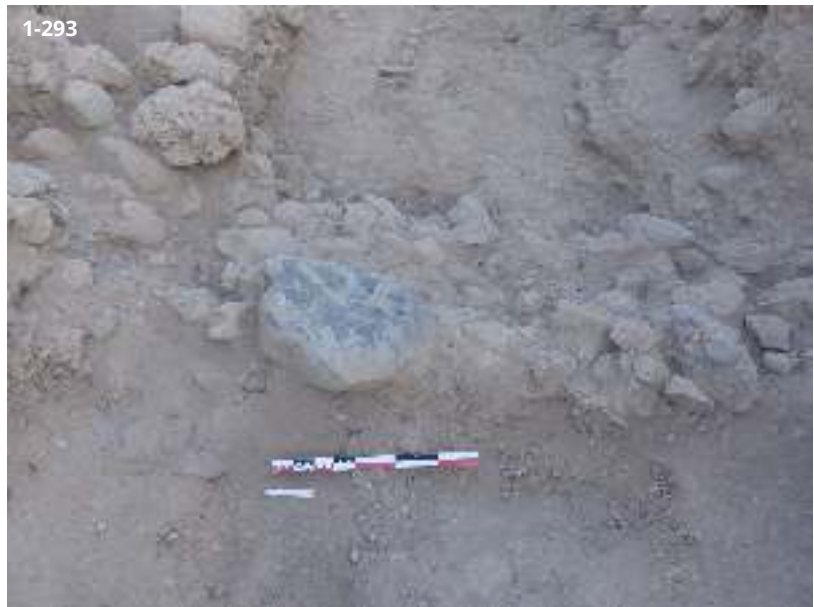
Fig 1-293 : the threshold B13-37

West of the threshold B13-37 and leaning against the upper step, the layer **Uf3545** is made of small pebbles mixed with sandy silt and must be considered as the street level. Though the ceramic material was not enough characteristic, this street level may have been put in place as early as the foundation of the Mosque and regularly kept in a decent state of use. It is however the last level of occupancy, as it is covered, with the threshold B13-37, by the layer Uf3543, already described in previous report, which contained windy sand and few elements of collapse and must so be considered as a level of abandonment.

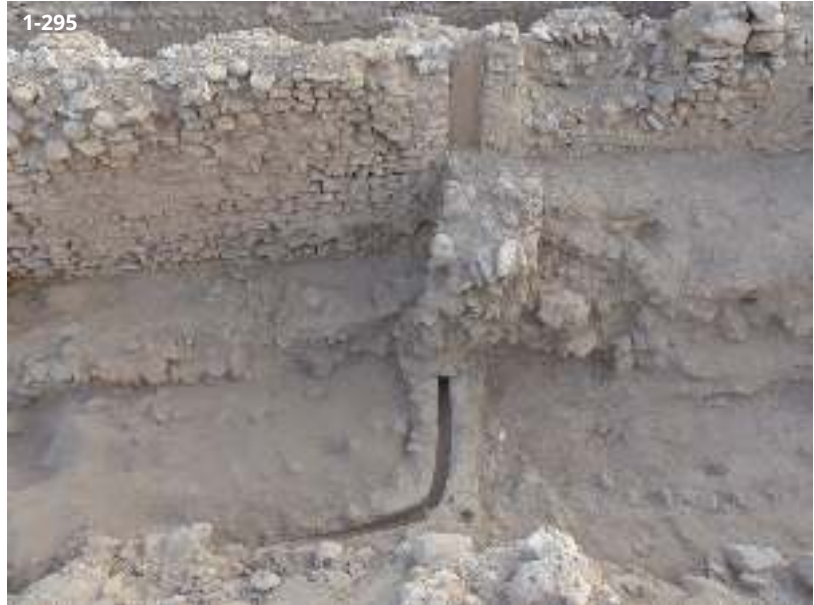
Fig 1-295 : the canalization B13-36 and the vertical gutter B95-15

It is very likely that the two gutters B95-15 and B13-36 originally worked together and were used to recover the rainwater from the roofs and the rainwater running off the street (Fig 1-295). They could have been part of a fitting contemporary to the first building B95 and worked with the easterly gutters B13-21 and B13-35 observed along the south facing of the buildings B13. The buttresses B95-14 and B13-20 and their nearby benches B13-05, B95-16 and B13-25 were only built in a second stage, quite likely when the actual second building B95 was made. It is very likely that the passageway was originally wider, around 3.80 m wide, before being reduced to the actual 1.60m wide.

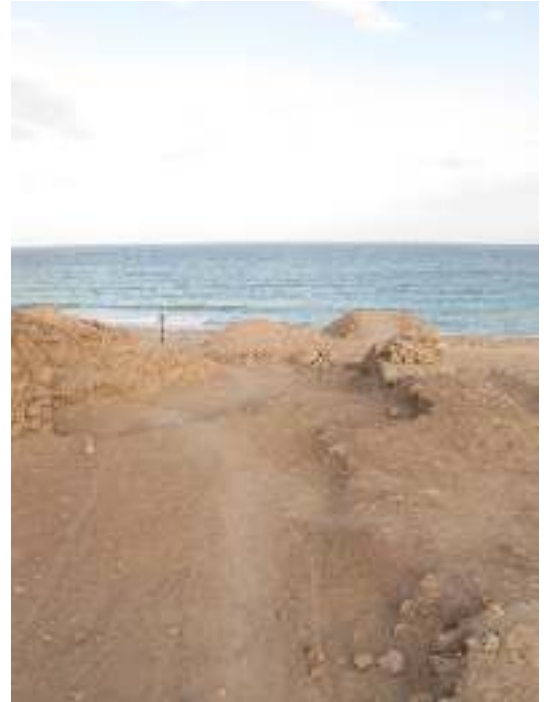
Fig 1-302 : *the passageway between the tower in B13 and the high courtyard, down to the beach*

conservation works at B12, it is very likely that these three walls are delimiting a second inner high courtyard, similar to the inner high courtyard B12-D right at south-west, overlooking the low courtyard. (Fig 1-302)

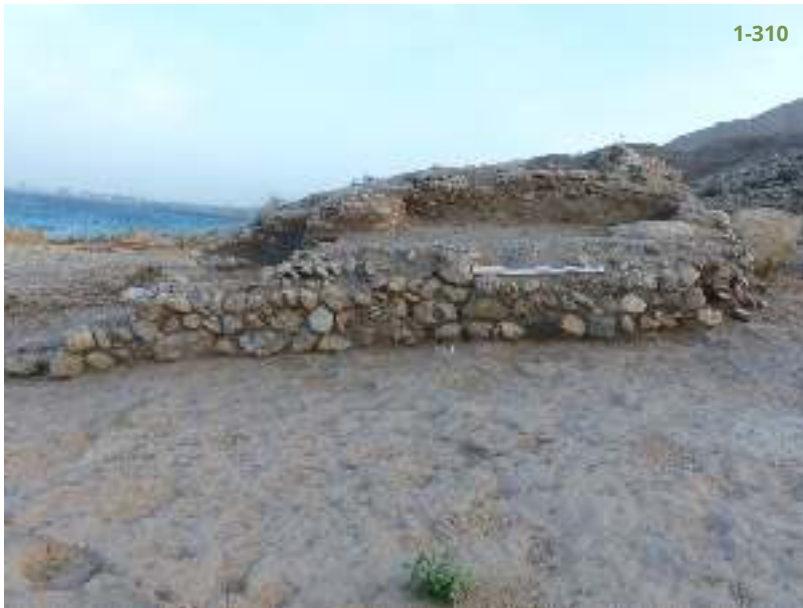
Fig 1-310 : the wall B197-07, in the foreground

The north side of the stairs is made by the wall **B197-07 (Fig 1-310)**, nearly parallel to the wall B197-05, 5m long by 0.50m wide for a maximal preserved elevation of 0.70m high. It is made with large to medium corals and limestone blocks, bonded with earthen mortar, and no trace of coating was observed. Its west end, at the junction with the wall B197-08, is unfortunately destroyed.

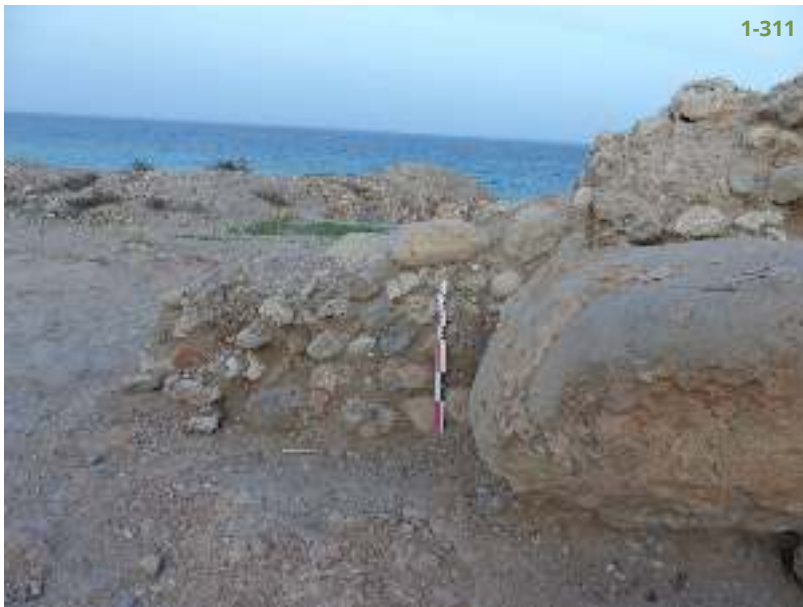
Fig 1-311 : the wall B197-08, with the massive natural pebble at right

The west wall **B197-08 (Fig 1-311)**, poorly preserved, is built against a very massive natural pebble which has detached from the puddingstone cliff edge and has rolled down the slope. It is in fact quite impossible to state if the stair was built against the large stone or if it has later detached from the cliff and has rolled against the wall. It is 1.46m long and around 0.50m wide in average with a maximal preserved elevation of 0.70m, made of large to medium unorganized corals and limestone blocks bounded with earthen mortar and without coating. Though the presence of the large stone did not help the observation, it seems that the wall B197-08 is leaning against the corner of the walls B197-03 and B197-05, and could so be a later addition.

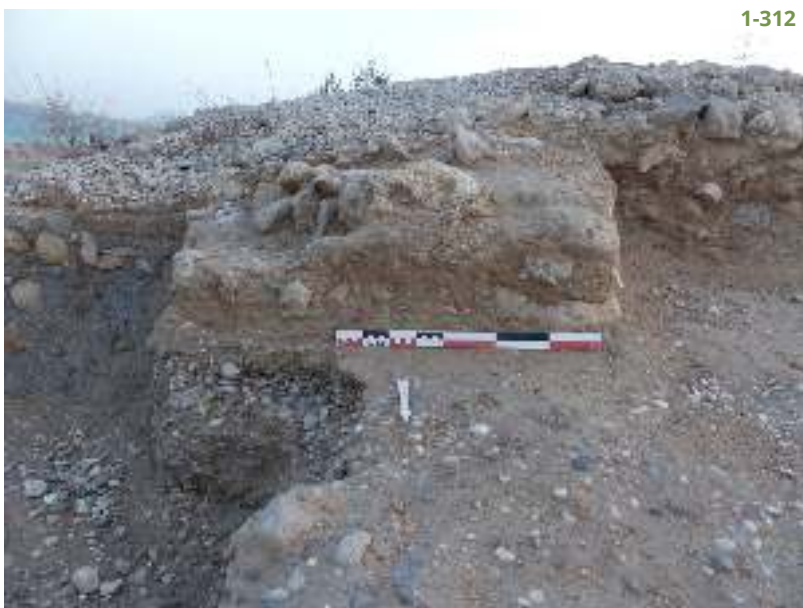
Fig 1-312 : the assumed step B197-05

In the east part, built against the wall **B197-05 (Fig 1-312)**, the construction B197-09 is 1m long by 0.55m wide for a preserved elevation of 0.35m high, and is entirely covered by a strong grayish beige coating. It has been interpreted as the final step of the stair, reaching the circulation level of the southerly main building. Other much damaged steps are guessable at east and it is very likely that the west part was occupied by a small terrace or a high bench.

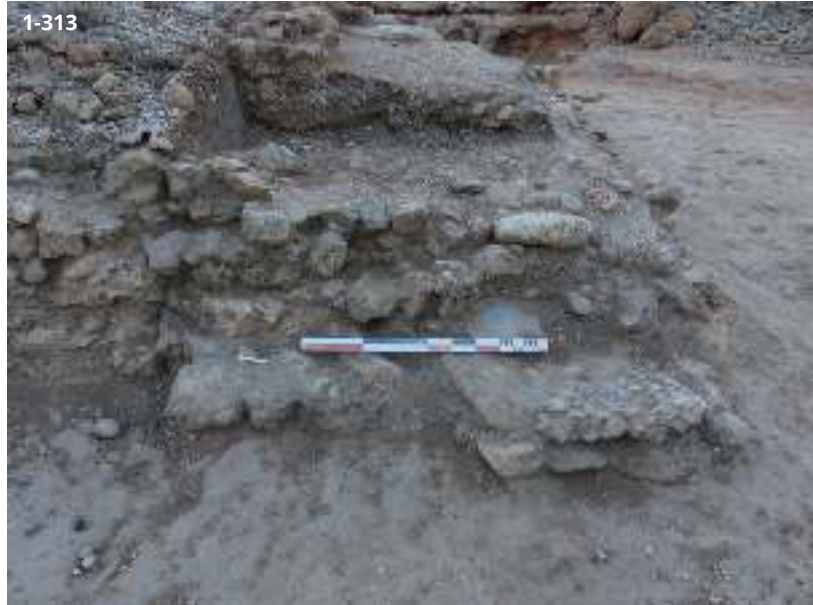
Fig 1-313 : the steps B197-10

At east, the construction **B197-10 (Fig 1-313)** is very badly preserved but several lines of stones might be the remains of damaged steps. The lowest one, leaning against the wall B197-06, is made with plaques of bedrock, protruding for around 0.50m from the alignment of the wall B197-06. A second step can be seen above by the alignment of few medium limestone blocks and a third one can more be guessed than observed and the other ones have entirely disappeared.

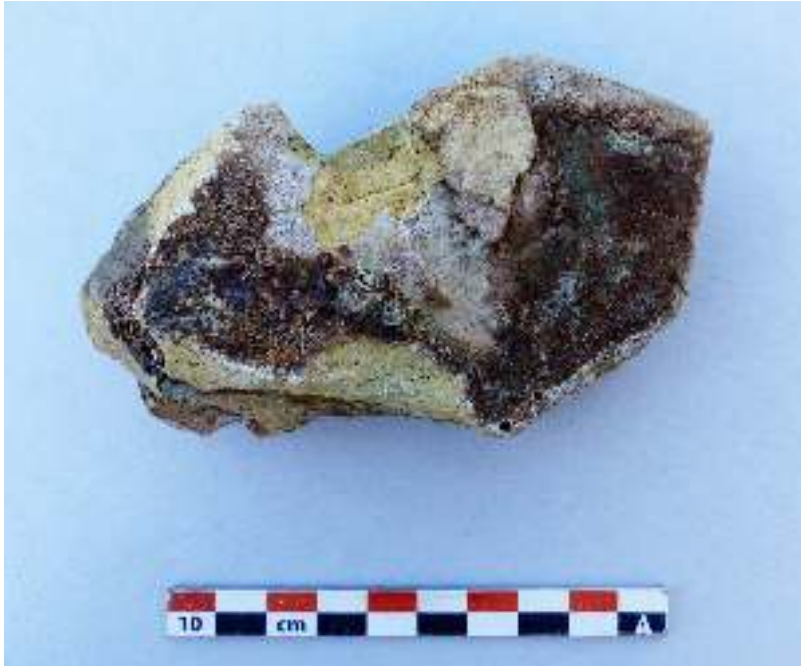
Fig A- 85: *Waste of cross*
(UF 6046 B41-15)

II-D1.h Tiles (**Fig A-85**)

Two fragments of green glazed tiles in shape of cross were found in the workshop. This indicates that from the beginning of the 14th century, it produced decoration elements of the Great Mosque at Qalhat.

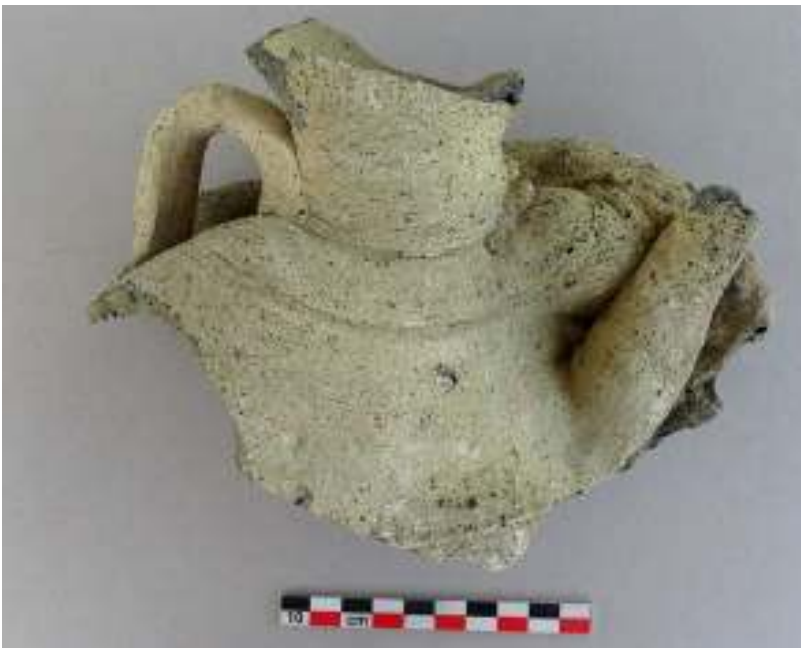
Fig A- 87: Waste

The agglomerates of ceramics (**Fig A-87**) or tripods (**Fig A-88**) are clues of firing techniques. Tripods were found in bowls agglomerates. Comparing the evolution of the number of tripods by phases with glazed bowls and unglazed bowls, it was observed that the tripods are always used with glazed bowls (**Fig A-89**). Different sizes of tripods correspond to the diameters and thicknesses of the various types of bowls. So that the glazed bowls do not stick, potters put tripods between each piece. An agglomerate of large jars shows that they were superimposed by neck in the firing room.

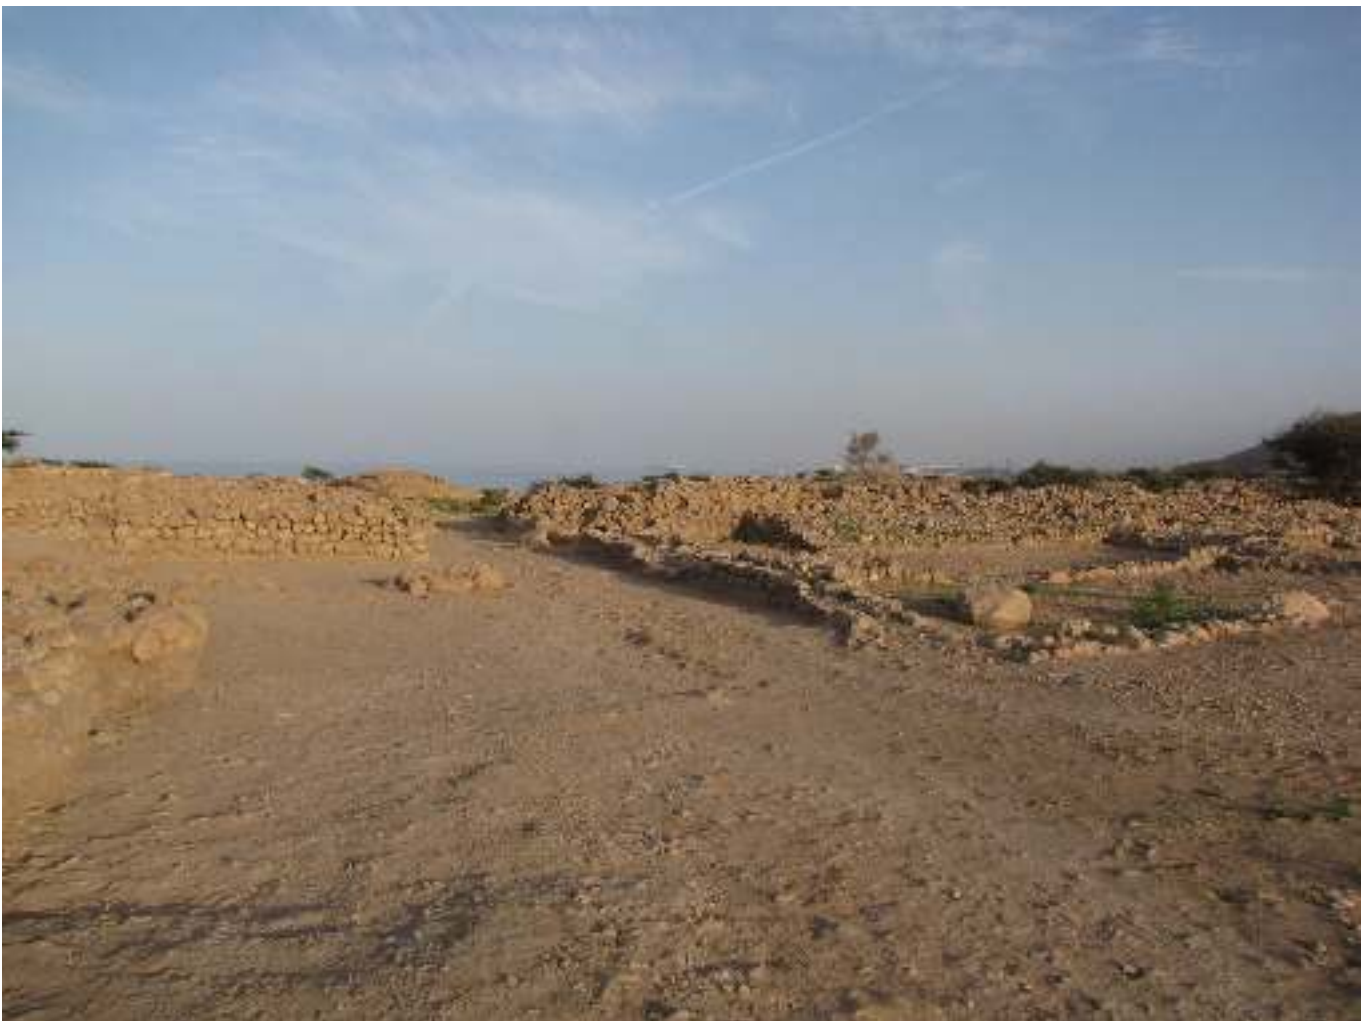
Fig 3-1 : general view of the west gate (B31), from the outside of the city

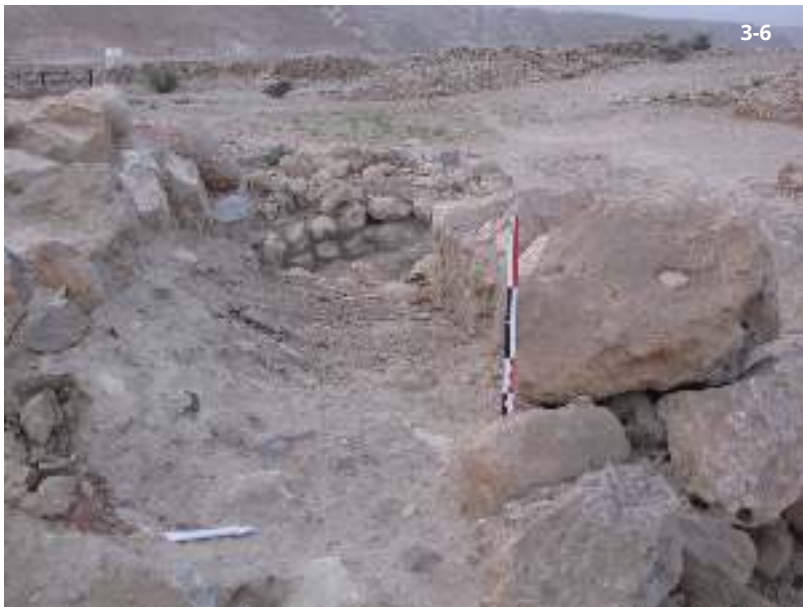
Fig 3-6 : the crossing hole B31-08

Two rectangular holes crossing the wall were observed in the south wall B31-01, and others similar fittings were observed elsewhere in the fortification wall B6. The north one, B31-08, (Fig 3.6) is set around 2.60 m south of the south jamb of the gate B31-06. The south side of the crossing hole is partially collapsed, the bottom is very damaged and the top has disappeared. The structure is actually preserved for no more than 0.20 m high and its width varies from 0.36 m at west to 0.56 m at east. Its actual length is 1.10 m, the east and south extremities having collapsed but it was originally as long, like the width of the wall.

The functions of those holes is yet unclear. As their bottom is about 1.40 m to 1.5 m higher than the ground, they can have been used as scaffolding holes, or beamholes to support the assumed walkway for the guards. They can also be interpreted as arrow or gun loops but their asymmetrical setting and the fact that the western buildings were obstructing the view are not in support of this interpretation. Maybe further excavations of the others holes visible in the fortification wall could bring an answer to this question.

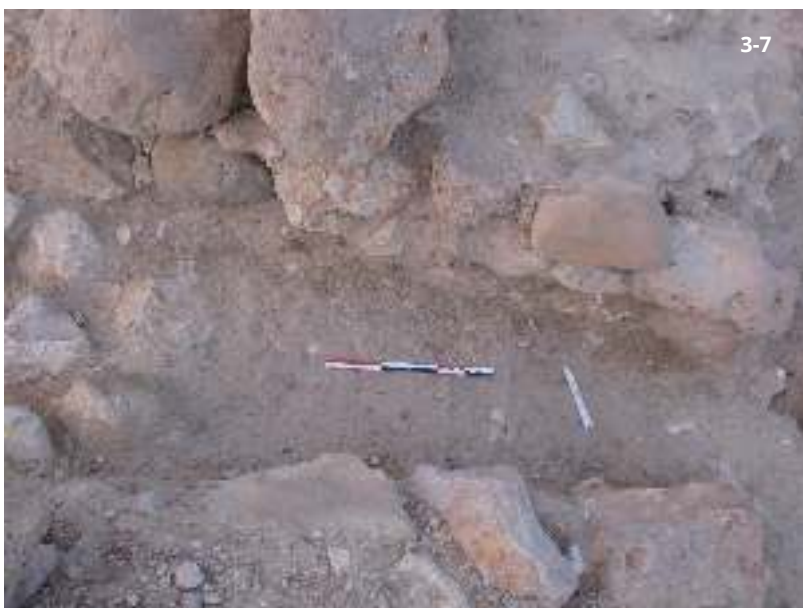
Fig 3-7 : the crossing hole B31-07

The south hole B31-07, (Fig 3-7) around 4.5 m south of the north one, is preserved for a little more height, around 0.45 m for two courses of stones and its width also varies from 0.47 m at west to 0.27 m at east, asymmetrically of the north hole B31-08. Its actual length is along 1.35 m but it was also originally around 2.60 m, as the width of the wall.

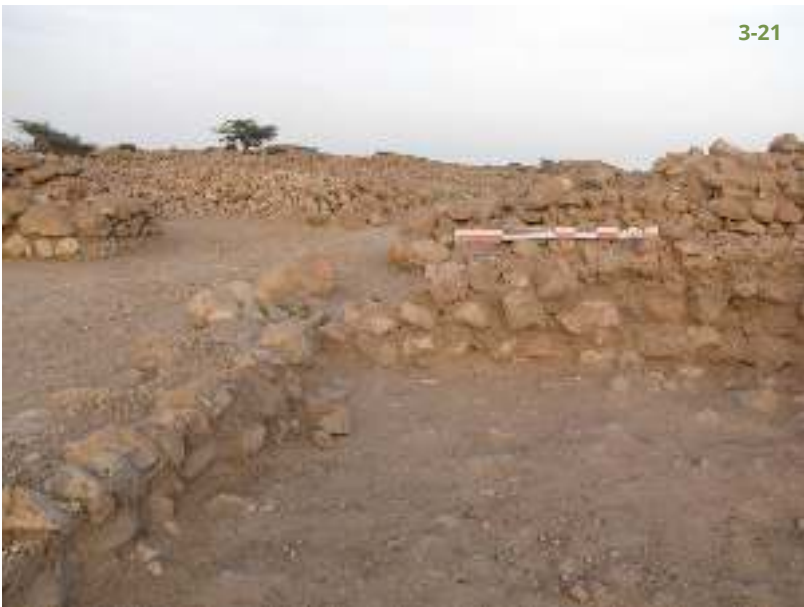
The north limit is made by the wall B280-01 and the eastern limit is made by the connected wall B280-07 and the wall B280-08 leaning against it. The wall B280-07 (Fig 3-21) is 2.65m long by 0.80m wide for a preserved elevation of 0.80m high, made of four regular courses of medium limestone blocks bounded with earth.

Fig 3-21 : the wall B280-07, inside elevation

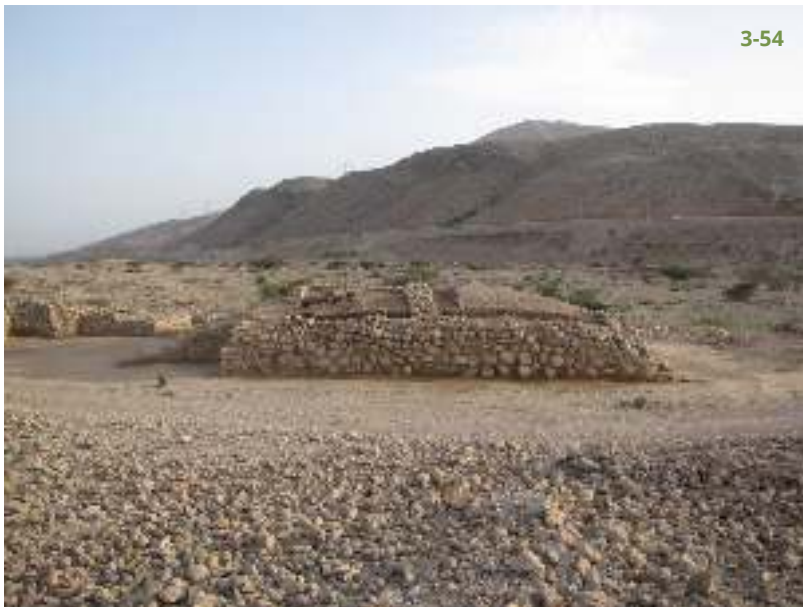
Fig 3-54 : general view of the building B29 at the end of excavations from the north, with the rooms B29-A and B29-B on each sides of the dividing walls B29-04 and B29-30, on top

As most of the elevation of the first floor seems to have been pillaged before the general collapse it is very difficult to assumed the original height of the building. It is very likely that the walls of the prayer hall were at least 2 m high but the walls of the room B29-B could have been lower, less than 1 m high, and have only consist on a guard-rail. Also, the prayer hall must have been covered by a roof, maybe only made by palms, but the room B29-B could have been at open sky. In any case, the fragments found in the collapse strongly suggest that the building was covered by simple coating without any particular decoration. It is possibly this simplicity which explains the use of a platform, to distinguish the religious buildings from the civilians nearby.

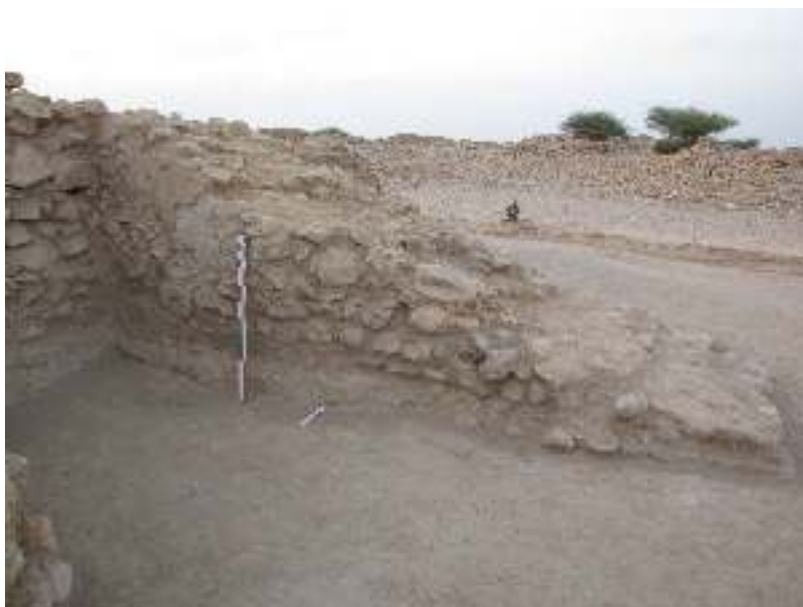
Fig 3-56 : the south side of the stair B29-33, with the beige coating on top at left, the gray coating at feet and the disturbed facing at right

Several remains of coating were observed on both sides of the stair, with a beige one on the upper part and a strong gray one, similar to cement, all around its foot. The north and south sides have also suffered a pressure, due to the internal filling, which has pushed the elevation to the outside and some of the stones from the facing have either collapsed or slide, explaining why the facings are not yet strictly vertical and some stones are missing (**Fig 3-56**).

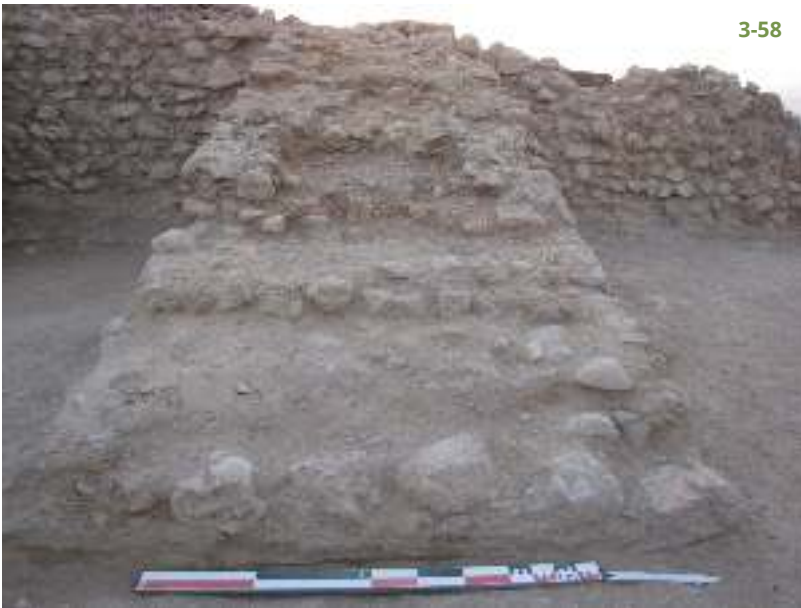
Fig 3-58 : *the first two steps (in the foreground) and the upper steps (guessable in the background) of the stair B29-33*

The upper steps are more damaged and it is difficult to be affirmative about them (**Fig 3-58**). They were apparently bounded at north and south by a handrail, which is very badly preserved, and so were smaller than the low steps, about 0.80m long by 0.60m wide. They could also have been higher, probably 0.50m but five steps about 0.30m high were probably enough to reach the east upper gallery, where one large step or two small ones were sufficient to reach the floor of the room B29-B.

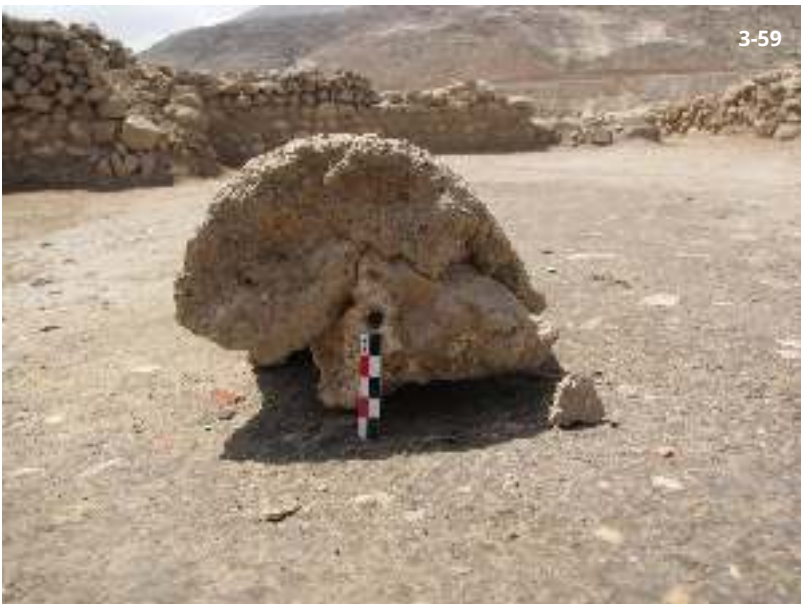
Fig 3-59 : *lateral view of the possible remains of a handrail (IsoArc 1165)*

In the layer of collapse (**Uf5531**) excavated around the stair B29-33, a fragment of masonry with a half-round face covered with strong gray coating (**IsoArc1165** ; **Fig 3-59**) was found. According to its location, it could be the remains of the handrail outlying the upper steps, the top of which was half-round. This handrail could have been very low, no more than 0.50m high, as some examples of stairs with low handrail are still visible today in the oldest houses of the actual village of Qalhât. The handrail could have extended until the walls B29-05 and B29-27 and have the same height; in this configuration, the access to the upper gallery in front of the room B29-B was blocked by the pursuit of the handrail, and was so probably not used as a passageway.

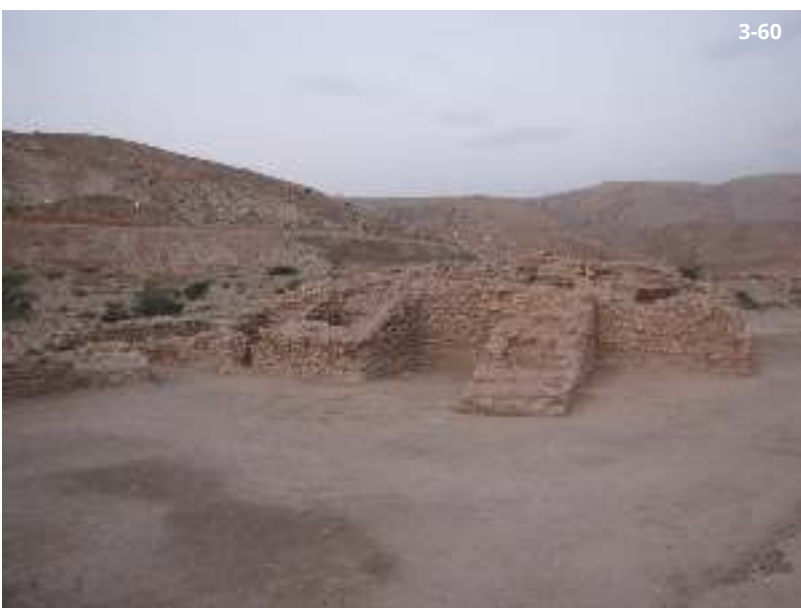
Fig 3-60 : *general view of the east side of the building B29, with the stair B29-33 at right*

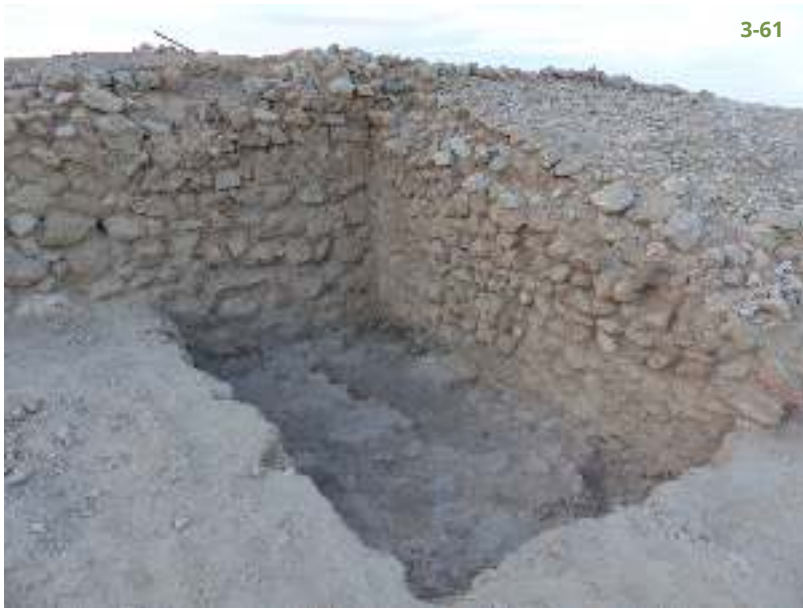
Fig 3-61 : the wall B29-06 (at right) leaning on the wall B29-03 (at left)

The room B29-C is delimited to the east by the wall **B29-06 (Fig 3-61)**, which is built against the wall B29-03 and over the bedrock partially leveled. It is 3.76m long and 0.60m thick for a preserved elevation from nearly 2m near the wall B29-03 to 0.80m at its south end. It is made with medium pebbles and limestone blocks bonded with earthen mortar with few remains of coating.

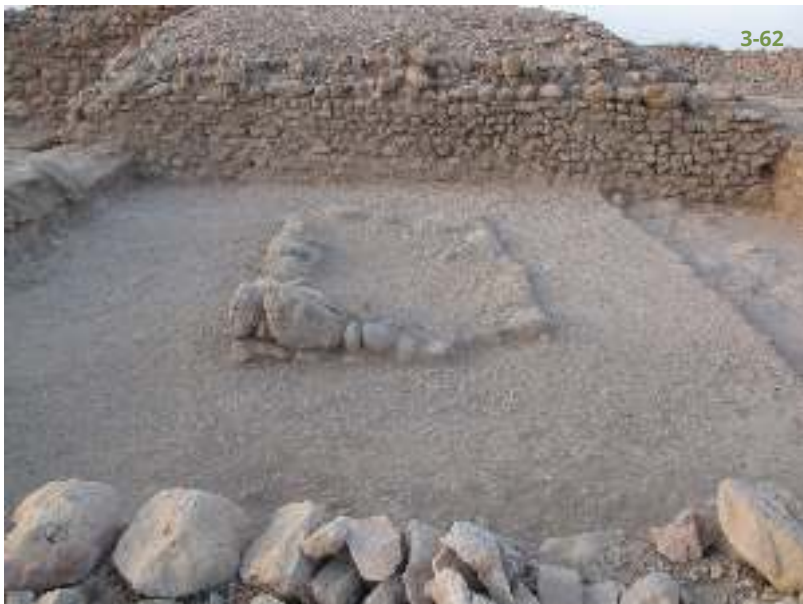
Fig 3-62 : the wall B29-08, in the background

The south limit is made by the wall **B29-08 (Fig 3-62)** which is common with room B29-D. It is here 6.30m long and 0.65m thick for a preserved elevation of 0.80m in average, made with medium pebbles and limestone blocks bonded with earthen mortar and few remains of beige coating were observed in the lower parts of the wall.

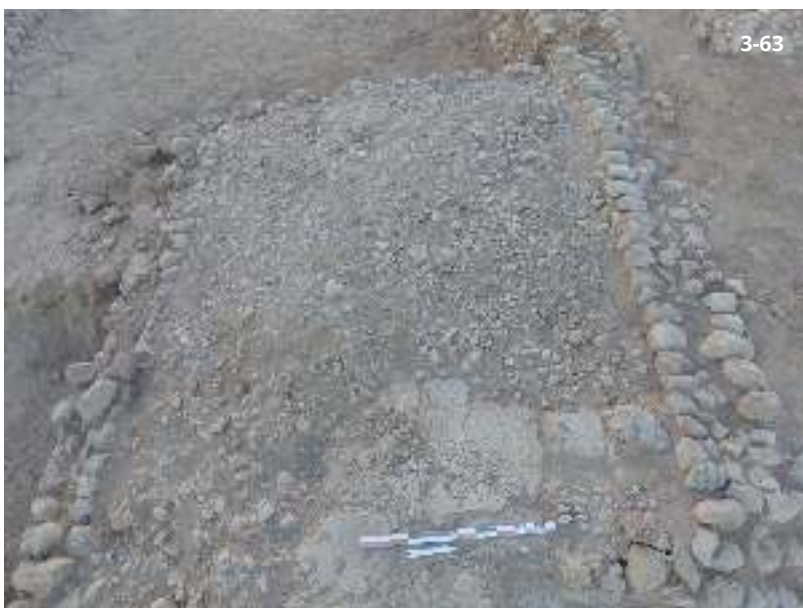
Fig 3-63 : general view of the room B29-C with the level of backfill Uf5510, mainly made of rocks

The top of the room B29-C was only cleaned as quickly appeared a level made with small rocks, gravels and pebbles (**Uf5509** and **Uf5510**), which was not looking as collapse (**Fig 3-63**). A sounding (SD8) opened to the north of the room confirmed that this layer goes at least 0.50m downwards, and probably until the bottom of the construction (**Fig 3-64**). The room B29-C, internally 5.50m long by 3.30m wide, was so a high terrace, only usable at first floor and reachable through the room B29-B or the east upper gallery, or by both. A remain of a beige to gray coated floor **B29-11 (Fig 3-65)** was found in the north-east quarter of the room and was probably covering all the top of the structure. According to the volume of collapse (**Uf5511**) excavated south of the room, it is very unlikely that there ever was any elevation at first floor, apart from a small wall probably bounding the edges of the terrace. Even if there is no clue to be affirmative, it is also strongly probable that the space was not covered by a roof and was used as a high terrace at open sky.

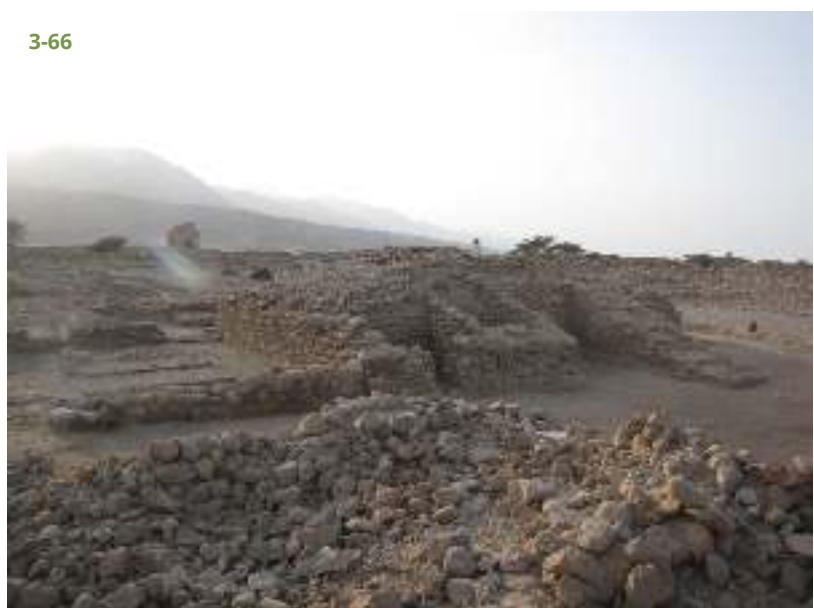
Fig 3-66 : *general view of the rooms B29-D and B29-E, with the high terrace B29-C behind*

The room B29-C is bounded to the east by two square small rooms B29-D and B29-E at ground level, which were built at the same time though an internal later refitting has probably occurred. (**Fig 3-66**).

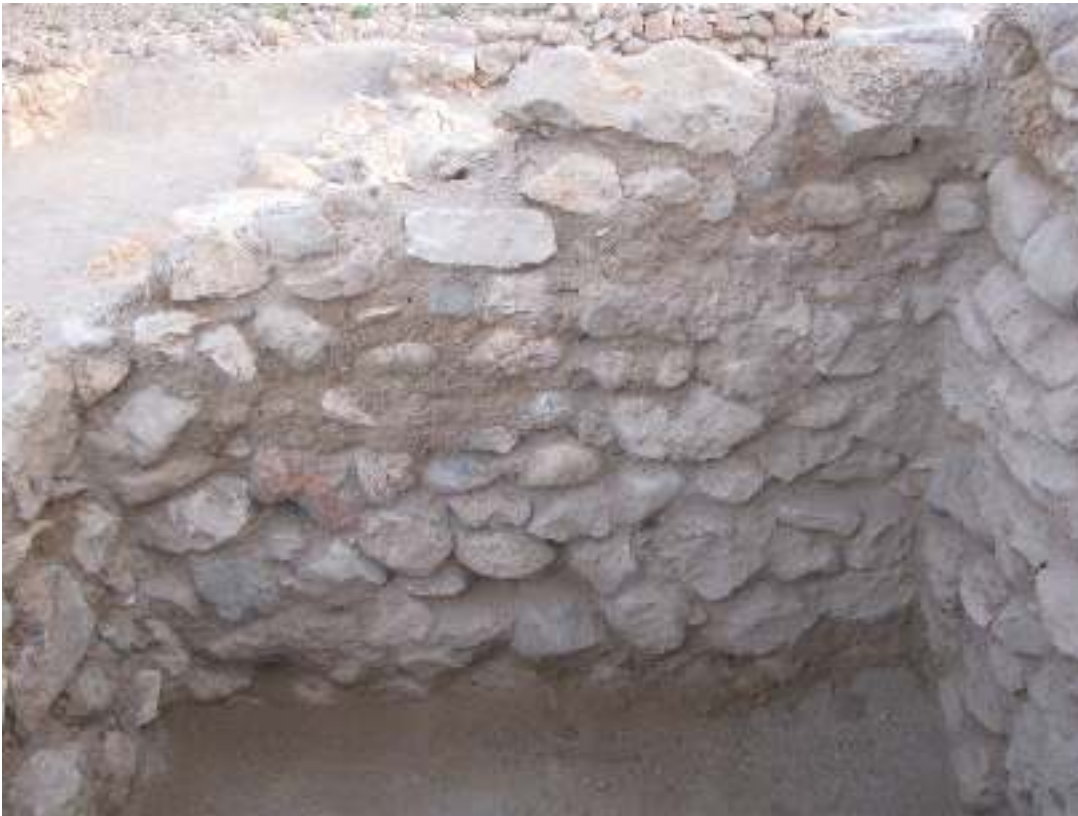
Fig 3-67 : the internal elevation of the wall B29-08 in room b29-D

The south room B29-D is now 1.70m long by 1.30m wide and is reachable at east by a very narrow gate. The south limit is made by the wall B29-08, common with room B29-C and which is here 1.30 m long internally and 0.70m thick for a maximal preserved elevation of around 1.30m (**Fig 3-67**). The west limit is made by the wall **B29-07 (Fig 3-68)** which is also the east wall of the room B29-C. It is 1.60m long and 0.55m thick for a maximal preserved elevation of 1.80m; it is made with large and medium pebbles and limestone blocks poorly bonded with earthen mortar and without any remain of coating.

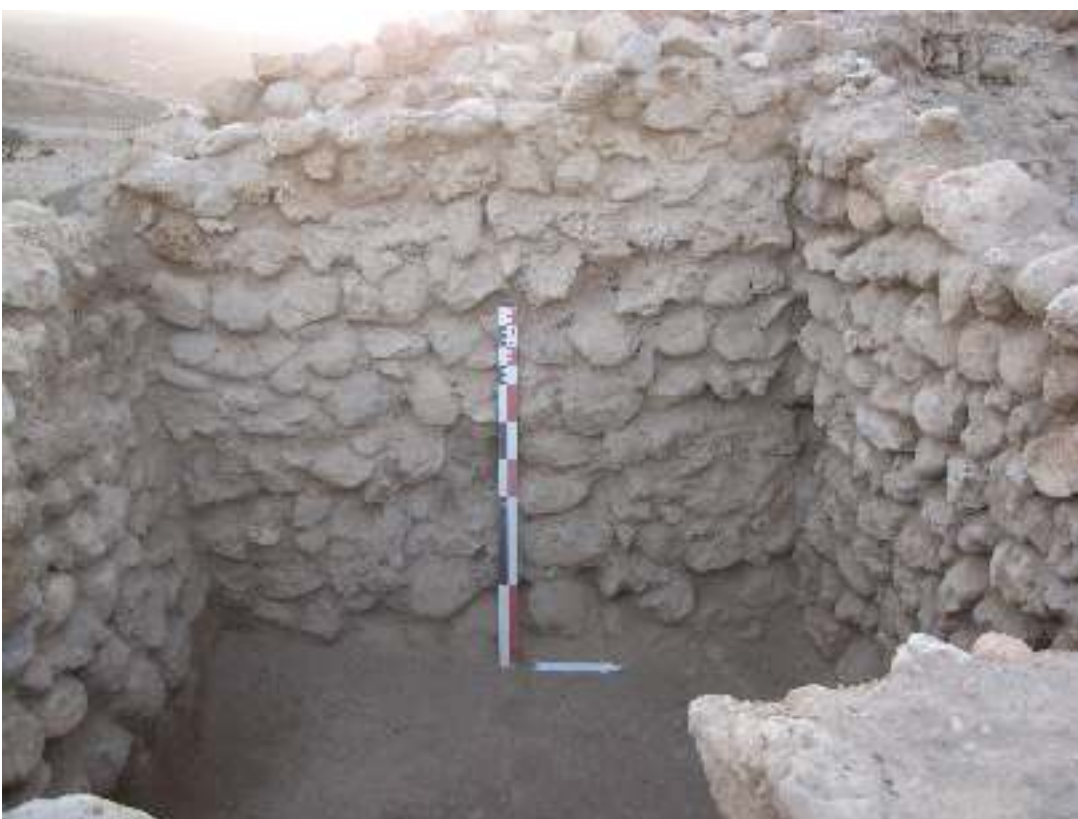
Fig 3-68 : the wall B29-07 in room B29-D

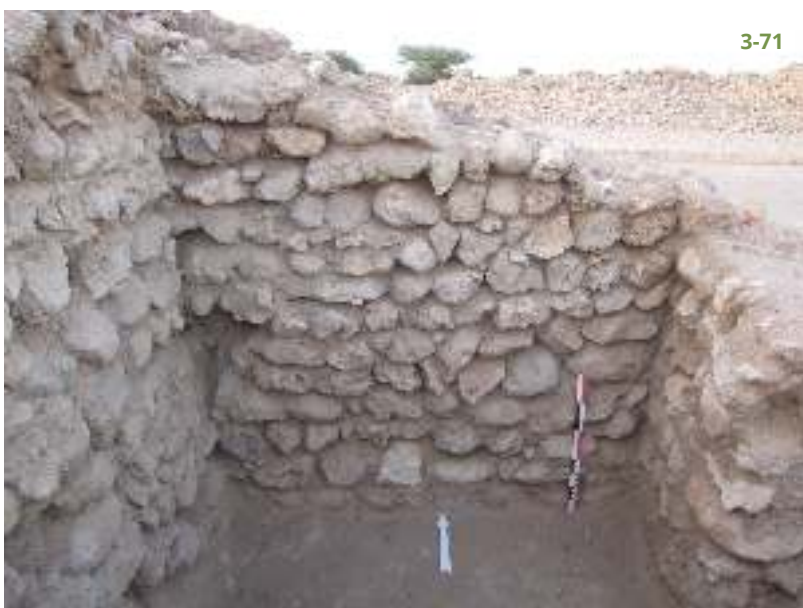
Fig 3-71 : the wall B29-23 in the room B29-D

The north limit of the room B29-D, and its separation with the room B29-E is made by the wall **B29-23** (**Fig 3-71**), which is a wall with only one facing on the south side. If it is leaning on the wall B29-22 to the east, its west connection is more complex as it is leaning on the wall B29-07 in its low half but enters into it in its upper half (**Fig 3-72**). The most convenient explanation for this unusual connection is that a niche was in existence north of the wall B29-07, around 1.50m above the ground, and that the wall B29-23 was built against its south facing.

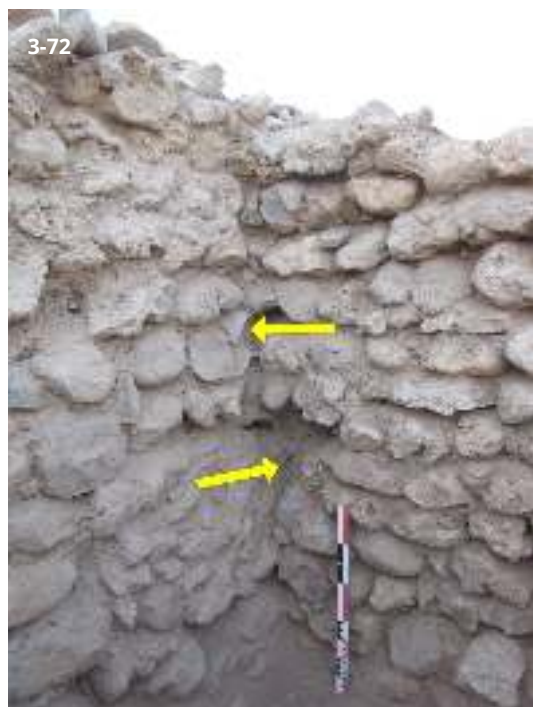
Fig 3-72 : the complex connection between the walls B29-07 (at left) and B29-23 (at right)

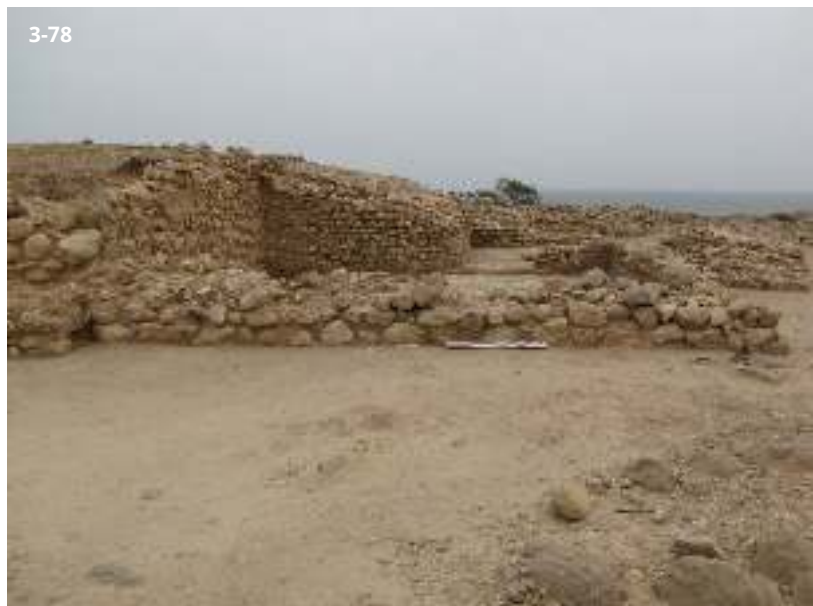
Fig 3-78 : *the wall B29-10, outside elevation*

The south-west courtyard, 6.50m long by 5m wide, is set against the south side of the prayer hall B29-A and the high terrace B29-C to the east. The west limit is made by the wall **B29-10** (Fig 3-78), 7.30 m long and 0.75 m thick, 0.60 m high in average, built with large pebbles and limestone blocks bonded by earth. No coating was found on the outside face, but the internal elevation is partly covered with the strong gray mortar (Fig 3-79).

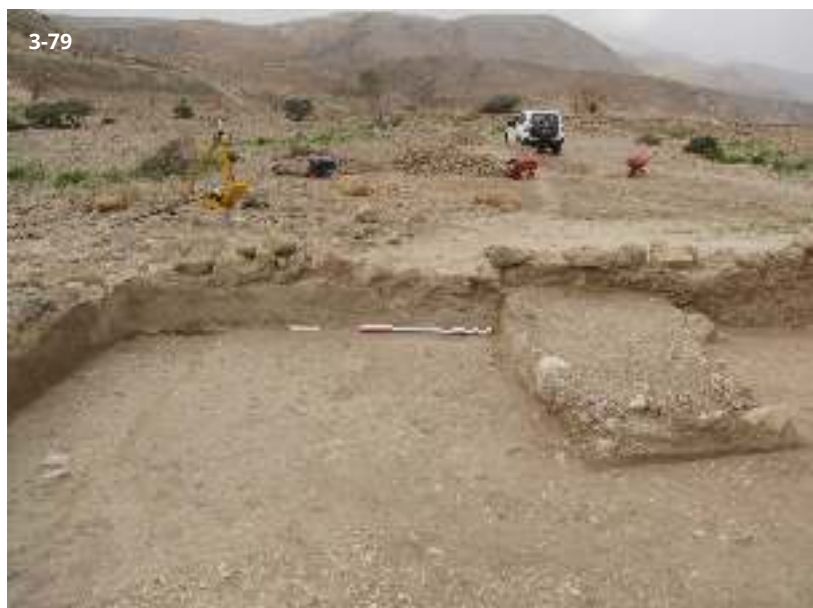
Fig 3-79 : *the wall B29-10, inside elevation*

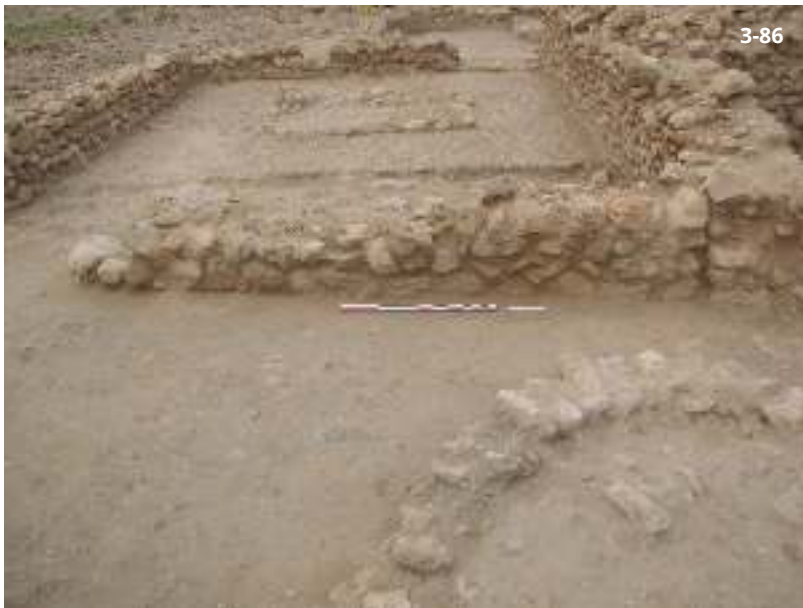
Fig 3-86 : the wall B29-15, outside elevation

The east limit is made by the wall **B29-15** (Fig 3-86), 4.40m long, 0.70m thick and 0.50m high in average, leaning on the high terrace to the north and made with large pebbles and limestone blocks bonded with earth. The south limit is made by the wall **B29-13** (Fig 3-87), 8m long, 0.65m wide and 0.50m high in average, built in the same way. Between these two walls, in the south-east corner of the courtyard, an opening without any particular fitting is the access to the south-east courtyard and beyond to the south-west one (Fig 3-88).

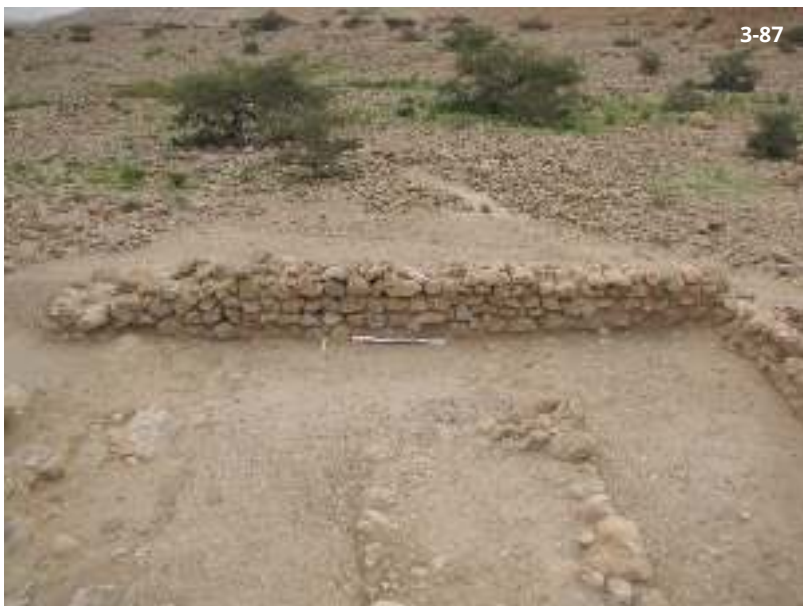
Fig 3-87 : the wall B29-13, inside elevation

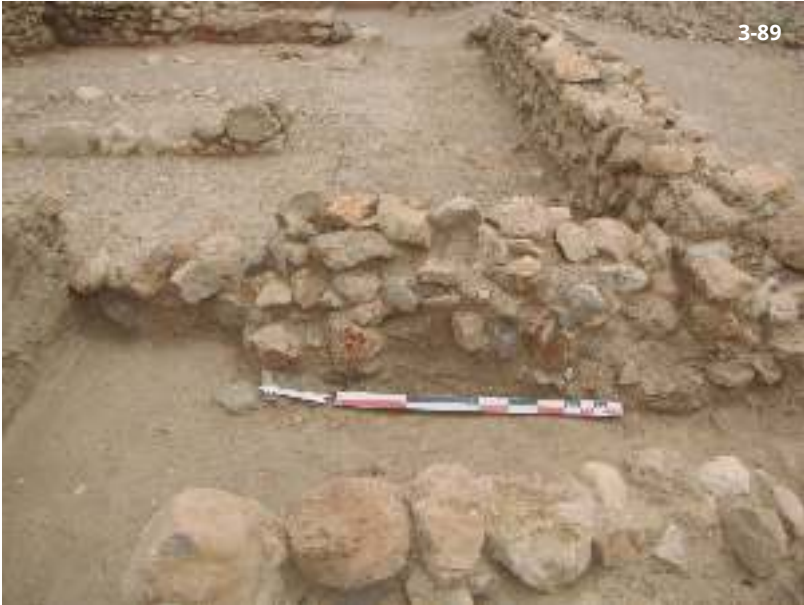
Fig 3-89 : the wall B29-14, outside view

To the west, the limit is made by the wall **B29-14 (Fig 3-89)**, which is leaning on the south wall B29-13 of the south-east courtyard and on the south wall B29-16 of the south-west courtyard and has only one internal facing. It is possible that this wall is a later addition related with the wall B29-31 to the west (see below) and that the passage was originally opened.
