Qalhât Development Project, Season 2015B-2016A, Final Report

SEASON 2015B-2016A

FINAL REPORT

Excavations on the Ceramic Workshop B41

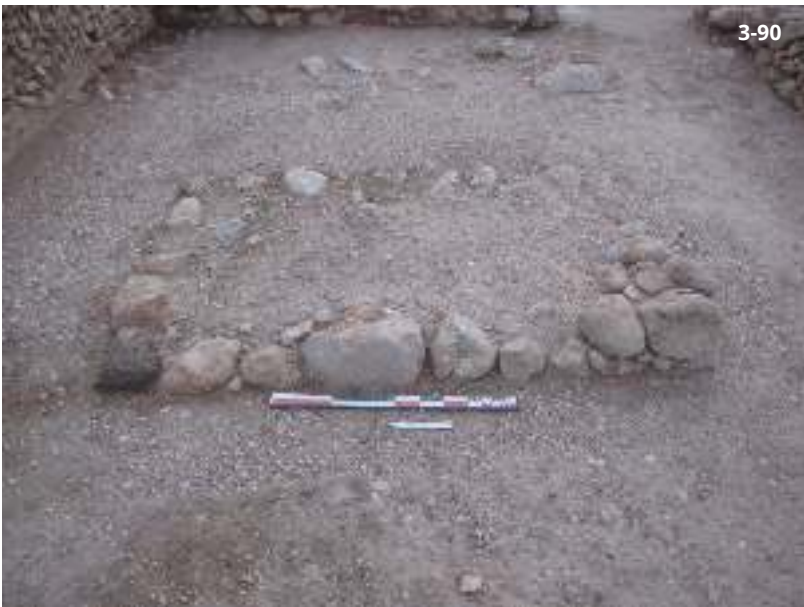
Fig 3-90 : the grave B29-17

Nearly in the center of the south-east courtyard, a rectangular structure (**B29-17; Fig 3-90**) was also unearthed. The structure, 2.80m long by 1.90m wide, was damaged by the collapse and some of it was accidentally removed during excavations before its identification. The south-west corner is however well preserved and the structure was originally at least 0.40m high. As for the grave B29-18, the structure B29-17 was made with a formwork of massive pebbles and limestone blocks, nearly without binder, and afterwards filled with small pebbles and gravels. No remain of coating was here observed. According to its location and shape, this structure must also be identified with a masoned grave, similar to the western one but simpler made.

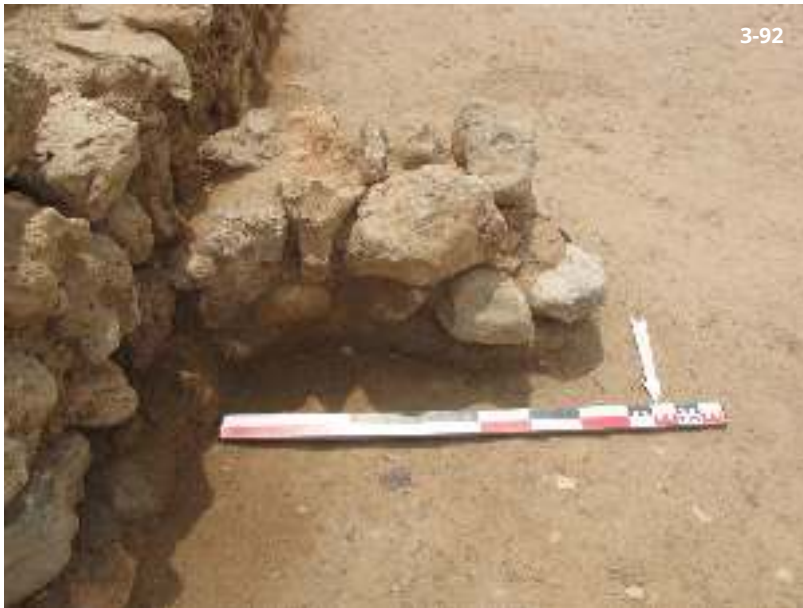
Fig 3-92 : *the small wall B29-36*

To the west, a very small wall (**B29-36 ; Fig 3-92**) was found, built against the wall B29-12. It is now only 0.75m long, 0.50m thick and 0.40m high and, as it is built above the circulation floor and not over the bedrock, it could reasonably be considered as a late addition and its function remains unknown.

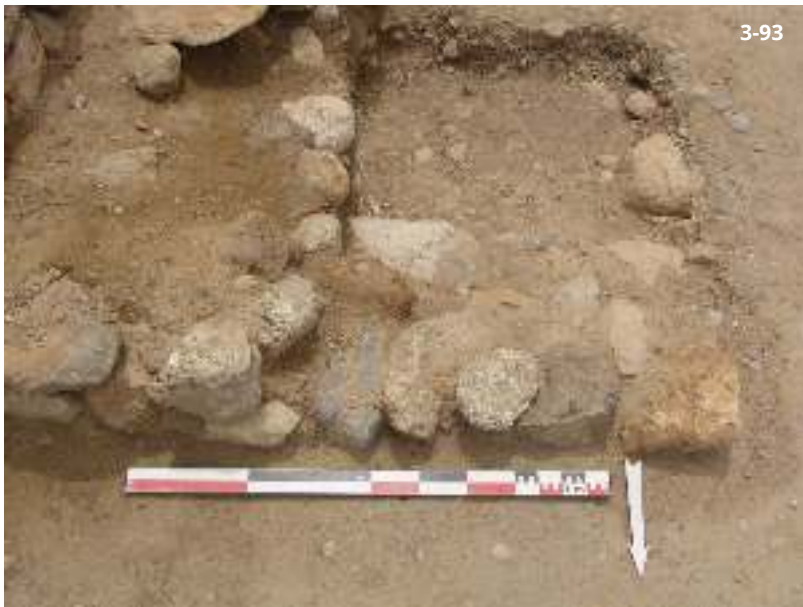
Fig 3-93 : *the low wall B29-35*

To the north, the low wall **B29-35 (Fig 3-93)** is also problematical. It was observed for 1.60m by 0.70m wide and is preserved for one to two courses of stones, made by large and medium pebbles and limestone blocks bonded with mortar and partially covered by the circulation floor. It might extend westward and, to the east, it goes under the wall B29-12 and the corner of the walls B29-01 and B29-02, with which it is perfectly aligned. It could so be part of a former building entirely leveled and of which nothing visible remains. It can also participate to the original setting of the building. The wall B29-35 might have been built first, not much higher than it is today, to indicate the direction of Mekka, and it was shortly after used by the builders to make the whole building, following the orientation given by the low wall. This is only a hypothesis but there is no much better explanation.

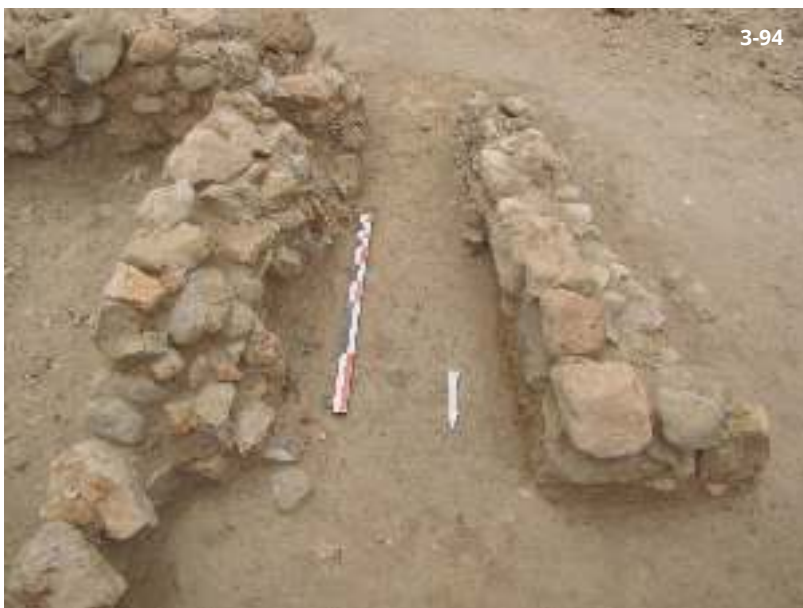
Fig 3-94 : *the wall B29-31, at right*

At the junction of the two south courtyards, a small and badly preserved wall (**B29-31 ; Fig 3-94**) was uncovered. It is now 2.40m long, 0.55 m to 0.80 m wide, and 0.40 m high, made with medium pebbles and limestone blocks bonded with earth with a facing to the east, north and west, the south part being too damaged to be known. The bottom of this wall is a little bit higher than the foundations of the enclosure walls of the courtyard and could be a later addition. The space between this wall and the east wall B29-14, which has no facing on this side, was filled with pebbles and small rocks. It is possible that a bench was made here in a late stage of the building, blocking what was firstly an access to the south-east courtyard from the west but no facing was observed to the north. It could also have been some kind of a ramp to climb over the enclosure wall.

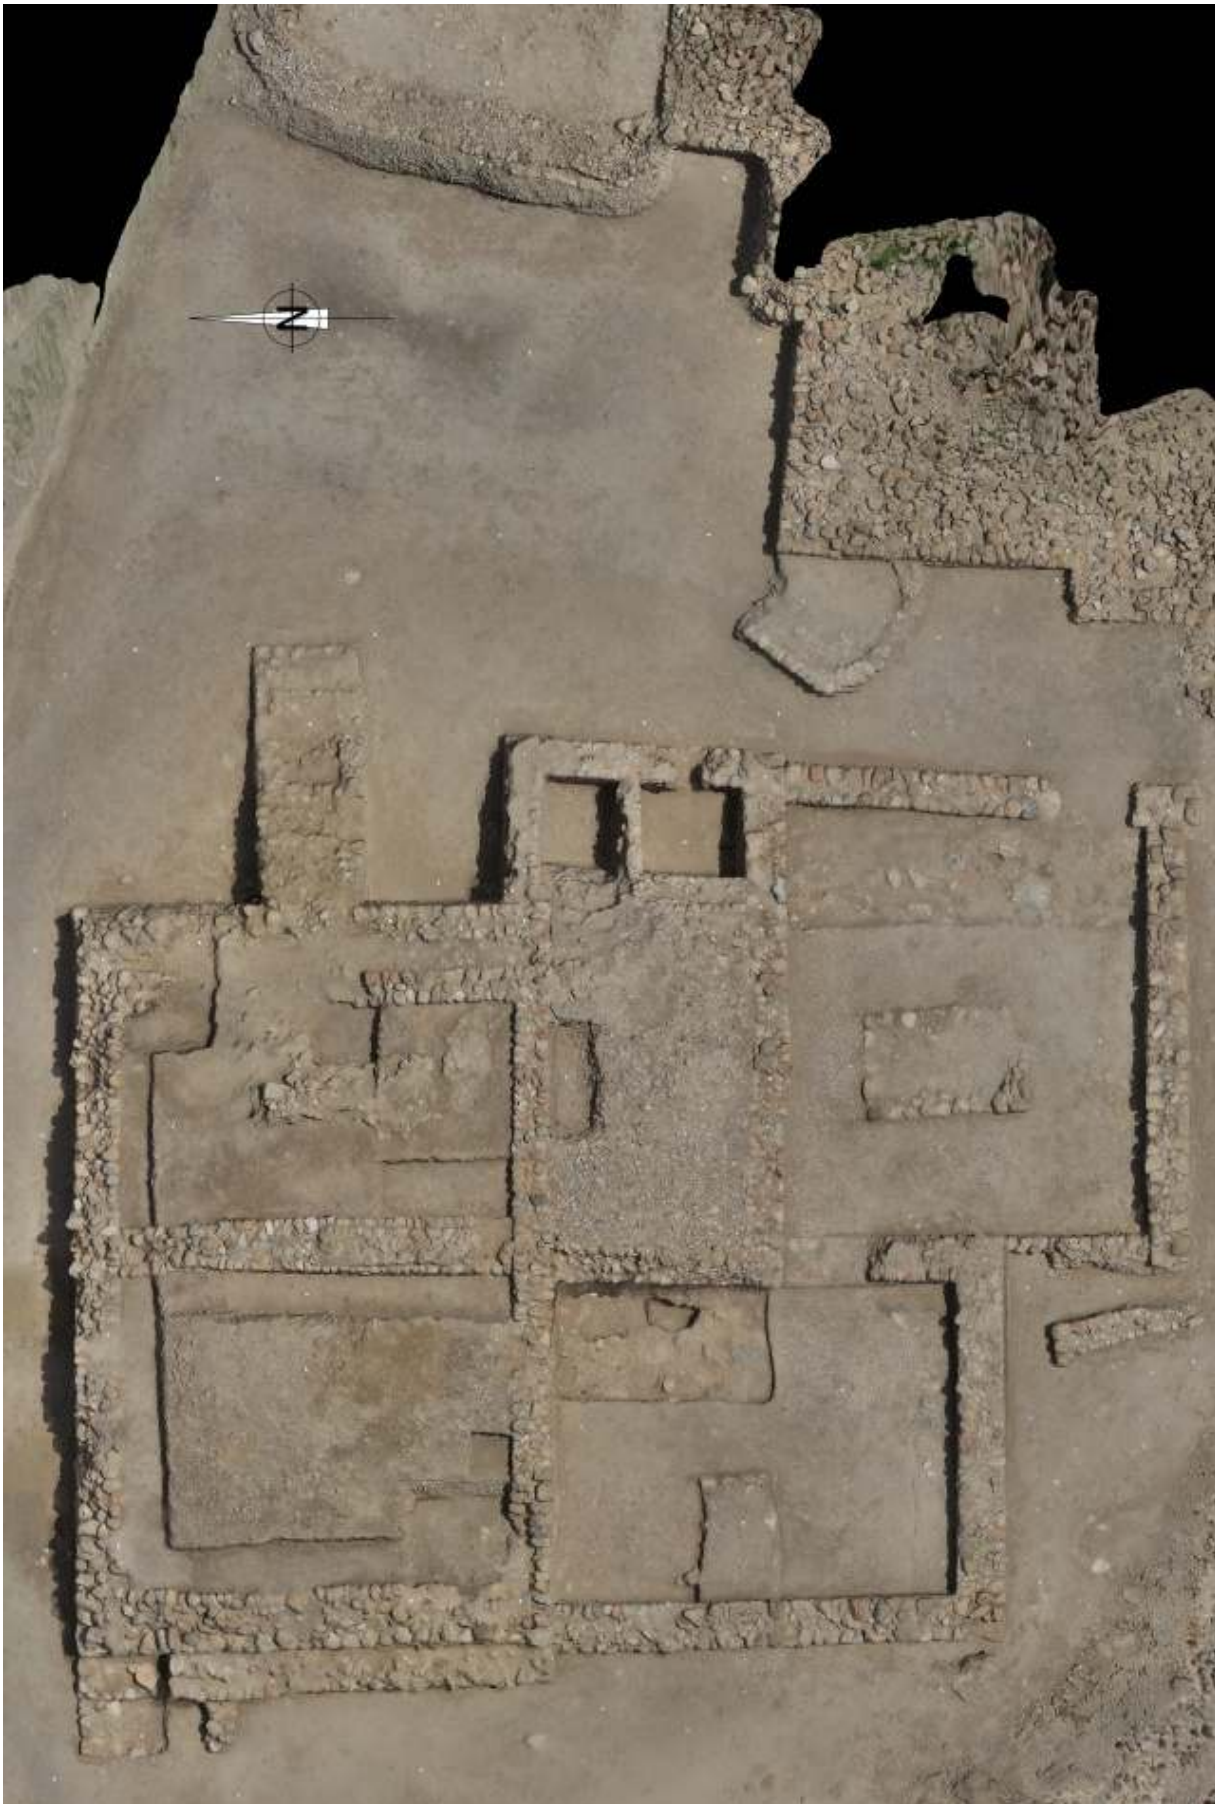
Fig 3-97 : photogrametry of the building B29 and its surroundings

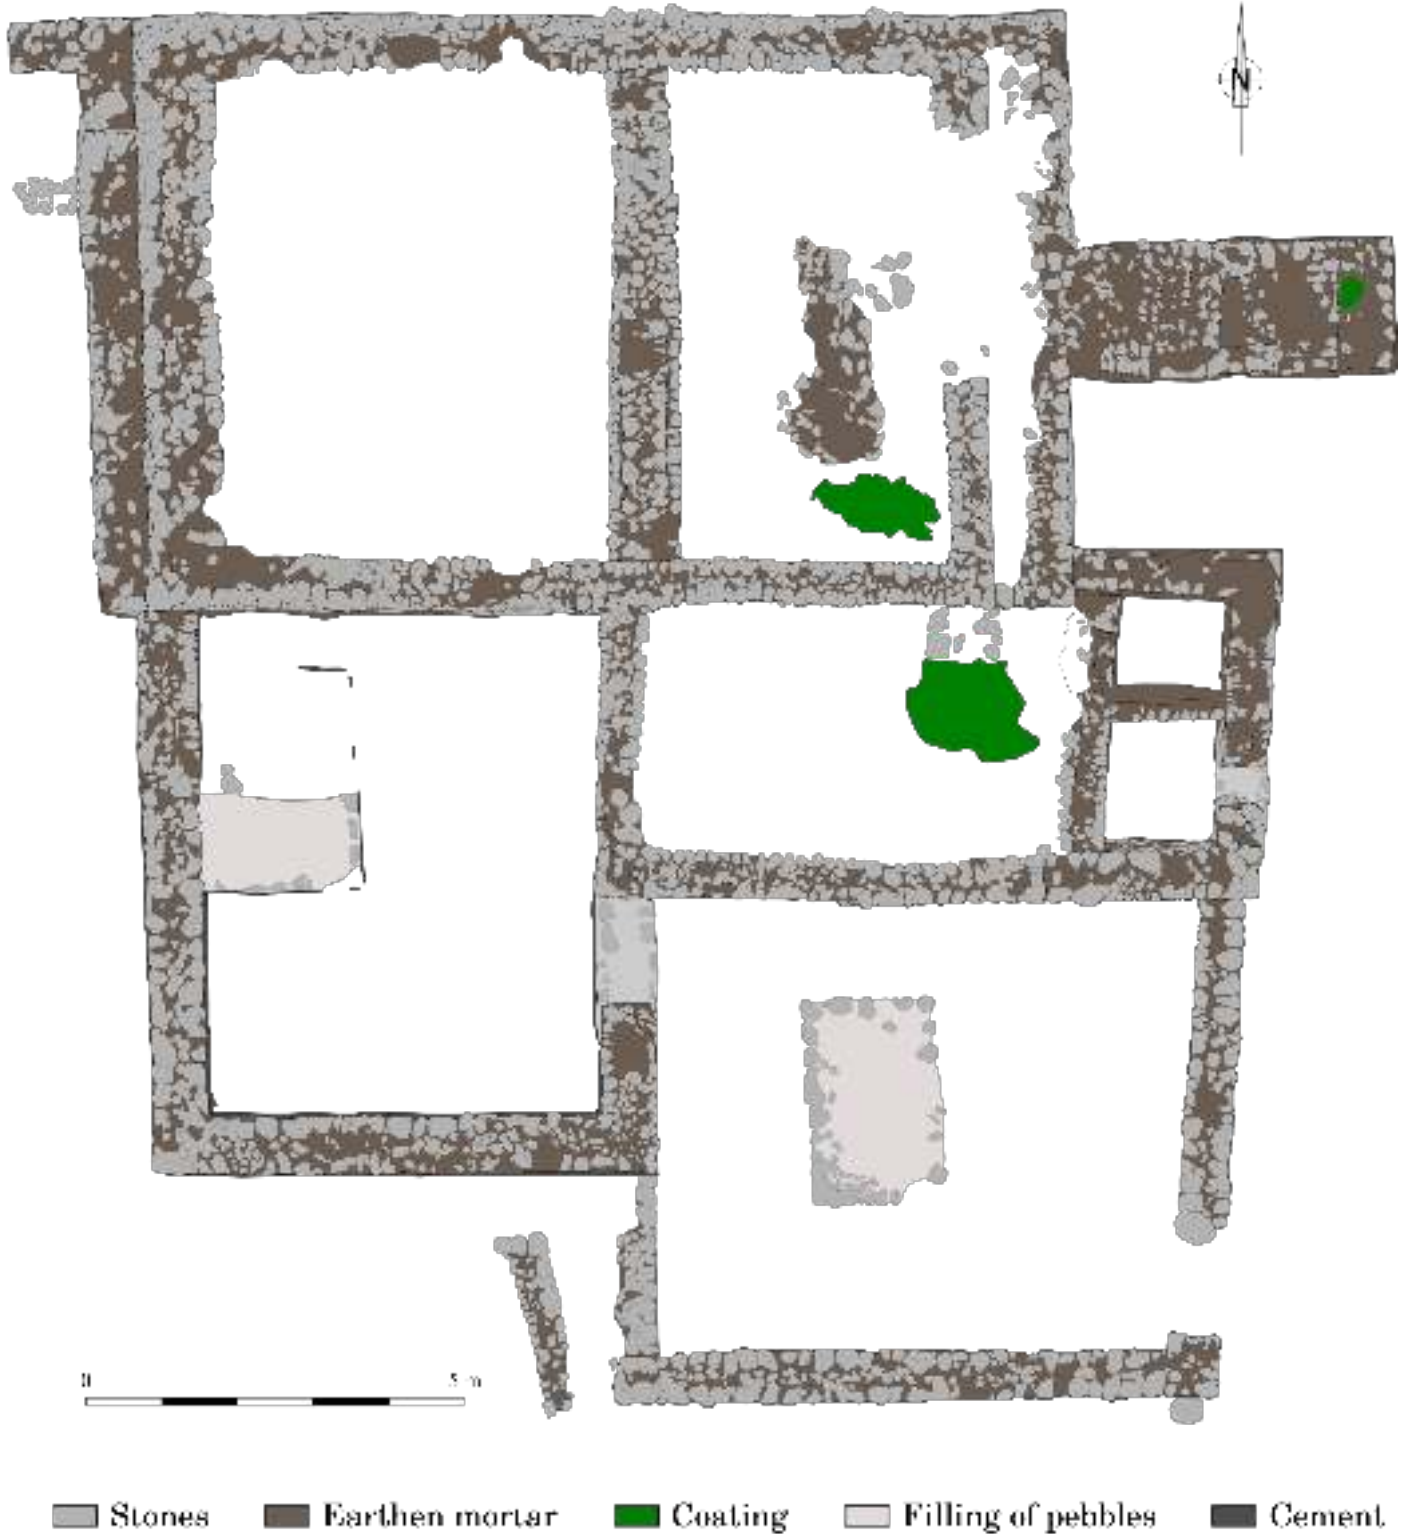
Fig 3-98 : archaeological site plan of the building B29
