## Impact of ion and neutron irradiation on the corrosion of the 6061-T6 aluminium alloy

Sarah L'haridon-Quaireau, Kimberly Colas, Bénédicte Kapusta, Bénédicte Verhaeghe, Marie Loyer-Prost, Gaëlle Gutierrez, Dominique Gosset, Sylvie Delpech

Sarah L'haridon-Quaireau, Kimberly Colas, Bénédicte Kapusta, Bénédicte Verhaeghe, Marie Loyer-Prost, et al.. Impact of ion and neutron irradiation on the corrosion of the 6061-T6 aluminium alloy. Journal of Nuclear Materials, 2021, 553, pp.153051. 10.1016/j.jnucmat.2021.153051 . hal-03412888

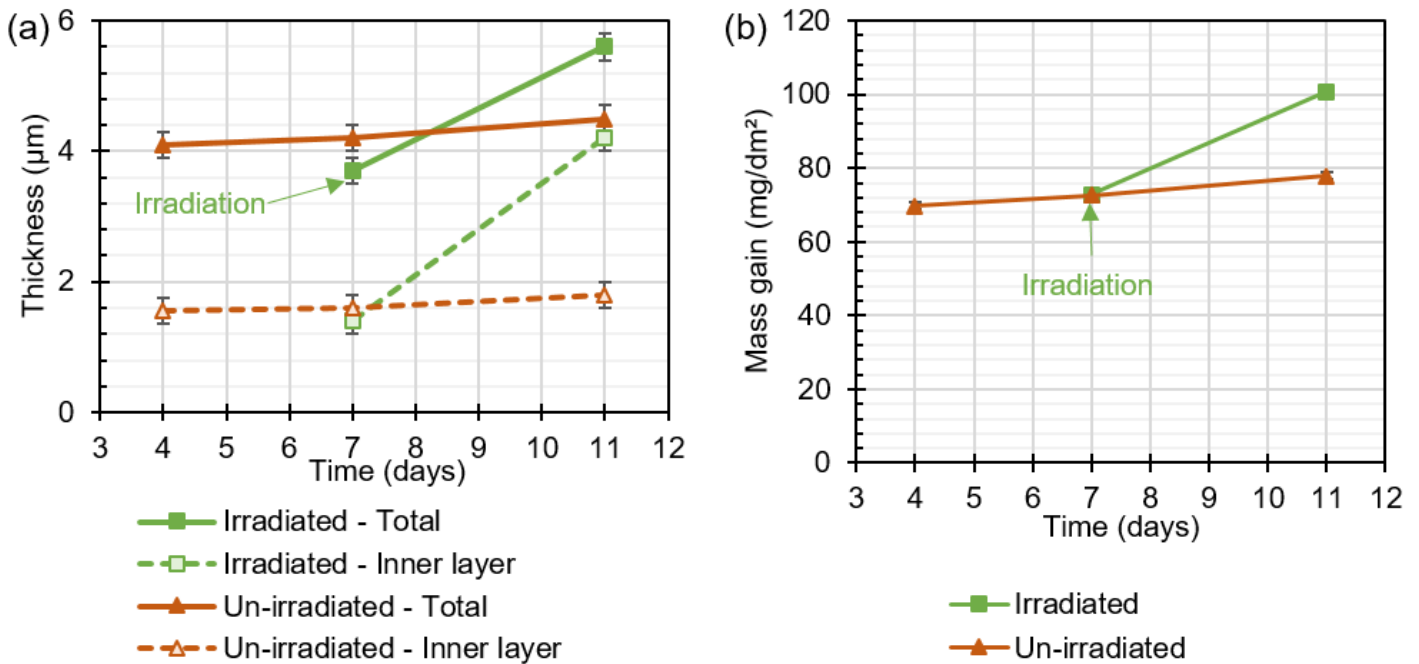
Figure 6: (a) Average thickness of the aluminium hydroxide film and (b) average mass gain of the samples unirradiated and irradiated with Al ions of successive energies 5 MeV then 1.2 MeV (the term "irradiation" on the graphics indicates when the ion irradiation occurs).

Irradiated samples are re-corroded at 70°C, for 4 days and in 2.8L of demineralised water in order to follow the evolution of the damage in an aqueous medium. After ion irradiation and re-corrosion, the aluminium hydroxide film has the same microstructure than the unirradiated film presented in Fig. 3.a: it is composed of a compact inner layer of boehmite and an outer layer of cuboid microcrystals (similar to the ones observed in Fig. 4.a). A thin intermediate layer of needle-like nanocrystallites is present between these two main layers and voids are not observed (TEM observation). The crystalline structure, [analysed by  \$\mu\$ -Raman](#), is also the same for the unirradiated samples and for the irradiated and re-corroded samples: the inner layer is composed of boehmite ( $\gamma$ -AlOOH) and the outer layer, of bayerite ( $\alpha$ -Al(OH)<sub>3</sub>, [the crystalline structure is analysed by  \$\mu\$ -Raman](#)). Traces of  $\eta$ -Al<sub>2</sub>O<sub>3</sub> are not detected by SAED. As a result, the film is fully rehydrated and the damage due to ion irradiation is not still present in the aluminium hydroxide film. However, ion irradiation has an influence on the thickness of the film. Fig. 6.a presents the thickness of the inner and outer layers and Fig. 6.b is about the mass gain of samples. The points on the curves represent the average of measurements performed on the three samples. For 11 days (which is the total corrosion time, 7 days before irradiation and 4 days after), the total average thickness of the film and the average mass gain are the most important on irradiated samples: ion irradiation increases aluminium corrosion. In addition, for 11 days, the inner layer composed of boehmite is thicker and the outer layer composed of bayerite is thinner on irradiated samples than on un-irradiated samples. Thus, ion irradiation facilitates the formation of boehmite ( $\gamma$ -AlOOH) to the detriment of bayerite ( $\alpha$ -Al(OH)<sub>3</sub>). This

Fig. 6: (a) Average thickness of the aluminium hydroxide film and (b) average mass gain of the samples unirradiated and irradiated with Al ions of successive energies 5 MeV then 1.2 MeV (the term "irradiation" on the graphics indicates when the ion irradiation occurs).
