Impact of ion and neutron irradiation on the corrosion of the 6061-T6 aluminium alloy

Sarah L'haridon-Quaireau, Kimberly Colas, Bénédicte Kapusta, Bénédicte Verhaeghe, Marie Loyer-Prost, Gaëlle Gutierrez, Dominique Gosset, Sylvie Delpech

Journal of Nuclear Materials

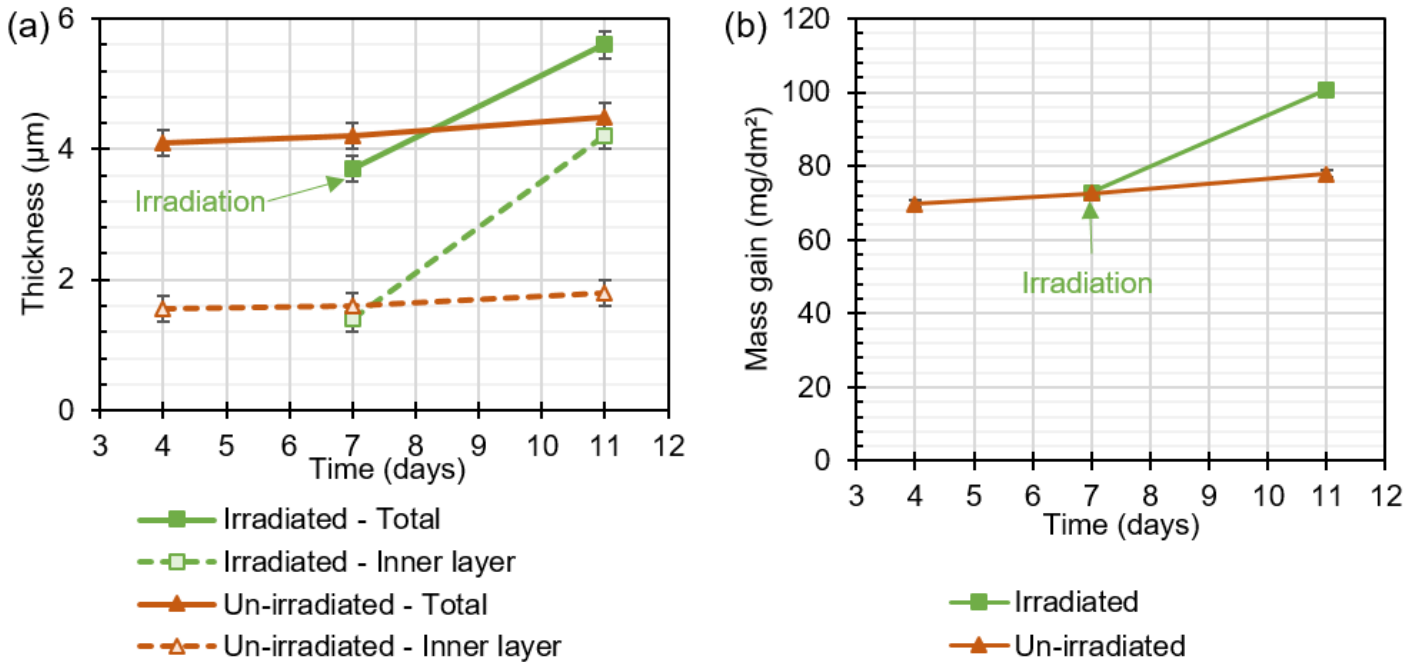
Figure 6: (a) Average thickness of the aluminium hydroxide film and (b) average mass gain of the samples unirradiated and irradiated with Al ions of successive energies 5 MeV then 1.2 MeV (the term "irradiation" on the graphics indicates when the ion irradiation occurs).

Fig. 6: (a) Average thickness of the aluminium hydroxide film and (b) average mass gain of the samples unirradiated and irradiated with Al ions of successive energies 5 MeV then 1.2 MeV (the term “irradiation” on the graphics indicates when the ion irradiation occurs).
