Impact of ion and neutron irradiation on the corrosion of the 6061-T6 aluminium alloy

Sarah L'haridon-Quaireau, Kimberly Colas, Bénédicte Kapusta, Bénédicte Verhaeghe, Marie Loyer-Prost, Gaëlle Gutierrez, Dominique Gosset, Sylvie Delpech

Impact of ion and neutron irradiation on the corrosion of the 6061-T6 aluminium alloy --Manuscript Draft--

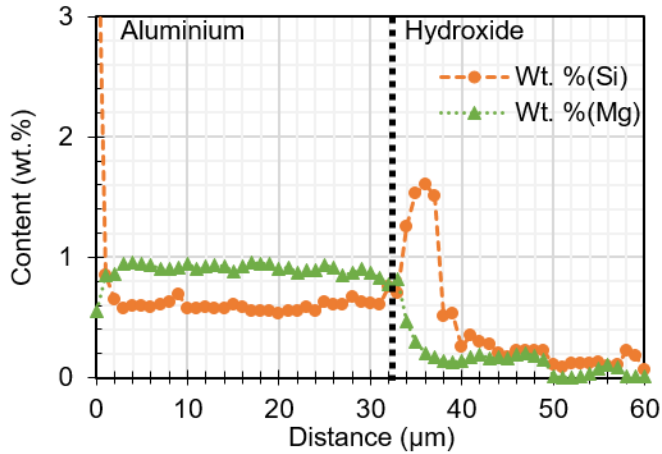
Figure 10: Chemical evolution of magnesium and silicon by EMPA in the aluminium matrix and in the aluminium hydroxide film obtained on a sample corroded for 560 days at pH 6 and at 42°C in the Osiris reactor.

Silicon enrichment of the film had already been observed during corrosion tests performed in MTR [10,39]. Magnesium content decreases from 0.9 wt. % in the alloy to 0.1 wt. % from a depth of 5/6 μm in the film. Magnesium is thus present only in the inner layer of the film and the decreasing profile of magnesium content indicates a release of this chemical element in solution after a diffusion through the film. This profile agrees with the literature: during corrosion of Mg-containing aluminium alloy, a magnesium release in solution had already been observed during unirradiated corrosion tests [3,20,39] and in an aqueous medium at a pH of 6, the stable form of

44 Fig. 10: Chemical evolution of magnesium and silicon by EMPA in the aluminium matrix and in
45 the aluminium hydroxide film obtained on a sample corroded for 560 days at pH 6 and at 42°C
46 in the Osiris reactor.
47
48
49

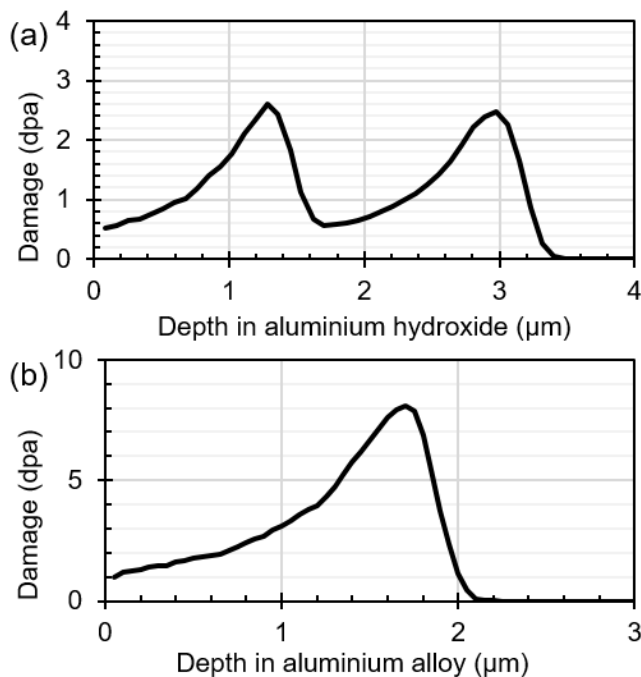
Figure 2: Damage profiles (dpa: displacement per atom) created by (a) Al ions with successive energies of 5 MeV and then 1.2 MeV irradiating the aluminium hydroxide film and by (b) Al ions with an energy of 1.8 MeV irradiating the aluminium matrix, profiles calculated by SRIM with the mode “full damage cascade” [21].

The ion irradiation experiments are performed at the JANNuS platform (Joint Accelerators for Nanoscience and Nuclear Simulation), in CEA Paris-Saclay, in France. The first ion irradiation is performed on aluminium hydroxide. Prior to irradiation, aluminium alloy samples are corroded in autoclave at 70°C, for 7 days and in 2.8L of demineralised water (Fig. 1). The temperature of 70°C is chosen because this is relevant of core structures in MTRs. The thickness of the obtained hydroxide film is about 4 µm. After the corrosion test, ion irradiation is performed: the hydroxide film is irradiated with Al ions under vacuum. The energy of the Al ions used is 5 MeV and then 1.2 MeV in order to irradiate the hydroxide film on all its thickness. A SRIM calculation (using the Stopping and Range of Ions in Matter software [21] with the mode “full damage

cascade”) indicates the damage is at most 2.5 dpa (displacement per atom) and 1.5 dpa on average in the aluminium hydroxide film (Fig. 2.a). For the SRIM calculation, the threshold displacement energies used are 20 eV and 50 eV for the aluminium and oxygen sublattice, respectively [22]. After ion irradiation experiment, the irradiated samples are corroded a second time in autoclave in order to study the impact of ion irradiation on the corrosion kinetics. For this corrosion experiment, the conditions are: 4 days, 70°C and 2.8 L of demineralised water. The second ion irradiation is performed on the metal aluminium matrix. Metal samples are irradiated with Al ions with an energy of 1.8 MeV. A SRIM calculation indicates the damage is at most 8 dpa in the aluminium matrix (Fig. 2.b, obtained with the mode “full damage cascade”). For the SRIM calculation, the aluminium threshold displacement energy used is 16 eV [23,24]. After the ion irradiation, the samples are corroded at 70°C, for 4 days and in 2.8L of demineralised water in order to evaluate the influence of the irradiation on aluminium alloy corrosion. During the two irradiations, the temperature is monitored using a thermocouple in contact with a sample, the maximum temperature is 20°C for the two irradiation experiments. For each irradiation, four samples are irradiated together on one face and for each corrosion condition, three samples are used.

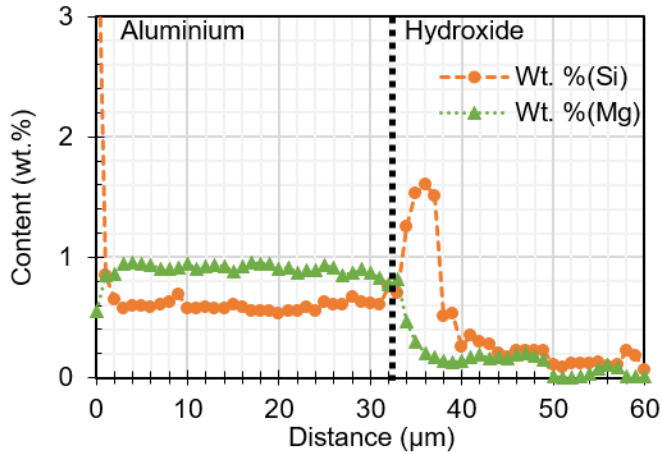
Figure 10: Chemical evolution of magnesium and silicon by EMPA in the aluminium matrix and in the aluminium hydroxide film obtained on a sample corroded for 560 days at pH 6 and at 42°C in the Osiris reactor.

The chemical composition of the film is analysed by EPMA. For this analysis, a sample is embedded in a tin-bismuth mixture and then polished down to a 1 μm finish with diamond past. The film is composed on average of 50-55 wt. % of aluminium and 40-45 wt. % of oxygen. Silicon and magnesium are also observed in the film (Fig. 10). In particular, the film is enriched in silicon on a depth of 5/6 μm near the aluminium matrix. This depth corresponds to the thickness of the inner layer: this indicates that only the inner layer of the film is enriched with silicon. Silicon enrichment is not observed for unirradiated samples. This enrichment could be due to the transmutation of aluminium in silicon due to thermal neutrons following the reactions (2) and (3) [37,38]:

Silicon enrichment of the film had already been observed during corrosion tests performed in MTR [10,39]. Magnesium content decreases from 0.9 wt. % in the alloy to 0.1 wt. % from a depth of 5/6 μm in the film. Magnesium is thus present only in the inner layer of the film and the decreasing profile of magnesium content indicates a release of this chemical element in solution after a diffusion through the film. This profile agrees with the literature: during corrosion of Mg-containing aluminium alloy, a magnesium release in solution had already been observed during unirradiated corrosion tests [3,20,39] and in an aqueous medium at a pH of 6, the stable form of

Fig. 10: Chemical evolution of magnesium and silicon by EMPA in the aluminium matrix and in the aluminium hydroxide film obtained on a sample corroded for 560 days at pH 6 and at 42°C in the Osiris reactor.
