Cure and damage monitoring of flax fiber-reinforced epoxy composite repairs for civil engineering structures using embedded piezo micro-patches

Mingfa Zhang, Olivier Bareille, Michelle Salvia

CURE AND DAMAGE MONITORING OF FLAX FIBER-REINFORCED EPOXY COMPOSITE REPAIRS FOR CIVIL ENGINEERING STRUCTURES USING EMBEDDED PIEZO MICRO-PATCHES

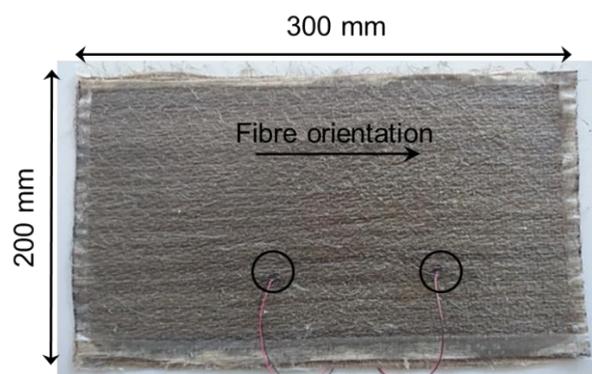
Figure 1: Flax reinforced epoxy composite material with embedded PZT discs; the position of the sensors is given by the black circles

The purpose of embedding two piezo-cells between the two layers of the flax fabric was to ensure a way to perform an analysis of the composite material integrity, by signal transmission through the plate. However, it was here used to confirm the recorded signal shape by comparison with one another. The PZT sensors were connected to an impedance analyser and the impedance was monitored as a function of time at room temperature (RT) at 4 kHz. The principle of the measurement was to record the voltage at the poles of the electrical resistor which is mounted in series with the piezo-disc. The ratio of this voltage to the voltage supplied to the two elements (piezo + resistor) gives the value of the piezo's electrical impedance. Due to the electromechanical properties of the piezo-component, this electrical impedance is linked to the mechanical ones and therefore to the level of curing for the matrix. The choice of the signal frequency is led by the signal-to-noise ratio of the mounted electromechanical system. The choice of the resistor's value is made in order to have the same order of magnitude as the expected piezo impedance. The recorded signal is the time-dependent electrical impedance of the piezo-disc. They confirmed the efficiency and the reliability of the method when compared to conventional methods as shown further in the paper in section 4.2.

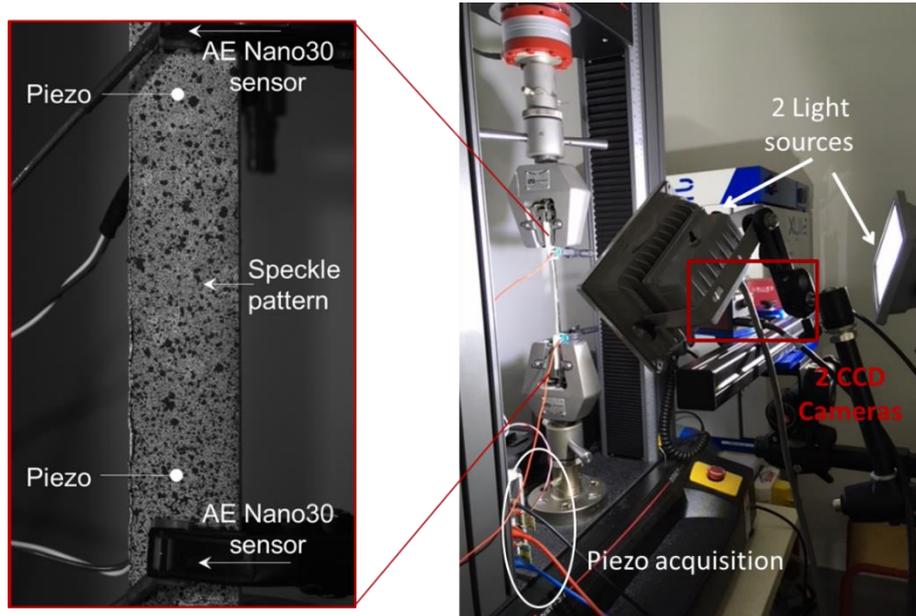
Figure 2: (a) Position of the PZT piezoelectric and AE sensors and the speckle pattern; (b) Tensile test Configuration

Monotonic tensile tests (Figure 2) were performed using an INSTRON tester equipped with a load cell of 30 kN at a cross-head speed of 2 mm/min and digital image stereo correlation (DISC or 3D-DIC) was used to determine in and out of displacements and strain maps on deformed surfaces [12]. For this purpose, the samples were painted with aerosol white and black spray paint on one face to create a speckle pattern with adequate contrast. A region of interest (ROI) was defined on the specimen surface. The correlation algorithm compared gray level of each pixel in subset defined in the region of interest (ROI). Once the matching was done, the displacement components of the center of the reference and deformed subset can be determined. In this study, strain computation was carried out by Vic3D[®] software developed by Correlated Solutions[®].

In order to better analyse piezoelectric insert response, conventional acoustic emission (AE) signals were monitored during tests using Mistras 2001 system from Physical Acoustics Corporation (PAC). The AE sensor (Nano30) were attached to the sample by silicon grease and a mechanical specific device. The detection threshold of AE was fixed at 35dB.

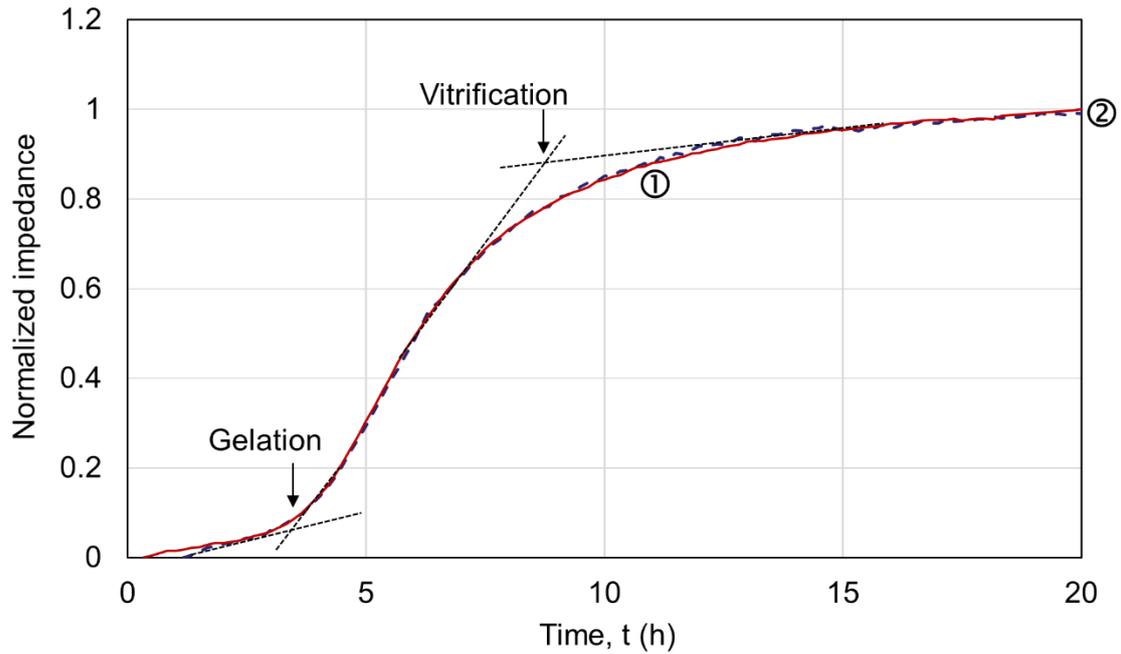
Figure 3: Normalized impedance vs time during cure at RT of two different plates (arrows indicate gelation and vitrification)

Once the impregnation process was completed, the impedance was monitored at 4 kHz every 10 min at room temperature (23°C). A comparison of normalized change in impedance vs. time obtained on two different plates manufactured two weeks apart, shows the high reproducibility that was achieved (Figure 3).

The variation of impedance versus time had a sigmoidal shape. At the very early beginning, a slight increase in impedance appeared. Beyond this lag-time, the impedance increased sharply, then levelled off until it reached a quasi-asymptotic value. At the very beginning, the thermoset mixture was composed of low-molecular pre-polymers. As the reaction proceeded, chain extension occurred to produce relatively high molecular weight reaction products resulting in an increase in impedance. Gelation which corresponded to the first appearance of an infinite cross-linked network may be associated to the time at which the first significant increase in stiffness. As mentioned previously, vitrification was associated with the transition from a rubbery modulus to a glassy modulus. Above vitrification, the mobility of the reacting groups was restricted with the reduction of free volume. Thereby, this phenomenon led to an extremely slow reaction, as the reaction became diffusion-controlled. Therefore, vitrification was associated to the instant at which the impedance reached an almost constant value. Beyond, the impedance continued to increase slowly long after the vitrification: the reaction dramatically slowed, since the cure mechanism was controlled by the molecular diffusivity, but did not come to end.

The joint analysis of the impedance (Figure 3) and DMA (Figure 4) results shows that the in-situ measurement of impedance of PZT insert embedded in a composite provides a powerful tool for monitoring the changes in physical properties of thermoset during cure.

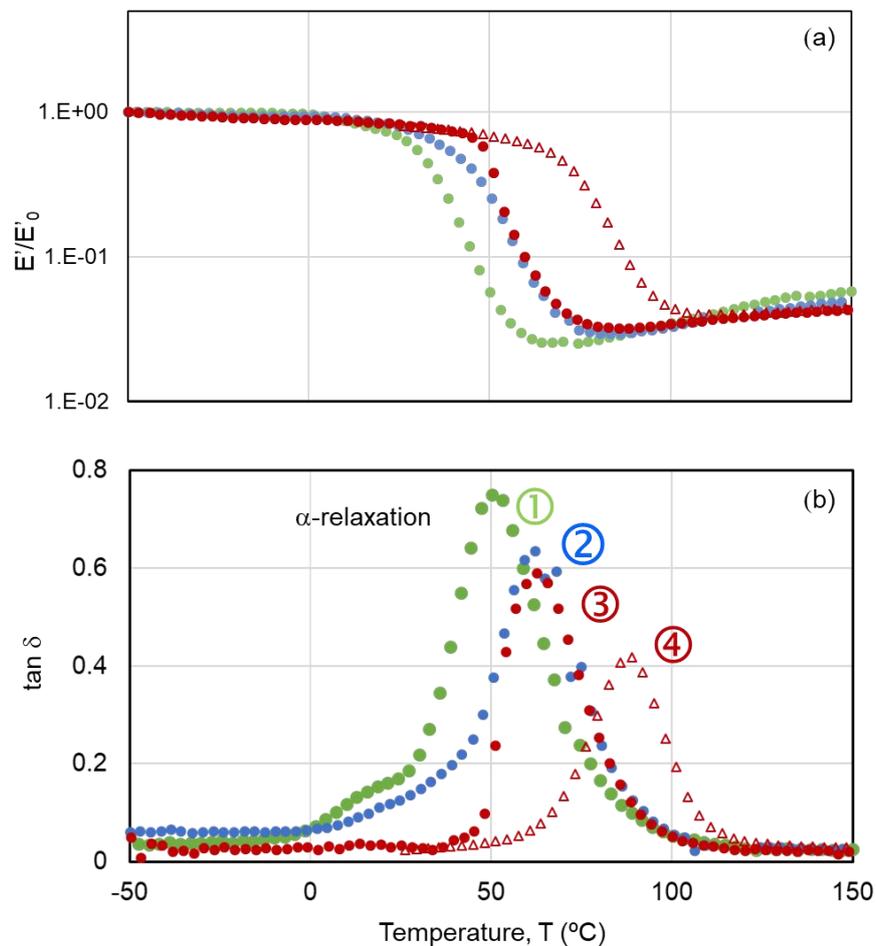
Figure 4: Temperature dependence of (a) $\tan \delta$ and (b) E'/E_0' response at $F=1$ Hz for flax reinforced composites at various curing states: (●) 12 hours; (●) 2 days; (●) 8 days; (△) 8 days + sweep until 150°C

Typical plots of the loss factor $\tan \delta$ and the storage modulus E' versus temperature were given in Figure 4a and 4b respectively. In the range of temperature studied, the $\tan \delta$ spectra showed two peaks whatever the sample. The highest temperature peak is concurrent in a large drop in the storage modulus (near 2 decades); this relaxation, named α -relaxation is associated with the glass transition and corresponded to the coordinated motion of relatively long chain segments by debonding of low energy bonds (hydrogen bonds). It is well known that the measurement of α -relaxation temperature which is associated with T_g can be used as an accurate indication of cross-link density of a thermosetting. The small process occurring just below the α -relaxation, so called ω -relaxation was attributed to different mechanisms: the presence of water in the material, physical aging [13], and to unreacted chain segments in the network [14].

As shown in Figure 4, the onset of the storage modulus drops and the maximum of $\tan \delta$ associated with α -relaxation were shifted towards high temperatures and the area under the curve of loss factor was reduced when the curing time increases from 12h (sample 1) to 24h (sample 2), and the magnitude of the ω -relaxation decreased. These results were consistent with a progressive decrease in chain motion due to a degree of crosslink increase during curing. Conversely, the α -relaxation temperature is similar for the samples cured during 2 (sample 2) or 8 (sample 3) days. But, it is interesting to note that from sample 2 to 3, the height of the $\tan \delta$ peak associated with the glass transition decreased slightly, and the intensity of

- The curing conditions lead to a slight incomplete matrix cure. Indeed, as can be observed from Figure 4, the α -relaxation of the epoxy composite, after 8 days at room conditions, was about (61°C), and increases by about 25°C after a second DMA scan

(sample 4). Moreover, a slight and continuous increase in the rubbery modulus is observed above the α -relaxation temperature for samples cured at RT (samples 1 to 3). This also confirms that the curing at RT led to a partially cured network, and underwent a post-curing during DMA test. Indeed, it is well known that the rubbery modulus of networked structures is inversely proportional to the average mass of the segments between crosslinking nodes (concept of rubber elasticity [15]) which decreases with the degree of cure, up to the completion of curing. When exposed to a temperature higher than T_g , residual reactions occurred as the mobility of the residual reactive epoxy and amine groups is increased.

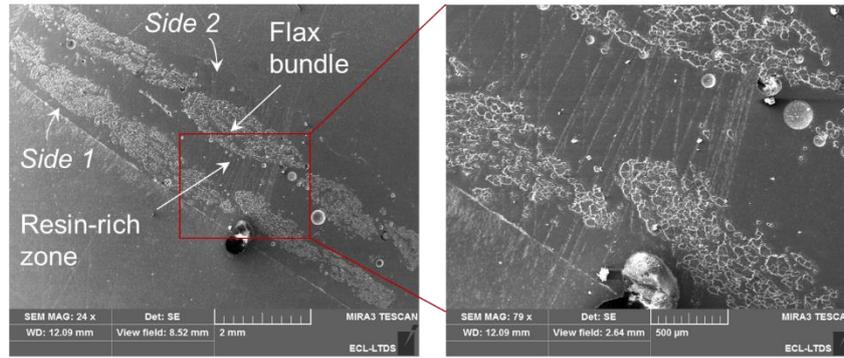
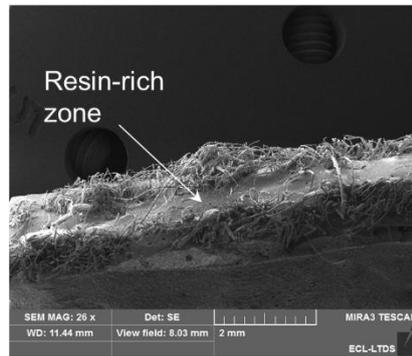
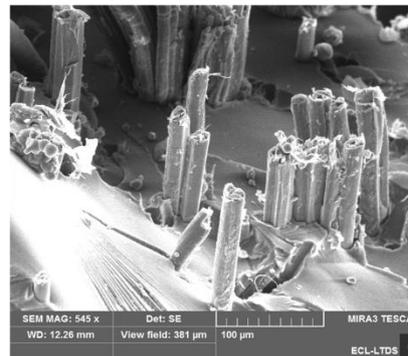
Figure 5: (a) Polished cross-section of flax reinforced epoxy composite; (b) and (c) Post-mortem scanning electron micrograph after tensile test up to failure

- SEM micrographs of a polished cross-section observed perpendicular to the axis of fibres (Figure 5a) and of a post-mortem failure feature after tensile test (Figure 5b) of the flax reinforced bio-epoxy composite, show different defects: voids due to air trapped, large resin-rich zone between the two reinforcement layers and around the bundles. Figure 5c shows a magnified view of the fracture feature. In this figure, it can be observed, even if the fibres were not treated, that bonding between flax fibers and matrix was strong enough. Indeed, the process of failure mainly involved cohesive phenomena with fracture of the surrounding matrix shown by the presence of matrix debris on the fibres. Probably, the adhesion is associated with two main processes: (i) fibre surface roughness resulting in mechanical anchoring, (ii) hydrogen bondings between hydroxyl (OH) groups in the backbone chain of the epoxy resin and the flax fibres, which also contain OH groups (cellulose) [16].

However, it seems that the piezo-sensor is inoperative during the last phase of the testing. Yet, the setting of the sensor, inside the composite material, is the key element to explain such behavior. Indeed, the piezo sensor is placed inside the matrix-rich zone between the two fibre layers (Figure 5). Hence, it is only sensitive to events occurring in this zone. Whether the matrix is broken or is debonding from the plies, a vibrational signal is recorded. However, once the separation between the ply and the matrix is locally initiated, the sensor is less loaded. This loss of efficiency of the sensor is a sharp and preliminary signal that the material is entering a critical state, not yet breaking, but prone to do so in the short term.

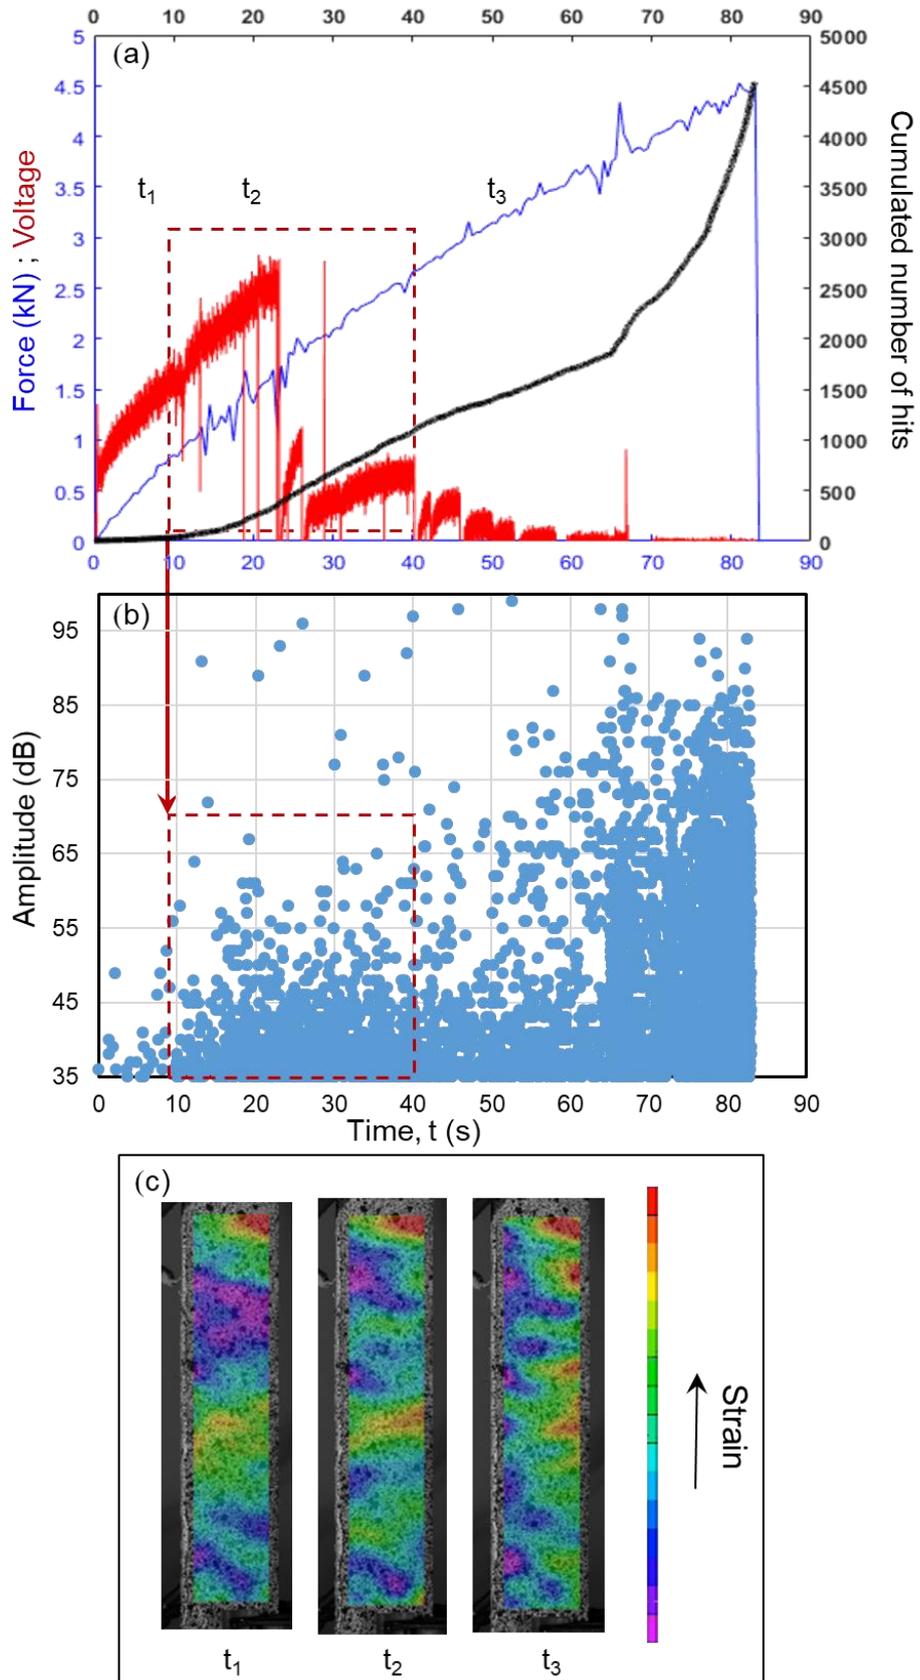
Figure 6: (a) Unfiltered Force, sensor voltage, and cumulative AE hits vs. time; (b) Amplitude of the AE signals vs. time; (c) Strain distribution at different times

Figures 6a to 6c show the results obtained on one specimen. Unfiltered Force, sensor voltage, and cumulative AE hits vs. time (or displacement) are given in Figure 6a. Figure 6b gives the amplitude of the AE signals according to time. The strain distribution observed in the region of interest (ROI) for different times t_1 , t_2 and t_3 is shown in Figure 6c.

The most relevant contribution of the piezo-sensor was at the early stage of the damage evolution. Indeed, as visible in Figure 6a, the voltage exhibits a sharper and stronger evolution than the acoustic counting. At a low level of stress, it is more sensitive than acoustic sensors bonded on the surface of the sample. A correlation between sensor voltage measurement and the other results can be exhibited in a specific phase of the damage evolution (framed area in Figures 6a and 6b). On both the force and the cumulative acoustic counting records, there is a change in the intensity of the damage processes. This change is perceived by a change on the slope of the cumulative acoustic counting and the occurrence of disturbances on the uniform increase of the force. The measurement of the force is unfiltered on purpose.

- AE signals are detected very early and until the specimen fails (Figure 6b). In the first phase, up to 16% of the maximum force (Figure 6a), events of small amplitude (between 35–50 dB) occur. These events are often related to matrix cracking [17]. In the second phase, events of low to average amplitude are measured. These aspects combined could indicate, in addition of resin failures, friction due to matrix–matrix debonding (delamination), microcracking coalescence (50 dB to 60dB) and matrix/fiber debonding (60 dB-70 dB). The third phase is when a failure occurs: multiple high amplitude events indicate fiber/matrix friction associated with pull-out (70 dB-85 dB) and multiple fibre breakages (>85 dB).

- As shown Figure 6c, at the very beginning (t1), the axial strain distribution is layer distributed in the height of the specimen, associated with local morphological differences (fibre distribution, matrix layer thickness, thickness) along the specimen axis due to the manual manufacturing method. This distribution tends to change in the second phase (t2), and the strain distribution is no longer axisymmetrical in the last phase (t3) which may be related to a large extent of the damage especially on one side of the specimen.
