## Removal of riprap within channelized rivers: a solution for the restoration of lateral channel dynamics and bedload replenishment?

Anaïs Arfeuillère, Johannes Steiger, Emmanuèle Gautier, Stéphane Petit, Erwan Roussel, Franck Vautier, Olivier Voltaire, Julien Saillard

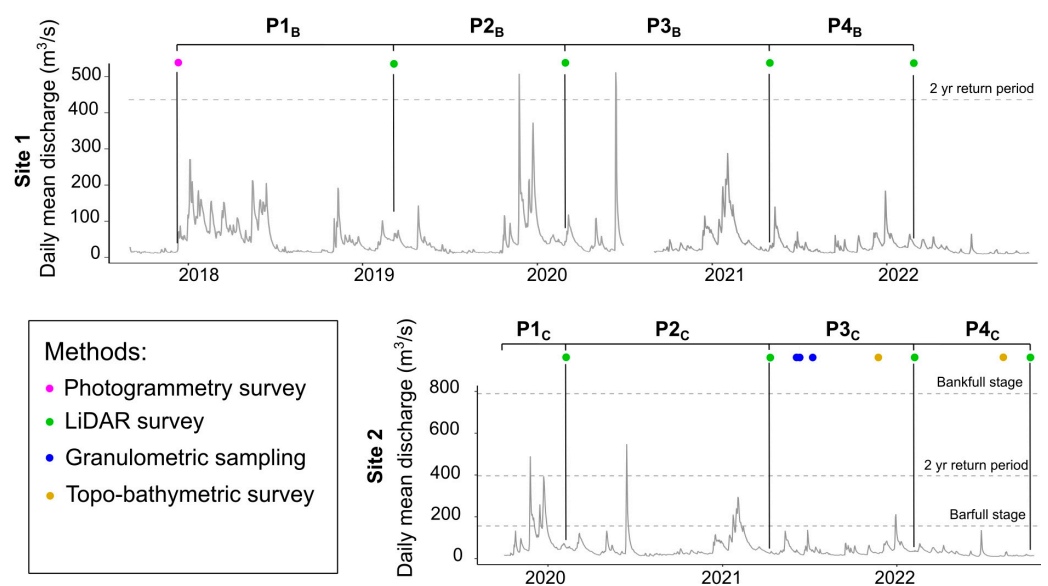
**Figure 2.** Daily mean discharges of the Allier River at the Vic-le-Comte gauging station (Site 1) between September 2017 and October 2022 in the top graph ("<https://hydro.eaufrance.fr> (accessed on 15 February 2023)"). Daily mean discharges at the Limons gauging station (Site 2) between September 2019 and October 2022 in the bottom graph ("<https://hydro.eaufrance.fr> (accessed on 15 February 2023)"). The calendar of the different surveys carried out is represented by coloured dots. The hydrological series is divided into four periods (from P1<sub>B</sub> to P4<sub>B</sub> for Site 1 and from P1<sub>C</sub> to P4<sub>C</sub> for Site 2) according to the date of the LiDAR surveys. See the Methods section for the different methods employed.

Over the entire study period, from November 2017 to February 2022 at Site 1 and from September 2019 to October 2022 at Site 2, the maximum water discharge, with a return period of 2 years, occurred between late 2019 and mid-2020, corresponding to the P2<sub>B</sub>-P3<sub>B</sub> periods at Site 1 and P1<sub>C</sub>-P2<sub>C</sub> periods at Site 2 (Figure 2). These hydrologic events did not reach the bankfull stage. The other recorded hydrologic events were less intense, with a maximum exceeding the barfull stage at Site 2 (February 2021 in the P2<sub>C</sub> period and December 2021 in the P3<sub>C</sub> period).

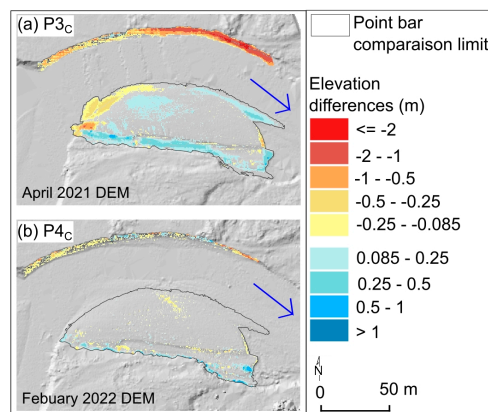
**Figure 5.** Altitudinal differences on the bank and the point bar at Site 2 for (a) the period P3<sub>C</sub> and (b) the period P4<sub>C</sub>. The blue arrow indicates the flow direction.

During the third (P3<sub>C</sub>; April 2021–February 2022) and fourth (P4<sub>C</sub>; February 2022–October 2022) periods, changes were minor (Figures 4 and 5). During the third period (P3<sub>C</sub>), 754 m<sup>3</sup> of sediments were eroded from the bank, preferentially located downstream from the apex of the bank, whereas the point bar gained 178 m<sup>3</sup> of sediment accretion. Erosion of the point bar was preferentially located at the bar head, and deposition occurred in the chute channel and on the bar tail near the main channel. During the fourth period (P4<sub>C</sub>), the erosion/deposition processes were insignificant, with a sediment balance of −78 m<sup>3</sup> on the bank and +48 m<sup>3</sup> on the point bar.

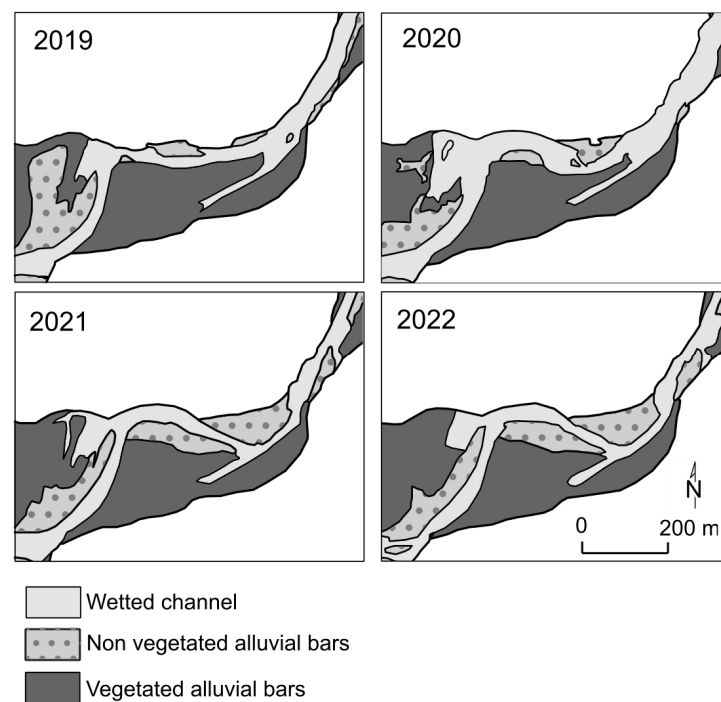
**Figure 6.** Planform evolution of Site 2 from 2019 to 2022.

At the Site 1 bank, despite a monitoring period of five years, the recorded erosion rates were so low and insignificant that no further analysis was carried out. Conversely, at Site 2, the bank erosion rates were significant within the three-year period after riprap removal. The initial state of the channel before the removal of the riprap was mapped for 2019 (Figure 6). The growth of the point bar and downstream bar occurred concomitantly with bank retreat. The sinuosity index increased from 1.43 in 2019 to 1.46 in 2022. On the basis of the width of the active channel each year, the water slope in 2020, and the  $Q_2$  discharge, the specific stream power decreased from  $135 \text{ W/m}^2$  in 2019 to  $82 \text{ W/m}^2$  in 2020 and to  $78 \text{ W/m}^2$  in 2021 and 2022.

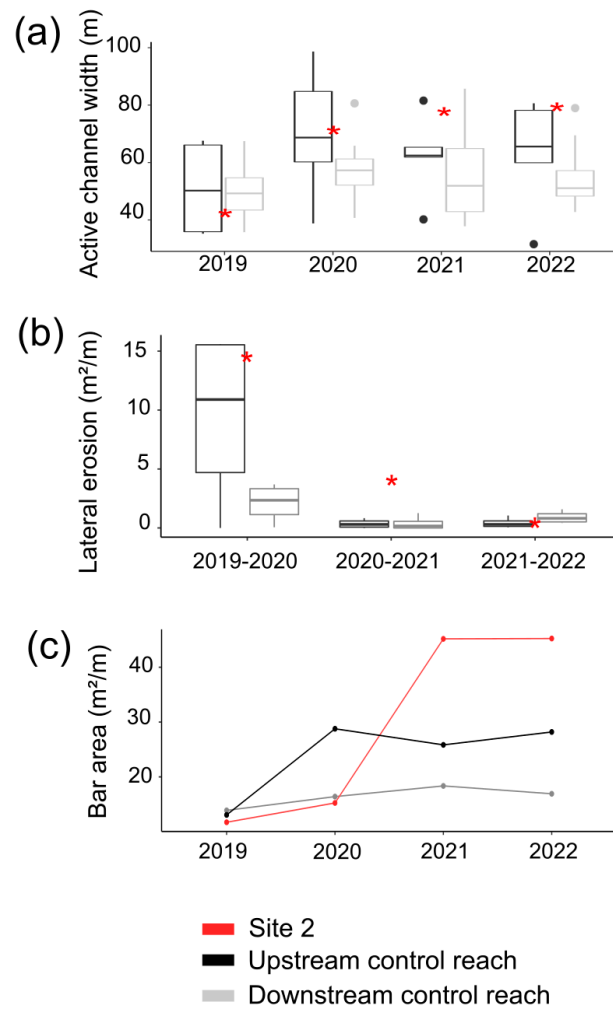
**Figure 7.** Evolution of planform indices and comparison of (a) active channel width (m), (b) bank erosion (m<sup>2</sup>/m), and (c) bar area (m<sup>2</sup>/m). The red asterisk (star) represents (a) the value of the channel width and (b) lateral erosion recorded at the restored bank, whereas the other values were recorded at the upstream and downstream control reaches. Riprap on site was removed in September 2019.

In comparison to the two control reaches, Site 2 showed a singular behaviour of active channel evolution (Figure 7). After the reactivation of bank erosion between 2019 and 2020, the active channel width at Site 2 continued to widen, which was marked by significant bank erosion and important sediment deposition on bars between 2020 and 2021.

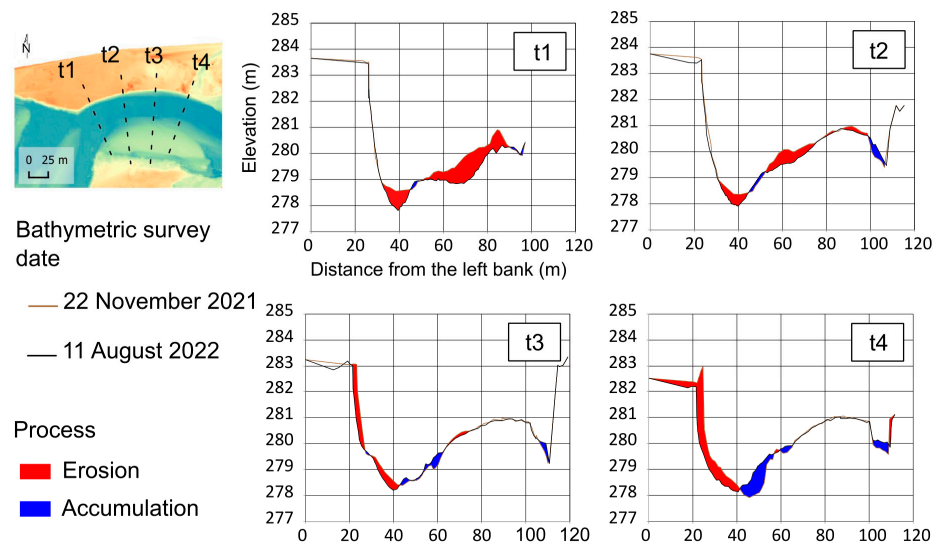
**Figure 8.** Comparison of topobathymetric surveys between 22 November 2021 and 11 August 2022 along four transects (t) at Site 2.

Between 22 November 2021 and 11 August 2022, bathymetric surveys recorded vertical and lateral morphological channel changes (Figure 8). At the two upstream cross-sections, no changes in the bank position were recorded, which contrasted with the main channel where the erosion process dominated, with an erosion area of  $26 \text{ m}^2$  on the first cross-section (t1) and an erosion area of  $15 \text{ m}^2$  on the second cross-section (t2). The two downstream cross-sections (t3 and t4) recorded bank retreats of  $-12 \text{ m}^2$  and  $-19 \text{ m}^2$ , respectively. At t4, where in-channel accumulation dominated, bank erosion caused an overall difference of  $-10 \text{ m}^2$ .
