Anaïs Arfeuillère, Johannes Steiger, Emmanuèle Gautier, Stéphane Petit, Erwan Roussel, Franck Vautier, Olivier Voltaire, Julien Saillard

Article

Removal of Riprap within Channelized Rivers: A Solution for the Restoration of Lateral Channel Dynamics and Bedload Replenishment?

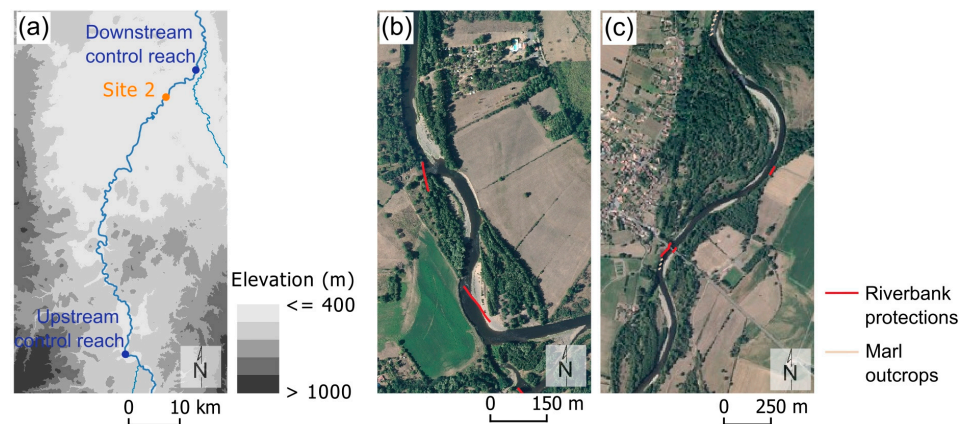
Figure 3. (a) Location of the two control reaches. (b) Upstream control reach. (c) Downstream control reach. Map background: 2019 orthophotography produced by IGN.

In order to highlight the channel readjustments after riprap removal, a channel plan-form analysis was carried out and compared to two control reaches with similar morphological characteristics but only very little impact from riverbank protections such as riprap (Table 3 and Figure 3).

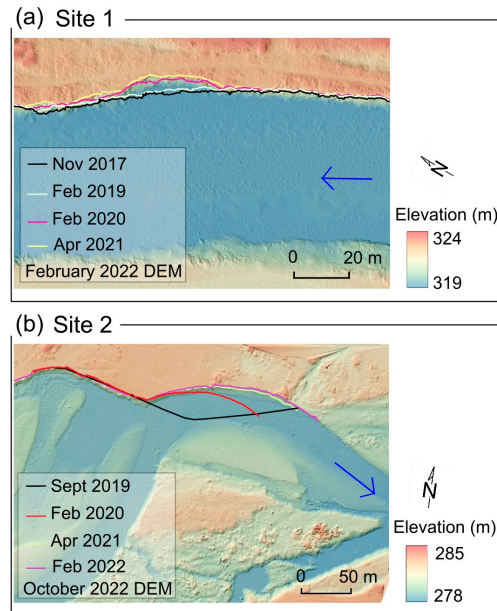
Figure 4. (a) Bank retreat at Site 1. November 2017: 2 months after work; February 2019: 17 months after work; February 2020: 29 months after work; April 2021: 43 months after work; February 2022: 53 months after work. (b) Bank retreat at Site 2. September 2019: 0 months after work; February 2020: 5 months after work; April 2021: 19 months after work; February 2022: 29 months after work; October 2022: 37 months after work. The blue arrow indicates the flow direction.

At Site 1, between November 2017 and February 2022, an erosion notch formed in the middle of the bank, mainly during the P2_B period (February 2019–February 2020; Figure 4a). The sediment balances of the emerged surfaces of the bank were -418 m³ for P1_B, -447 m³ for P2_B, -345 m³ for P3_B, and -96 m³ for P4_B.

At Site 2, the downstream half of the newly restored bank showed significant changes (Figure 4b). For the latter part, the first period P1_C (September 2019–February 2020) recorded the most important bank retreat, with a maximum bank retreat of 28 m. This eroded area corresponded to an erosion volume of 6086 m³ for emerged parts of the

bank, and the estimated total eroded volume was 9647 m³. During the second period P2_C (February 2020–April 2021), the eroded area was mainly located on the downstream part of the active bank, with a maximum width retreat of 21 m and an eroded volume of 3149 m³ for the emerged parts of the bank. The estimated total eroded volume for P2_C was 6152 m³.
