Removal of Riprap within Channelized Rivers: A Solution for the Restoration of Lateral Channel Dynamics and Bedload Replenishment?

Anaïs Arfeuillère ^{1,*}, Johannes Steiger ^{1,*}, Emmanuèle Gautier ², Stéphane Petit ³, Erwan Roussel ¹

Abstract: Riverbank erosion is an essential morphodynamic process for the improvement of river health and the ecohydrogeomorphological functioning of alluvial rivers. Lateral channel dynamics and sediment supply caused by bank erosion largely create and maintain heterogeneous in-channel habitats for fauna and aquatic or riparian plant species. However, humans very early started to stabilize riverbanks in order to favour navigation or to prevent valuable land and infrastructures close to the channel from eroding. During the 20th century, bank protection works such as riprap considerably increased and blocked lateral channel erosion, causing a loss of local sediment supply, which in turn resulted in a decrease in local bedload transport and channel incision. The aim of the article is to evaluate to what extent riprap removal may be an efficient restoration measure in terms of the reactivation of bank erosion and the replenishment of the local bedloa

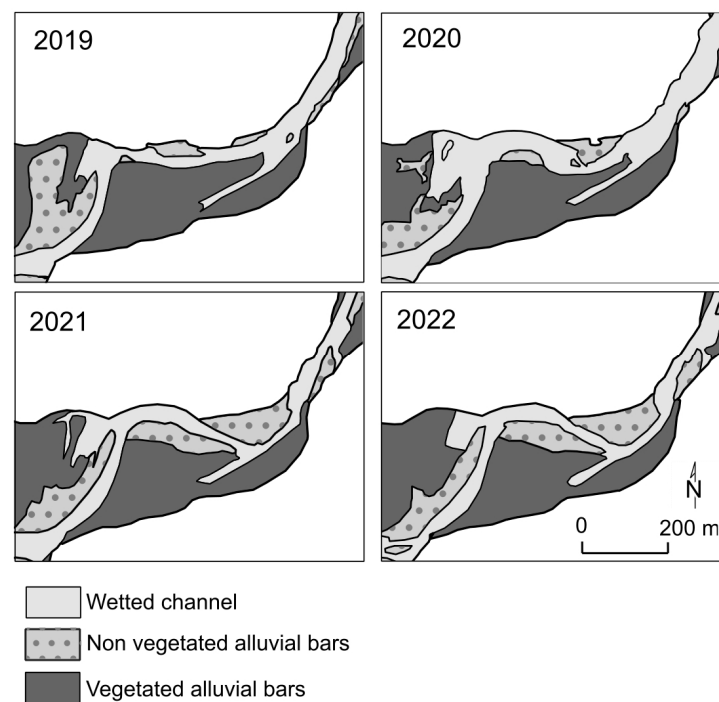
Figure 6. Planform evolution of Site 2 from 2019 to 2022.

At the Site 1 bank, despite a monitoring period of five years, the recorded erosion rates were so low and insignificant that no further analysis was carried out. Conversely, at Site 2, the bank erosion rates were significant within the three-year period after riprap removal. The initial state of the channel before the removal of the riprap was mapped for 2019 (Figure 6). The growth of the point bar and downstream bar occurred concomitantly with bank retreat. The sinuosity index increased from 1.43 in 2019 to 1.46 in 2022. On the basis of the width of the active channel each year, the water slope in 2020, and the Q_2 discharge, the specific stream power decreased from 135 W/m^2 in 2019 to 82 W/m^2 in 2020 and to 78 W/m^2 in 2021 and 2022.

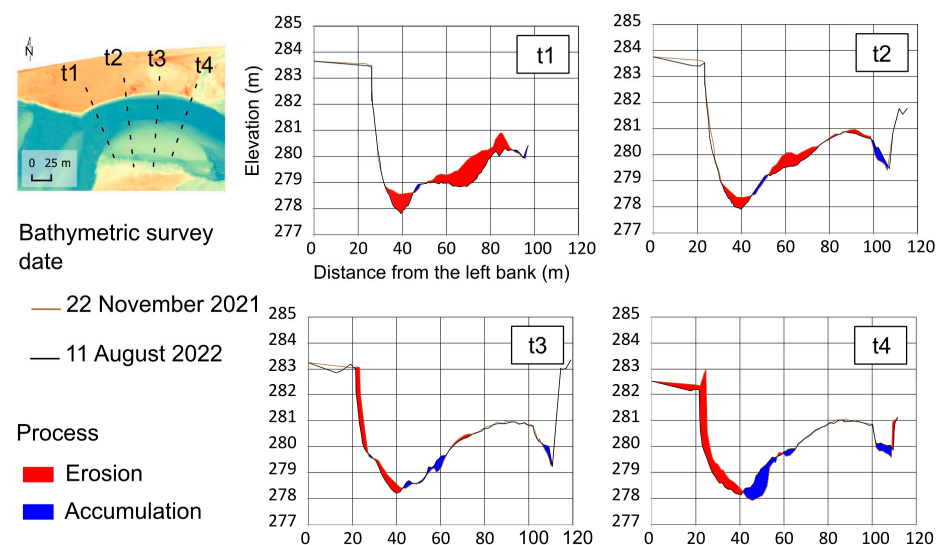
Figure 8. Comparison of topobathymetric surveys between 22 November 2021 and 11 August 2022 along four transects (t) at Site 2.

Between 22 November 2021 and 11 August 2022, bathymetric surveys recorded vertical and lateral morphological channel changes (Figure 8). At the two upstream cross-sections, no changes in the bank position were recorded, which contrasted with the main channel where the erosion process dominated, with an erosion area of 26 m^2 on the first cross-section (t1) and an erosion area of 15 m^2 on the second cross-section (t2). The two downstream cross-sections (t3 and t4) recorded bank retreats of -12 m^2 and -19 m^2 , respectively. At t4, where in-channel accumulation dominated, bank erosion caused an overall difference of -10 m^2 .
