Characterization of the Microstructure Changes Induced by a Rolling Contact Bench Reproducing Wheel/Rail Contact on a Pearlitic Steel

Keywords: microstructure; wheel-rail contact; rolling contact bench; pearlitic steel; Electron BackScattering Diffraction

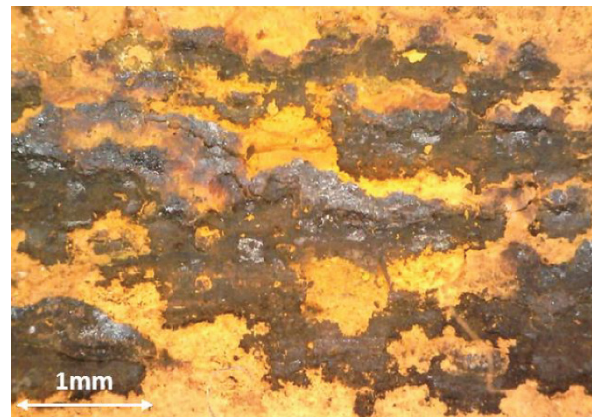
Figure 1. Optical image of the corroded surface of ring AT-C.

Two surface conditions for the disk/ring system were tested: either the ring was tested as turned (AT) with a slight ethanol cleaning, or a second step was added by slightly corroding the disk and ring surfaces (AT-C). The corrosion of the ring was generated by spraying the surface with water every 24 h for three days, whereas the disk was placed in water for 24 h. It led to a uniform attack. The surfaces were lightly cleaned to remove any detaching scale. An optical image of the obtained corrosion is shown in Figure 1.

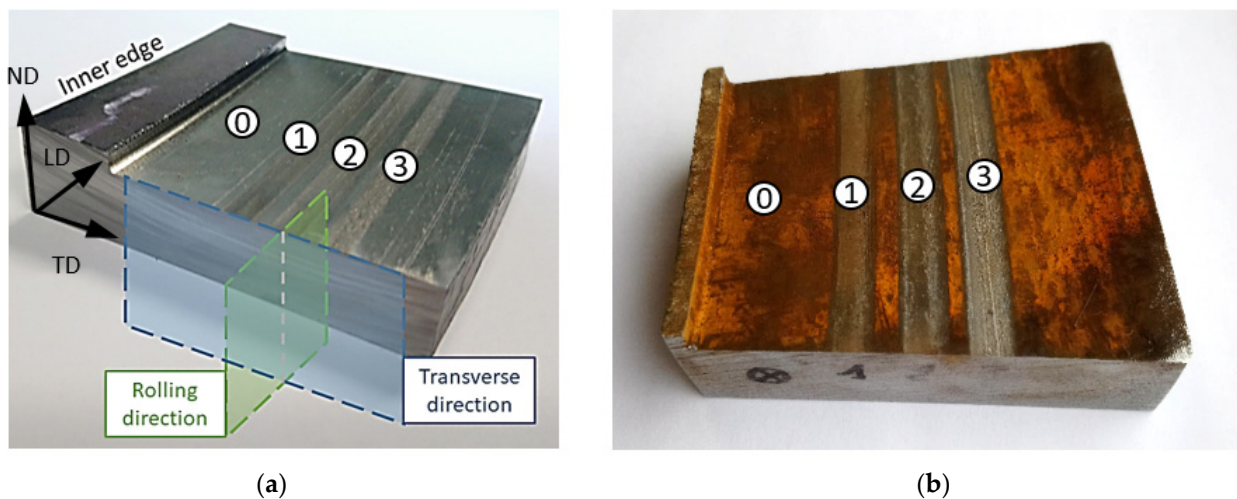
Figure 2. Images of parts of (a) Ring AT (b) Ring AT-C, with the different directions of observation and track numbers (0 stands for the non-deformed part).

Several samples were cut from the R260 rings after testing, either with a surface parallel to the rolling direction (longitudinal section) or with a surface perpendicular to the rolling direction (transverse section), as shown in Figure 2. The specimens were polished using successive abrasive papers (from P80 to P4000) and then a diamond solution (3 μm , 1 μm). For EBSD measurements, an additional polishing step using colloidal silica suspensions was added.

First, optical observations were performed on cross-sections in the transverse direction to detect cracking. The largest crack was observed for T1 (rolling with no sliding): its length was equal to 56 μm , and it reached a depth of 6 μm . However, globally, the number of significant cracks (i.e., with a length larger than 30 μm) was found to be low, as only two to five cracks were observed for each track. It is important to underline that the use of the term ‘crack’ does not presume to describe the underlying phenomenon. The crack may be caused by a local brittle fracture or may be the result of third body flow. As illustrated in Figure 2, each track underwent measurable wear and thus a loss of material.

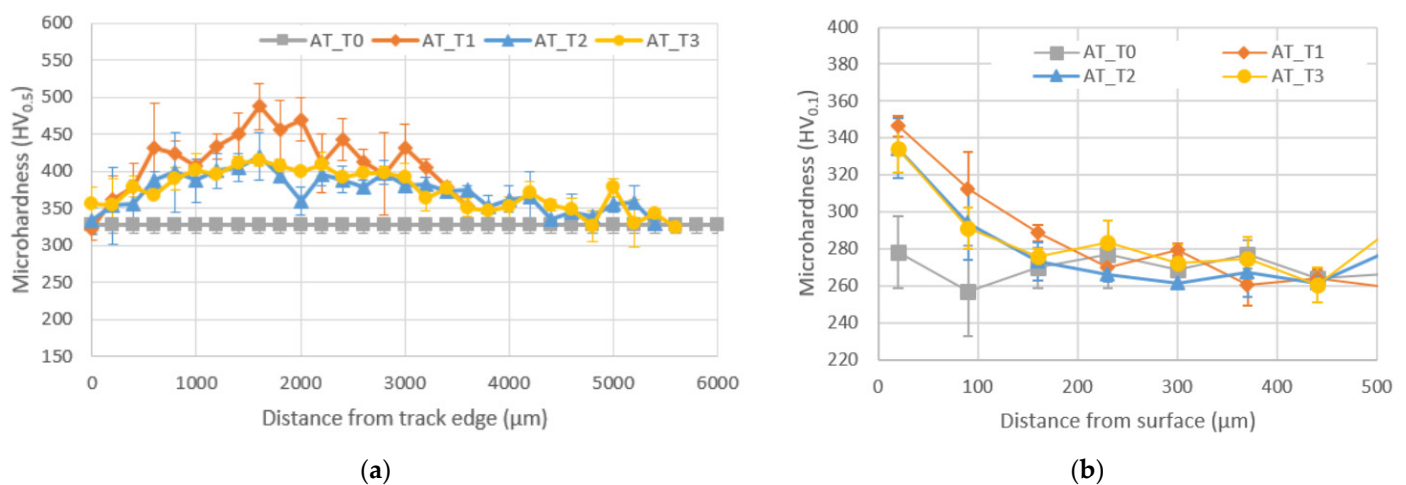
Figure 3. Microhardness results performed (a) on the surface of the tracks along their width and (b) on cross-sections for Ring AT.

Then, the effects of the different loadings were investigated using microhardness measurements. The microhardness was assessed at the surface of the tracks along their width (Figure 3a) and on cross-sections to follow the evolution of hardness along the depth (Figure 3b). A larger load (500 gf) was chosen for surface testing because of the roughened state of the tracks. In Figure 3a, a global increase in the microhardness compared to the reference (T0) can be observed, whatever the test conditions. Even if the values tend to be scattered because of local roughness, the microhardness values are sensitively higher for T1 than for the other conditions. Rolling with no sliding thus seems to cause higher surface strain-hardening than rolling with sliding. The microhardness profiles performed along the depth (Figure 3b) show an increase between the surface and a depth of approximately 150 μm , whatever the test conditions. Again, the microhardness values obtained for T1 are larger than the ones obtained for the other conditions, which show similar trends. Considering the test conditions, it seems that for T3, the addition of 1000 cycles with sliding removed the impact of the previous 1000 cycles with no sliding, maybe because of material removal. Microstructure observations were performed to try to understand the previous trends.

Figure 8 can also be compared with Figure 3 to assess the possible impact of corrosion on the surface hardness of the specimen. It seems that larger surface microhardness values are found for AT_T0 compared to AT-C_T0 (328 ± 10 HV_{0.5} versus 259 ± 59 HV_{0.5} at the surface or 278 ± 20 HV_{0.1} versus 262 ± 19 HV_{0.1} for a 20 μm depth). It could be assumed that the corrosion layer tends to decrease the surface microhardness locally. However, for AT_T0, larger microhardness values are obtained on the surface compared to a depth of 20 μm, while similar values are obtained for AT-C_T0 on the surface compared to a depth of 20 μm or even larger depths. As different loads were used, the values cannot be directly compared but clearly indicate a stronger microhardness gradient in AT_T0, thus confirming a possible strain-hardening caused by surface turning as suggested in Section 3.1.

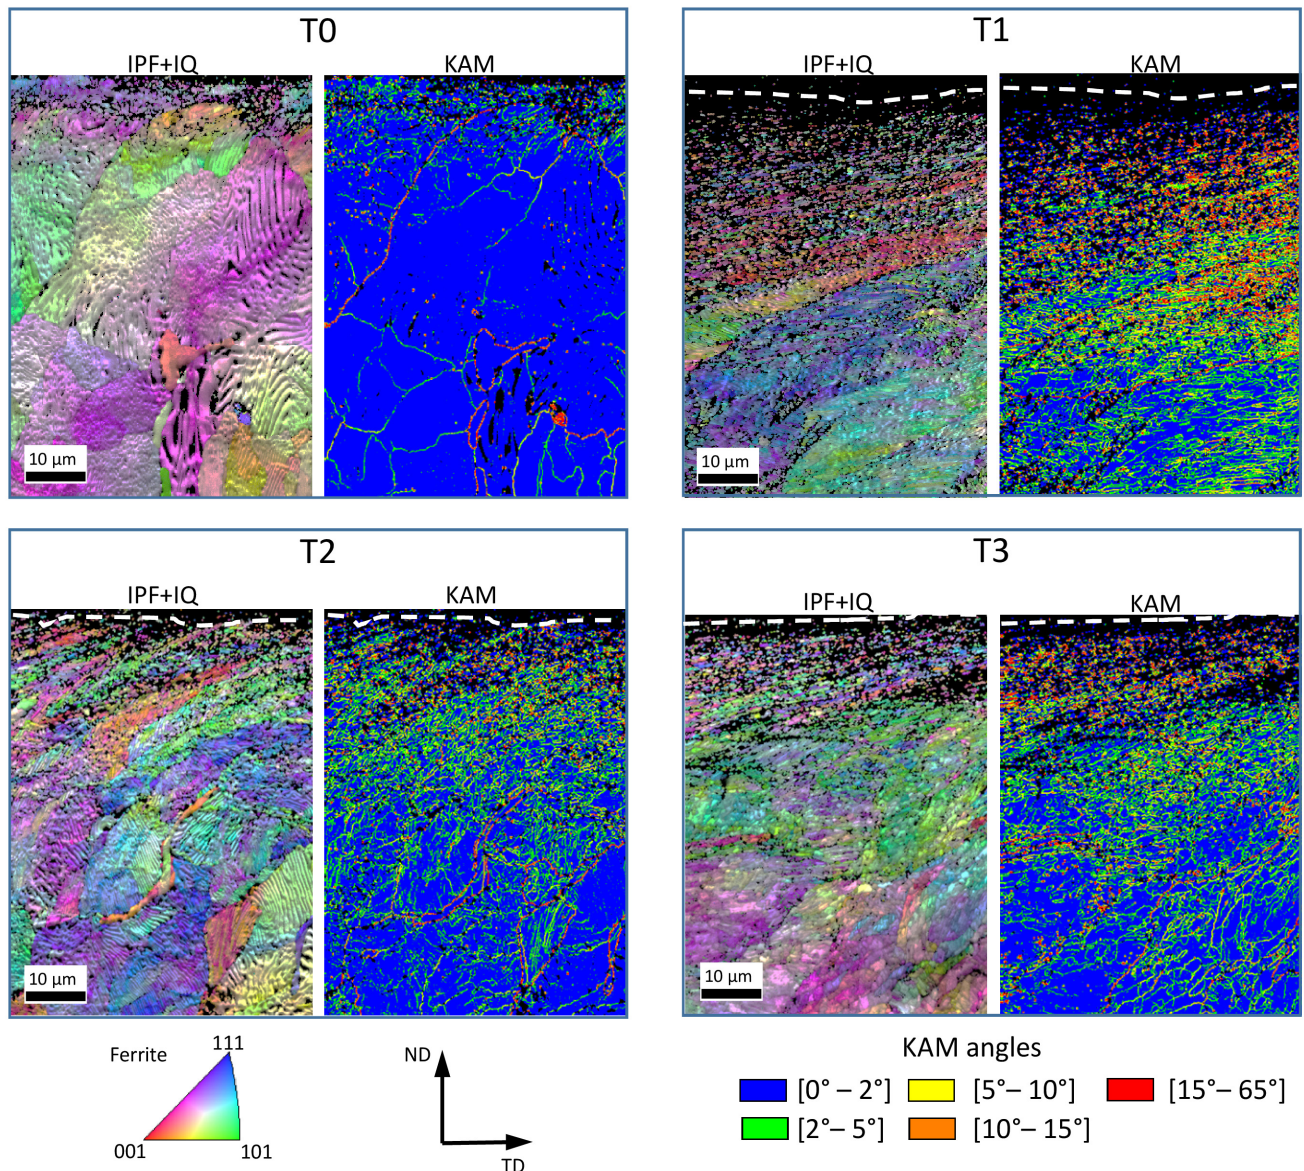
Figure 5. IPF map with IQ and KAM maps for the non-deformed state (T0) and the different testing conditions (T1, T2, T3), for Ring AT. The measurements were performed along the transverse direction.

By using the EBSD measurements, inverse pole figure (IPF) maps of ferrite were coupled with Index Quality (IQ) maps to visualize orientations and the underlying microstructures (as cementite is not indexed, it appears in black in the IQ map). Kernel Average Misorientation (KAM) maps were also computed to observe the evolution of local grain misorientation with deformation. Both types of maps are shown for all the tested conditions in Figure 5. For the non-deformed state (T0), the first 5–10 μm suffer from poor indexation. It leads to the appearance of very small grains on the maps that are not significant. This poor indexation is probably caused by surface turning. According to previous works [9,13], the nodules and colonies can be clearly identified by combining the map data: high-angle misorientations (KAM larger than 15°) surround the nodules while KAM around 5° tend to underline the colony boundaries. The maps corresponding to the different tested conditions are all characterized by deformed microstructures: a clear flattening and tilt of the microstructure components can be perceived, as well as fragmentation. For T1, the first 15 μm are strongly affected by a low indexation, thus preventing a robust conclusion. However, there seems to be a heavy fragmentation of the microstructure. Then, from a depth of 15 μm to 30 μm , nodule boundaries are lost, and the pearlite colonies are fragmented, as confirmed by the KAM map in which there is a high density of KAM angles comprised between 2 and 65° . After 30 μm , there is a gradual decrease in the density of KAM angles: nodules are still deformed but are now clearly visible. Larger EBSD maps were performed to determine the impacted depth. An example is given in Figure 6. Even if the IPF shows a microstructure similar to the non-deformed state around a depth of 50–60 μm , the KAM maps showed that KAM distribution similar to the non-deformed state was retrieved from a depth of around 100 μm . The near-surface of T2 is less affected by low indexation than T1, and the microstructure is globally less impacted by the deformation.

From 5 to 15 μm , the observed microstructure is less fragmented than T1, and KAM angles are mainly comprised between 2 and 5°. Then, around 25–30 μm of depth, nodules can be easily identified even if the density of KAM angles between 2 and 5° remains high. KAM distribution similar to the non-deformed state is retrieved for a depth of around 80 μm . Finally, T3 presents a structuration similar to T1 but on a smaller depth: using the IPF map, the nodules seem to be similar to the non-deformed state from a depth of 30 μm . The KAM map shows a distribution similar to the non-deformed state from a depth of around 70–80 μm .

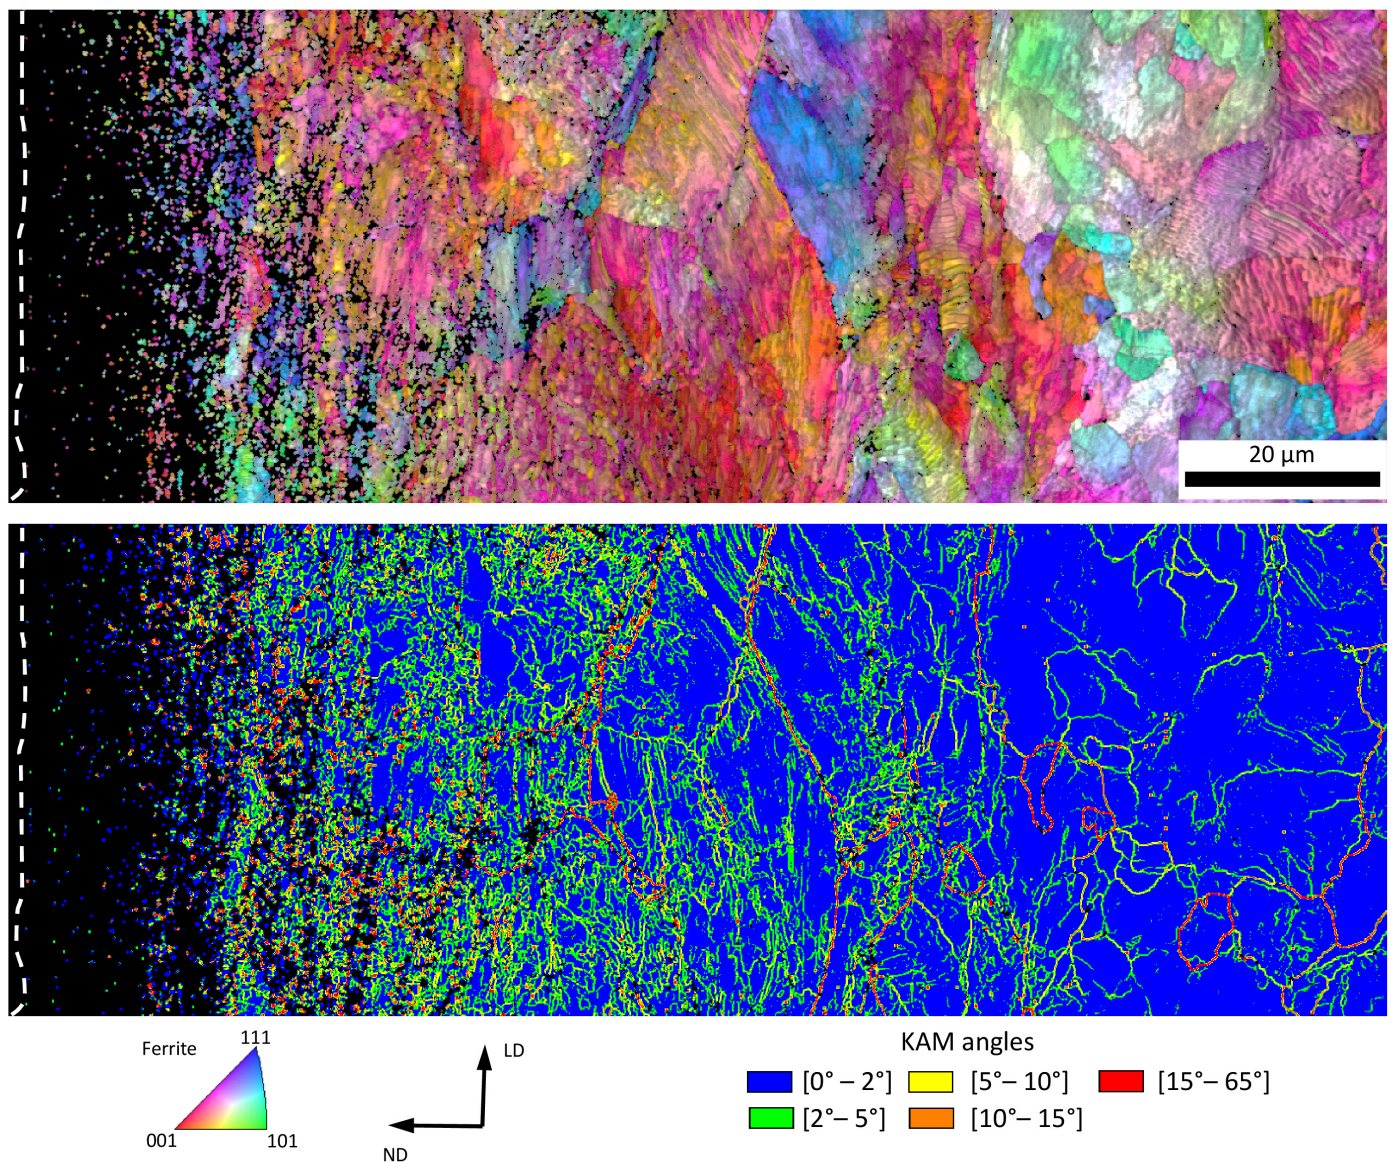
Figure 6. IPF map with IQ and KAM maps of a larger region for AT_T1 (as-turned with 1000 cycles with no sliding). The measurements were performed along the longitudinal direction.

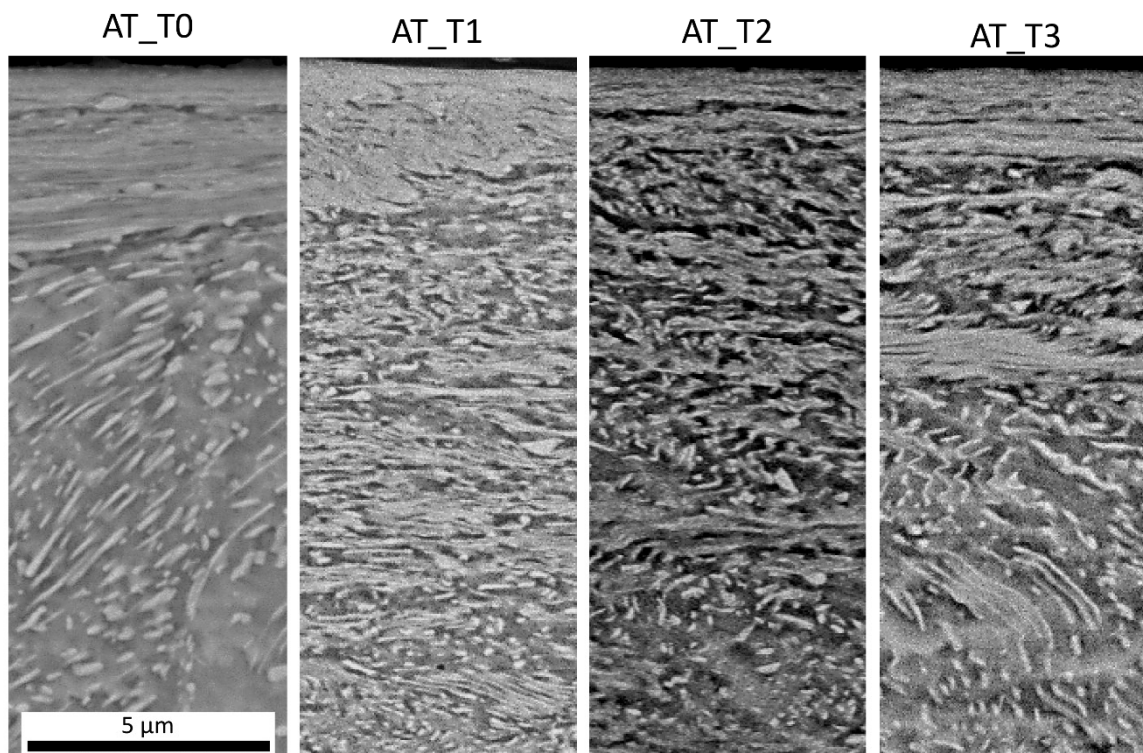
Figure 7. SEM images of the near-surface in the transverse direction, for all the tracks of Ring AT.

As the EBSD indexation is low near the surface, SEM pictures are provided for a better description of the microstructure (Figure 7). For AT_T0, the pearlite microstructure is lost for the first micrometers. It seems to be heavily by turning. Among all the tested conditions, T2 seems to present the lower sub-surface modification: the lamellar structure of pearlite can be detected from 2 μm below the surface. On the contrary, the lamellar microstructure is completely lost for T1 and T3 for the first 5 μm .

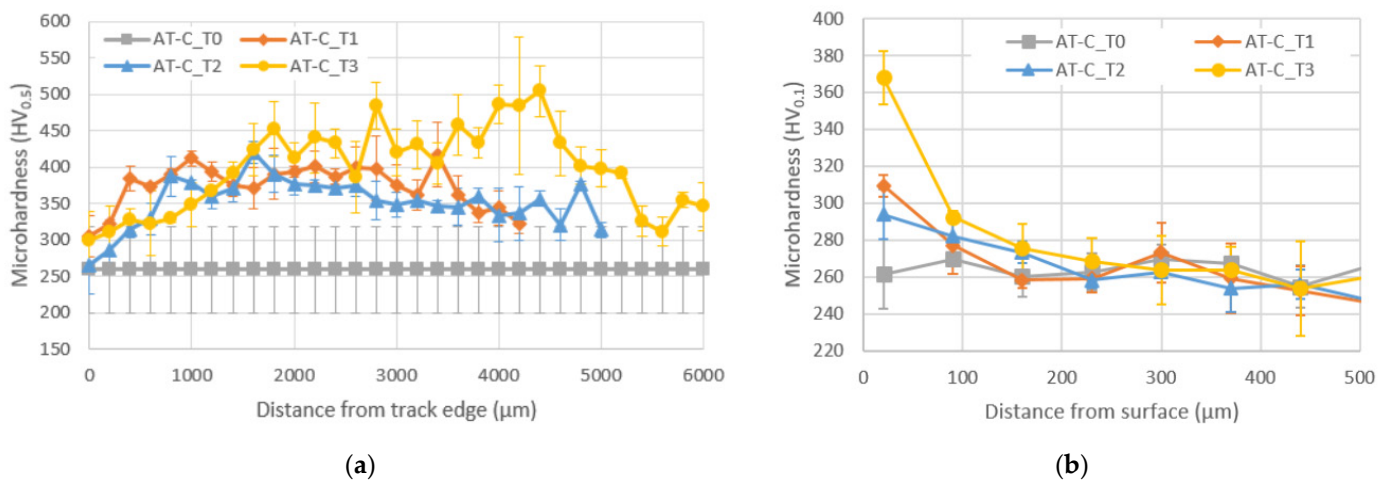
Figure 8. Microhardness results performed (a) on the surface of the tracks along their width and (b) on cross-sections for Ring AT-C.

Figure 8 shows the microhardness results obtained on the surface, along the track widths, and on the cross-sections. Despite the scatter of the values caused by roughness, a clear increase in microhardness can be identified on the surface of all the tracks (Figure 8a). Similar trends are obtained for T1 and T2, whereas larger microhardness values are obtained for T3: the maximum values are around $400\ \text{HV}_{0.5}$ for T1 and T2, while the maximum value is equal to $500\ \text{HV}_{0.5}$ for T3. As for the microhardness profiles performed on the cross-sections (Figure 8b), there is an increase in microhardness values from the surface to a depth of approximately $100\ \mu\text{m}$. Again, the largest values are obtained for T3 ($370\ \text{HV}_{0.1}$ against $290\text{--}310\ \text{HV}_{0.1}$ for the other tests).

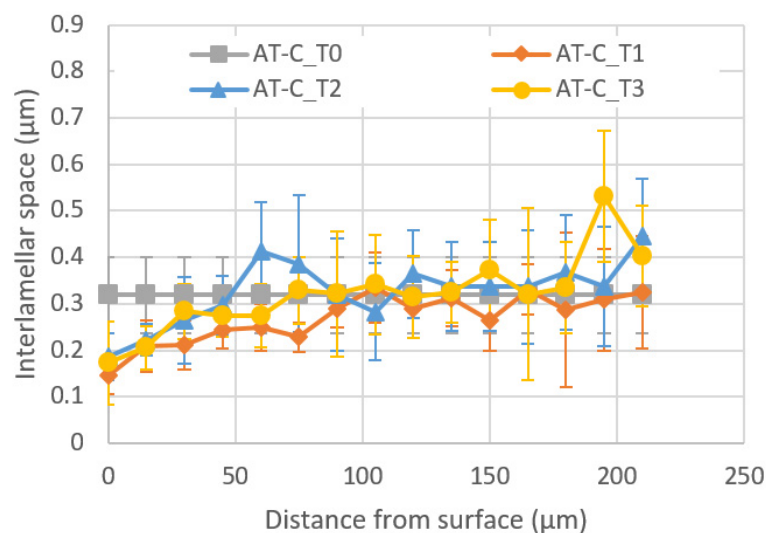
Figure 9. Evolution of interlamellar spacing with depth for Ring AT-C.

The initial microstructure of Ring AT-C can be observed in Figures A1 and A2. Again, the pearlite morphology is variable: the microstructure is similar to the one observed for Ring AT, except that some areas of small sizes containing only ferrite can also be observed. Thus, the difference in interlamellar spacing between the non-deformed conditions and the tests was difficult to assess because of the large data scatter (Figure 9). However, a significant decrease for T1, T2, and T3 can be perceived for the first 15 μm (with values between 150–200 nm against 300 nm for the reference).

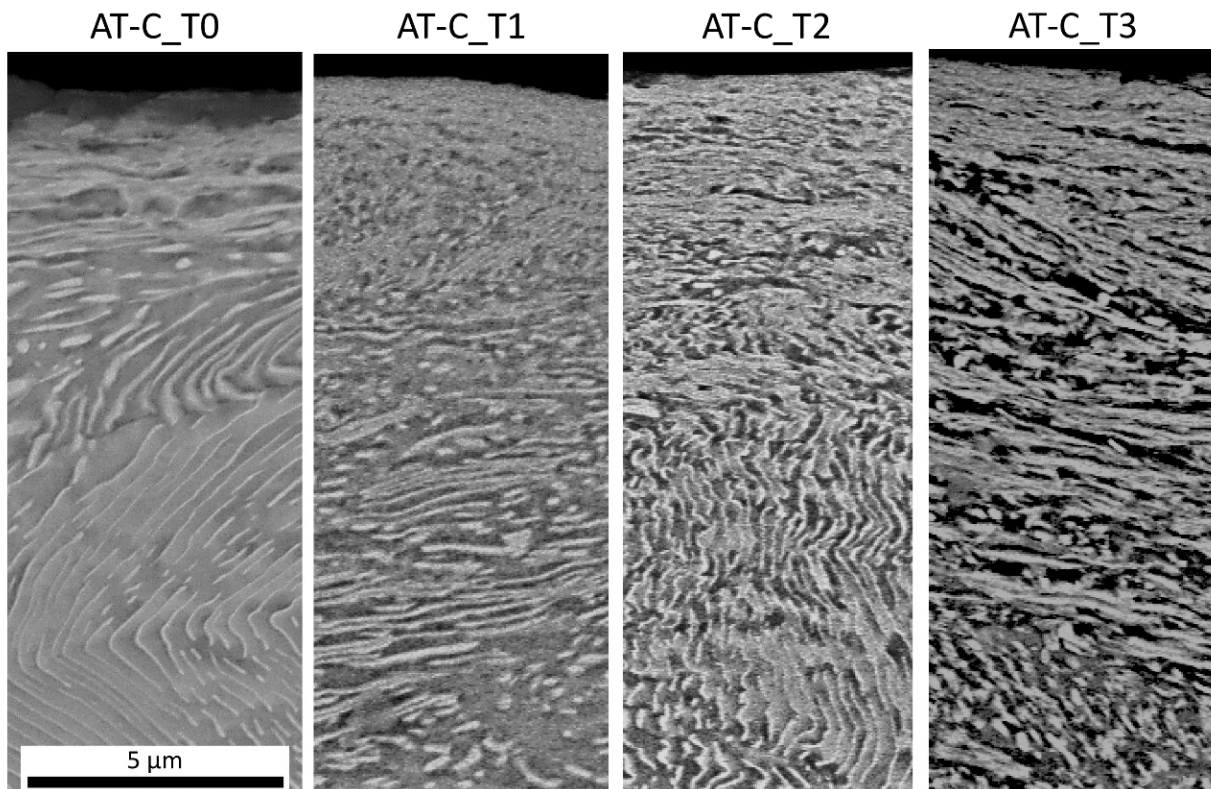
Figure 11. SEM images of the near-surface in the transverse direction, for all the tracks of Ring AT-C.

Again, as the EBSD indexation is too low for the first ten micrometers to be able to describe the microstructure changes, SEM pictures were taken to illustrate the microstructure changes caused by the different test conditions (Figure 11). For T0, only the first two micrometers seem to be impacted by turning (loss of pearlite microstructure). For T1 and T2, the lamellar microstructure can be easily distinguished from 2–3 μm . On the contrary, for similar depths, for T3, broken lamellae can still be observed and can be perceived until the end of the presented cross-section.

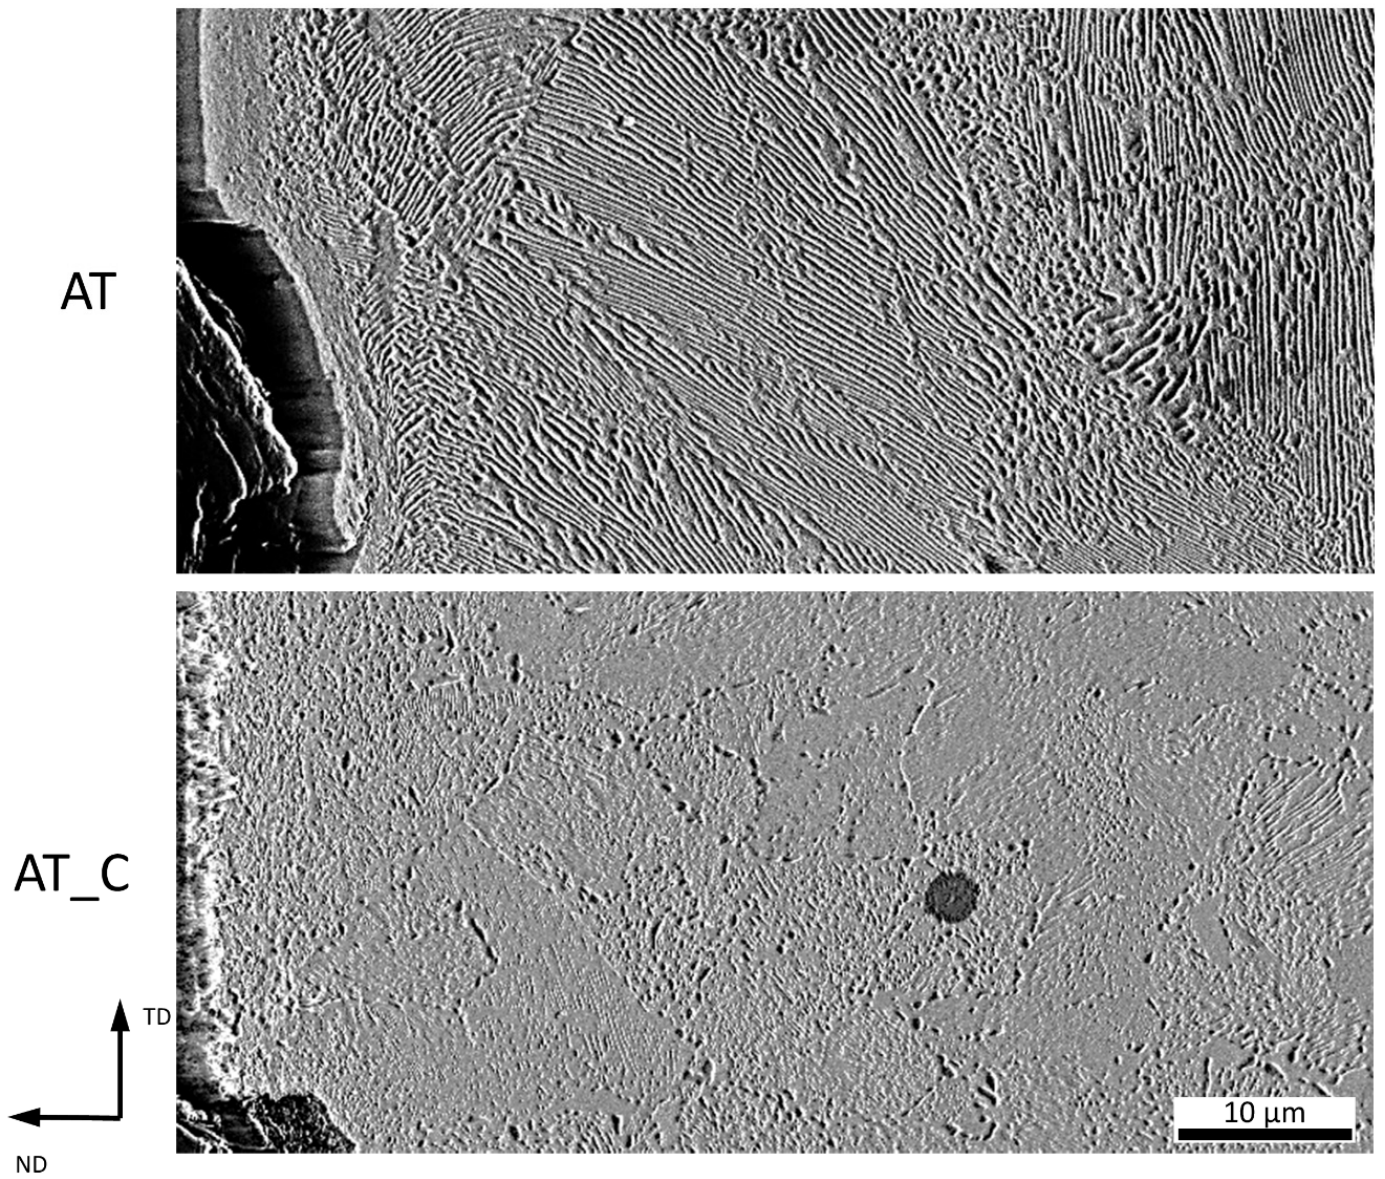
Figure A1. SEM images for the non-deformed state (T0) for Ring AT and Ring AT_C. The measurements were performed along the transverse direction.

The pearlitic microstructure can be observed in details in Figure 4a, while Figures A1 and A2 show larger areas of the initial microstructure. The pearlite morphology is variable: clear lamellar morphology can be observed as well as areas in which the cementite is spheroidized. This variation is further reinforced after deformation. Despite these fluctuations, interlamellar spacing in the pearlitic microstructure was measured to try to correlate its evolution with the previous microhardness trends. It was difficult to find straight lamellae groups fit for repeatable measurements. Figure 4b presents the median and standard deviations of the interlamellar spacing computed at different distances from the surface using an SEM image. Slightly lower values of the interlamellar spacing were obtained in the first 10 μm for all the tested conditions. However, the variability is too high to ensure data robustness.

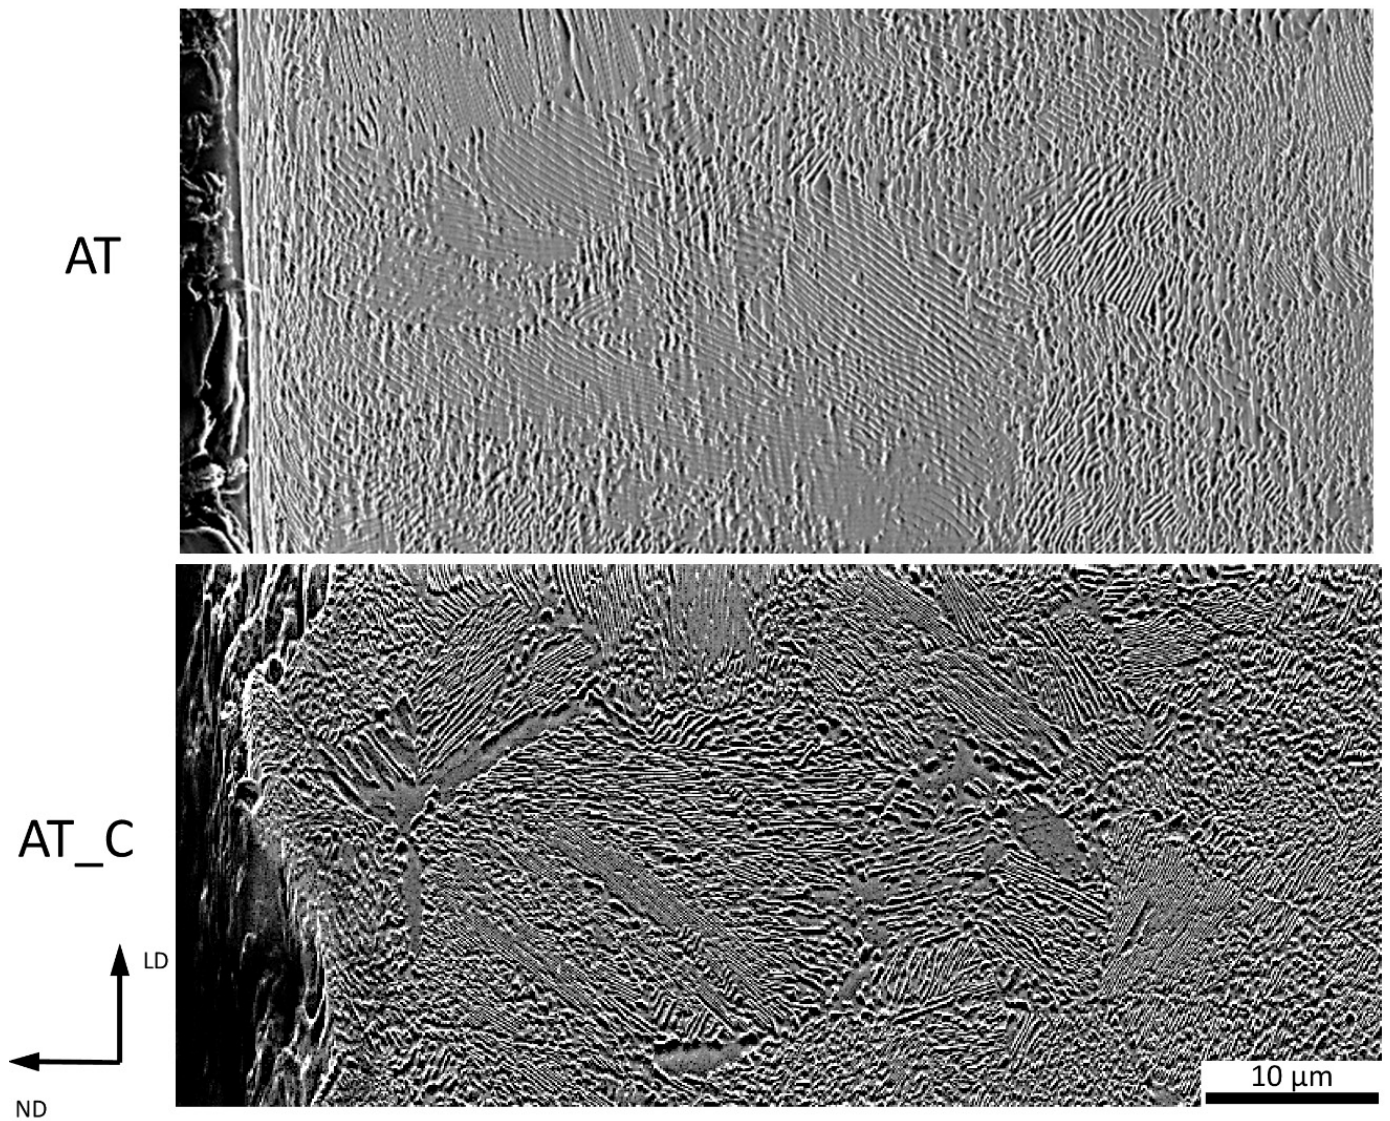
Figure A2. SEM images for the non-deformed state (T0) for Ring AT and Ring AT_C. The measurements were performed along the longitudinal direction.
