High-speed infrared thermography for in-situ damage monitoring during impact test

Julien Berthe, Salim Chaibi, Gérald Portemont, Pascal Paulmier, Frédéric Laurin, Christophe Bouvet

Julien Berthe, Salim Chaibi, Gérald Portemont, Pascal Paulmier, Frédéric Laurin, et al.. High-speed infrared thermography for in-situ damage monitoring during impact test. *Composite Structures*, 2023, 314, pp.116934. 10.1016/j.compstruct.2023.116934 . hal-04053467

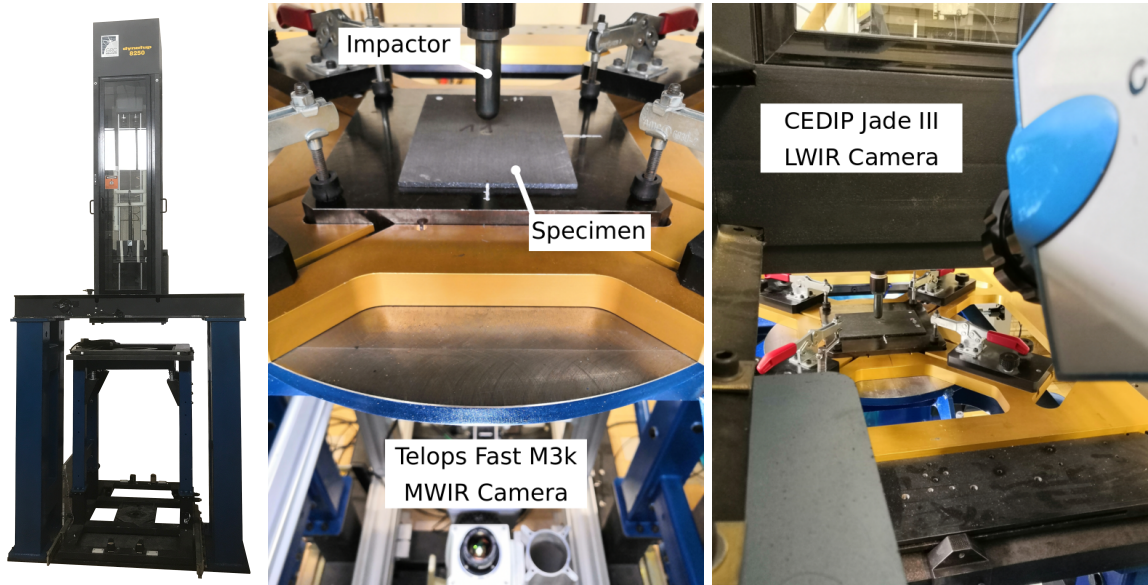
The experimental setup used in this study is described in Figure 1. The impact testing machine is an Instron Dynatup 8250 equipped with an anti-rebound system, which has been specifically modified as shown on the left hand side in Figure 1 to allow for the direct installation of the high speed infrared camera to monitor the non-impacted surface. The hemispheric impactor 16 mm diameter is fixed to a guided trolley to reach a total mass of 13.01 kg. The load applied to the specimen is measured with a load cell with a maximum load of 22 kN. The displacement of the impactor is measured with a laser transducer and the speed of the impactor just before the contact is measured with a photoelectric sensor. The signals are directly recorded by the acquiring system of the impact machine. Two different infrared cameras have been implemented to capture images on the impacted face of the specimen with a CEDIP JADE III LWIR camera as well as on the opposite face with a TELOPS FAST M3k MWIR camera. More details regarding IR

cameras acquisition will be given in the following section. Finally, in order to ensure a time synchronisation between the load and displacement measurements and the images captured by the different cameras, a DEWESOFT acquisition system was used. The displacement of the impactor and the trigger (TTL signal generated from a top send by a push button) sent to the different cameras were recorded at 1 MHz by the acquisition system.

Figure 1: Experimental setup.

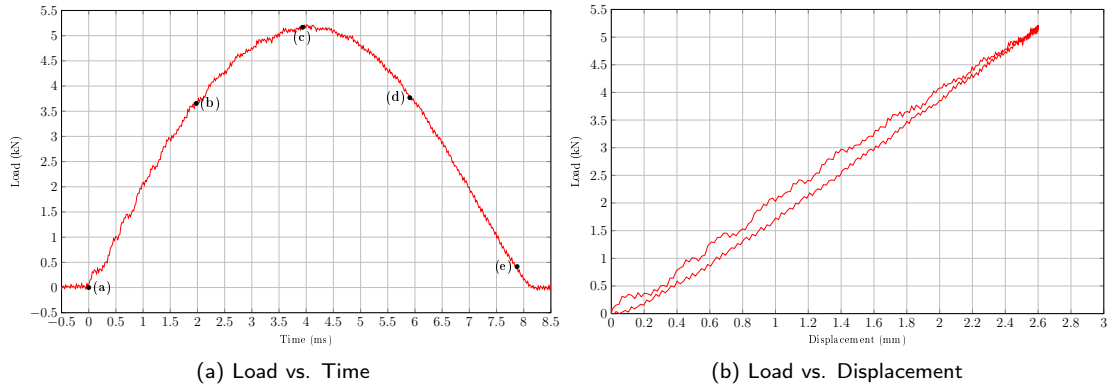
The global response of the laminate plate for a 6.5 J impact test is plotted in Figure 2. On the left hand side, the load versus time curve exhibits a quite smooth loading and unloading phases with a duration of test of approximately 8 ms. On the right hand side, the loading and unloading phases are almost superposed leading to the conclusion that a very small amount of energy may have been dissipated during the test by damage growth within the composite plate.

Figure 2: Global response of the composite plate for an impact test performed at 6.5 J.

For this test, the acquiring frequency of the CEDIP infrared camera has been fixed at 3050 Hz. Based on the test duration observed in Figure 2 and on the parameters described in Table 1, at least 24 images were captured by this camera during the test, whereas for the Telops camera, 100 images are taken during the test. An illustration of the IR images captured by the CEDIP camera during this test is plotted in Figure 3. It is possible to observe in these images horizontal lines with a fairly regular spacing. These lines are artifacts of the camera.

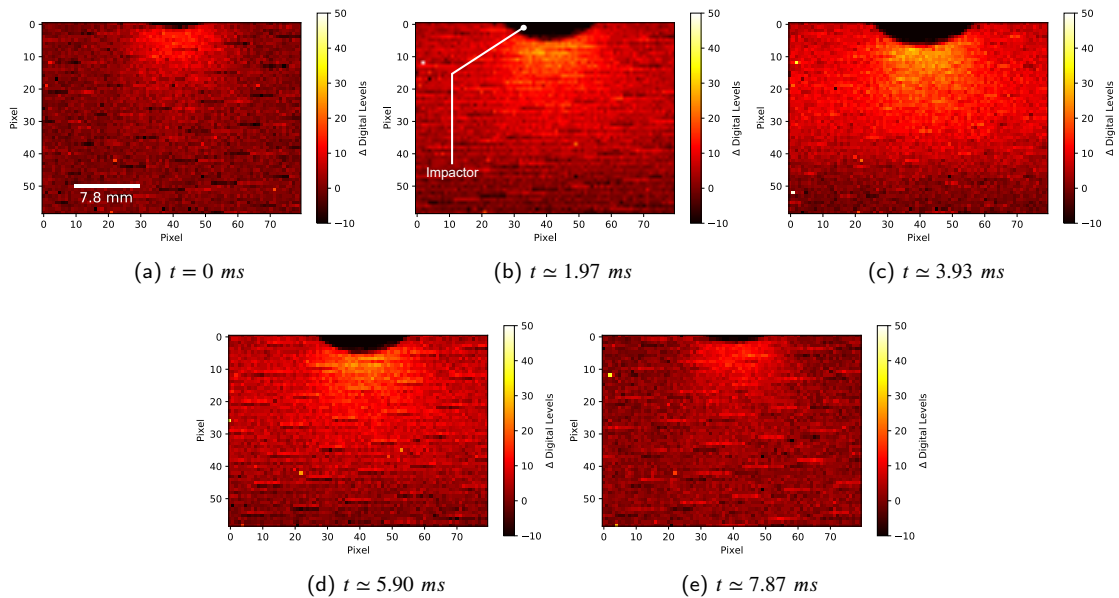
Figure 3: Infrared images captured by the CEDIP camera during the impact performed at 6.5 J.

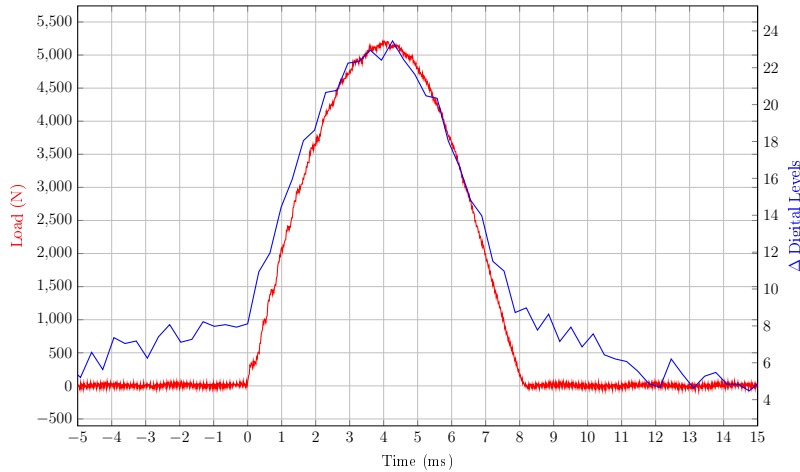
plotted in Figure 4 after treatment. It appears that a good correlation between the two signals can be obtained and, in the sequel, the time uncertainty linked to this procedure can be considered as the time between two images ($1/3050 = 3.27 \cdot 10^{-4}$ s).

Figure 4: Time synchronisation between the load applied to the composite plate and the images taken by the CEDIP infrared camera.

It can be observed in Figure 4 that the mean variation of Digital levels given by the camera is already increasing before the load application on the composite plate and continues decreasing even after the end of the test. This may be due to the reflection of the impactor on the composite plate captured by the camera when the impactor is approaching the plate. This phenomenon can also be observed in Figure 3(a) at $t = 0$ ms where the area close to the impactor exhibits higher DL variations than the rest of the plate. After that, when the plate starts to be loaded, an increase in the Digital Level is observed in Figure 4 and on the different pictures in Figure 3. This increase is linked to the thermoelasticity of the plate. The observed surface is mainly loaded in compression due to bending of the plate, which induces an increase of the temperature due to thermoelasticity. Finally, the last image in Figure 3 taken for a time close to the end of the test seems to exhibit almost no observable damage mechanisms on the observed area of the impacted surface.

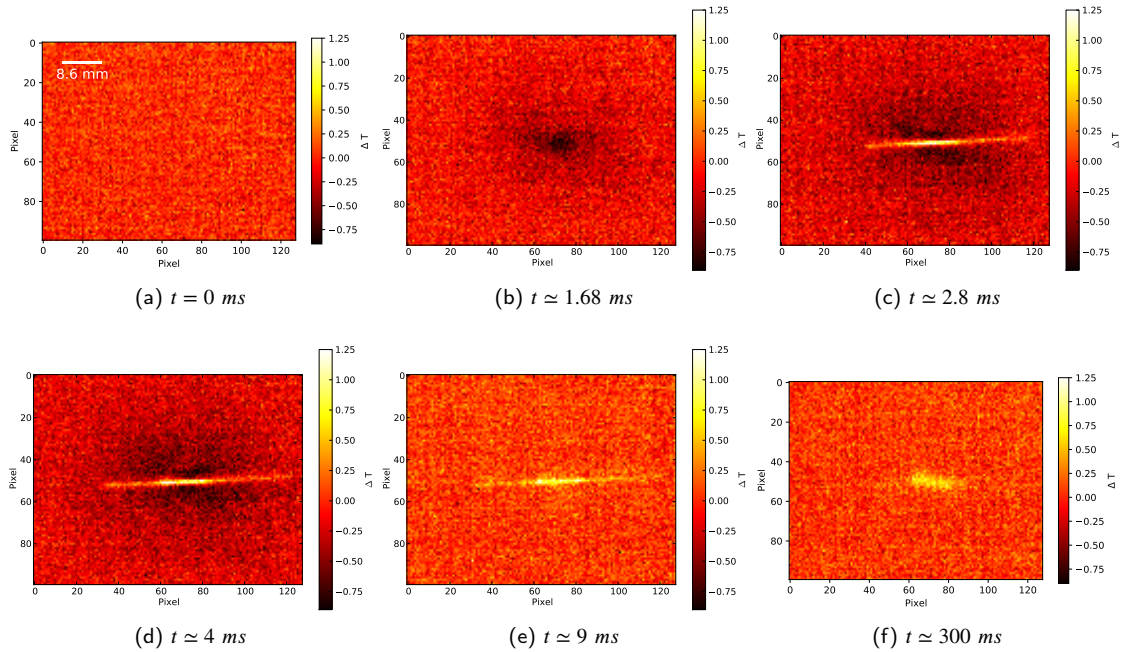
The thermal field variations captured by the TELOPS infrared camera for some particular time instants are plotted in Figure 5. For $t = 0$ ms, an homogeneous field is obtained with a mean value close to zero. After few milliseconds of loading, a decrease of the temperature in the middle of the plate is observed linked to thermoelasticity. Indeed, the observed surface is mainly loaded in tension due to bending which leads to a decrease of the temperature with thermoelasticity. With the image taken 2.8 ms after the beginning of the test, a crack on the surface of the composite plate is clearly observed. This crack is located in the middle of the plate, following the direction of the fibres in the 0° -outer ply. A small alignment default between the direction of the fibre in the surface plane and the horizontal axis of the IR camera can be observed on the image. For $t = 4$ ms, the crack seems to be a bit longer than on the previous image. The crack is still surrounded by an area with an apparent decrease of temperature linked to the tensile loading of this surface ply. On the image taken at $t = 9$ ms, the crack in the middle of the ply is still observable but as the load applied to the composite plate is now back to zero, the mean variation of temperature of the rest of the plate is back to zero. Finally, the acquisition has not been stopped right after the end of the loading, in order to be able to capture images after a hundred of milliseconds. These images can be compared to previous works performed on the use of infrared thermography during impact tests on composite materials (Meola and Carlomagno, 2009; Meola et al., 2018; Maierhofer et al., 2019). In this last image, an increase of the temperature can be observed in the middle of the sample, with an ellipsoidal shape which differs from the crack observed in previous images. In the literature, such a temperature increase after an impact test has been classically linked to damage extension area within the composite plate (Meola et al., 2018; Maierhofer et al., 2019). These authors have proposed various methodologies to quantify these areas and there is currently no standard procedure in the literature. Consequently, a specific study has to be done for this quantification and will be described in a dedicated section (see section 4).

Figure 5: Temperature field variations captured by the TELOPS camera during the impact performed at 6.5 J.

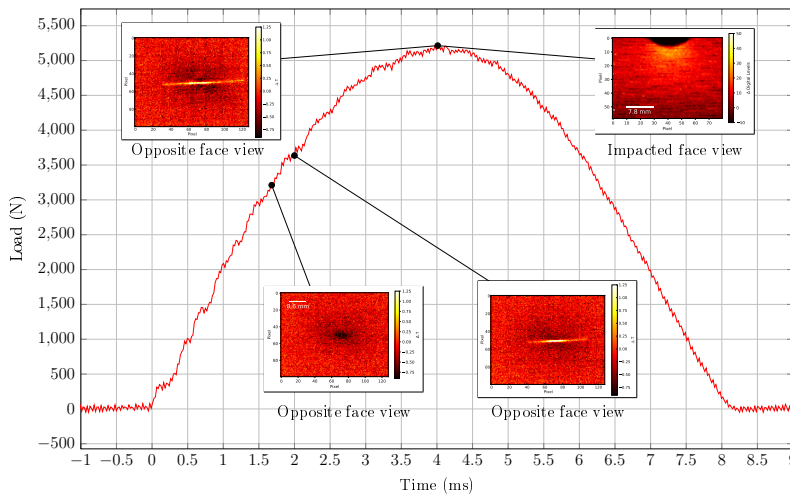
Finally, the results can be summarised in Figure 6 in which the load applied to the specimen is directly linked to the different damage phenomena that can be observed by the different infrared cameras. In this case, as low impact energy

level is considered, the main observable phenomenon is thermo-elasticity and a crack appearance on the opposite face for a load level around 3210 N. The crack opening is growing until the load peak. The infrared images captured on the impacted face do not appear to reveal any damage.

Figure 6: Cross analysis between the load applied to the composite plate and the images captured by the different infrared cameras for a 6.5 J impact test.

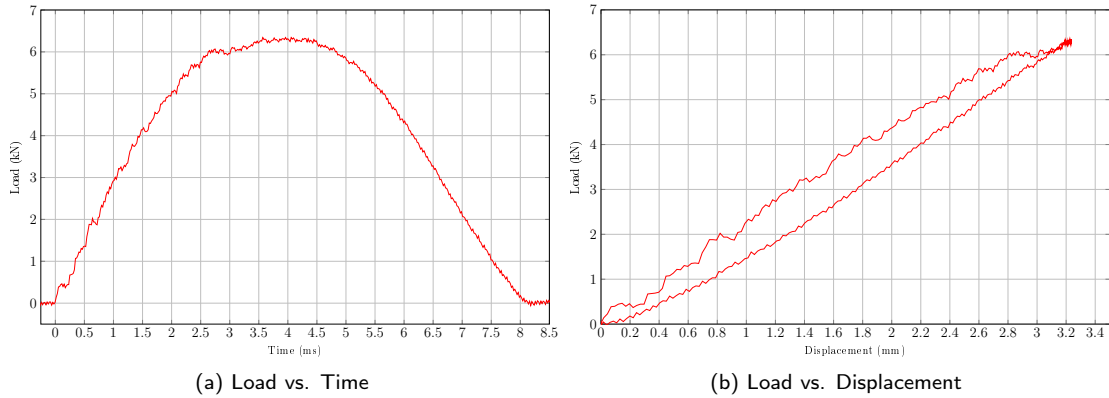
The global response of the laminate plate for a 11 J impact test is plotted in Figure 7. On the left hand side, the load versus time curve exhibits a quite smooth loading until approximately 6 kN where a small drop can be observed. The duration of the impact is approximately 8 ms. On the right hand side, the load versus displacement curve exhibits

more dissipated energy than for the test at 6.5 J. A sudden variation of the global slope of the loading phase is also observed in this figure at approximately 6 kN.

Figure 7: Global response of the composite plate for an impact test performed at 11 J.

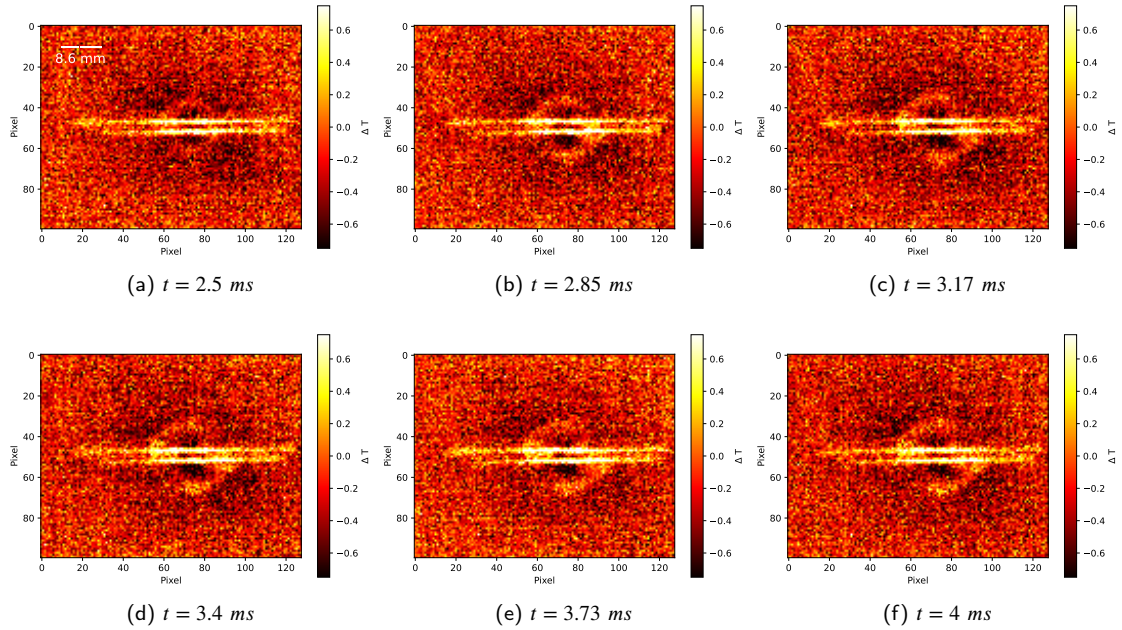
Figure 9: Temperature field variations captured by the TELOPS camera during the 11 J impact test between 2.5 ms and 4 ms.

two images, the shape appears to be more oval than circular with a long axis oriented at 45° . Moreover for these last two images, the propagation seems to be finished. This phenomenon can be compared to an image taken a long time after the beginning of the test as that plotted in Figure 10 taken for $t = 300\text{ ms}$. The observed shape in Figure 9f is

clearly in good agreement with the shape observed in Figure 10 which is usually linked to the extension of impact damage as it was previously mentioned. Moreover, the shape observed in Figure 9f is similar to the shape classically observed for delamination during impact tests and could be correlated to the post-mortem damage analysis performed in Figure 25. Based on this observation, the extend of this phenomenon between 2.5 ms and 3.4 ms is probably linked to the propagation of delamination between the 0° surface ply and the adjacent 45° ply. Consequently, the small drop observed between 2.5 ms and 3 ms on the load curve can be explained by the two phenomena previously mentioned: a compressive failure observed on the impacted surface and the propagation of delamination between adjacent plies close to the opposite surface.

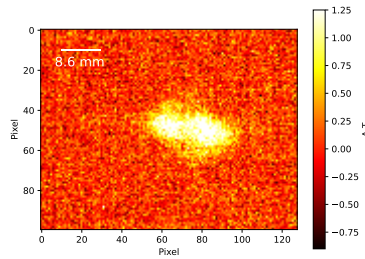
Figure 10: Temperature field variations captured by the TELOPS camera 300 ms after the beginning of the impact test.

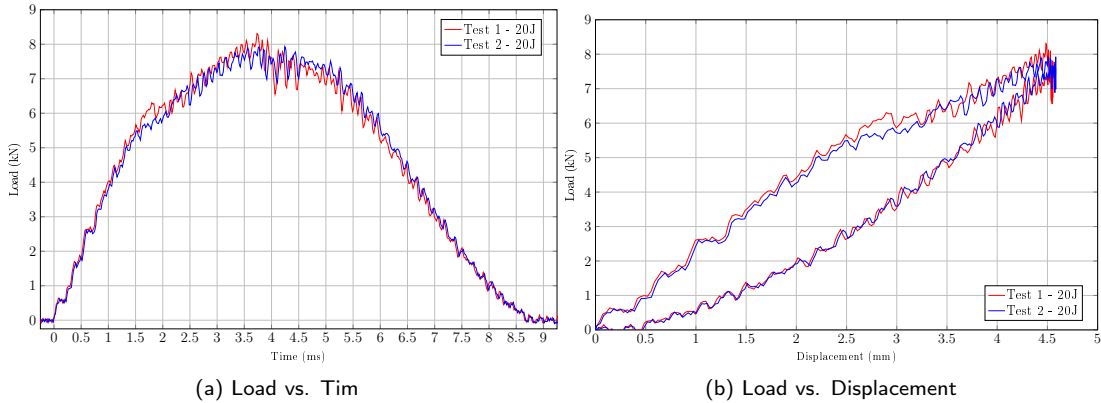
The global response of the laminate for the 2 tests performed at 20 J are plotted in Figure 11. The curves plotted on the left hand side exhibit a change of the loading slope for a load between 5.5 kN and 6 kN. The two curves are almost superimposed except for the appearance of the slope change between 5.5 kN and 6 kN. Compared to lower

impact energy tests, larger oscillations can be observed, particularly between 4 and 4.5 ms. On the right hand side of Figure 11, the load versus displacement curve are also superimposed except between 5.5 kN and 6 kN.

Figure 11: Global response of the composite plate for the 2 impact tests performed at 20 J.

As it was previously mentioned, the two loading curves plotted in Figure 11 are almost superimposed except between 5.5 kN and 6 kN, for times between 1.5 ms and 2.2 ms. Based on this observation, the variation of the thermal fields for the two tests for this specific interval of time are plotted in Figures 14 and 15. First of all, a small difference in the orientation of the tested specimens can be noticed based on the inclination of the main central crack particularly for the second test. This difference in the alignment of the two specimens can explain the very small difference which can be observed between the two curves before 1.5 ms which is linked to the apparent stiffness of the coupon. Apart from this difference, the two figures exhibit a damage scenario which is quite similar. Moreover, the different crack appearances are almost synchronised. For the second test plotted in Figure 15, the delamination growth seems to be quicker than for the first one. Indeed, for the first five images in Figure 15, the delamination area seems to be larger than for the first five images in Figure 14. This is the only difference that can be observed in these images regarding

kN, the load exhibits important oscillations. Such oscillations have also been observed in Figure 11 for the 20 J impact tests for an equivalent load level. As it can be observed on the right hand side of Figure 16, even if the displacement is still growing after the first important oscillation, the load does not seem growing anymore.

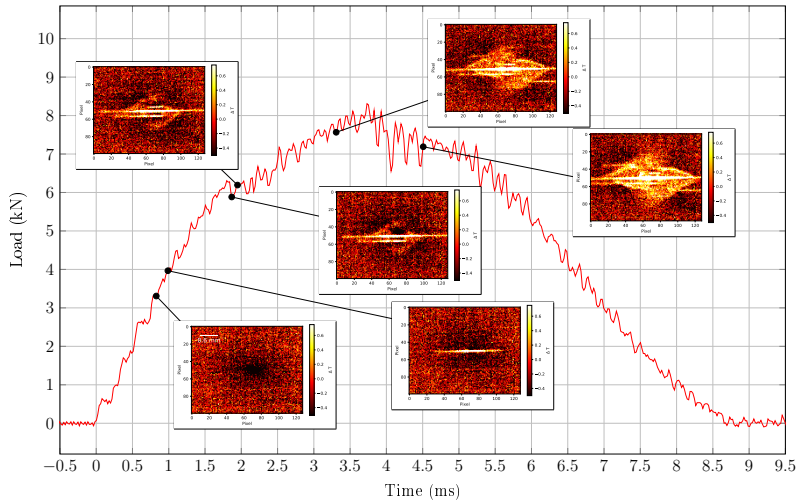
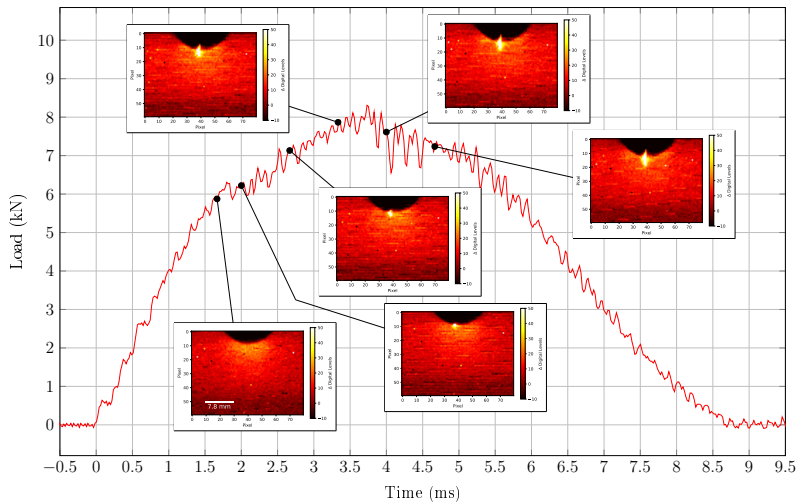
In the first instance, only one of the two tests is going to be deeply analysed regarding the IR images. In a second instance, a specific focus on the variations between the two tests will be performed in a dedicated subsection. For the test previously referred as "Test 1 - 20 J", a global analysis of the different images captured by the two infrared cameras can be performed using Figure 12. As it was already mentioned for the test at 11 J, the slope change observed for loads higher than 6 kN can be linked to the growth of delamination which can be observed on the opposite face but also to a compressive fibre failure observed on the impacted face. On the left hand, it can be observed that the extend of delamination and the number of cracks is higher than for tests at lower energies. Moreover, the shape of the delamination appears to be in agreement with those classically observed in such impact tests (Bouvet et al., 2009; Troussset, 2013). A higher extend of the compressive failure is also observed on the right hand side of Figure 12. All these observations are in good agreement with the higher dissipated energy level which can be observed in Figure 11.

(a) Images captured by the infrared cameras on the opposite face

(b) Images captured by the infrared cameras on the impacted face

Figure 12: Cross analysis between the load applied to the composite plate and the images captured by the different infrared cameras for an impact test performed at 20 J.

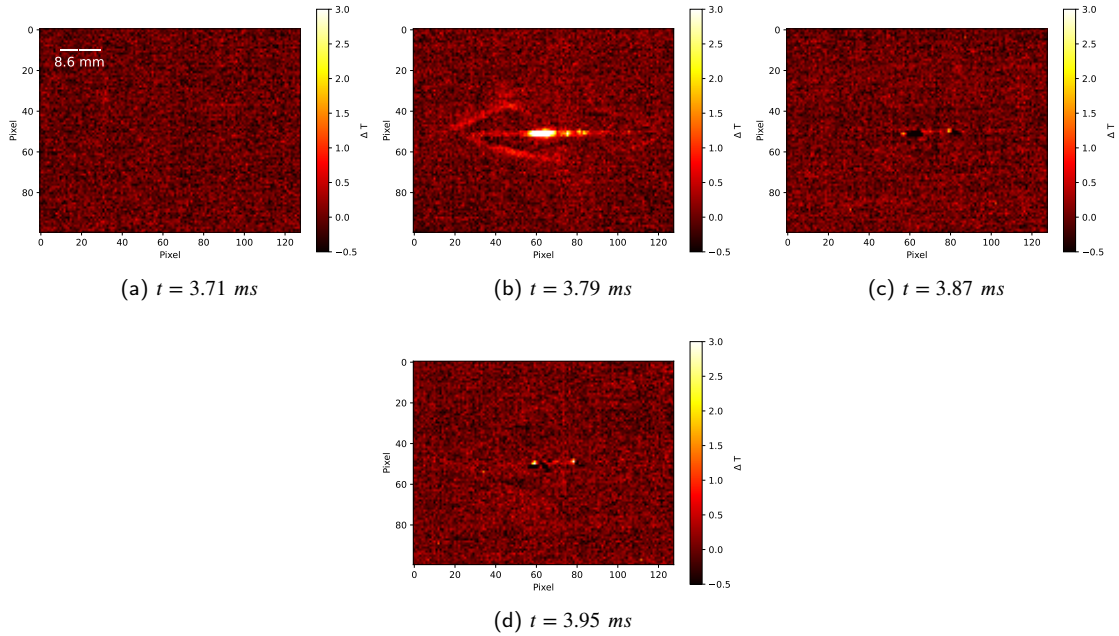
A specific focus is done in Figure 13 in order to analyse the highest level of oscillations observed between 3.7 ms and 4.5 ms in Figure 11. For that purpose, the analysis of the thermal fields has to be modified in order to exacerbate the phenomenon that happen between two captured images. Consequently, the temperature difference plotted in Figure 13 is obtained by making a difference between the image captured at the time t and the image previously captured at the time $t - (1/12500)$. These images clearly show that an important amount of energy is released as heat between $t = 3.71 \text{ ms}$ and $t = 3.79 \text{ ms}$. An important increase of the temperature (between 6°C and 20°C) can be observed within the central crack of the specimen. Such an increase of temperature has not been observed previously for the damage phenomenon observed on the opposite face. Therefore, it seems likely that this phenomenon is related to a sudden failure event with a significant amount of energy released, such as tensile fibre failure below the surface ply. This assumption has been confirmed with the post-mortem analysis that will be described in details in the sequel. Finally, for the last two images in Figure 13, some hot points can be observed which are linked to some debris generated by the event observed at $t = 3.79 \text{ ms}$ and which are flying within the images taken after this event.

Figure 13: Temperature field variations captured by the TELOPS camera during the 20 J impact test between 3.71 ms and 3.95 ms.

A comparison can also be performed for the instant of appearance of the brutal failure event previously mentioned. For the test referred as "Test 1 - 20 J", the event appears between $t = 3.71 \text{ ms}$ and $t = 3.79 \text{ ms}$. This interval of time can be linked to an interval of load which is between 7818 N and 7983 N. The same analysis can be done for the second test. It leads to the appearance of the brutal failure event between $t = 3.57 \text{ ms}$ and $t = 3.65 \text{ ms}$. This interval of time can be linked to an interval of load which is between 7349 N and 7836 N. A small difference between the two tests is observed but does not appear significant.

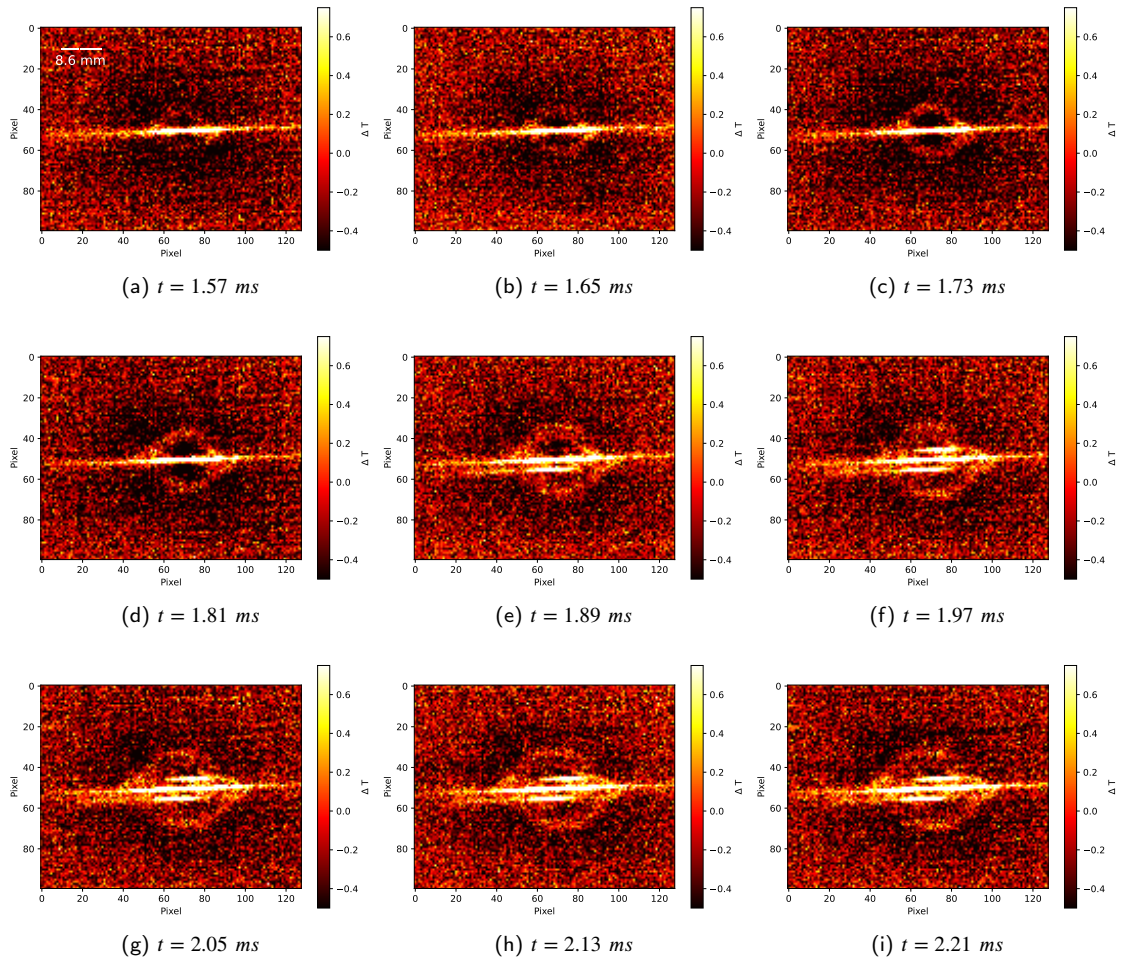
Figure 15: Temperature field variations captured by the TELOPS camera during a 20 J impact test (Test 2) between 1.5 ms and 2.2 ms.

damage growth. This difference may explain why the load curve for the second test is lower between 1.5 ms and 2.2 ms than that for the first test, as the damage appears to grow more rapidly during this test. The comparison for the two tests of the images captured for the impacted surface during such a small time interval is not relevant because of the lower time resolution.

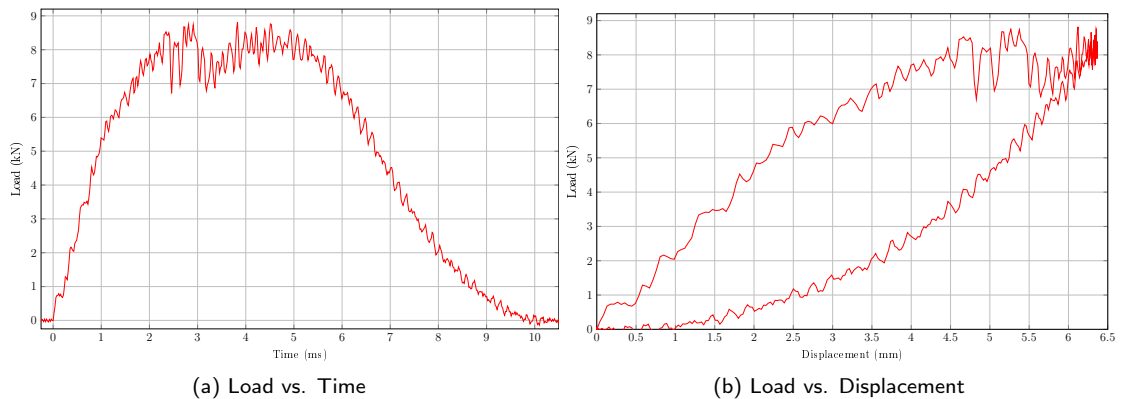
The global response of the laminate plate for a 35 J impact test is plotted in Figure 16. As it was previously observed, the loading slope exhibits a first decrease between 5.5 kN and 6 kN. After 2.5 ms and for a load of approximately 8

Figure 16: Global response of the composite plate for an impact test performed at 35J.

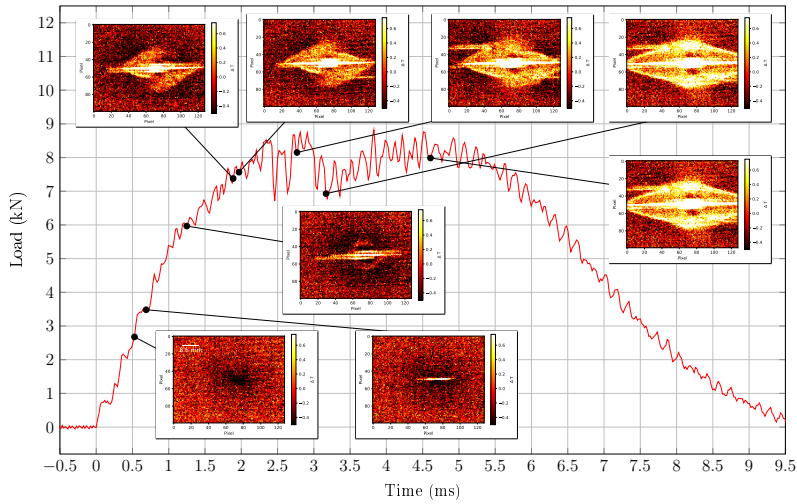
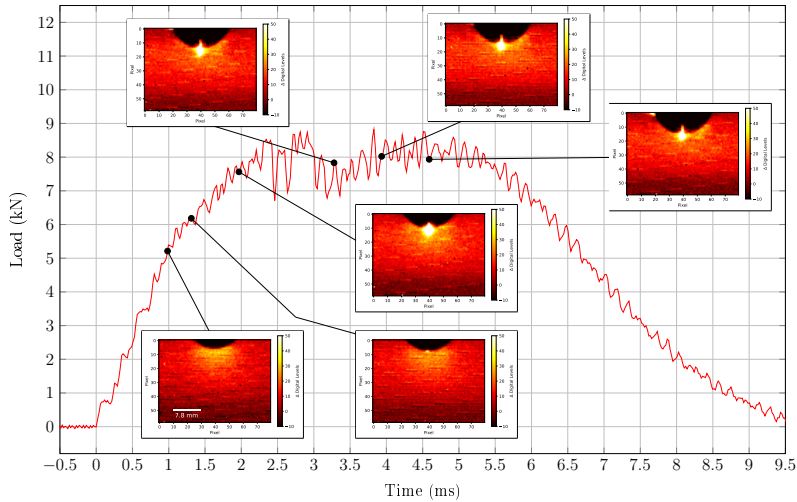
First of all, a global analysis of the different images captured by the two infrared cameras can be performed with Figure 17. As it was already mentioned for the tests at 11 J and 20 J, the change in slope observed for loads above 6 kN may be related to the growth of delamination that can be observed on the opposite side but also to the failure of the fibre in compression observed on the impacted side. Indeed, in the figure on the right, even if this compression failure is not very extensive for 6 kN, it is still visible. For the delamination, in the figure on the left, an important extension of the delamination can be observed between 6 and 7.5 kN. With this figure, it can also be observed that the damage extension during the 35 J test is larger than the observation window used in this experimental investigation for the Telops IR camera. Finally, based on Figure 17, the interpretation of the large oscillations observed after 2.5 ms is not obvious. As it was previously done for 20 J test analysis, a specific post-treatment can be applied to better understand the important oscillations that can be observed after 2.5 ms. For that purpose, the images plotted in Figure 18 have been analysed by making the difference between the image captured at the time t and the image previously captured at the time $t - 1/12500$.

(a) Images captured by the infrared cameras on the opposite face

(b) Images captured by the infrared cameras on the impacted face

Figure 17: Cross analysis between the load applied to the composite plate and the images captured by the different infrared cameras for an impact test performed at 35J.

These images clearly exhibit a brutal failure event below the surface of the laminate as it was also observed for the 20 J impact test. Post-mortem analysis will confirm, in the sequel, fibre failures below the surface of the specimen which may be linked to this high energy event. As these events occur below the IR observable surface, the diffusion phenomena require a sufficiently long time to allow the surface observation of these events. In a previous work (Berthe and Ragonet, 2018), diffusion time through one 0° ply of the composite material studied in this work has been qualitatively evaluated. After a time between 39 ms and 52 ms, the thermal increase due to the propagation of a transverse crack that has propagated below the 0° degree ply is clearly observable on the surface of this ply. Based on this result, a specific analysis of the images taken after the end of the test can be proposed in order to observe the temperature variation due to diffusion through the thickness. The images plotted in Figure 19 have been obtained by making the difference between the IR images taken at $t_1 = t_{end} + 45 \text{ ms}$ (diffusion through 1 ply) or $t_2 = t_{end} + 90 \text{ ms}$ (diffusion through 2 plies) and the IR image taken at t_{end} . The different images have been plotted based on the same interval for the colorbar. Firstly, it clearly appears that the area, in which the temperature increases are observed, is increasing with the energy applied to the specimen. For the three different energy levels, a quite homogeneous temperature increase

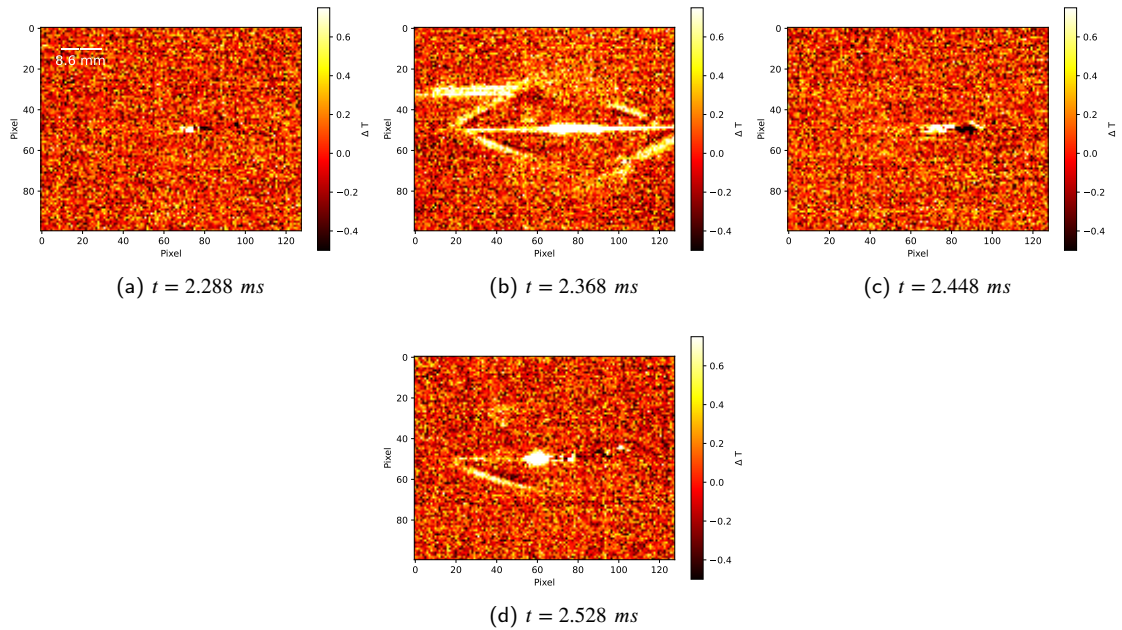
Figure 18: Temperature field variations between two successive images captured by the TELOPS camera during the 35 J impact test between 2.288 ms and 2.528 ms.

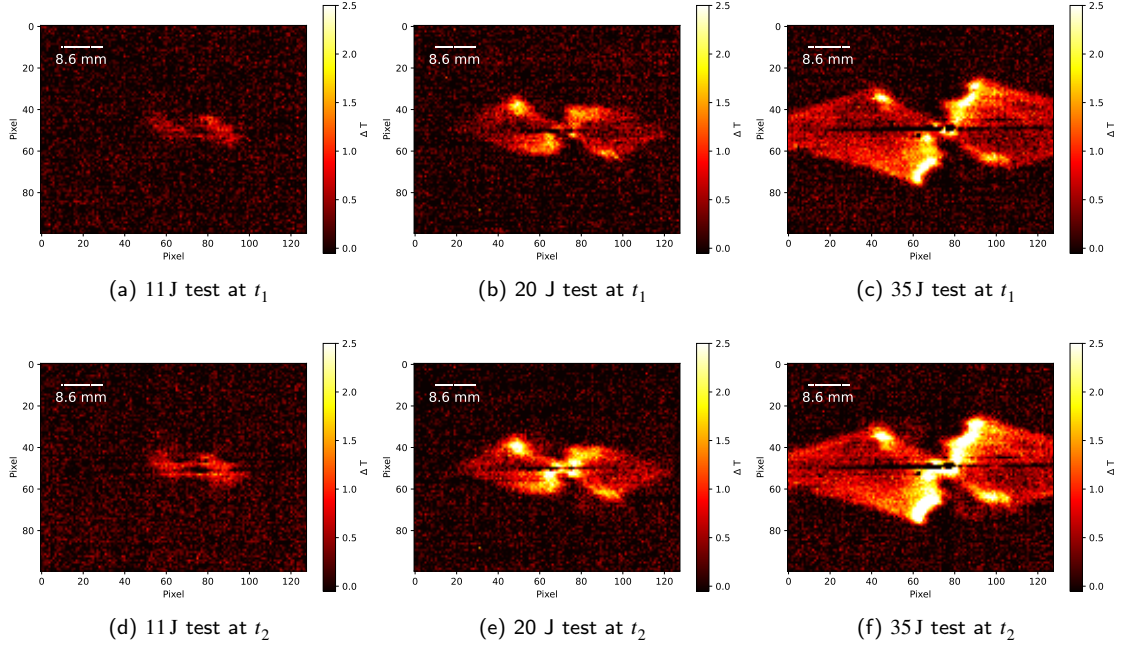
Figure 19: Temperature field variations between the end of the test and two particular times t_1 and t_2 for different impact energy levels.

On the other hand, by comparing Figure 19 and Figure 25, it can be seen that the analysis proposed for the construction of Figure 19 clearly highlights the shape of the delamination between the last 2 plies on the non-impacted side which is depicted in dark red on the right hand side in Figure 25.

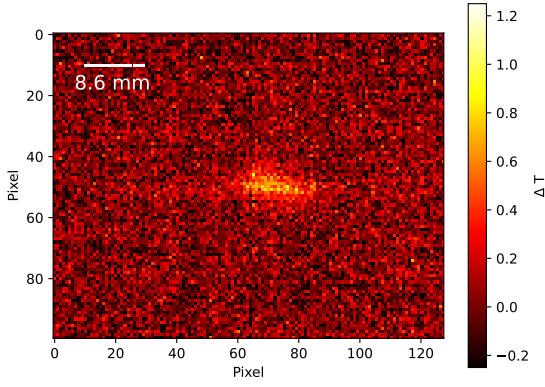
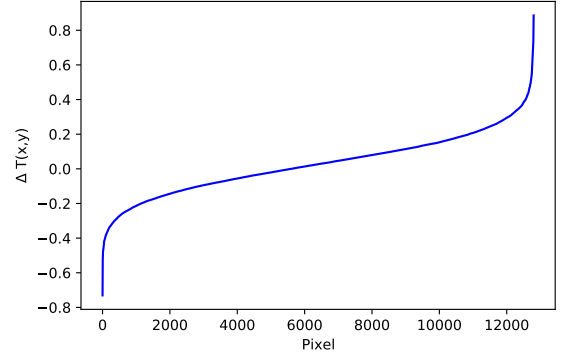
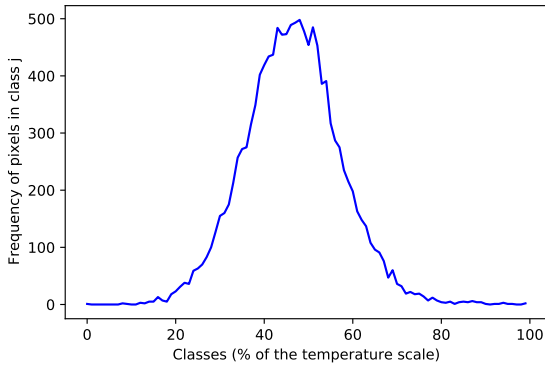
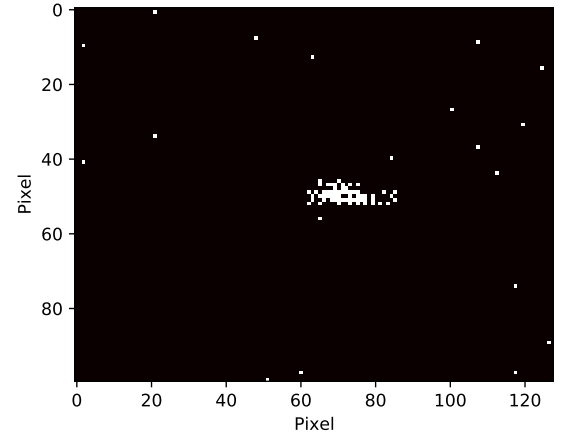
(a) Selected thermogram for the application of the analysis methodology proposed by Maierhofer et al. (2019)

(b) Resorted temperature values of the plotted thermogram.

(c) Histogram of the frequency of pixels belonging to each class. Classes 1 to 100 comprise the temperature from $T_{min}=-0.73K$ and $T_{max}=0.89K$.

(d) Heated area matrix obtained with this approach.

Figure 20: Results obtained in this study with the analysis methodology proposed by Maierhofer et al. (2019) which can be directly compared to the results plotted in Figure 2 in the original paper.

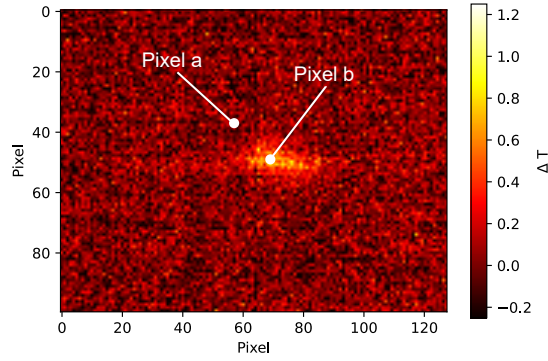
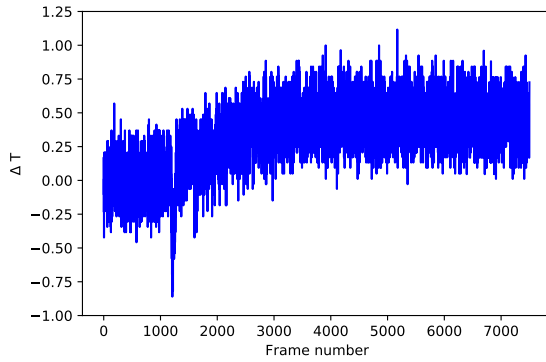
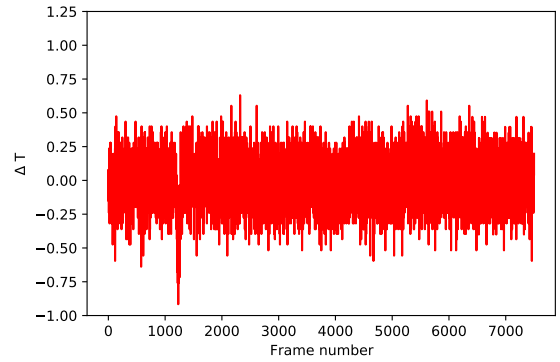
(a) Positions of two selected pixels in the studied image

(b) Thermogram of the pixel $x = 69$ and $y = 49$ (Pixel b)

(c) Thermogram of the pixel $x = 57$ and $y = 37$ (Pixel a)

Figure 21: Comparison of the thermograms for two pixels located in two different positions.

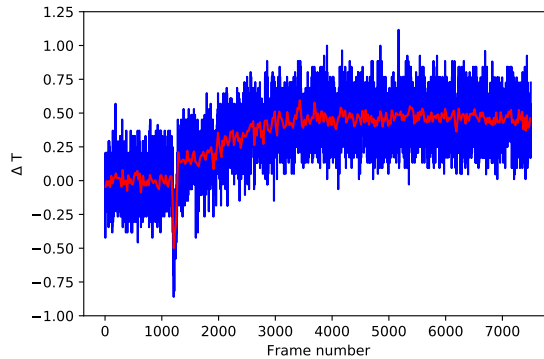
Figure 22: Comparison between the raw thermogram and the one obtained with an average value of the pixels over 20 images.

In order to evaluate the heated area after the impact, the high temporal discretisation used for the study of damage appearance during the impact test is no longer mandatory. Consequently, a data reduction can be performed based on the average value of the pixel over a given number of frames. As shown in Figure 22, a drastic reduction of the apparent noise for the selected pixel ($x = 69$ and $y = 49$) is observed by using an average value over 20 images. In that case, the apparent noise observed in Figure 22 appears to be in better agreement with the order of magnitude classically observed in the literature. Based on that observation, *the reference based method* proposed in Boccardi et al. (2016) will be used in the sequel to evaluate the heated area with the post-treated IR data obtained after the data reduction process. This choice is based on the fact that this methodology appears to the author as the simplest one and as it was mentioned by Maierhofer et al. (2019) the results obtained with the different methodologies are very similar. The analysis methodology proposed by Boccardi et al. (2016) will be briefly recalled. First of all, a reference image before the beginning of the test is generated based on an average value of each pixel over a given number of frames (100 in the work of Boccardi et al. (2016)). Due to the data reduction already performed on the results, only 50 images can be used in this study to build the reference image before the test:

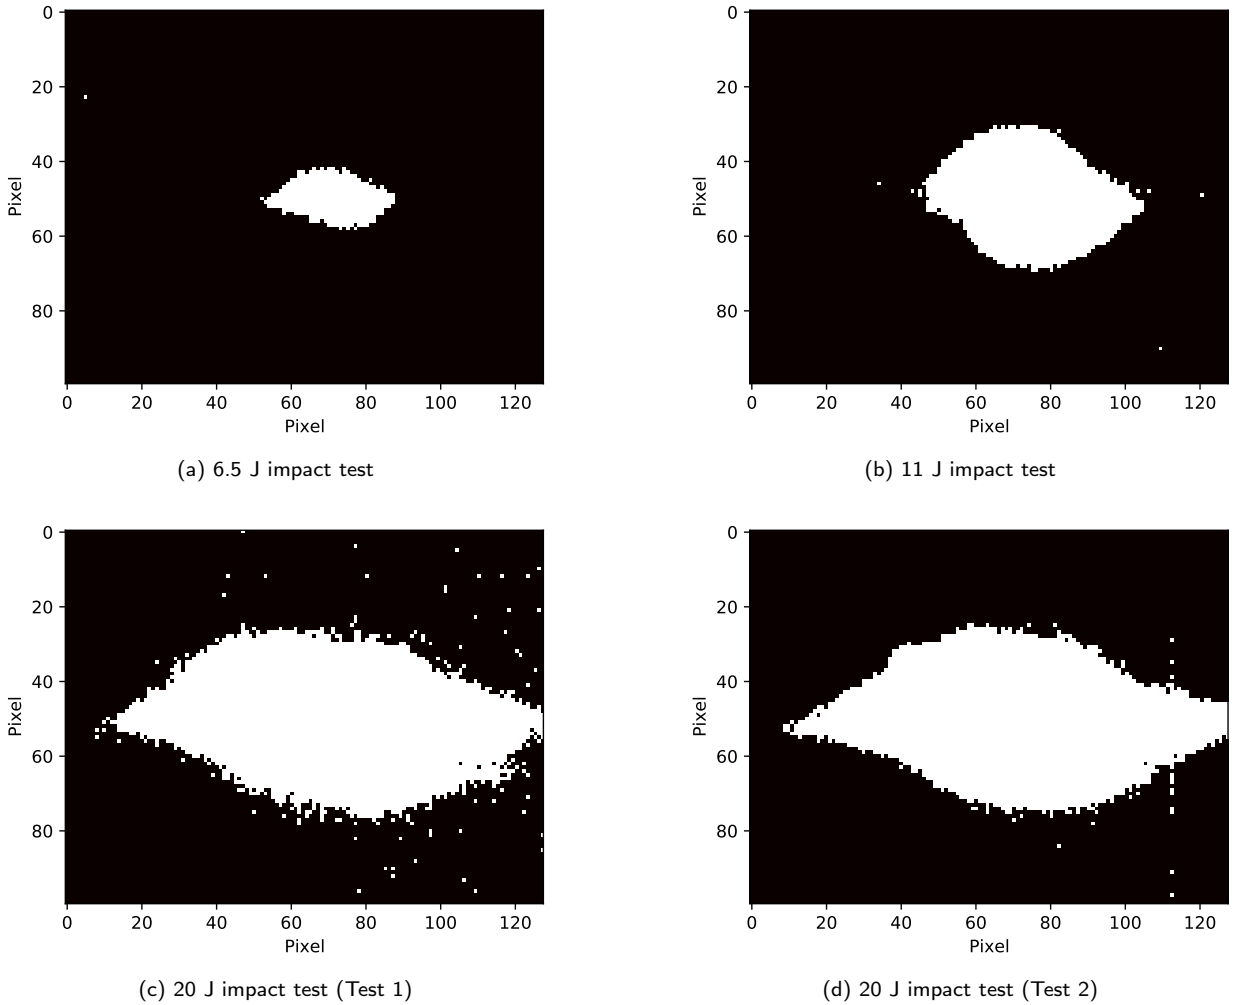
Figure 23: Results of the damage extension evaluation method for the different impact tests performed in this study.

As it was previously mentioned, in this study the sequence duration is shorter than those classically used by the different authors previously mentioned. In order to be as close as possible to the recommendations proposed by Meola et al. (2018), the last computational time (referred as *Evaluation instant*) of the heated area matrix will be used in the sequel to obtain the results summarised in Figure 23 and Table 2. First of all, as it was previously observed for the 35 J

test, the damage extension appears to be larger than the area observed by the IR sensor. Consequently, the area is not evaluated for this test. As it was previously observed by the different authors mentioned in this work, the heated area increases with the impact energy. It can be noticed for the two tests performed at 20J that the results are quite similar with a variation of less than 10% of the heated area between the two tests. The shape of the damaged area is globally the same between the different tests, only the size of this area is changing. Finally, it appears for the two 20J impact tests that the size of the images starts to become too small to be able to capture all the observable heated area.

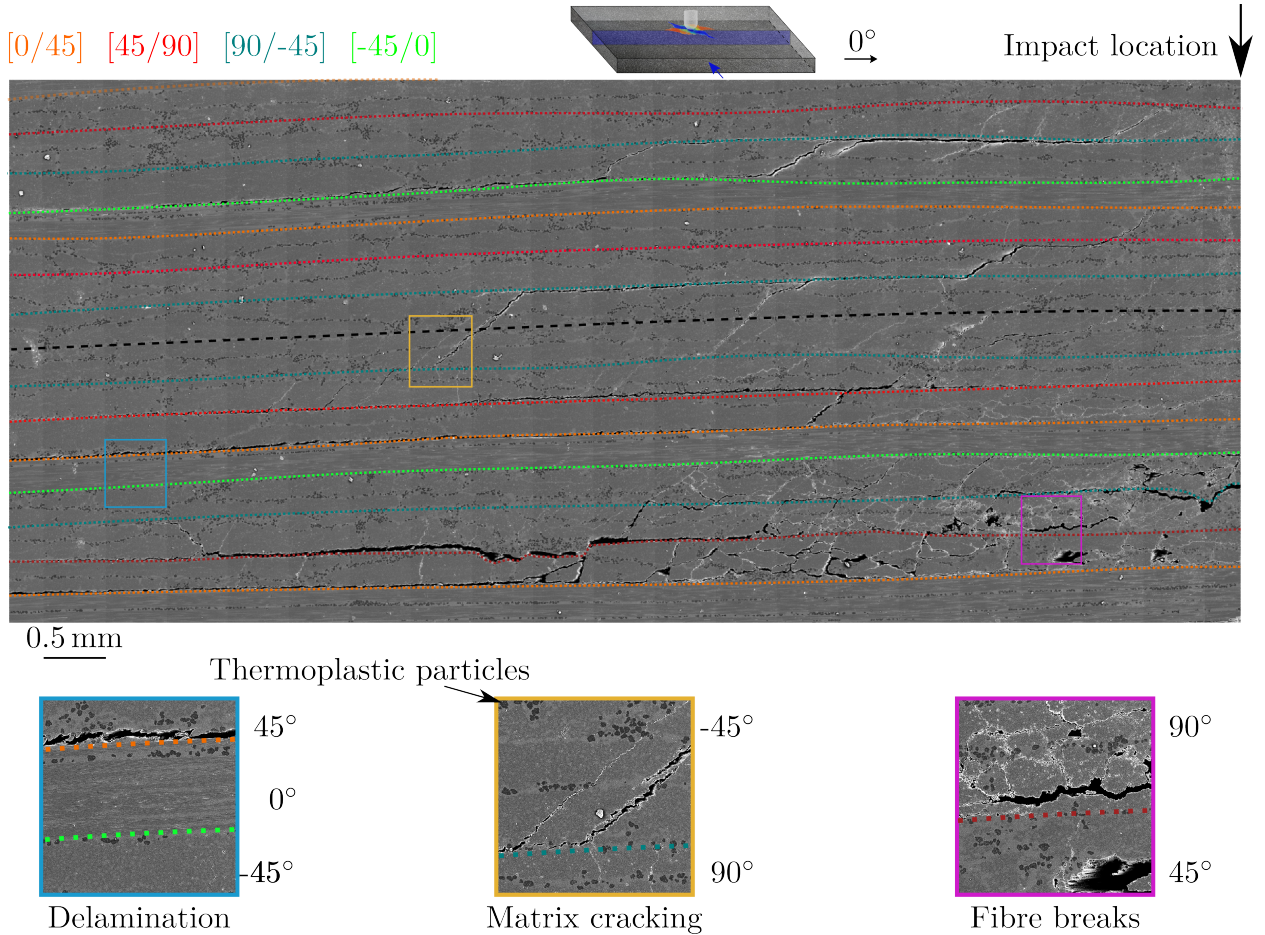
Figure 24: Micrograph observation using SEM for a sample impacted at 20J impact

After the impact event, observations were performed using a scanning electron microscope (SEM) for a sample impacted at 20J. The stitching of 0.5 mm images has been done to reconstruct a wide observation of the material's microstructure. A 0° micrograph cut is presented in Figure 24 where almost all the stacking sequence is highlighted. The black dashed line located at the midlaminar highlights the [45°/45°] interface whereas, four other colored lines represent the different interfaces. The micrograph presents an overview of the classical impact damages, where the three damage mechanisms related to matrix cracking, delamination and fibre breaks are shown in the colored square. It can be noticed that a strong interaction between the matrix cracking and the delamination is observed. Besides, for the bottom plies, a complex crack network is found. Indeed, fibre breaks in tension have occurred for the lower plies

except for the lowest 0° ply. The fibre breaks in tension is responsible for the cavities observed in the lower plies. In other words, broken fibres have been pulled out during the sample preparation for micrograph observation. This figure demonstrates the difficulty of reconstructing the damage scenario, which is very complex, using only the micrograph.
