High-speed infrared thermography for in-situ damage monitoring during impact test

Julien Berthe, Salim Chaibi, Gérald Portemont, Pascal Paulmier, Frédéric Laurin, Christophe Bouvet

Julien Berthe, Salim Chaibi, Gérald Portemont, Pascal Paulmier, Frédéric Laurin, et al.. High-speed infrared thermography for in-situ damage monitoring during impact test. *Composite Structures*, 2023, 314, pp.116934. 10.1016/j.compstruct.2023.116934 . hal-04053467

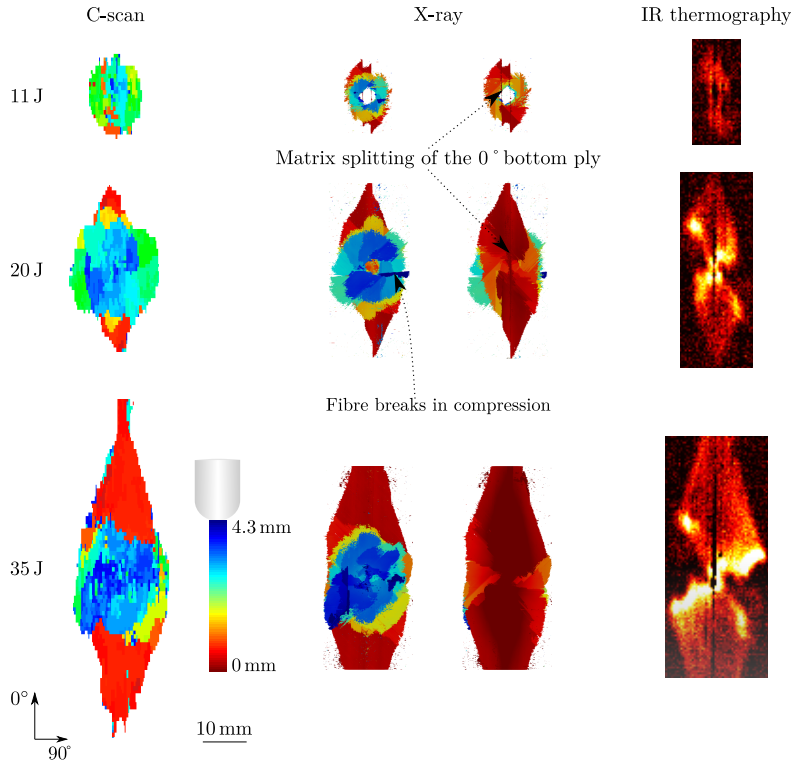
Figure 25: Segmentation of impact damage mechanisms obtained from C-Scan in depth, X-Ray and IR thermography at 3 different impact energy levels.

can be observed, with a typical delamination shape for such a quasi-isotropic laminate under impact. The size of this area is increasing with the energy and can be compared to post-mortem analysis performed in the sequel and particularly to Figure 25. The shape is clearly linked to the delamination between the last two plies on the side opposite of the impact. Secondly, more significant but this time more localized temperature increases can be observed with increasing impact energy levels (20 J and 35 J). In particular, a rather chaotic line seems to be drawn in the center of the specimen with a rather small angle to the vertical. A second line with an angle of 45° is also observed for the 20 J and 35 J tests. These two high temperature lines are not observed for the 11 J impact test. These dissipative phenomena appear for higher energy levels and therefore for higher applied forces. The more important oscillations on the stress signal observed on the 20 J and 35 J tests could therefore come from these phenomena. Considering their topology with respect to the studied stacking sequence, these dissipative phenomena seem to be linked to fibre breaks that could have been observed with the help of a post-mortem analysis. This specific analysis methodology is quite similar to other works in the literature whose objective is the analysis of damage extension during impact tests using infrared thermography (Meola and Carlomagno, 2010; Boccardi et al., 2016; Meola et al., 2018; Maierhofer et al., 2019). These methodologies will therefore be applied to our tests in the following.

The projected damage areas obtained by ultrasonic inspection are shown in Figure 25. This figure shows that impact damages are observed through the thickness. Moreover, it highlights the delamination evolution for the lowest interface in red, which corresponds to the highest delaminated surface at 35 J. The projected delaminated areas were estimated and are presented in Table 3. The inspection using ultrasonic scan gives an understanding of the projected damage area but is not sufficient to assess the complexity of impact damages.

3D rendering of impact damages was performed with Paraview using a depth-coded colormap. The results are presented in Figure 25. First of all, X-ray dissociates each kind of damage mechanism (matrix cracking, delamination and fibre breaks) with high-quality damage visualization. Based on what was previously observed with infrared thermography, some assumptions regarding the damage scenario can be made using this *post-mortem* analysis. The delamination cracks propagate from the non-impacted side for the 11 J test. Before fibre breaks in tension occur, the delamination of the lowest interface [0°/45°] is clustered between the matrix cracking of the 45° ply and the outer 0° ply. However, since 20J, fibre breaks in tension occur in the lowest 45° ply. The delamination of the lowest interface [0°/45°] increases until becoming the largest delaminated area. Indeed, as observed with infrared thermography, the fibre breaks in tension of the 45° ply open the split in the 0° ply and then trigger the delamination expansion. Thanks to the matrix splitting and the largest delamination of the lowest interface [0°/45°], the bottom 0° ply is unloaded and free of fibre breaks in tension. Concerning the damage mechanisms occurring near the impacted surface, tests from 11 J shows no damage under the impactor. It is probably explained by a reinforcement of the ply strength due to local hydrostatic pressure. Fibre breaks in compression occur since 11 J for the 0° surface ply close to the impactor. For the 35 J test, fibre breaks in compression are also observed for the 45° ply just below the outer 0° surface ply.

On the other hand, by comparing Figure 19 and Figure 25, it can be seen that the analysis proposed for the construction of Figure 19 clearly highlights the shape of the delamination between the last 2 plies on the non-impacted side which is depicted in dark red on the right hand side in Figure 25.
