# High-speed infrared thermography for in-situ damage monitoring during impact test

Julien Berthe<sup>a,\*</sup>, Salim Chaibi<sup>b</sup>, Gérald Portemont<sup>a</sup>, Pascal Paulmier<sup>b</sup>, Frédéric Laurin<sup>b</sup> and Christophe Bouvet<sup>c</sup>

Infrared thermography  
Impact tests  
Damage  
Composite materials

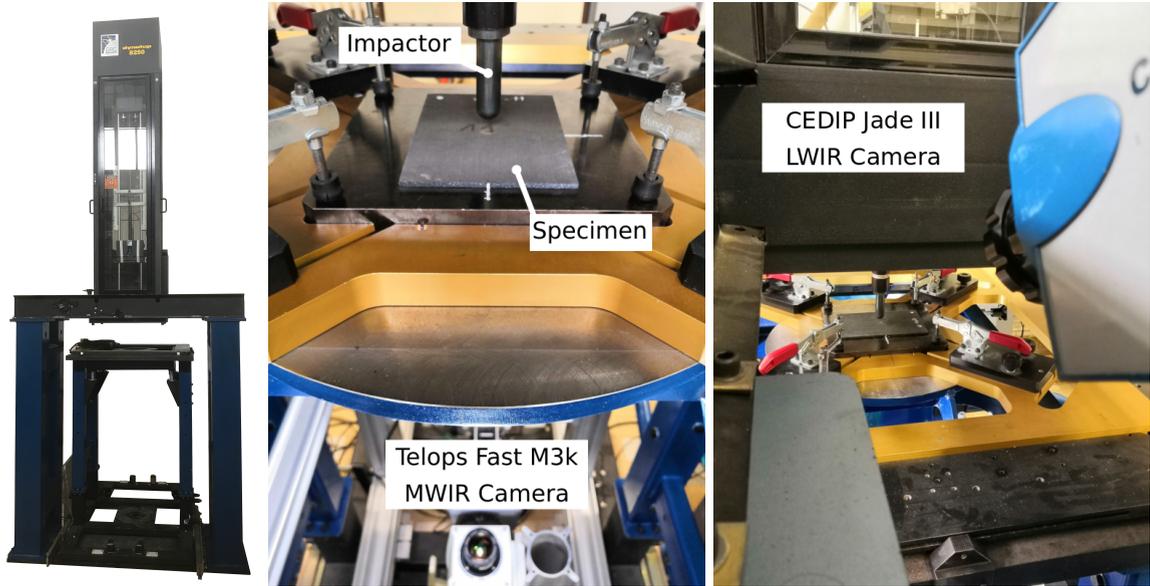
The experimental setup used in this study is described in Figure 1. The impact testing machine is an Instron Dynatup 8250 equipped with an anti-rebound system, which has been specifically modified as shown on the left hand side in Figure 1 to allow for the direct installation of the high speed infrared camera to monitor the non-impacted surface. The hemispheric impactor 16 mm diameter is fixed to a guided trolley to reach a total mass of 13.01 kg. The load applied to the specimen is measured with a load cell with a maximum load of 22 kN. The displacement of the impactor is measured with a laser transducer and the speed of the impactor just before the contact is measured with a photoelectric sensor. The signals are directly recorded by the acquiring system of the impact machine. Two different infrared cameras have been implemented to capture images on the impacted face of the specimen with a CEDIP JADE III LWIR camera as well as on the opposite face with a TELOPS FAST M3k MWIR camera. More details regarding IR

cameras acquisition will be given in the following section. Finally, in order to ensure a time synchronisation between the load and displacement measurements and the images captured by the different cameras, a DEWESOFT acquisition system was used. The displacement of the impactor and the trigger (TTL signal generated from a top send by a push button) sent to the different cameras were recorded at 1 MHz by the acquisition system.

**Figure 1:** Experimental setup.

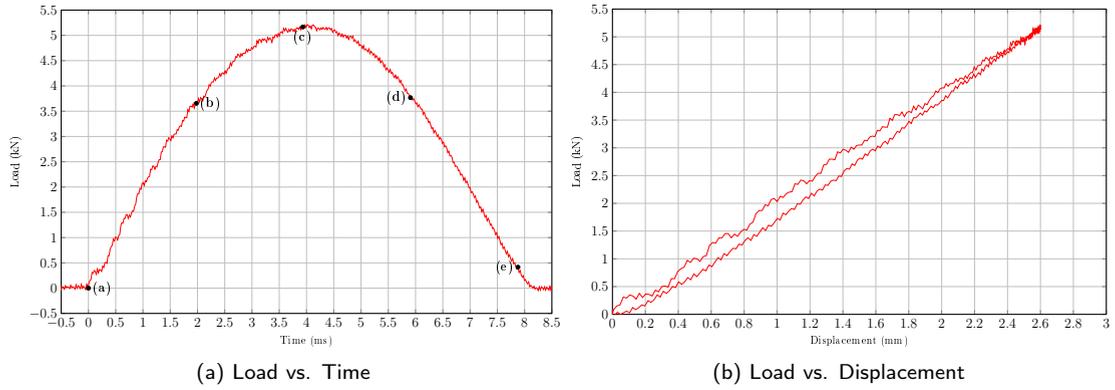
The global response of the laminate plate for a 6.5 J impact test is plotted in Figure 2. On the left hand side, the load versus time curve exhibits a quite smooth loading and unloading phases with a duration of test of approximately 8 ms. On the right hand side, the loading and unloading phases are almost superposed leading to the conclusion that a very small amount of energy may have been dissipated during the test by damage growth within the composite plate.

**Figure 2:** Global response of the composite plate for an impact test performed at 6.5 J.

For this test, the acquiring frequency of the CEDIP infrared camera has been fixed at 3050 Hz. Based on the test duration observed in Figure 2 and on the parameters described in Table 1, at least 24 images were captured by this camera during the test, whereas for the Telops camera, 100 images are taken during the test. An illustration of the IR images captured by the CEDIP camera during this test is plotted in Figure 3. It is possible to observe in these images horizontal lines with a fairly regular spacing. These lines are artifacts of the camera.

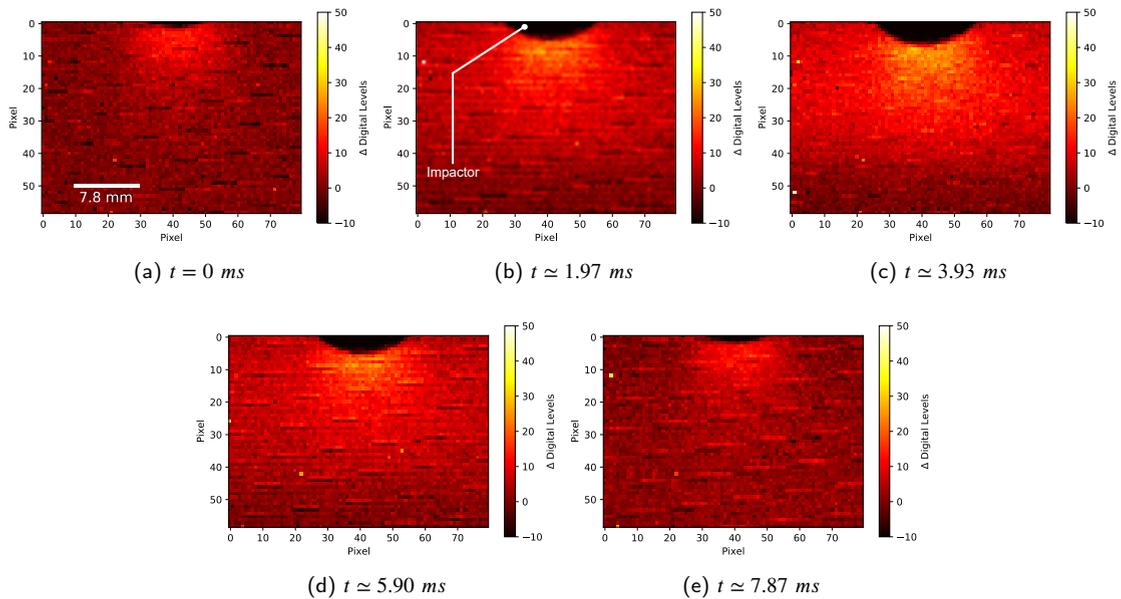
**Figure 3:** Infrared images captured by the CEDIP camera during the impact performed at 6.5 J.

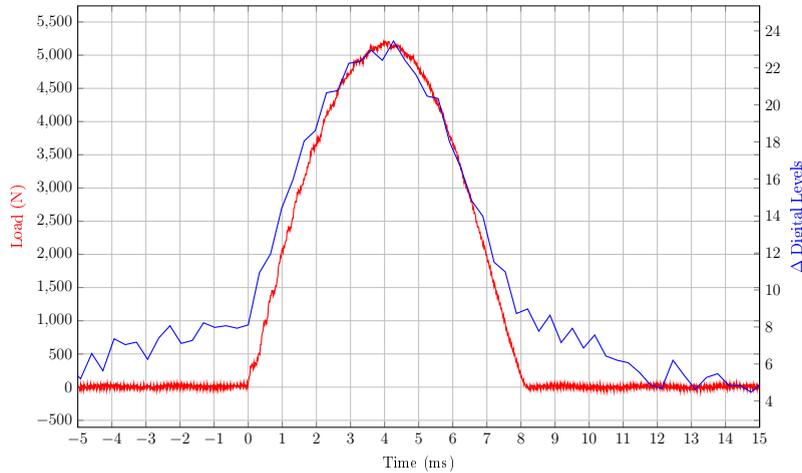
plotted in Figure 4 after treatment. It appears that a good correlation between the two signals can be obtained and, in the sequel, the time uncertainty linked to this procedure can be considered as the time between two images ( $1/3050 = 3.27 \cdot 10^{-4}$  s).

**Figure 4:** Time synchronisation between the load applied to the composite plate and the images taken by the CEDIP infrared camera.

It can be observed in Figure 4 that the mean variation of Digital levels given by the camera is already increasing before the load application on the composite plate and continues decreasing even after the end of the test. This may be due to the reflection of the impactor on the composite plate captured by the camera when the impactor is approaching the plate. This phenomenon can also be observed in Figure 3(a) at  $t = 0$  ms where the area close to the impactor exhibits higher DL variations than the rest of the plate. After that, when the plate starts to be loaded, an increase in the Digital Level is observed in Figure 4 and on the different pictures in Figure 3. This increase is linked to the thermoelasticity of the plate. The observed surface is mainly loaded in compression due to bending of the plate, which induces an increase of the temperature due to thermoelasticity. Finally, the last image in Figure 3 taken for a time close to the end of the test seems to exhibit almost no observable damage mechanisms on the observed area of the impacted surface.

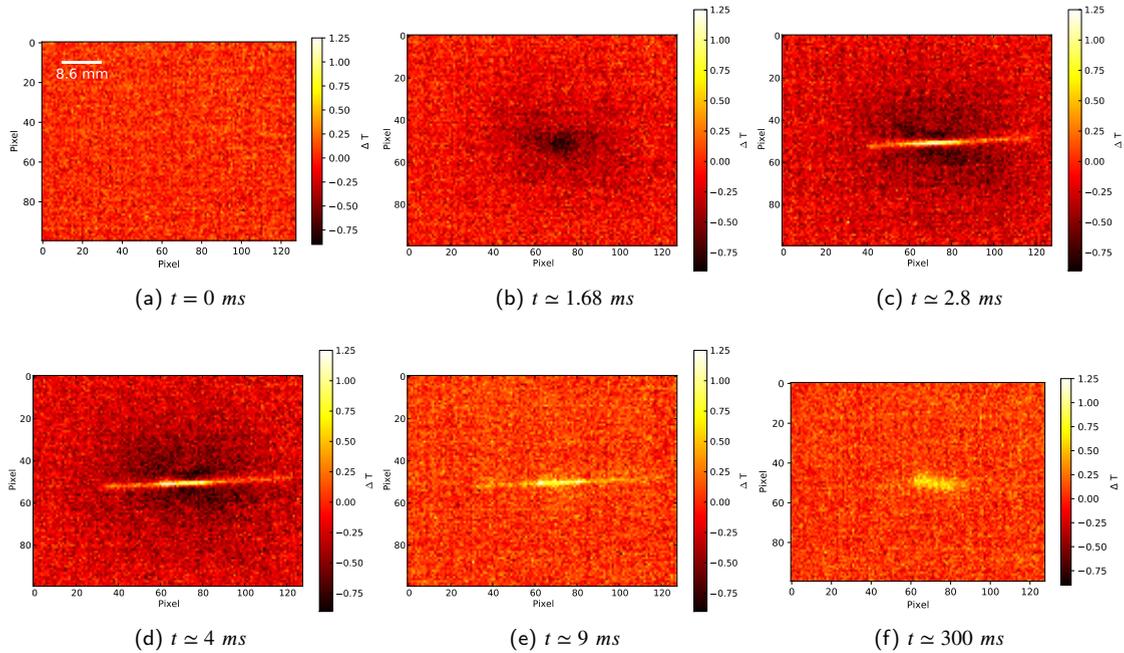
The thermal field variations captured by the TELOPS infrared camera for some particular time instants are plotted in Figure 5. For  $t = 0$  ms, an homogeneous field is obtained with a mean value close to zero. After few milliseconds of loading, a decrease of the temperature in the middle of the plate is observed linked to thermoelasticity. Indeed, the observed surface is mainly loaded in tension due to bending which leads to a decrease of the temperature with thermoelasticity. With the image taken 2.8 ms after the beginning of the test, a crack on the surface of the composite plate is clearly observed. This crack is located in the middle of the plate, following the direction of the fibres in the  $0^\circ$ -outer ply. A small alignment default between the direction of the fibre in the surface plane and the horizontal axis of the IR camera can be observed on the image. For  $t = 4$  ms, the crack seems to be a bit longer than on the previous image. The crack is still surrounded by an area with an apparent decrease of temperature linked to the tensile loading of this surface ply. On the image taken at  $t = 9$  ms, the crack in the middle of the ply is still observable but as the load applied to the composite plate is now back to zero, the mean variation of temperature of the rest of the plate is back to zero. Finally, the acquisition has not been stopped right after the end of the loading, in order to be able to capture images after a hundred of milliseconds. These images can be compared to previous works performed on the use of infrared thermography during impact tests on composite materials (Meola and Carlomagno, 2009; Meola et al., 2018; Maierhofer et al., 2019). In this last image, an increase of the temperature can be observed in the middle of the sample, with an ellipsoidal shape which differs from the crack observed in previous images. In the literature, such a temperature increase after an impact test has been classically linked to damage extension area within the composite plate (Meola et al., 2018; Maierhofer et al., 2019). These authors have proposed various methodologies to quantify these areas and there is currently no standard procedure in the literature. Consequently, a specific study has to be done for this quantification and will be described in a dedicated section (see section 4).

**Figure 5:** Temperature field variations captured by the TELOPS camera during the impact performed at 6.5 J.

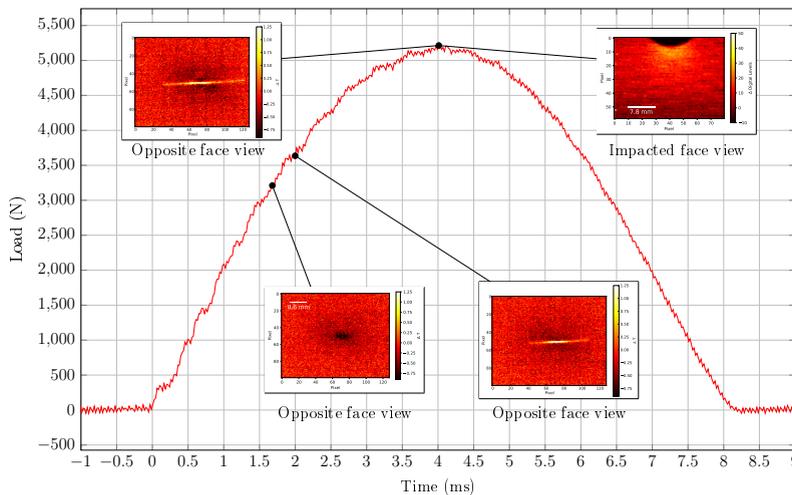
Finally, the results can be summarised in Figure 6 in which the load applied to the specimen is directly linked to the different damage phenomena that can be observed by the different infrared cameras. In this case, as low impact energy

level is considered, the main observable phenomenon is thermo-elasticity and a crack appearance on the opposite face for a load level around 3210 N. The crack opening is growing until the load peak. The infrared images captured on the impacted face do not appear to reveal any damage.

**Figure 6:** Cross analysis between the load applied to the composite plate and the images captured by the different infrared cameras for a 6.5 J impact test.

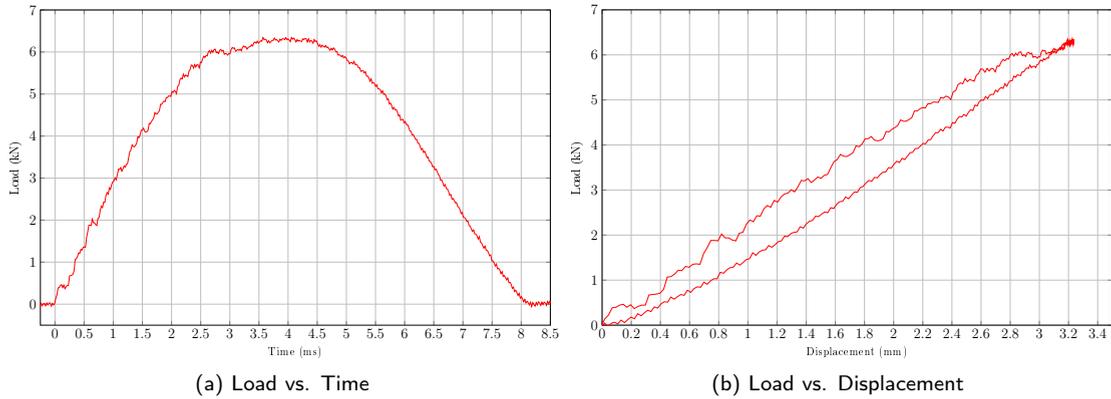
The global response of the laminate plate for a 11 J impact test is plotted in Figure 7. On the left hand side, the load versus time curve exhibits a quite smooth loading until approximately 6 kN where a small drop can be observed. The duration of the impact is approximately 8 ms. On the right hand side, the load versus displacement curve exhibits

more dissipated energy than for the test at 6.5 J. A sudden variation of the global slope of the loading phase is also observed in this figure at approximately 6 kN.

**Figure 7:** Global response of the composite plate for an impact test performed at 11 J.

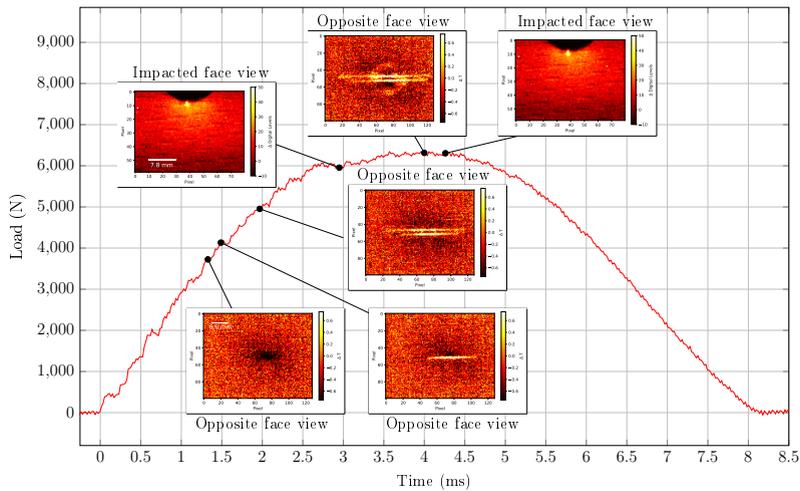
First of all, a global analysis of the different images captured by the two infrared cameras can be performed with Figure 8. In a first stage, a global decrease of the temperature can be observed on the opposite face due to tensile load of the outer ply as for 6.5 J test. The first crack is observed for an applied load of 4131 N and the second one appears for an applied load of 4953 N. For an applied load higher than 6 kN, two new phenomena can be observed: some

**Figure 8:** Cross analysis between the load applied to the composite plate and the images captured by the different infrared cameras for a 11 J impact test.

hot spots on the impacted face and a diffuse temperature increase with a circular shape on the opposite face. The hot spots observed on the impacted surface ply may be linked to compressive fibre failure in the surface ply in a direction perpendicular to the fibre orientation and will be confirmed with post-mortem observations in the sequel. This failure is captured with the infrared camera with the lower time resolution consequently, the uncertainty regarding the exact time appearance of this phenomenon is of approximately 0.33 ms. The failure appears on the image taken 2.9 ms after the beginning of the test and for an applied load of 5955 N. The second phenomenon with a diffuse circular shape below the impactor needs to be further studied to be understood. For that purpose, some infrared images captured on the opposite face between 2.5 ms and 4 ms after the beginning of the test are plotted in Figure 9. Apart from the two observable cracks, these images clearly exhibit the extend of the border of a circle starting for the middle of the impacted area. This circle is clearly observable as an increase of the apparent temperature on the non-impacted surface. For the last

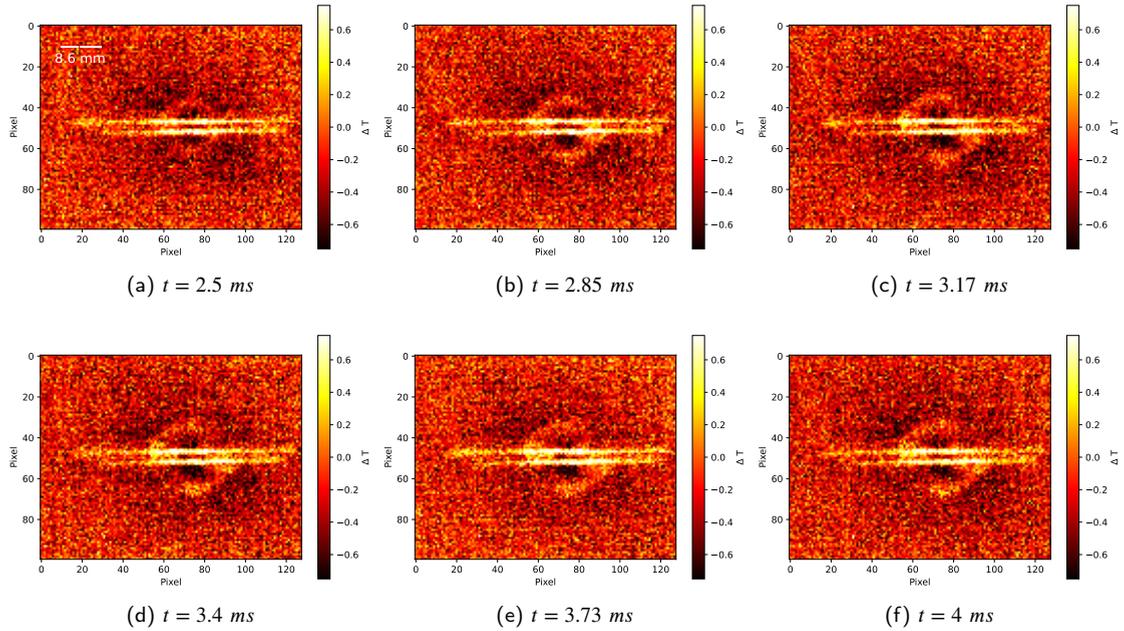
**Figure 9:** Temperature field variations captured by the TELOPS camera during the 11 J impact test between 2.5 ms and 4 ms.

two images, the shape appears to be more oval than circular with a long axis oriented at  $45^\circ$ . Moreover for these last two images, the propagation seems to be finished. This phenomenon can be compared to an image taken a long time after the beginning of the test as that plotted in Figure 10 taken for  $t = 300$  ms. The observed shape in Figure 9f is

clearly in good agreement with the shape observed in Figure 10 which is usually linked to the extension of impact damage as it was previously mentioned. Moreover, the shape observed in Figure 9f is similar to the shape classically observed for delamination during impact tests and could be correlated to the post-mortem damage analysis performed in Figure 25. Based on this observation, the extend of this phenomenon between 2.5 ms and 3.4 ms is probably linked to the propagation of delamination between the  $0^\circ$  surface ply and the adjacent  $45^\circ$  ply. Consequently, the small drop observed between 2.5 ms and 3 ms on the load curve can be explained by the two phenomena previously mentioned: a compressive failure observed on the impacted surface and the propagation of delamination between adjacent plies close to the opposite surface.

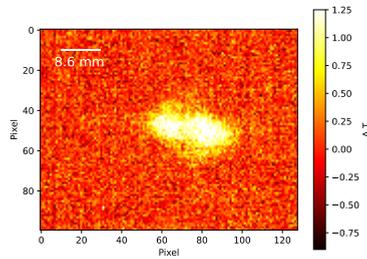
**Figure 10:** Temperature field variations captured by the TELOPS camera 300 ms after the beginning of the impact test.

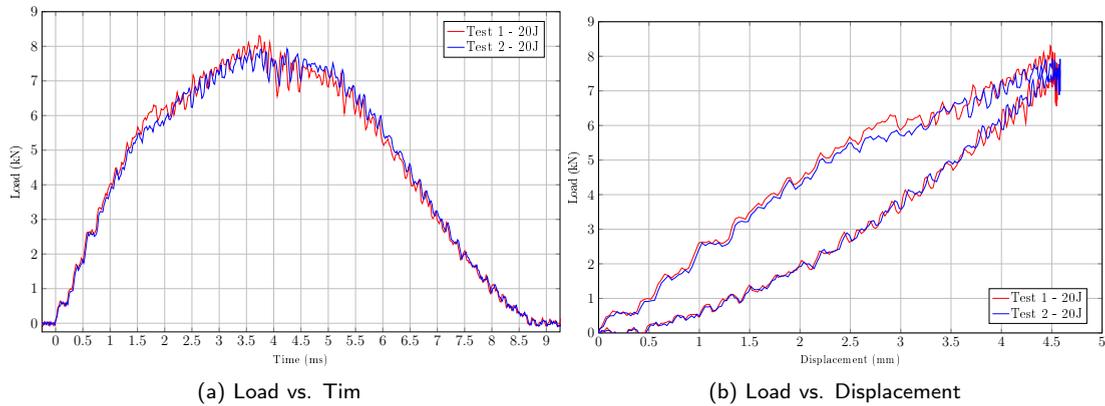
The global response of the laminate for the 2 tests performed at 20 J are plotted in Figure 11. The curves plotted on the left hand side exhibit a change of the loading slope for a load between 5.5 kN and 6 kN. The two curves are almost superimposed except for the appearance of the slope change between 5.5 kN and 6 kN. Compared to lower

impact energy tests, larger oscillations can be observed, particularly between 4 and 4.5 ms. On the right hand side of Figure 11, the load versus displacement curve are also superimposed except between 5.5 kN and 6 kN.

**Figure 11:** Global response of the composite plate for the 2 impact tests performed at 20 J.

As it was previously mentioned, the two loading curves plotted in Figure 11 are almost superimposed except between 5.5 kN and 6 kN, for times between 1.5 ms and 2.2 ms. Based on this observation, the variation of the thermal fields for the two tests for this specific interval of time are plotted in Figures 14 and 15. First of all, a small difference in the orientation of the tested specimens can be noticed based on the inclination of the main central crack particularly for the second test. This difference in the alignment of the two specimens can explain the very small difference which can be observed between the two curves before 1.5 ms which is linked to the apparent stiffness of the coupon. Apart from this difference, the two figures exhibit a damage scenario which is quite similar. Moreover, the different crack appearances are almost synchronised. For the second test plotted in Figure 15, the delamination growth seems to be quicker than for the first one. Indeed, for the first five images in Figure 15, the delamination area seems to be larger than for the first five images in Figure 14. This is the only difference that can be observed in these images regarding

kN, the load exhibits important oscillations. Such oscillations have also been observed in Figure 11 for the 20 J impact tests for an equivalent load level. As it can be observed on the right hand side of Figure 16, even if the displacement is still growing after the first important oscillation, the load does not seem growing anymore.

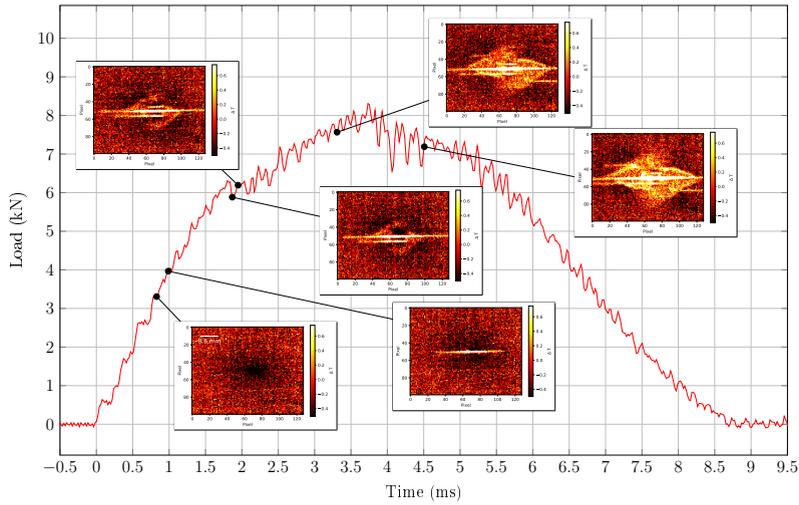
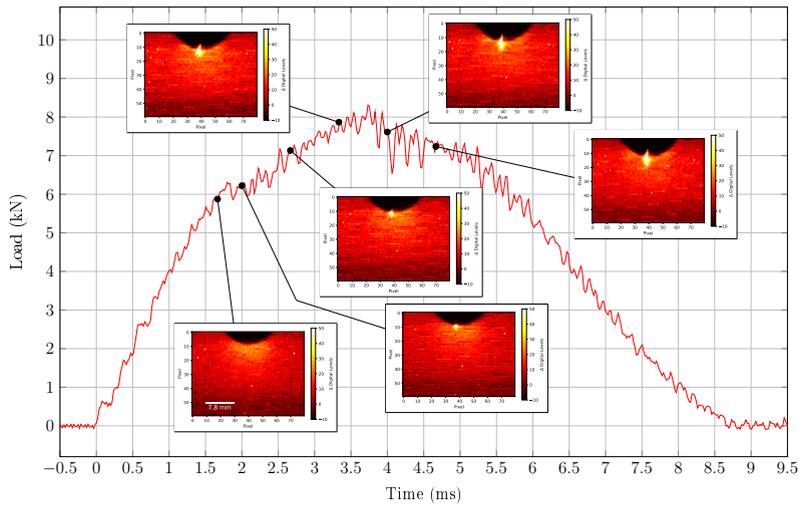
In the first instance, only one of the two tests is going to be deeply analysed regarding the IR images. In a second instance, a specific focus on the variations between the two tests will be performed in a dedicated subsection. For the test previously referred as "Test 1 - 20 J", a global analysis of the different images captured by the two infrared cameras can be performed using Figure 12. As it was already mentioned for the test at 11 J, the slope change observed for loads higher than 6 kN can be linked to the growth of delamination which can be observed on the opposite face but also to a compressive fibre failure observed on the impacted face. On the left hand, it can be observed that the extend of delamination and the number of cracks is higher than for tests at lower energies. Moreover, the shape of the delamination appears to be in agreement with those classically observed in such impact tests (Bouvet et al., 2009; Troussset, 2013). A higher extend of the compressive failure is also observed on the right hand side of Figure 12. All these observations are in good agreement with the higher dissipated energy level which can be observed in Figure 11.

(a) Images captured by the infrared cameras on the opposite face

(b) Images captured by the infrared cameras on the impacted face

**Figure 12:** Cross analysis between the load applied to the composite plate and the images captured by the different infrared cameras for an impact test performed at 20 J.

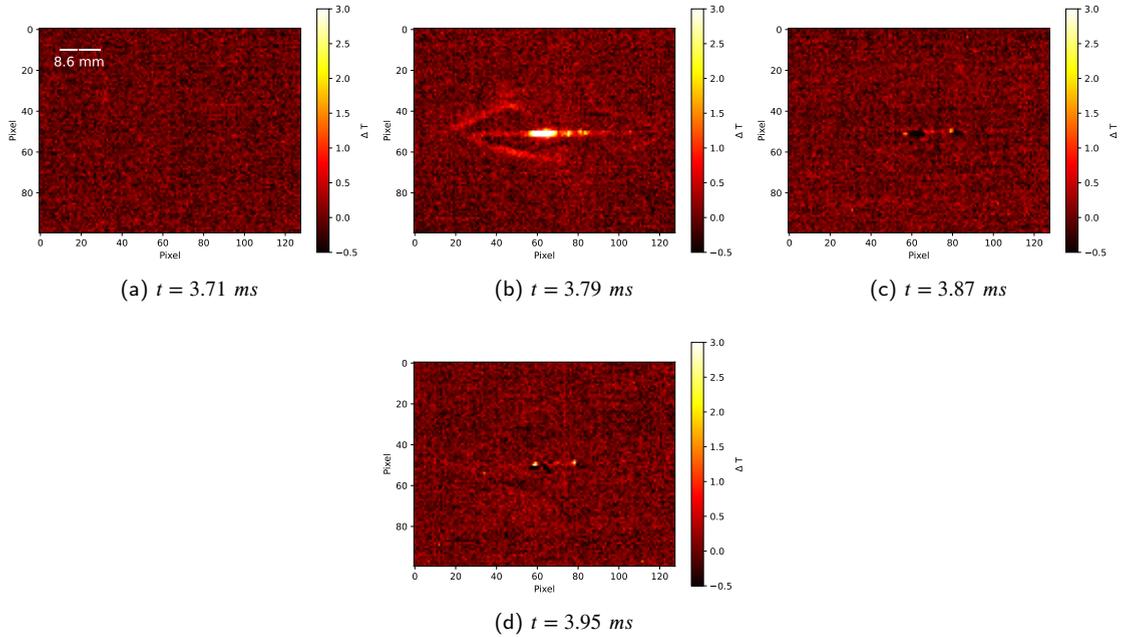
A specific focus is done in Figure 13 in order to analyse the highest level of oscillations observed between 3.7 ms and 4.5 ms in Figure 11. For that purpose, the analysis of the thermal fields has to be modified in order to exacerbate the phenomenon that happen between two captured images. Consequently, the temperature difference plotted in Figure 13 is obtained by making a difference between the image captured at the time  $t$  and the image previously captured at the time  $t - (1/12500)$ . These images clearly show that an important amount of energy is released as heat between  $t = 3.71 \text{ ms}$  and  $t = 3.79 \text{ ms}$ . An important increase of the temperature (between  $6^\circ\text{C}$  and  $20^\circ\text{C}$ ) can be observed within the central crack of the specimen. Such an increase of temperature has not been observed previously for the damage phenomenon observed on the opposite face. Therefore, it seems likely that this phenomenon is related to a sudden failure event with a significant amount of energy released, such as tensile fibre failure below the surface ply. This assumption has been confirmed with the post-mortem analysis that will be described in details in the sequel. Finally, for the last two images in Figure 13, some hot points can be observed which are linked to some debris generated by the event observed at  $t = 3.79 \text{ ms}$  and which are flying within the images taken after this event.

**Figure 13:** Temperature field variations captured by the TELOPS camera during the 20 J impact test between 3.71 ms and 3.95 ms.

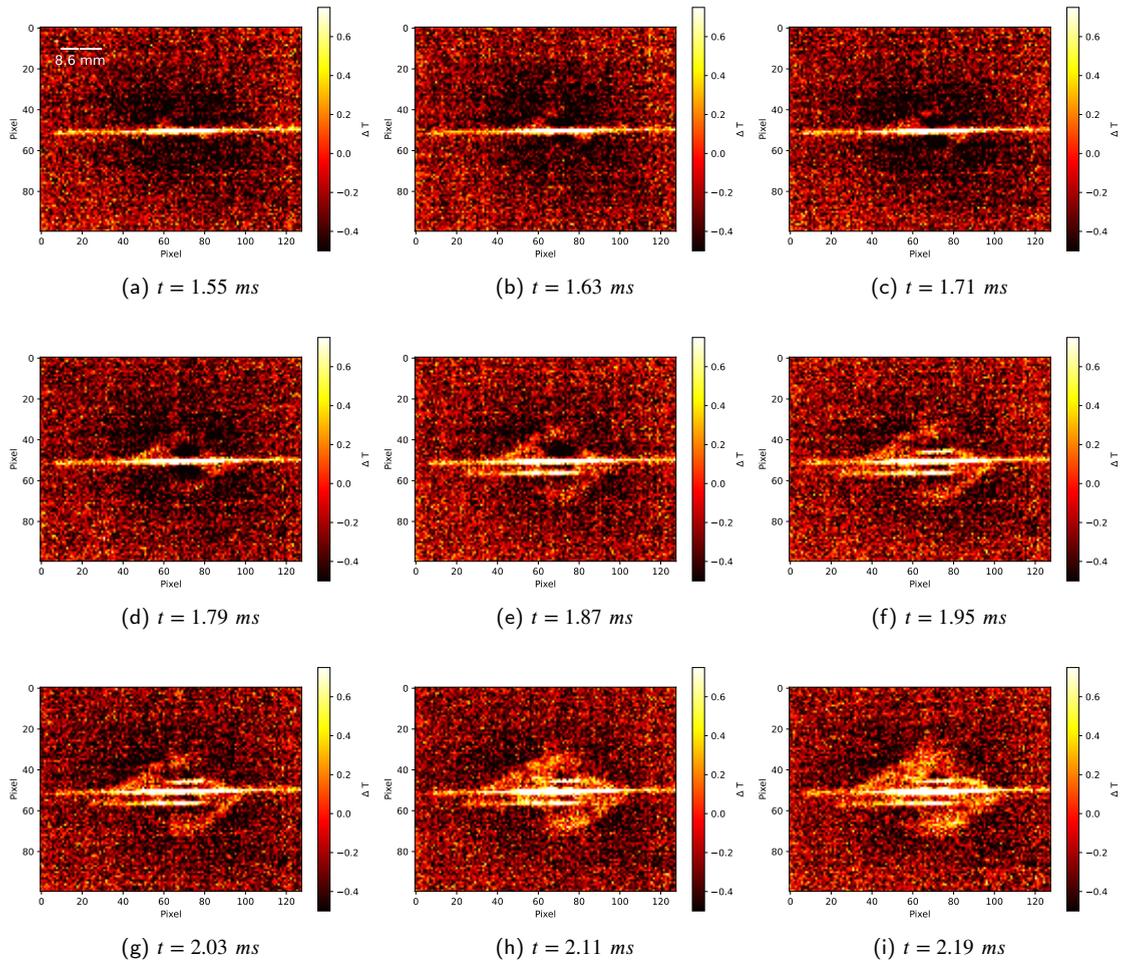
**Figure 14:** Temperature field variations captured by the TELOPS camera during a 20 J impact test (Test 1) between 1.5 ms and 2.2 ms.

damage growth. This difference may explain why the load curve for the second test is lower between 1.5 ms and 2.2 ms than that for the first test, as the damage appears to grow more rapidly during this test. The comparison for the two tests of the images captured for the impacted surface during such a small time interval is not relevant because of the lower time resolution.

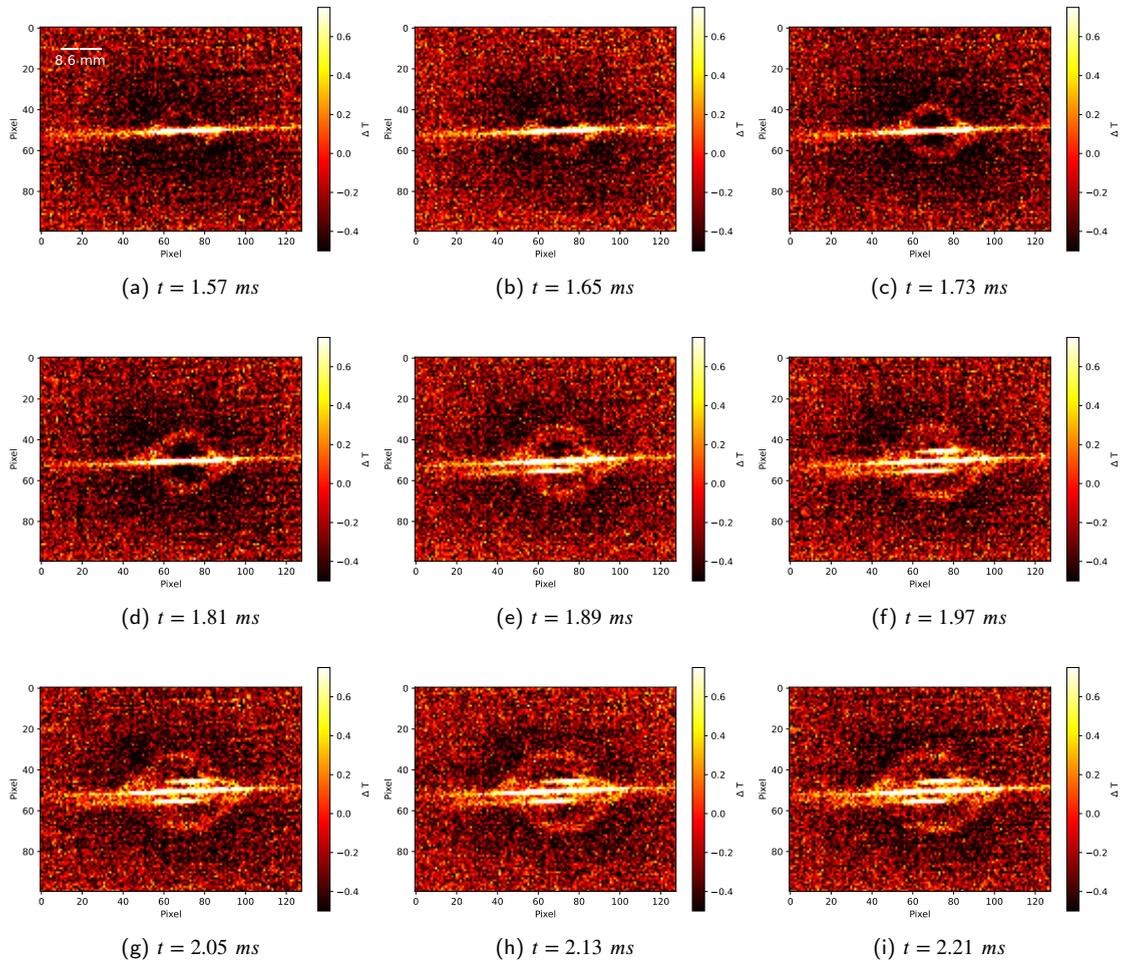
**Figure 15:** Temperature field variations captured by the TELOPS camera during a 20 J impact test (Test 2) between 1.5 ms and 2.2 ms.

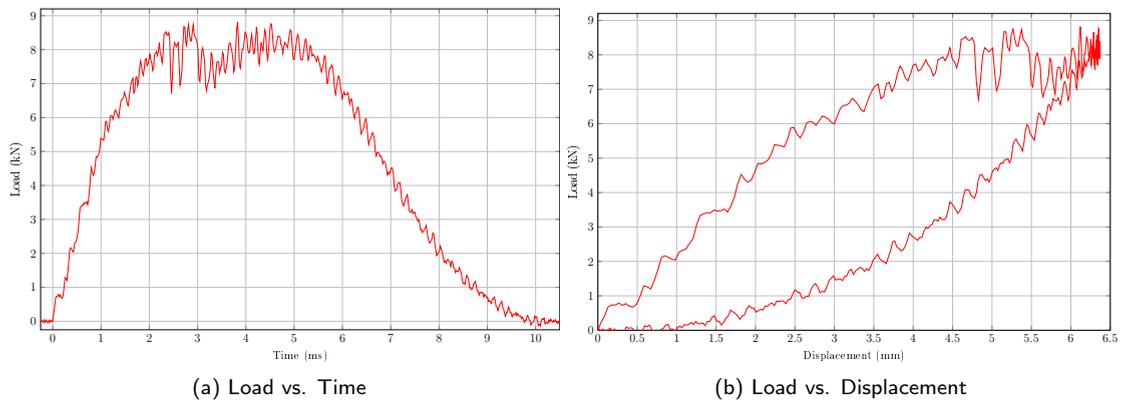
The global response of the laminate plate for a 35 J impact test is plotted in Figure 16. As it was previously observed, the loading slope exhibits a first decrease between 5.5 kN and 6 kN. After 2.5 ms and for a load of approximately 8

**Figure 16:** Global response of the composite plate for an impact test performed at 35J.

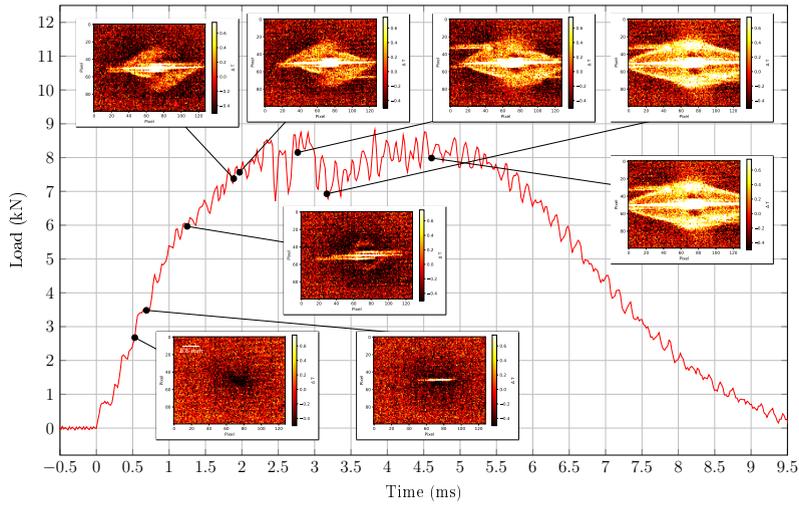
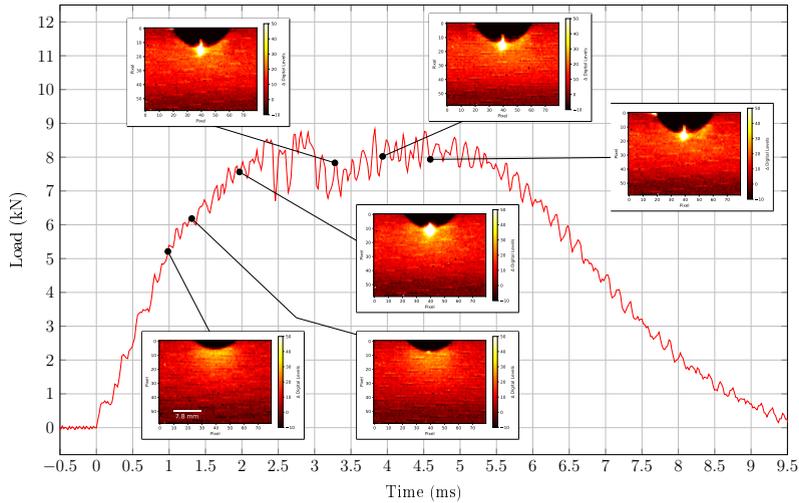
First of all, a global analysis of the different images captured by the two infrared cameras can be performed with Figure 17. As it was already mentioned for the tests at 11 J and 20 J, the change in slope observed for loads above 6 kN may be related to the growth of delamination that can be observed on the opposite side but also to the failure of the fibre in compression observed on the impacted side. Indeed, in the figure on the right, even if this compression failure is not very extensive for 6 kN, it is still visible. For the delamination, in the figure on the left, an important extension of the delamination can be observed between 6 and 7.5 kN. With this figure, it can also be observed that the damage extension during the 35 J test is larger than the observation window used in this experimental investigation for the Telops IR camera. Finally, based on Figure 17, the interpretation of the large oscillations observed after 2.5 ms is not obvious. As it was previously done for 20 J test analysis, a specific post-treatment can be applied to better understand the important oscillations that can be observed after 2.5 ms. For that purpose, the images plotted in Figure 18 have been analysed by making the difference between the image captured at the time  $t$  and the image previously captured at the time  $t - 1/12500$ .

(a) Images captured by the infrared cameras on the opposite face

(b) Images captured by the infrared cameras on the impacted face

**Figure 17:** Cross analysis between the load applied to the composite plate and the images captured by the different infrared cameras for an impact test performed at 35J.

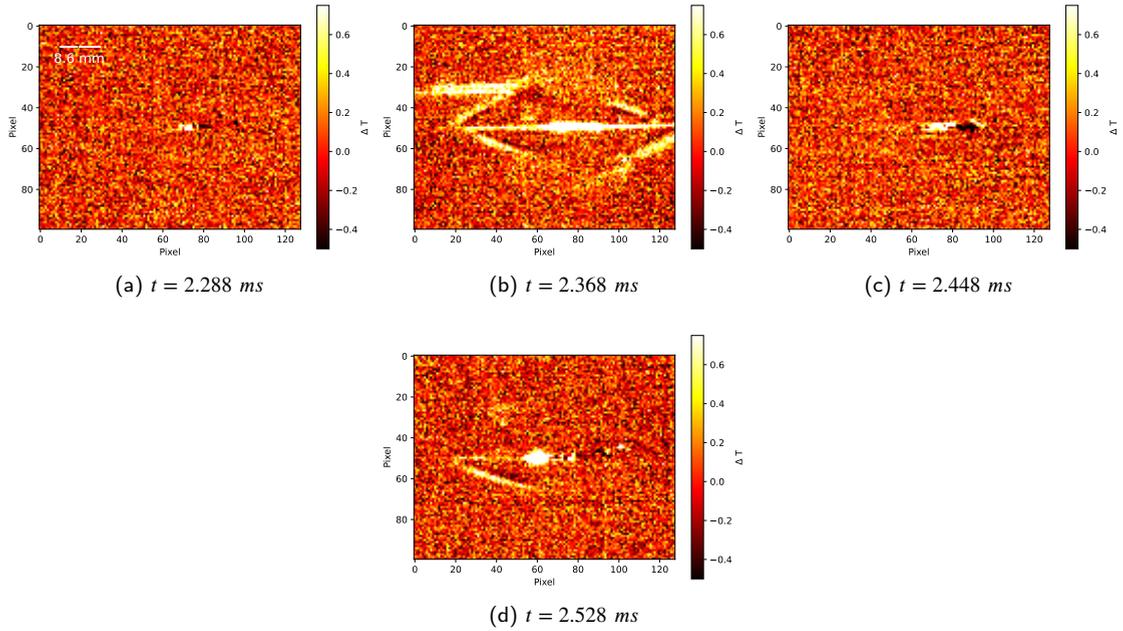
These images clearly exhibit a brutal failure event below the surface of the laminate as it was also observed for the 20 J impact test. Post-mortem analysis will confirm, in the sequel, fibre failures below the surface of the specimen which may be linked to this high energy event. As these events occur below the IR observable surface, the diffusion phenomena require a sufficiently long time to allow the surface observation of these events. In a previous work (Berthe and Ragonet, 2018), diffusion time through one  $0^\circ$  ply of the composite material studied in this work has been qualitatively evaluated. After a time between 39 ms and 52 ms, the thermal increase due to the propagation of a transverse crack that has propagated below the  $0^\circ$  degree ply is clearly observable on the surface of this ply. Based on this result, a specific analysis of the images taken after the end of the test can be proposed in order to observe the temperature variation due to diffusion through the thickness. The images plotted in Figure 19 have been obtained by making the difference between the IR images taken at  $t_1 = t_{end} + 45 \text{ ms}$  (diffusion through 1 ply) or  $t_2 = t_{end} + 90 \text{ ms}$  (diffusion through 2 plies) and the IR image taken at  $t_{end}$ . The different images have been plotted based on the same interval for the colorbar. Firstly, it clearly appears that the area, in which the temperature increases are observed, is increasing with the energy applied to the specimen. For the three different energy levels, a quite homogeneous temperature increase

**Figure 18:** Temperature field variations between two successive images captured by the TELOPS camera during the 35 J impact test between 2.288 ms and 2.528 ms.

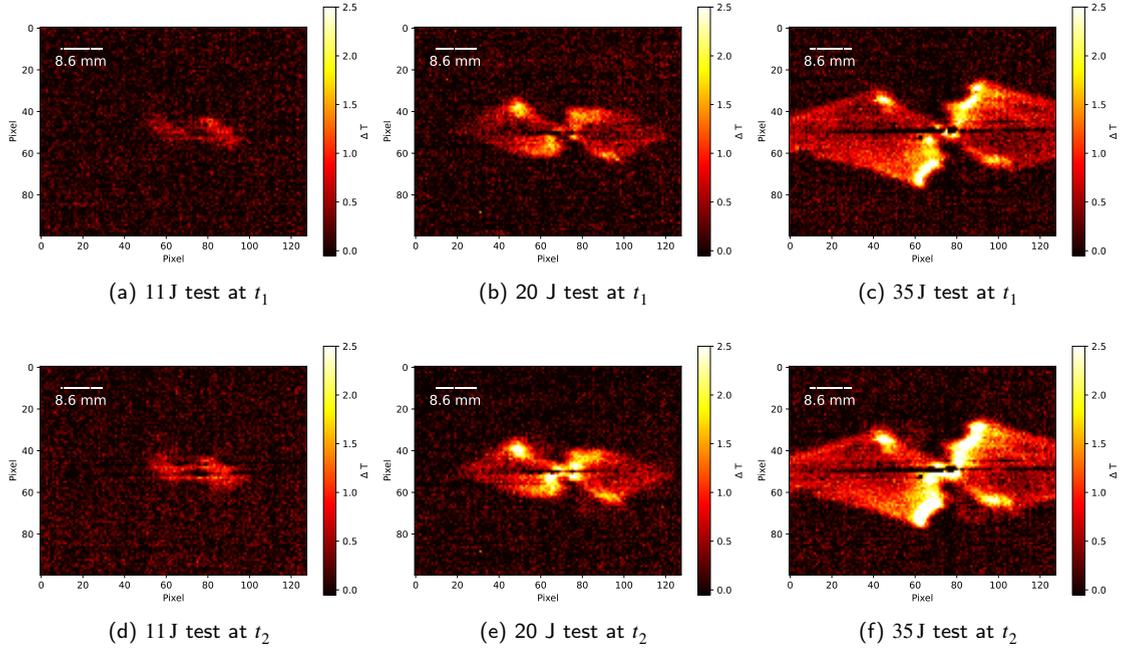
can be observed, with a typical delamination shape for such a quasi-isotropic laminate under impact. The size of this area is increasing with the energy and can be compared to post-mortem analysis performed in the sequel and particularly to Figure 25. The shape is clearly linked to the delamination between the last two plies on the side opposite of the impact. Secondly, more significant but this time more localized temperature increases can be observed with increasing impact energy levels (20 J and 35 J). In particular, a rather chaotic line seems to be drawn in the center of the specimen with a rather small angle to the vertical. A second line with an angle of  $45^\circ$  is also observed for the 20 J and 35 J tests. These two high temperature lines are not observed for the 11 J impact test. These dissipative phenomena appear for higher energy levels and therefore for higher applied forces. The more important oscillations on the stress signal observed on the 20 J and 35 J tests could therefore come from these phenomena. Considering their topology with respect to the studied stacking sequence, these dissipative phenomena seem to be linked to fibre breaks that could have been observed with the help of a post-mortem analysis. This specific analysis methodology is quite similar to other works in the literature whose objective is the analysis of damage extension during impact tests using infrared thermography (Meola and Carlomagno, 2010; Boccardi et al., 2016; Meola et al., 2018; Maierhofer et al., 2019). These methodologies will therefore be applied to our tests in the following.

**Figure 19:** Temperature field variations between the end of the test and two particular times  $t_1$  and  $t_2$  for different impact energy levels.

On the other hand, by comparing Figure 19 and Figure 25, it can be seen that the analysis proposed for the construction of Figure 19 clearly highlights the shape of the delamination between the last 2 plies on the non-impacted side which is depicted in dark red on the right hand side in Figure 25.

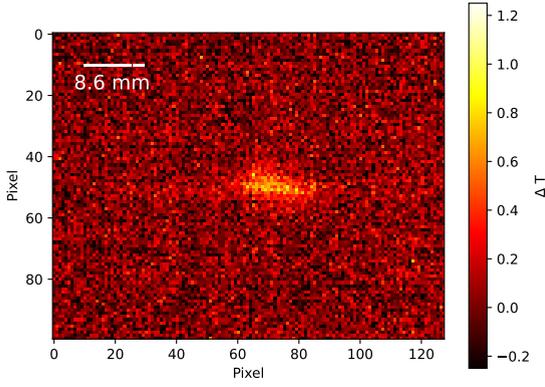
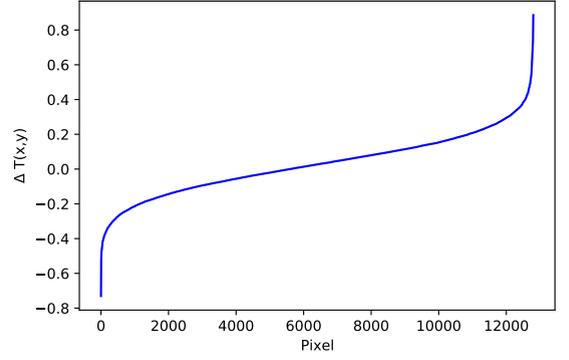
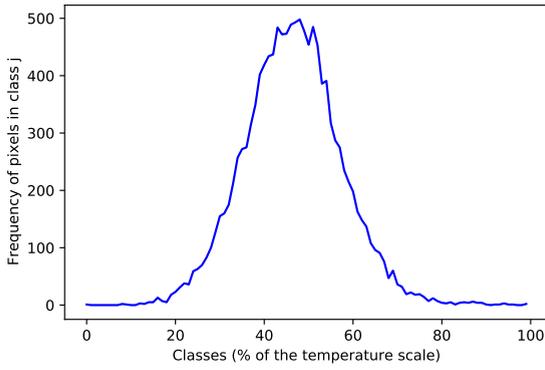
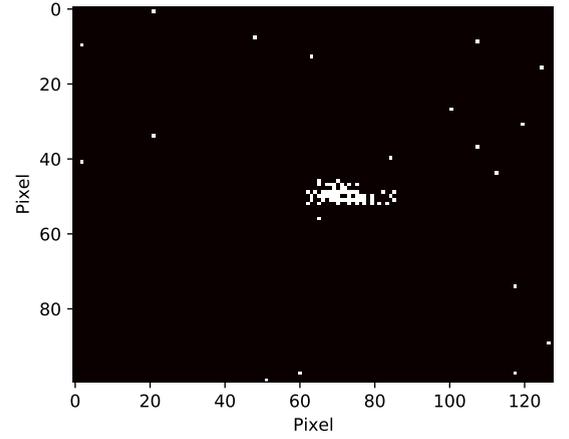
(a) Selected thermogram for the application of the analysis methodology proposed by Maierhofer et al. (2019)

(b) Resorted temperature values of the plotted thermogram.

(c) Histogram of the frequency of pixels belonging to each class. Classes 1 to 100 comprise the temperature from  $T_{min}=-0.73K$  and  $T_{max}=0.89K$ .

(d) Heated area matrix obtained with this approach.

**Figure 20:** Results obtained in this study with the analysis methodology proposed by Maierhofer et al. (2019) which can be directly compared to the results plotted in Figure 2 in the original paper.

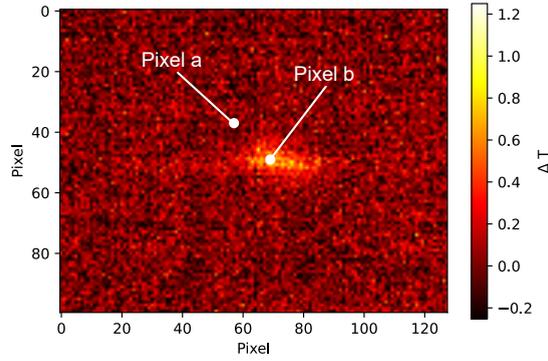
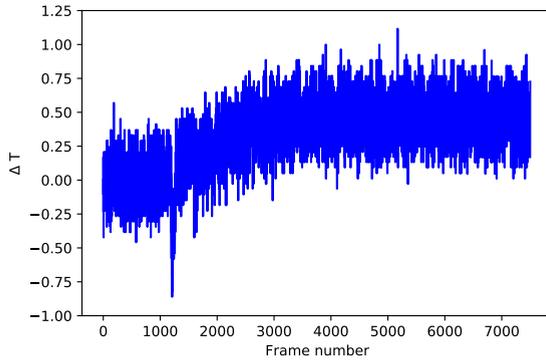
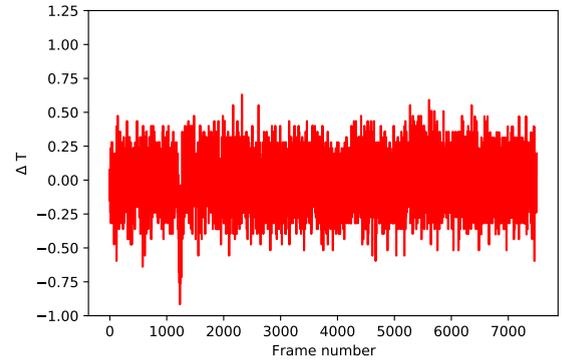
(a) Positions of two selected pixels in the studied image

(b) Thermogram of the pixel  $x = 69$  and  $y = 49$  (Pixel b)

(c) Thermogram of the pixel  $x = 57$  and  $y = 37$  (Pixel a)

**Figure 21:** Comparison of the thermograms for two pixels located in two different positions.

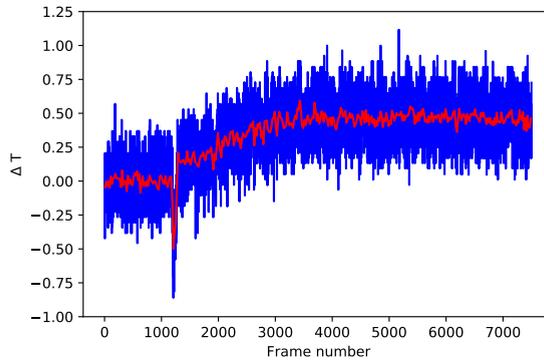
**Figure 22:** Comparison between the raw thermogram and the one obtained with an average value of the pixels over 20 images.

In order to evaluate the heated area after the impact, the high temporal discretisation used for the study of damage appearance during the impact test is no longer mandatory. Consequently, a data reduction can be performed based on the average value of the pixel over a given number of frames. As shown in Figure 22, a drastic reduction of the apparent noise for the selected pixel ( $x = 69$  and  $y = 49$ ) is observed by using an average value over 20 images. In that case, the apparent noise observed in Figure 22 appears to be in better agreement with the order of magnitude classically observed in the literature. Based on that observation, *the reference based method* proposed in Boccardi et al. (2016) will be used in the sequel to evaluate the heated area with the post-treated IR data obtained after the data reduction process. This choice is based on the fact that this methodology appears to the author as the simplest one and as it was mentioned by Maierhofer et al. (2019) the results obtained with the different methodologies are very similar. The analysis methodology proposed by Boccardi et al. (2016) will be briefly recalled. First of all, a reference image before the beginning of the test is generated based on an average value of each pixel over a given number of frames (100 in the work of Boccardi et al. (2016)). Due to the data reduction already performed on the results, only 50 images can be used in this study to build the reference image before the test:

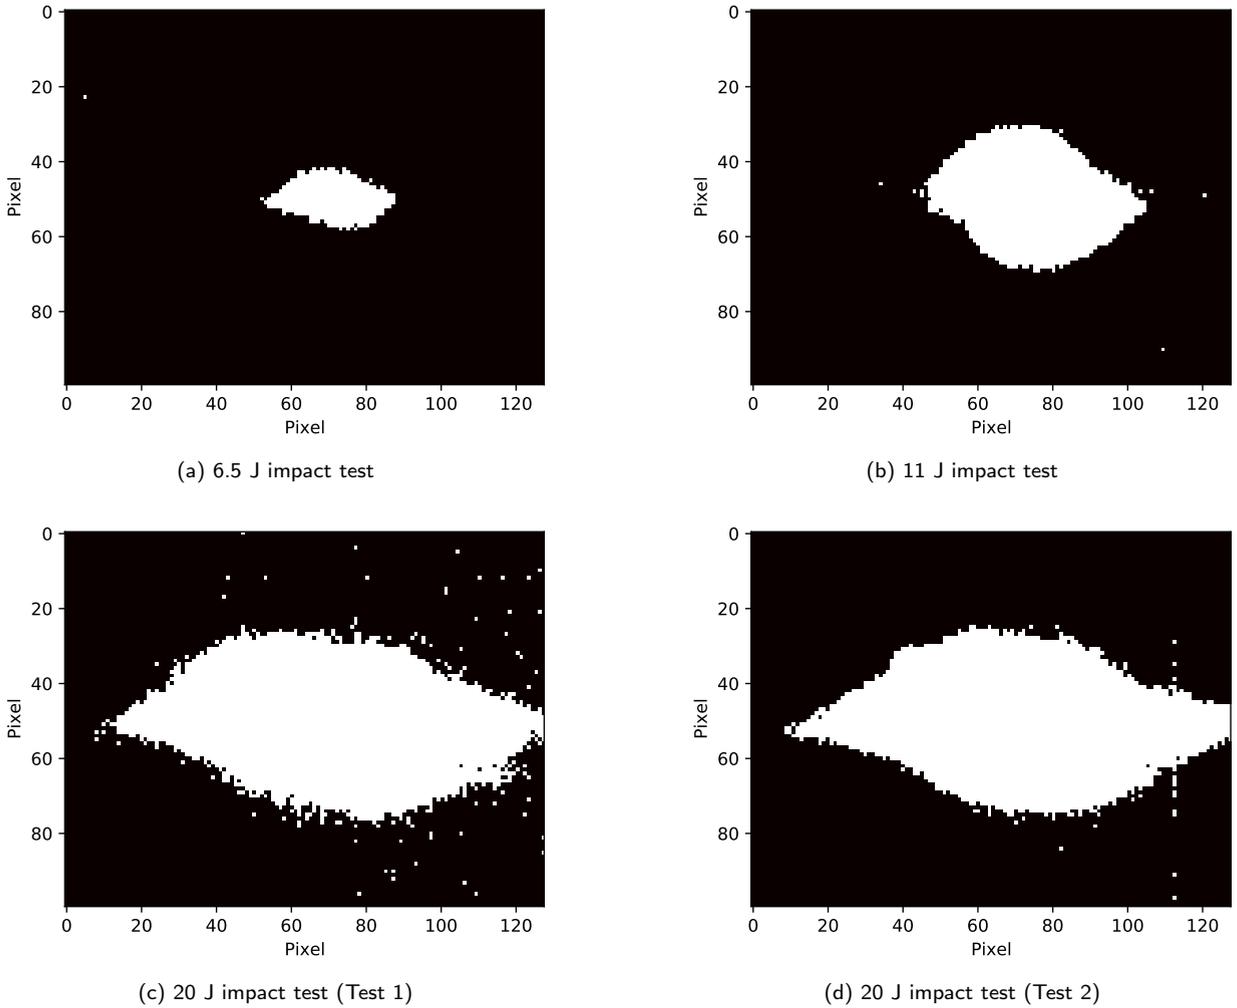
**Figure 23:** Results of the damage extension evaluation method for the different impact tests performed in this study.

As it was previously mentioned, in this study the sequence duration is shorter than those classically used by the different authors previously mentioned. In order to be as close as possible to the recommendations proposed by Meola et al. (2018), the last computational time (referred as *Evaluation instant*) of the heated area matrix will be used in the sequel to obtain the results summarised in Figure 23 and Table 2. First of all, as it was previously observed for the 35 J

test, the damage extension appears to be larger than the area observed by the IR sensor. Consequently, the area is not evaluated for this test. As it was previously observed by the different authors mentioned in this work, the heated area increases with the impact energy. It can be noticed for the two tests performed at 20J that the results are quite similar with a variation of less than 10% of the heated area between the two tests. The shape of the damaged area is globally the same between the different tests, only the size of this area is changing. Finally, it appears for the two 20J impact tests that the size of the images starts to become too small to be able to capture all the observable heated area.
