# High-speed infrared thermography for in-situ damage monitoring during impact test

Julien Berthe<sup>a,\*</sup>, Salim Chaibi<sup>b</sup>, Gérald Portemont<sup>a</sup>, Pascal Paulmier<sup>b</sup>, Frédéric Laurin<sup>b</sup> and Christophe Bouvet<sup>c</sup>

Infrared thermography  
Impact tests  
Damage  
Composite materials

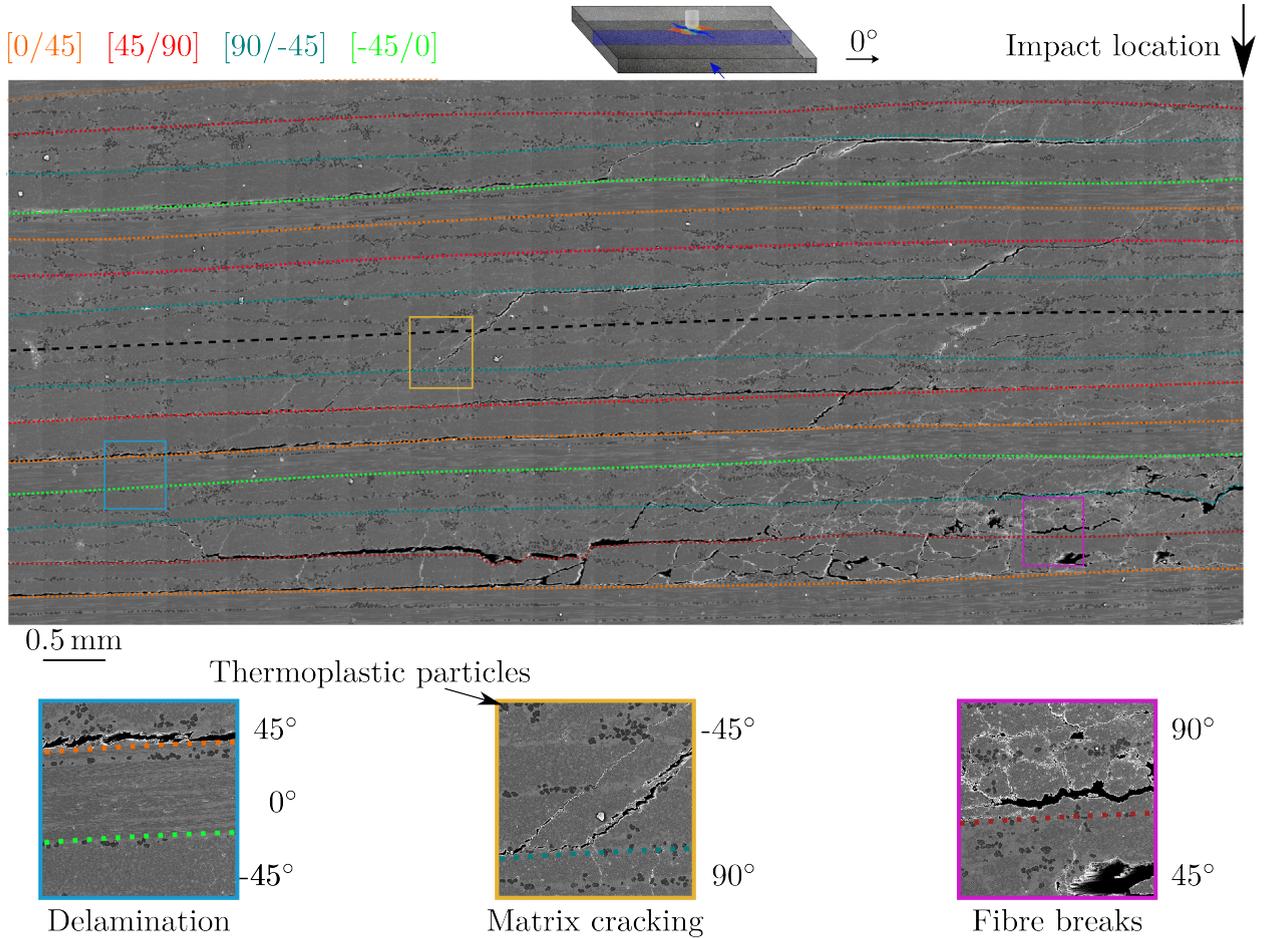
Figure 24: Micrograph observation using SEM for a sample impacted at 20J impact

After the impact event, observations were performed using a scanning electron microscope (SEM) for a sample impacted at 20J. The stitching of 0.5 mm images has been done to reconstruct a wide observation of the material's microstructure. A 0° micrograph cut is presented in Figure 24 where almost all the stacking sequence is highlighted. The black dashed line located at the midlaminar highlights the [45°/45°] interface whereas, four other colored lines represent the different interfaces. The micrograph presents an overview of the classical impact damages, where the three damage mechanisms related to matrix cracking, delamination and fibre breaks are shown in the colored square. It can be noticed that a strong interaction between the matrix cracking and the delamination is observed. Besides, for the bottom plies, a complex crack network is found. Indeed, fibre breaks in tension have occurred for the lower plies

except for the lowest 0° ply. The fibre breaks in tension is responsible for the cavities observed in the lower plies. In other words, broken fibres have been pulled out during the sample preparation for micrograph observation. This figure demonstrates the difficulty of reconstructing the damage scenario, which is very complex, using only the micrograph.

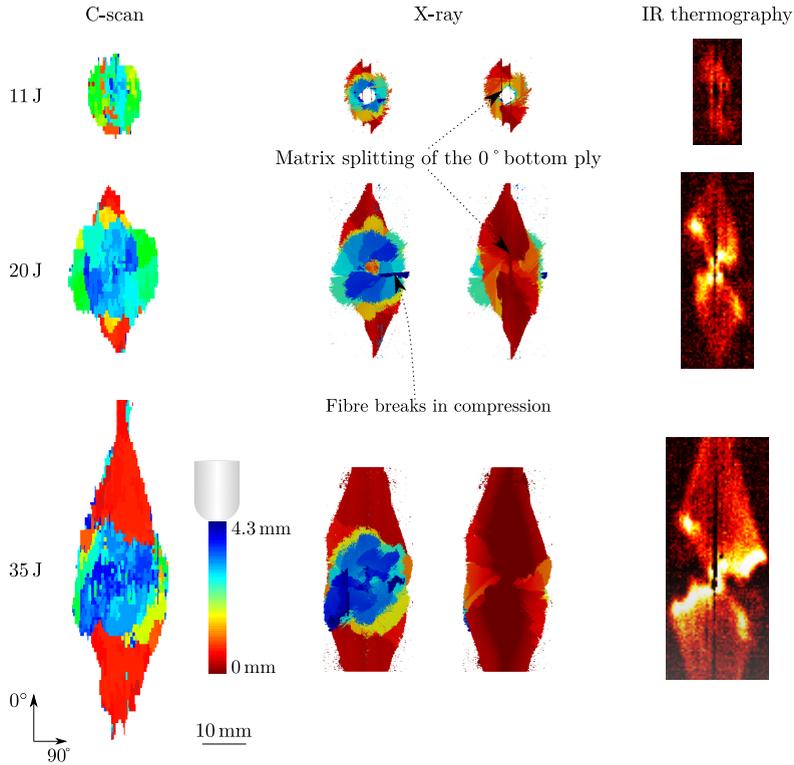
**Figure 25:** Segmentation of impact damage mechanisms obtained from C-Scan in depth, X-Ray and IR thermography at 3 different impact energy levels.

can be observed, with a typical delamination shape for such a quasi-isotropic laminate under impact. The size of this area is increasing with the energy and can be compared to post-mortem analysis performed in the sequel and particularly to Figure 25. The shape is clearly linked to the delamination between the last two plies on the side opposite of the impact. Secondly, more significant but this time more localized temperature increases can be observed with increasing impact energy levels (20 J and 35 J). In particular, a rather chaotic line seems to be drawn in the center of the specimen with a rather small angle to the vertical. A second line with an angle of  $45^\circ$  is also observed for the 20 J and 35 J tests. These two high temperature lines are not observed for the 11 J impact test. These dissipative phenomena appear for higher energy levels and therefore for higher applied forces. The more important oscillations on the stress signal observed on the 20 J and 35 J tests could therefore come from these phenomena. Considering their topology with respect to the studied stacking sequence, these dissipative phenomena seem to be linked to fibre breaks that could have been observed with the help of a post-mortem analysis. This specific analysis methodology is quite similar to other works in the literature whose objective is the analysis of damage extension during impact tests using infrared thermography (Meola and Carlomagno, 2010; Boccardi et al., 2016; Meola et al., 2018; Maierhofer et al., 2019). These methodologies will therefore be applied to our tests in the following.

The projected damage areas obtained by ultrasonic inspection are shown in Figure 25. This figure shows that impact damages are observed through the thickness. Moreover, it highlights the delamination evolution for the lowest interface in red, which corresponds to the highest delaminated surface at 35 J. The projected delaminated areas were estimated and are presented in Table 3. The inspection using ultrasonic scan gives an understanding of the projected damage area but is not sufficient to assess the complexity of impact damages.

3D rendering of impact damages was performed with Paraview using a depth-coded colormap. The results are presented in Figure 25. First of all, X-ray dissociates each kind of damage mechanism (matrix cracking, delamination and fibre breaks) with high-quality damage visualization. Based on what was previously observed with infrared thermography, some assumptions regarding the damage scenario can be made using this *post-mortem* analysis. The delamination cracks propagate from the non-impacted side for the 11 J test. Before fibre breaks in tension occur, the delamination of the lowest interface [0°/45°] is clustered between the matrix cracking of the 45° ply and the outer 0° ply. However, since 20J, fibre breaks in tension occur in the lowest 45° ply. The delamination of the lowest interface [0°/45°] increases until becoming the largest delaminated area. Indeed, as observed with infrared thermography, the fibre breaks in tension of the 45° ply open the split in the 0° ply and then trigger the delamination expansion. Thanks to the matrix splitting and the largest delamination of the lowest interface [0°/45°], the bottom 0° ply is unloaded and free of fibre breaks in tension. Concerning the damage mechanisms occurring near the impacted surface, tests from 11 J shows no damage under the impactor. It is probably explained by a reinforcement of the ply strength due to local hydrostatic pressure. Fibre breaks in compression occur since 11 J for the 0° surface ply close to the impactor. For the 35 J test, fibre breaks in compression are also observed for the 45° ply just below the outer 0° surface ply.

On the other hand, by comparing Figure 19 and Figure 25, it can be seen that the analysis proposed for the construction of Figure 19 clearly highlights the shape of the delamination between the last 2 plies on the non-impacted side which is depicted in dark red on the right hand side in Figure 25.

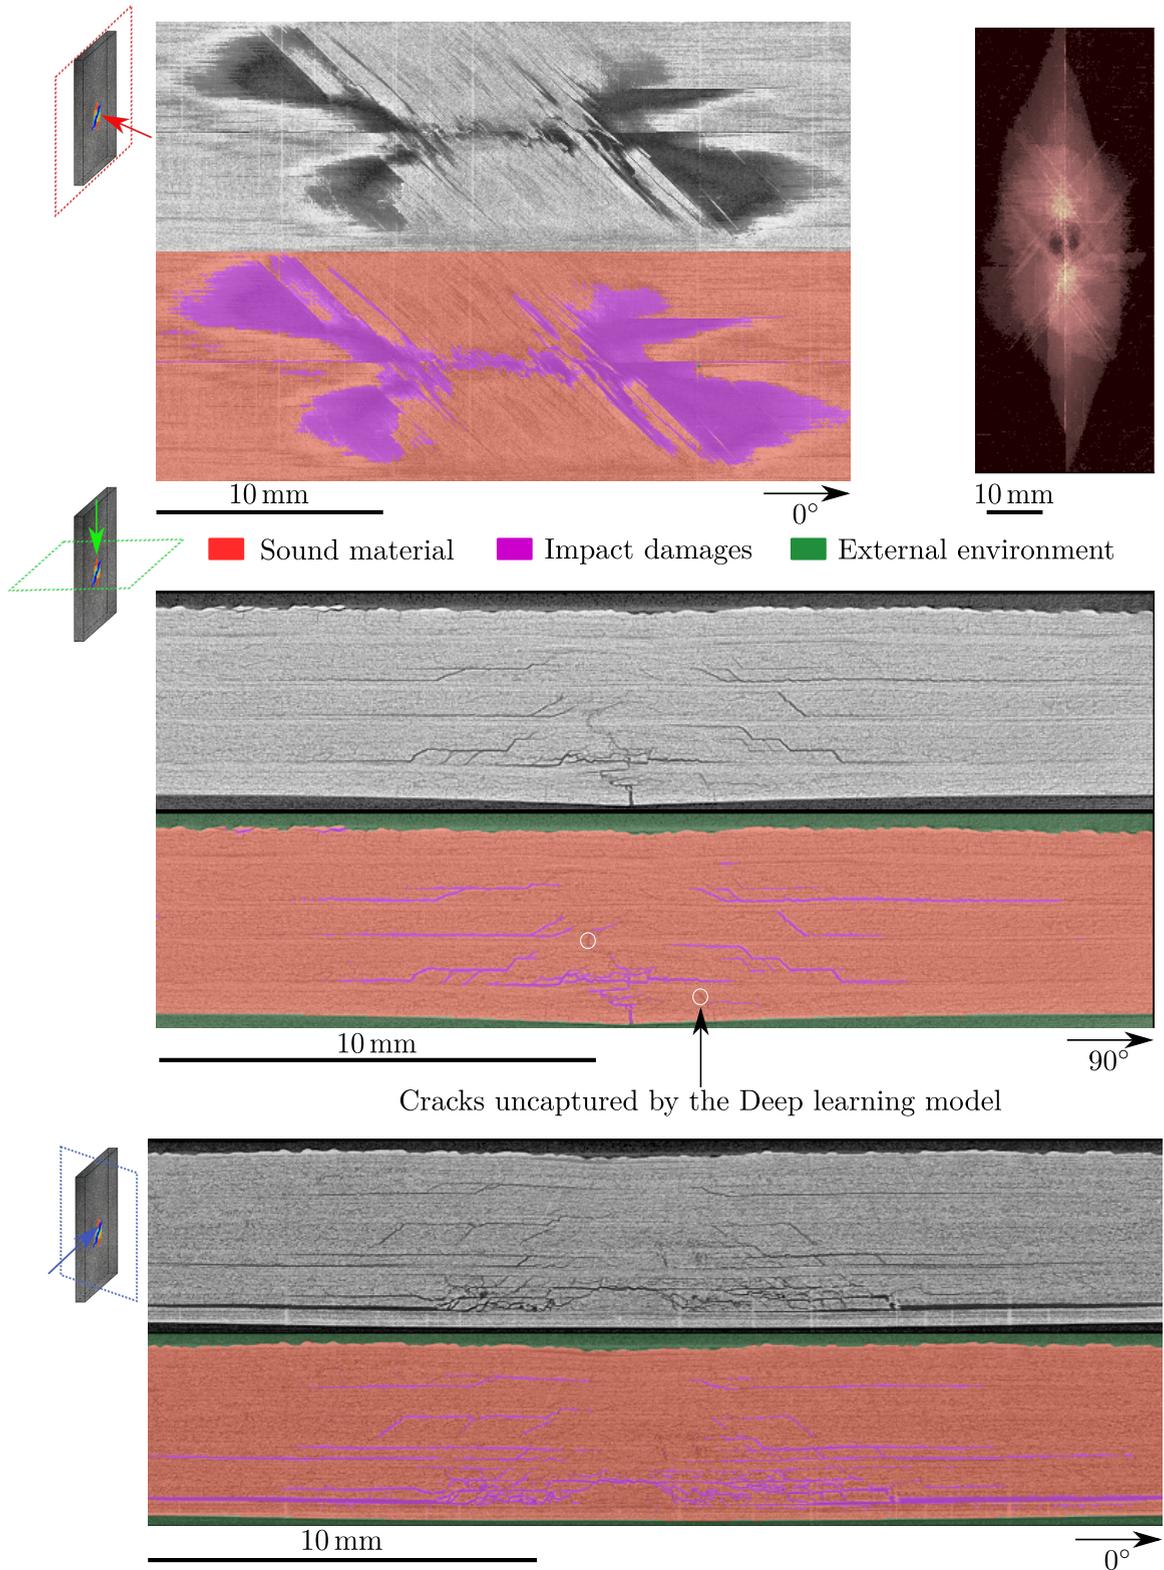
**Figure 26:** Segmentation of the different labels performed with the U-net deep learning algorithm on the untrained X-ray data. The data is obtained from the sample impacted at 20 J

gray value is similar to the exterior environment. Therefore, as shown in Figure 26, three labels have been defined. The first label in green is for the external environment, the second in red for the sound material, and the last in purple for the impact damages. The training data has been performed on 2D slices containing the entire thickness. It has been motivated to distinguish the three different labels easily.

Once the model is trained, the segmentation has been performed on the untrained CT images of the composite plate. Full segmentation of the impact damages in a X-ray volume was performed in 90 minutes. Visual inspection confirmed the result's reliability. The prediction results are presented for 3 slices in different planes for the specimen impacted at 35 J in Figure 26. It can be observed that the segmentation of the three labels was performed accurately. Despite the similar grayscale levels, the impact damage is dissociated from the external environment, which confirm the reliability of the algorithm. The complex damage pattern was straightforwardly captured. It can be observed surrounded in white, that some damaged pixels were not captured by the algorithm. It could be explained by the smallest size of the damaged pixel networks which are not recognized as a crack. The projected impact damages at 20J were finally observed on the top right in Figure 26.
