## Effect of salt spray ageing on the fracture of composite-to-metal bonded joints

M.M. Arouche, M.N. Saleh, S. Teixeira de Freitas, Silvio DE BARROS

Fracture toughness  
Bi-material bonded joints  
Adhesion  
Fractography  
Ageing

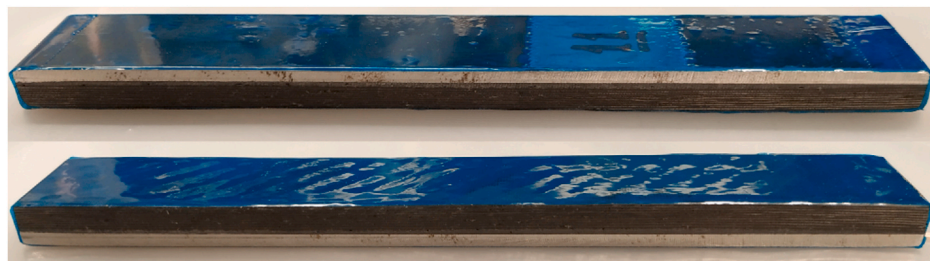
**Fig. 2.** A specimen prepared for ageing.

Specimens were placed for ageing in a salt spray chamber. A solution of 5% mass sodium chloride [NaCl] was atomized at 200 ml/h and 35 °C. The exposure zone remained in a relative humidity between 95% and 98% and pH between 6.5 and 7.2, according to the ASTM B117 standard practice [30]. Specimen's top and bottom surfaces were covered with a layer of tape to avoid degradation of the adherends as shown in Fig. 2.
