Effect of salt spray ageing on the fracture of composite-to-metal bonded joints

M.M. Arouche, M.N. Saleh, S. Teixeira de Freitas, Silvio DE BARROS

M.M. Arouche, M.N. Saleh, S. Teixeira de Freitas, Silvio DE BARROS. Effect of salt spray ageing on the fracture of composite-to-metal bonded joints. *International Journal of Adhesion and Adhesives*, 2021, 108, pp.102885. 10.1016/j.ijadhadh.2021.102885 . hal-04246278

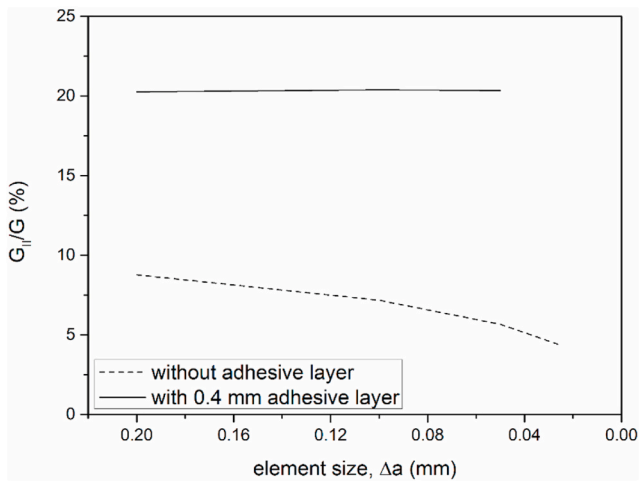
Fig. 5. Mesh sensitivity analysis.

A mesh sensitivity analysis was performed using the model of the MMB test with a crack length (a) of 30 mm. Elements of the same size were used on both sides of the crack and the aspect ratio of the elements in the vicinity of the crack tip was maintained at 1/1. The numerical analysis takes into consideration the effects of geometric nonlinearity. Results are shown in Fig. 5. The calculated fracture mode ratio (G_{II}/G) of a model without the adhesive layer showed dependency on the element size around the crack tip (Δa) and did not represent the actual fracture

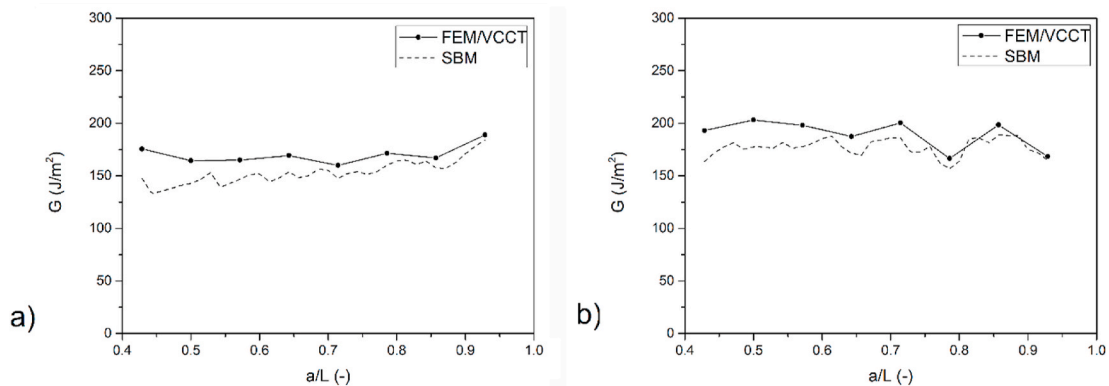
Fig. 10. Fracture energy of a representative specimen tested at a lever length of (a) 110 mm and (b) 150 mm.

Fig. 10 shows comparative results of the fracture energy obtained from the FEM/VCCT and the SBM in the two different testing configurations. Numerical values of the total fracture energy are shown to be consistent along crack propagation. Results calculated using the SBM deviated by 15% from the FEM/VCCT at crack initiation and converged as the crack length increases. This is attributed to the effect of shear stresses that are not considered in the SBM but can be significant when testing beams with high thickness-to-span ratio [29].

energy is noted at 15% mode II. As expected, the SBM showed good agreement with the numerical results. Moreover, the average fracture energy obtained from the SBM deviated by 15% from the FEM/VCCT at crack initiation (Figs. 12a) and 6% during propagation (Fig. 12b), as observed in Fig. 10.

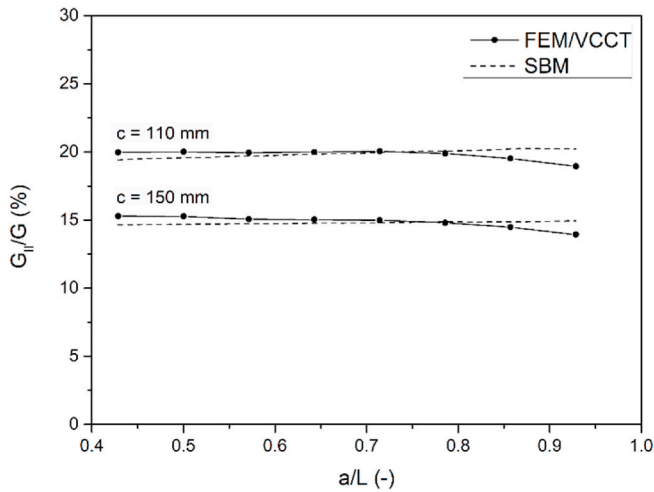
Fig. 11. Fracture mode ratio.

The fracture mode ratio obtained from numerical and analytical methods is presented in Fig. 11. Numerical results (FEM/VCCT) presented nearly constant results along the crack propagation with a slight reduction of the mode II portion at the crack propagation points near the

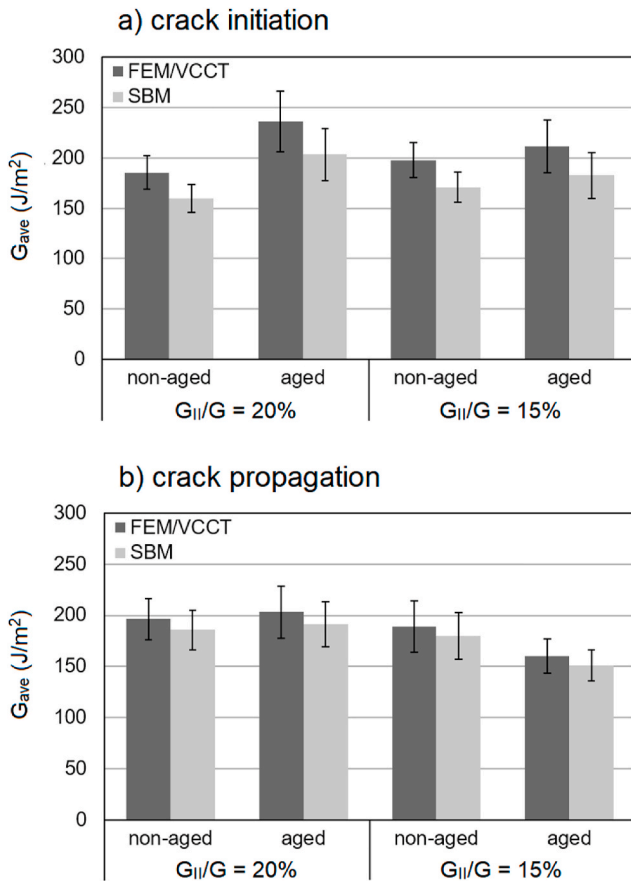
Fig. 12. Average fracture energy at (a) crack initiation and (b) propagation.

The average fracture energy (G_{ave}), presented in Fig. 12, provides a comparable data for the evaluation of the ageing effect on the fracture performance of the tested specimens. Fig. 12a shows the mean fracture energy at crack initiation of the 4 repeats of each configuration. It reveals a significant increase of 27% of the fracture energy at crack initiation when tested in 20% mode II. In the case of specimens tested in 15% mode II, the fracture energy showed a slight increase of 7% at crack initiation. The region of crack initiation is directly affected by the moisture across the whole width and resulted in an increase of the fracture toughness. This seems to be related to the shear behavior of the adhesive and is attributed to the effect of plasticization [19,21].

Fig. 12b shows the mean fracture energy at crack propagation points (from 35 to 65 mm crack length) of the 4 repeats of each configuration. A negligible variation is observed of 3% of the fracture energy at 20% mode II during crack propagation, while a reduction 15% of the fracture

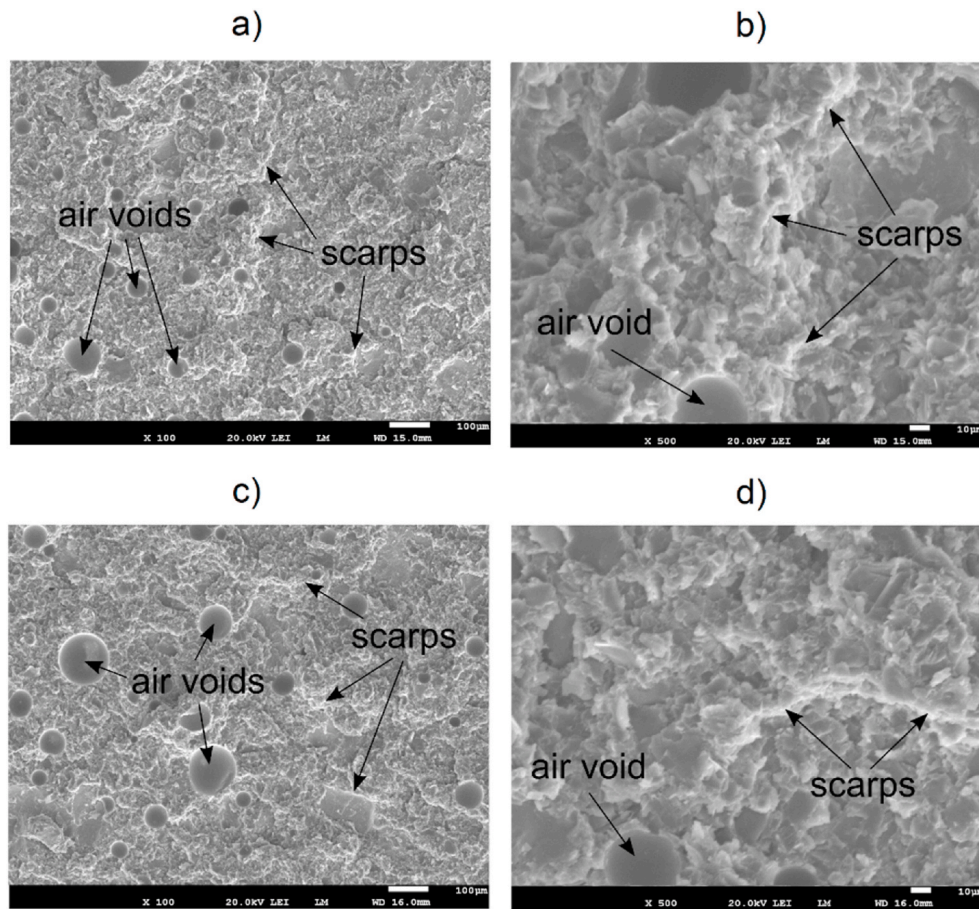
Fig. 14. SEM images of non-aged specimen tested with $c = 110$ mm (20% mode II) at (a) x100 and (b) x500 and tested with $c = 150$ (15% mode II) mm at (c) x100 and (d) x500.

A detailed analysis of the fracture surfaces was performed using a field emission scanning electron microscope (SEM) (JSM-7500F, JEOL, Japan). Prior to examination, samples were coated with two ultra-thin (15 μm) layers of gold using a sputtering system (Q300T D, Quorum Technologies, United Kingdom) for the SEM analysis of non-conductive materials. Fig. 14 shows typical fracture surfaces from the metal side of non-aged specimens using magnifications of 100 and 500 times. Crack propagation direction is from the left to the right side of the images. Both test configurations of 20% mode II (Fig. 14a and b) and 15% mode II (Fig. 14c and d) demonstrated similar surfaces of cohesive failure with the presence of air voids and scarps. These features confirm that the fracture occurred with dominant mode I loadings in both test configurations [11,14]. No significant difference in the failure mechanisms was noticed between the two mode ratios.

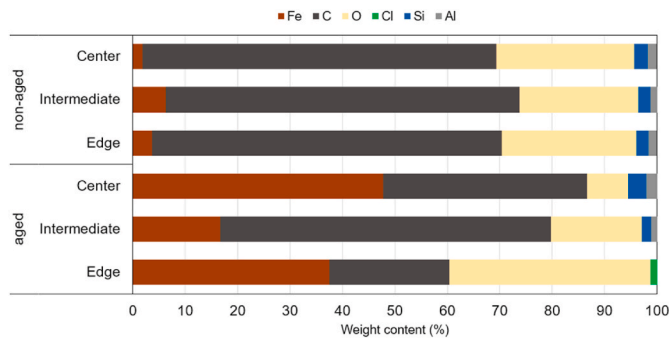
Fig. 17. EDS of aged specimen at center, intermediate and edge regions of the fracture surface.
