Interlaminar adhesion assessment of carbon-epoxy laminates under salt water ageing using peel tests

Marcio Arouche, Sandip Budhe, Mariana Banea, Sofia Teixeira de Freitas,
Silvio DE BARROS

Proc IMechE Part L:

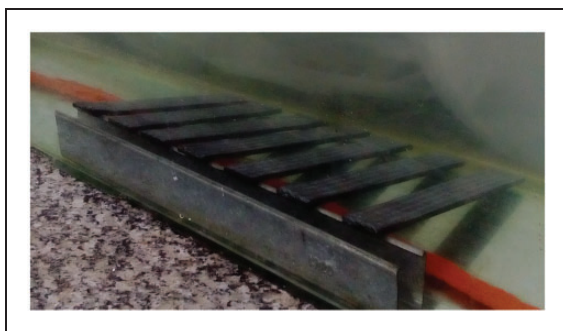
Figure 2. Specimens inside the salt water tank.

environmental exposure on the joint. Specimens were kept inside the salt water tank (5% NaCl) at room temperature for 60 days. The ageing process simulates the effect of environmental conditions wherein the materials are exposed to marine environment. Three reference specimens were tested without any ageing. Figure 2 shows the specimens inside the salt water tank.

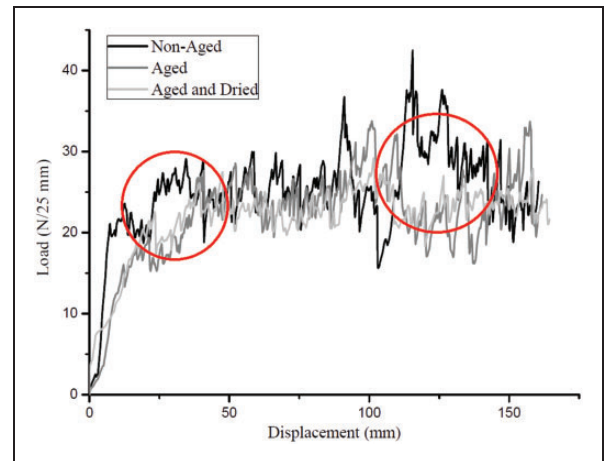
Figure 4. Representative load–displacement curves of the peel tests.

Specimens were tested in three different conditions: (1) non-aged; (2) immediately after 60 days ageing; and (3) after 60 days ageing and subsequent 280 days drying. Figure 4 shows the representative load–displacement curves of each test condition. Significant differences on the peel load are noted in the highlighted areas. This suggests a consequence of the ageing process. Previous work³⁰ showed that water ingress from the edge towards the centre of the interface and it has an irregular pattern. However, no relevant change on the peel strength is observed as consequence of the drying process.

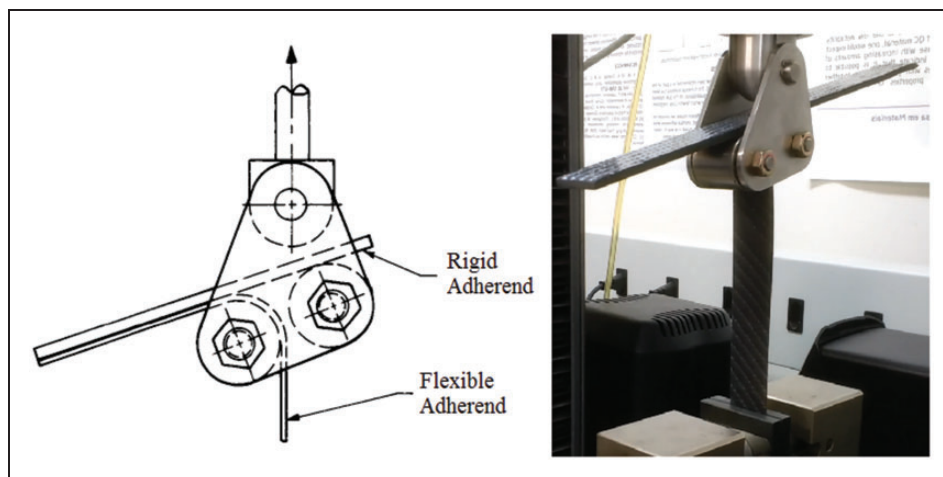
Figure 3. Floating roller peel test setup.

Figure 3 shows the test set up. The initial crack of the specimens was too short for clamping on the machine grips and had to be manually increased by pre-loading to enable testing. Load–displacement curves were recorded during testing. Three specimens were tested for each condition.

The floating roller peel test allows determining the peel strength between a rigid and a flexible adherend. Tests were performed on the specimens at room conditions, by means of an electro mechanic Instron machine (Series 5966) with a maximum capacity of 20 kN, coupled with a load cell of 1 kN. The testing speed was 125 mm/min, in accordance with the Composite Peel Test.²⁸ During the test, the flexible adherend is peeled off from the rigid adherend.
