# **An assessment of composite repair system in offshore platform for corroded circumferential welds in super duplex steel pipe**

Silvio de Barros, Sandip Budhe, Mariana D Banea, Ney R.F. Rohen, Eduardo M Sampaio, Valber A Perrut, Luiz D.M. Lana

**ABSTRACT.** The main aim of this study is to assess the effectiveness of a composite repair system in severely corroded circumferential welds in super duplex stainless steel pipes as a preventive measure against the premature corrosion damage at the welds. Artificial defects were fabricated on the super duplex steel tube in order to reproduce the localized corrosion damage defects found in real welded joints. Three kinds of through thickness defects were considered: 25%, 50% and 96% of the perimeter of the pipe. The performance of the repaired pipe was assessed by hydrostatic tests as per ISO 24817 standard. The results showed that the composite repair system can sustain the designed failure pressure even for the pipe damaged with through-wall defect up to 96% of the perimeter of the pipe. Hence, the composite

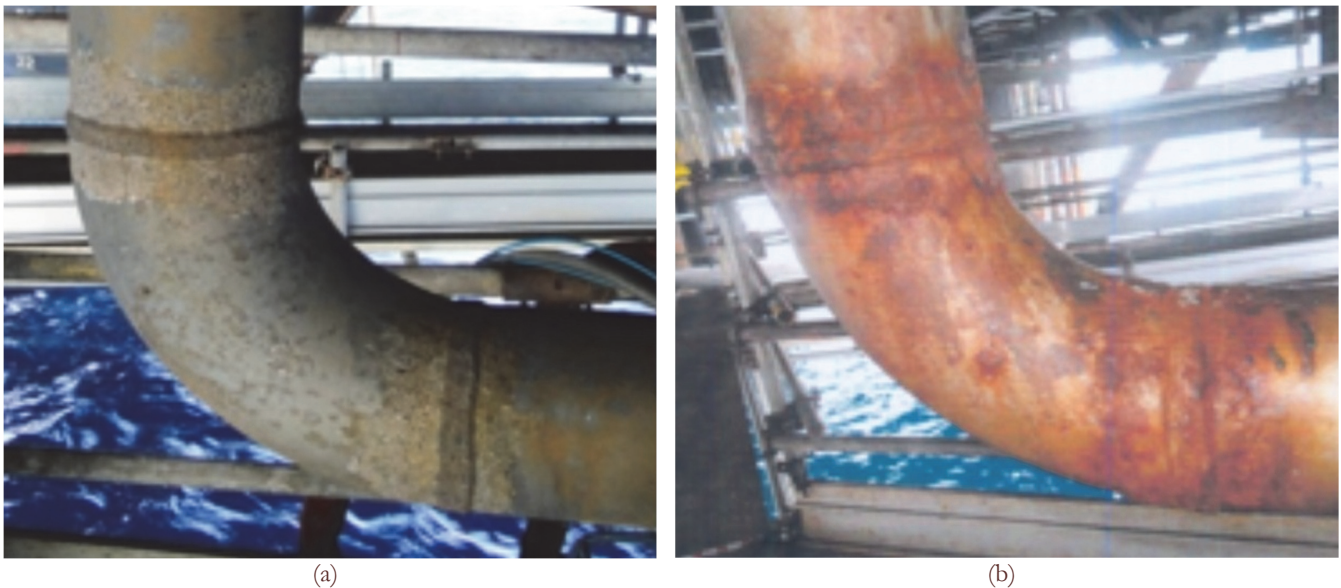
Figure 1: Super duplex steel piping assembly: (a) uncorroded welds (b) corroded welds.

Nowadays, the super duplex stainless steel pipes are increasingly used due to an excellent resistance to corrosion in harsh environments combined with good mechanical properties. However, despite the high resistance to corrosion, the welding process of this material is not simple and is susceptible to corrosion, if the welding parameters are not properly controlled [7-9]. Thus, it is possible to have duplex or super duplex steel piping assemblies with significant corrosion damage at the welds (Fig.1).

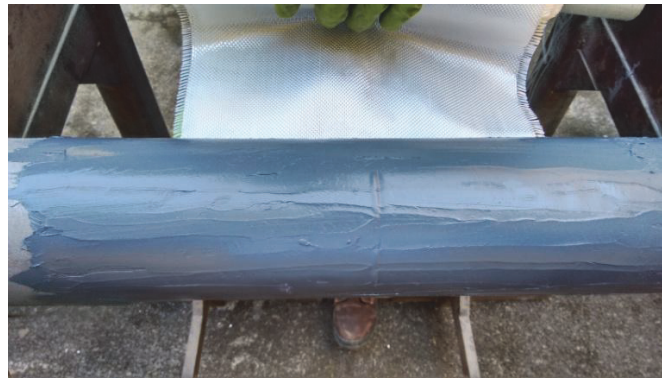
Figure 4: Primer Layer.

of super duplex stainless steel tube was cleaned with acetone to remove dust and foreign particles and then a layer of primer NVT was applied, as shown in Fig.4. The defect pipe is wrapped with concentric layers of a fiberglass tape with laminating resin (32 layers with approximately 0.298 mm thickness each). The calculation of composite repair thickness was based on the ISO 24817 standard. The calculated composite repair thickness was 9.5 mm. The repair system used PIPEFIX, adhesive and 32 turns of the laminate being applied with an axial length of 300 mm. Each laminate turn was followed by a layer of resins and pressed with a metallic roller for compact, as shown in Fig. 5.

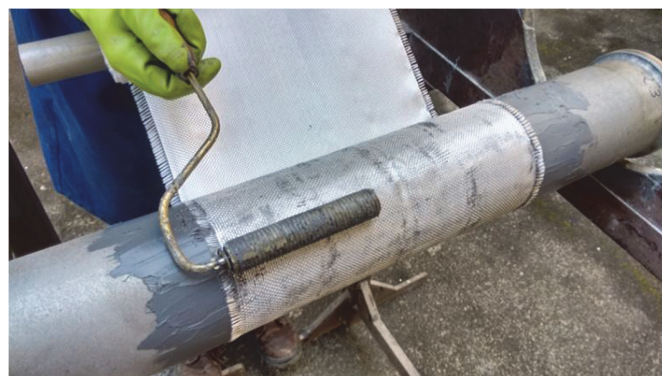
Figure 5: Pre-impregnated, bi-directional composite.

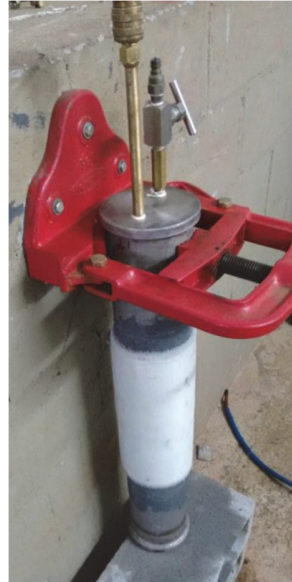
Figure 6: Hydrostatic testing.

The hydrostatic tests were performed in the bunker at room temperature condition. The specimen used in the hydrostatic test is presented in Fig.6. For the hydrostatic test, the Flutrol's Test Pac equipment was used. The pressure was increased by approximately 1 bar/second and after reaching a certain level, the pressure was maintained for 30 minutes. Then again raised by 1 bar/second up to next level, until the repair system fails. Load the tube specimen for 30 min at a particular operating pressure and then increased for next pressure level. Each test shall be monitored by a PID system to record the test results.
