An assessment of composite repair system in offshore platform for corroded circumferential welds in super duplex steel pipe

KEYWORDS. Pipe repair; Super duplex steel; Corrosion; Composites; Hydrostatic tests; Offshore.

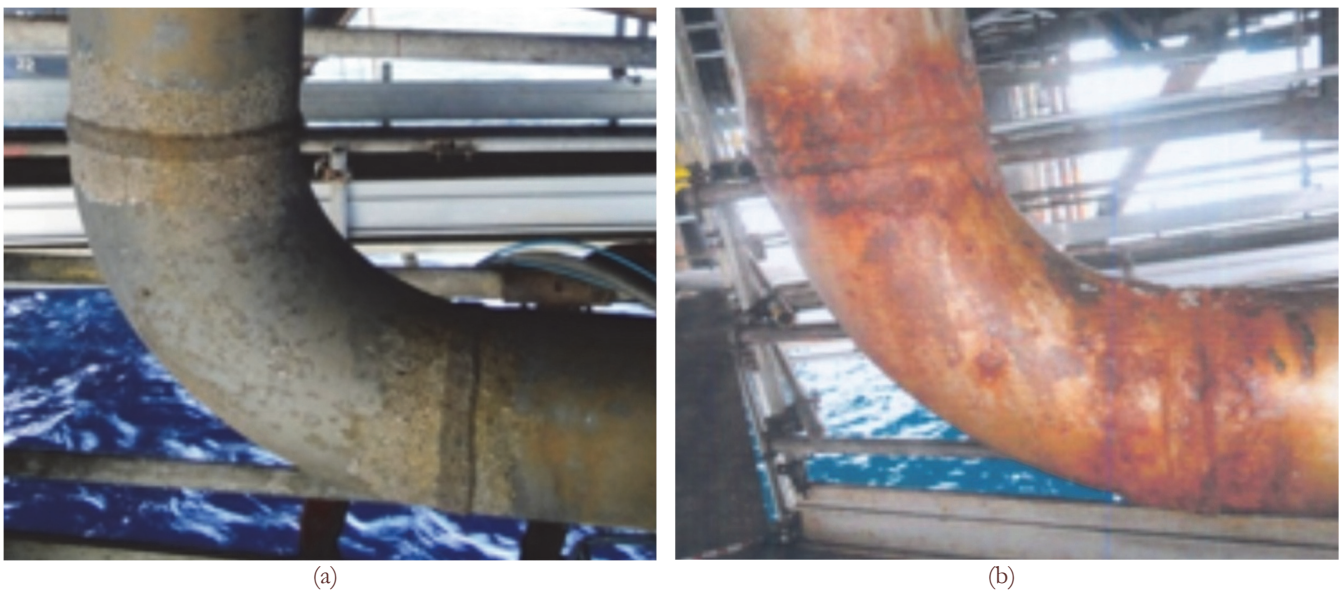
Figure 1: Super duplex steel piping assembly: (a) uncorroded welds (b) corroded welds.

Nowadays, the super duplex stainless steel pipes are increasingly used due to an excellent resistance to corrosion in harsh environments combined with good mechanical properties. However, despite the high resistance to corrosion, the welding process of this material is not simple and is susceptible to corrosion, if the welding parameters are not properly controlled [7-9]. Thus, it is possible to have duplex or super duplex steel piping assemblies with significant corrosion damage at the welds (Fig.1).

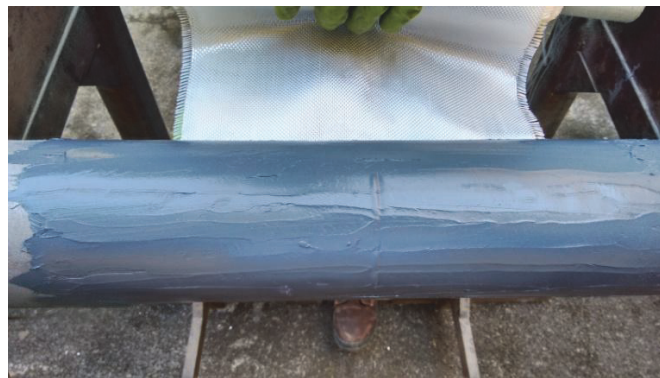
Figure 4: Primer Layer.

of super duplex stainless steel tube was cleaned with acetone to remove dust and foreign particles and then a layer of primer NVT was applied, as shown in Fig.4. The defect pipe is wrapped with concentric layers of a fiberglass tape with laminating resin (32 layers with approximately 0.298 mm thickness each). The calculation of composite repair thickness was based on the ISO 24817 standard. The calculated composite repair thickness was 9.5 mm. The repair system used PIPEFIX, adhesive and 32 turns of the laminate being applied with an axial length of 300 mm. Each laminate turn was followed by a layer of resins and pressed with a metallic roller for compact, as shown in Fig. 5.

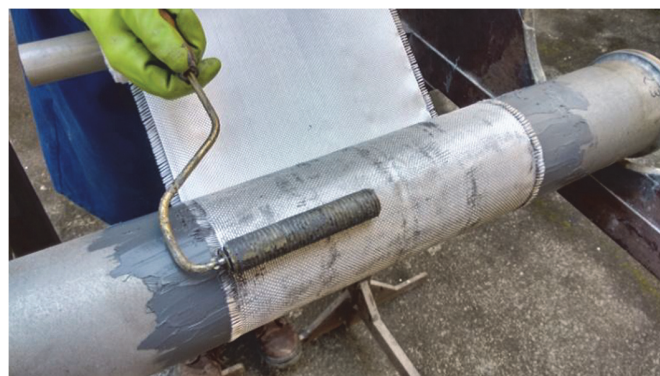
Figure 5: Pre-impregnated, bi-directional composite.

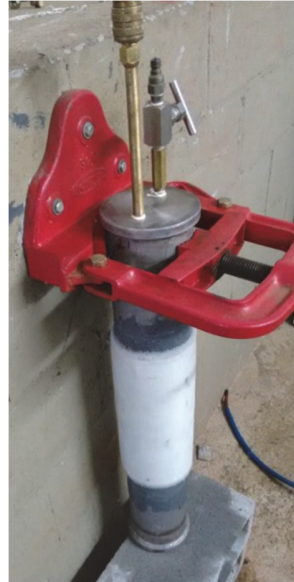
Figure 6: Hydrostatic testing.

The hydrostatic tests were performed in the bunker at room temperature condition. The specimen used in the hydrostatic test is presented in Fig.6. For the hydrostatic test, the Flutrol's Test Pac equipment was used. The pressure was increased by approximately 1 bar/second and after reaching a certain level, the pressure was maintained for 30 minutes. Then again raised by 1 bar/second up to next level, until the repair system fails. Load the tube specimen for 30 min at a particular operating pressure and then increased for next pressure level. Each test shall be monitored by a PID system to record the test results.
