Terahertz pulsed imaging of low velocity impact damage in woven fiber composite laminates

Recently, terahertz pulse imaging has been used extensively to characterize internal defects in various electrically insulating materials. In this work, terahertz pulse imaging is used to identify the damage induced by low-velocity impact on woven glass-fiber reinforced polyamide laminates. Several impact energies are considered to study the damage initiation and propagation. The permanent indentation, known to be a relevant damage indicator, is extracted from the terahertz results and validated through comparison with profilometry. Further, the criticality of the damage, in terms of the number of composite plies in which the cracks propagate, can be clearly determined from terahertz imaging. These observations are validated through X-ray tomographic observations and analysis. Finally, a strong connection is established between the evolution of the permanent indentation and the appearance, and criticality, of the low-velocity impact-induced damage. These observations suggest that terahertz imaging is a reliable technique for the nondestructive assessment of impact damage in glass fiber compos

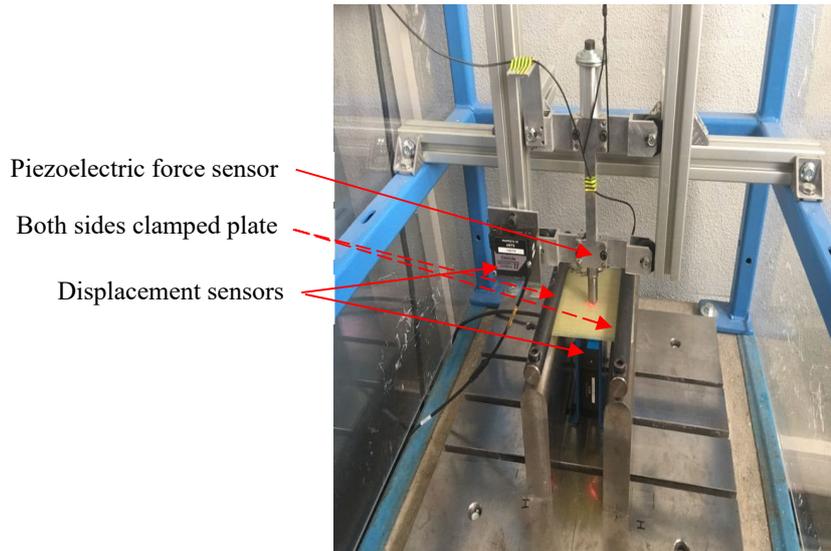
Figure 1: Drop-weight impact machine. A piezoelectric force sensor and a laser displacement sensor monitor the striker contact force and its displacement. Another laser displacement sensor monitors the sample deformation during the impact [15].

The impact tests are performed with a drop-weight impact machine (Figure 1). A 16-mm-diameter hemispherical impactor of 1.02 kg is used. The system consists of a piezoelectric load sensor and two laser displacement sensors, as well as a data acquisition system. Eight samples of 100 x 150 x 1.53 mm³, plates clamped at both ends during the impact tests, are tested. The impactor height is varied in order to obtain 7 impact energy levels, namely 8.5, 13.1, 13.7, 14.2, 15.7, 18.1, 23, and 25 J. An undamaged sample is also retained as a control.

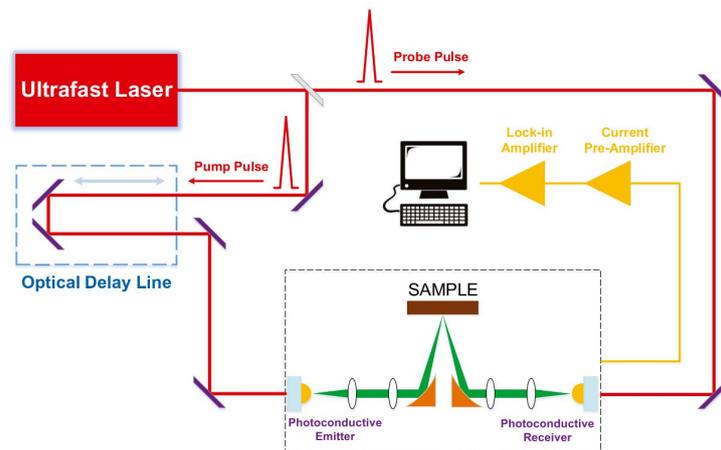
Figure 2: Schematic diagram of THz time-domain spectroscopy (THz-TDS) system in reflection mode [35].

For all the THz measurements described in this paper, a THz time-domain spectroscopy (THz-TDS) system (TeraView Ltd. TPS Spectra 3000) is employed in reflection mode. The acquisitions were done at a room temperature of 25°C. The system is shown schematically in Figure 2. The apparatus produces THz pulses with a bandwidth from 60 GHz to 3 THz and the signal is averaged over 5 shots per time delay per pixel. The recorded THz waveforms have 2048 data points with a time sampling of 0.023 ps. An xy scanner is used to image a 60 x 60 mm xy region with a 0.2 mm spatial step. The transverse resolution at 1 THz is ~ 400 μm due to the choice of the numerical aperture of the THz optics that provide a depth of focus the well exceeds the sample thickness. The acquired data is also used later for the internal damage investigation.

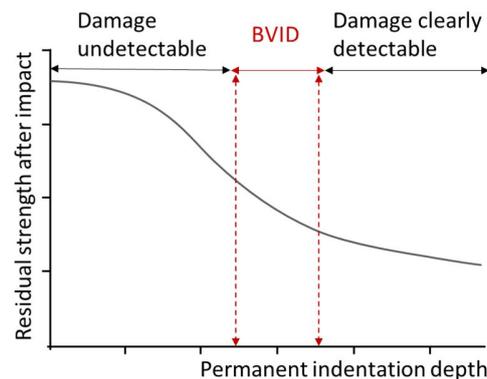
Figure 3: Schematic representation of the evolution of the residual strength after impact as a function of the measured PI on composites materials. The visual detectability range is also indicated from undetectable to detectable.

After an impact test, the impactor leaves a **permanent indentation (PI)** mark on the impacted surface. The depth of the PI is known to increase with the impact energy, and it reflects the level of the induced internal damage as illustrated in Figure 3. In this section, the PI depth **is measured** using two techniques: optical profilometry that is used to provide reference measurements and THz imaging in reflection. For both methods, the PI location is first identified and then the maximum depth of the PI is measured accordingly.

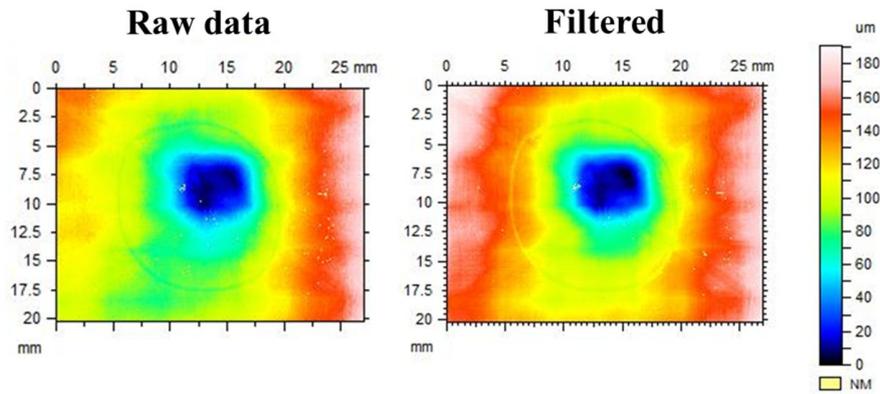
Figure 4: Surface texture of a sample, after an impact of 25 J, obtained using the optical profilometry, before (left) and after (right) applying a filter.

For the optical profilometry measurements, a LEICA DCM3D is employed. A magnification of 5x is chosen with a scan size of 27 x 20.23 mm². This gives a lateral resolution of 0.94 μm and a vertical resolution smaller than 150 nm. All the seven impacted samples are scanned and the surface-texture maps obtained are post-processed using Leica Maps software. A filter is applied to elevate the surface around the impacted area, to separate the roughness of the sample from the waviness due to the impact. **An example of surface texture obtained before and after applying the filter is given in Figure 4.** The PI depth is then extracted as the deepest value. The evolution of the PI depth with impact energy is plotted in Figure 5. From this result, three main stages **can be identified**. First, the PI increases slightly until a value around 25 μm depth

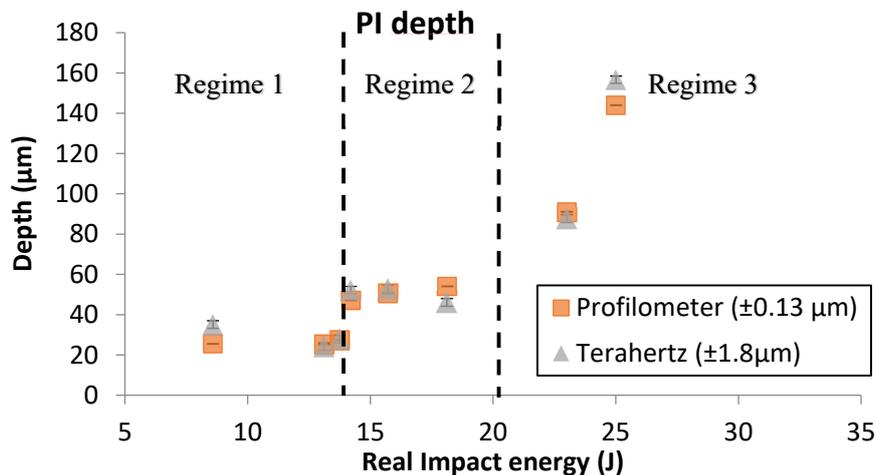
Figure 5: Comparison of PI depth obtained by optical profilometry and THz imaging. The two methods are in substantial agreement and exhibit three impact-energy regimes. The first shows an increase of PI depth with impact energy, then a stabilization regime, and at high impact energy, a regime with a large increase of the PI depth with impact energy.

corresponding to an impact energy level of 14.2 J. A stabilization of the PI depth is observed until 18.1 J of impact energy. The PI depth finally further increases significantly reaching a value of 144 μm .

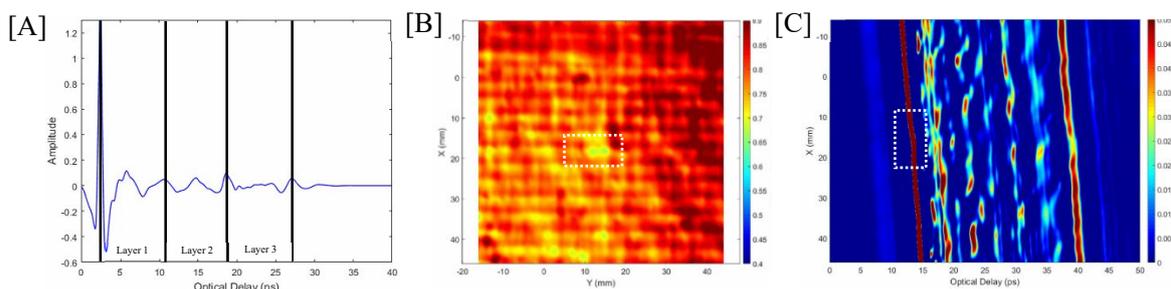
Figure 6: [A] Example of THz signal after a 0.2 THz high pass filter and wavelet denoising. Several echoes corresponding to the interfaces are visible and are indicated by the vertical black lines. The three layers of the sample are indicated on the figure. [B] C-scan based on the amplitude of the first echo (~ 2.45 ps) after spatial averaging. The impacted area is clearly visible in the center. [C] B-scan near PI visible at the coordinates $t = 12$ ps and $y = 18$ mm. All figures were obtained from the sample impacted at 18.1 J. The PI location is indicated by dotted boxes.

An example of recorded signals after processing is shown in Figure 6A. To extract the PI, the time of arrival of the first positive peak is measured as illustrated in Figure 6C around the coordinates [12 ps 18 mm] of the PI. Visualizing the impacted area from the C-scan of the top surface can help to narrow the investigated area (see Figure 6B). The contrast mechanism chosen is the amplitude of the first positive peak in the reflected signal, which has the highest amplitude due to the large refractive-index mismatch between air and the composite matrix. Thus, the C-scan shown using this contrast mechanism provides information about the sample-surface morphology. An example of the procedure to extract the time of arrival from the THz data is depicted in Figure 7. First, a linear-regression algorithm is used on the first peaks at the ends

~~The same signal processing method, described in Sec. 3.2, is used in this part for THz data.~~ When examining a typical B-scan (Figure 6C), evidence of individual plies from reflections (echoes) due to refractive-index mismatch between the matrix and the fibers determined by the Fresnel coefficients. In addition, there is a 4.1 mm long periodic increase of the amplitude along each layer for a fixed optical delay. This is due to the 2/2 twill weave architecture of the woven-fabric layer as this length scale corresponds to the yarns' diameter. Indeed, the intersection between the 0° and 90° yarns will create a local refractive-index mismatch between the matrix and the fabric reinforcement bringing about a local increase of the amplitude. It means that even in the absence of PI or internal damage, the composite microstructure induces a complex THz B-scan that can be difficult to interpret and analyze. Consequently, analyzing the internal damage in this material requires a thorough examination with respect to a reference configuration of an undamaged sample.

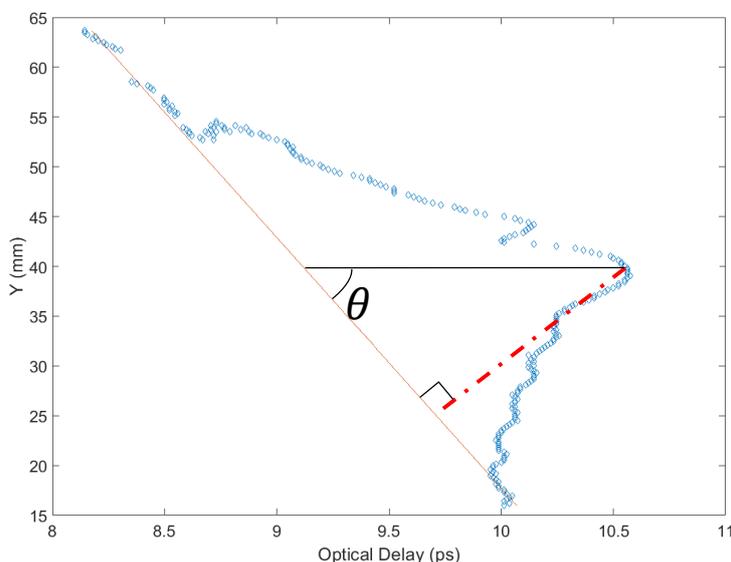
Figure 7 : Linear PI-depth regression plot on a B-scan at $x = -15.5$ mm of a sample impacted at 25 J with example of PI depth. The solid red line is the nonimpacted sample surface obtained by regression. The red dotted line is the arrival time corresponding to the PI depth for a given point we wish to measure. The black line links this point to the continuous black line, with the y -coordinate constant. The sine of the angle θ times the length of the black line gives the expected time of arrival. This calculation needs to be carried out at all points and all x -slices to find the largest PI depth.

of the surface (not taking into account the PI) to obtain the position of the nonimpacted sample surface, represented as a red continuous line in the figure. Then, the time of arrival differences, between all the positive first peaks of the entire sample surface and the nonimpacted surface, are calculated. An example of this time difference, for a given first peak, is represented as a dashed red line in the figure. The black line links this first peak to the point on the nonimpacted sample surface sharing the same x coordinate. This time difference is calculated as the sine of the angle between the nonimpacted sample surface and this black line θ times the length of the black line. Finally, all PI depths of each B-scan are compared to determine the largest indentation depth. All the PI measured are shown in Figure 5. Good agreement with the results from optical profilometry is observed, establishing the suitability of the THz imaging as a resolved measurement of the PI.

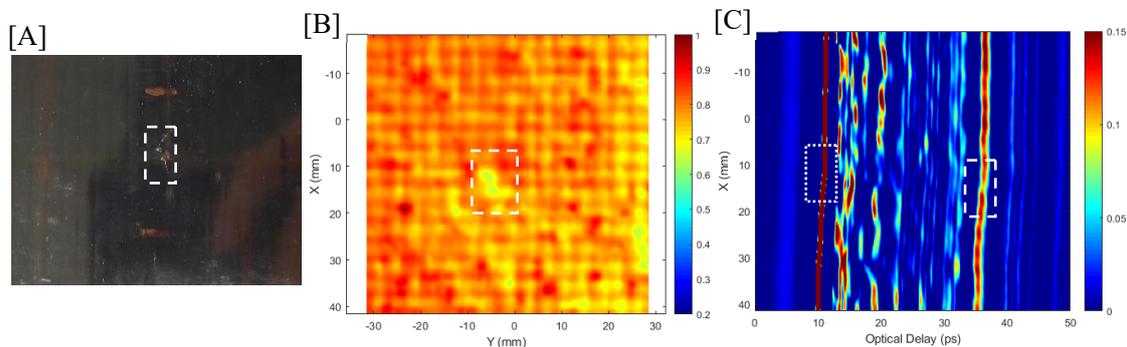
Figure 8: Analysis of the sample impacted at 14.2 J. [A] Photograph of the nonimpacted surface showing matrix cracking within dashed box. [B] THz C-scan of the non-impacted surface of the sample. Matrix cracking is visible as a decrease of the amplitude. [C] THz B-scans of the sample. The damage mechanisms are indicated as follows: *dotted box*: PI, *dashed box*: cracking of bottom surface.

With the exception of creating a PI on the impacted surface, the lowest impact energies do not induce discernable damage within the samples; nothing is visible either in the THz or X-ray tomography results. In increasing the impact energy, the first damage mechanism is matrix cracking on the surface opposite the impacted side observed after an impact energy of 14.2 J. This is visible in X-ray tomography but also visually on the sample (see Figure 8A). In the THz B-scan (see Figure 8C), matrix cracking appears as a local decrease of the amplitude of the echo corresponding to the matrix/air interface (near 37 ps). This cracking is also visible in the THz C-scan of the nonimpacted surface in Figure 8B. This can be explained by THz scattering due to the enhancement of surface inhomogeneity ensuing matrix and fiber crack propagation to the surface [37]. When analyzing the image of the interior plies, no additional damage is immediately evident.

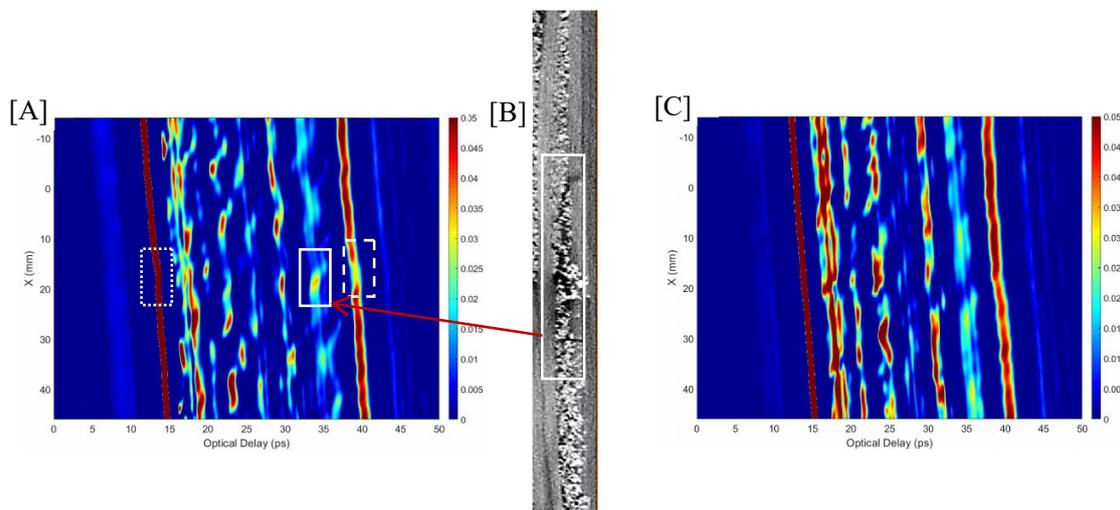
Figure 9: Analysis of the sample impacted at 18.1 J. [A] THz B-scan at impact location. [B] X-ray tomography image of the third layer near the impact location with a visible delamination. [C] Typical THz B-scan representation of an undamaged sample for comparison. Various damage types are visible: dotted box: permanent indentation (PI), dashed box: cracks on the bottom surface and continuous line box: delamination in the third layer.

When the impact energy reaches 18.1 J, additional damage mechanisms come into play, the accumulation of which leads to the initiation of delamination. The latter is clearly visible in the third ply of the sample by X-ray tomography in Figure 9B. Indeed, this delamination originates in matrix cracking on the nonimpacted surface and is created by an increase of bending, leading to the propagation of the cracks within the material. The same location is analyzed using THz B-scans in Figure 9A. Similar to Figure 8, the PI on the top surface and the matrix cracks on the bottom are observed. Moreover, in the third layer, there is a local increase of the amplitude around 35 ps and $x = 20$ mm. This increase of the amplitude is located just below the matrix cracks indicating that it results from pseudo-delamination in the third layer of the sample. Indeed, the delamination creates a new air/matrix interface at this location, which results in a new echo in the reflected signal [37]. A typical B-scan of a nondamaged sample is shown in Figure 9C for comparison. As already mentioned, the interpretation of the results can be arduous due to the interaction of the THz beams with the structure of the woven fabric creating amplitude variations along a layer. Nevertheless, these observations highlight and assess the capability of THz imaging to detect internal damage even in a composite material exhibiting complex microstructure such a woven fiber composite laminate.

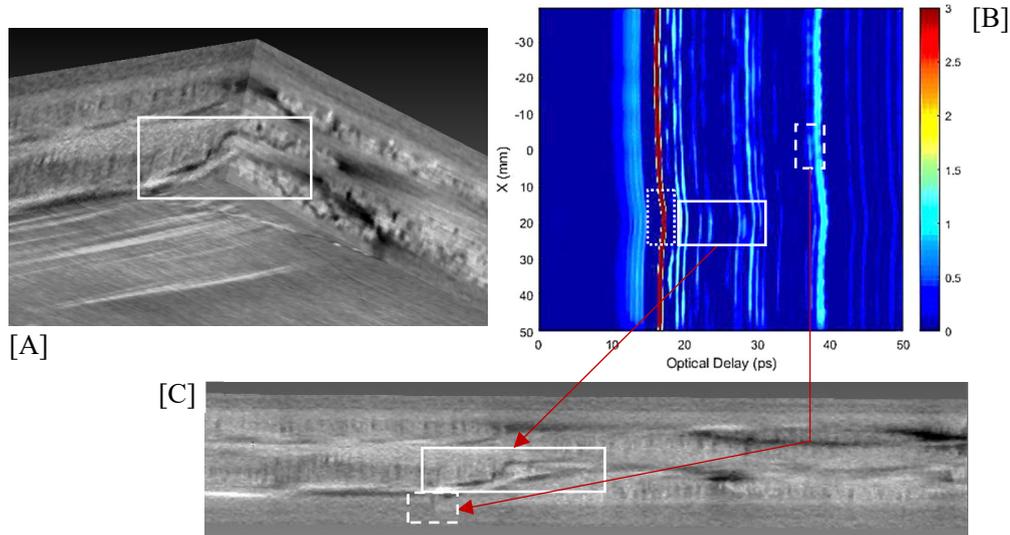
Figure 10: Analysis of the sample impacted at 23 J. [A] X-ray tomography image of the interior of the sample with the propagation of a crack to the second ply. [B] THz B-scan near the impacted region. [C] X-ray tomography image near the impacted region. Multiple damage types are visible: dotted box: Permanent Indentation (PI), dashed box: cracks on the bottom surface, and continuous line box: delamination in the third layer.

For an even larger impact energy of 23 J, a crack network starting from the non-impacted side propagates until the second layer of the plate. This is visible in X-ray tomography and boxed in white in Figure 10A and C and. It is the only crack network detected from the X-ray investigation and is located near the impacted region, as expected. This highlights the fact that the damage mechanisms are strongly concentrated near this region.

The propagation of the damage area is also detected from the THz images (see Figure 10B). The impact region is clearly visible around 17 ps and $x = 20$ mm. The small delamination near the nonimpacted side appears as a local increase of the amplitude (white dashed box). Similar local increases of the amplitude in the second layer (continuous-line box) are noticed. As the impact energy is important, the deformation of

layer is also visible inside of the material and not only in the surface. It appears as ripples in the white box in the Figure 10B.

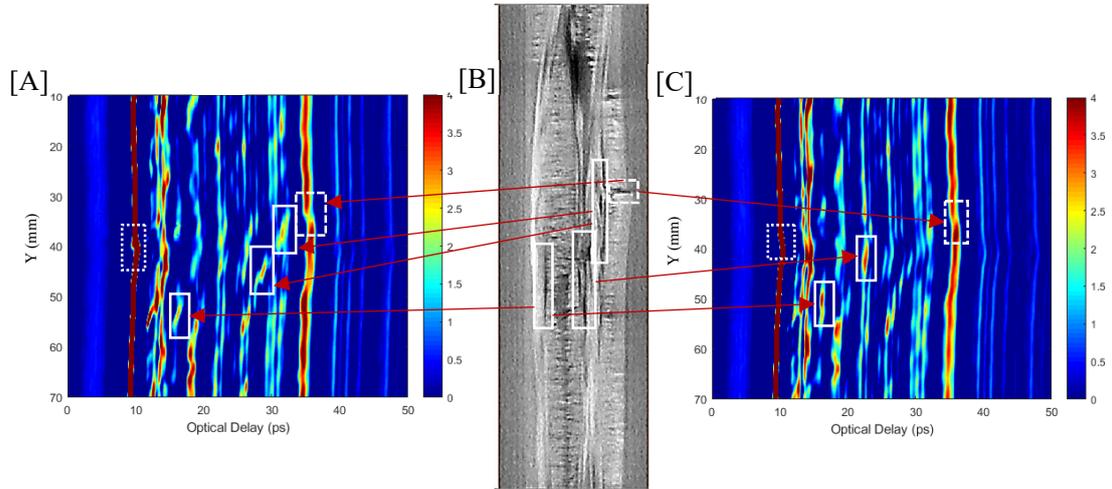
Figure 11: Analysis of sample impacted at 25 J. THz B-scan near PI at [A] $x = -15.5$ mm and [C] $x = -17.28$ mm. Some delaminations are more visible in one or the other B-scans. [B] X-ray tomography image of the damage mechanisms near the PI. Delamination and matrix cracking propagate in all layers. Various damage types are visible: *dotted box*: permanent indentation (PI) + matrix cracks, *dashed box*: cracks on the bottom surface, and *continuous line box*: delamination.

Finally, for an impact energy of 25 J, the damage propagates further and reaches the third layer, as seen in X-ray tomography in Figure 11B and in Figure 12B and C. In these figures, matrix cracking and delamination are visible in various layers and are connected with each other, indicating again matrix cracking, originating from the non-impacted surface, and propagating toward the impacted surface. This is especially visible in Figure 12B. In addition to the PI, matrix cracks appear on the impacted surface and are especially visible in Figure 12B and C.

From the THz B-scans, delamination can also be detected between various layers. They appear as several local increases of the amplitude, highlighted by the continuous-line boxes, in Figure 11A and C and in Figure 12A. As the damage path does not propagate within a single cross-section of the material, THz B-scans at $x = -15.5$ mm and -17.28 mm, are plotted in Figure 11A and C, respectively. The internal damage area follows the same path as in the X-ray tomography of Figure 11B. Matrix cracking on the nonimpacted surface again appears as an amplitude decrease (near 34 ps). Matrix cracking on the impacted surface also occurs; however, as the first echo is large in amplitude, it appears saturated in the figures. Similar observations can be made from the THz B-scans of Figure 12. The matrix cracks and the delamination propagating from the nonimpacted surface to the other are detected, as well as the matrix cracks near the two outer surfaces of the sample.

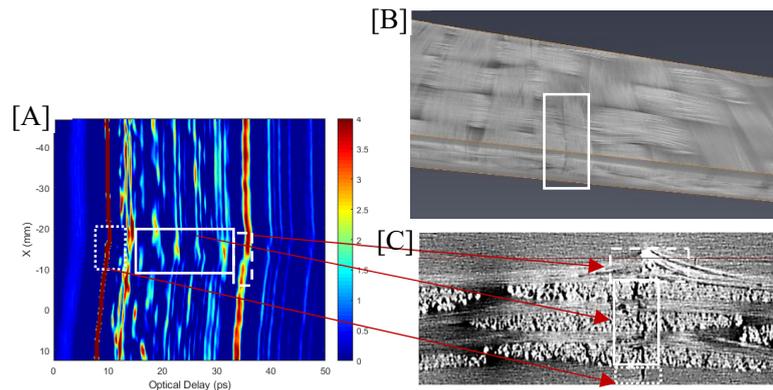
Figure 12: Analysis of the sample impacted at 25 J. [A] THz B-scan at near the impacted region. X-ray tomography image of the matrix cracks running from the non-impacted surface to the other in 3D [B] and in a longitudinal slice [C]. Various damage types are visible: *dotted box*: permanent indentation (PI) + matrix cracks, *dashed box*: cracks on the bottom surface, and *continuous line box*: delamination.

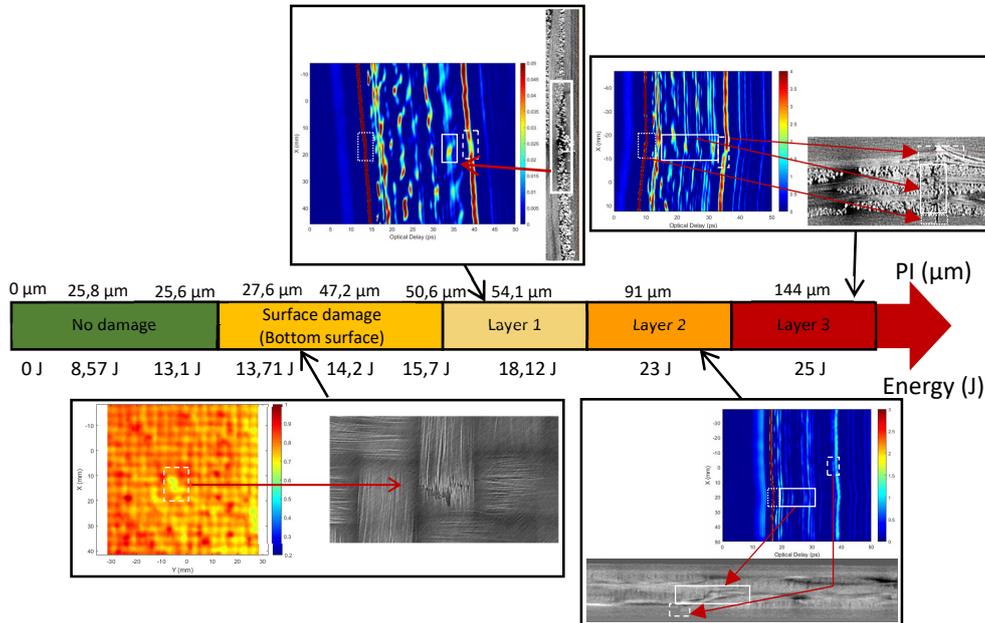
Figure 13: Summary of the proposed damage scenario for the studied material when undergo impact event. The propagation of damage through the sample are indicated. The impact energy as well as the PI depth are also given

With THz imaging, the damage initiation and propagation can be observed, which allow to determine the following scenario of the progressive material degradation. All the chosen impact energies lead to the generation of a PI on the impacted surface. From 8.5 to 13.7 J, no additional damage has been generated. When reaching 14.2 J, matrix cracking is visible on the non-impacted surface, a significant increase of the PI depth is also noted. As expected, the size of the matrix cracks increases with impact energy. In this impact-energy range, PI depth also gradually increases. For an energy level about 18.1 J, delamination mechanism is initiated between the surface plies on the non-impacted side. The PI depth is in a stabilization regime until 18.1 J. After this energy level, the PI depth increases drastically with the impact energy, which is consistent with the increase of the observed damage area. Indeed, the crack network propagates deeper

into the sample, along the second (at 23 J) and then the third layer (at 25 J). This damage scenario and the associated impact-energy level, as well as the corresponding PI depths, are summarized in Figure 13.
