USING X-RAY COMPUTED TOMOGRAPHY TO MEASURE FIRE DEGRADATION OF A TIMBER CONNECTION

Quentin Rodrigues¹, Johannes A. J. Huber², Lars Hansson³, Rhoda Afriyie Mensah⁴, Rostand Moutou Pitti⁵

ABSTRACT: The charring behaviour of timber elements under fire is well understood, however, the effects of fire and heat on connections are not equally well known. Timber connections often use steel fasteners, like screws or angle brackets, which conduct heat much better than wood. Moreover, these fasteners lose their mechanical resistance and capacity under elevated temperatures. X-ray computed tomography (CT) can be used to reconstruct the internal structure of wood non-destructively. It should therefore be possible to use this technology to also study the progressive degradation due to fire of a timber connection. The goal of the present study is to investigate how CT can be used to analyse the degradation of a timber connection due to fire. Samples of Norway spruce with self-tapping screws were scanned before and after a fire exposure, and mechanical tests were performed. The results indicate that the degradation due to fire in a timber connection can be observed in CT scans, but that certain

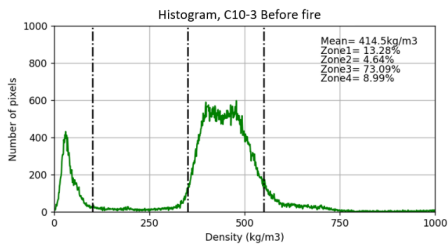
Figure 8: Histogram of the image before fire exposition

shows the histogram of the unburnt sample in Figure 7. The histogram was truncated at 1000 kg/m³ for a better readability, but there was also an additional peak at

4000 kg/m³ caused by the metal of the screw. The histogram was separated into four distinct zones (vertical lines in the figure). We can distinguish two density peaks in

, which were characteristic for unburnt wood: the first in zone 1 around 50 kg/m³ representing air around the sample and covering approximately 13 % of the image, and the second in zone 3 between 400 and 550 kg/m³ representing wood and covering approximately 73 % of the image. The flat area in zone 2 represents approximately 5 % of the image.

thus shifted to lower values due to the charring process and the resulting lower density of charcoal. The greyscale histogram can therefore be used to detect and quantify fire degradation.

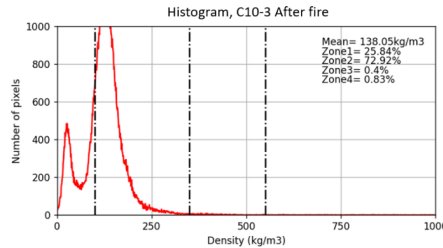
Figure 9 shows the histogram of the sample in Figure 7 that has been fire exposed for 10 minutes, again truncated for density. We are still able to distinguish two main peaks, however, they are now located in zone 1 (26 %) and zone 2 (73 %). The peak around 500 kg/m³ in

Figure 9: Histogram of the image after a 10-minute fire exposure

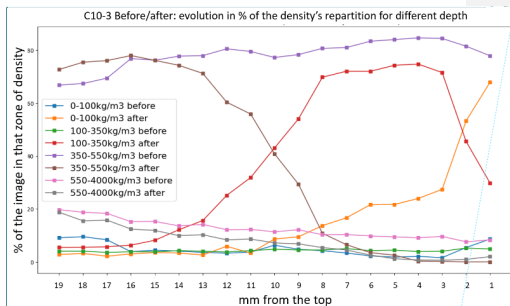
Figure 10 shows this evolution for one representative sample before and after fire exposure along the top 20 mm from the surface exposed to fire. The figure clearly shows a shifting of the density from zone 3 (350-550 kg/m³) to zones 1 and 2 (0-350 kg/m³) when approaching the exposed surface. For the same sample before the fire exposition, we can notice that the zone classification remains constant when traversing the sample. Note also the rise of zone 1 (0-100 kg/m³) close to the top of the sample, which was due crack opening during the burning.

Figure 10: Evolution of density zones on the top 20 mm of the sample, before and after fire exposure

The classification of the pixels according to the four density zones defined above can be used to study the evolution of the distribution in each class in consecutive slices along the CT scan of each sample.

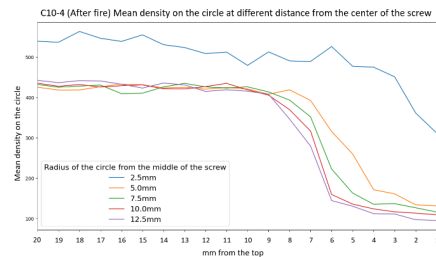
Figure 15 shows the evolution of the degradation around the screw hole on a representative sample after a fire exposure of 10 minutes and where the screw axis was perpendicular to the fibre direction. All curves follow the similar trend as with the screw inserted, and the noise affecting the innermost circle disappeared. Interestingly, the average density on the innermost circle was considerably higher than on circles further away from the hole. This higher density in the immediate proximity of the hole edge can be explained by compression of the wood during screw insertion, which can also be seen in the corresponding scan of the graph in Figure 16.

Figure 15: Graph of density measured on circles around the screw hole for samples after 10 minutes fire exposure and where the screw axis was perpendicular to the fibre direction

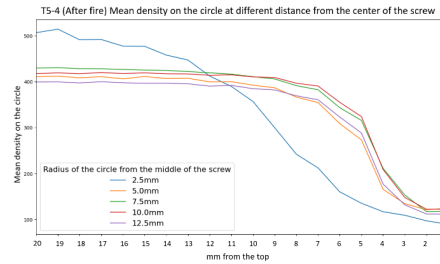
Figure 17 **Erreur ! Source du renvoi introuvable.** shows the evolution of the degradation around the screw hole on a representative sample after a fire exposure of 10 minutes

and where the screw axis was parallel to the fibre direction.

Figure 17: Graph of density measured on circles around the screw hole for samples after 10 minutes fire exposure and where the screw axis was parallel to the fibre direction

In contrast to the perpendicular case, the average density of the innermost circle clearly drops below the density of the areas further away from the hole when approaching the top (burnt) surface, which happens at around 10 mm from the top. This indicates that heat degradation in the screw hole has occurred. The lower density in the hole can also be observed in the corresponding scan in Figure 18.

The observations indicate that the insertion direction of the screw with regards to the fibres could affect the fire resistance of the connection. When the screw is inserted, it densifies the wood around this as such should have a protective effect against charring in the hole. However, for the tests in this study, the charring progressed into the hole more easily if the screw was inserted parallel to the fibre directions. The effect could, however, also have been a result of the different sample geometries for the different insertion directions.

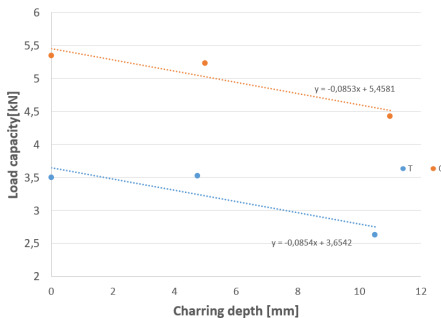
Figure 20 shows the evolution of the load capacity of the connection as a function of the charring depth along the screw. Mean values were used for the figure. Compression and tension samples followed the same trend. Linear regression lines in the figure indicate a negative correlation between charring depth and load capacity.

Figure 20: Evolution of load capacity as a function of the charring depth
