L. Sorrentino, G. Lama, L. Verdolotti, M. Oliviero, Fabienne Touchard, David Mellier, Pawel Malinowski

ASSESSMENT OF THE IMPACT PERFORMANCE OF REPAIRED THERMOPLASTIC LAMINATES

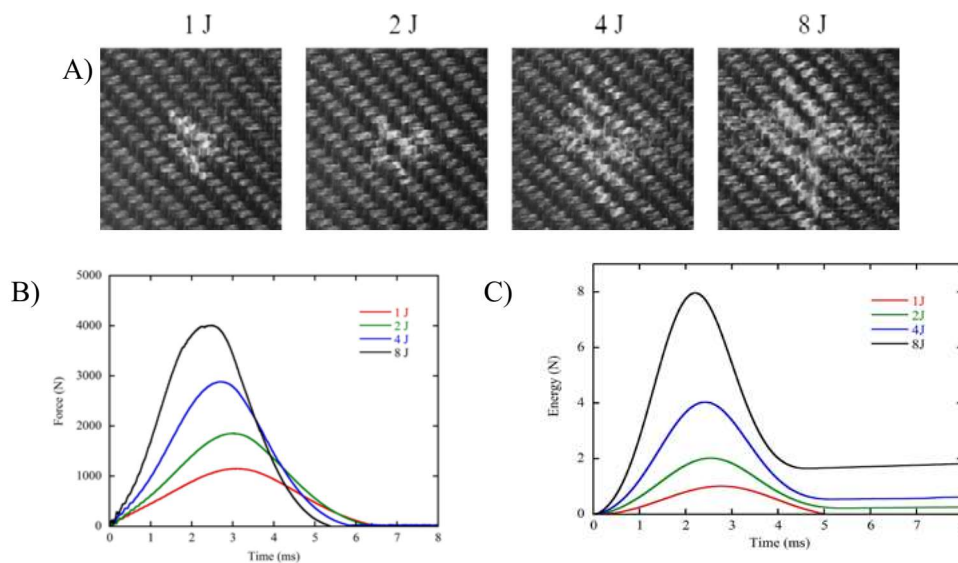
Figure 1. A) Appearance of the impact point at different impact energies; B) Force- and C) Energy-versus time curves as function of the impact energy.

Preliminary impact tests on laminates showed a perforation threshold higher than 8 J, hence that was set as limit for testing. Figure 1A shows the impact points at different impact energies. It is evident the increase in size of the damaged area. The force peak during impacts increased with the impact energy as well (Figure 1B). The widening of damaged area can also be associated with the increased energy dissipation during the impact, as evident from the residual value of the energy-displacement curves, which represent the un-recovered energy (Figure 1C).

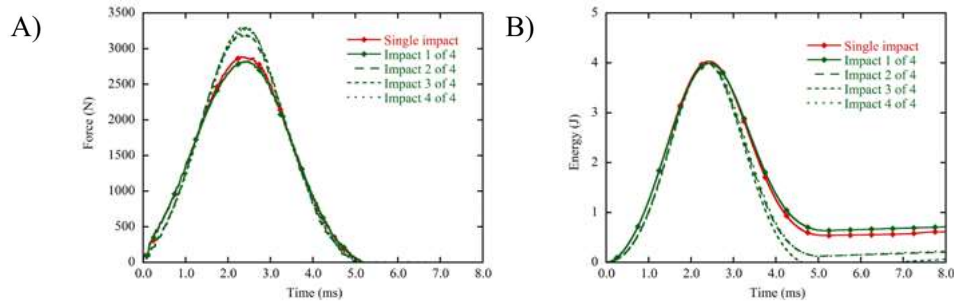
Figure 2. Energy versus time (A) and Force versus time (B) curves after 4 J impacts. Curves from first impacts have a diamond mark.

The plots of consecutive impacts show a peculiar behaviour, because the force peak during the first impact is lower than that detected during the subsequent ones (Figure 2A, impacts at 4 J). Additionally, impacts following the first do not show residual dissipated energy up to 4 J (Figure 2B). This verifies at all impact energy values, and has been related to the fact that irreversible phenomena like matrix cracking and delaminations only occur after the first impact, while the subsequent ones do not induce further significant damages until 8 J is used.

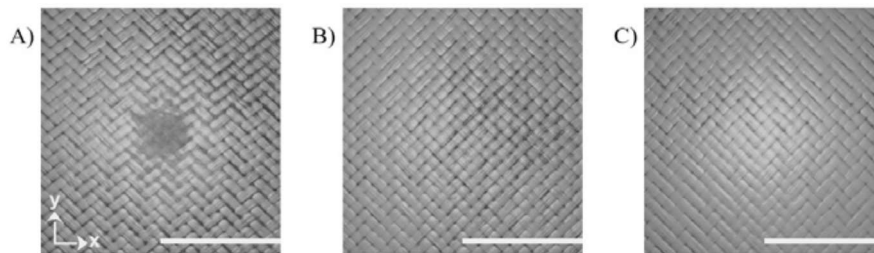
Figure 5. Top surface of microtomographic 3D reconstructions of laminates A) impacted four time at 4 J, b) repaired at 100 °C and c) repaired at 175 °C. White scale bar is 25 mm.

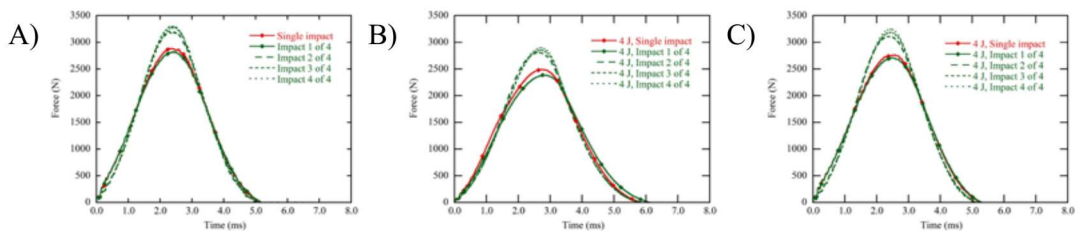
Figure 6. Force versus time curves of laminates impacted at 4 J before and after repairing: A) not repaired, B) repaired at 100 °C, C) repaired at 175 °C.

The second impact testing campaign on the same previously impacted points showed that the laminates repaired at 100 °C were still able to show a good performance but force peak values were significantly lower with respect to the first impacts series. On the contrary, the laminates repaired at the matrix melting temperature showed almost the same performances than before repairing, and this is remarkable when considering the fact that each repaired laminate received on each impact point twice the number of impacts with respect to the not repaired laminate.
